### ADS Emerald Park Landfill Audit Summary

**TO:** ADS Emerald Park Landfill Standing Committee, City of Muskego  
**FROM:** Faith Spear.  
**COPIES:** File  
**DATE:** 10/14/16  
**PROJECT NUMBER:** 1012.10030

**ADVANCED DISPOSAL SERVICES  
EMERALD PARK LANDFILL / CITY OF MUSKEGO  
AUDIT PHOTOS**

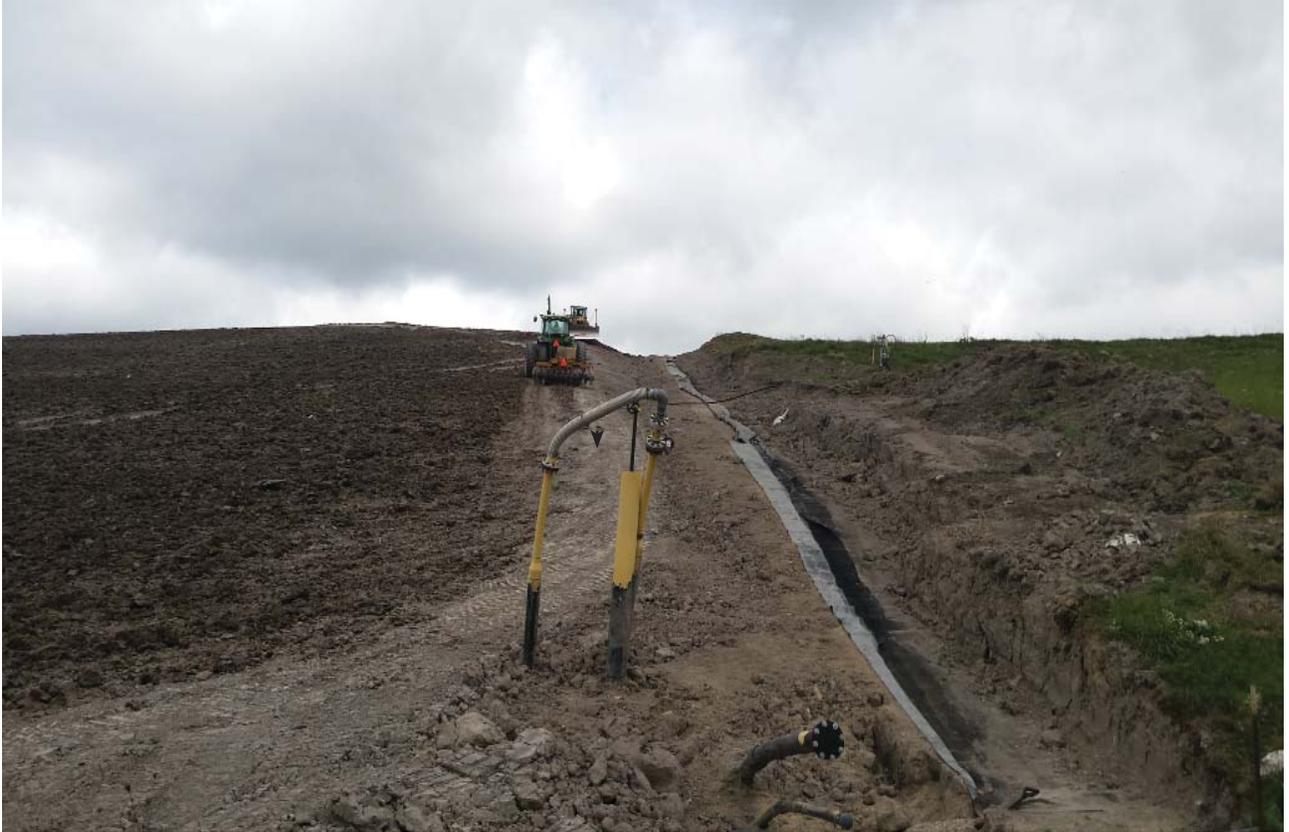
Closure Area IV junction with Closure Area III; equipment working to dry clay

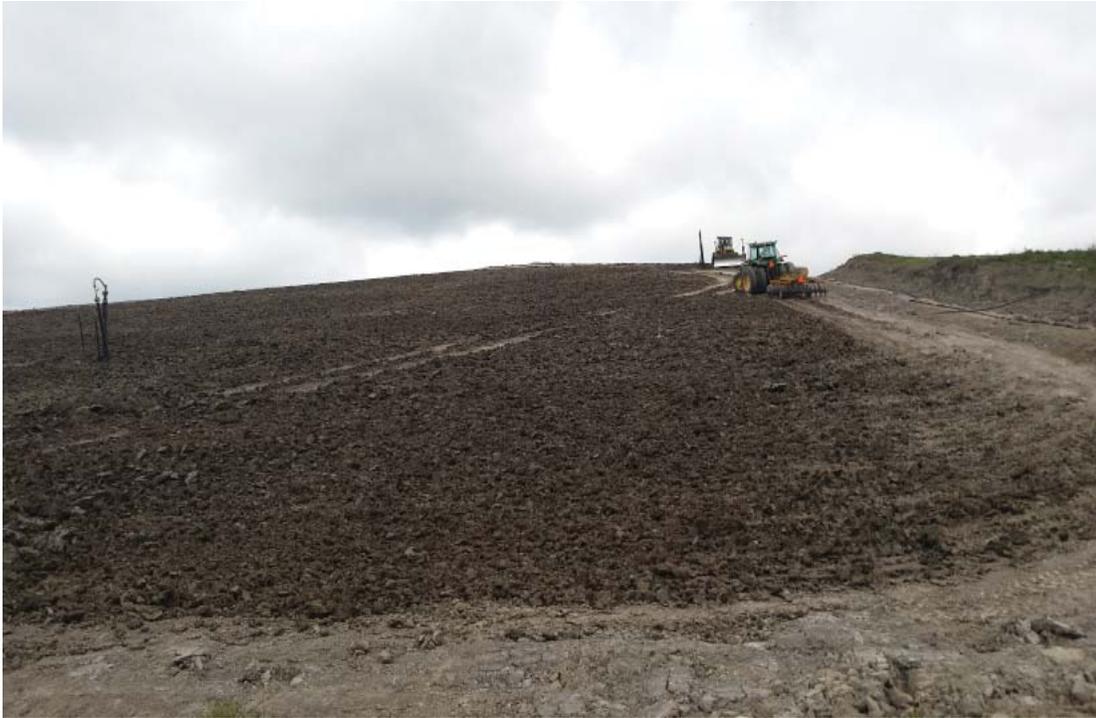
Equipment actively working clay to increase drying speed

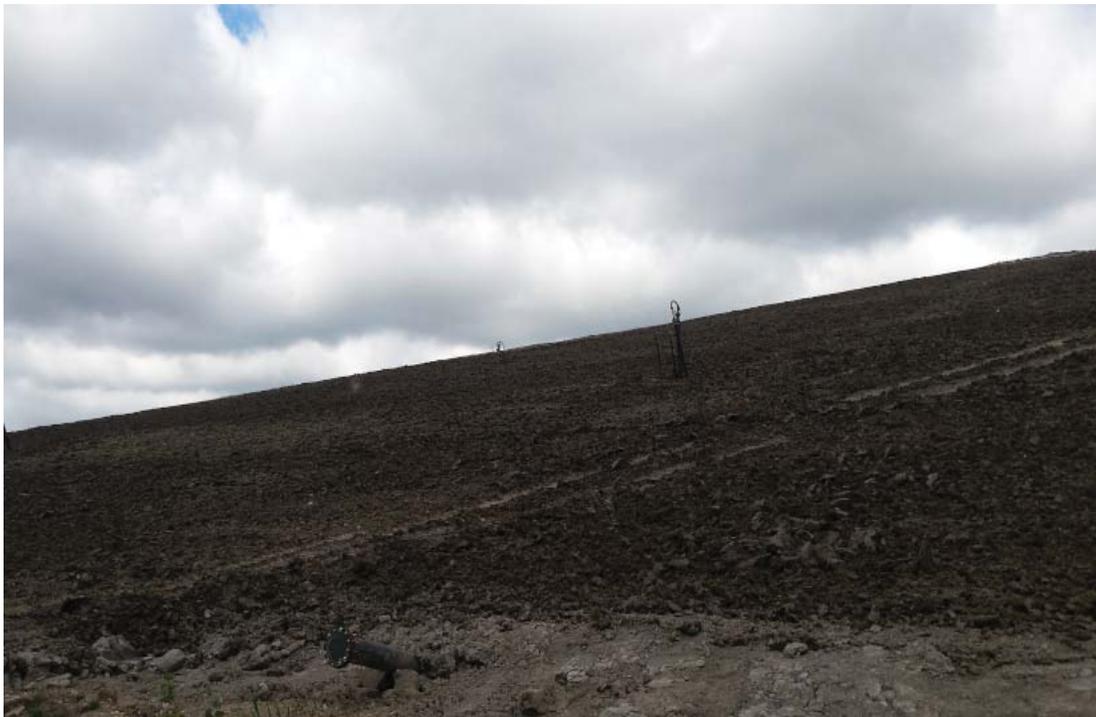
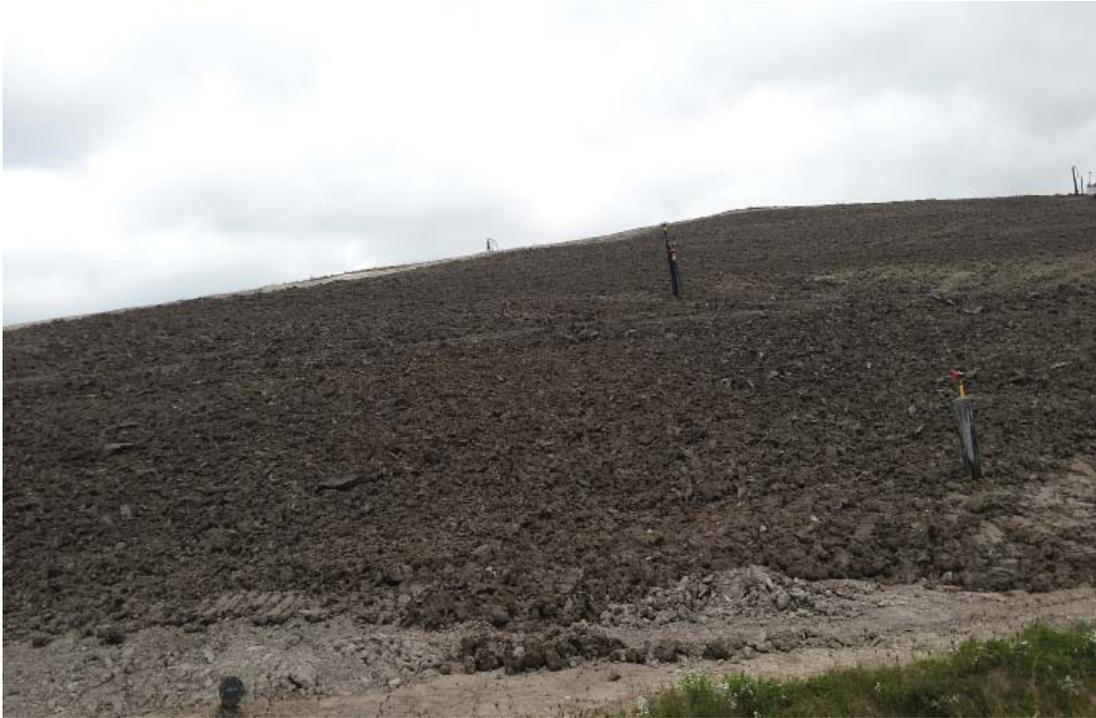
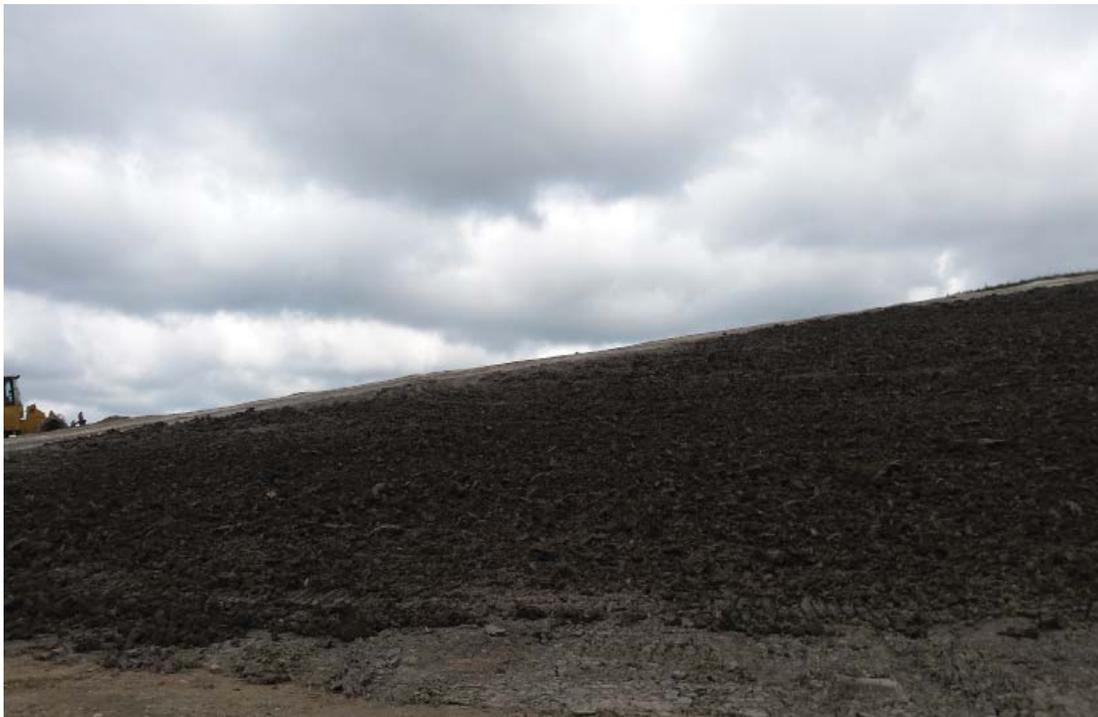
Second clay lift, drying before additional lift placements

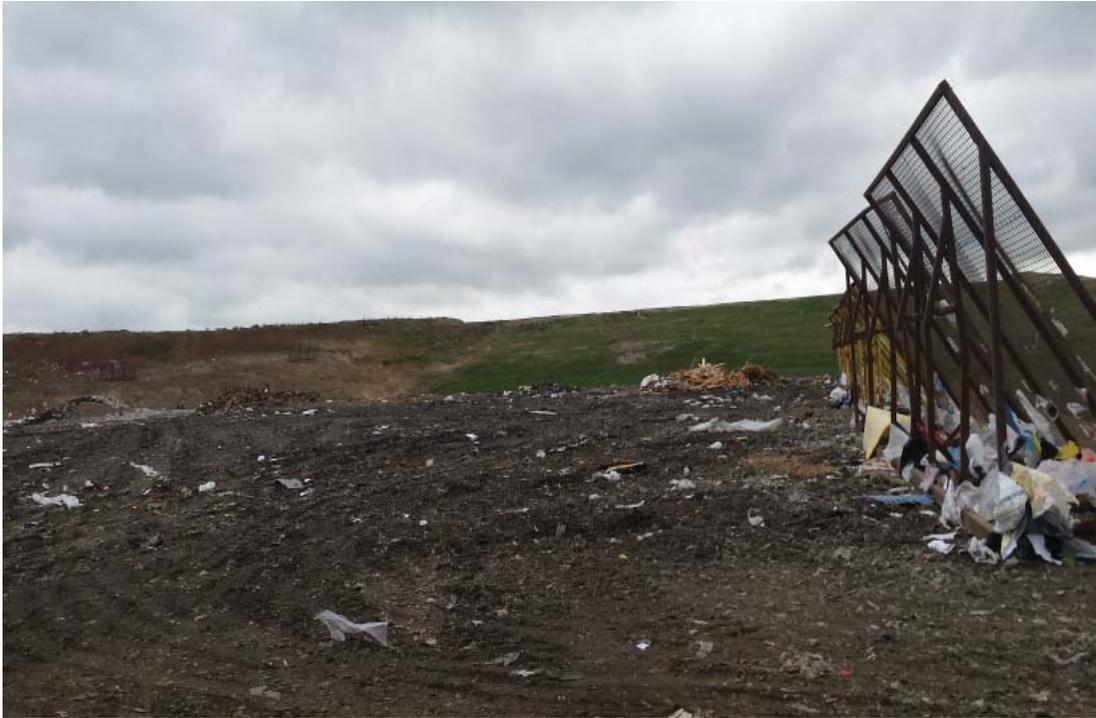
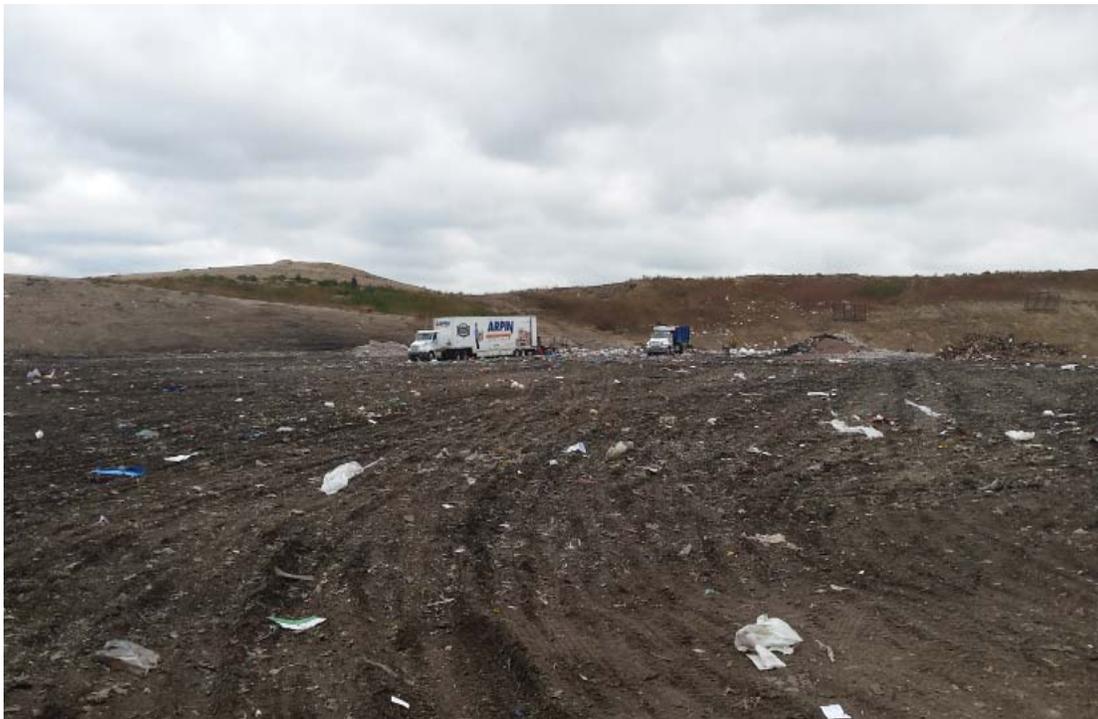
View to the East across Phase 7, active area and working face

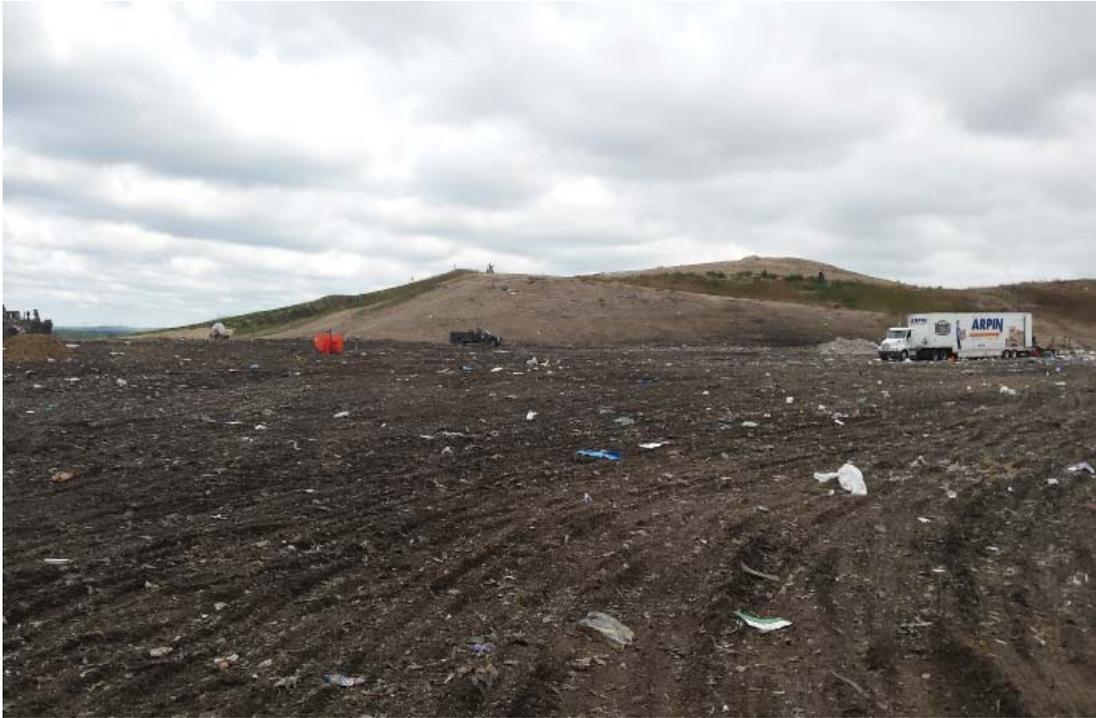
View to the North across Phase 7, active area

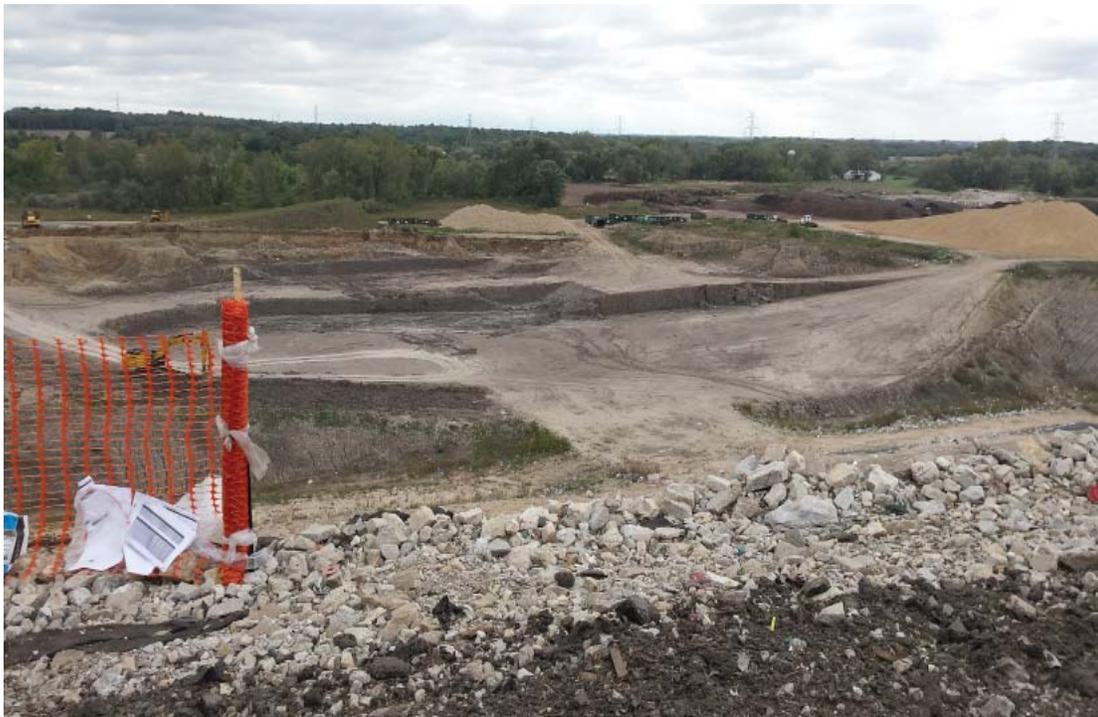
Excavation area South of Phase 7. No excavation today

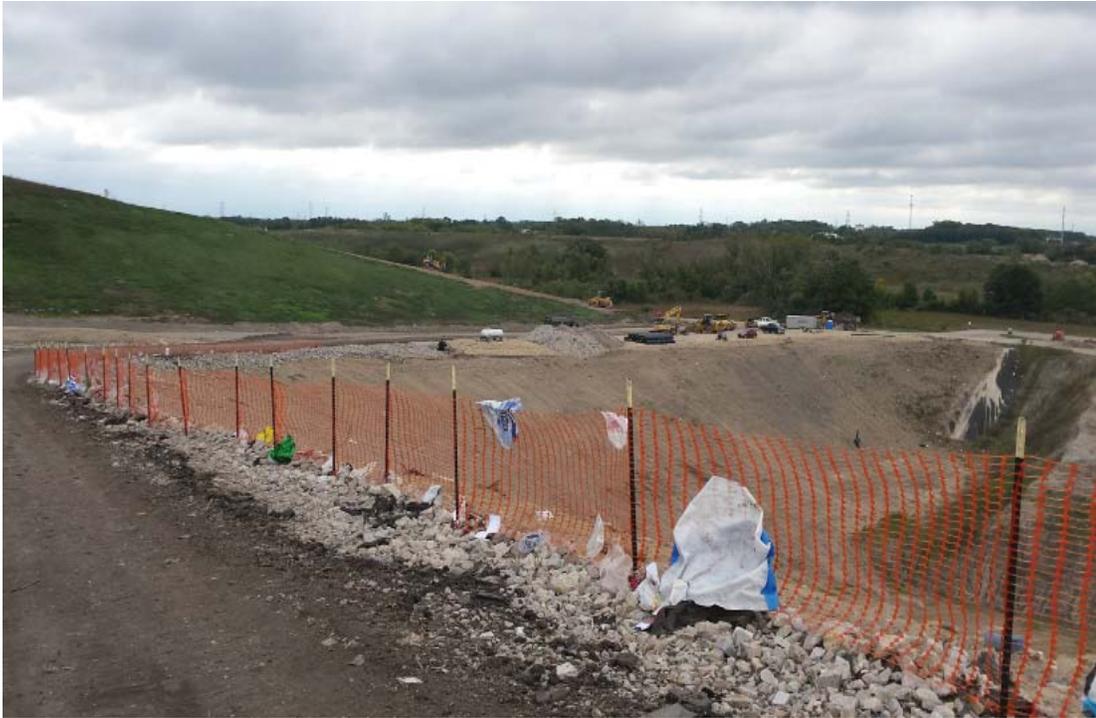
Fencing for litter and demarkation along access into working face in Phase 7

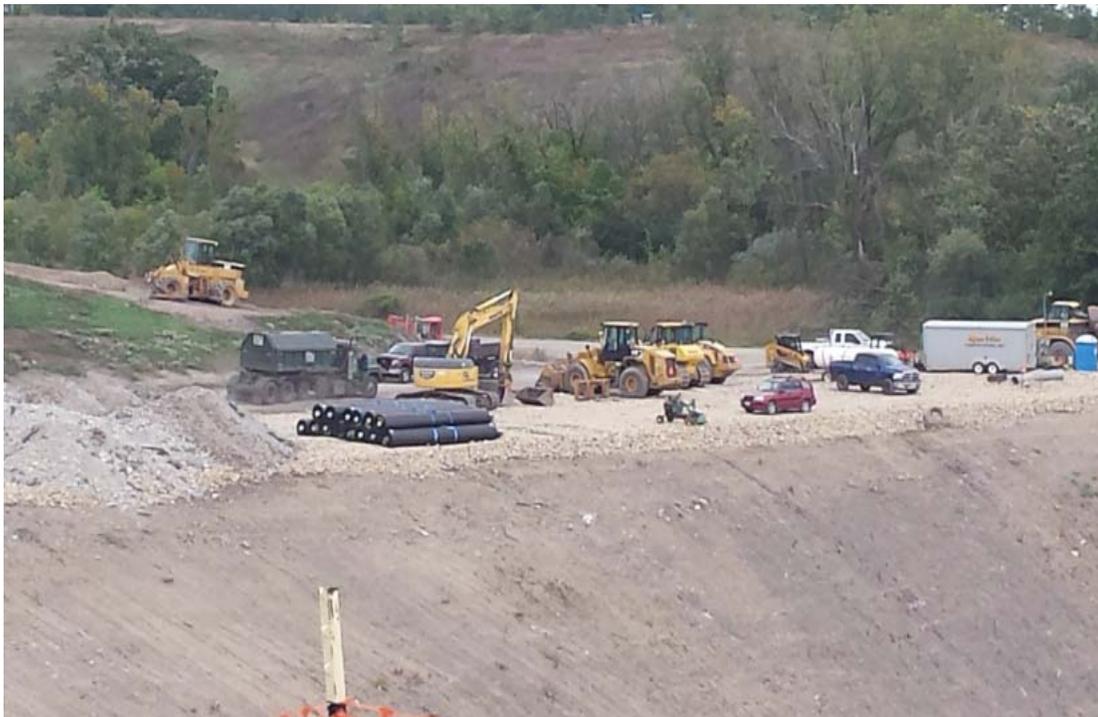
Staged out equipment and materials for Closure Area IV on access to Phase  
7

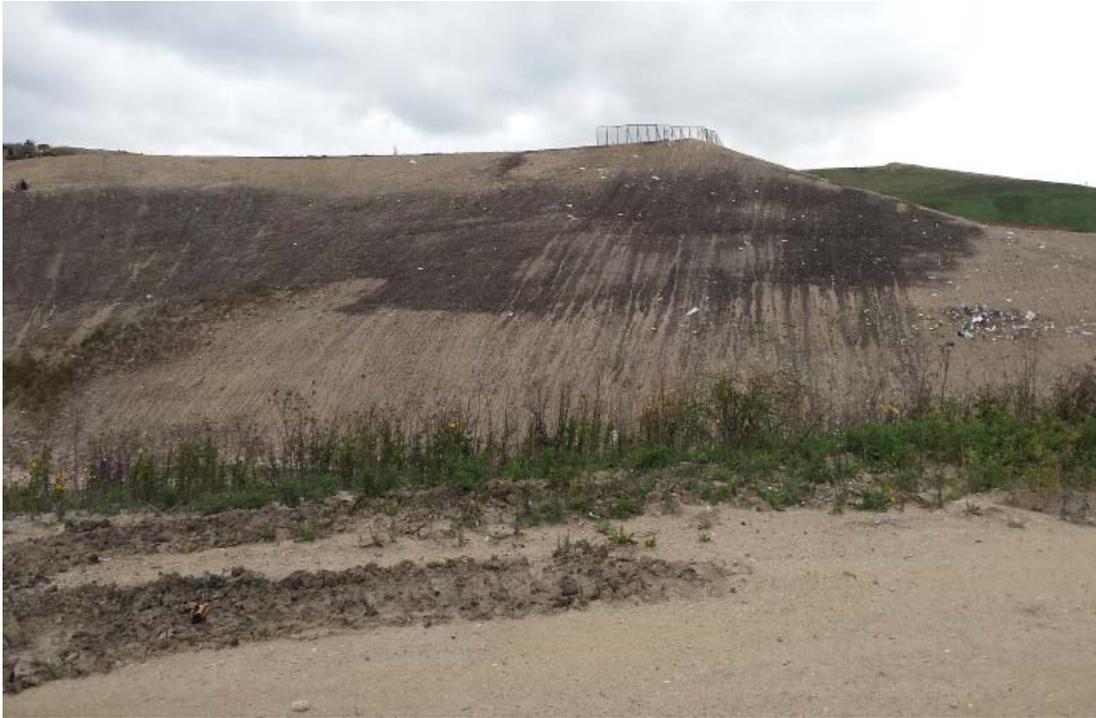
Compost on West slope of Phase 7

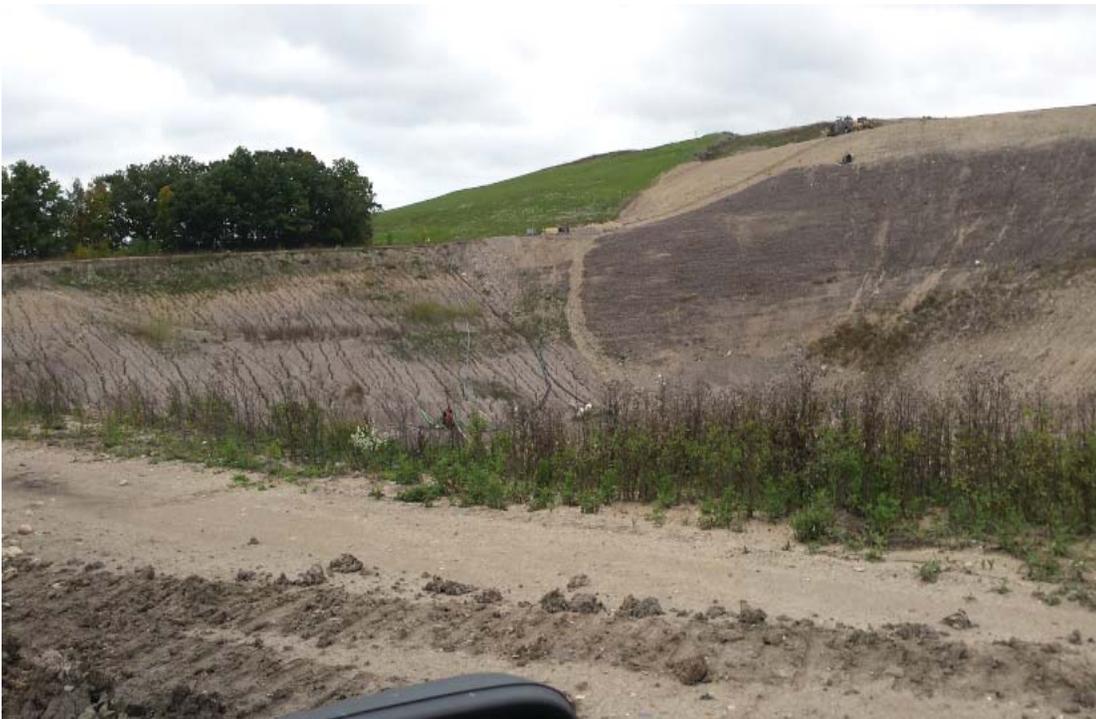
Above temp sed basin, compost cover for vegetation, seeding later in the fall

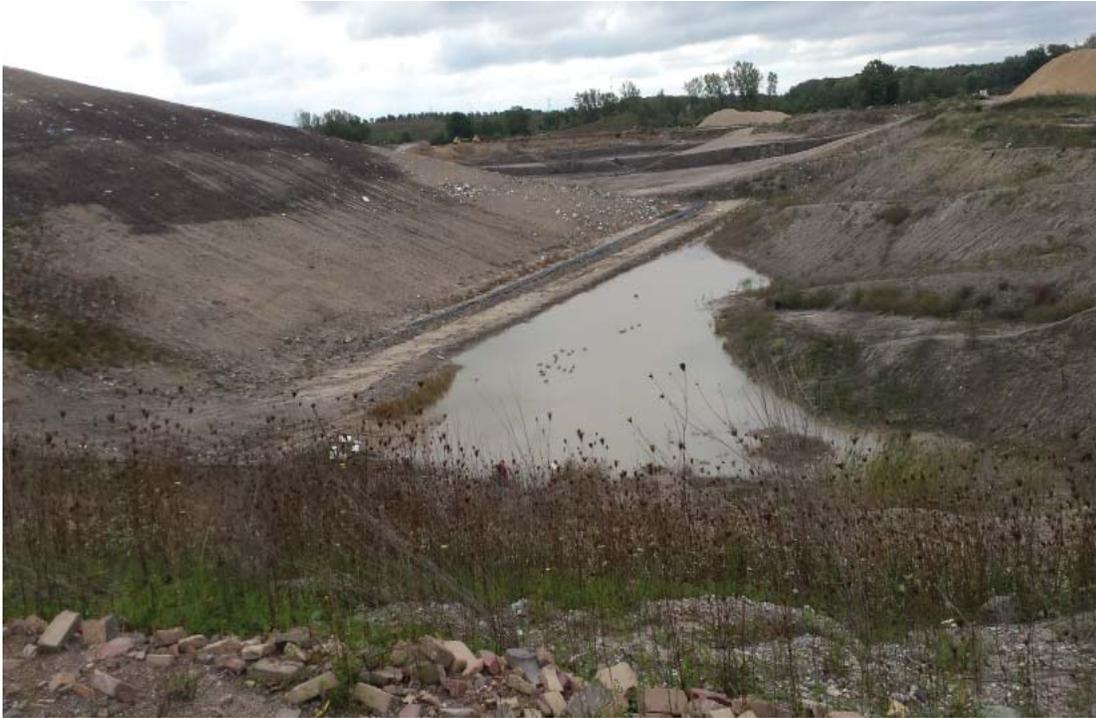
Temp Sed Pond well drained (pumped down) after rain events
