VEOLIA EMERALD PARK LANDFILL  
CITY OF MUSKEGO

## 2010 Veolia Emerald Park Landfill Year End Compliance Officer Report and Audit Summary

**TO:** Veolia Emerald Park Standing Committee  
**FROM:** Jo-Walter Spear, Jr., P.E.  
**COPIES:** File  
**DATE:** 01/20/11  
**PROJECT NUMBER:** 1012

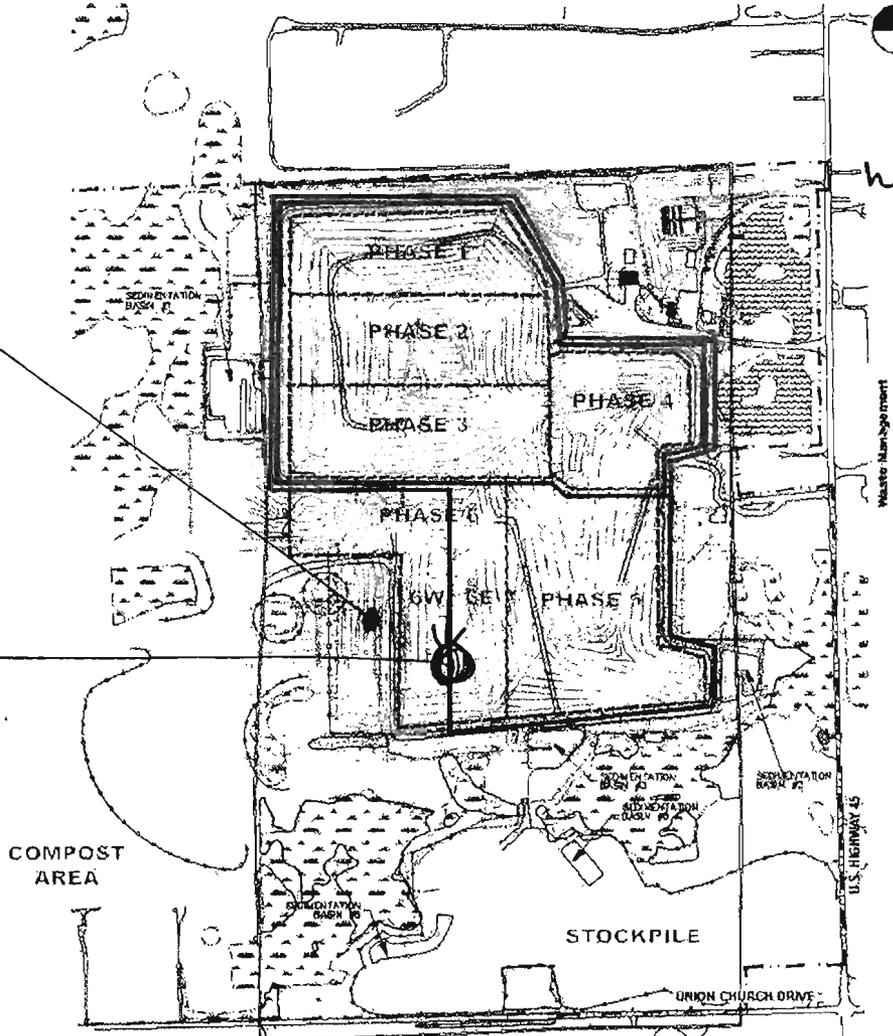
- Seep identified and repaired on West Slope of Phase 6W
  - See photos
- Compost lot gate unsecured with no attendant.

*Small  
Seep.*

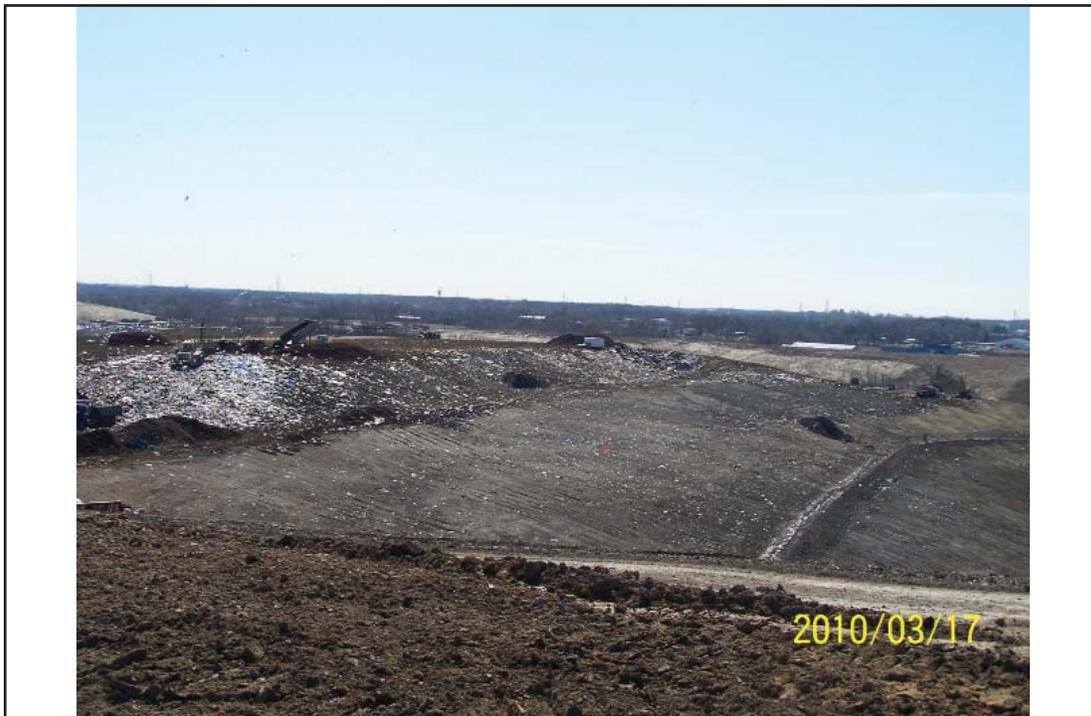
Slope alignment on West slope of Phase 6E to be regraded in dryer conditions

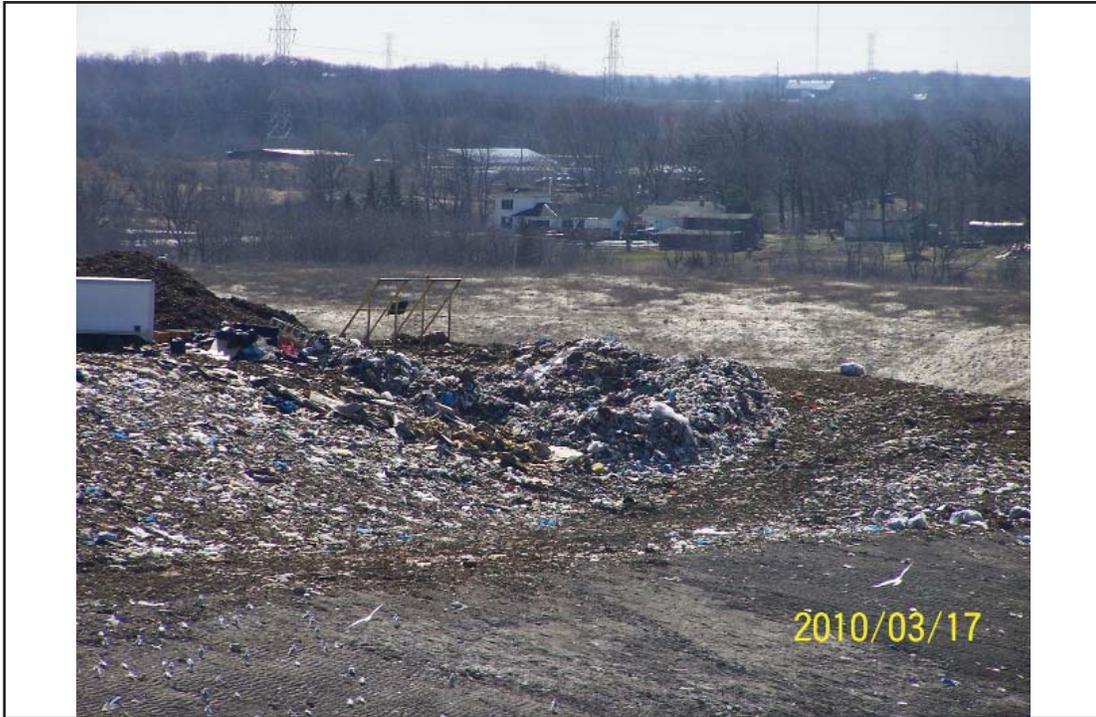
Asbestos pit at South end of Phase 5/6E

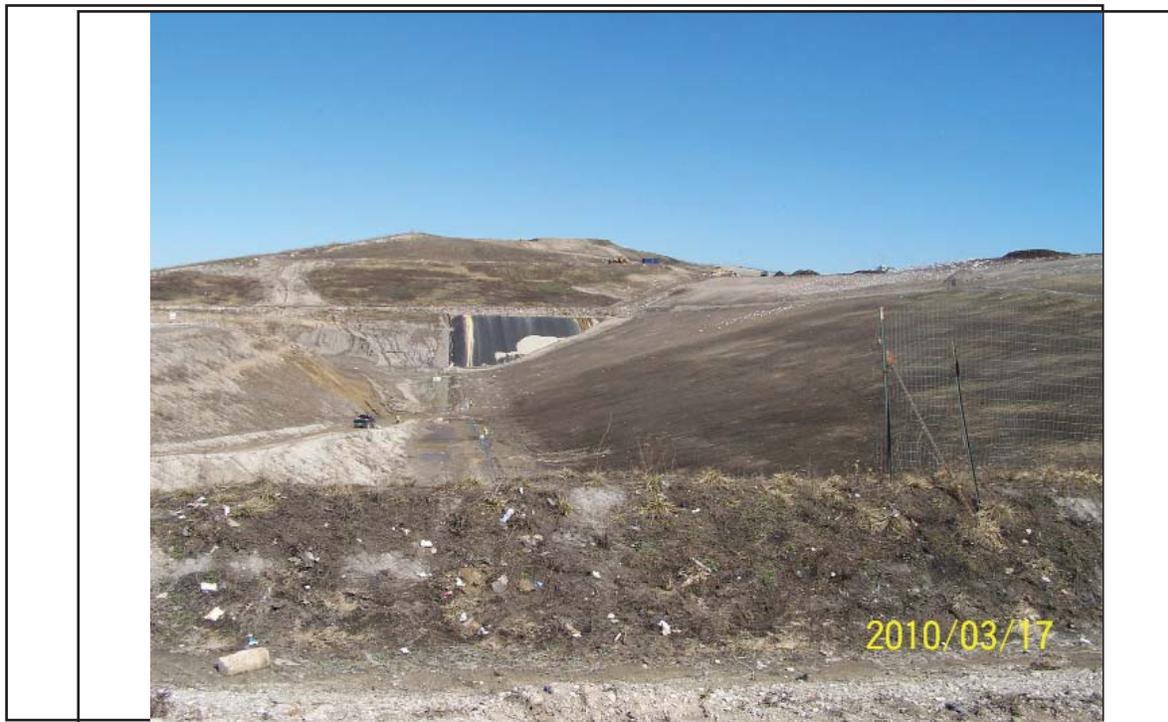
West slope of Phase 6W, temp sed pond being picked during audit.

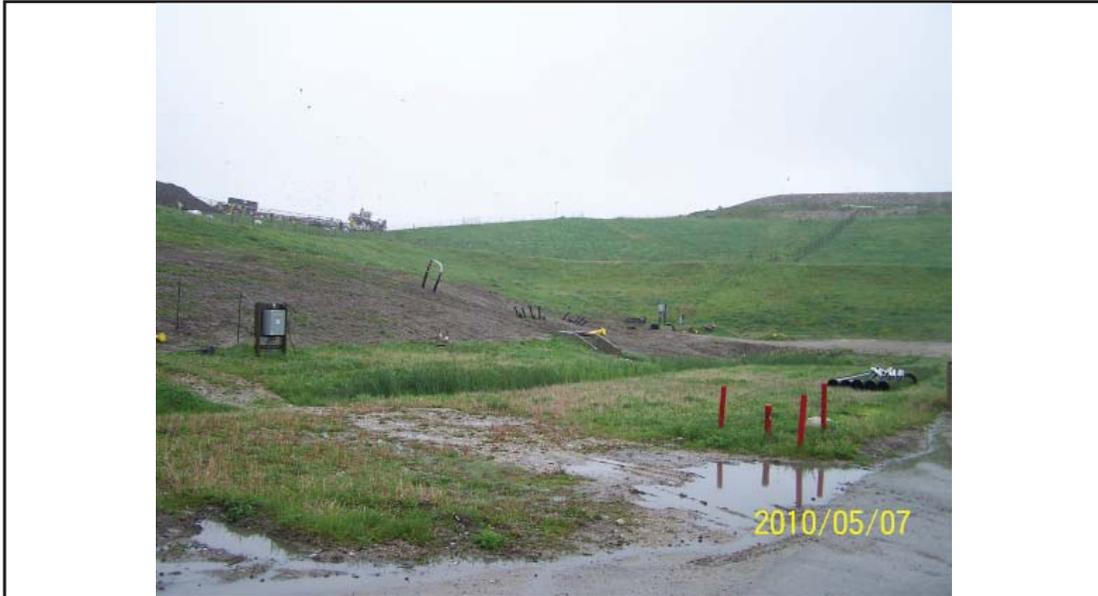
Area at Phase 3/4 junction where header repair occurred

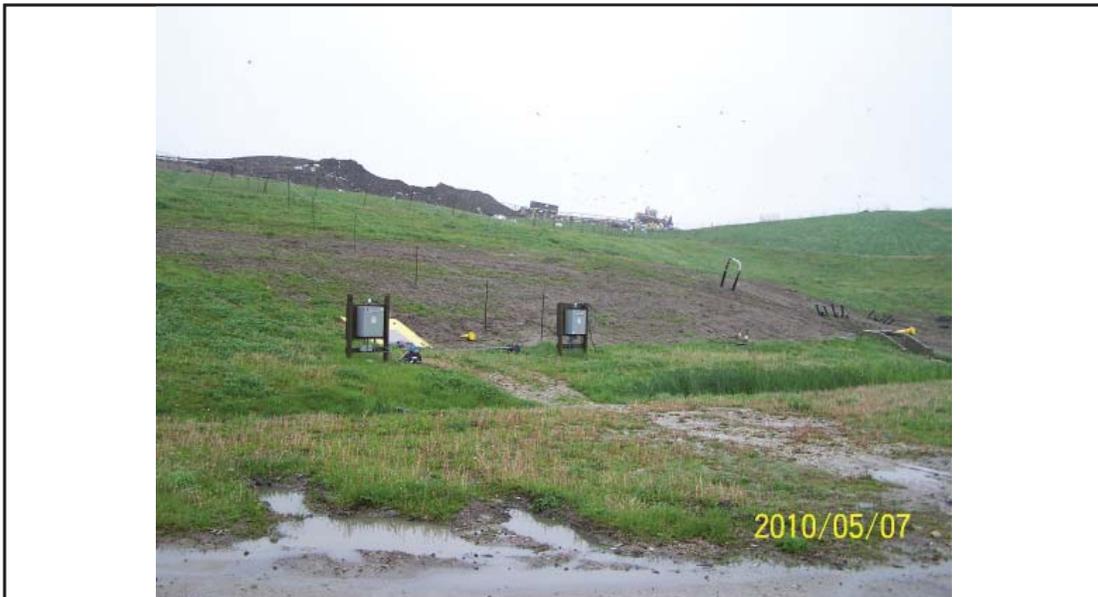
Slope restored, awaiting seeding.

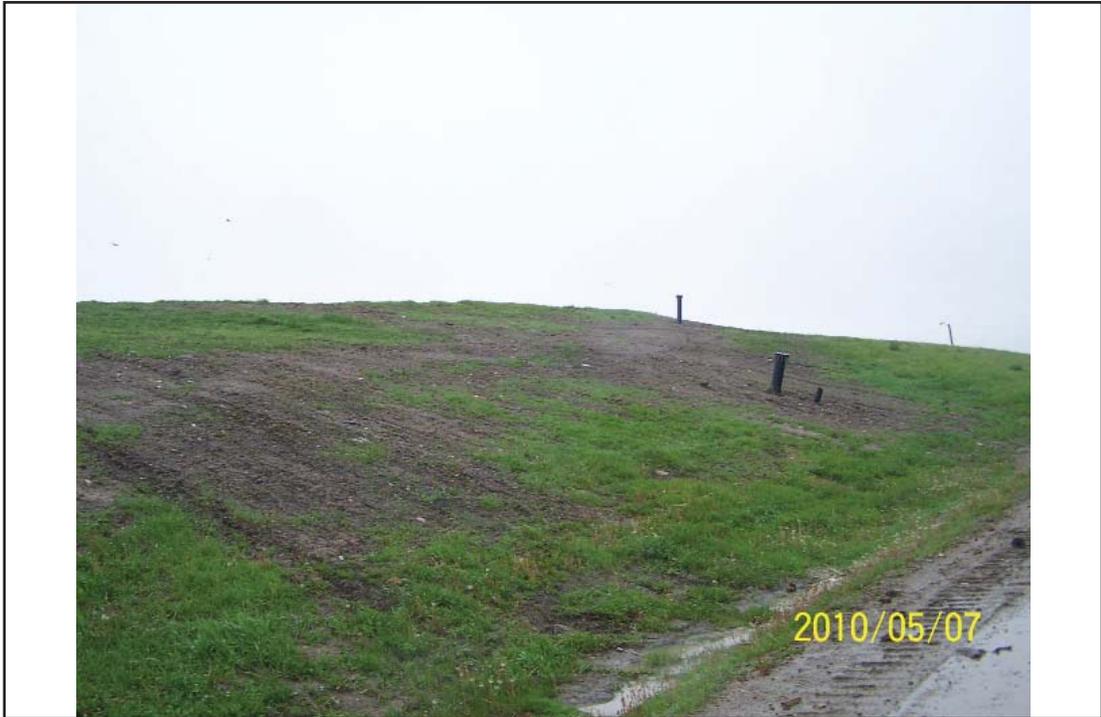
Areas repaired on Phase 4, East slope

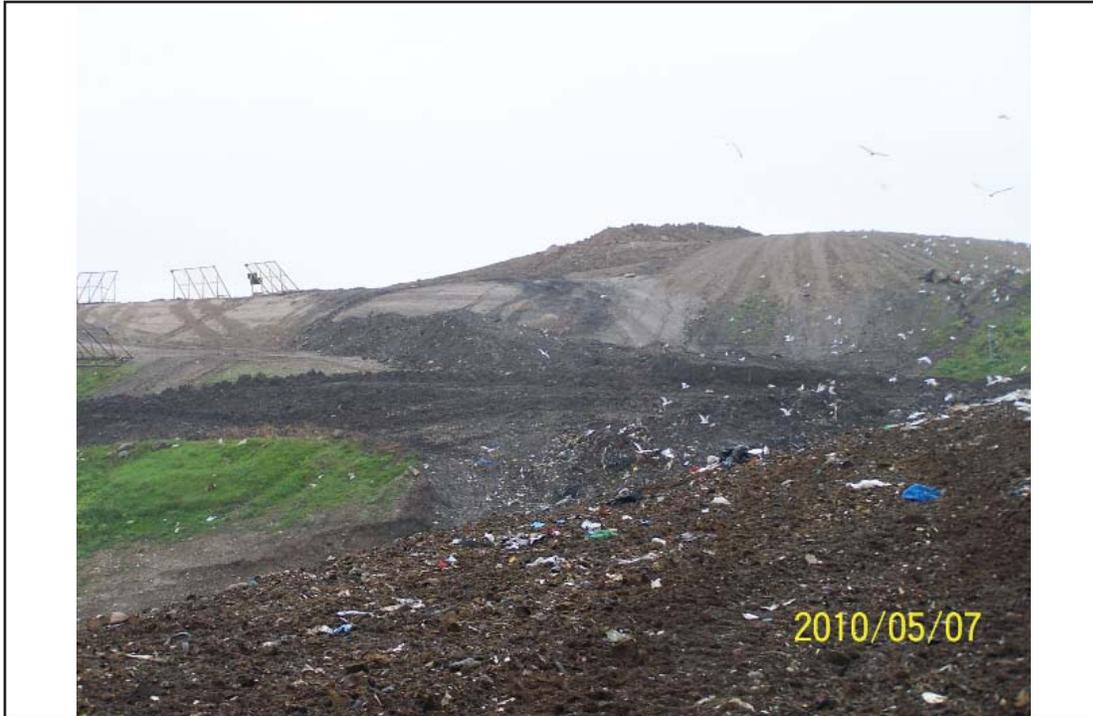
Existing outboard slope conditions

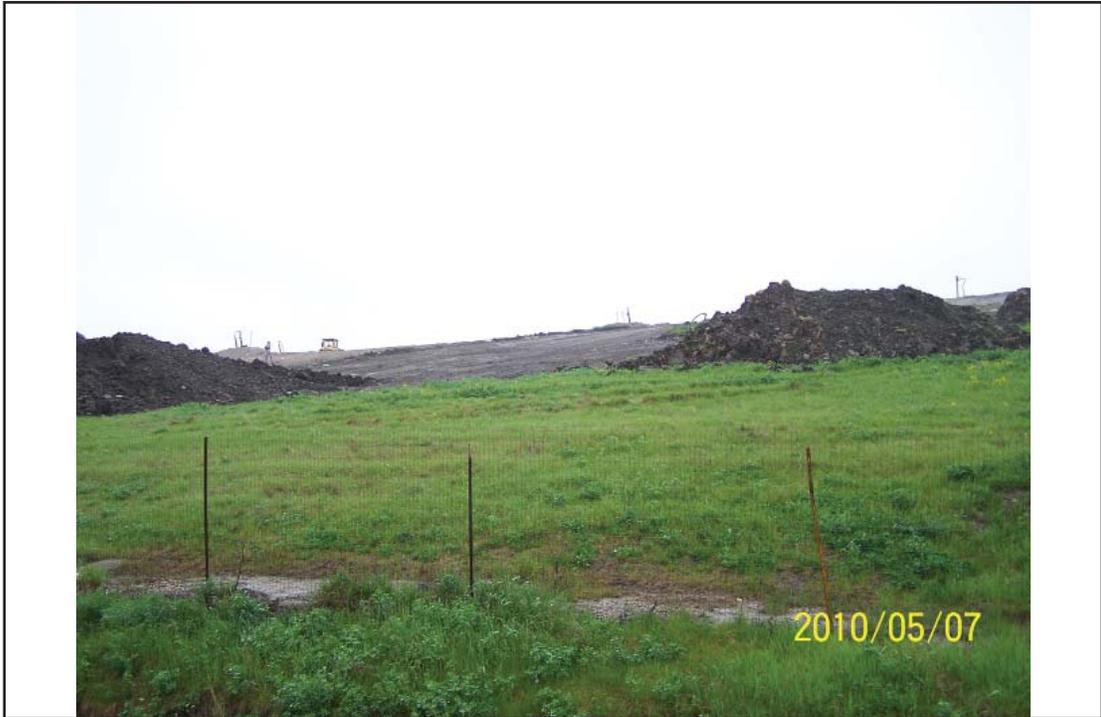
South slope of Phase 5, under repair

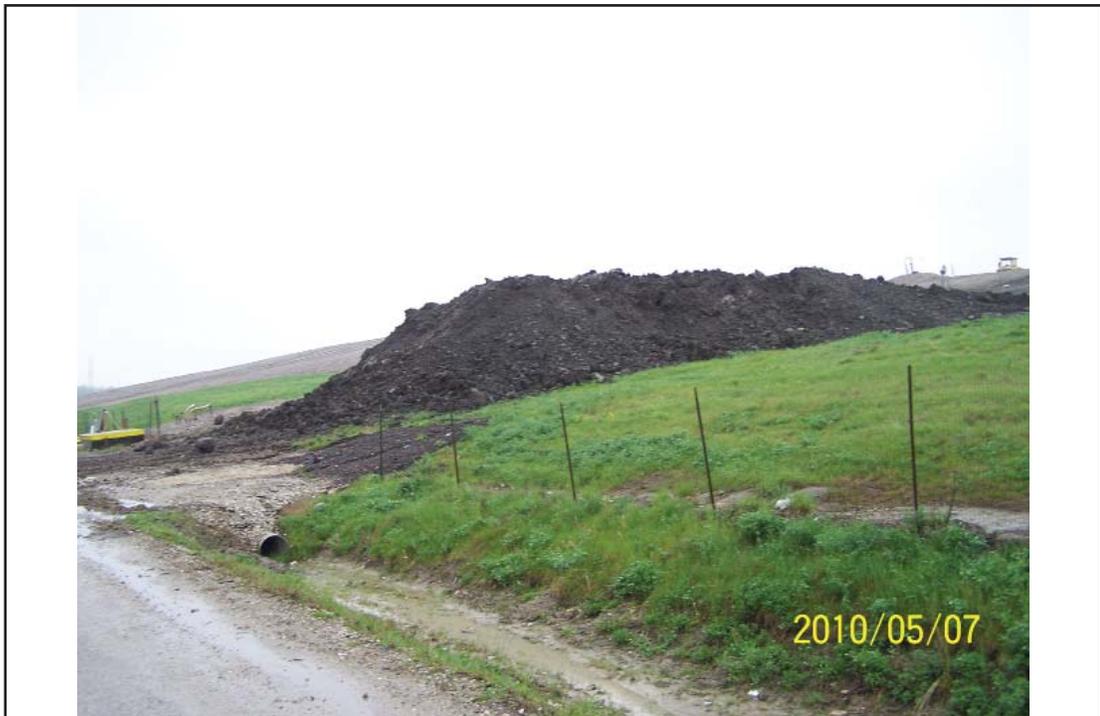
Top soil recovered from slope, stock piled to be replaced

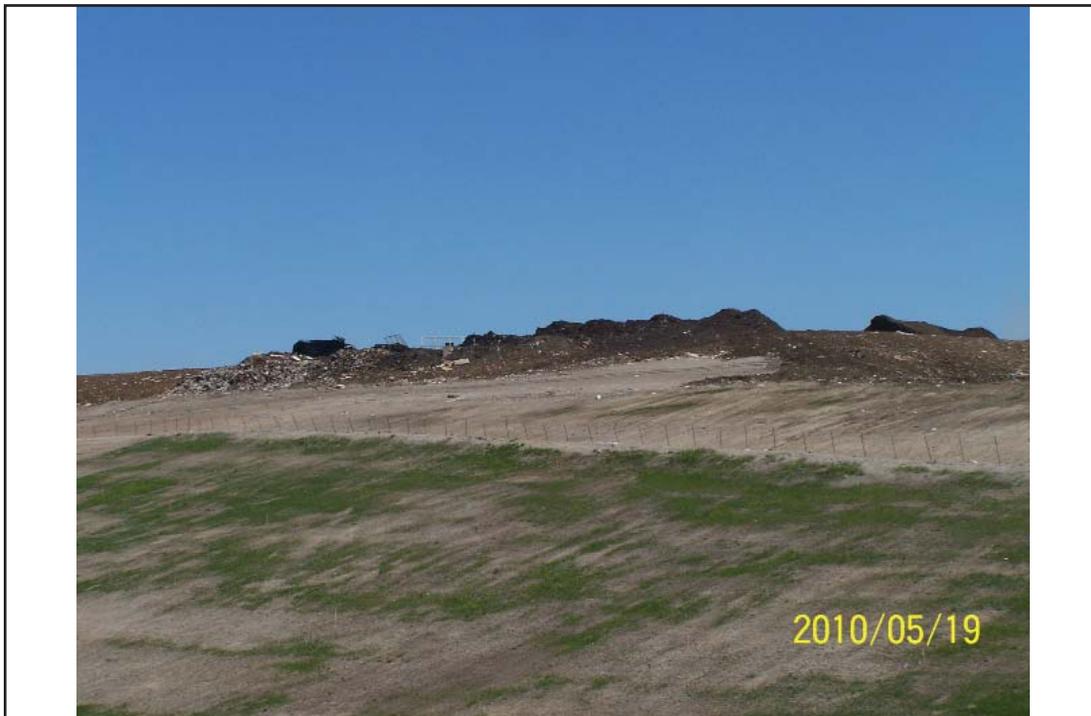
Previously poor cover repaired at Southwest corner of Phase 6E

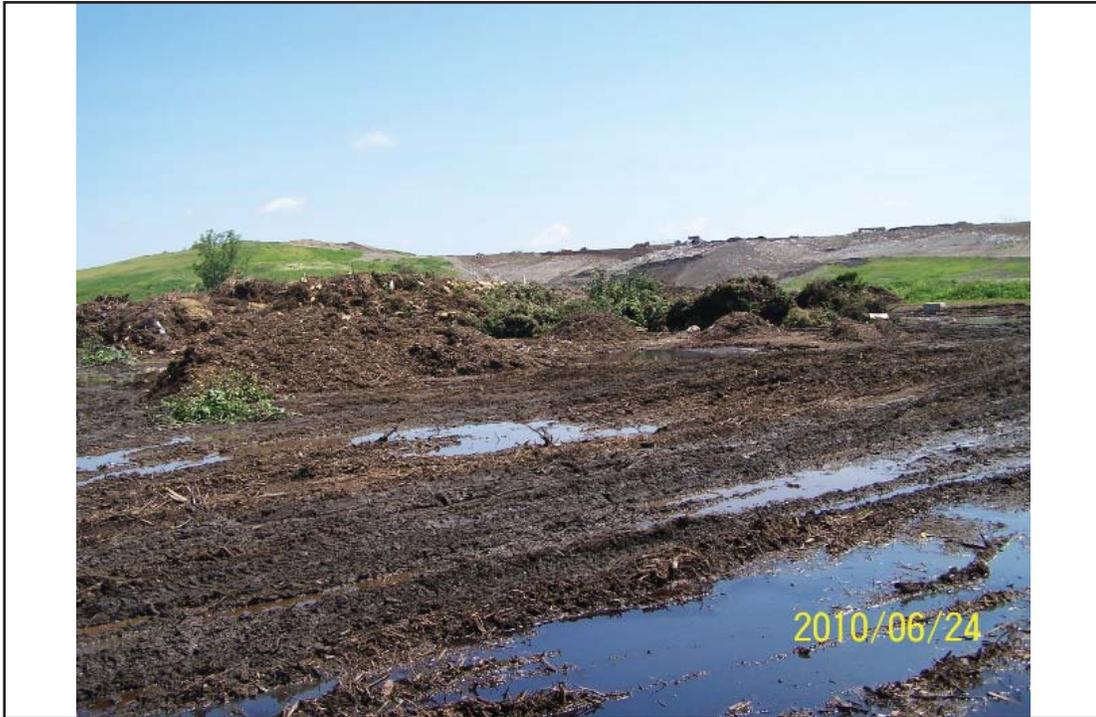
Wet conditions in compost lot

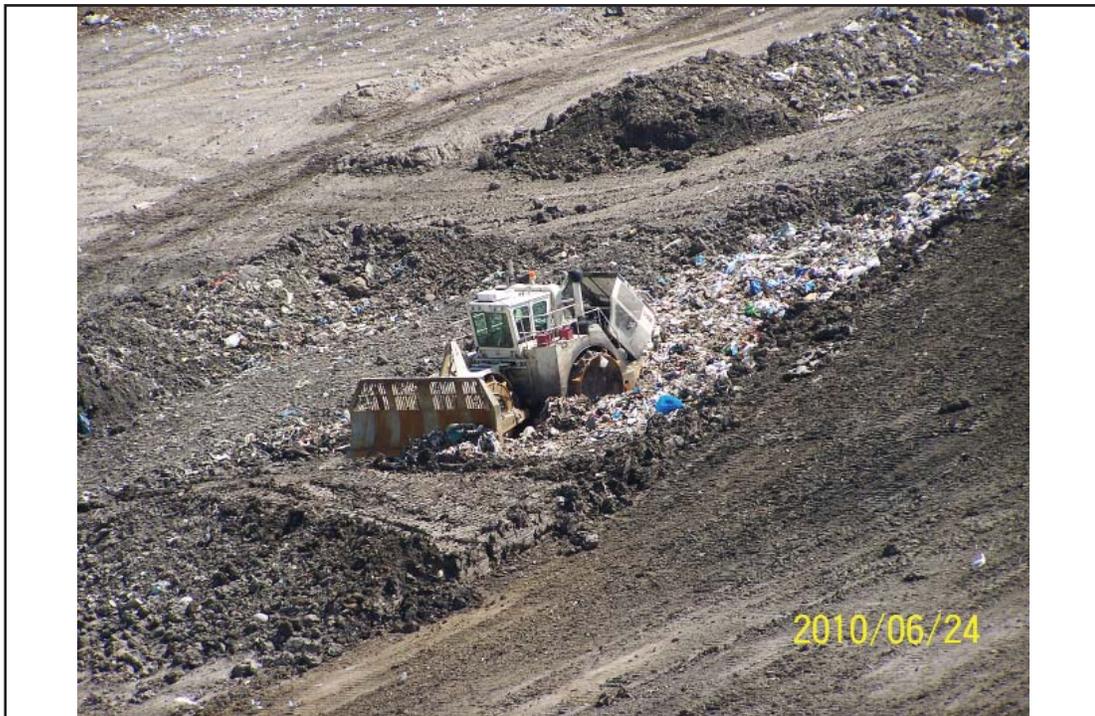
Working face far down on West slope of Phase 6. Recovering waste grades

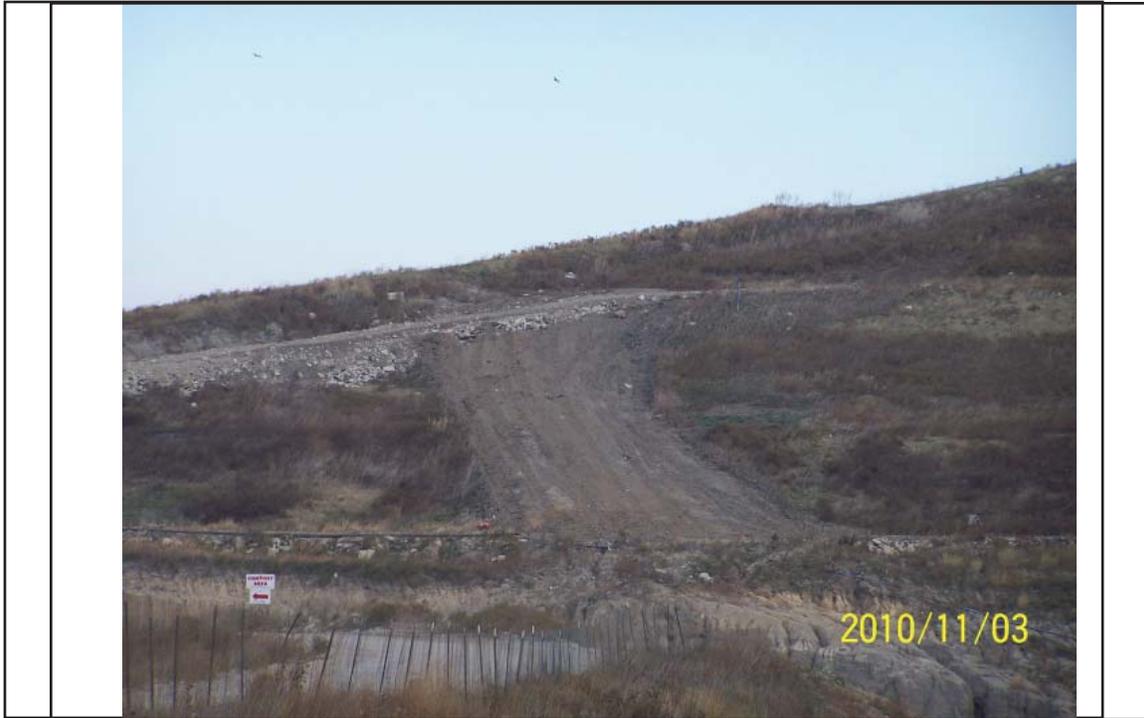
New equipment access road and repaired rils on South Slope of Phase 3
