Veolia Emerald Park Landfill
City of Muskego

2011 Veolia Emerald Park Landfill Year End Compliance Officer Report and Audit Summary

TO: Veolia Emerald Park Standing Committee
FROM: Jo-Walter Spear, Jr., P.E.
COPIES: File
DATE: 04/02/2012
PROJECT NUMBER: 1012.10030

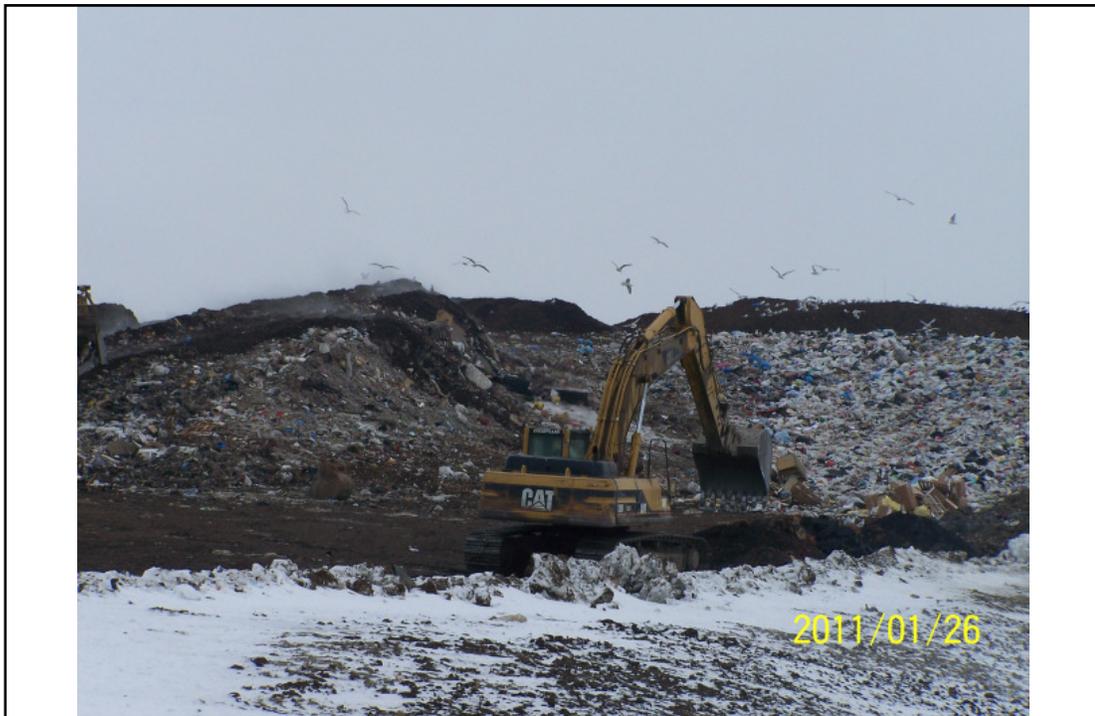
Working face

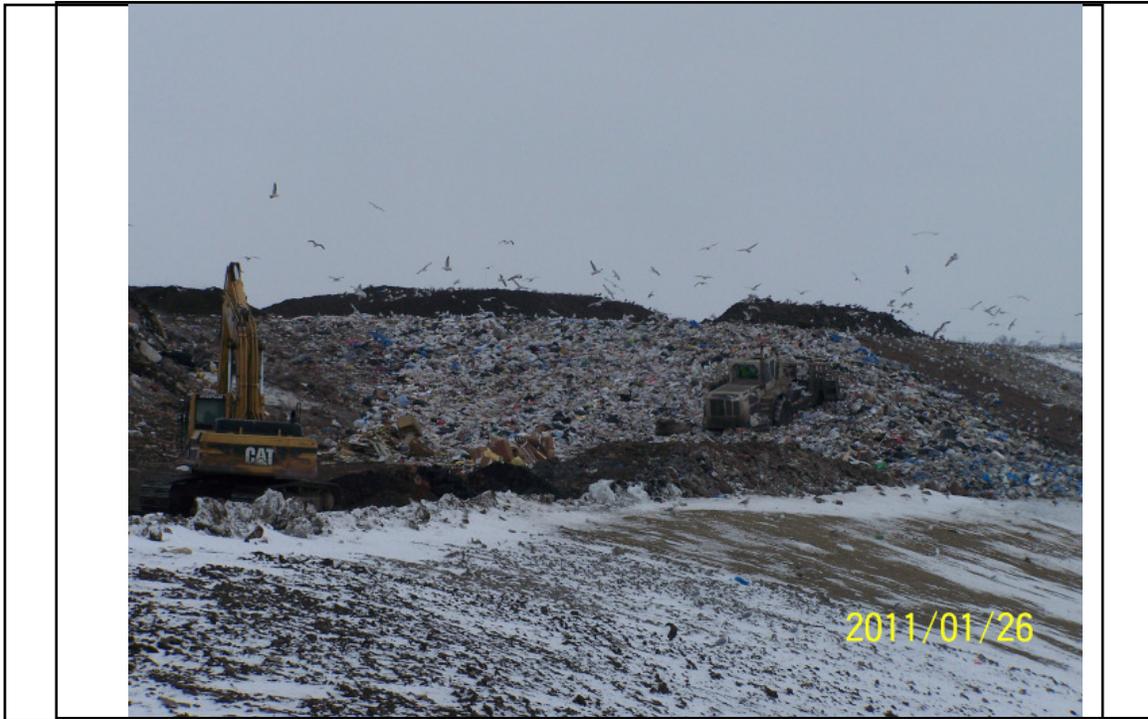
Excavator managing foundry sands along top of slope

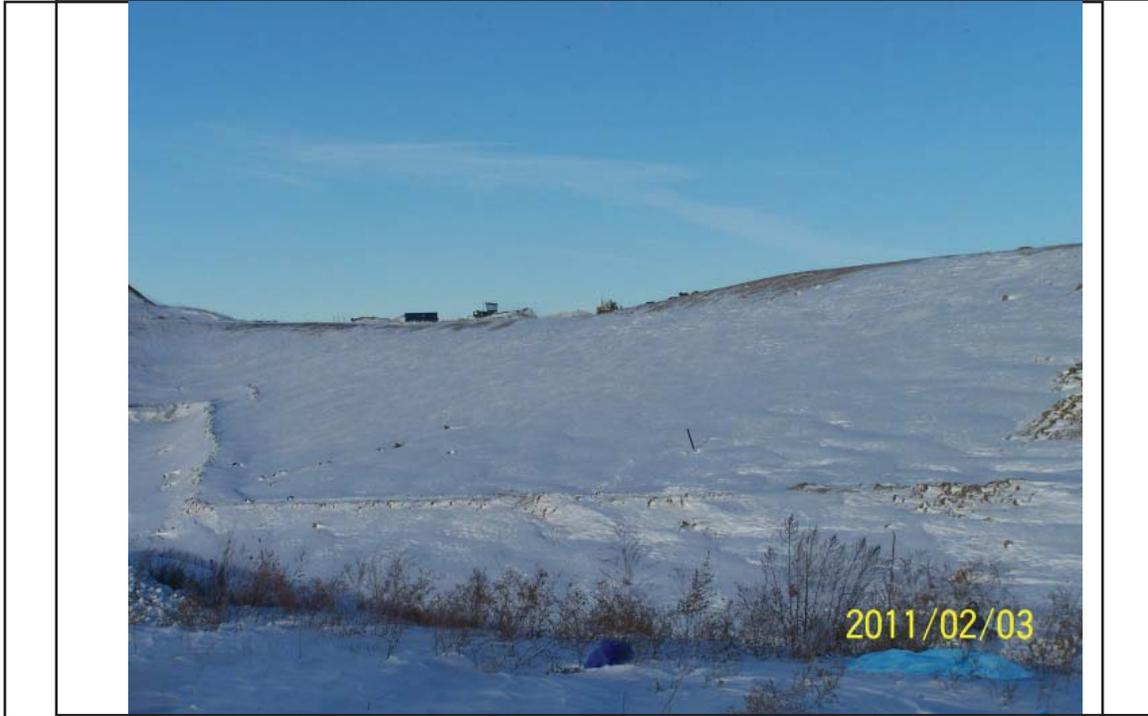
Southwest corner of Phase 6

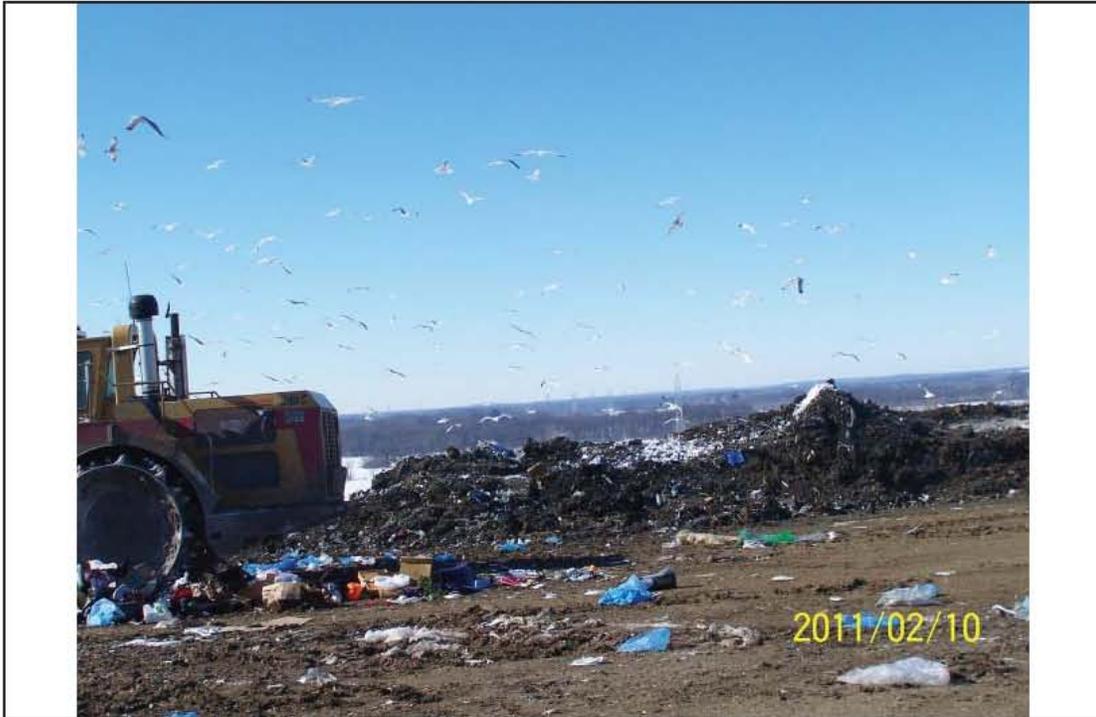
Foundry sands tipped as a berm along active area, top of West Slope

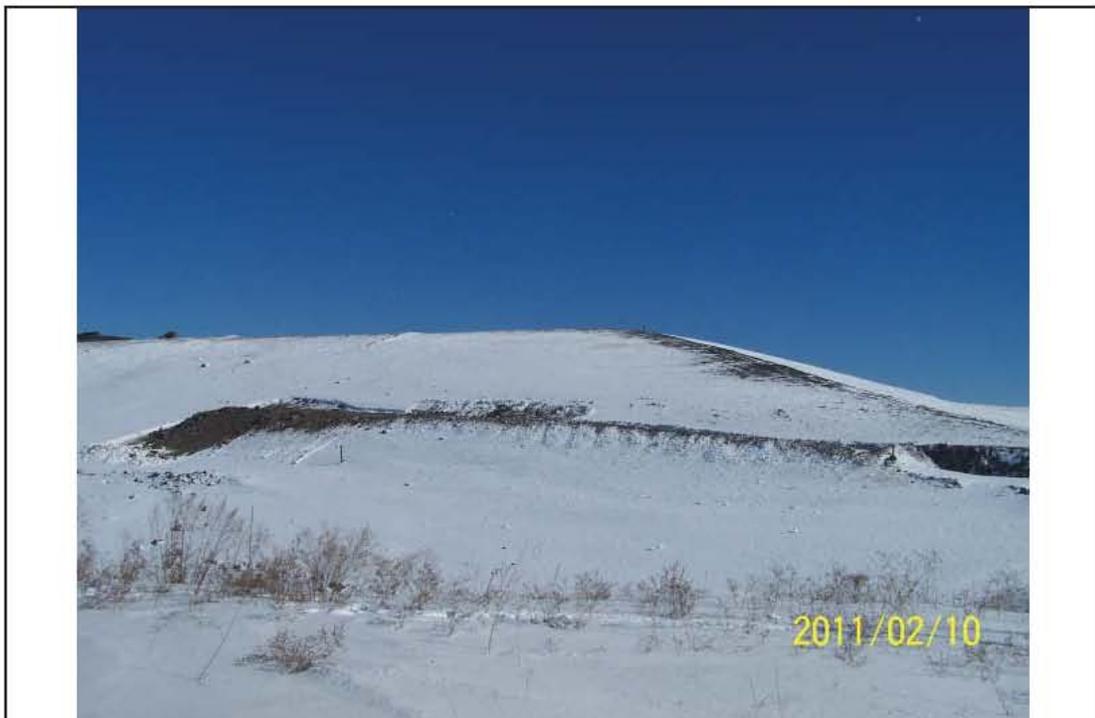
Access road under construction, construction halted due to weather

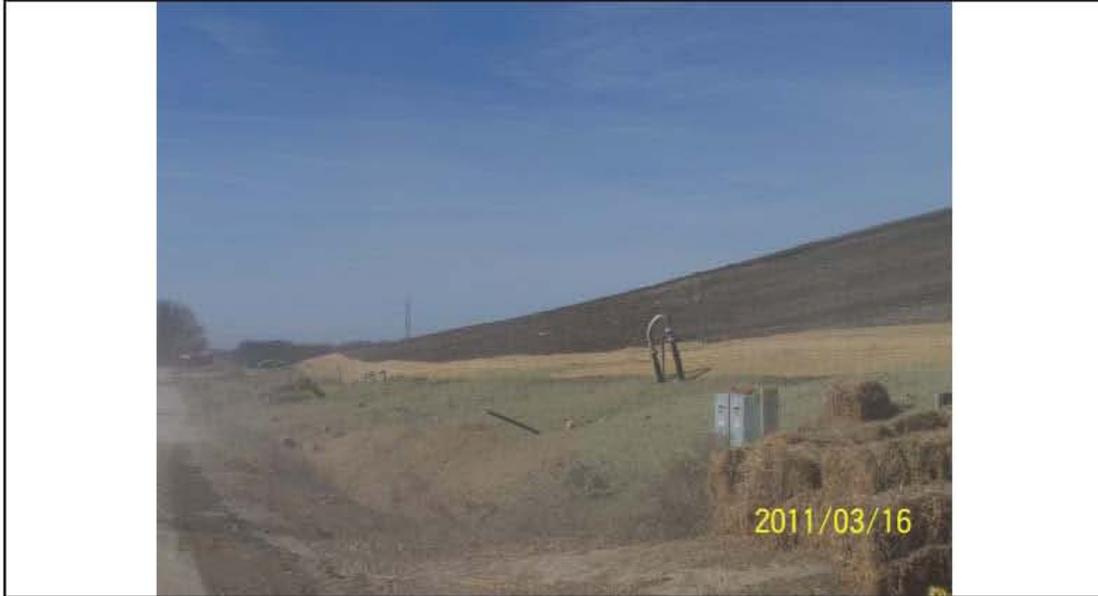
Repair to erosion ongoing, South Slope of Phases 5 & 6

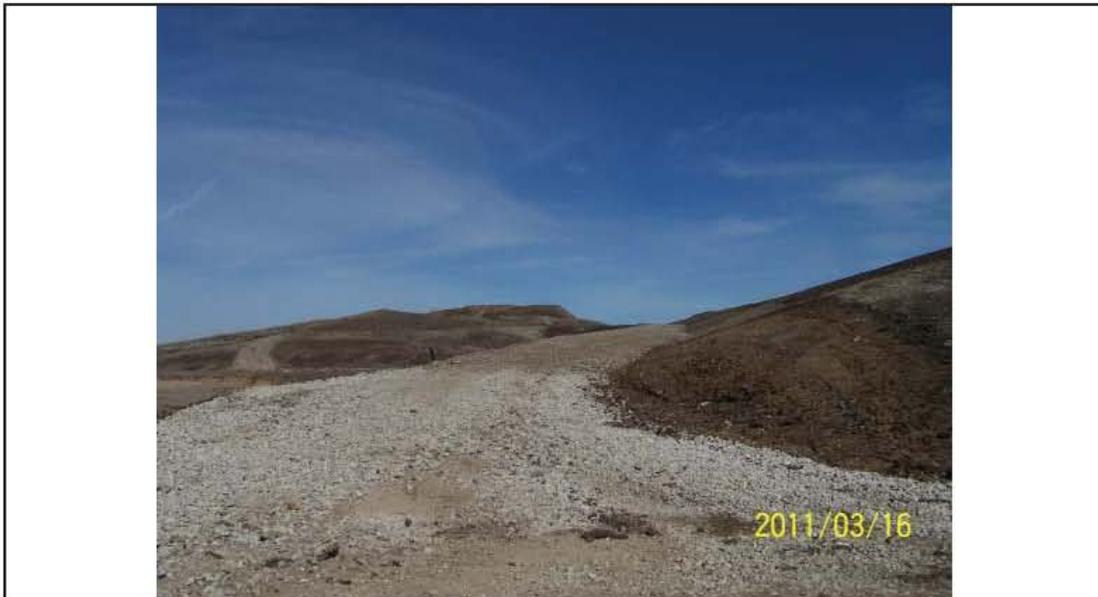
West slope access road nearly completed

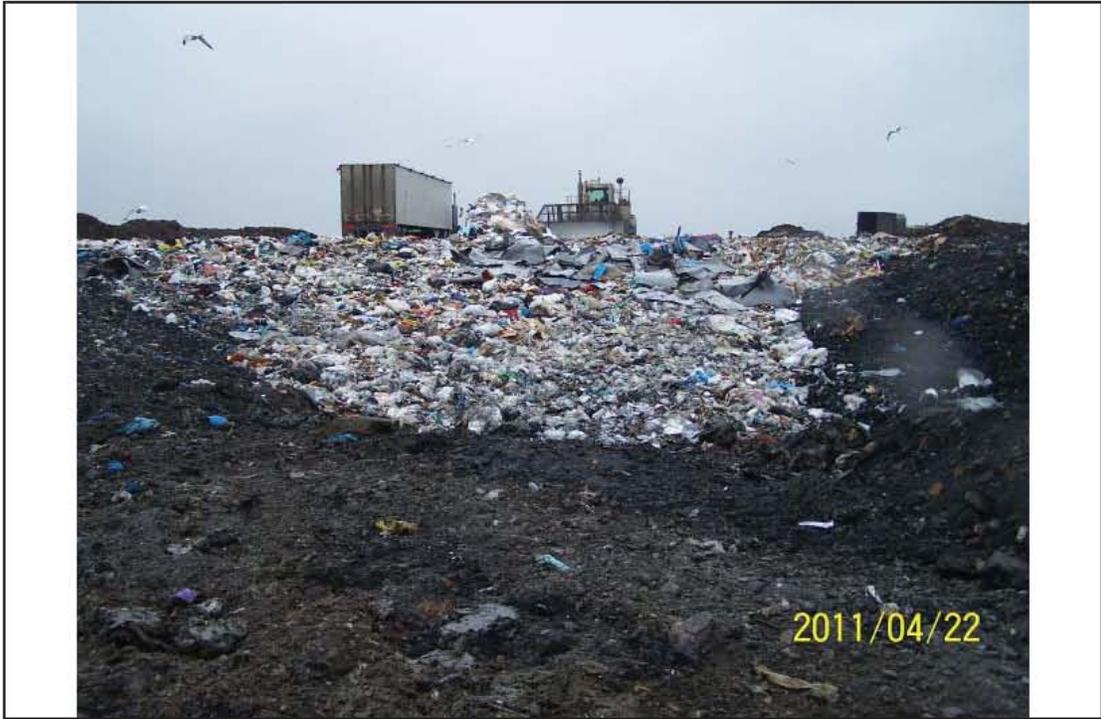
Working face, very tight conditions

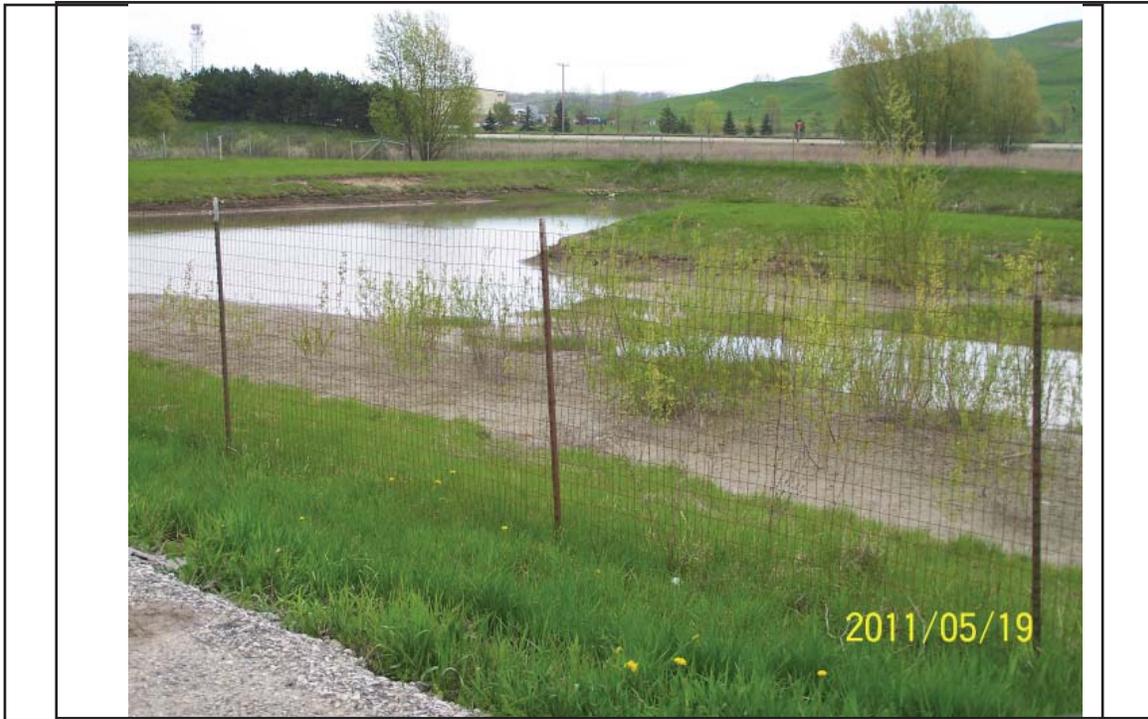
Basins have plenty of freeboard, but require maintenance for depth and condition of side slopes

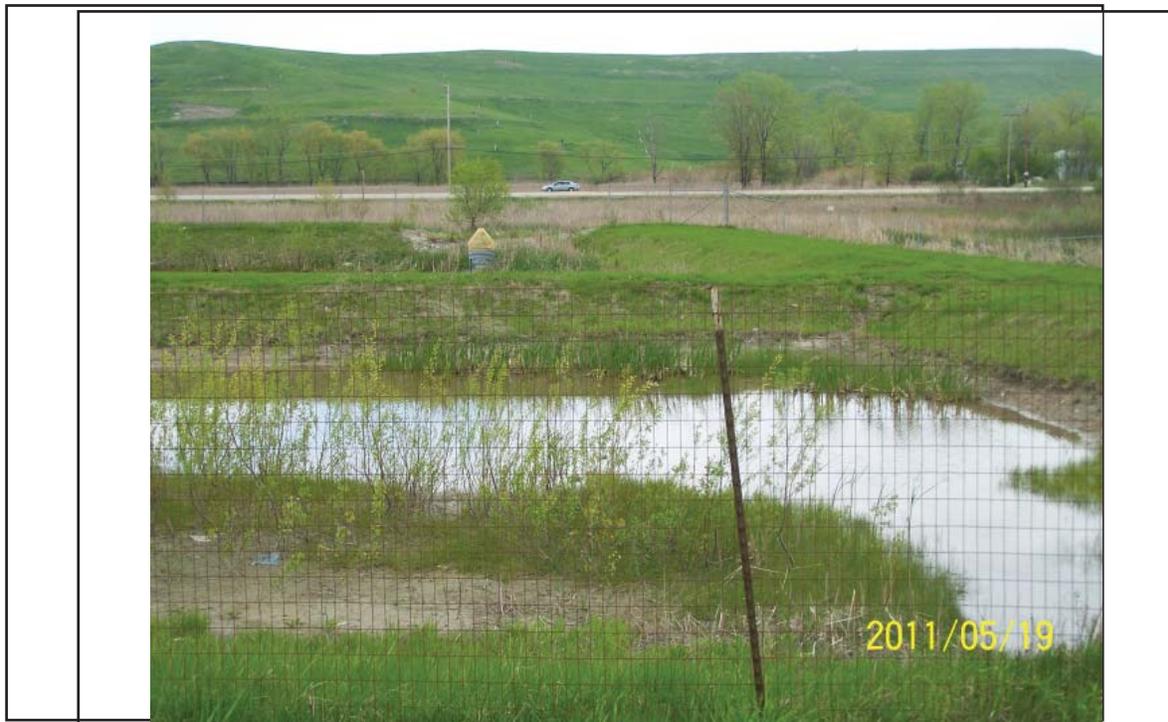
Silt and woody vegetation in Basins

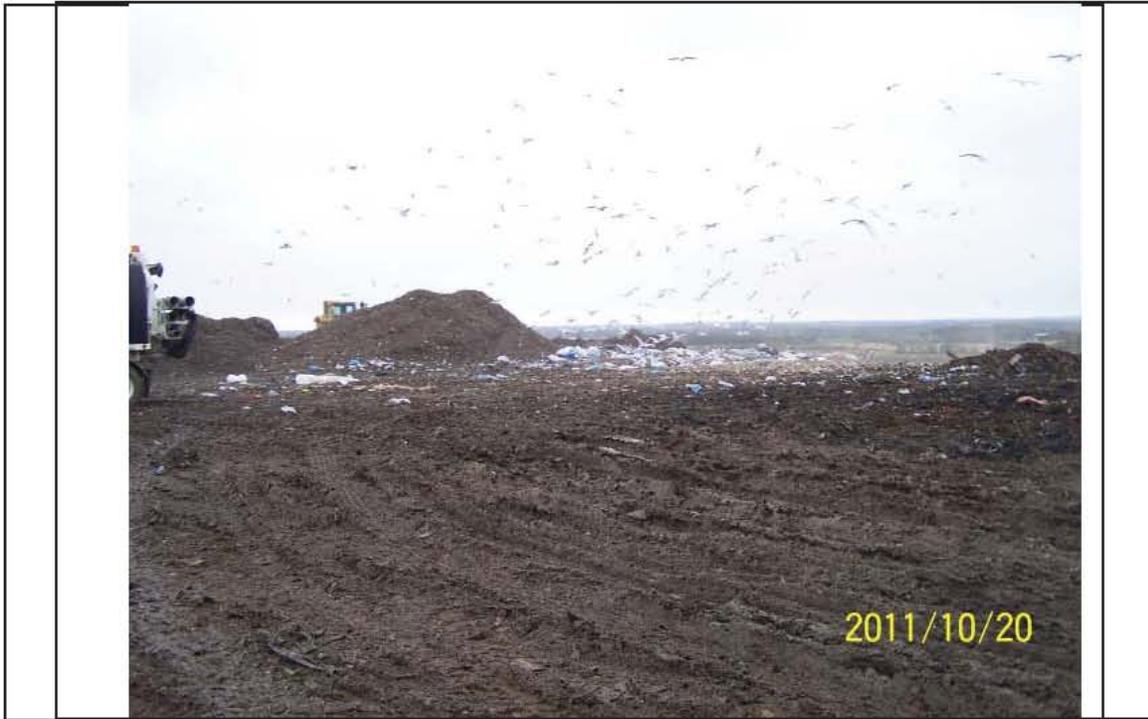
Active area, wet conditions

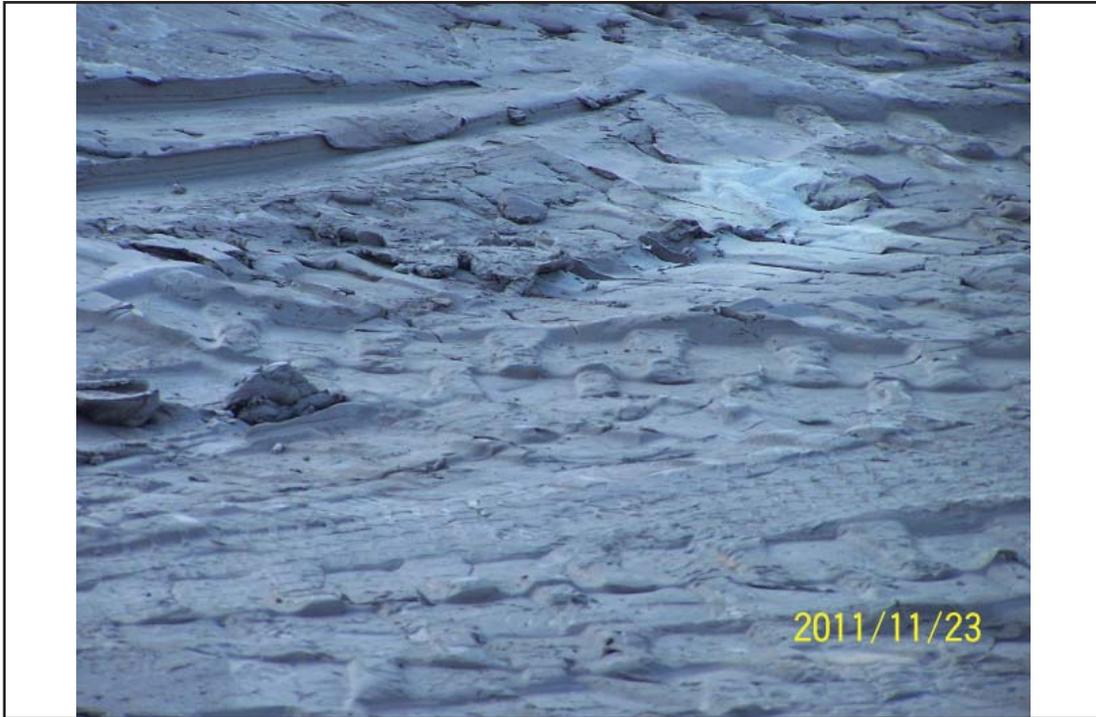
Clay conditions outside of liner

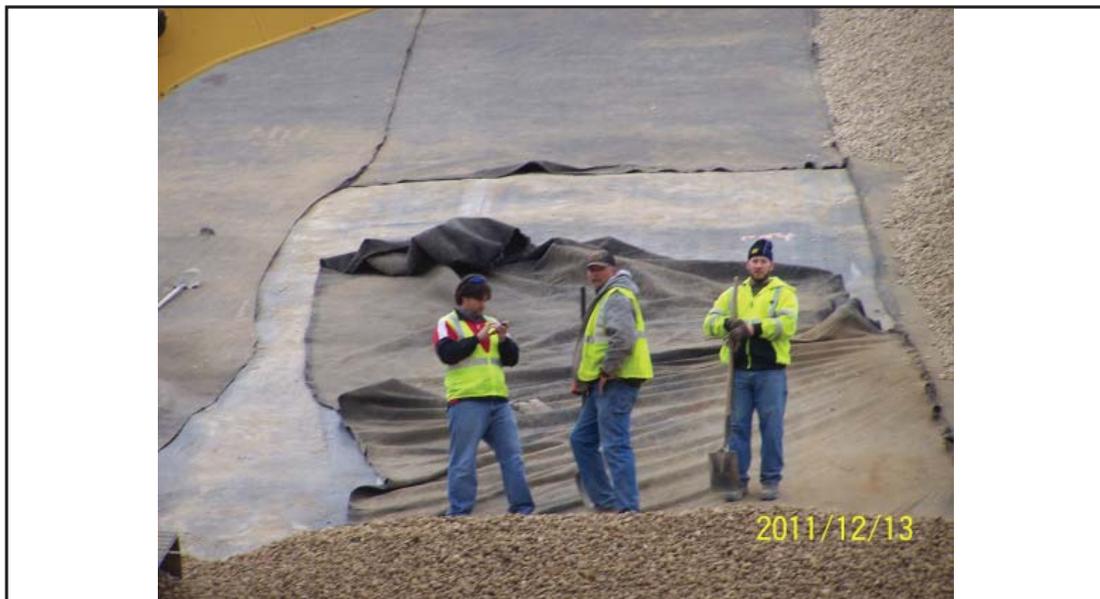
Area of liner that stone slid.

Engineer, foreman, and crew engaged in investigation and repair

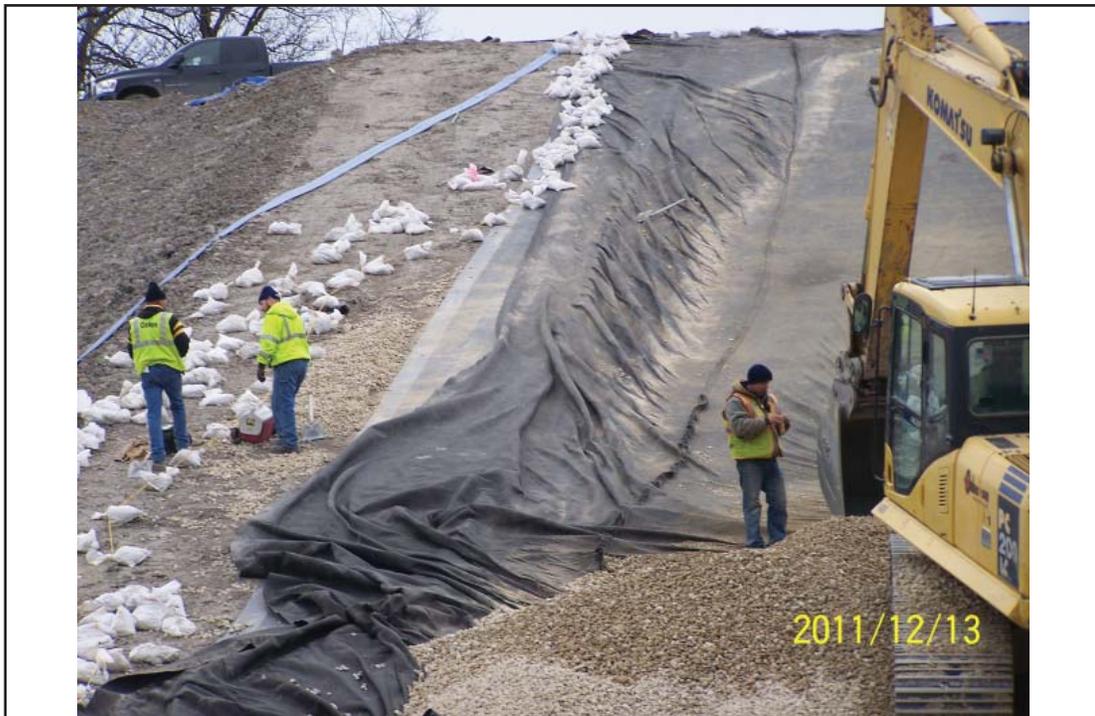
Geo-textile dragged and wrinkled by sliding stone

Crews removing stone and preparing to repair geo-textile

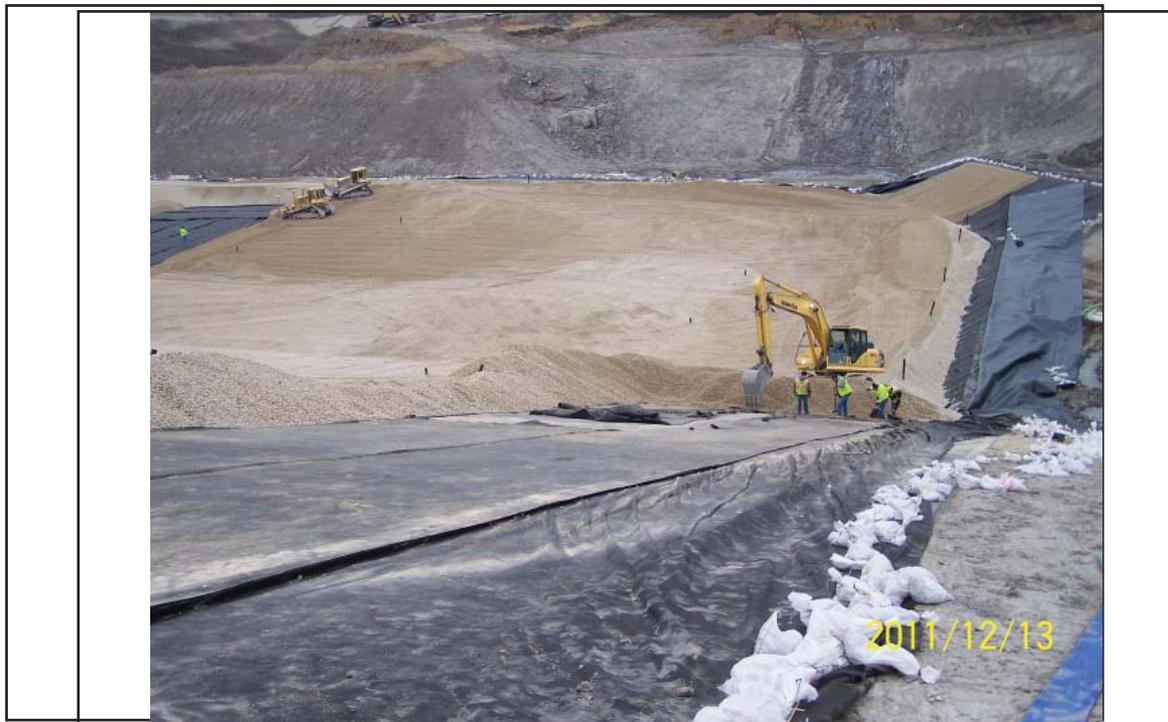
Area below slide

Stone being pulled back to investigate liner condition
