VEOLIA Emerald Park Landfill Audit Summary

TO: Veolia Emerald Park Landfill Standing Committee, City of Muskego
FROM: Anna Krajcik
COPIES: File
DATE: 01/05/13
PROJECT NUMBER: 1012.10030

VEOLIA EMERALD PARK LANDFILL
LANDFILL OPERATIONS AUDIT FORM
CITY OF MUSKEGO

**VEOLIA EMERALD PARK LANDFILL
AUDIT PHOTOS
CITY OF MUSKEGO**

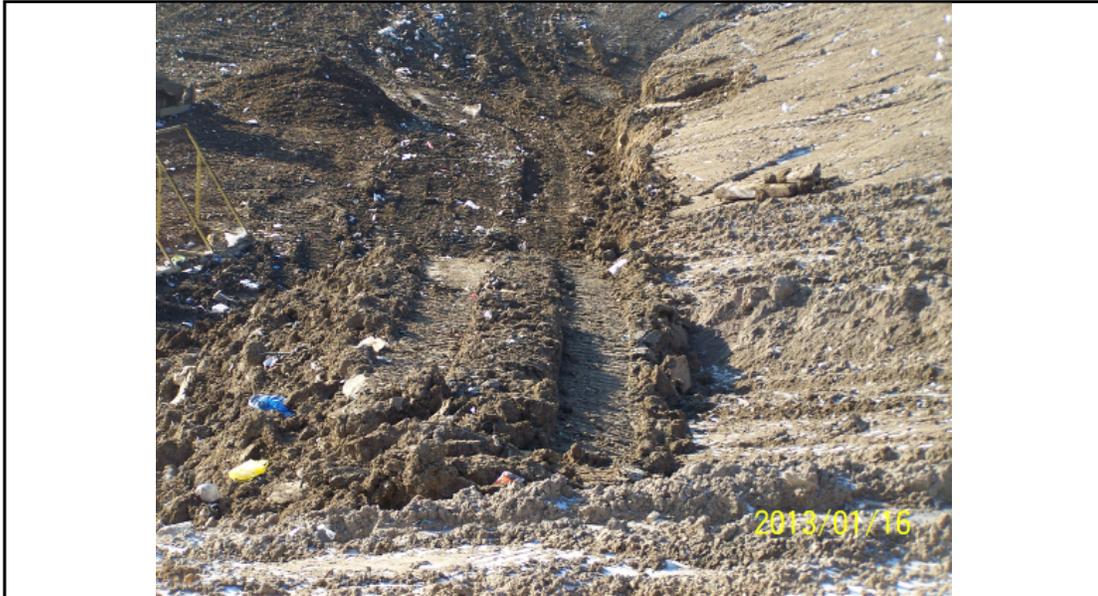
Previously tipped soils being cut and used for intermediate cover

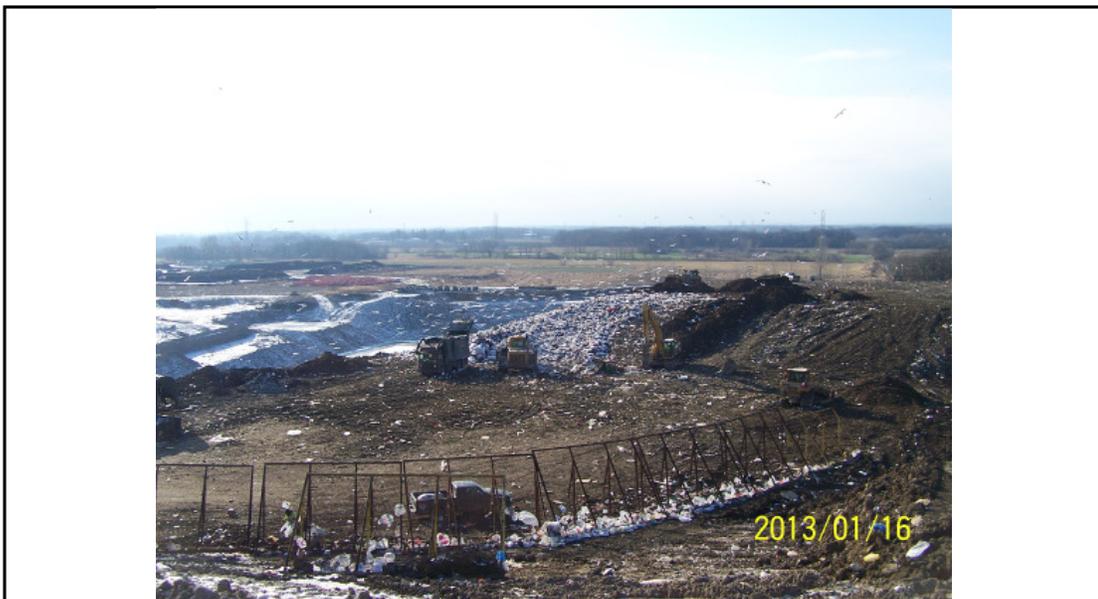
Active area

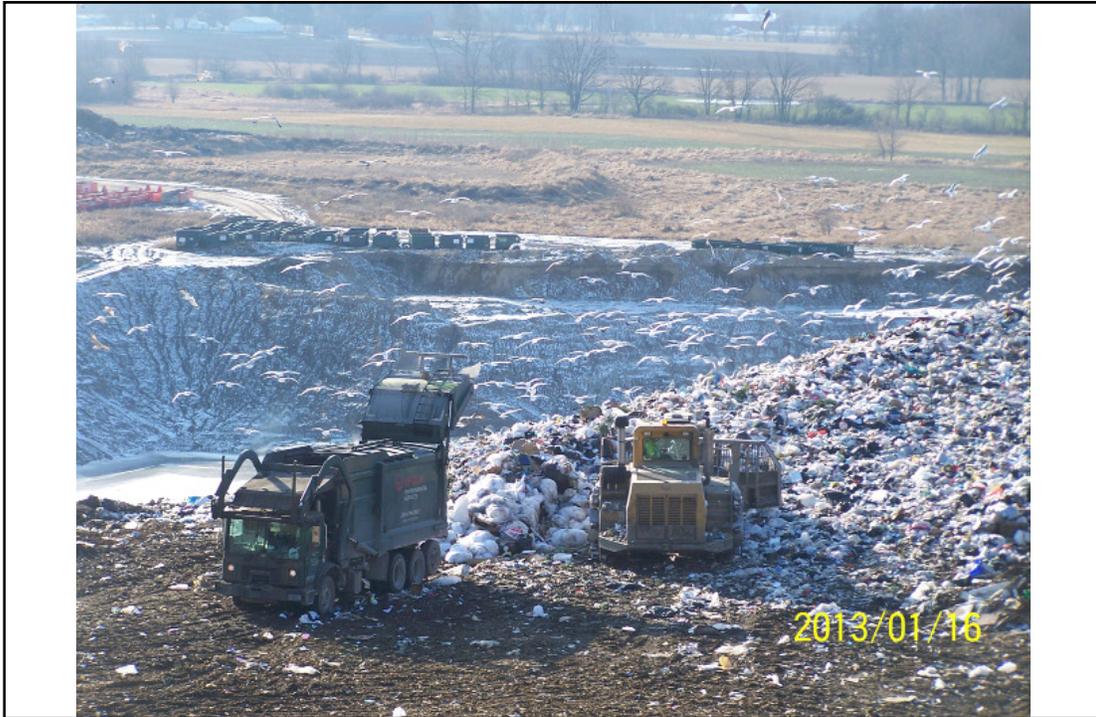
Compactor in action

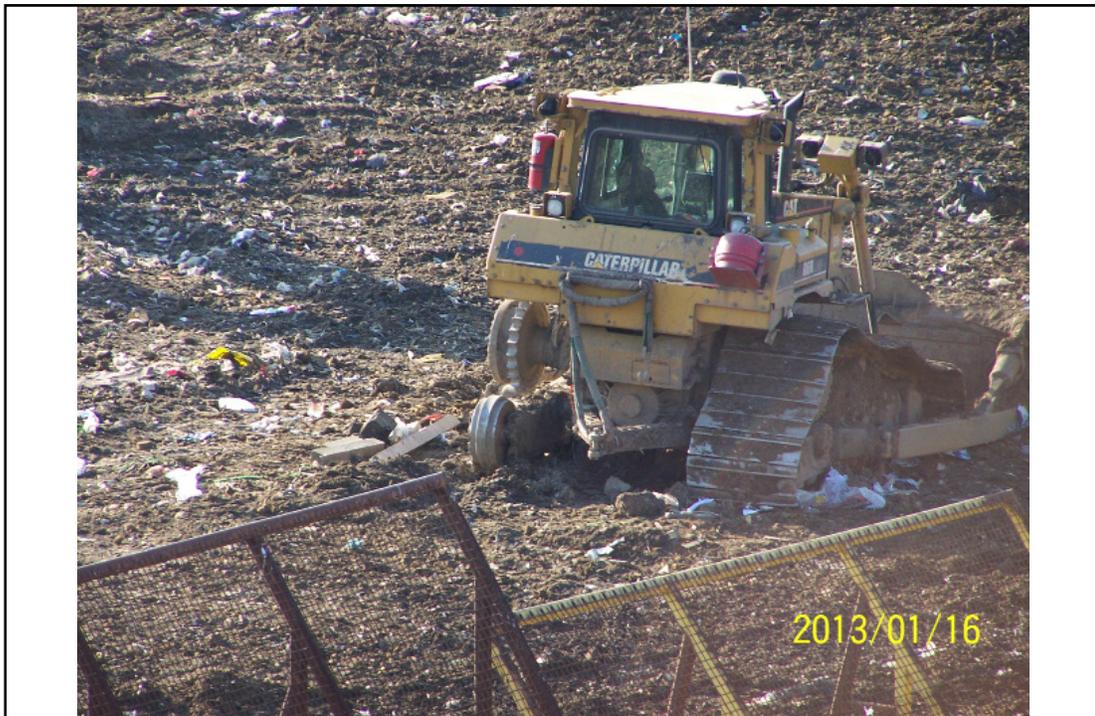
- D6 dozer has broken track
- New gate being installed in compost area
- Temp basins pumping system repaired and actively pumping down

D6 Dozer with broken track

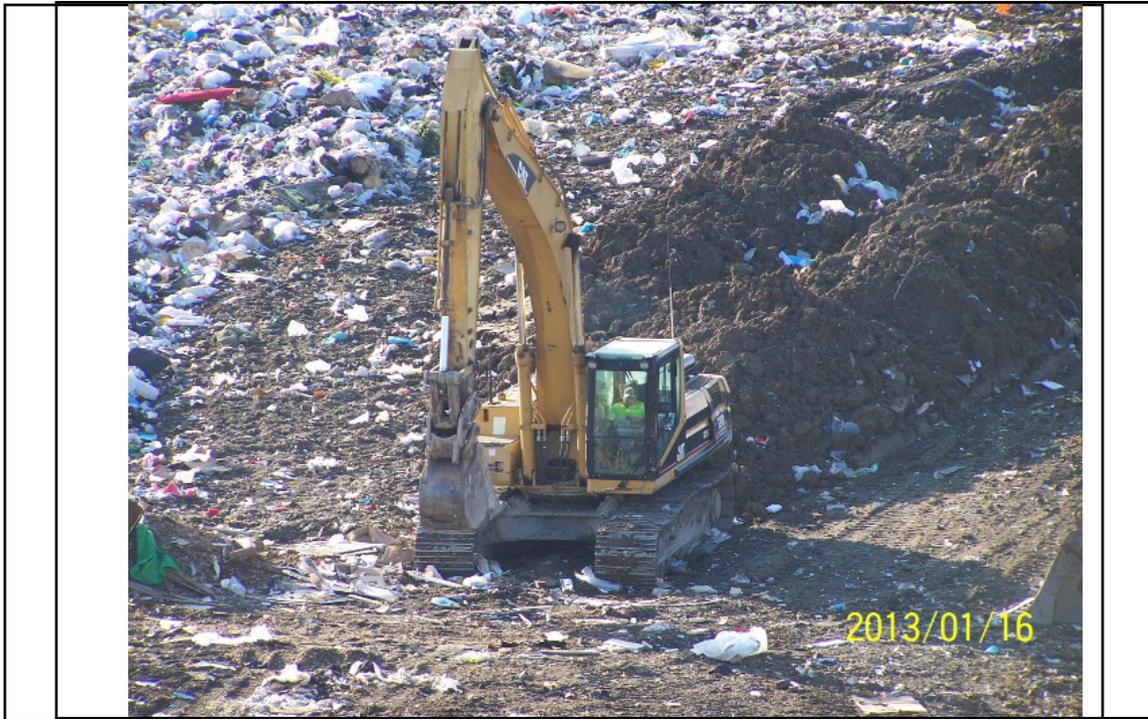
Excavator digging out frozen loads while backhoe is in for repairs

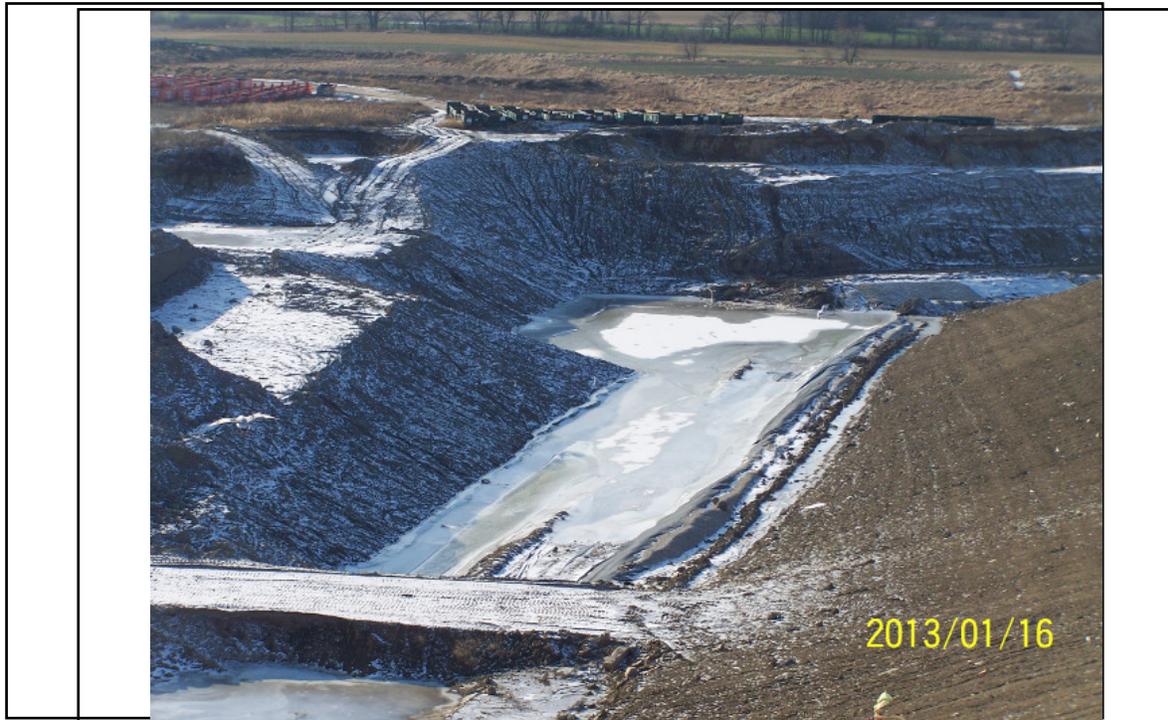
Snow event, very cold condition
Basins & Surface water frozen

Basin being drained by pump, surface only is frozen

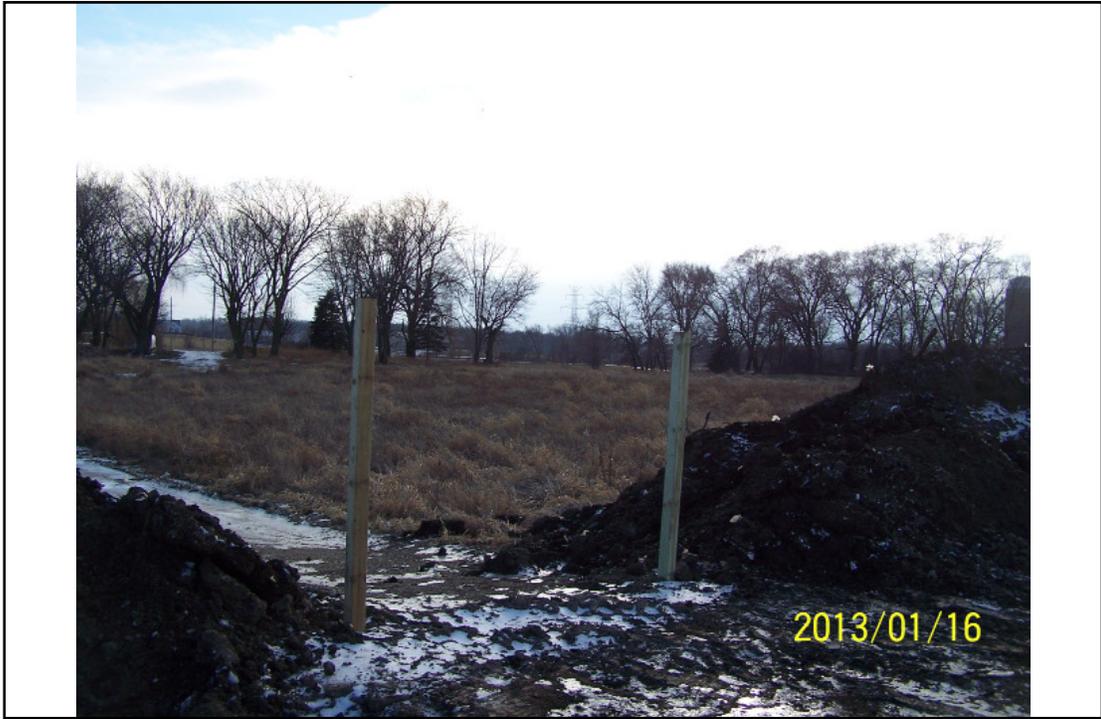
Uprights for new gate into Compost area from the South
