2012 Advanced Disposal Services Emerald Park Landfill Year End Compliance Officer Report and Audit Summary

TO: Veolia Emerald Park Standing Committee
FROM: Jo-Walter Spear, Jr., P.E.
COPIES: File
DATE: 04/04/13
PROJECT NUMBER: 1012.10030

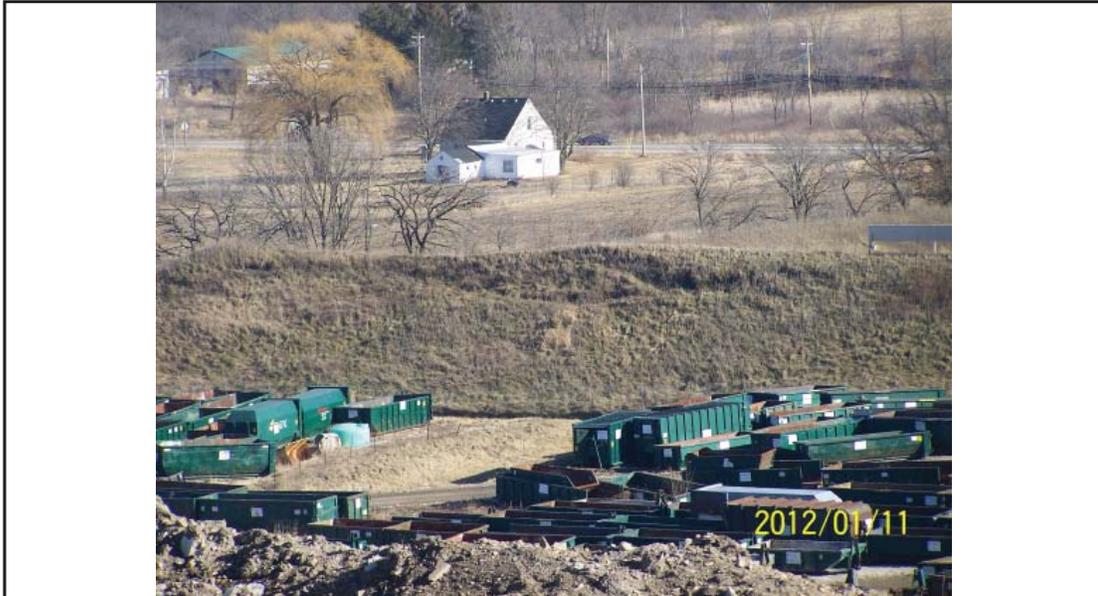
Conditions on berm behind Shooting Range

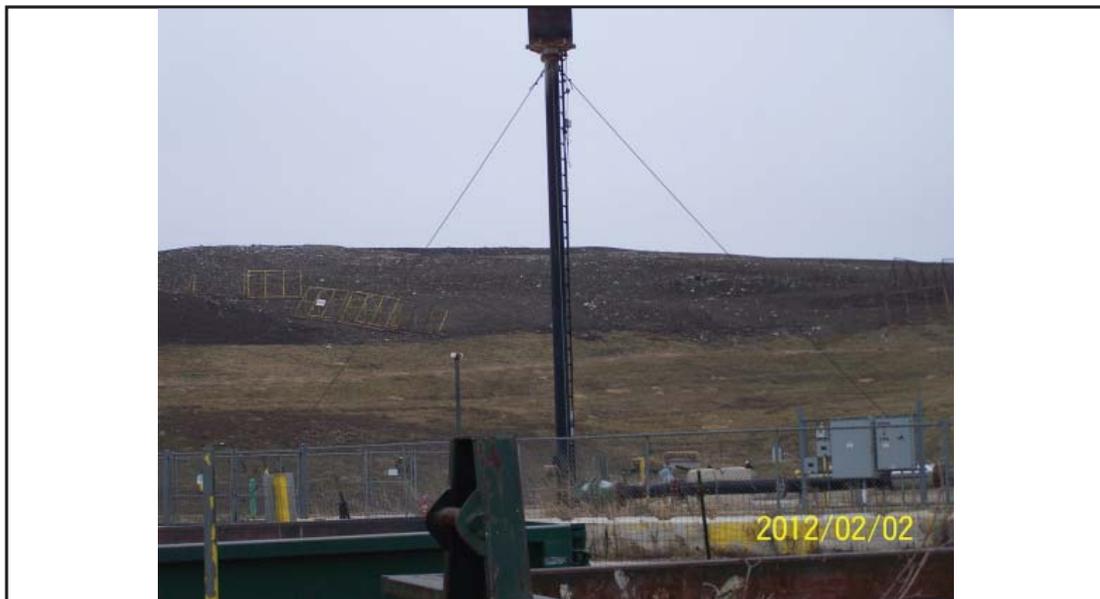
Slope conditions behind flare. Closure Area III needs seeding

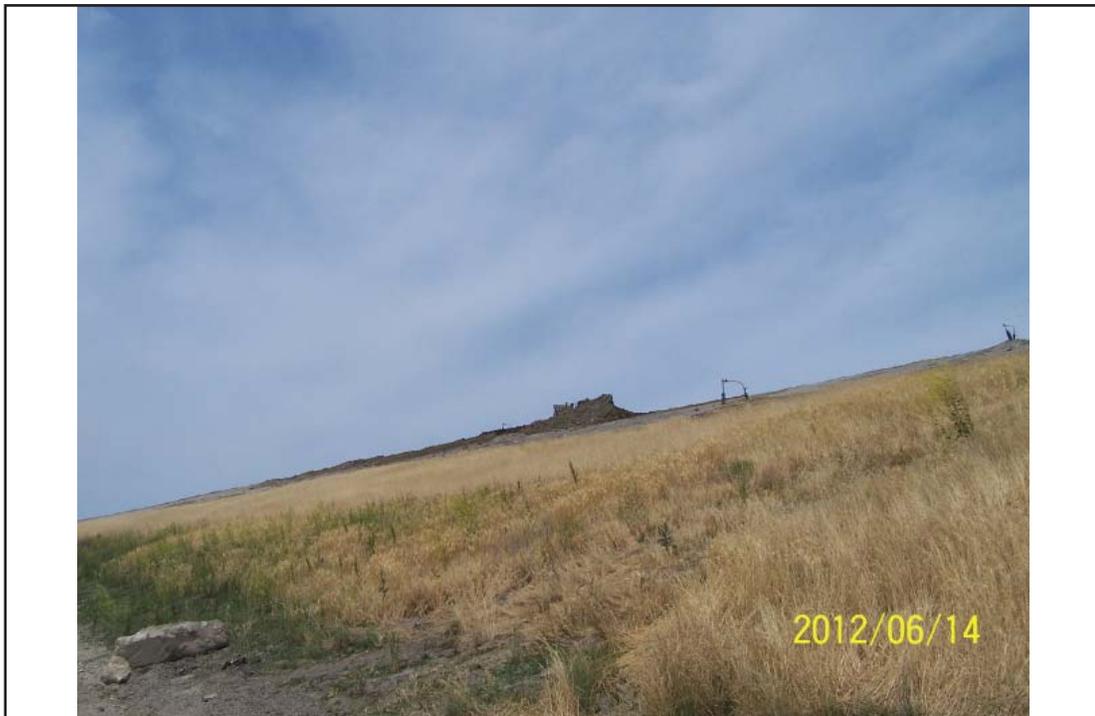
Phase 5, area identified with gas leak, addressed by clay placement

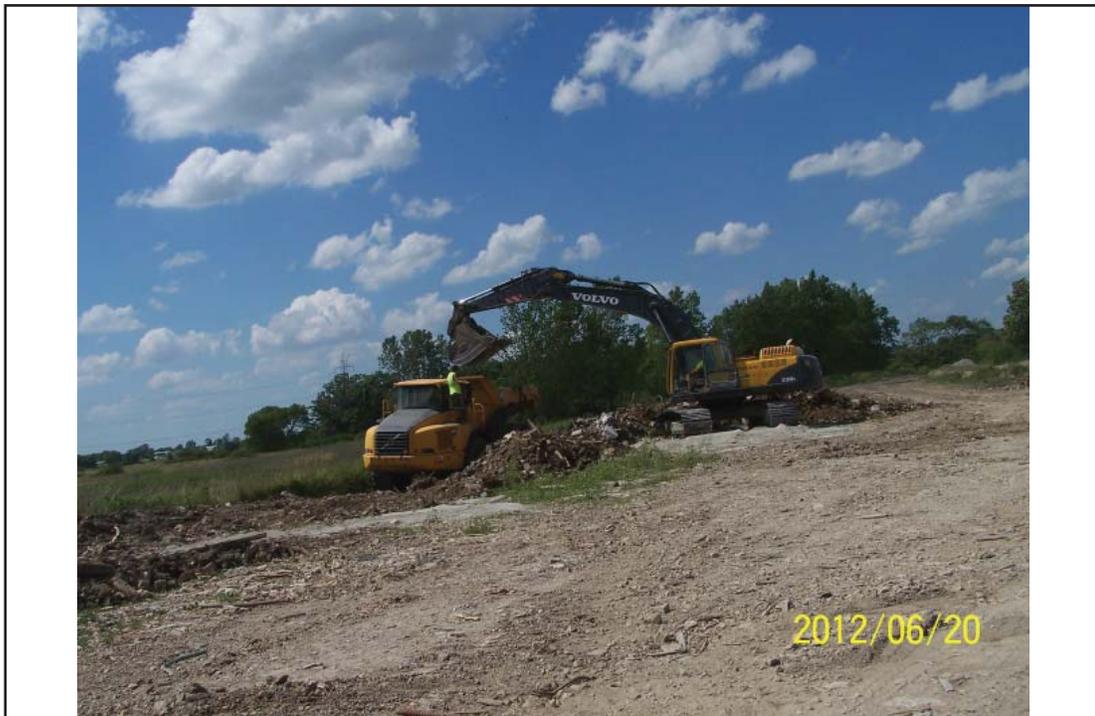
Poor road material being removed for replacement

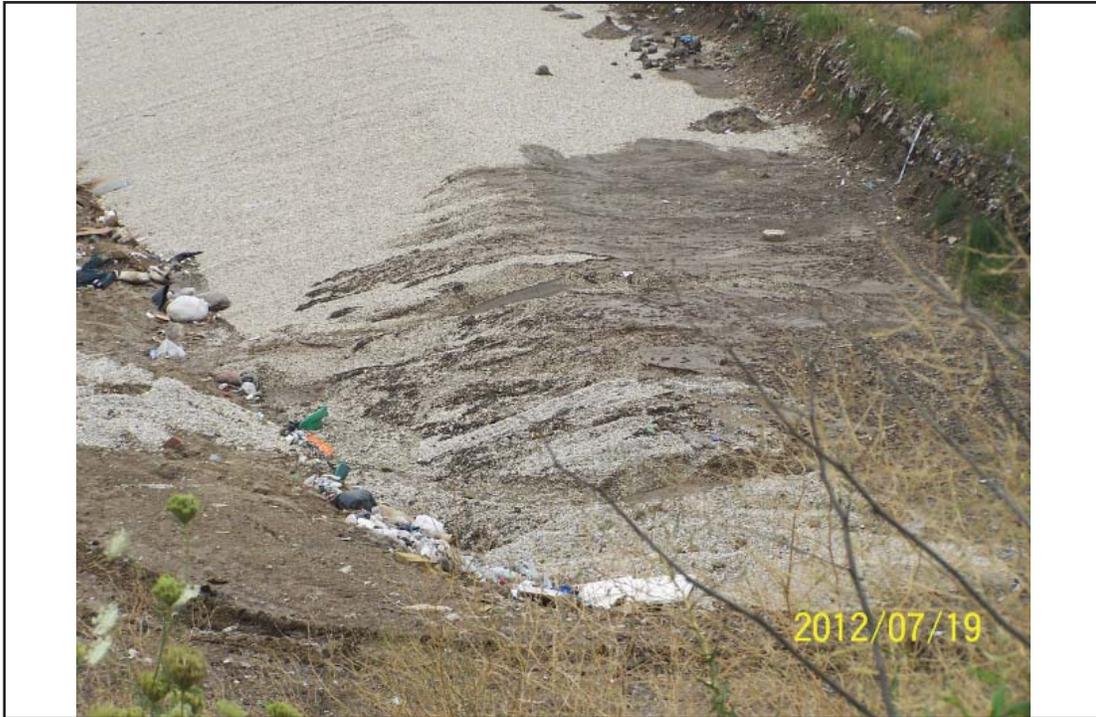
Pea gravel over liner washed out, replacement material available on site.

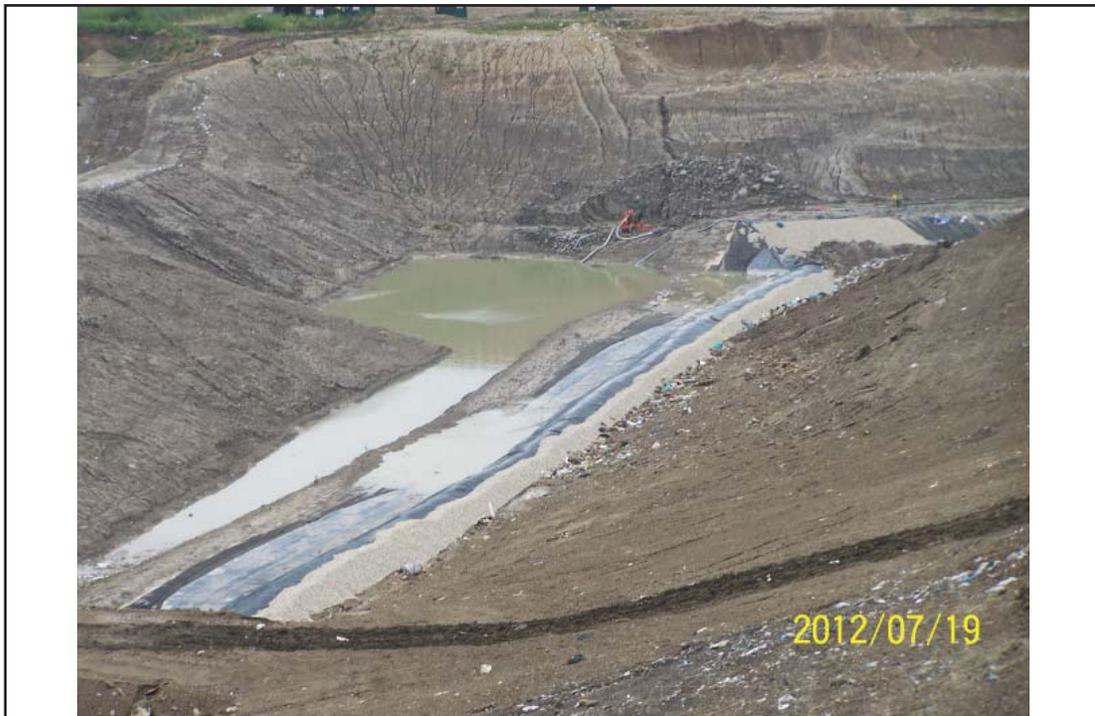
Temp sed basin, pumped down to an acceptable level

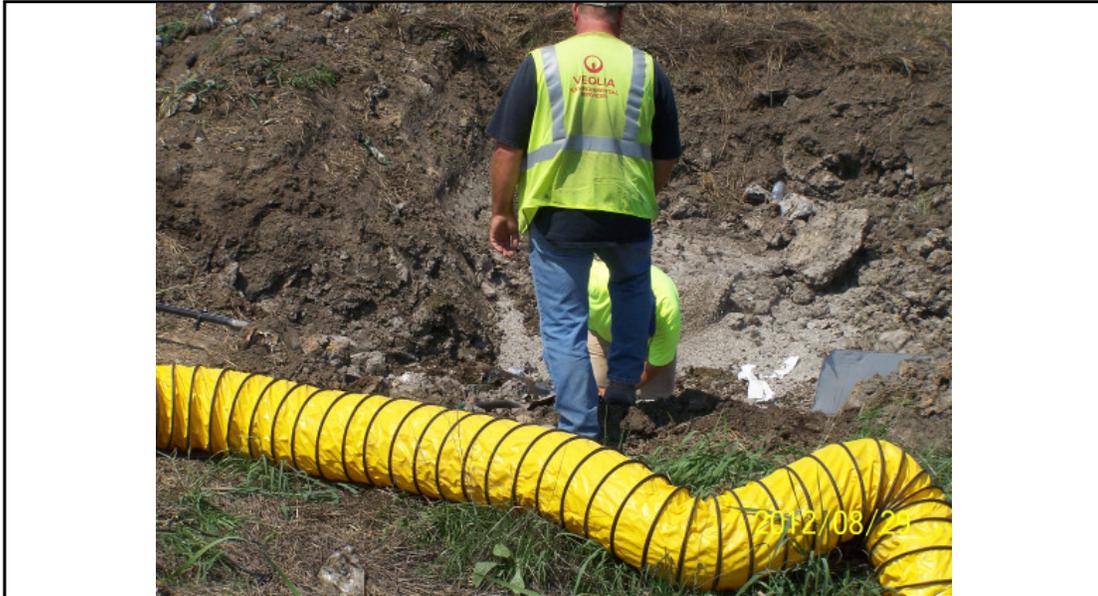
Gas line being checked for leaks

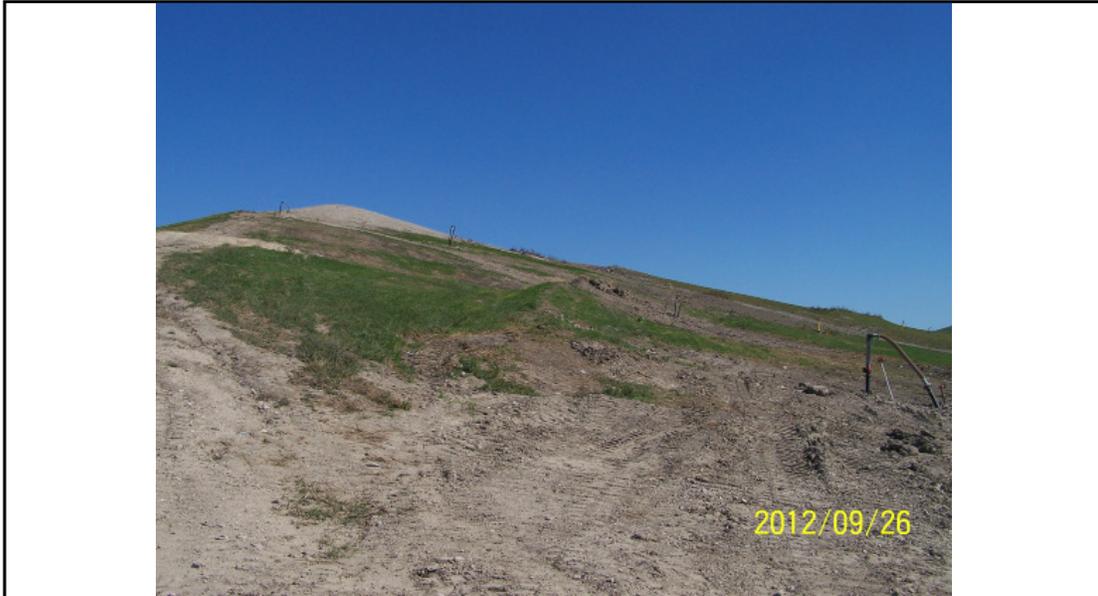
South slope of Phase 5 & 6, greening after gas repairs

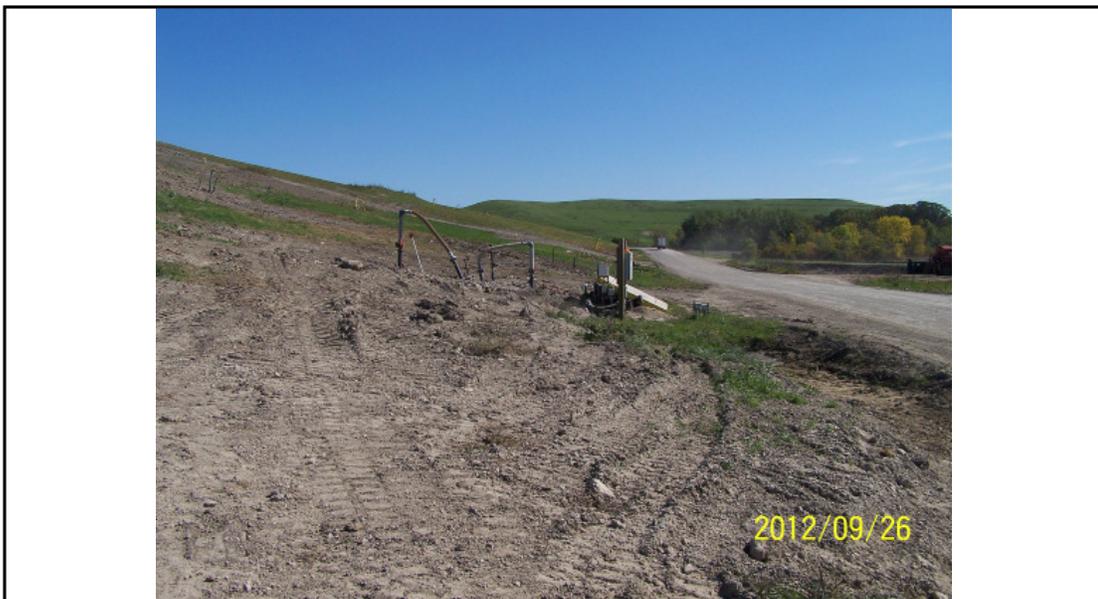
Backfilled gas repairs to be hydroseeded with ditches

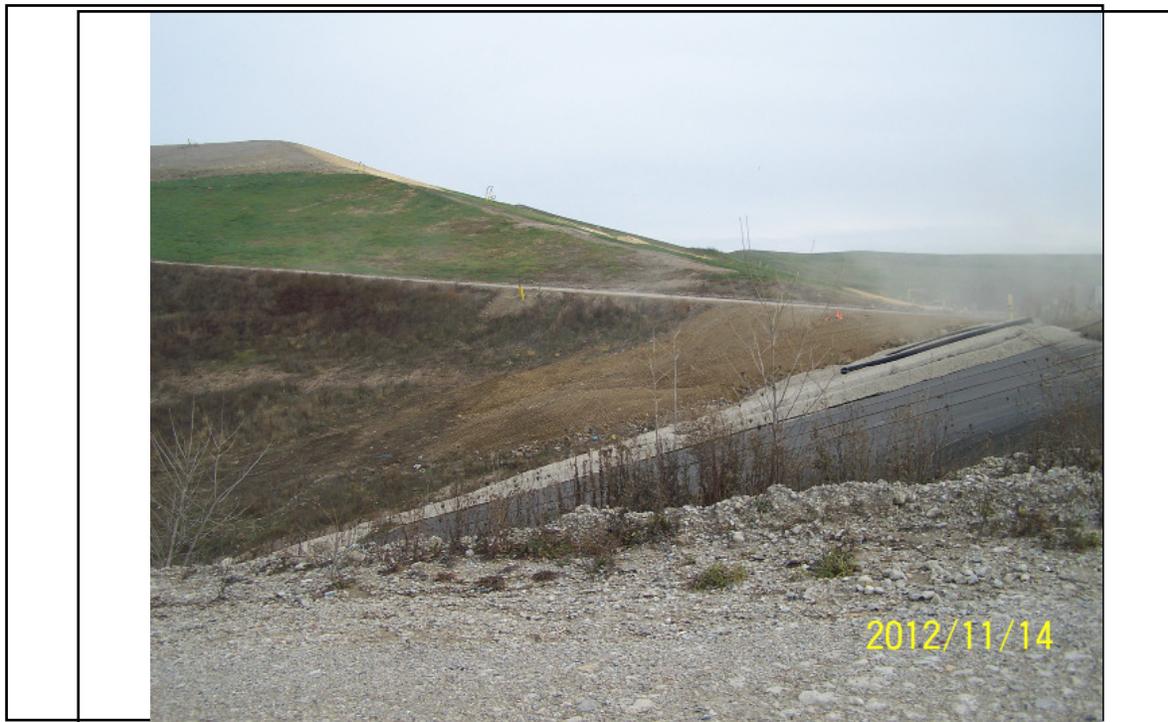
East slope of Phase 6E, below haul road, patched after repairs to gas system

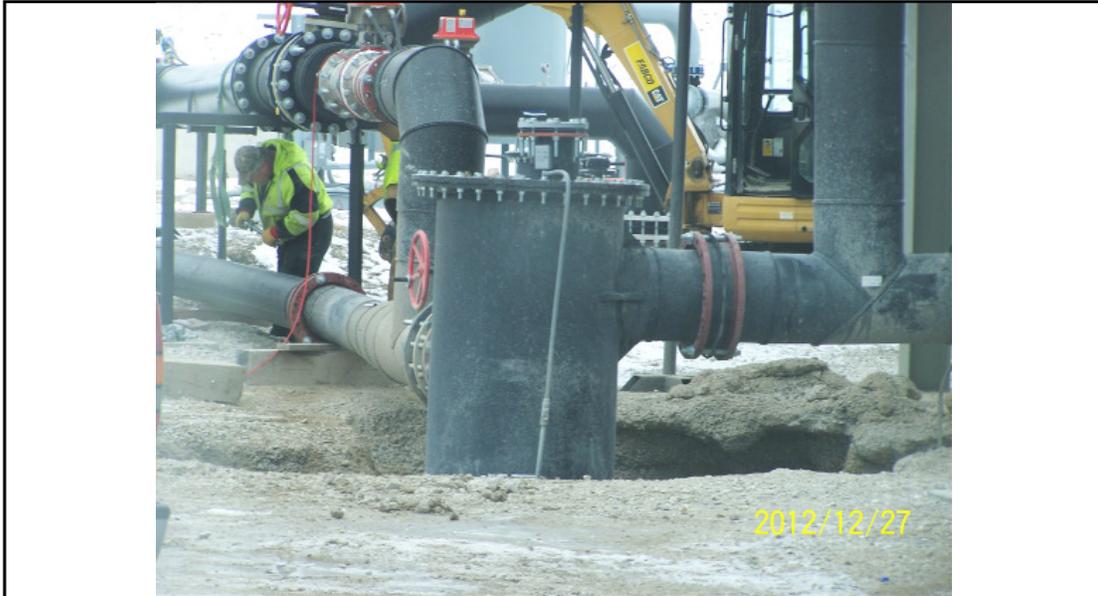
Small knock out to be replaced.

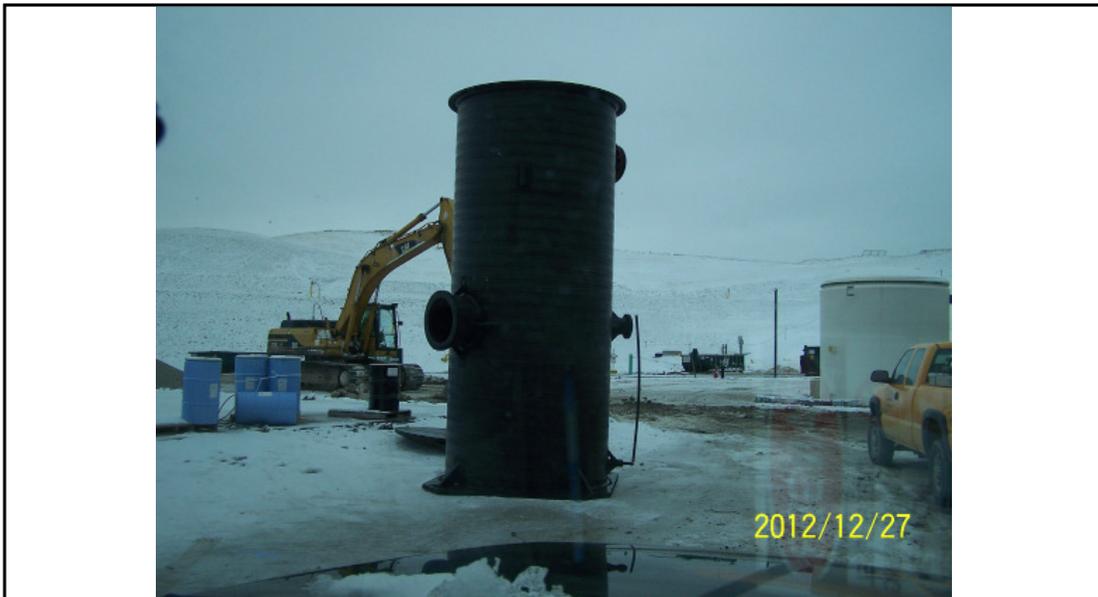
Large knock out replacement.
