ADS Emerald Park Landfill Audit Summary

To: ADS Emerald Park Landfill Standing Committee, City of Muskego
FROM: Faith Spear.
COPIES: File
DATE: 06/02/15
PROJECT NUMBER: 1012.10030

Attached is the audit report for activities at the ADS Emerald Park Landfill for the week of May 4, 2015. The audit was performed at 2:25 PM on **May 8, 2015**, by Jo Spear, Jr. in the presence of Michael Hackney, General manager.

**ADVANCED DISPOSAL SERVICES
EMERALD PARK LANDFILL / CITY OF MUSKEGO
AUDIT PHOTOS**

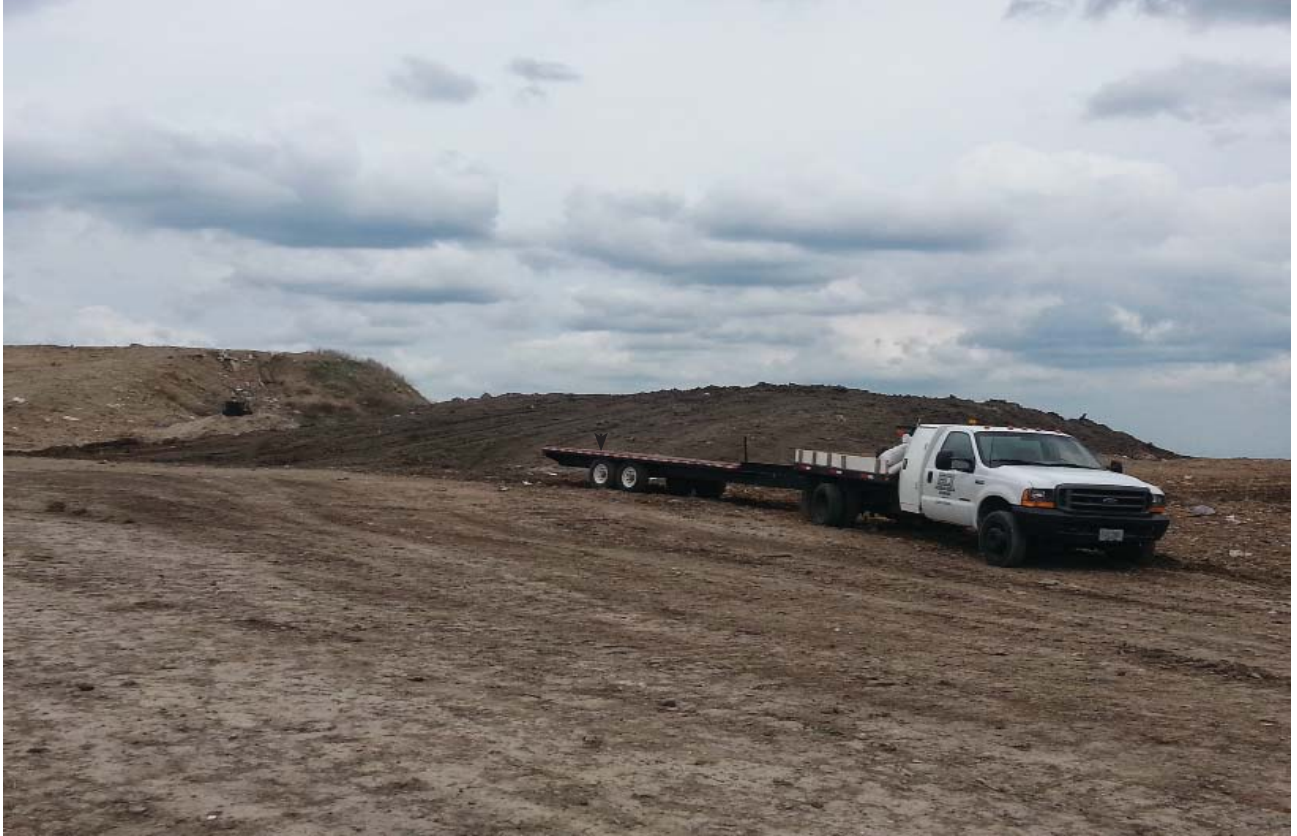
Working face in Phase 7B, on out board, South
slope receiving MSW and special
waste along with C&D materials
Another working face in Phase 3 for
Bio soil flipping

Bio soil tipping in Phase 3

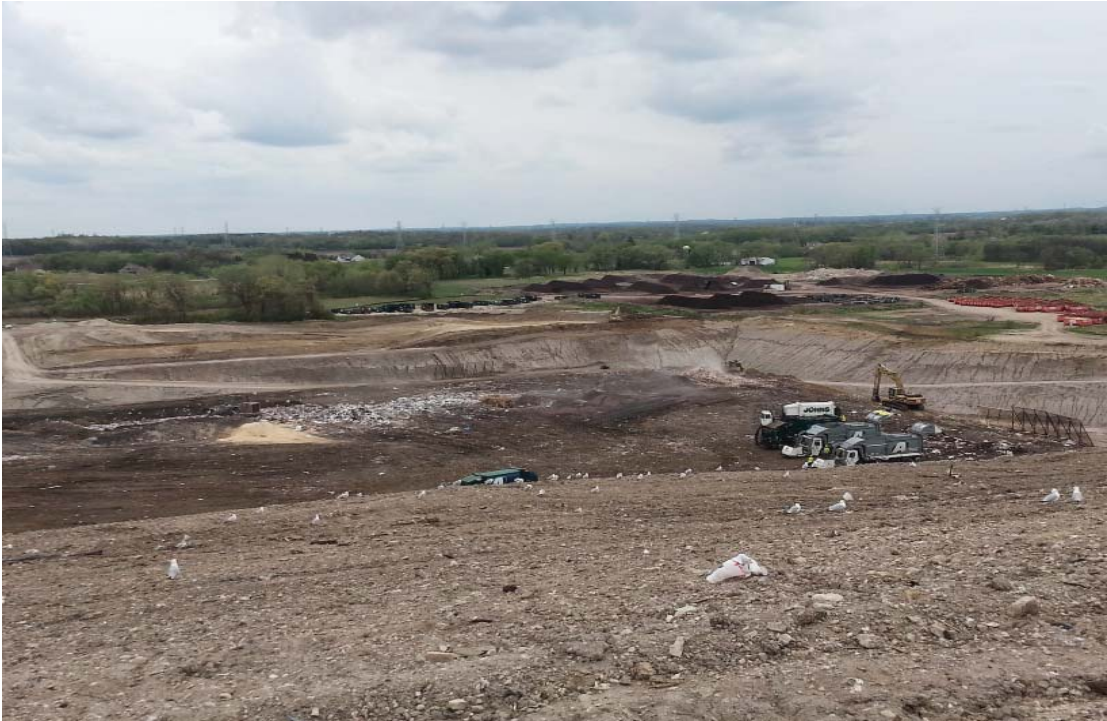
West end of Phase 7

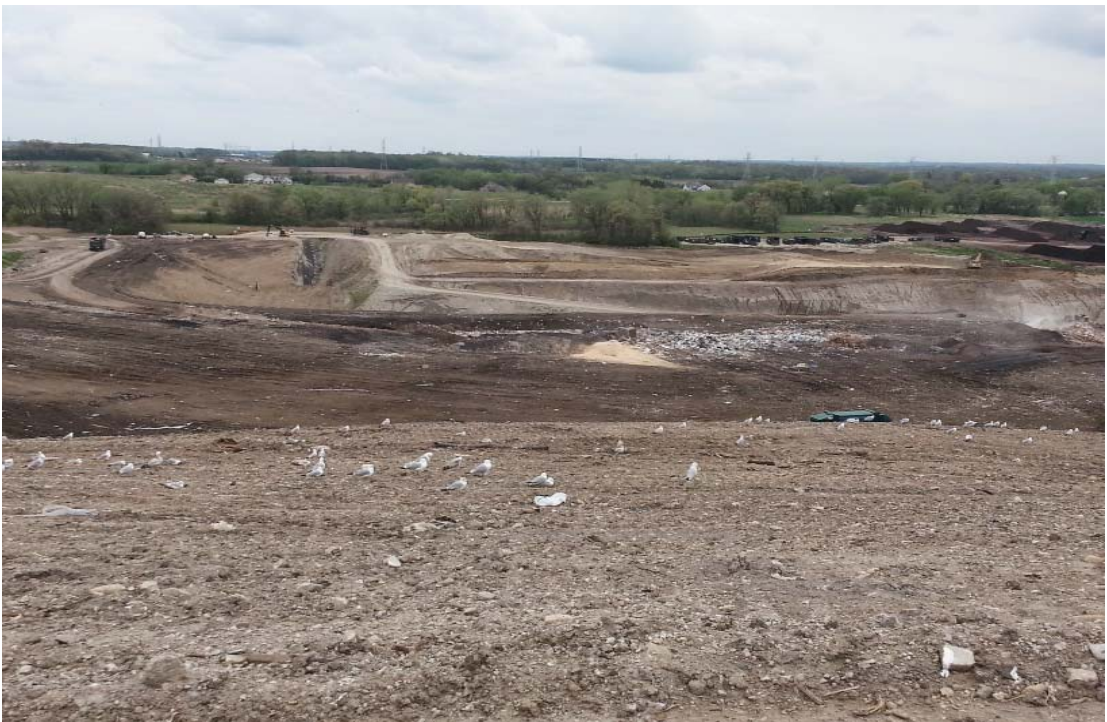
Working face viewed from North and above

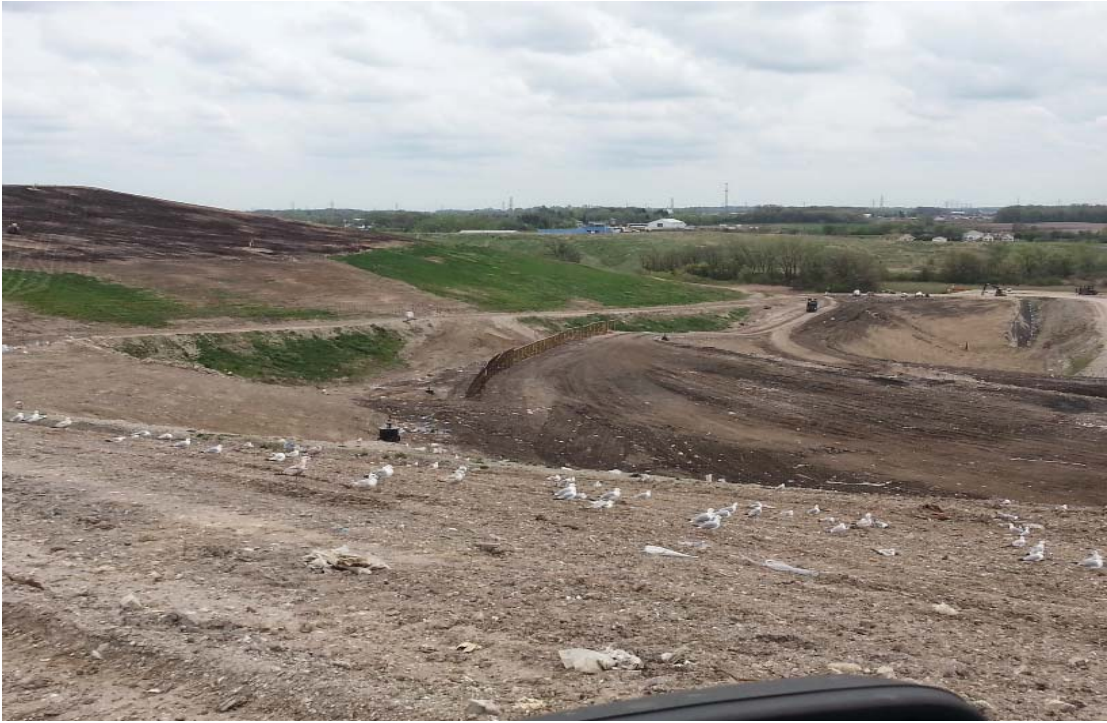
Access to Phase 7

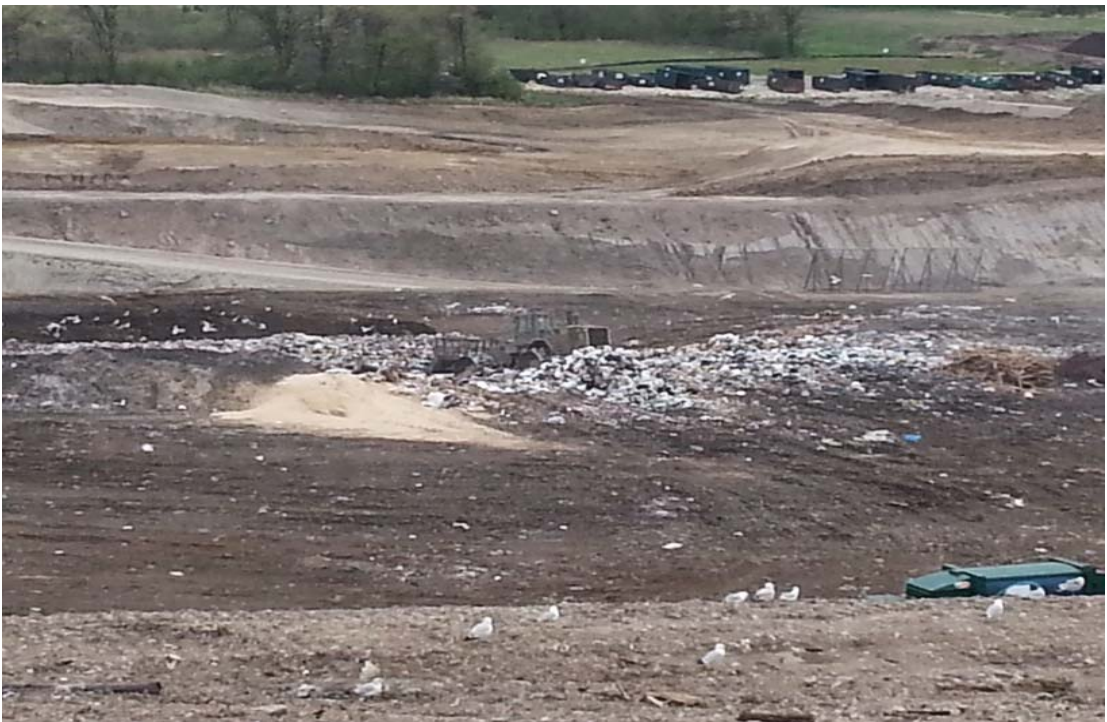
Active area viewed from the North

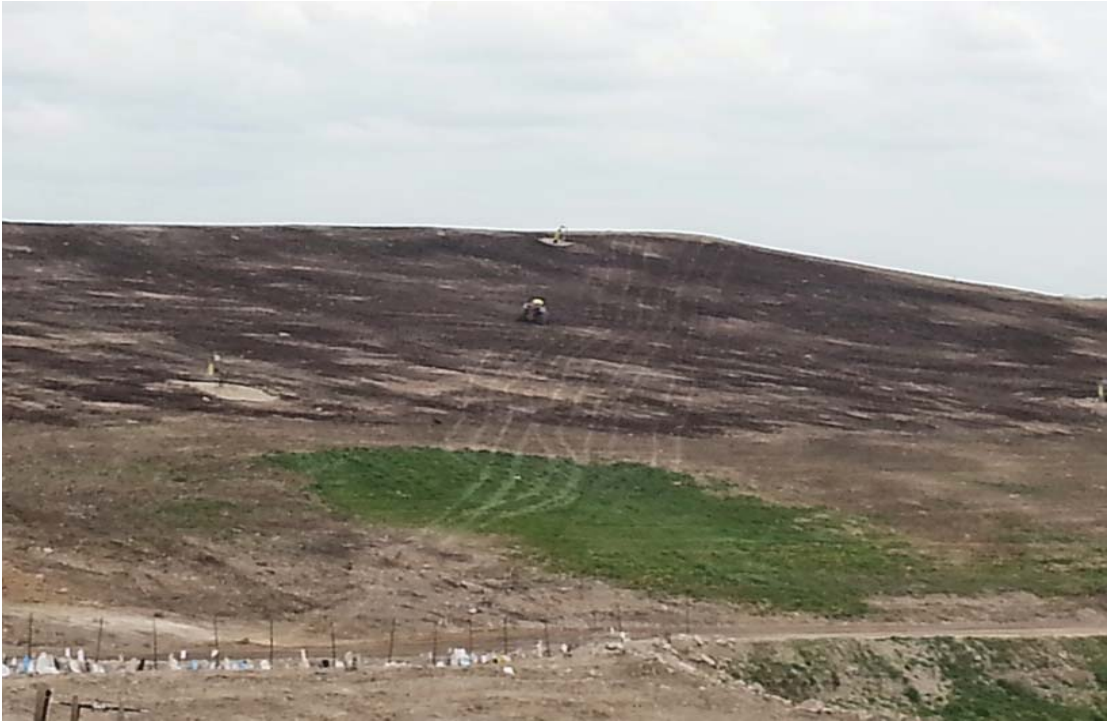
* Side surface repair ongoing contractor on site seeding during audit. Will follow with straw as tackifier.

Seeding of the West slope of Phase 6

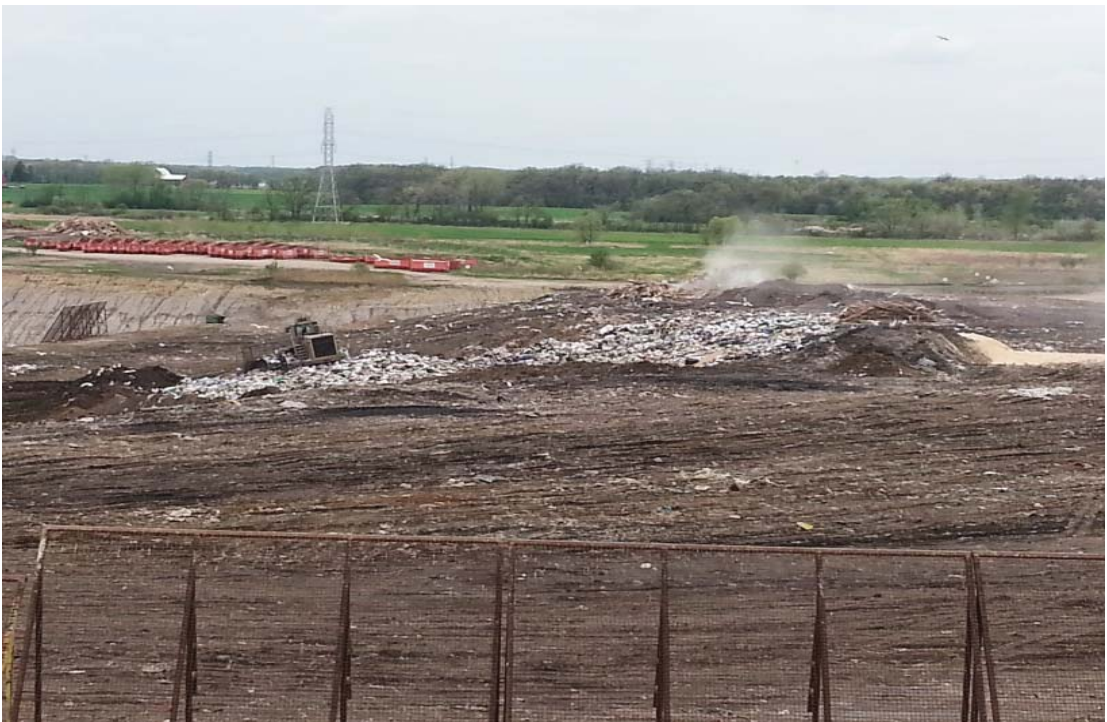
Working face viewed from the East
