Memorandum

ADS Emerald Park Landfill Audit Summary

To: ADS Emerald Park Landfill Standing Committee, City of Muskego
FROM: Faith Spear.
COPIES: File
DATE: 06/03/15
PROJECT NUMBER: 1012.10030

**ADVANCED DISPOSAL SERVICES
EMERALD PARK LANDFILL / CITY OF MUSKEGO
AUDIT PHOTOS**

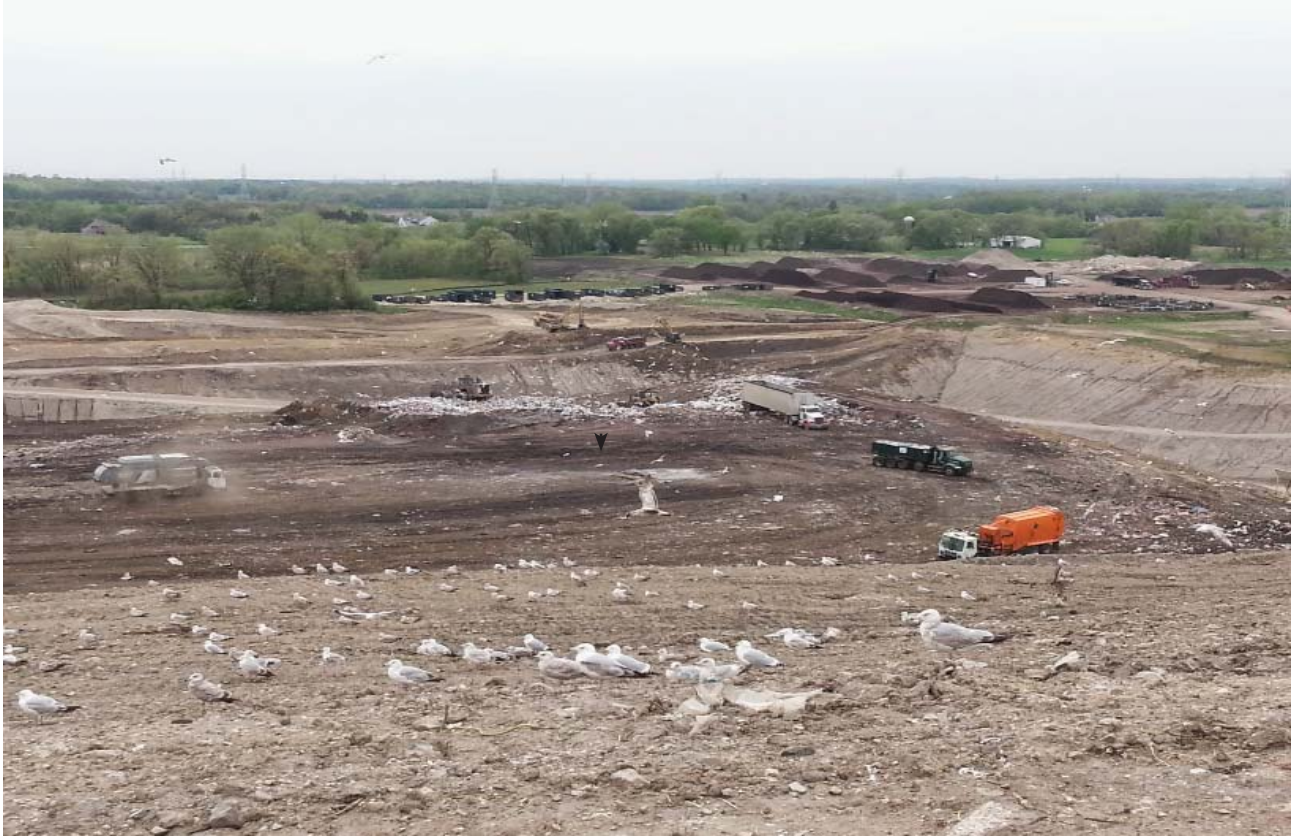
Active area viewed from the North

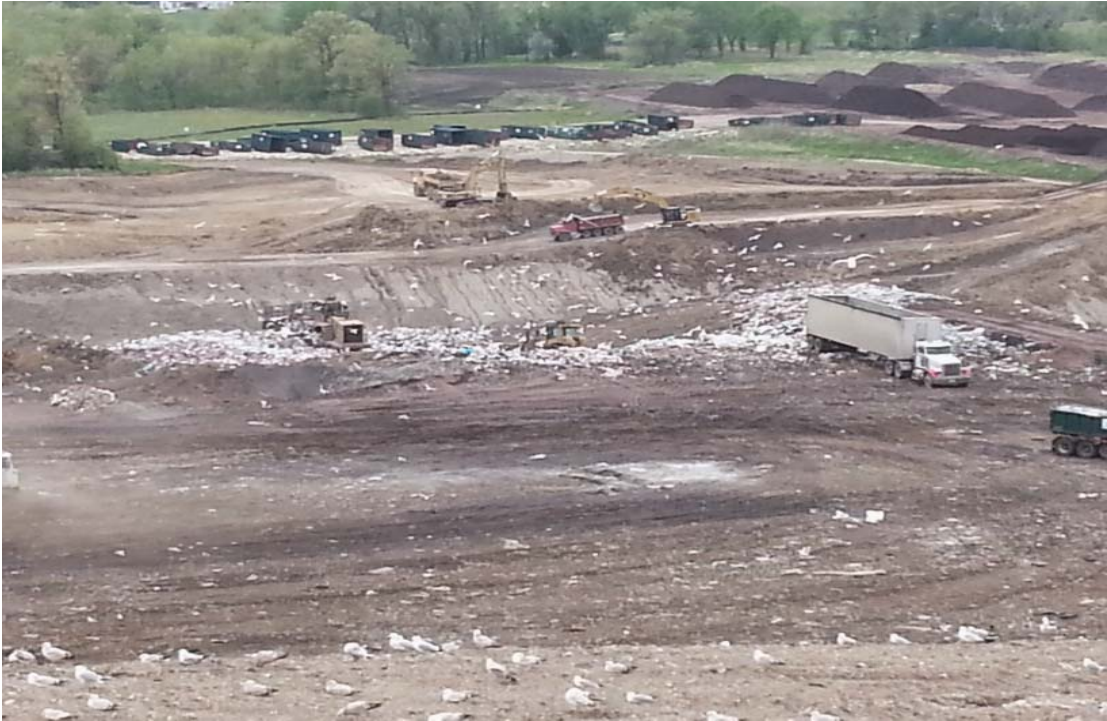
Working face viewed from North, excavation for back haul going on in the background

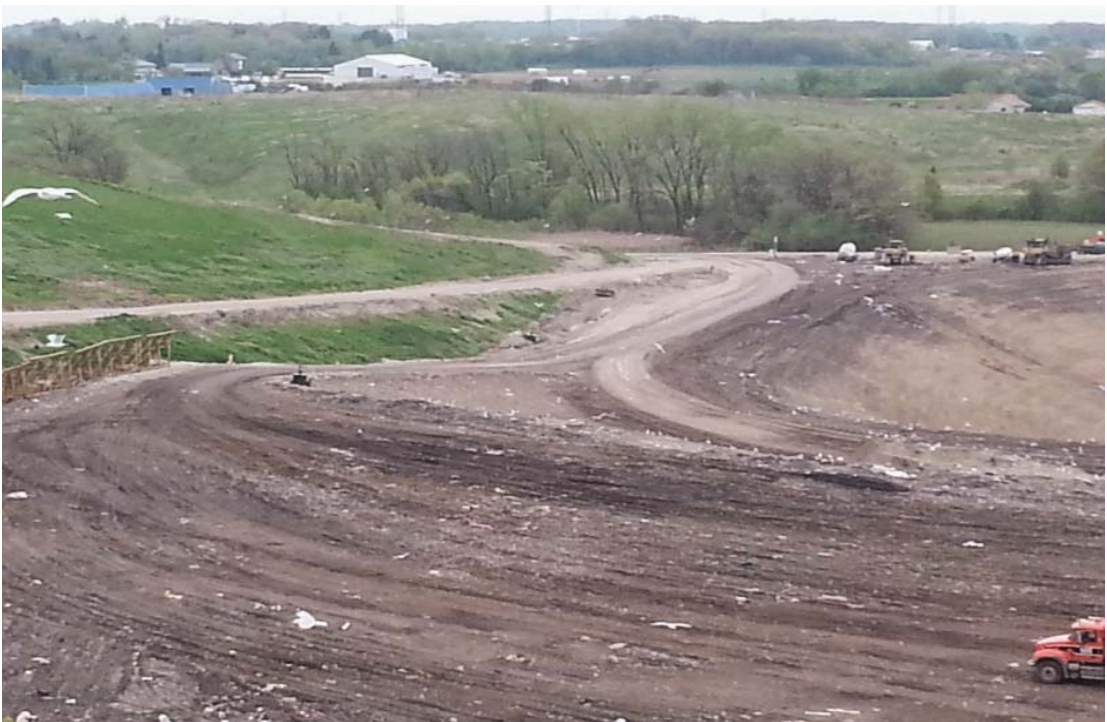
Access to Phase 7

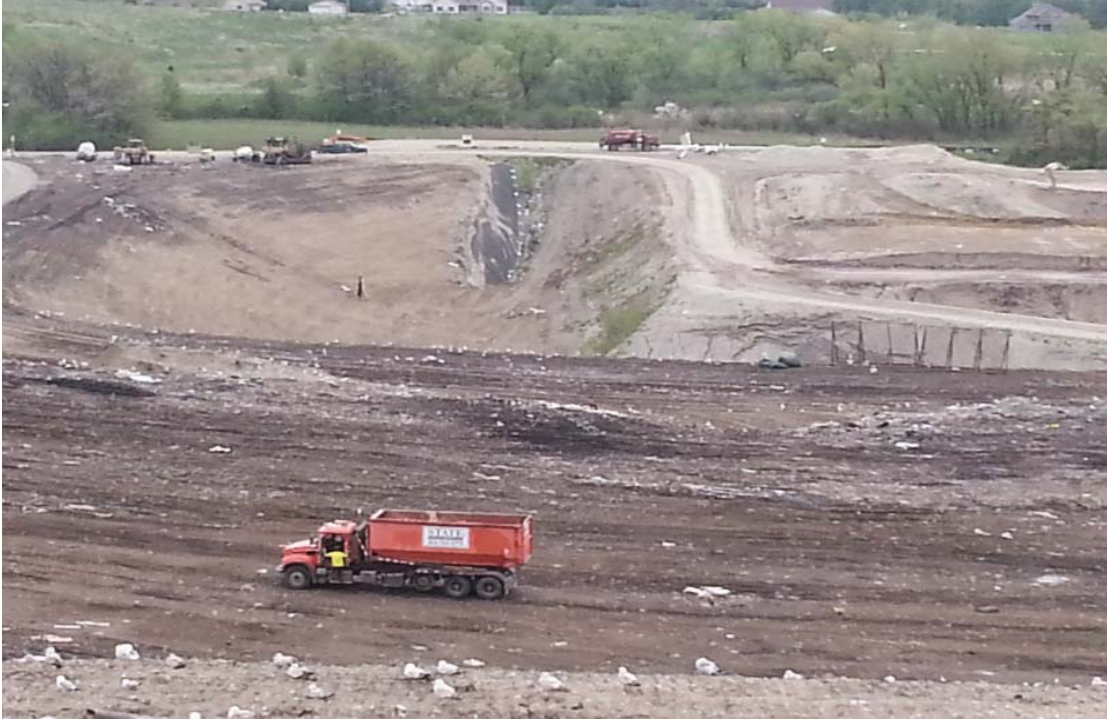
East edge of Phase 7

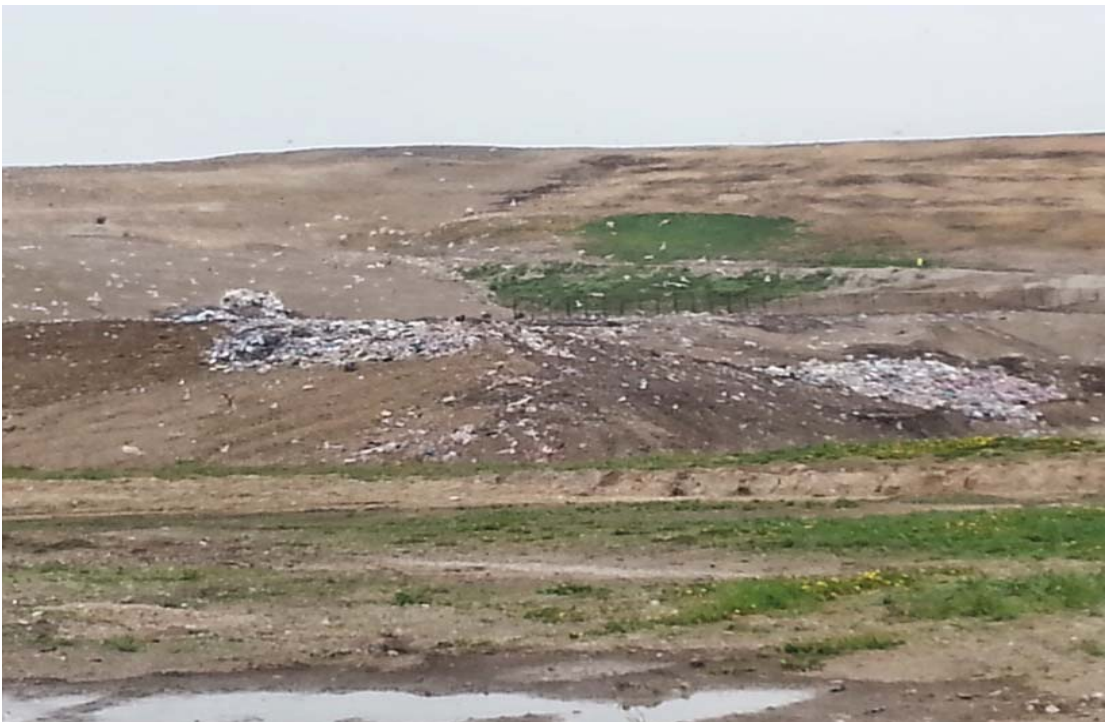
Southwest corner of Phase 7B

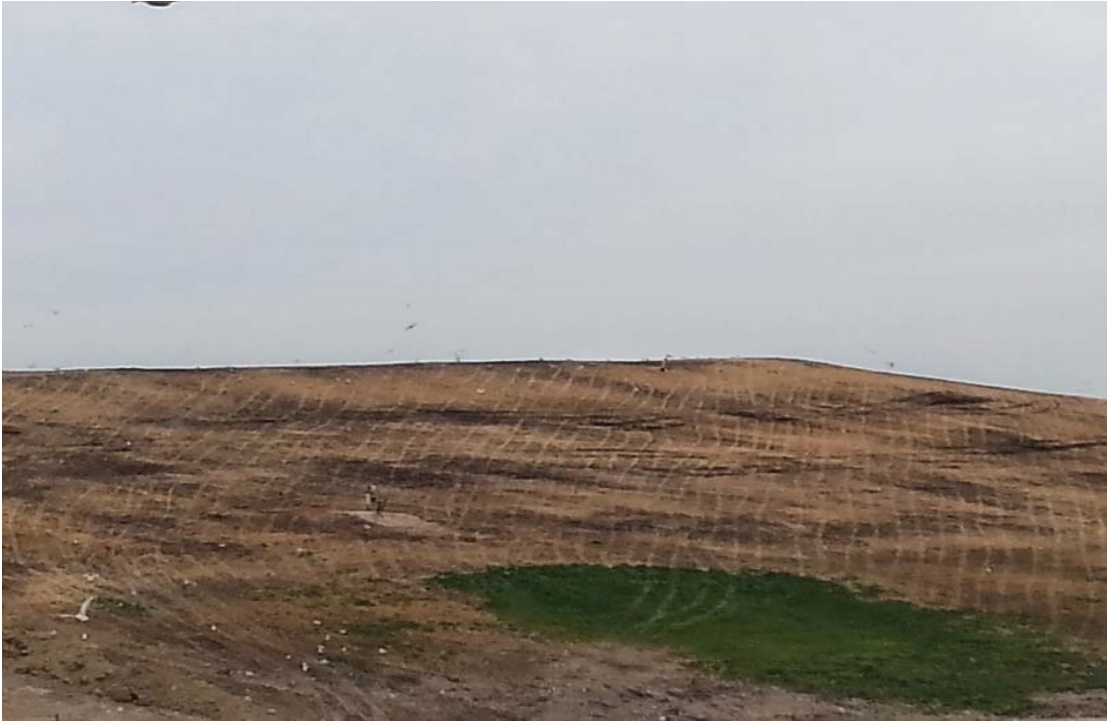
West slope of Phase 6, seeded and crimped

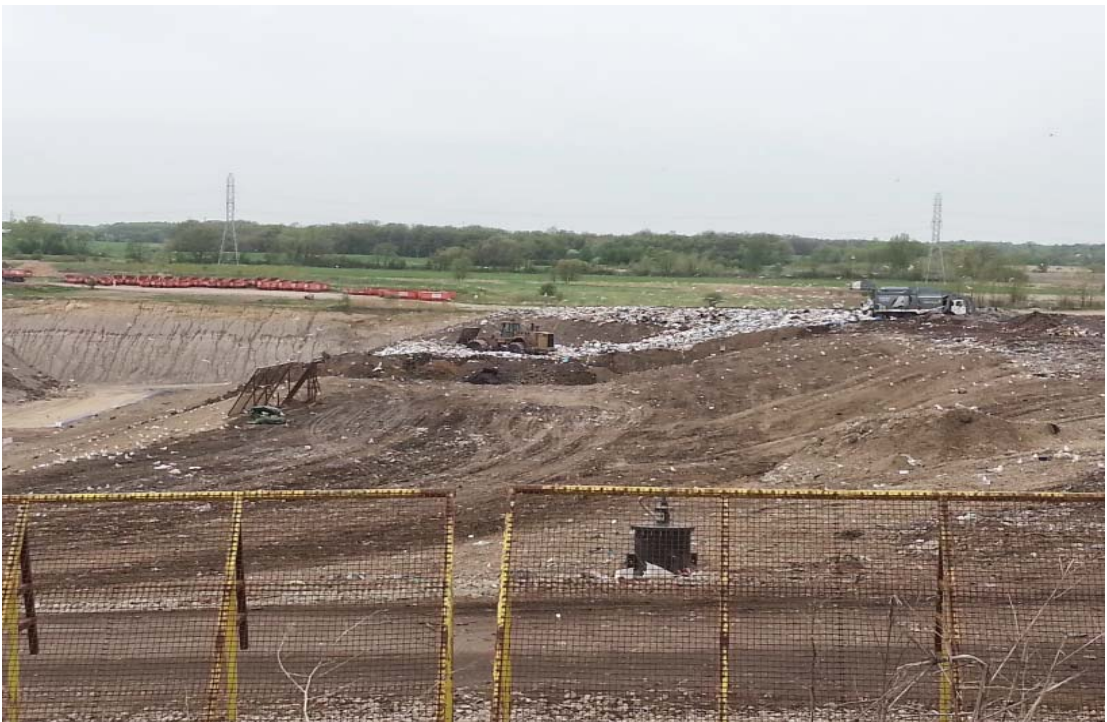
Working face viewed from the East
