ADS Emerald Park Landfill Audit Summary

To: ADS Emerald Park Landfill Standing Committee, City of Muskego
FROM: Faith Spear.
COPIES: File
DATE: 08/17/15
PROJECT NUMBER: 1012.10030

Attached is the audit report for activities at the ADS Emerald Park Landfill for the week of July 13, 2015. The audit was performed at 3:55 PM on **July 16, 2015** by Jo Spear, Jr. in the presence of Michael Hackney, General Manager.

**ADVANCED DISPOSAL SERVICES
EMERALD PARK LANDFILL / CITY OF MUSKEGO
AUDIT PHOTOS**

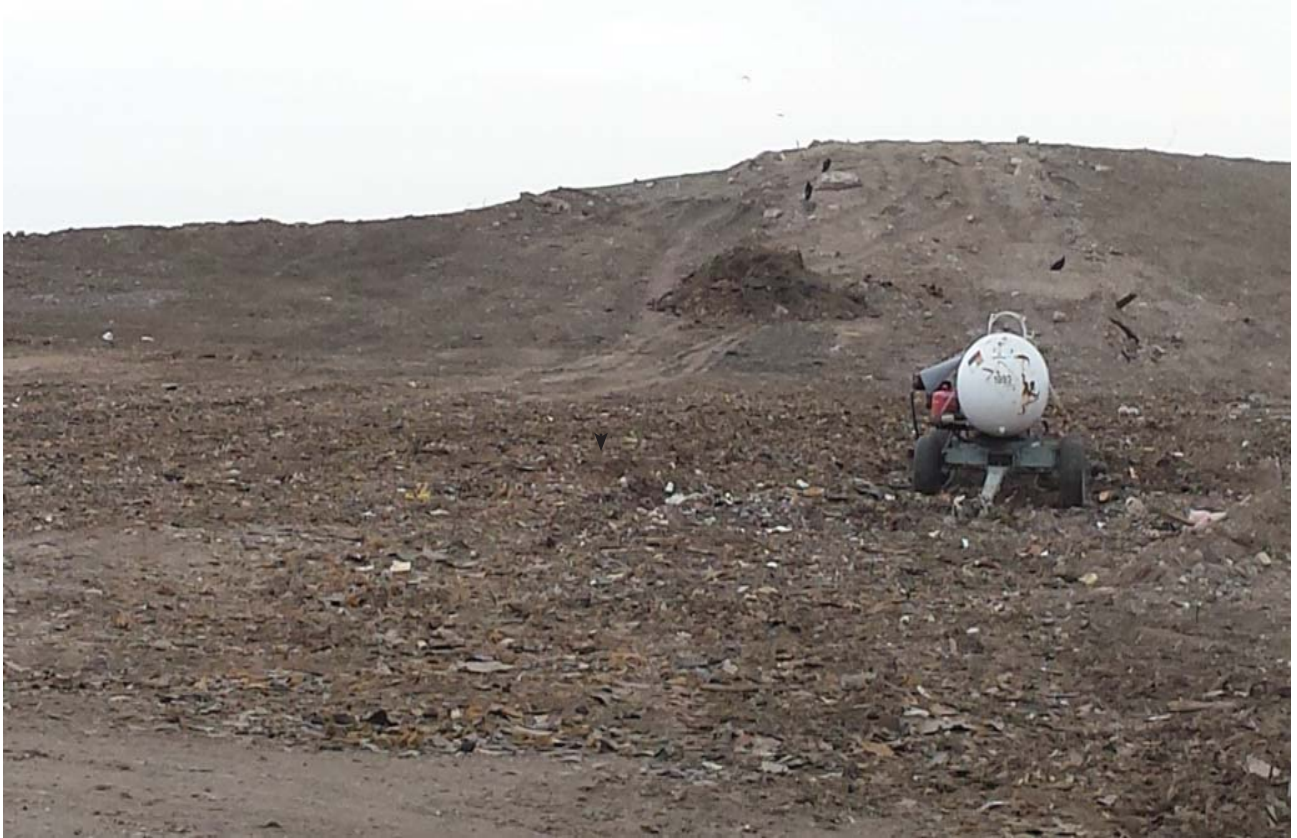
Cover soil was high volume at start of month. Volume reduced to an occasional truck.

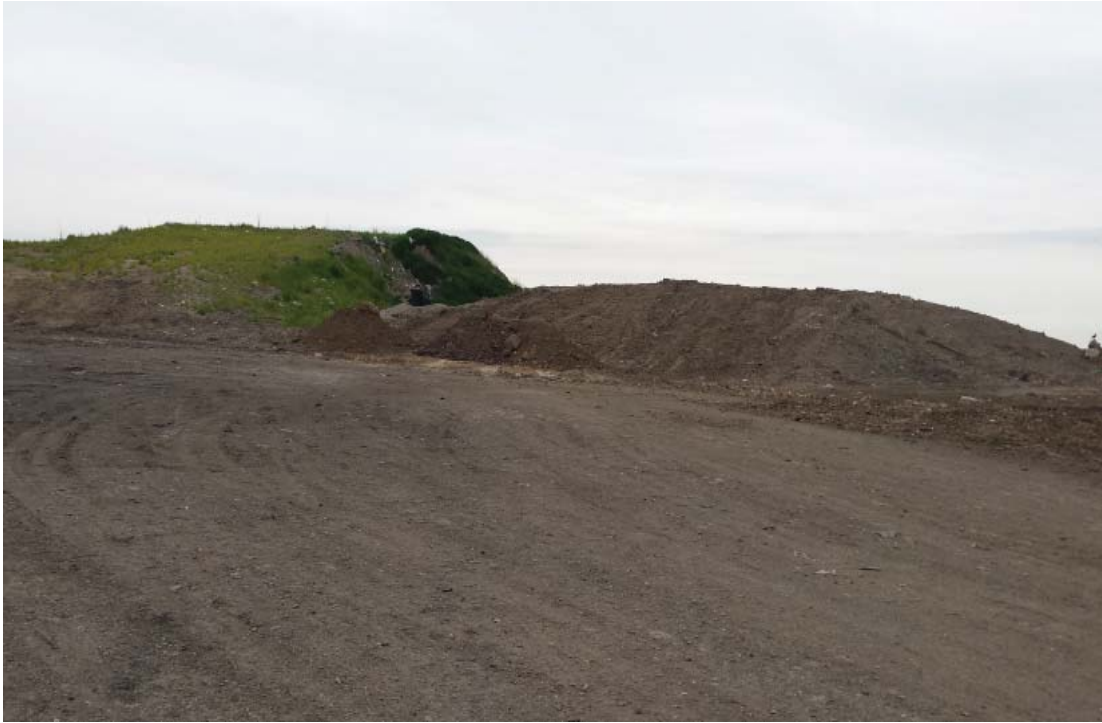
Bio soils, very little change over the last month

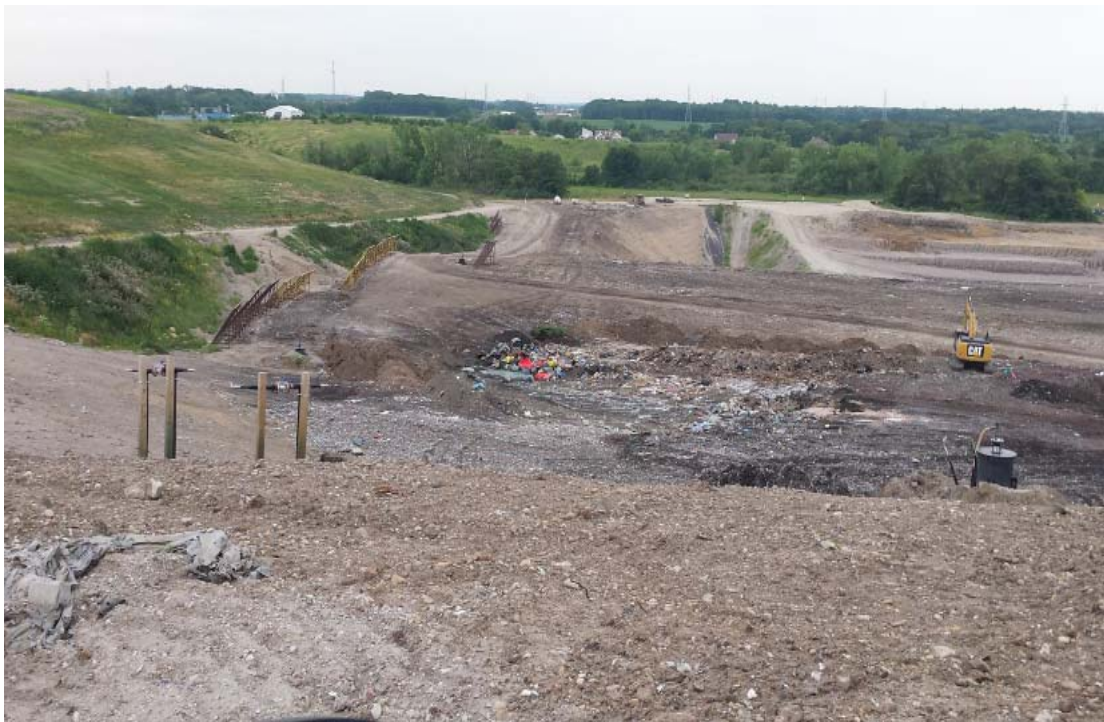
Active area viewed from North. Cover of waste active below.

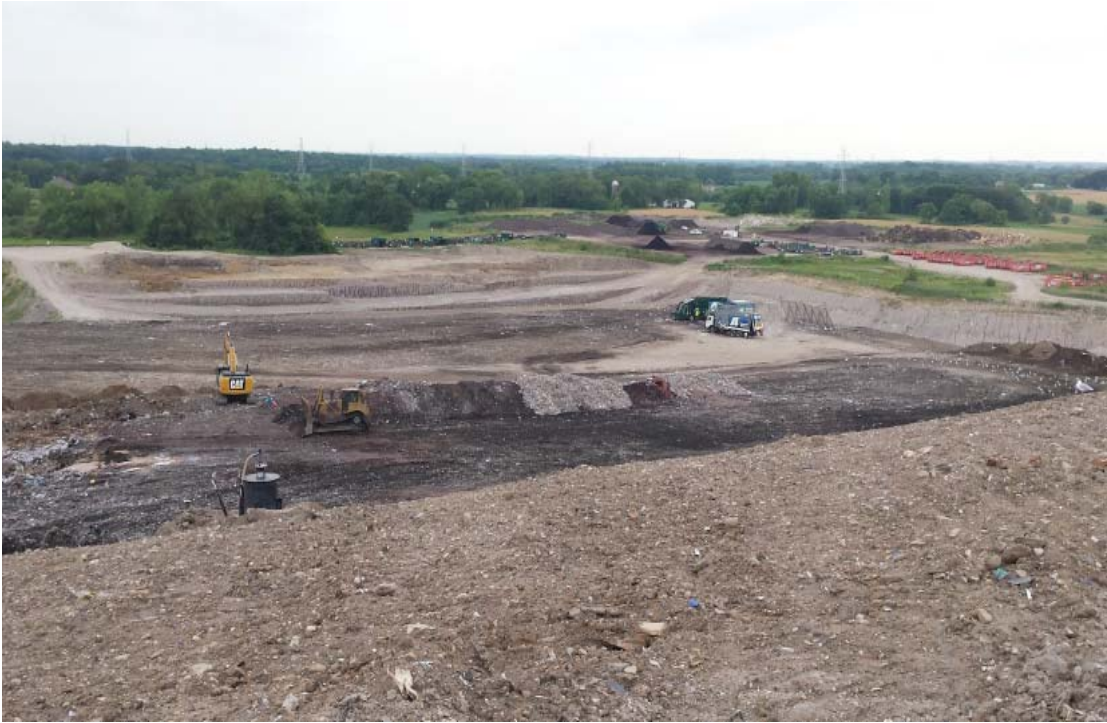
Access and approach to access area

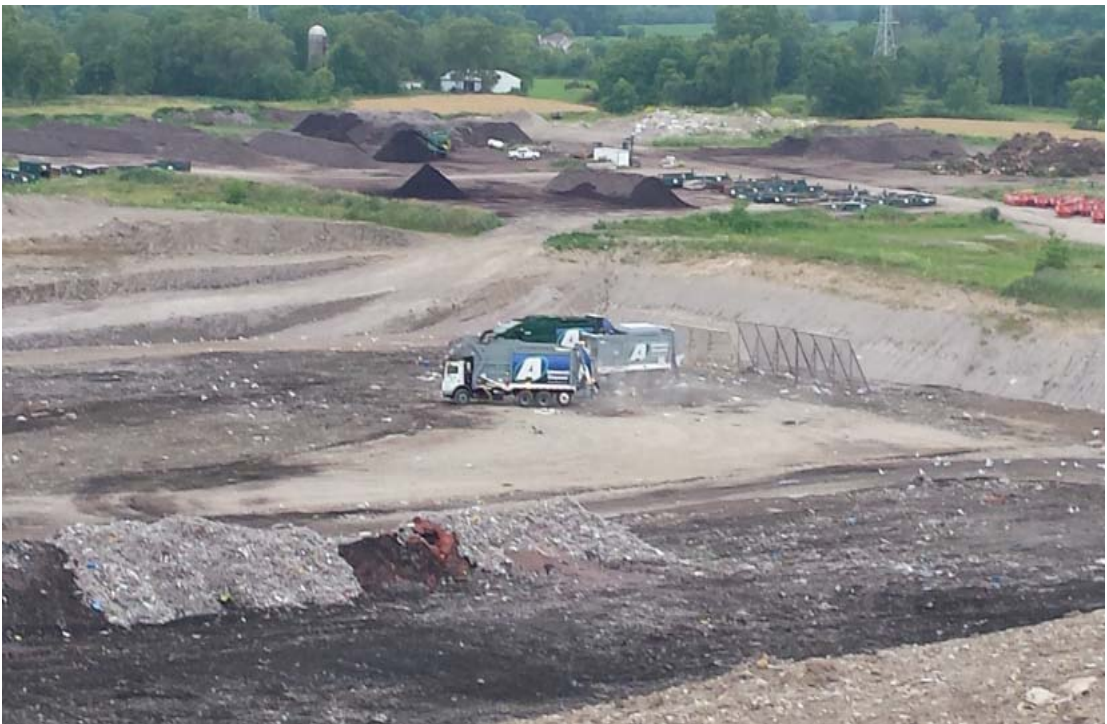
Overview of Active area, trucks in cleanout area in Southwest corner of Phase

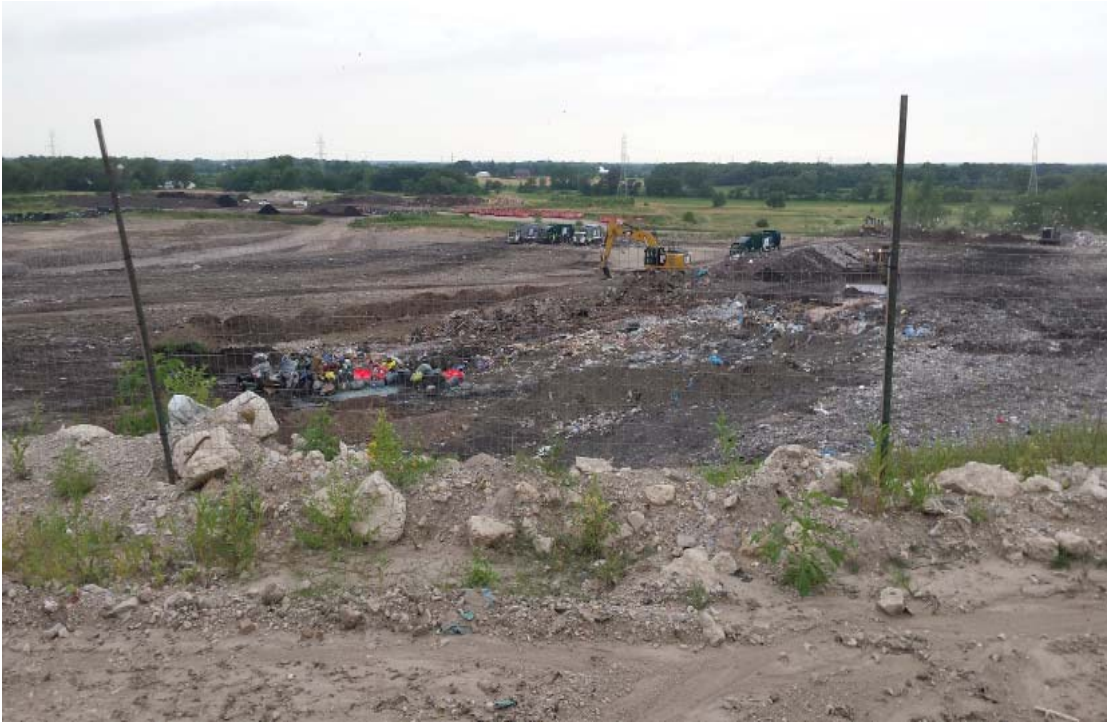
Working face and cover activities

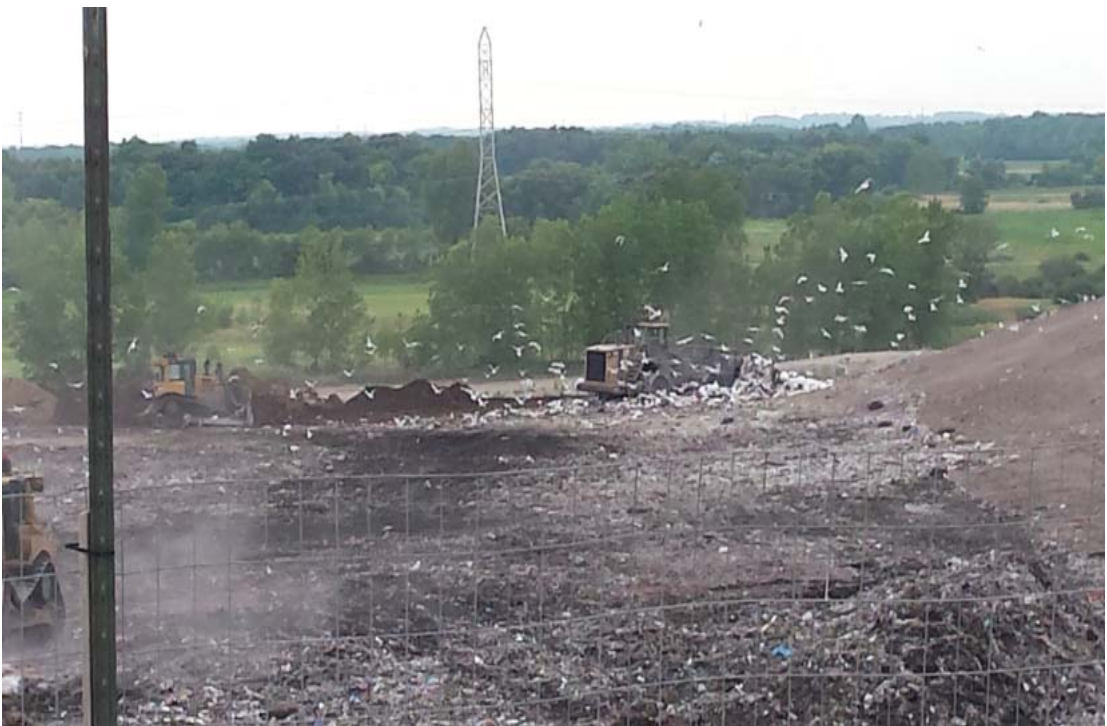
Compactor working in waste at top of slope

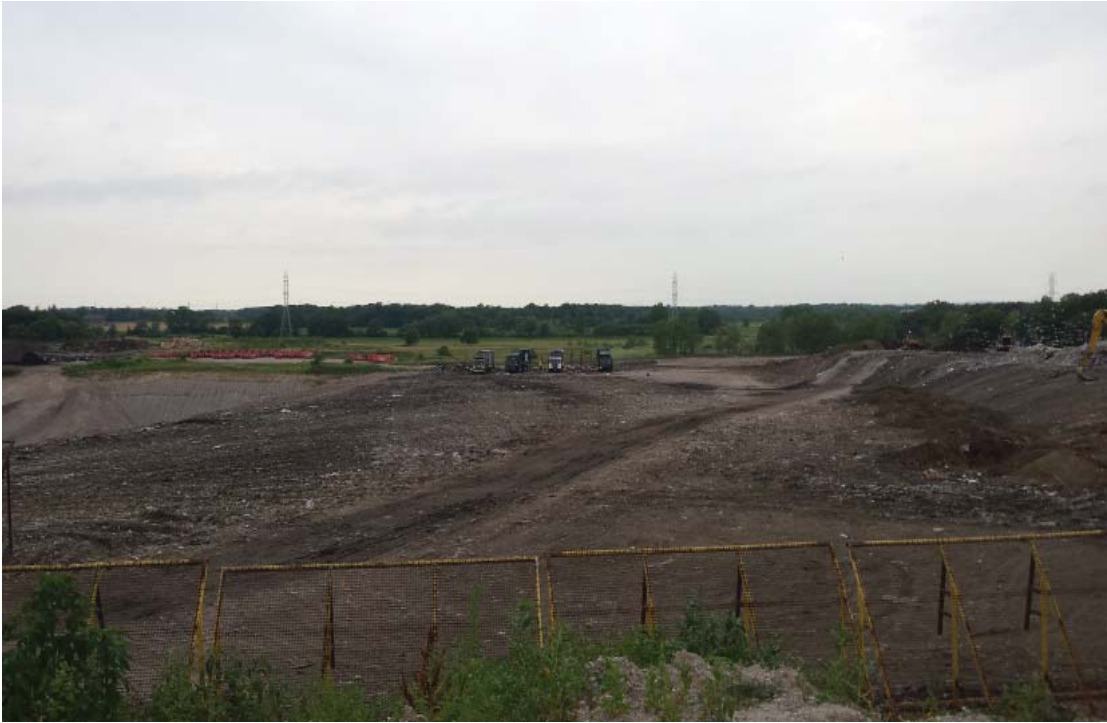
Surface of active area, trucks cleaning out in the far distance of photo

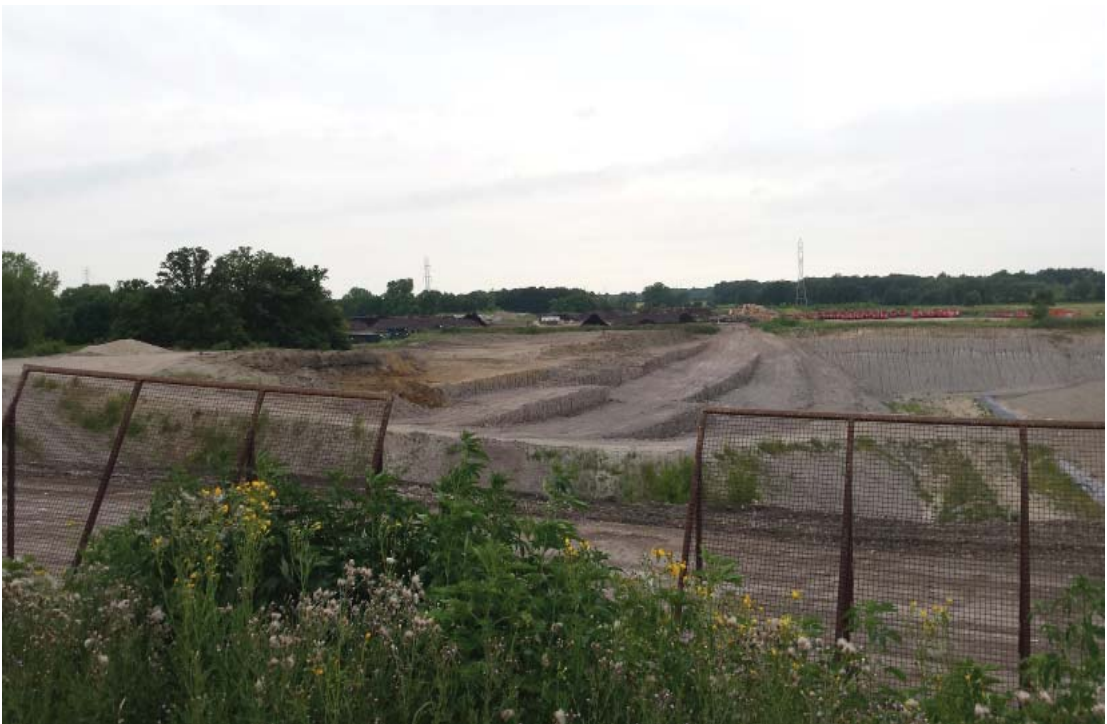
Excavation area for future Phase 8, no back haul or excavation this week
