Memorandum

ADS Emerald Park Landfill Audit Summary

TO: ADS Emerald Park Landfill Standing Committee, City of Muskego
FROM: Faith Spear.
COPIES: File
DATE: 11/28/16
PROJECT NUMBER: 1012.10030

**ADVANCED DISPOSAL SERVICES
EMERALD PARK LANDFILL / CITY OF MUSKEGO
AUDIT PHOTOS**

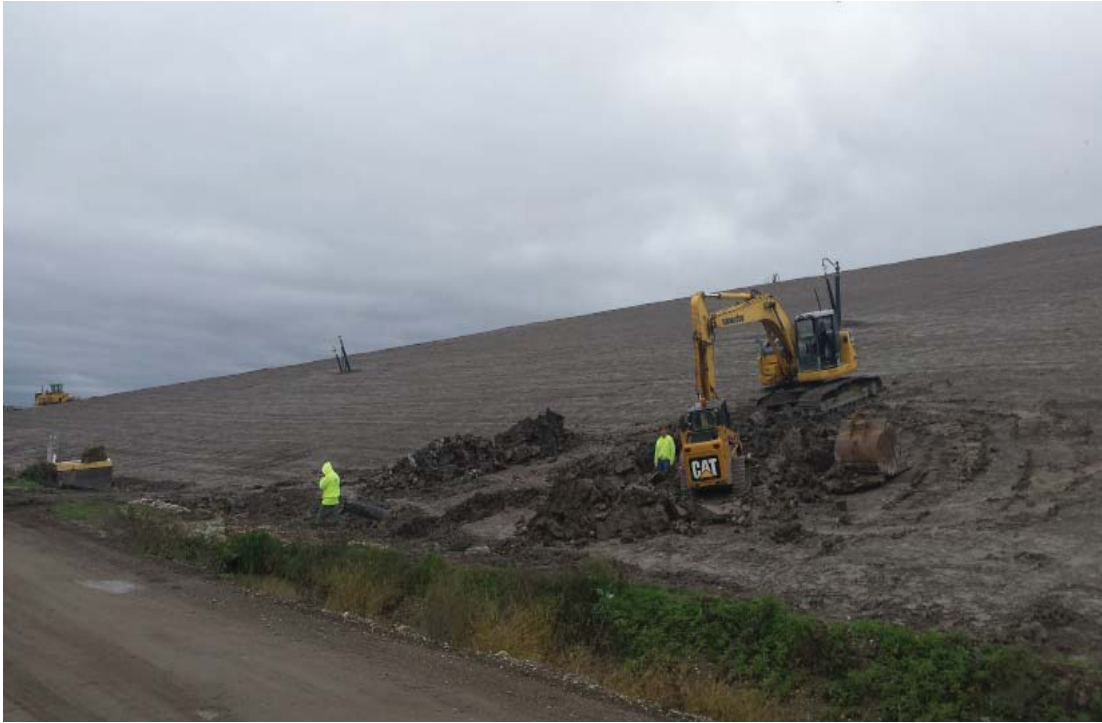
- Old access road removal ongoing
 - Road base clay depths up to 20 feet
- Access to Phases 1 thru 3 to be restored after removal of old access road completed
- Gas line in Phase 6 Closure Area IV under repair during audit. Pipe was damaged by equipment during soil placement. Moisture in soil was making repair difficult.

Repair of pneumatic gas line in cover layers

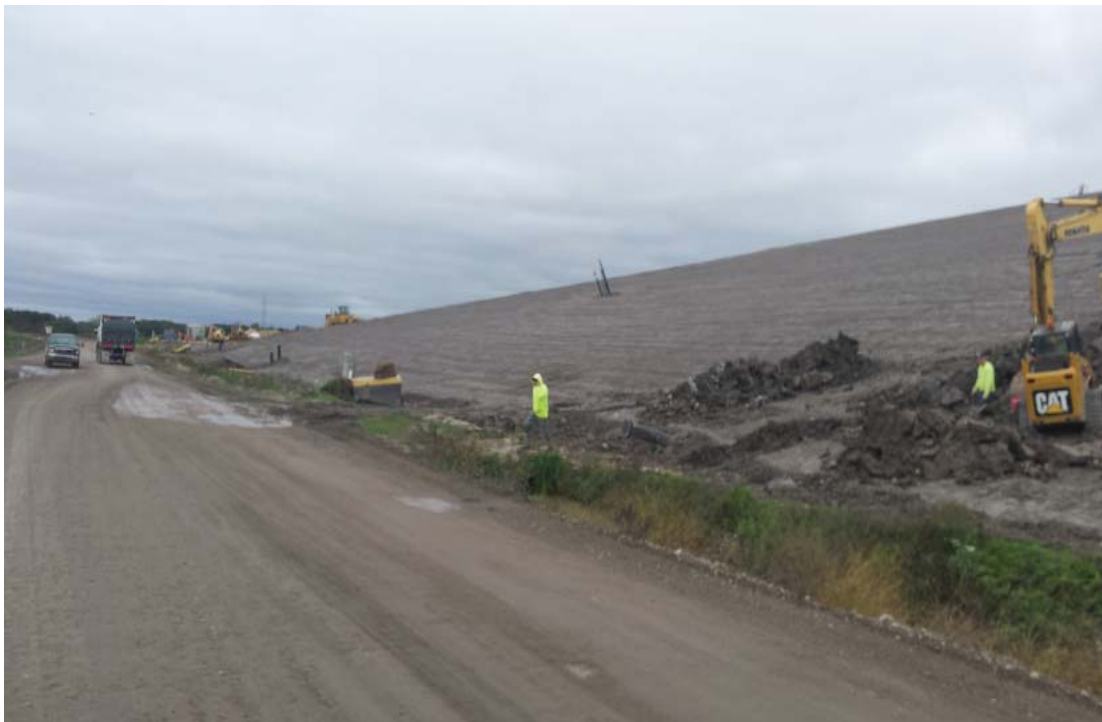
South slope of Phases 5 and 6, closure area IV with first lift of clay placement

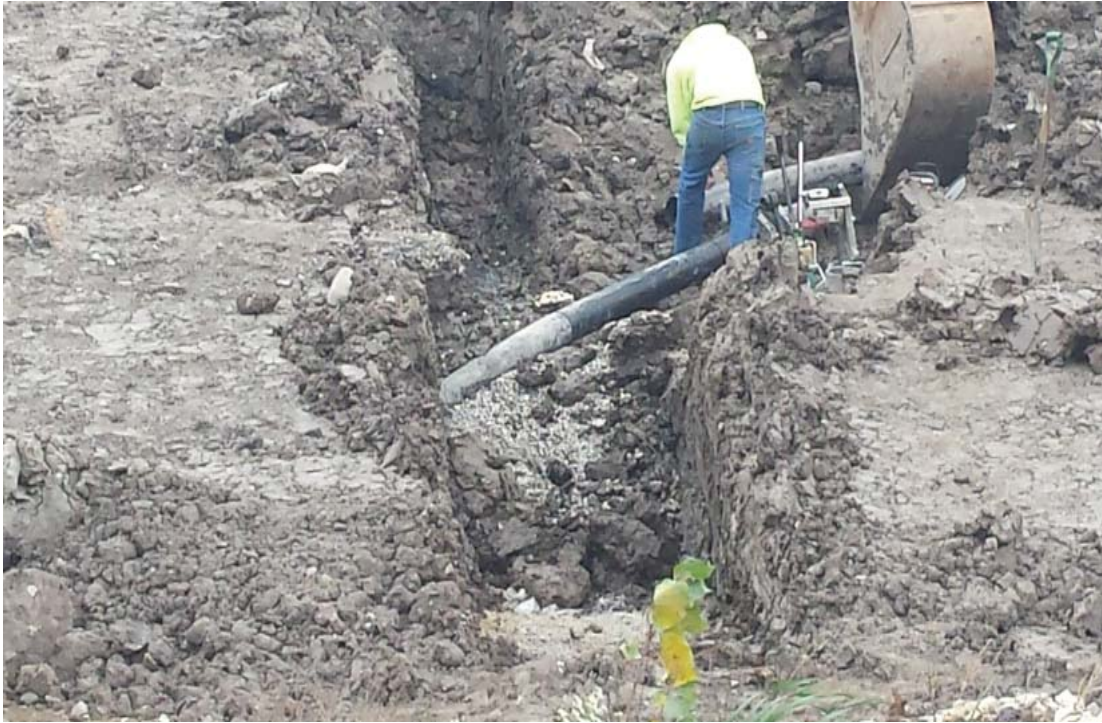
- Work suspended due to wet conditions
- Attempts to speed drying of clay soils caused a break in a gas line this morning
- Repair taking place during audit
- One excavator working in construction area

Damaged pipe during drying of clay lift for Closure Area IV

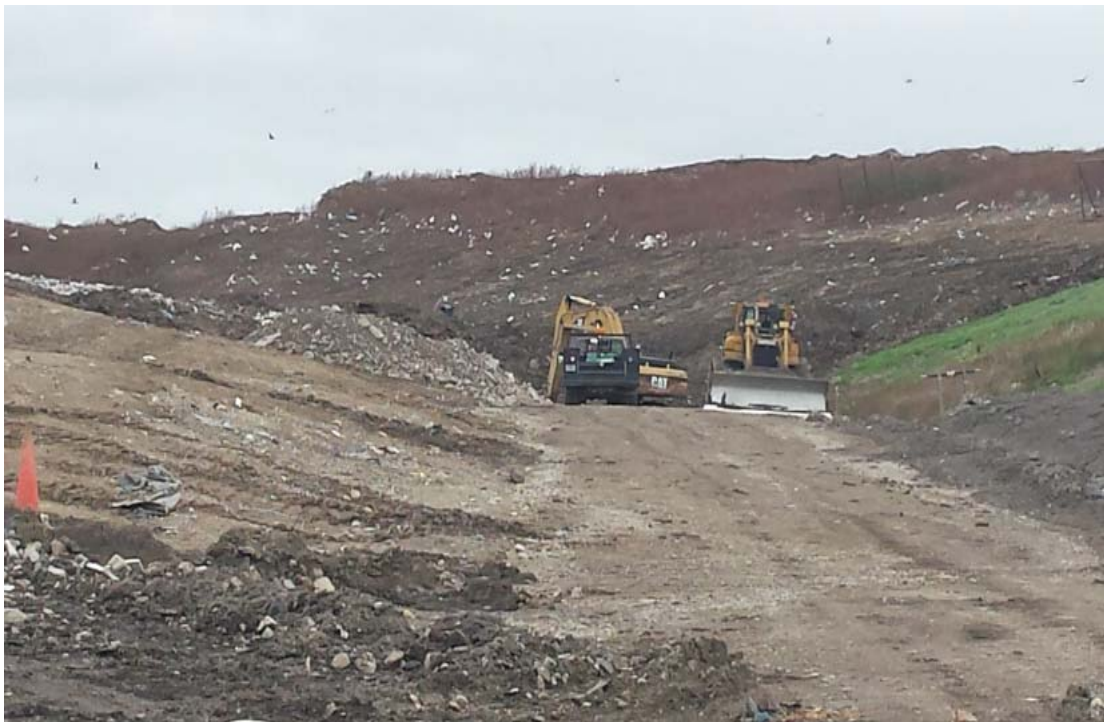
* Road removal ongoing, clay depths to 20'

Removal of the access road to Phases 1 thru 3 to allow overlay between Phases 6 and 7

* Access to Phase 1 thru 3 to be restored after old access removed.
