ADS Emerald Park Landfill Audit Summary

To: ADS Emerald Park Landfill Standing Committee, City of Muskego
FROM: Faith Spear.
COPIES: File
DATE: 7/9/18
PROJECT NUMBER: 1012.10030

Attached is the audit report for activities at the ADS Emerald Park Landfill for the week of March 25, 2018. The audit was performed at 12:37 PM on **March 27, 2018** by Jo Spear, Jr. in the presence of Brett Coogan, Operations Manager.

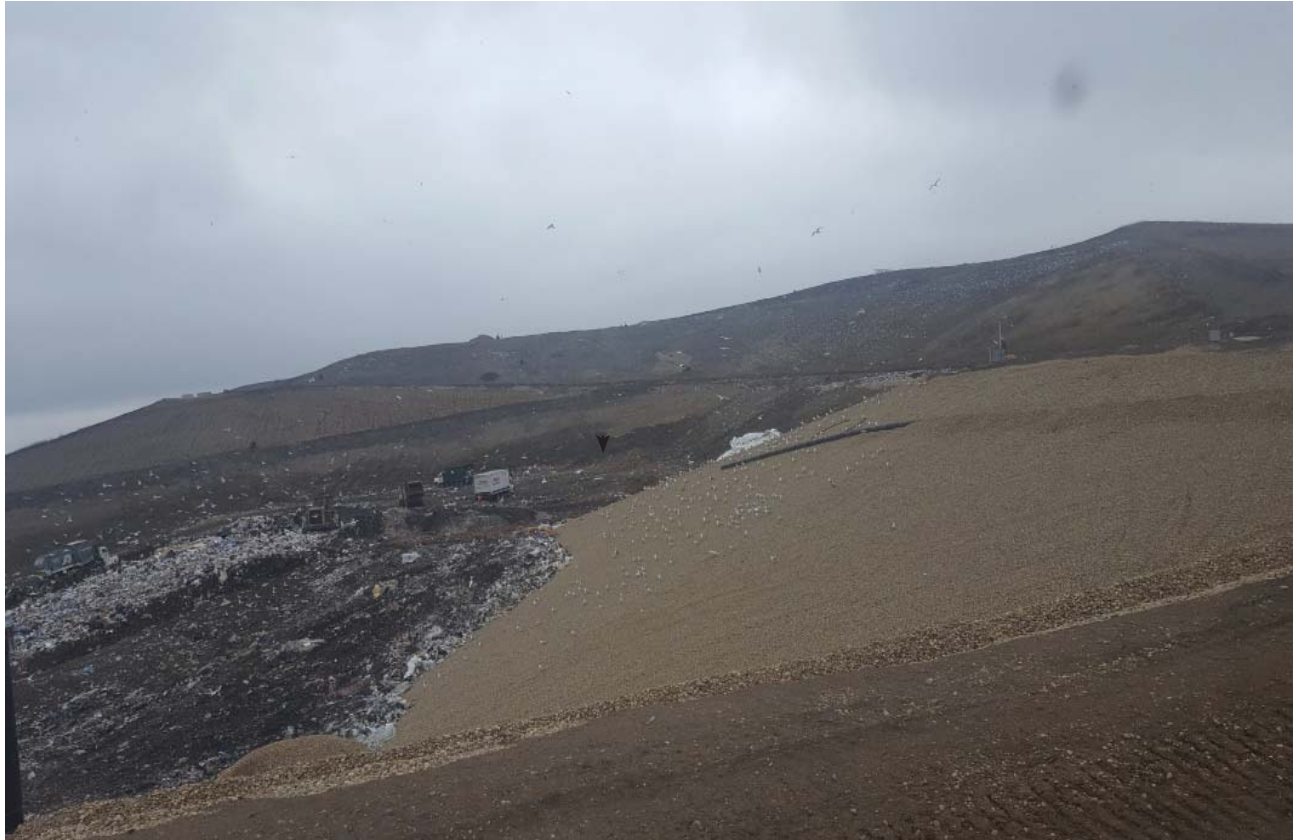
East edge of Phase 7 South

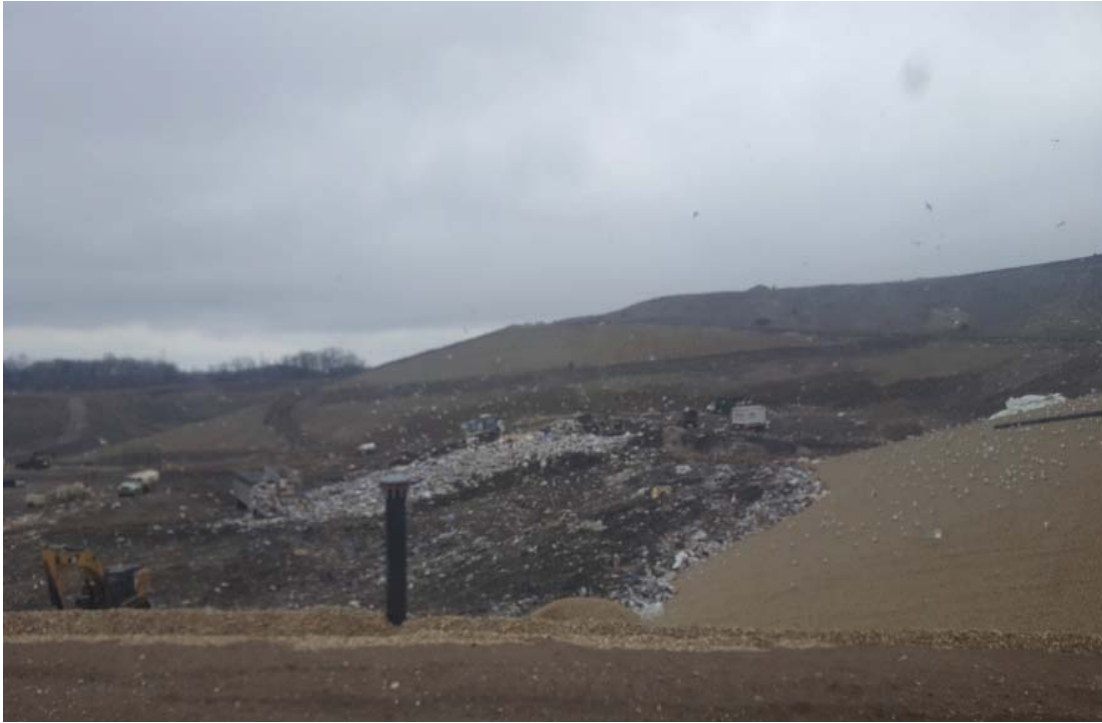
Phase 7 South, working face in center of Phase

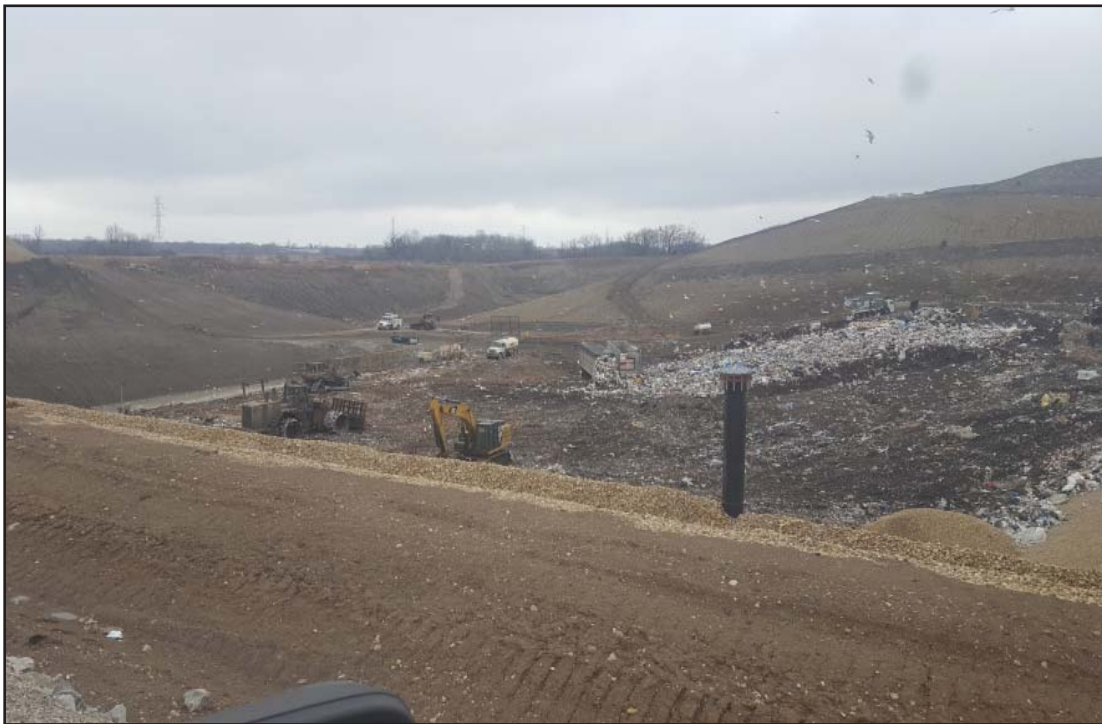
Phase 7 South viewed from the South

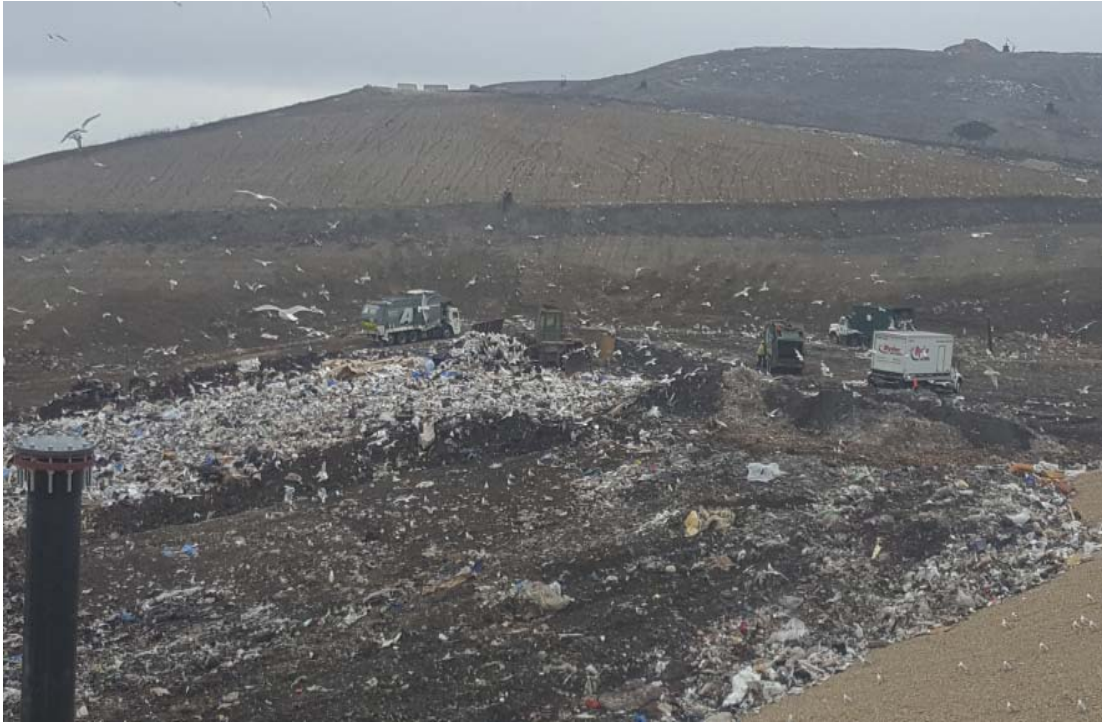
Working face in center of Phase 7 South

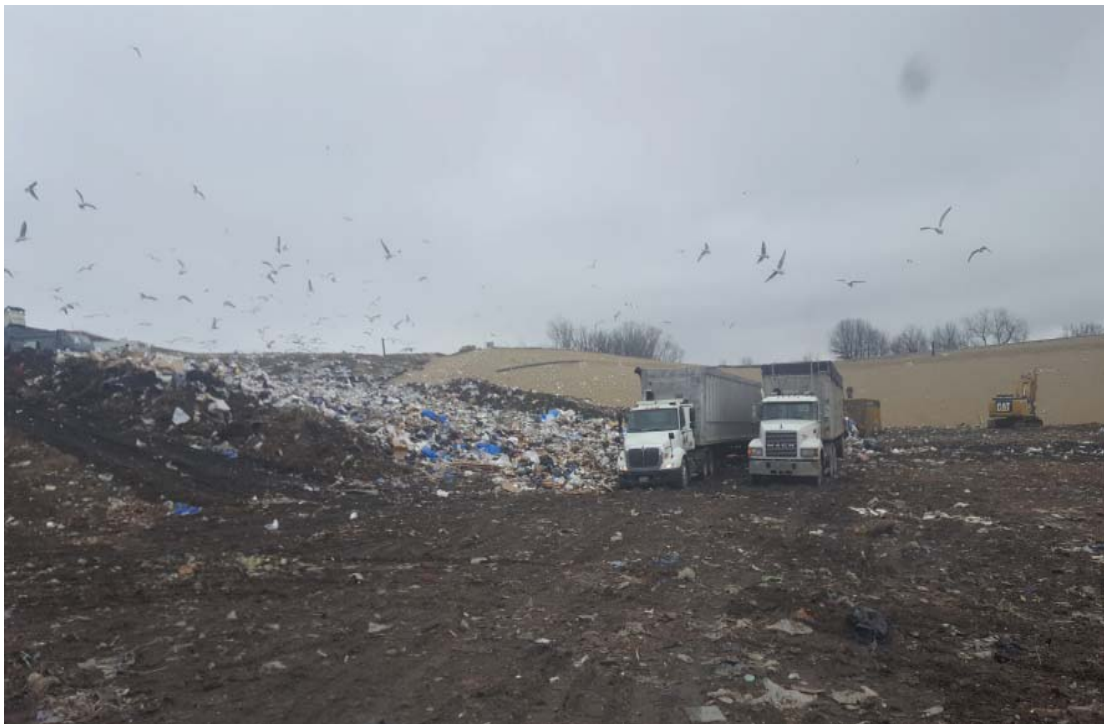
Working face in Phase 7 South, toe of face
