ADS Emerald Park Landfill Audit Summary

To: ADS Emerald Park Landfill Standing Committee, City of Muskego
FROM: Jo-Walter Spear, Jr., P.E.
COPIES: File
DATE: 09/18/2020
PROJECT NUMBER: 1012.10030

Attached is the audit report for activities at the ADS Emerald Park Landfill for the week of September 13, 2020. The audit was performed at 11:15 AM on **September 15, 2020** by Jo Spear, Jr.; in the presence of Chad Siegle; the Site Manager.

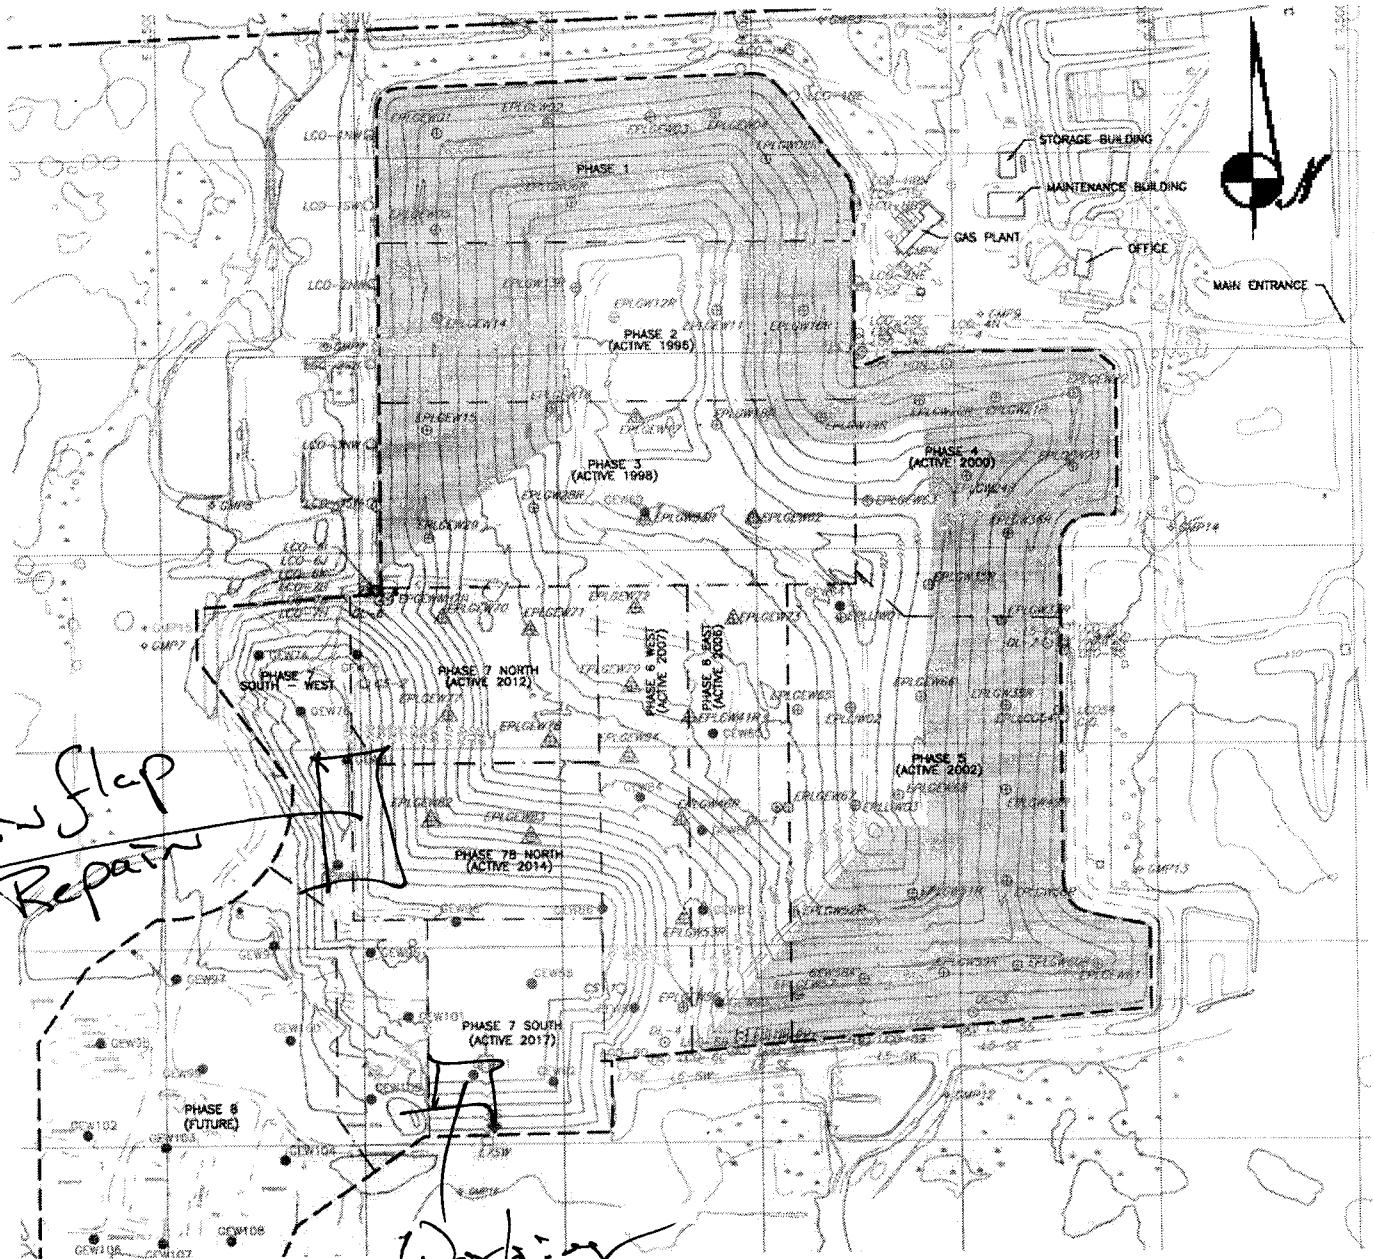
Advanced Disposal Emerald Park Landfill Audit Map

Repair Flap
Repair

Working Face

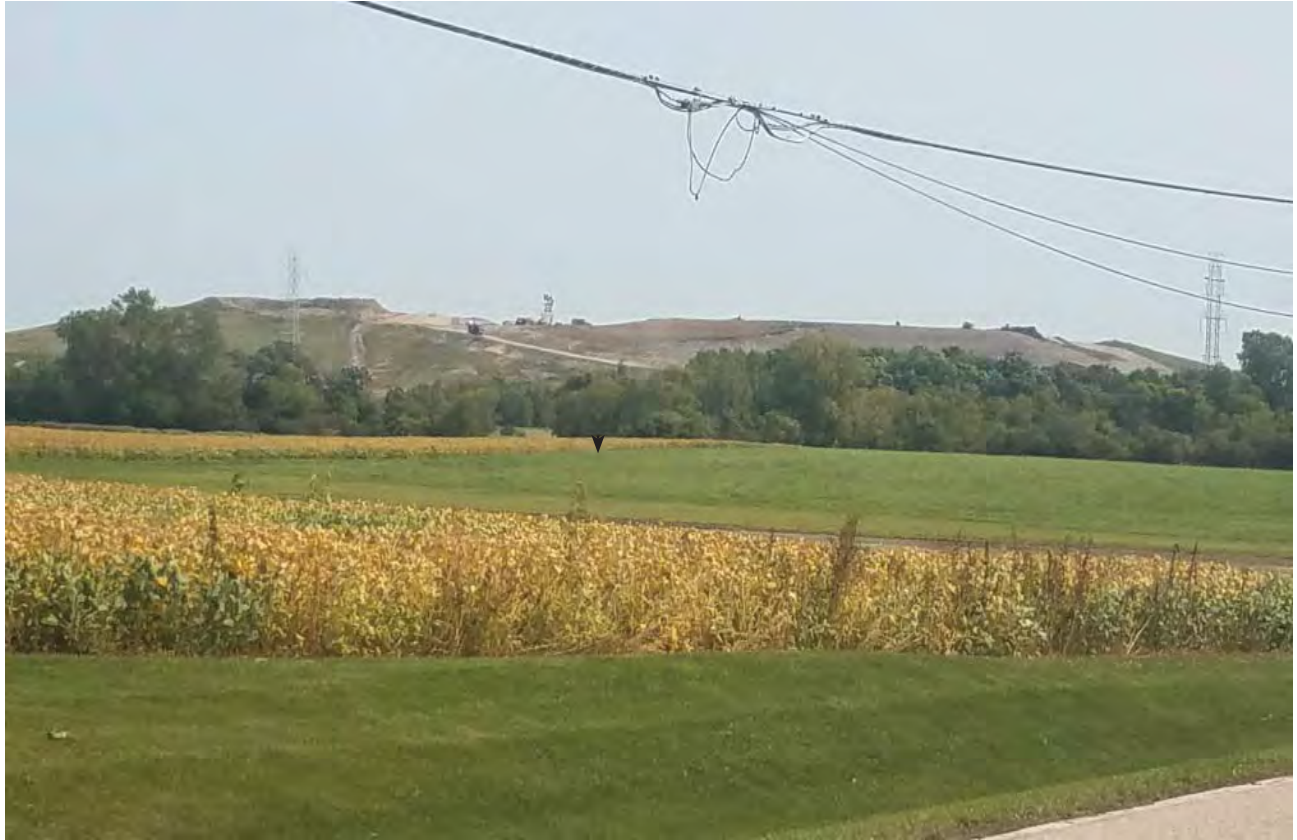
Overview of Emerald Park Landfill from West

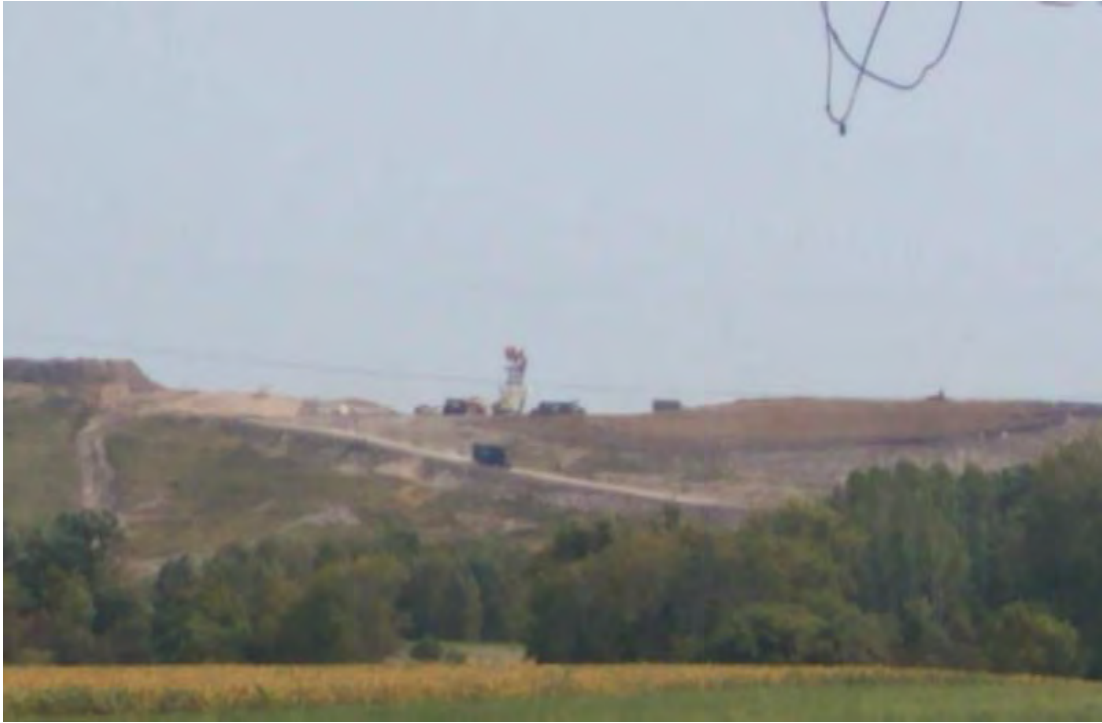
- Vehicle traffic erosion at junction of Phase 3 and 7, West slope
- E) Odor Control
 - Autofluff and waste odors on US 45
 - No odors on Access road
- F) Liquid Loads

Erosion channels on West slope of Phase 3/7, left side of photo

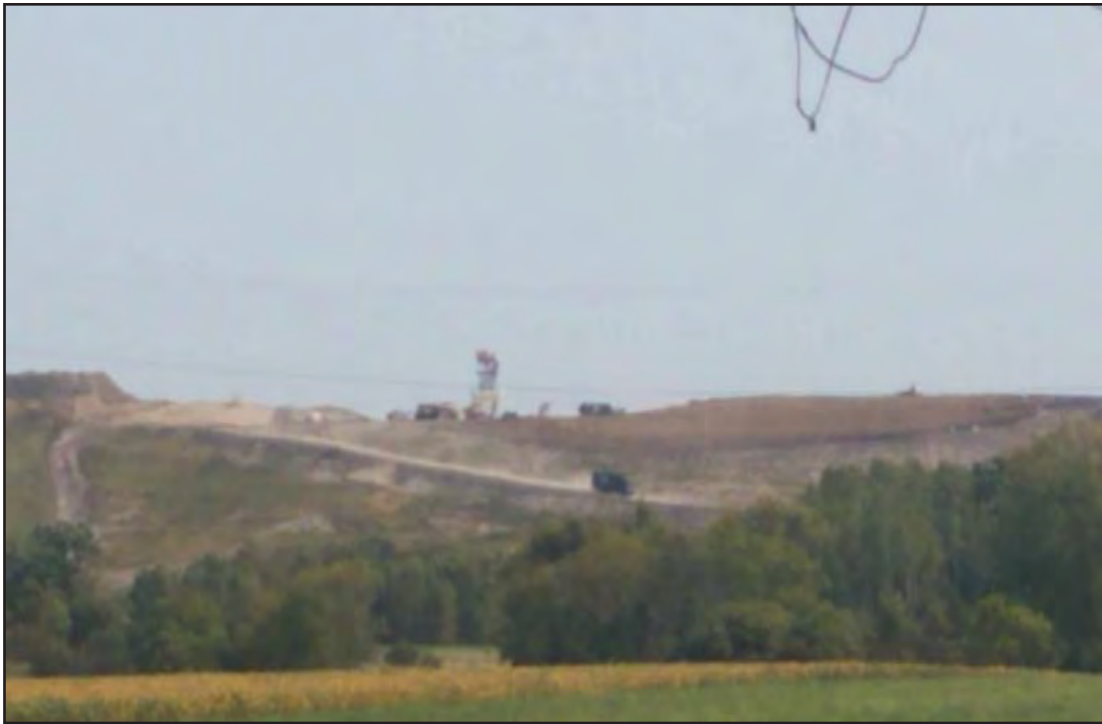
Overview of landfill from West

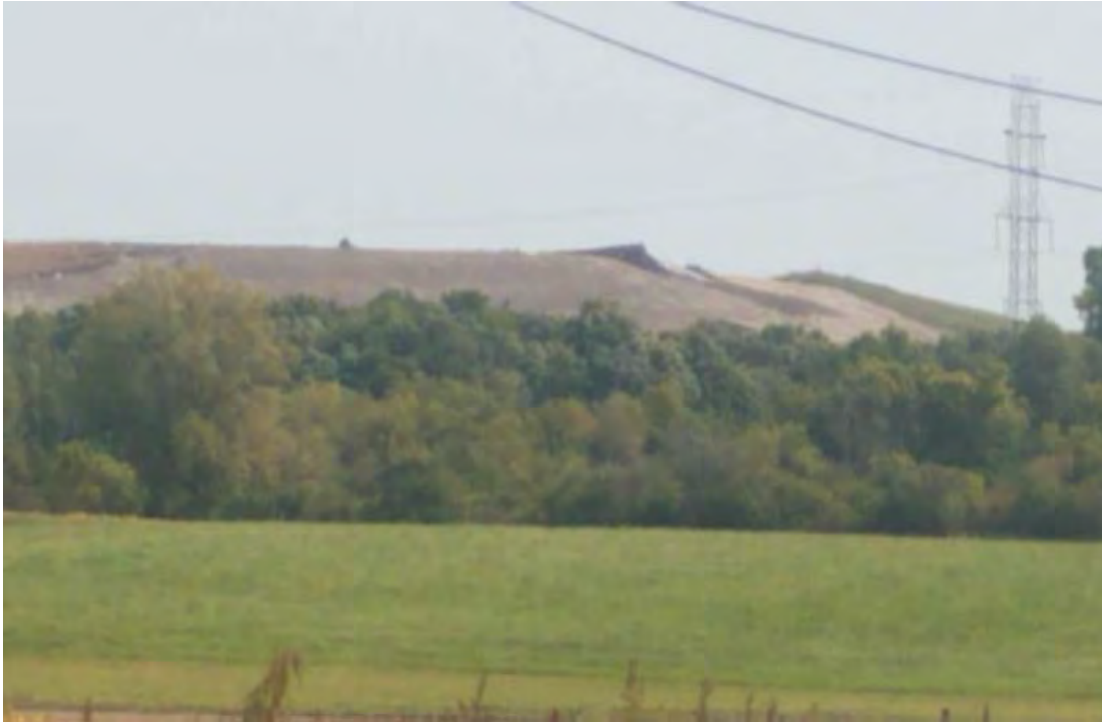
South end of footprint viewed from West

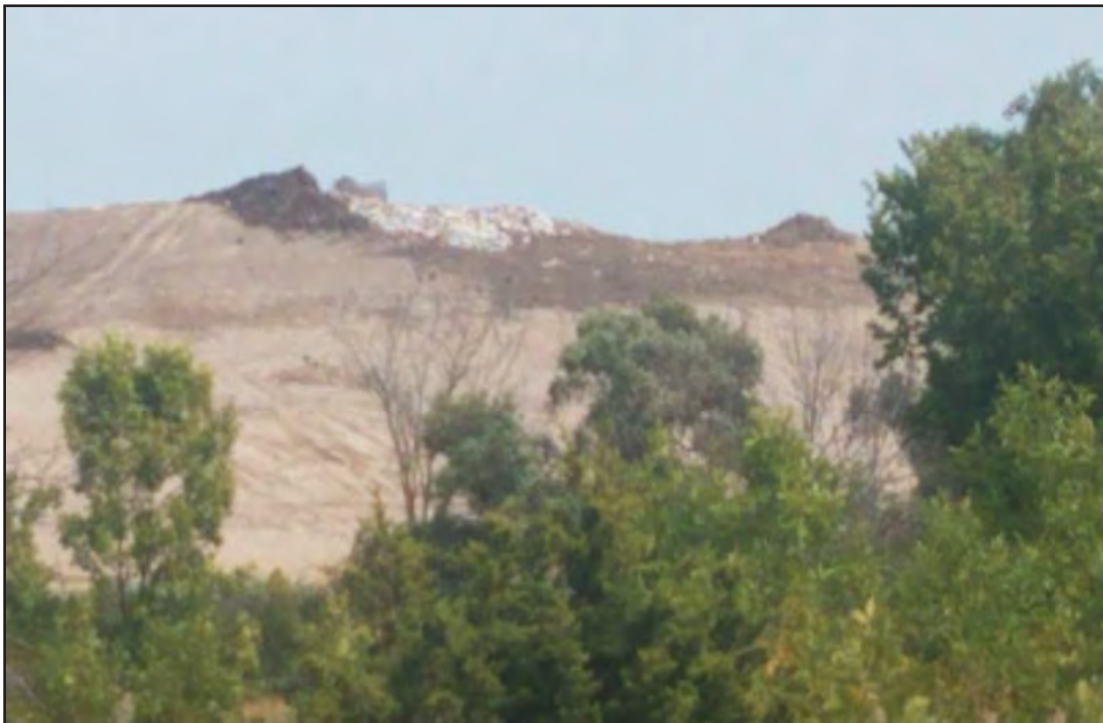
Working face at South end of Phase 7 South

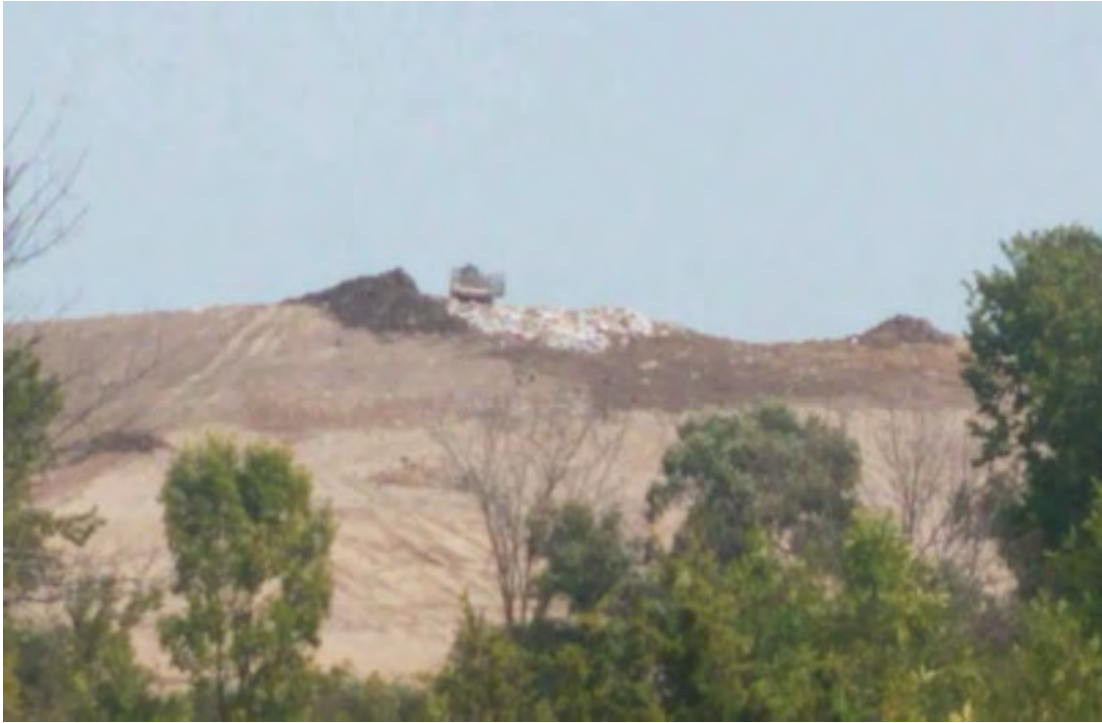
Southwest corner of Phase 7 South, working face being developed to bring lift up to current grade

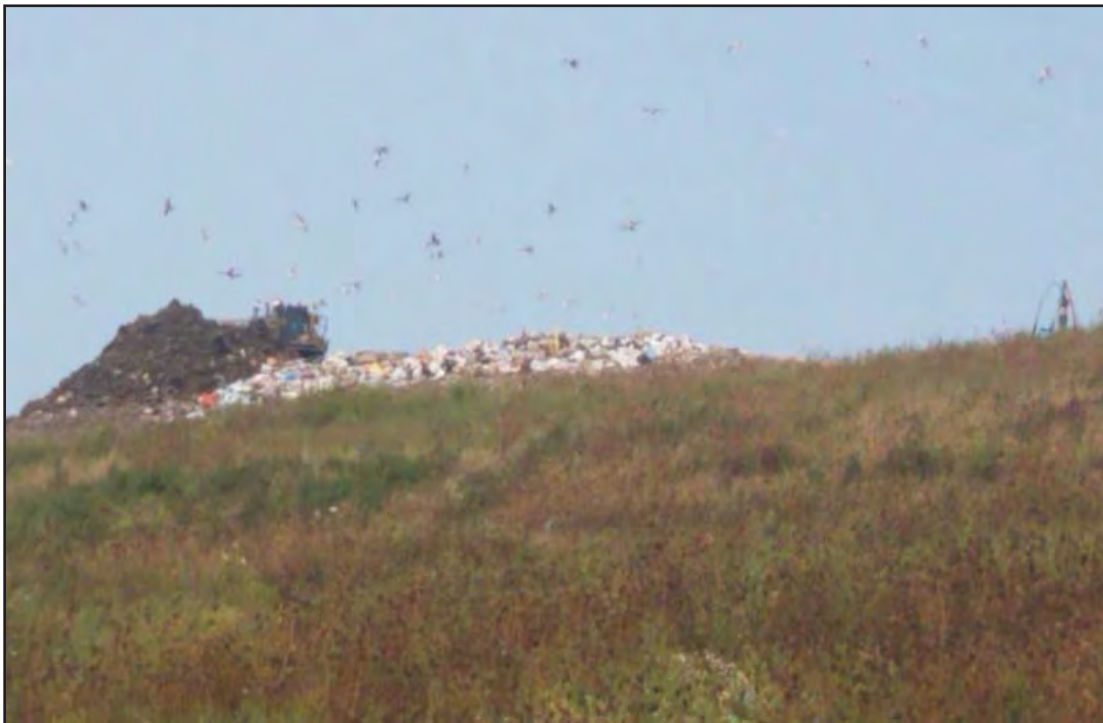
Working face at very South end of Phase 7 South, bring grade up to current lift

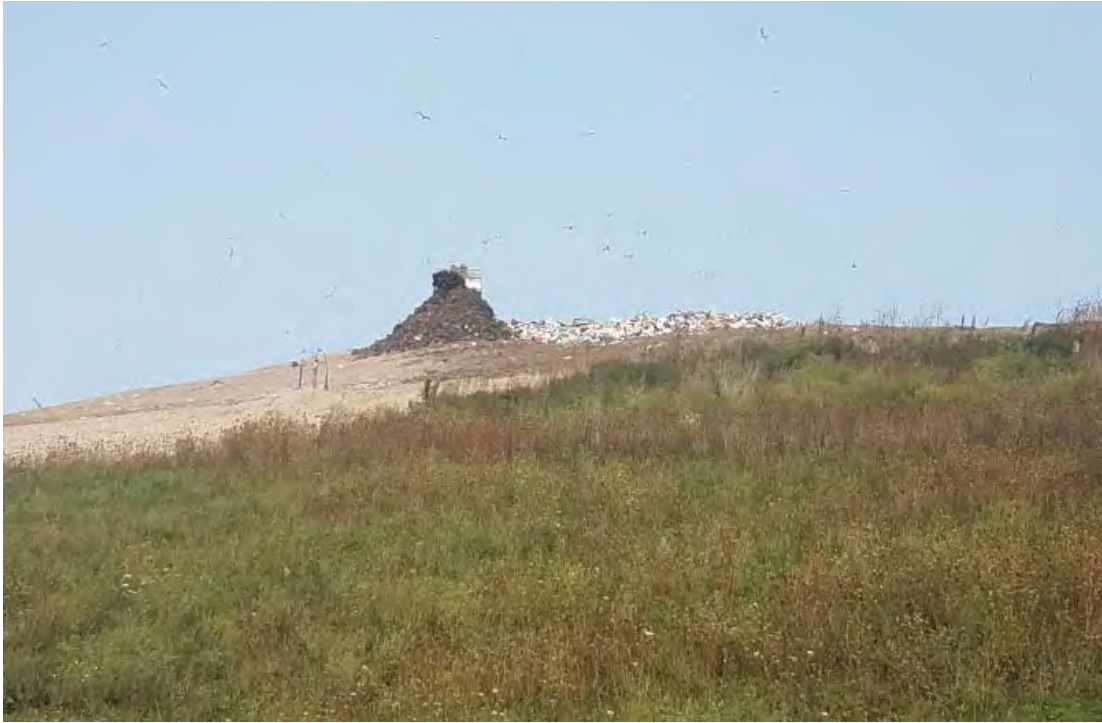
Stockpiled cover adjacent to working face at Southwest corner of Phase 7 South

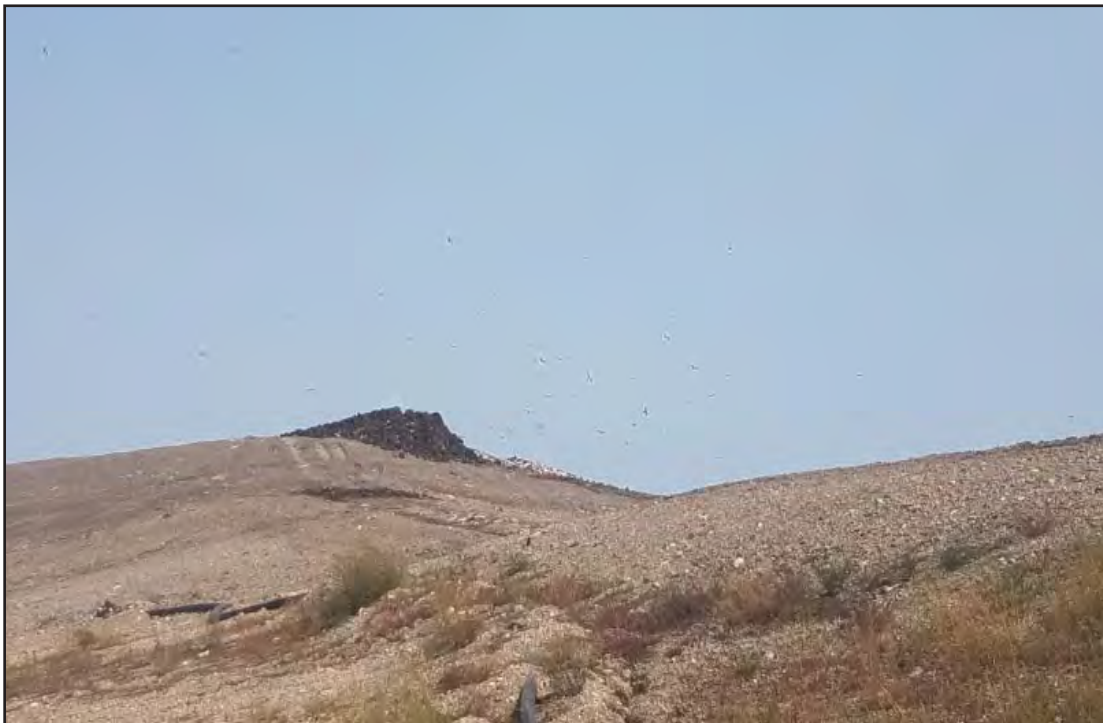
Stockpiled cover adjacent to working face at Southwest corner of Phase 7 South

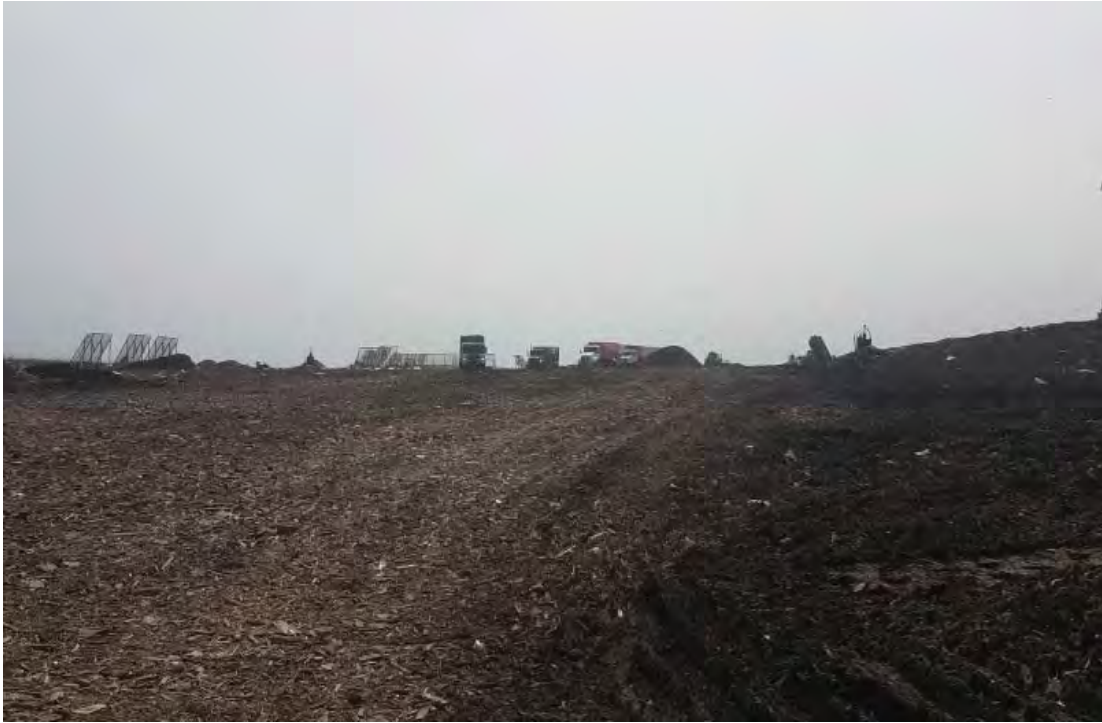
Active area viewed from North, working face below visible grade

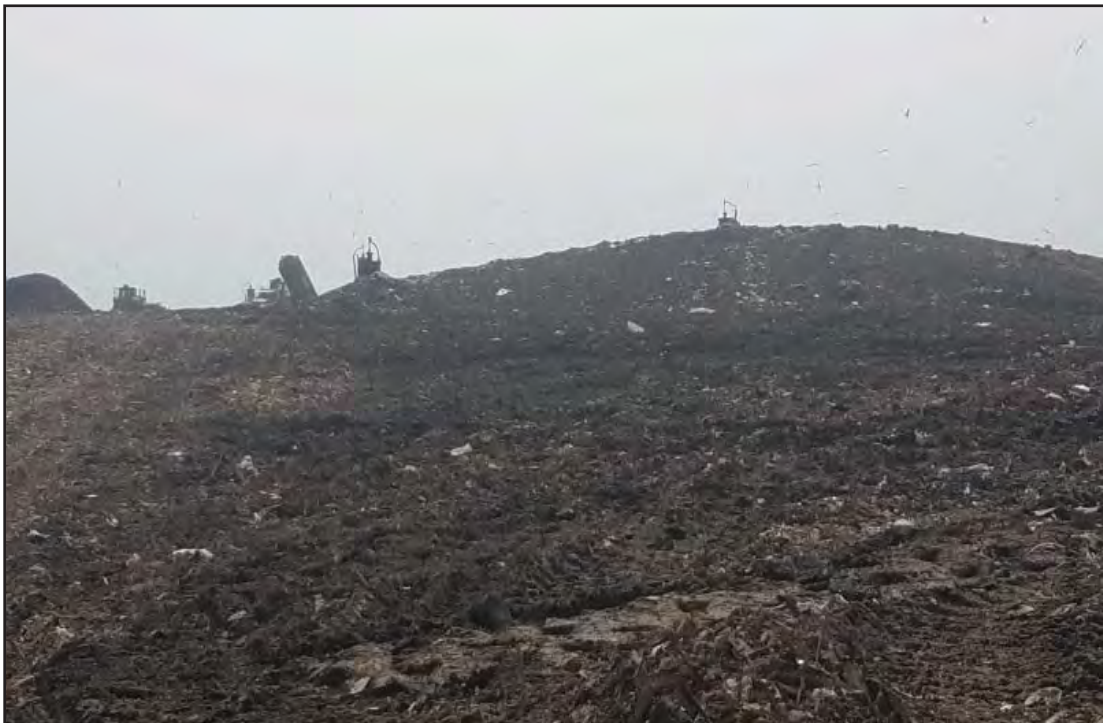
Lift along West slope of Phase 7 South, creates protected areas for future placements
