## ADS Emerald Park Landfill Audit Summary

**To:** ADS Emerald Park Landfill Standing Committee, City of Muskego  
**FROM:** Jo-Walter Spear, Jr., P.E.  
**COPIES:** File  
**DATE:** ~~XXXXXX~~ 10/22/2020  
**PROJECT NUMBER:** 1012.10030

**ADVANCED DISPOSAL SERVICES  
EMERALD PARK LANDFILL / CITY OF MUSKEGO  
AUDIT PHOTOS**

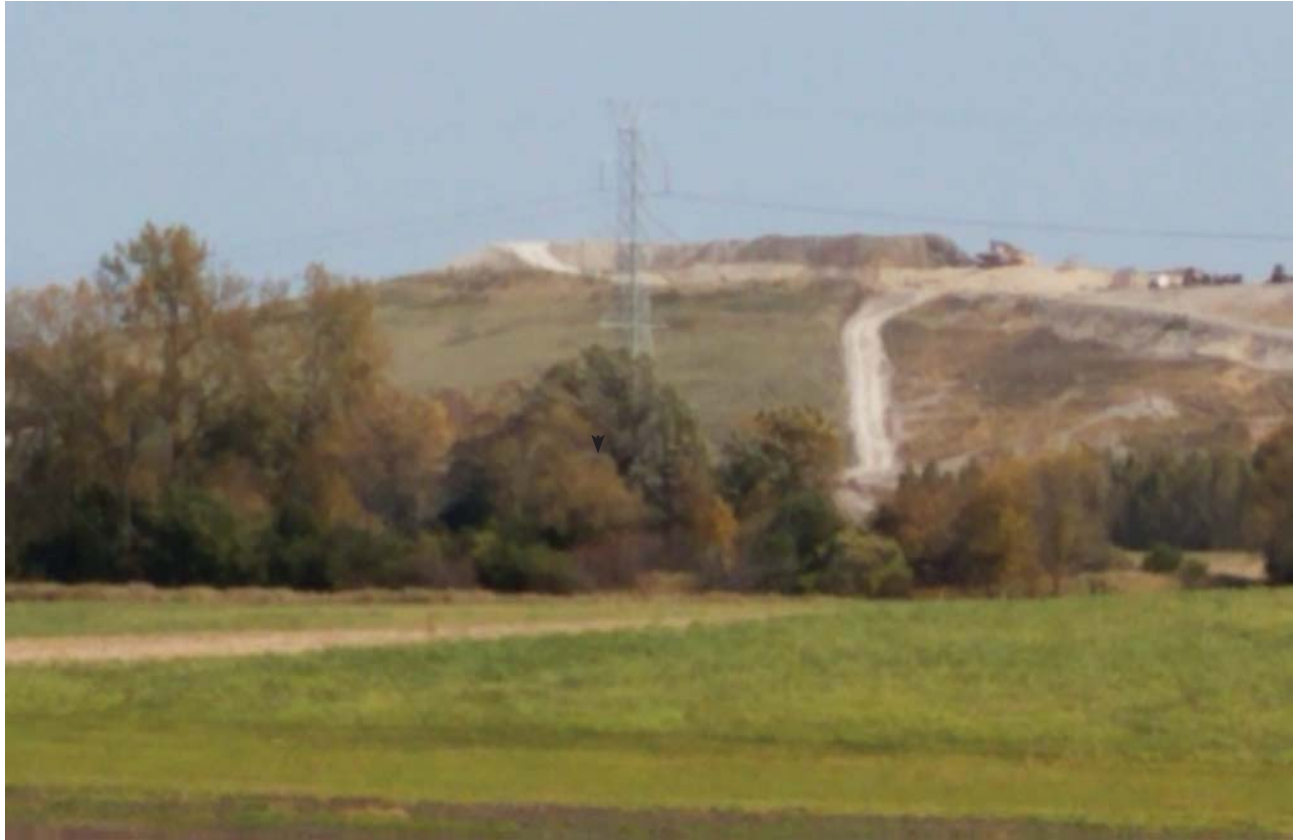
Phase 3, erosion from haul truck activities on West slope

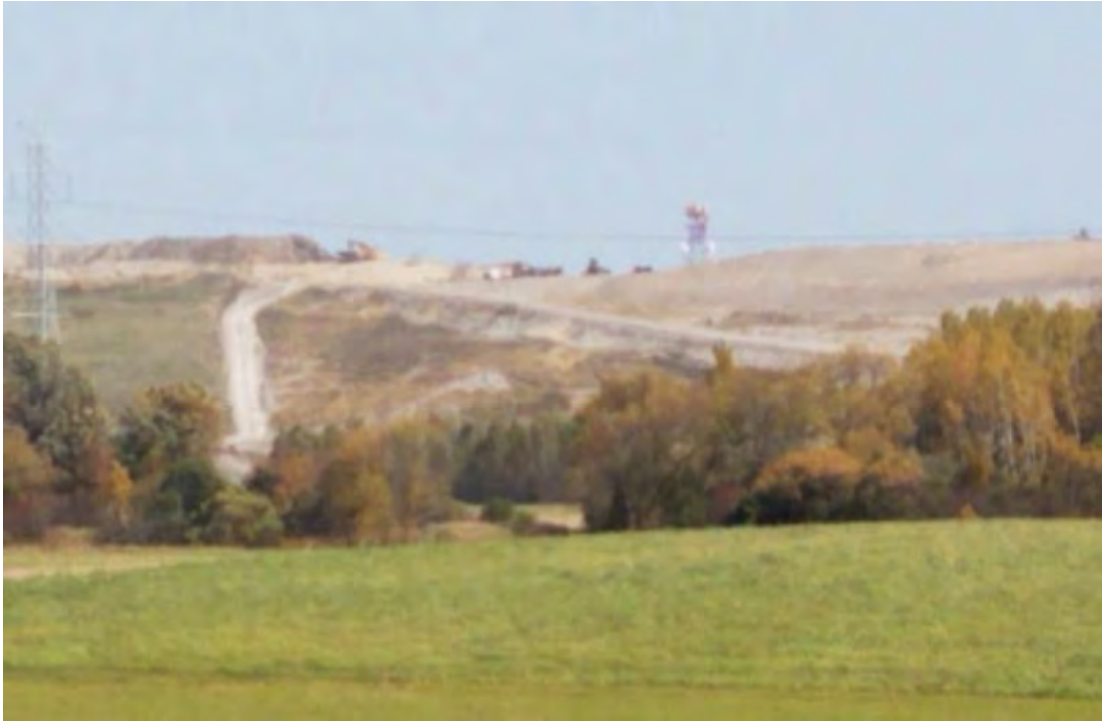
Phase 3 & 7 viewed from a distance and the West, note erosion on "left" of image from haul truck travel

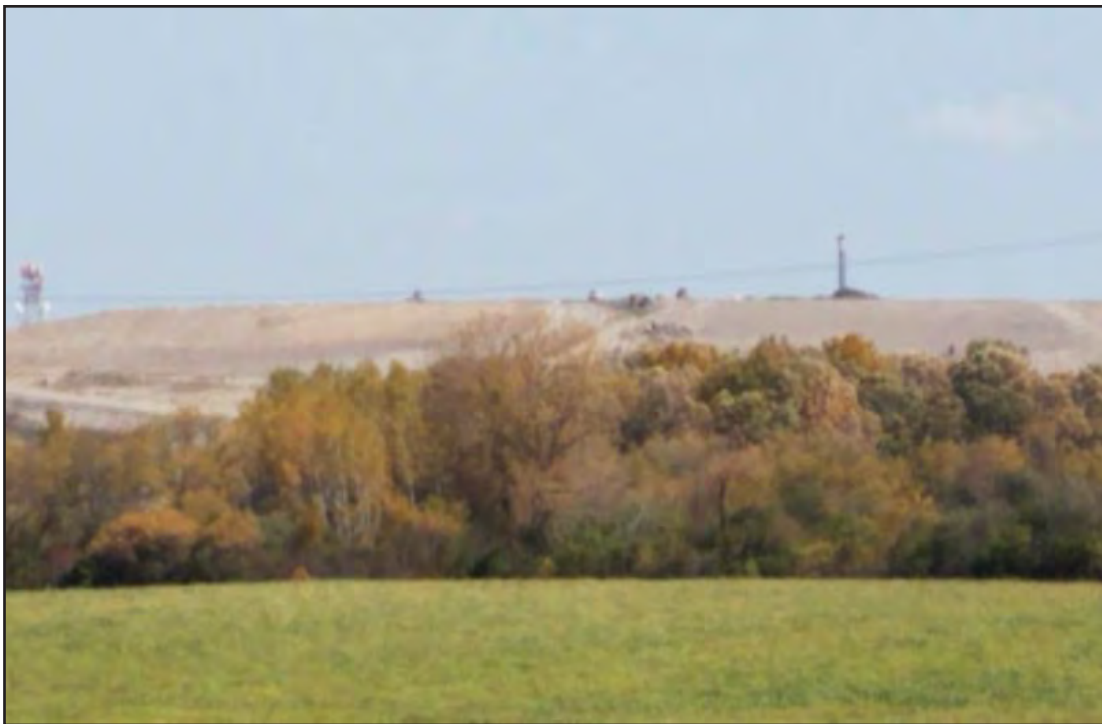
Phase 7 viewed from a distance and the West

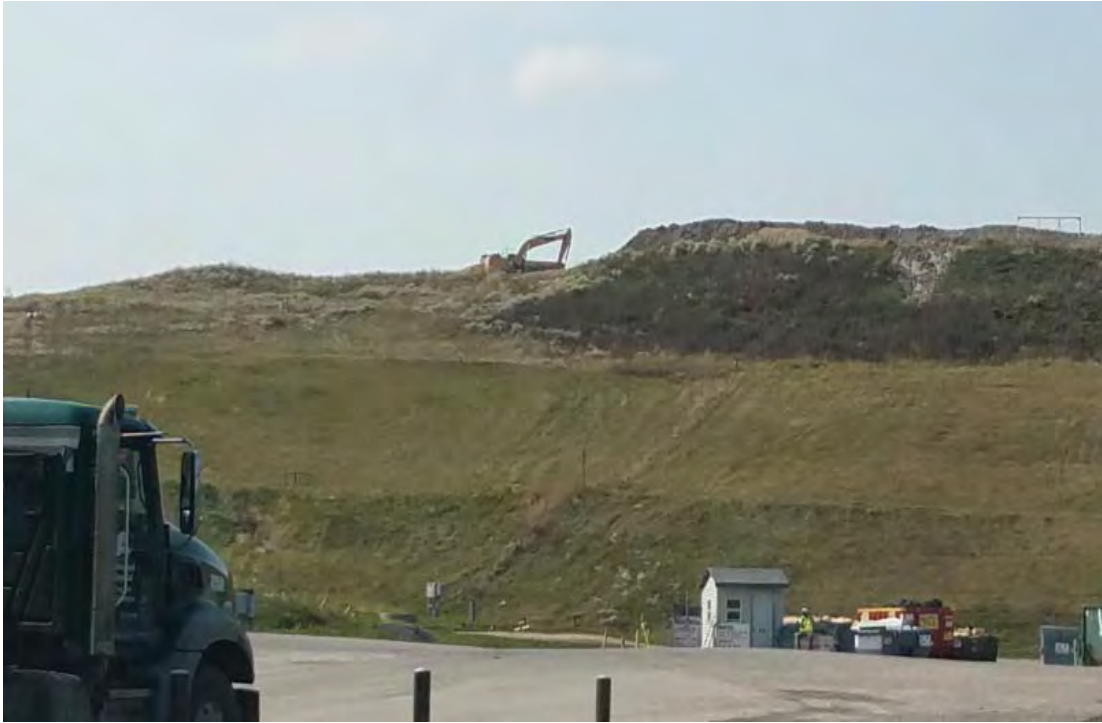
East slope of Phase 1, view of bio and direct soils

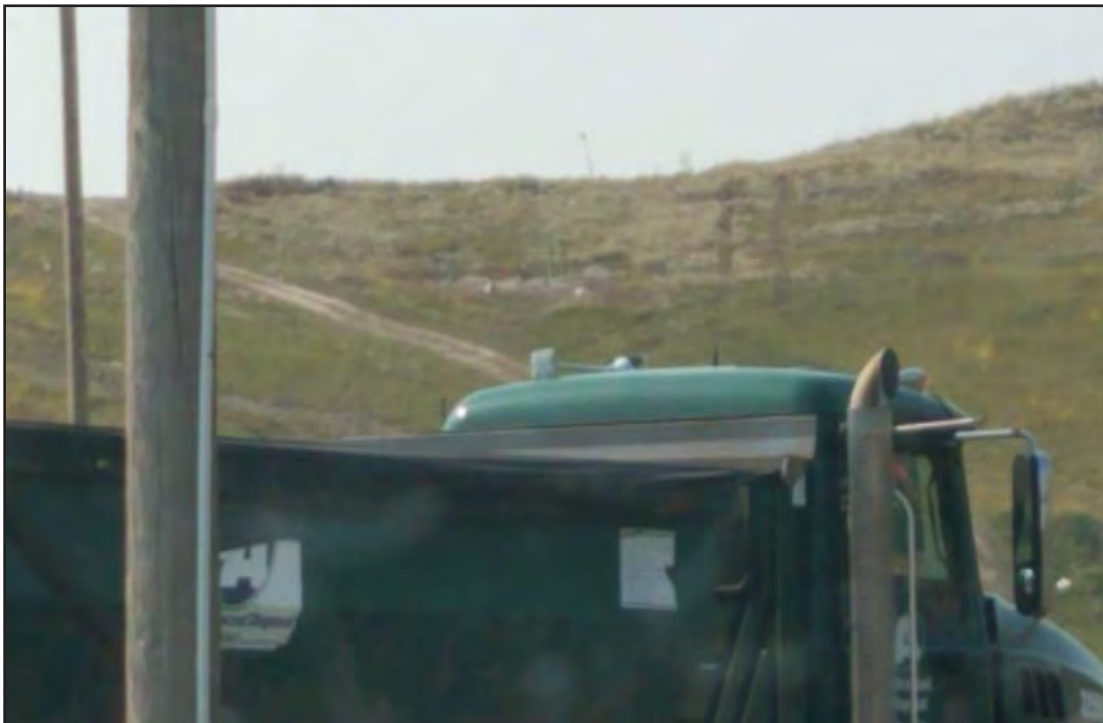
Erosion in back ground from vehicle travel

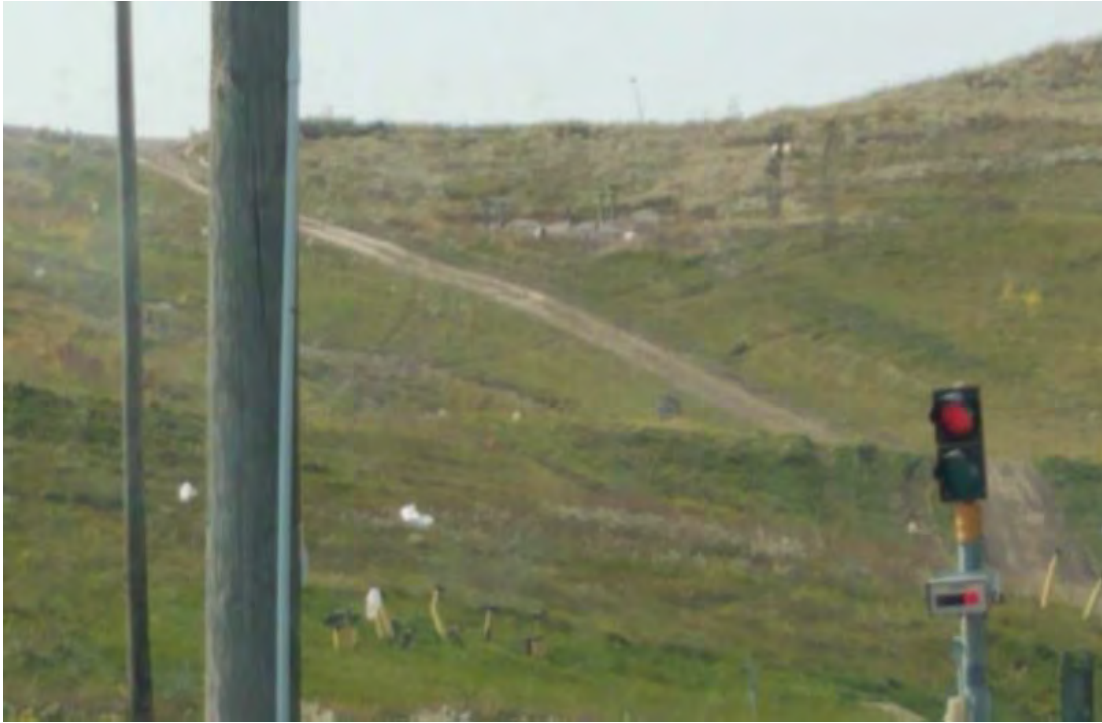
Erosion from the travel of vehicles on the slope of Phase 4

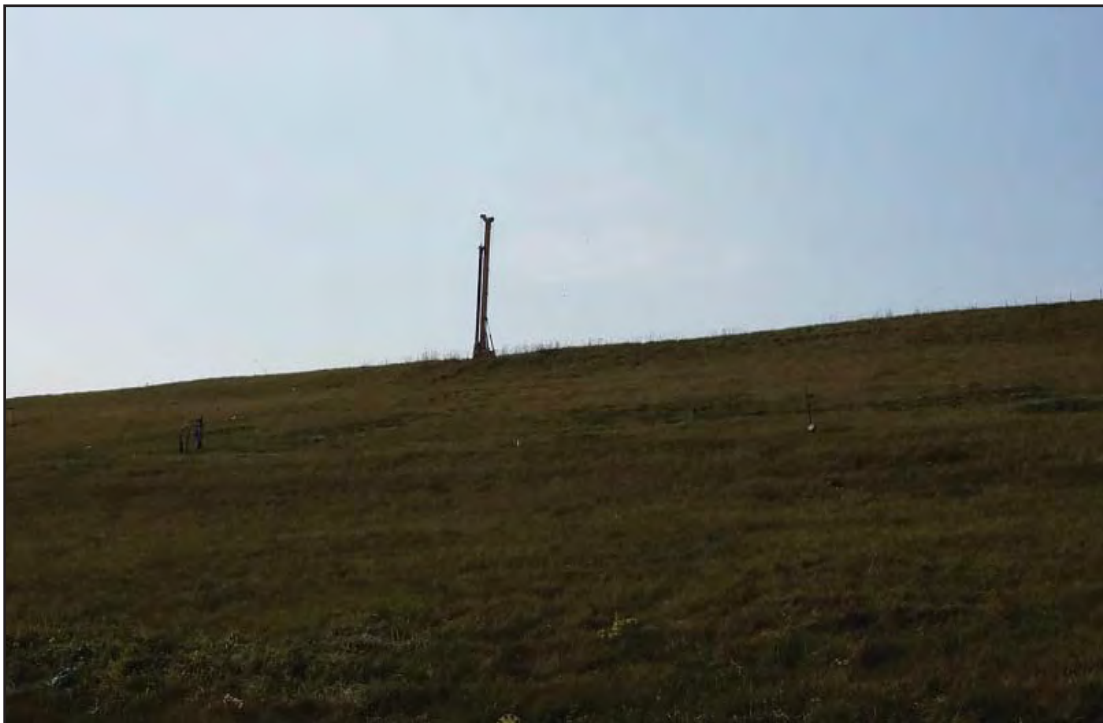
Drill rig in Phase 7 placing replacement gas well
