JSA Environmental

ADS Emerald Park Landfill Audit Summary

To: ADS Emerald Park Landfill Standing Committee, City of Muskego
FROM: Jo-Walter Spear, Jr., P.E.
COPIES: File
DATE: 10/22/2020
PROJECT NUMBER: 1012.10030

ADVANCED DISPOSAL SERVICES EMERALD PARK LANDFILL
 LANDFILL OPERATIONS AUDIT FORM
 CITY OF MUSKEGO

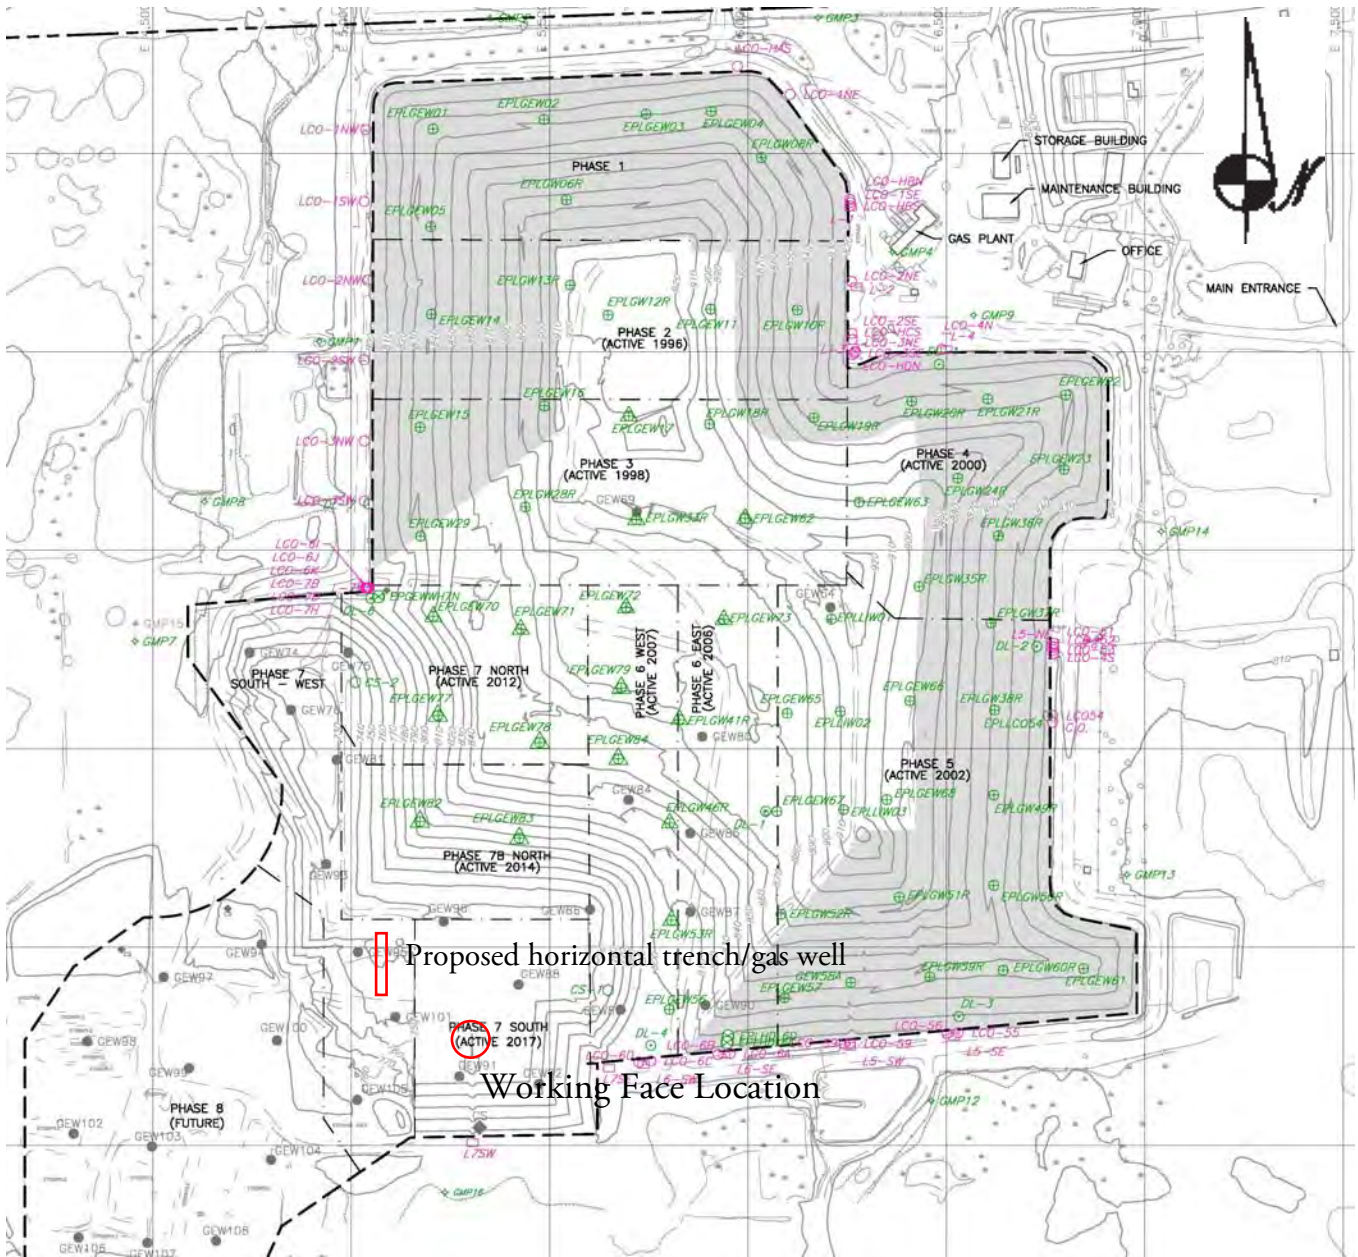
Advanced Disposal Emerald Park Landfill Audit Map

Proposed horizontal trench/gas well

Working Face Location

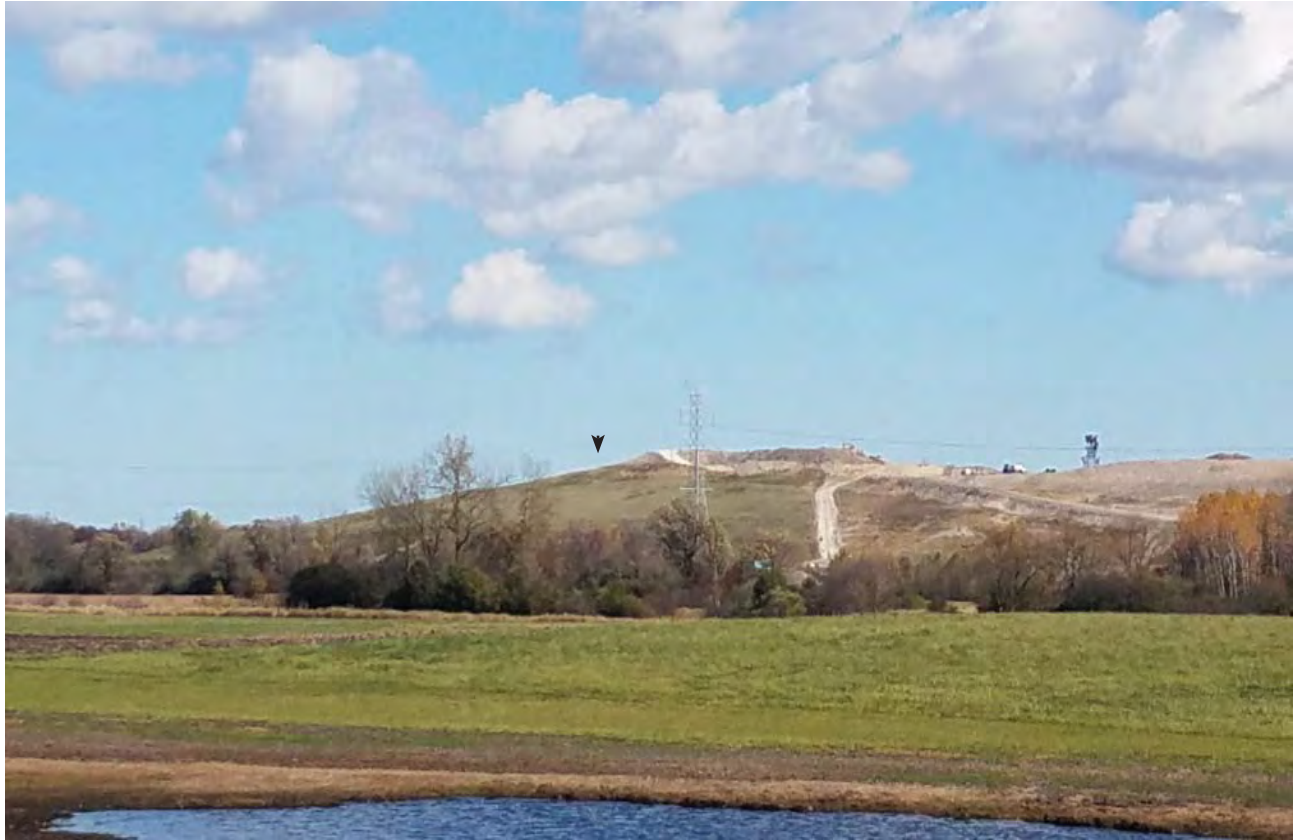
Phase 3, West slope. Erosion from Haul Truck activities.

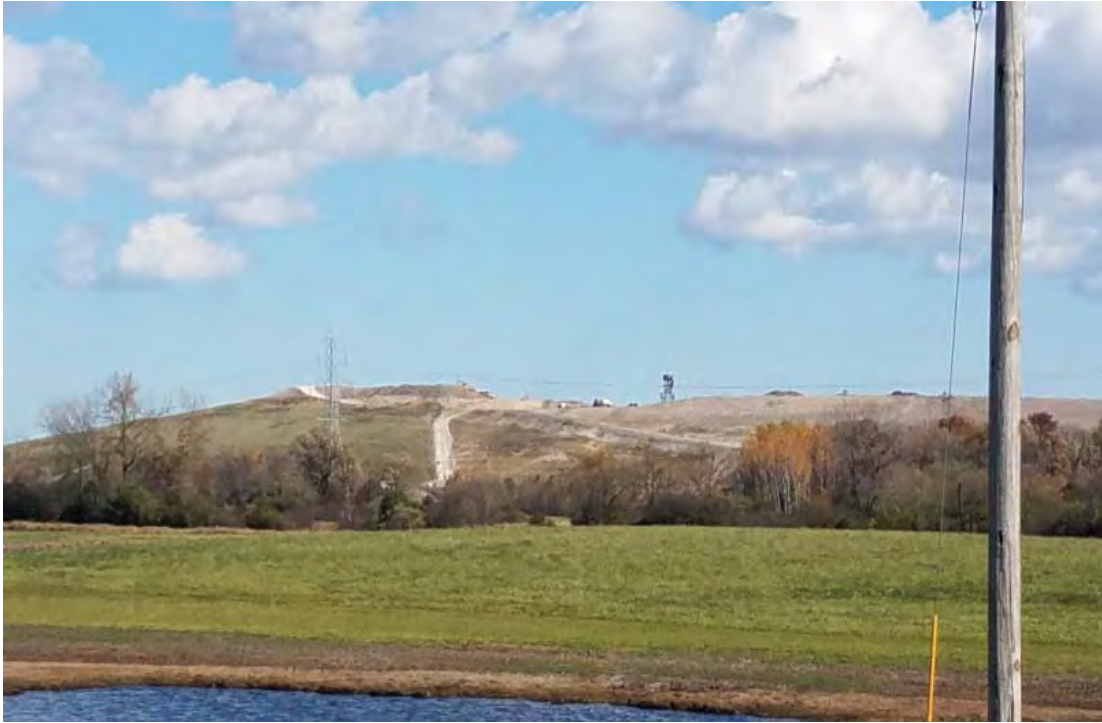
Phase 3 & 7 viewed from a distance and the West

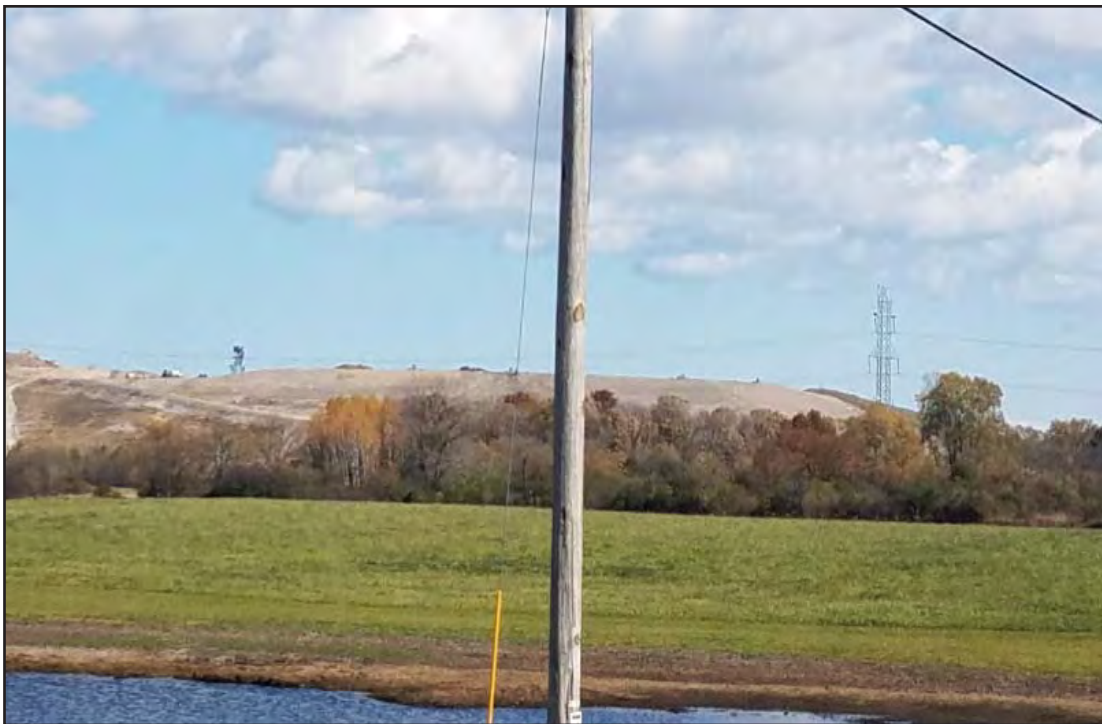
Phase 7 viewed from a distance and the West

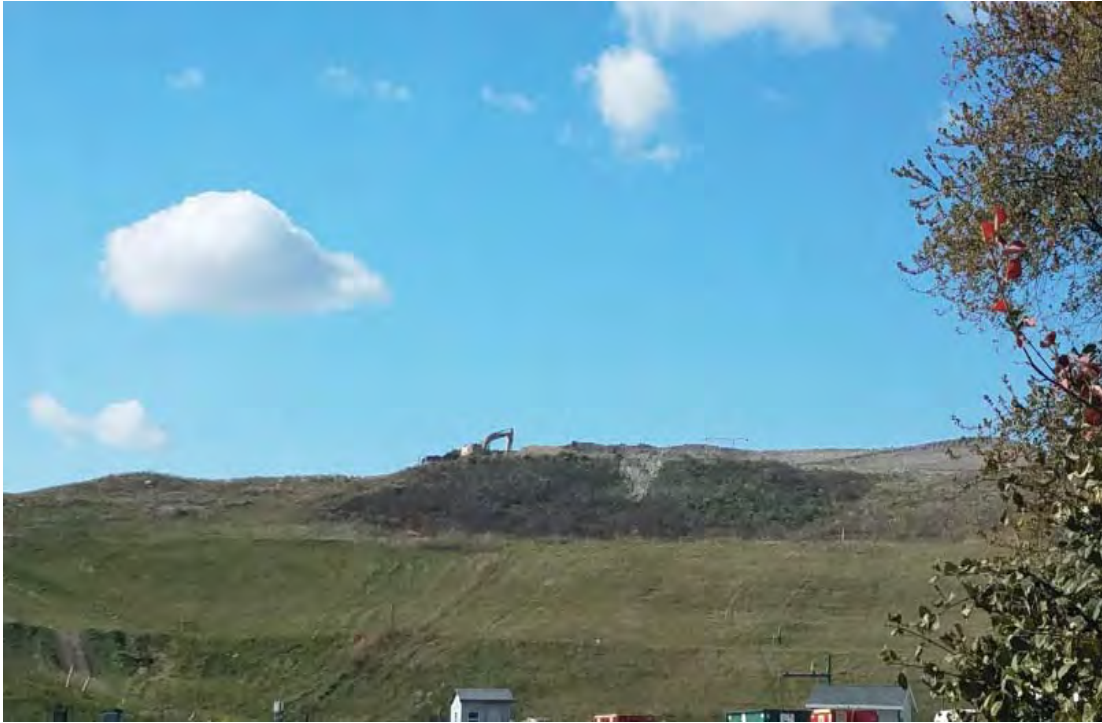
Stockpiled Soils on top of Phase 3

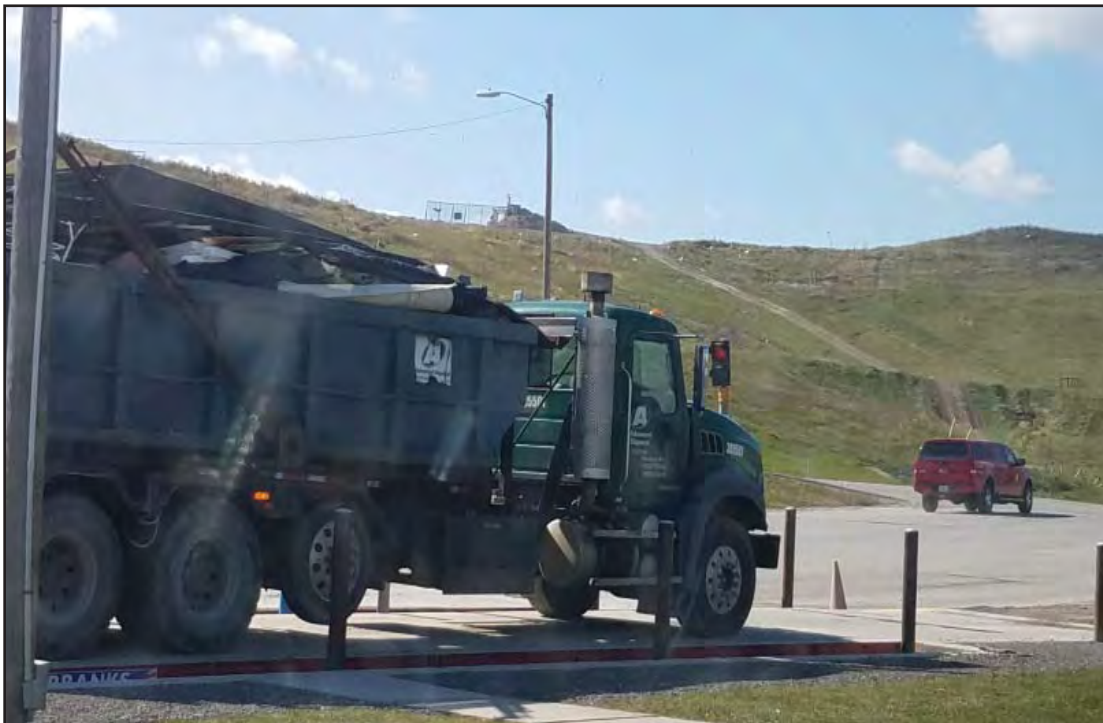
Basins appear to be well drained. No additional erosion evident, except for vehicle tracks

on Phase 4

Erosion in Phase 4
