# *JSA* Environmental

## ADS Emerald Park Landfill Audit Summary

**To:** ADS Emerald Park Landfill Standing Committee, City of Muskego  
**FROM:** Jo-Walter Spear, Jr., P.E.  
**COPIES:** File  
**DATE:** 10/22/2020  
**PROJECT NUMBER:** 1012.10030

Attached is the audit report for activities at the ADS Emerald Park Landfill for the week of October 18, 2020. The audit was performed at 12:35 PM on **October 21, 2020** by Jo Spear, Jr.; in the presence of Chad Siegle; the Operations Manager.

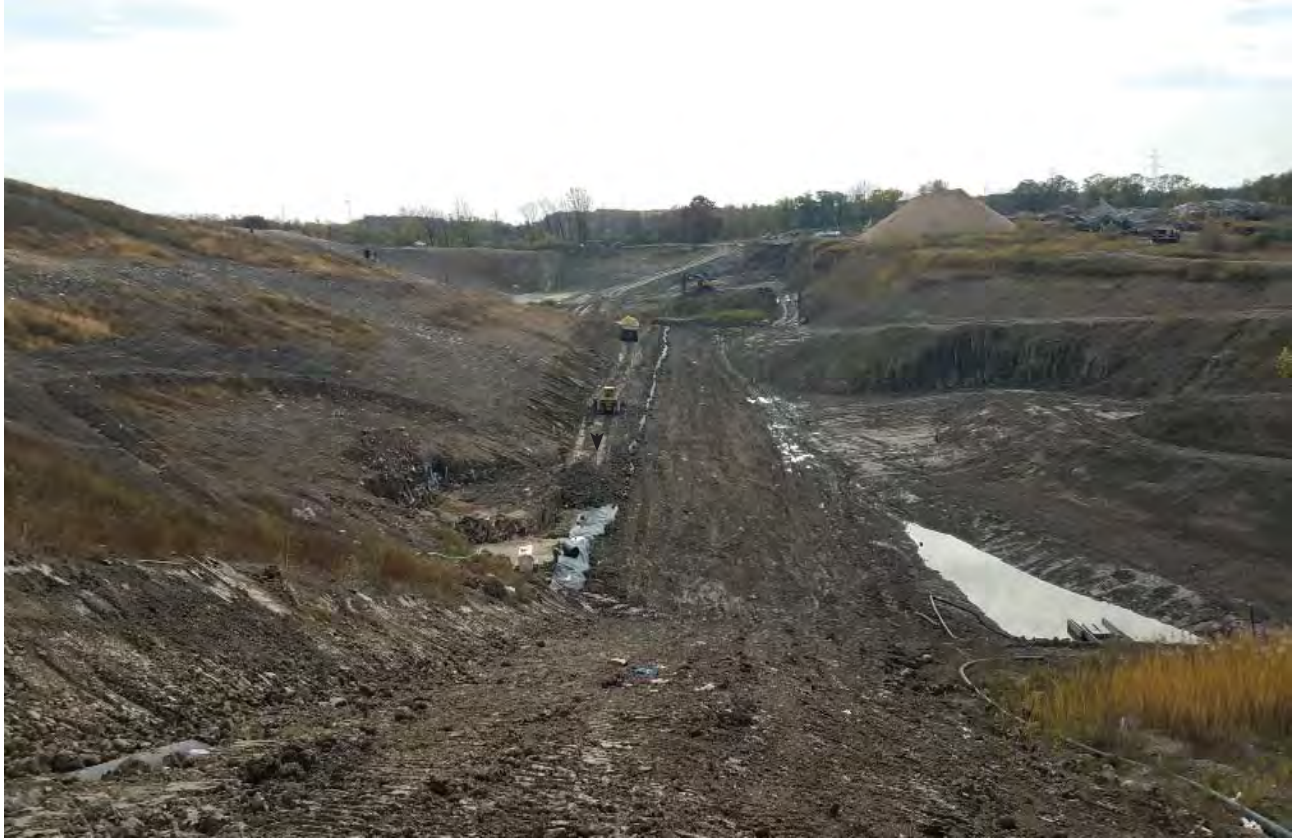
Overview of Phase 7, West edge and temp sed basin, viewed from North

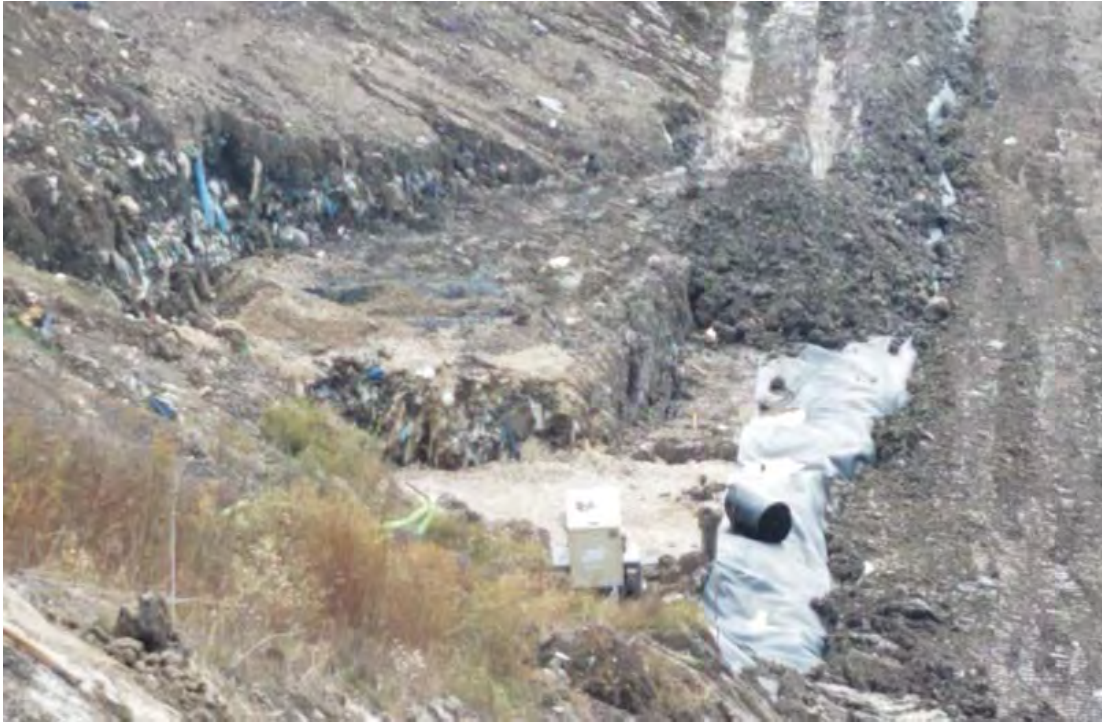
Restored and filled sump in Phase 7

\* Sump restored

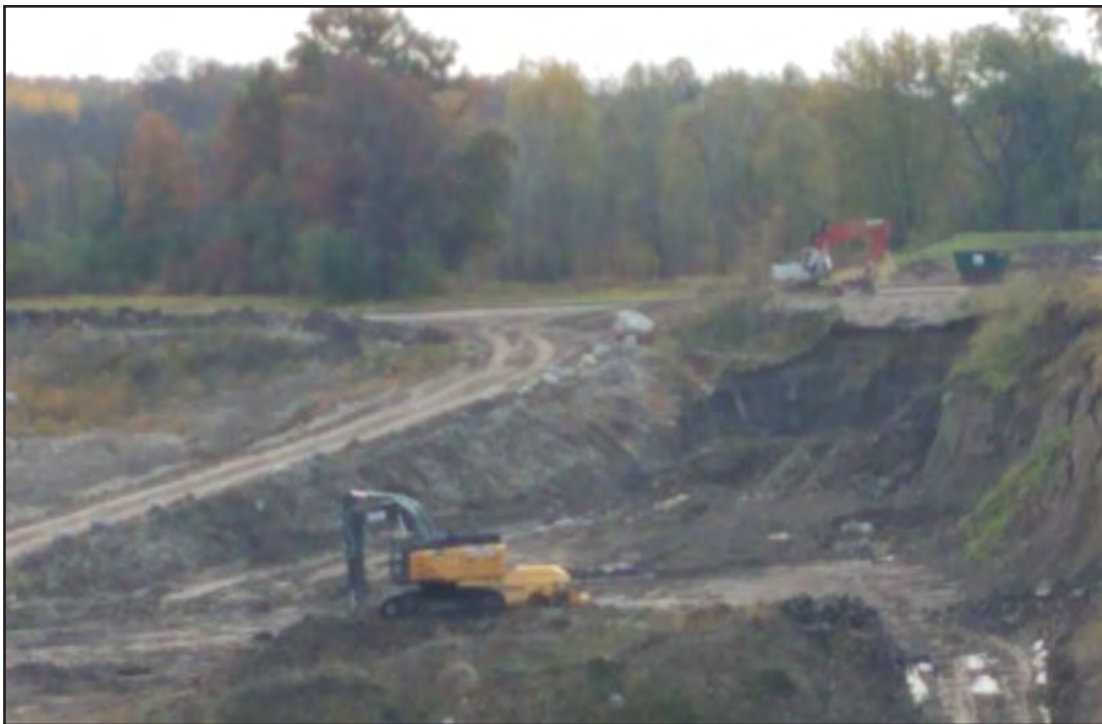
Excavation of soils as needed for construction of road and possibly cover

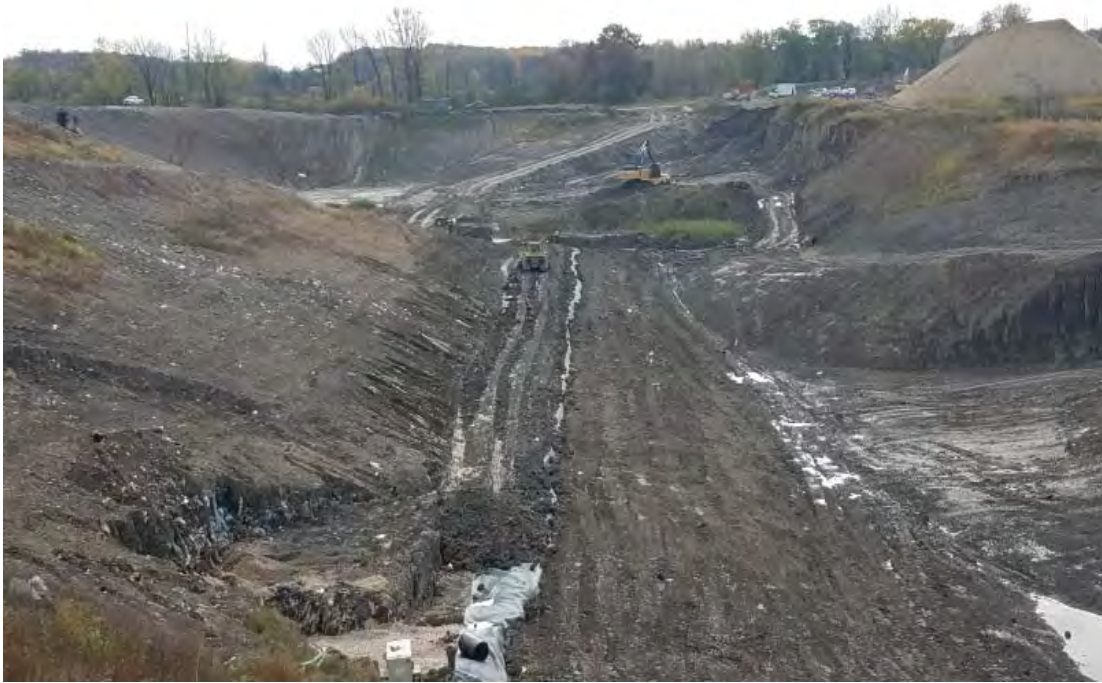
Rainflap repair complete, contractor placing road at base of slope

\* Rain flap restored and slope reconstructed.

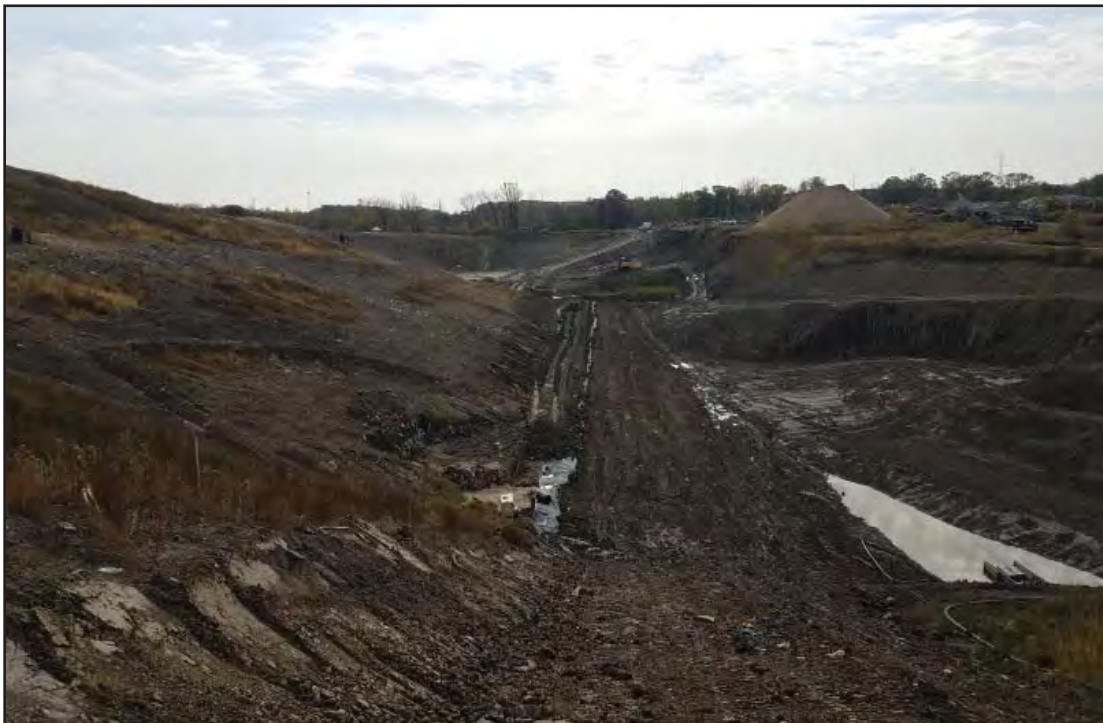
Run of rainflap repaired and temp sed basin regraded

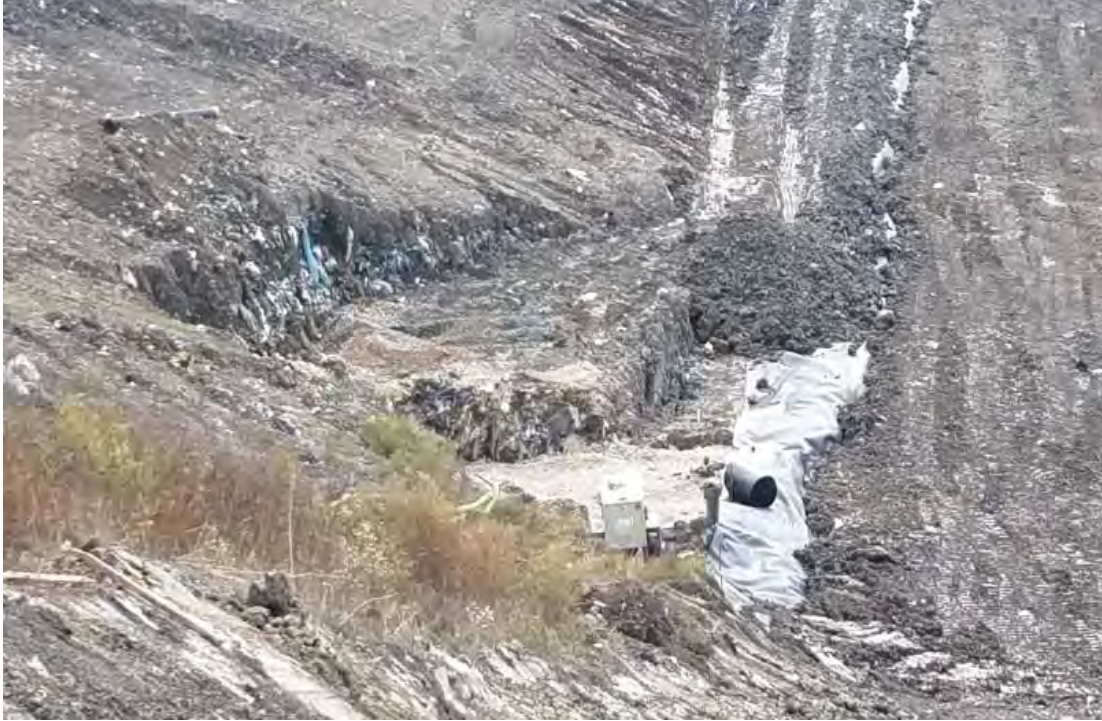
Sump backfilled with stone, more stone will be placed and then cover placed over

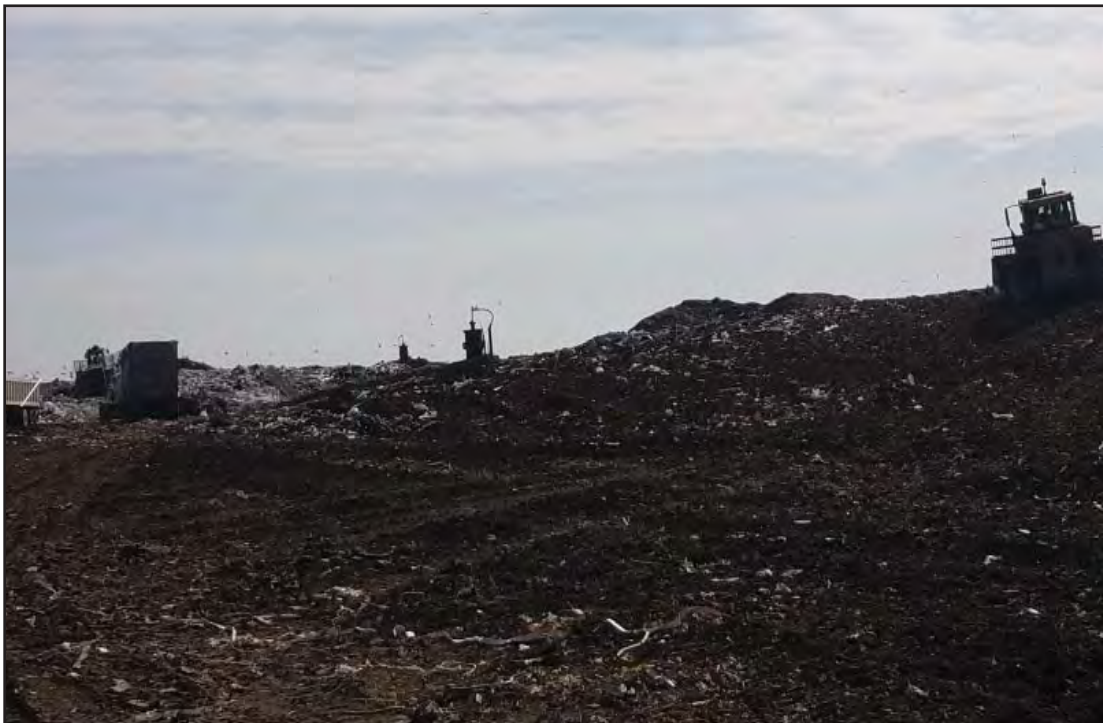
Previous lift along West slope of Phase 7, creates a protected area for current waste placement

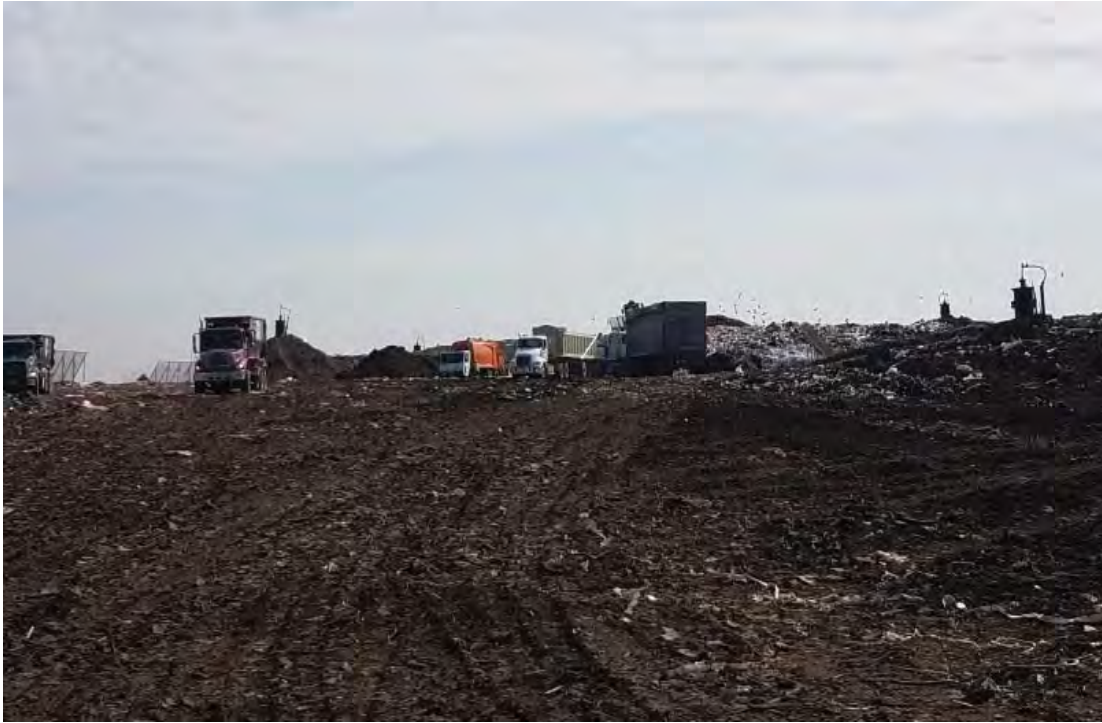
Working face in South end of Phase 7, offset from top of West slope

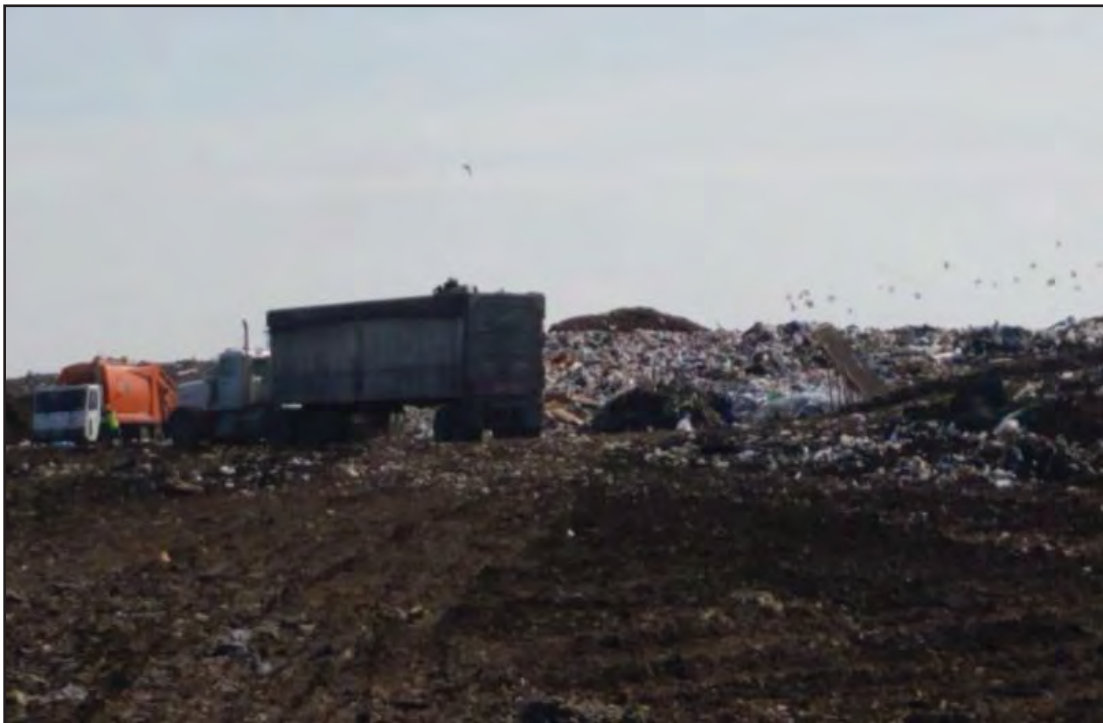
Working face in South end of Phase 7, offset from top of West slope

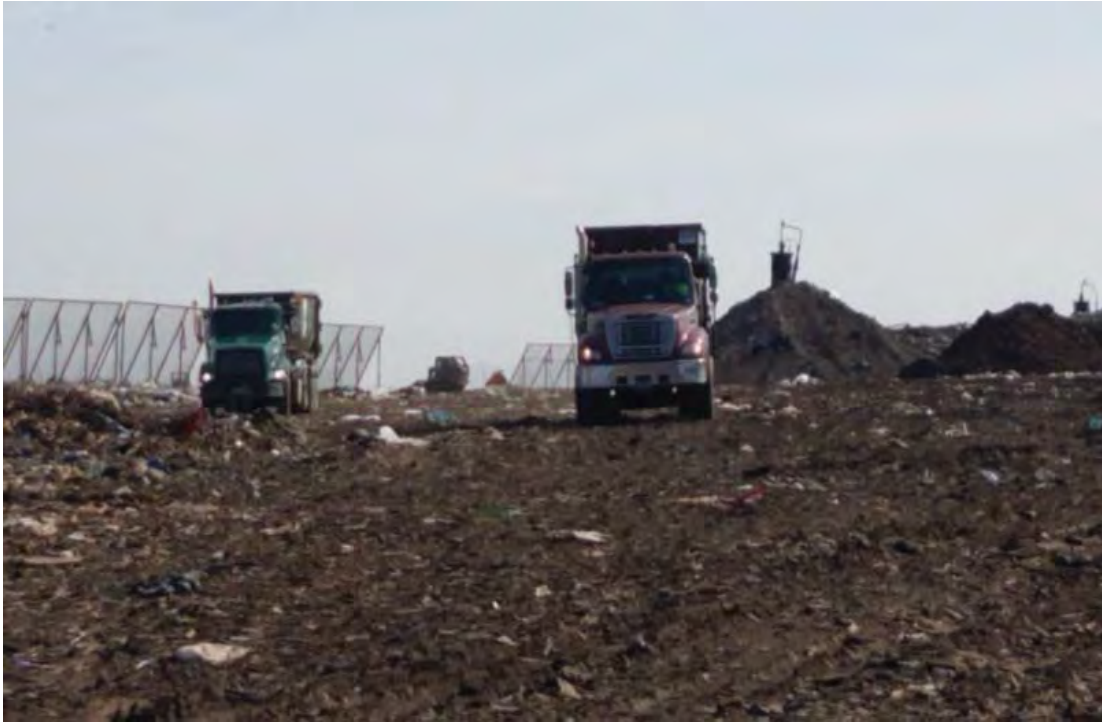
Phase 7 South, viewed North to South

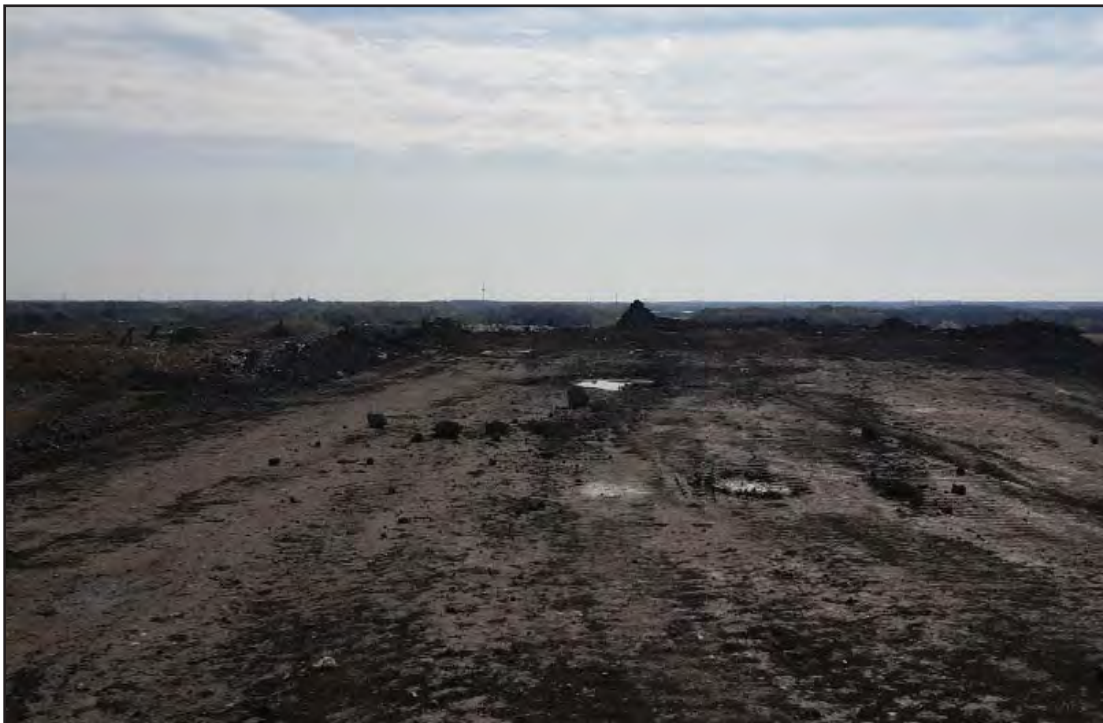
High point in Phase 3, on top of soils
