GFL Emerald Park Landfill Audit Summary

To: GFL Emerald Park Landfill Standing Committee, City of Muskego
FROM: Jo-Walter Spear, Jr., P.E.
COPIES: File
DATE: 1/11/2021
PROJECT NUMBER: 1012.10030

Attached is the audit report for activities at the GFL Emerald Park Landfill for the week of January 7, 2021. The audit was performed at 12:40 PM on **January 8, 2021** by Jo Spear, Jr.; in the presence of Chad Seigel; the Site Manager.

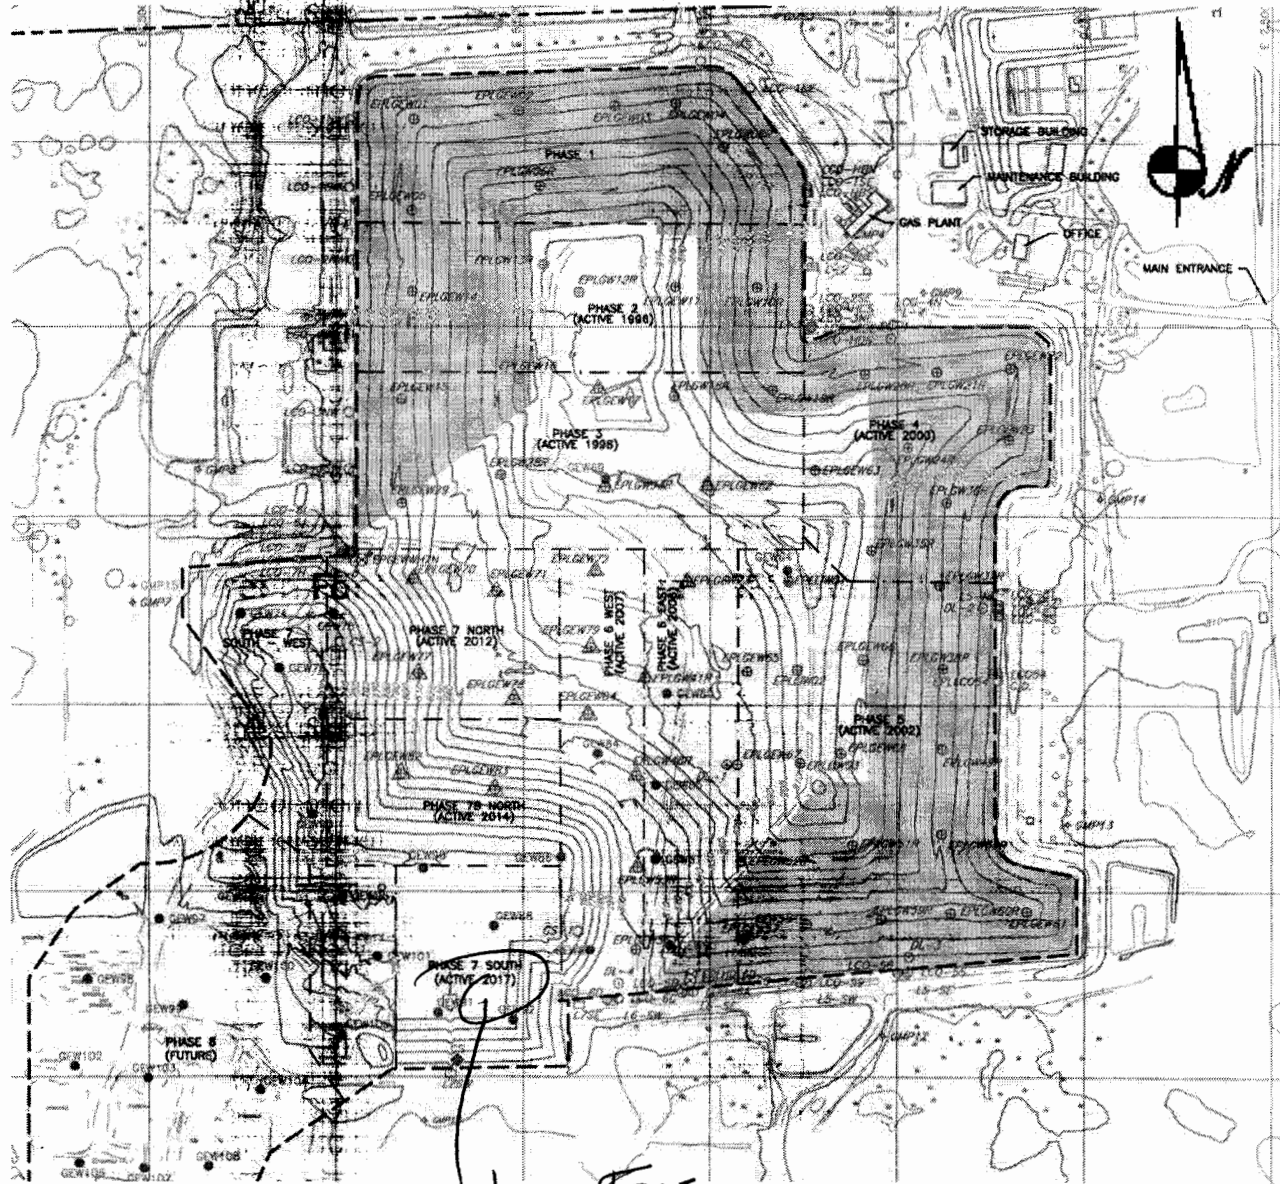
Green For Life Environmental (GFL) Emerald Park Landfill Audit Map

Working Face

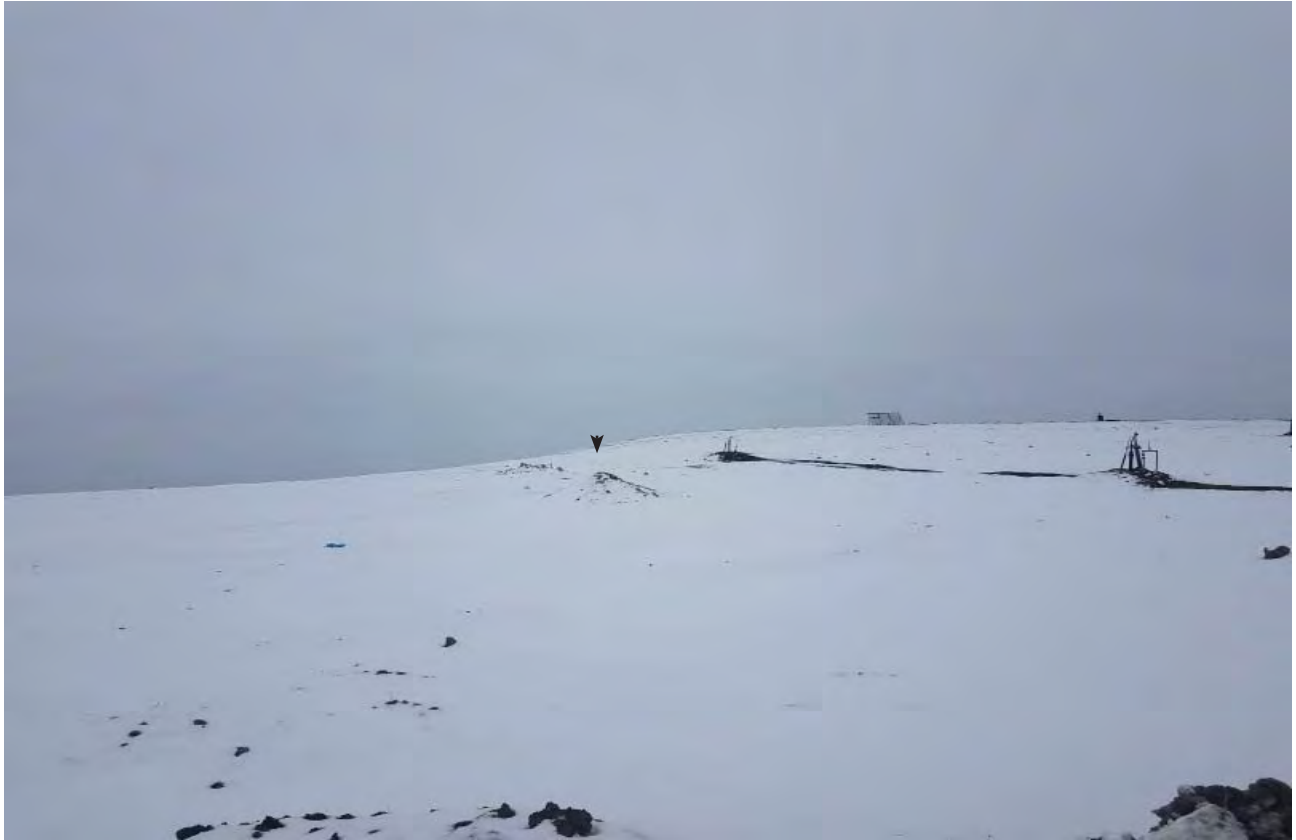
South slope of Phase 7, no disturbed or discolored snow

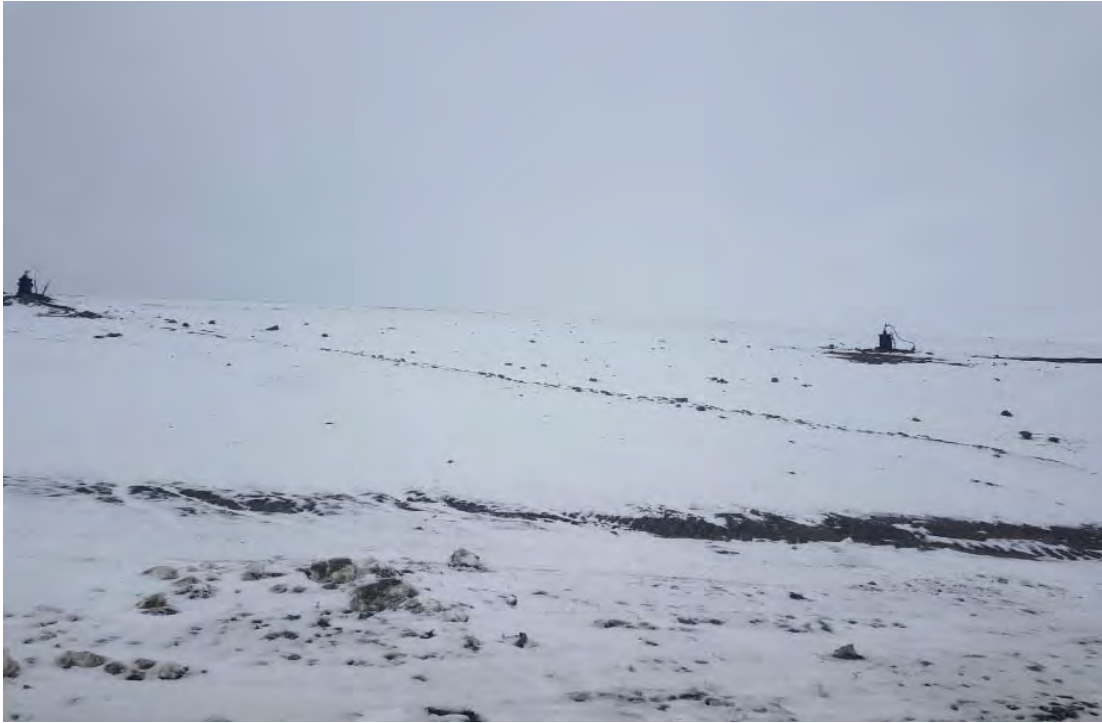
- Erosion minimal
- E) Odor Control
 - No odors detected off site.
 - Minor odors on West slope of Phase 7, some snow melted over gas collection lines; no evidence of seeps

West slope of Phase 7, some snow melt over gas lines, but not flows or discoloration

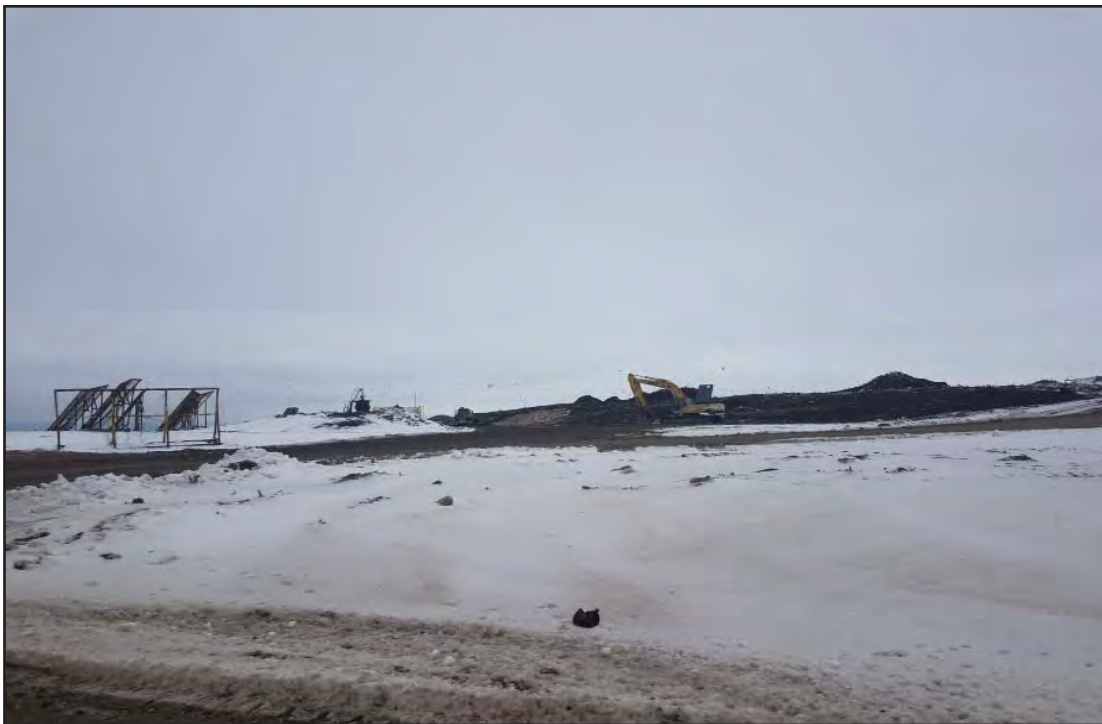
Top of Phase 7 North and South

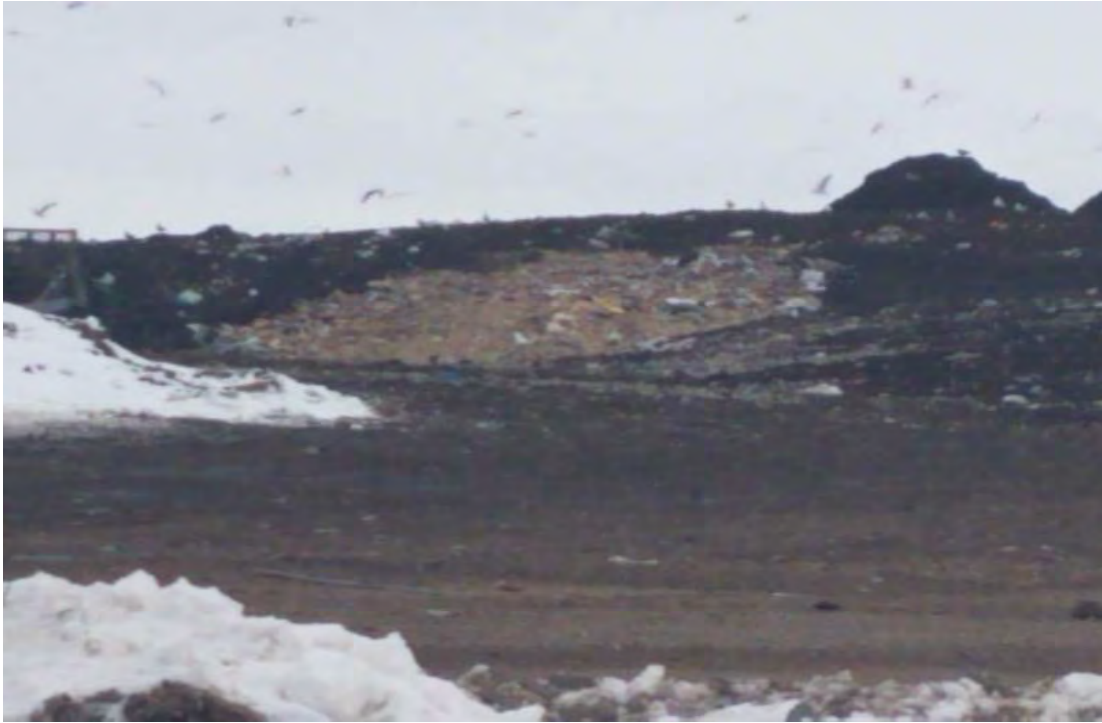
Cover materials stockpiled in active area

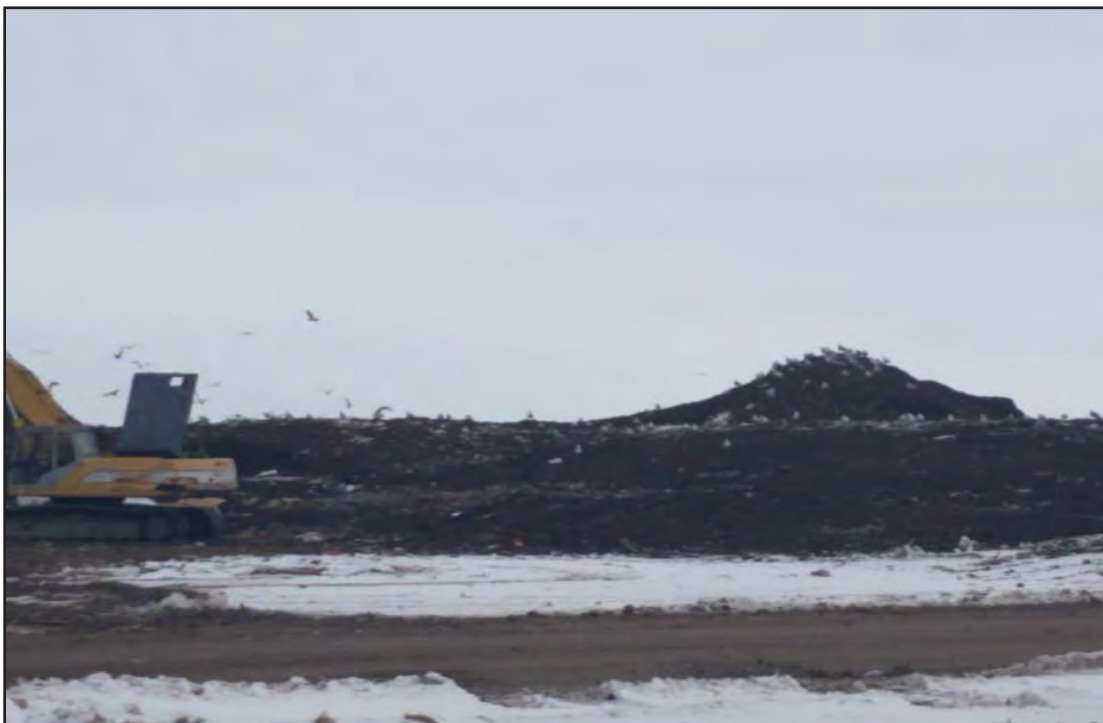
Current lift of waste placement moving slowly about Phase edges and North

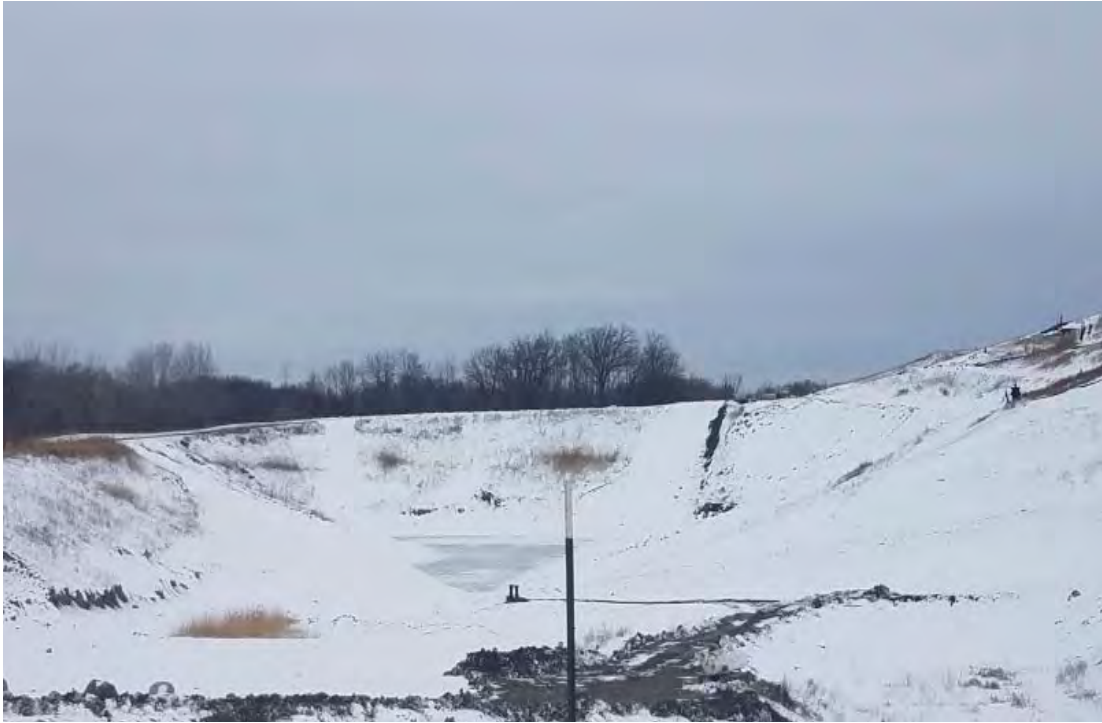
Temp sed basin frozen, side slope clean

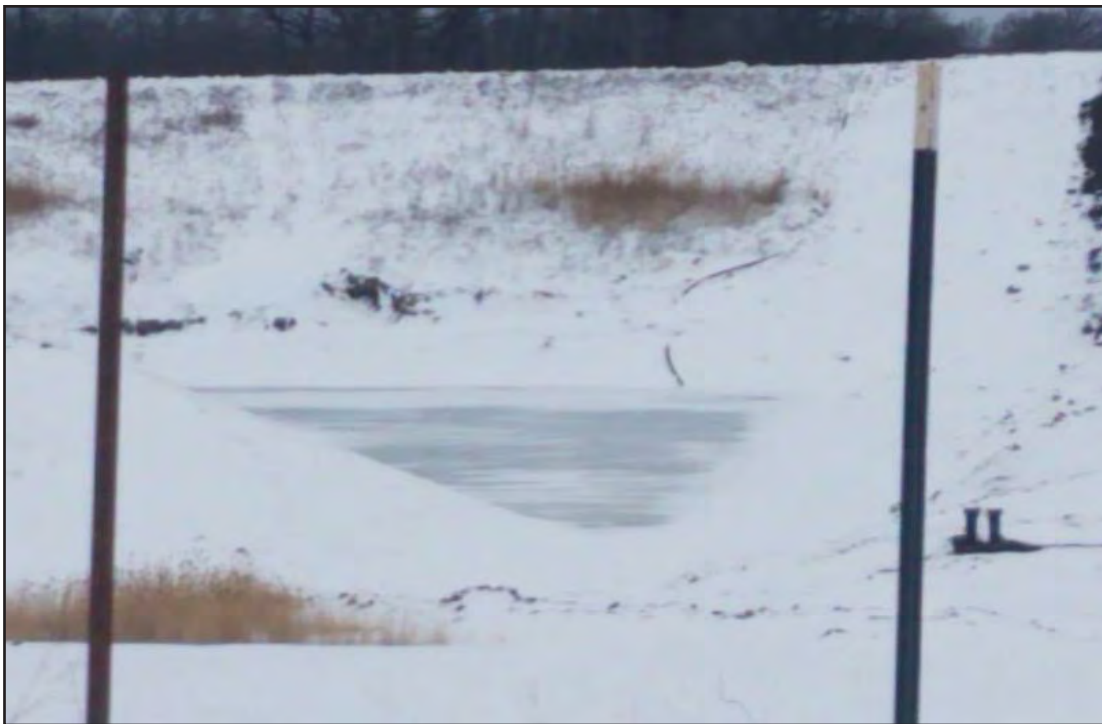
- Total destruction volume 2,500 cfm; 1,400 being delivered to MMSD
- D) Surface Water Management
 - Temp sed basin without pump
 - Temp sed basin frozen, pumping not viable

Temp sed basin missing pump, but frozen conditions prevent pump operation
