GFL Emerald Park Landfill Audit Summary

To: GFL Emerald Park Landfill Standing Committee, City of Muskego

DATE: 3/1/2021

PROJECT NUMBER: 1012.10030

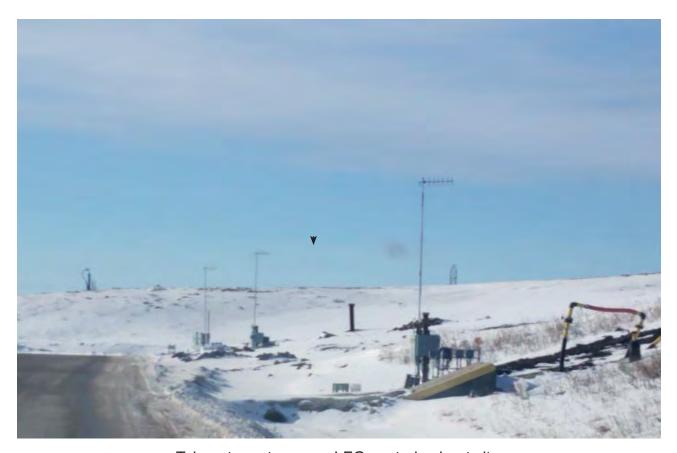
Telemetry antenae on LFG controls about site

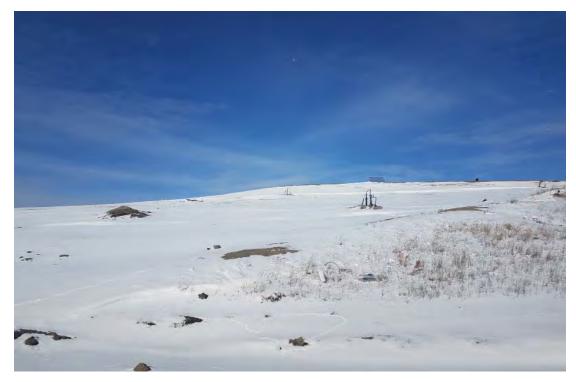
South slope of Phase 6 & 7

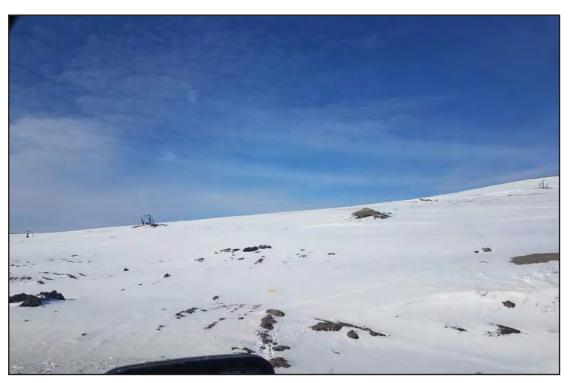
South Slope of Phase 7

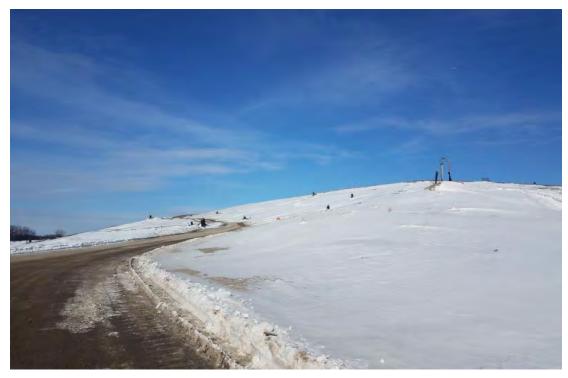
Access road North up access road

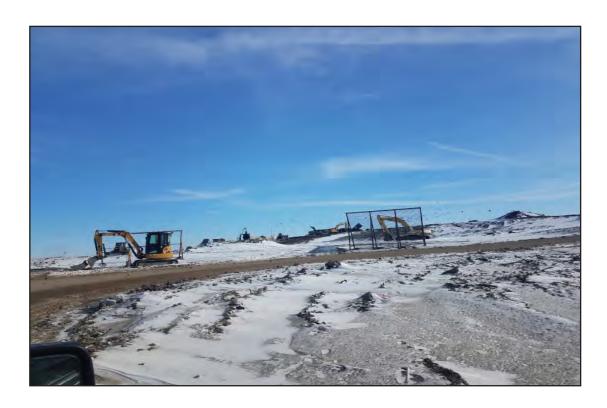
Approach to active area in Phase 7

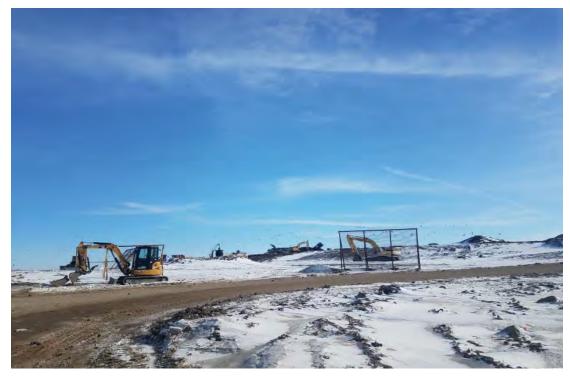
Access at top of Phase 7

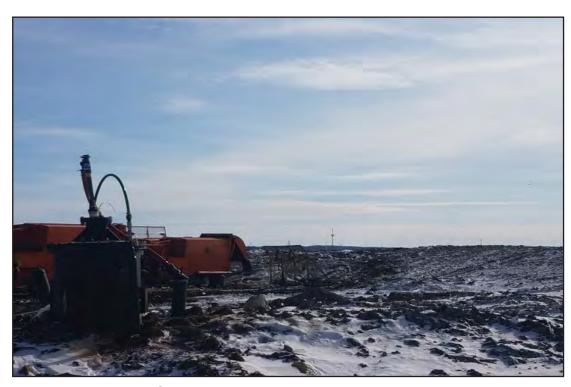
Active area viewed from access road, previous tippings creating berm about working face

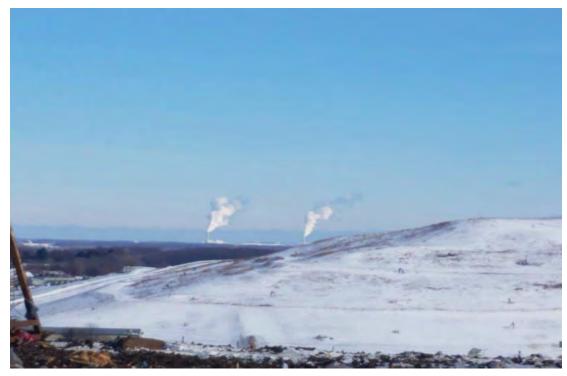
Slope conditions under snow

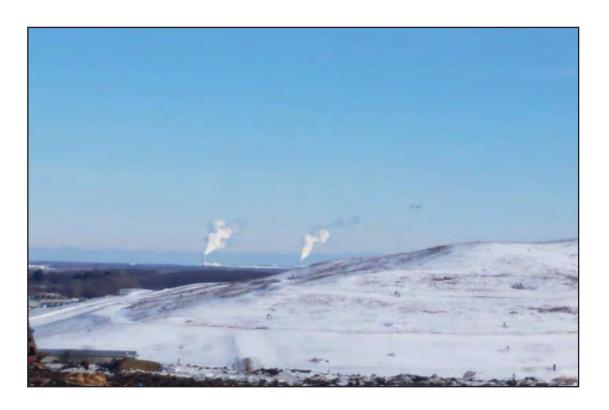
View West across site foot print

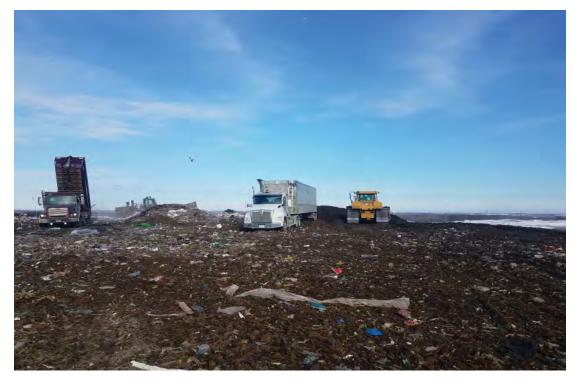
Clean out on Phase 7, dozer spreading cover

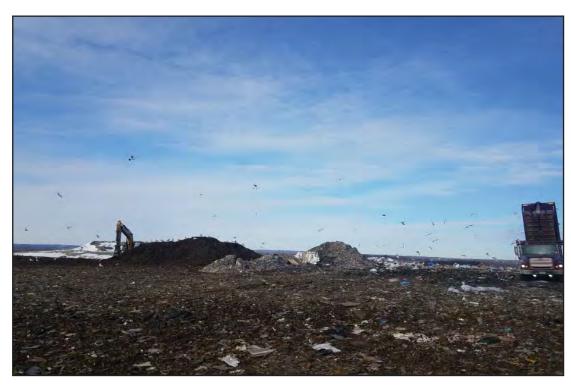
View South across active area

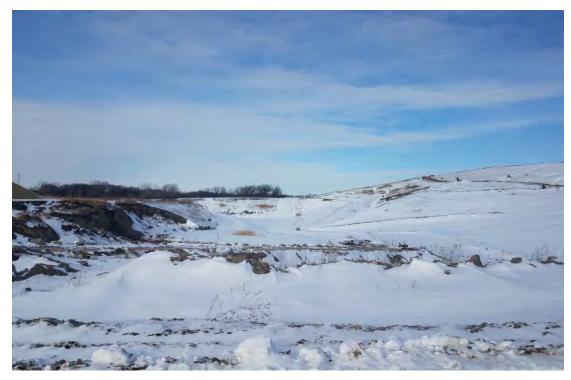
West slope at junction with Phase 3

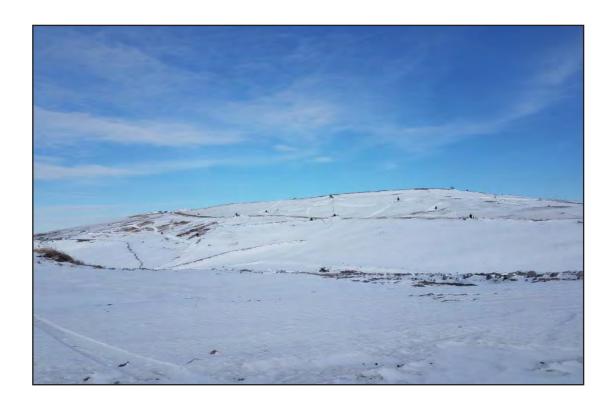
West slope of Phase 7
