GFL Emerald Park Landfill Audit Summary

TO: GFL Emerald Park Landfill Standing Committee, City of Muskego
FROM: Jo-Walter Spear, Jr., P.E.
COPIES: File
DATE: 3/1/2021
PROJECT NUMBER: 1012.10030

Attached is the audit report for activities at the GFL Emerald Park Landfill for the week of February 14, 2021. The audit was performed at 11:00 AM on **February 19, 2021** by Jo Spear, Jr.; in the presence of Chad Seigel, the Site Manager.

**GREEN FOR LIFE ENVIRONMENTAL (GLE) EMERALD PARK LANDFILL
LANDFILL OPERATIONS AUDIT FORM
CITY OF MUSKEGO**

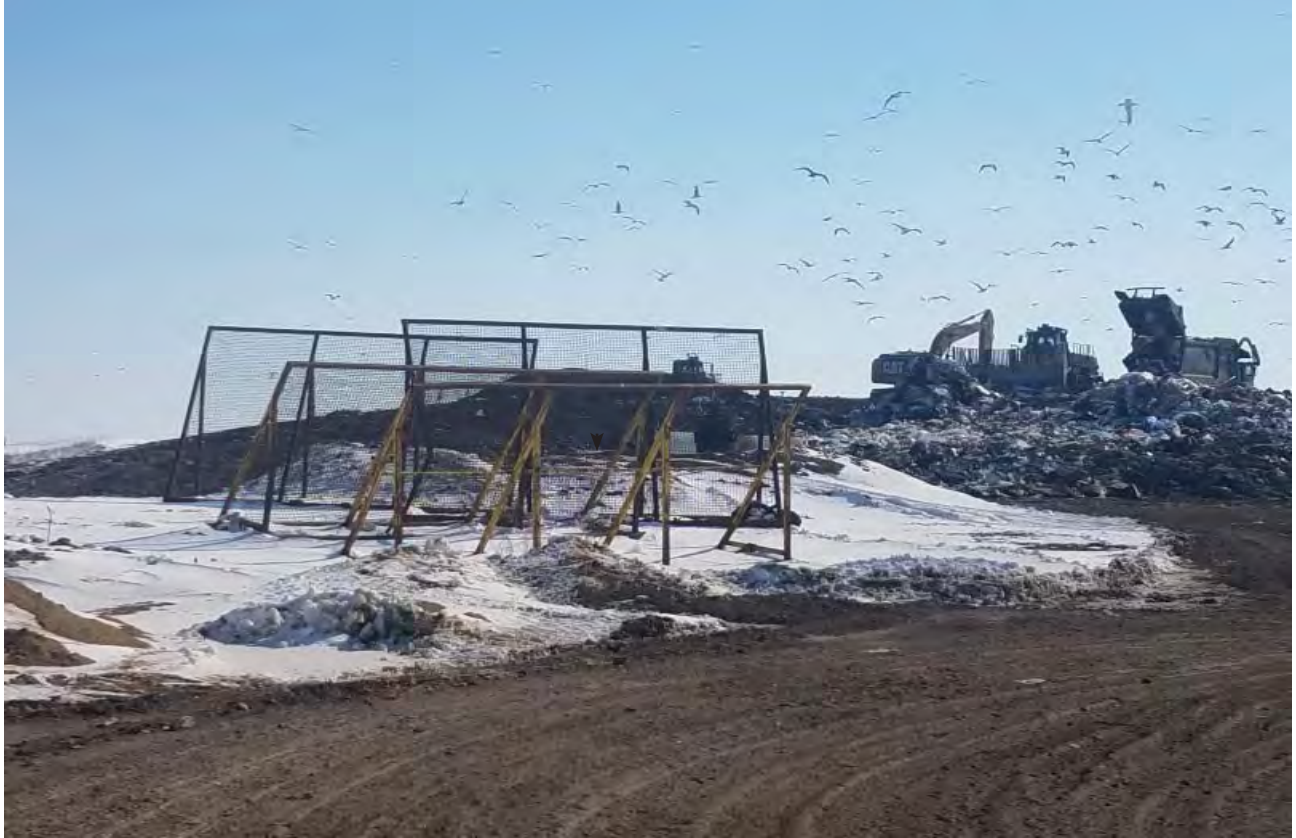
Active area, cleared of snow and receiving waste at top of working face, pushing down with equipment

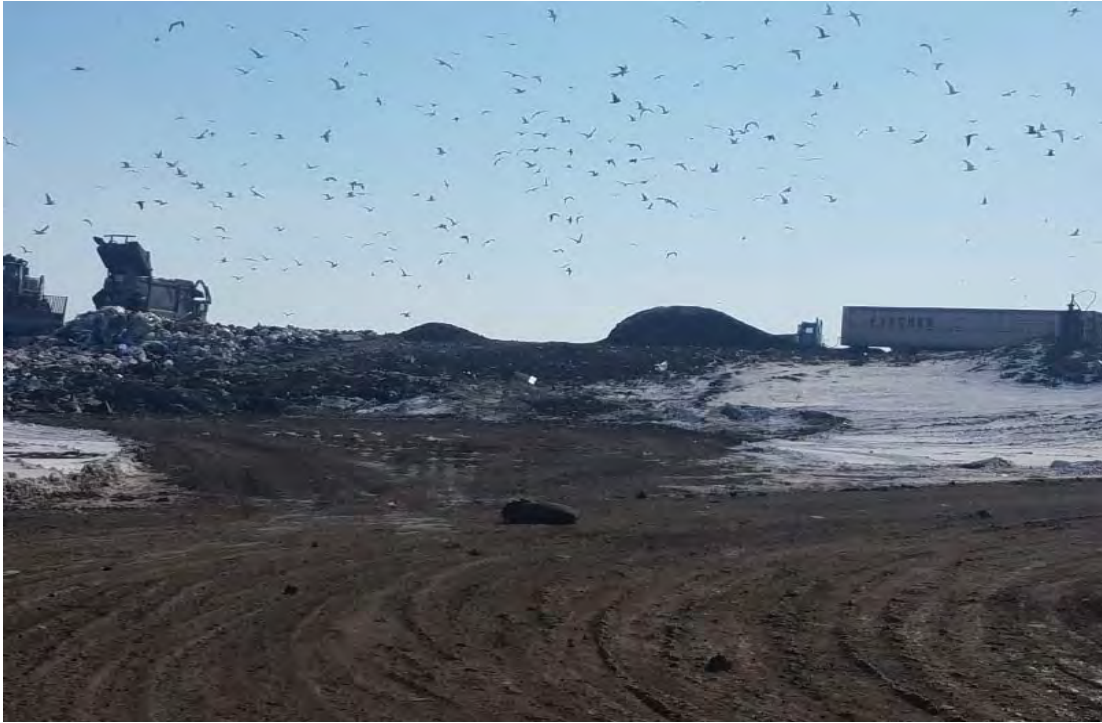
View Southwest across Phase 7, tipping to the Left, ADC stockpiles to the right

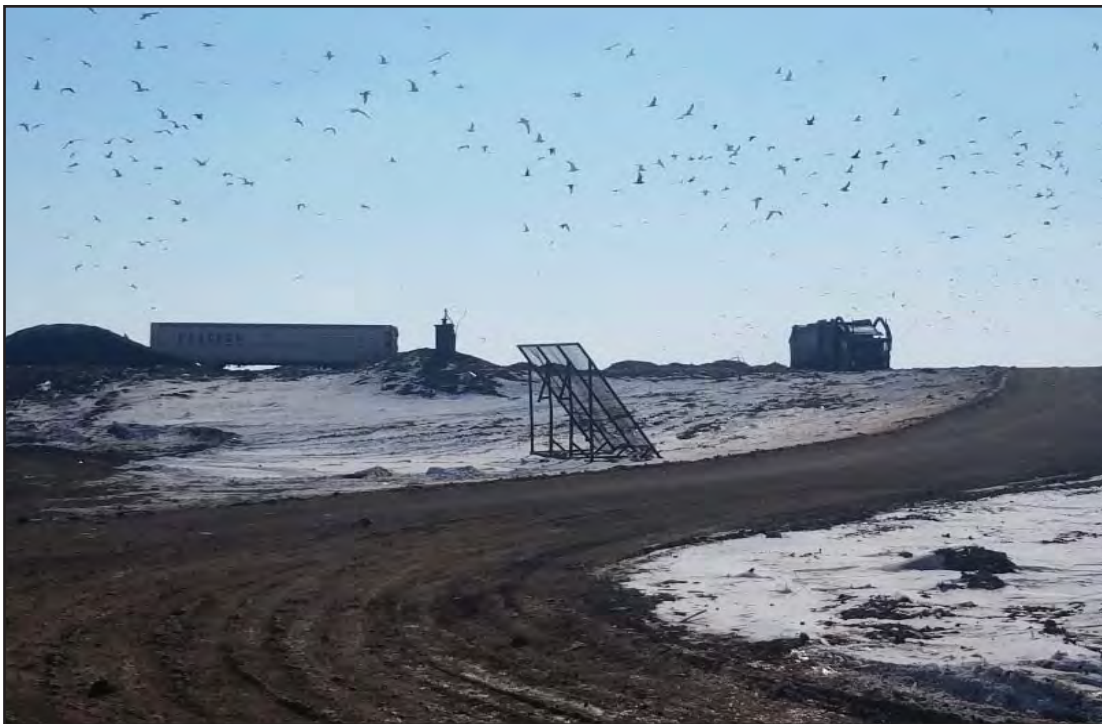
Vehicles travel around outside edge of Phase 7 to reach working face on East side to tip above the waste

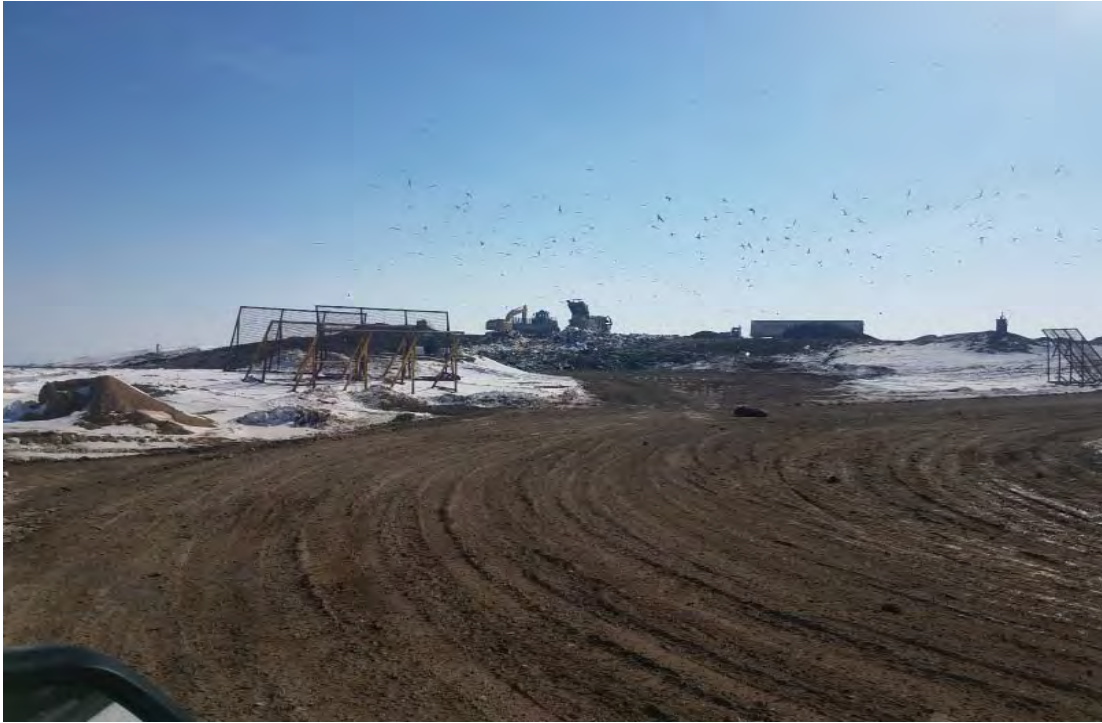
Phase 7, view from access point. Working face still on East edge
