GFL Emerald Park Landfill Audit Summary

To: GFL Emerald Park Landfill Standing Committee, City of Muskego
FROM: Jo-Walter Spear, Jr., P.E.
COPIES: File
DATE: 3/1/2021
PROJECT NUMBER: 1012.10030

Attached is the audit report for activities at the GFL Emerald Park Landfill for the week of February 21, 2021. The audit was performed at 1:24 PM on **February 24, 2021** by Jo Spear, Jr.; in the presence of Chad Seigel, the Site Manager.

**ADVANCED DISPOSAL SERVICES
EMERALD PARK LANDFILL / CITY OF MUSKEGO
AUDIT PHOTOS**

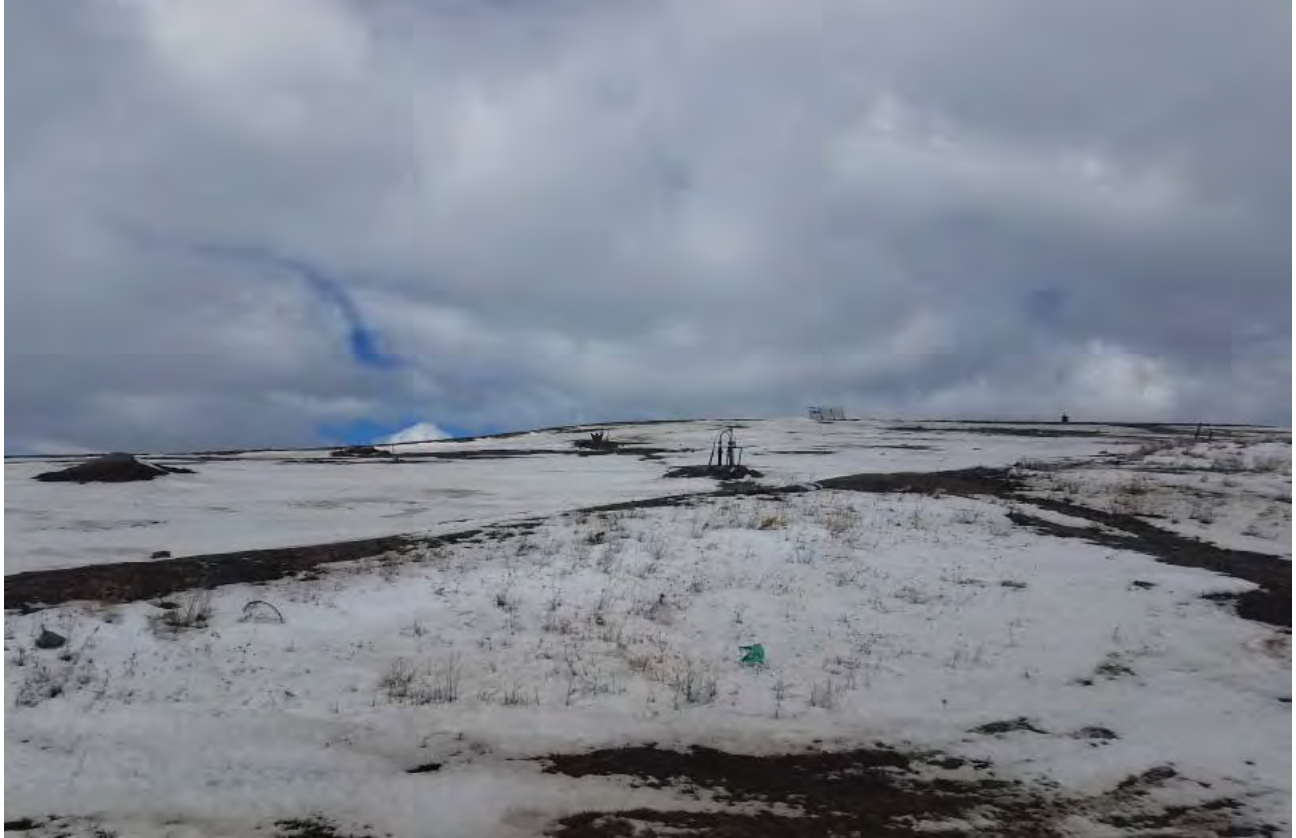
South slope of Phase 7. Some thawed patches from header and similar locations. No odors or seeps

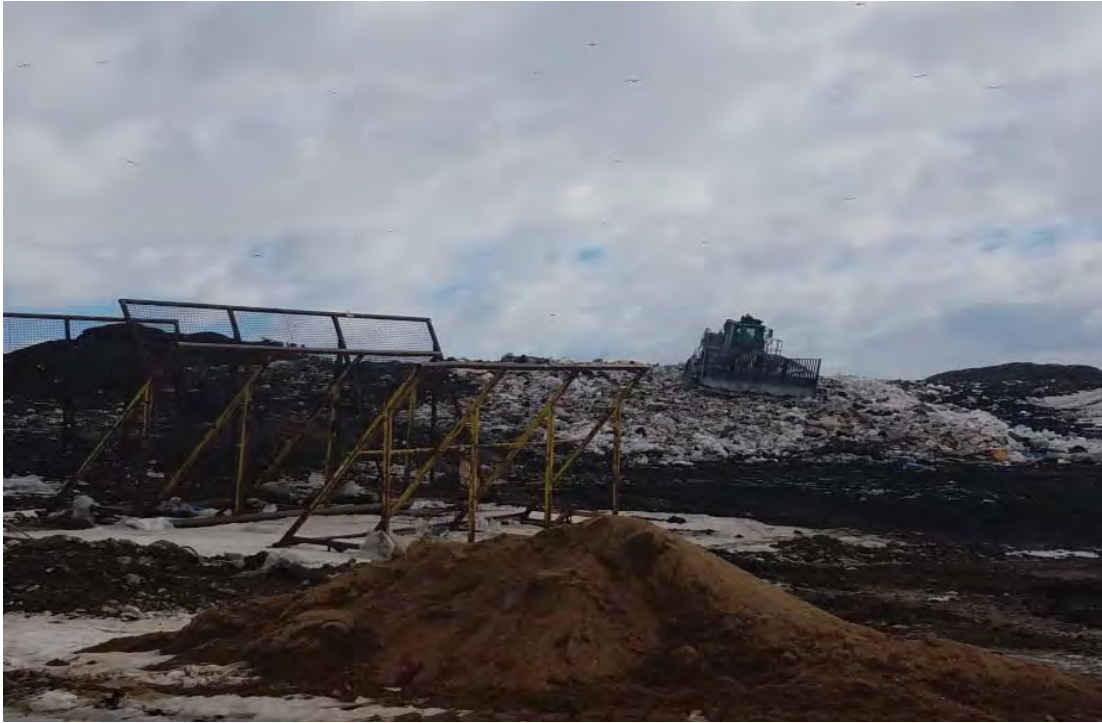
Tipping continues on top of working face and pushing waste down

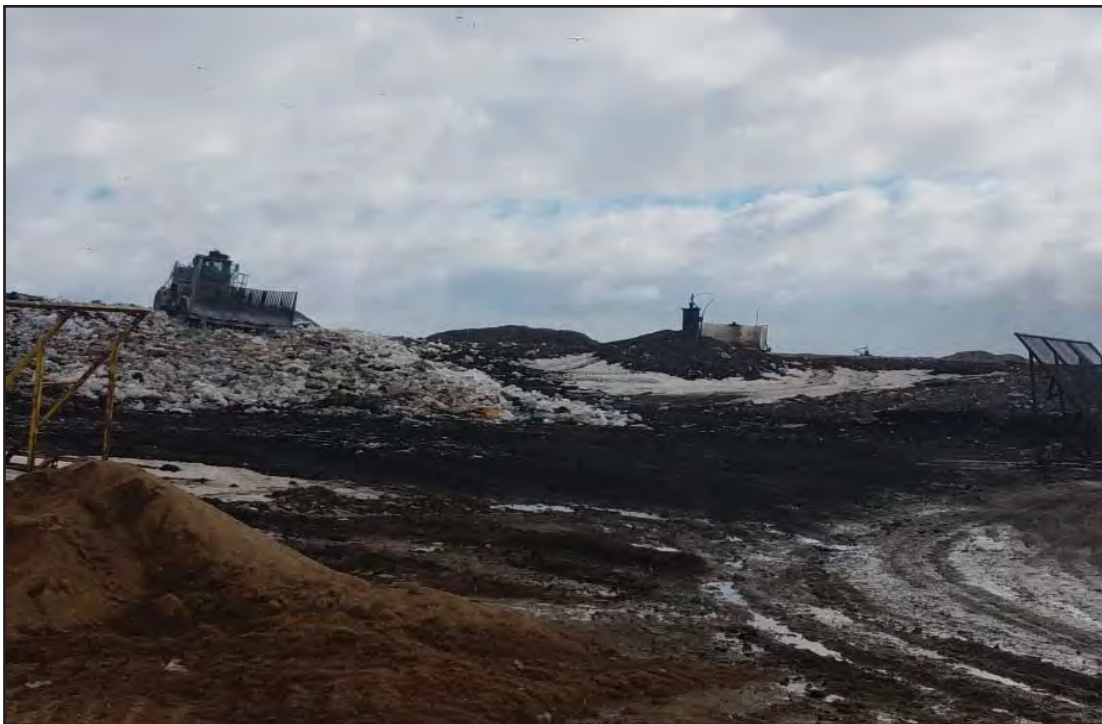
Working face moving Westward across Phase

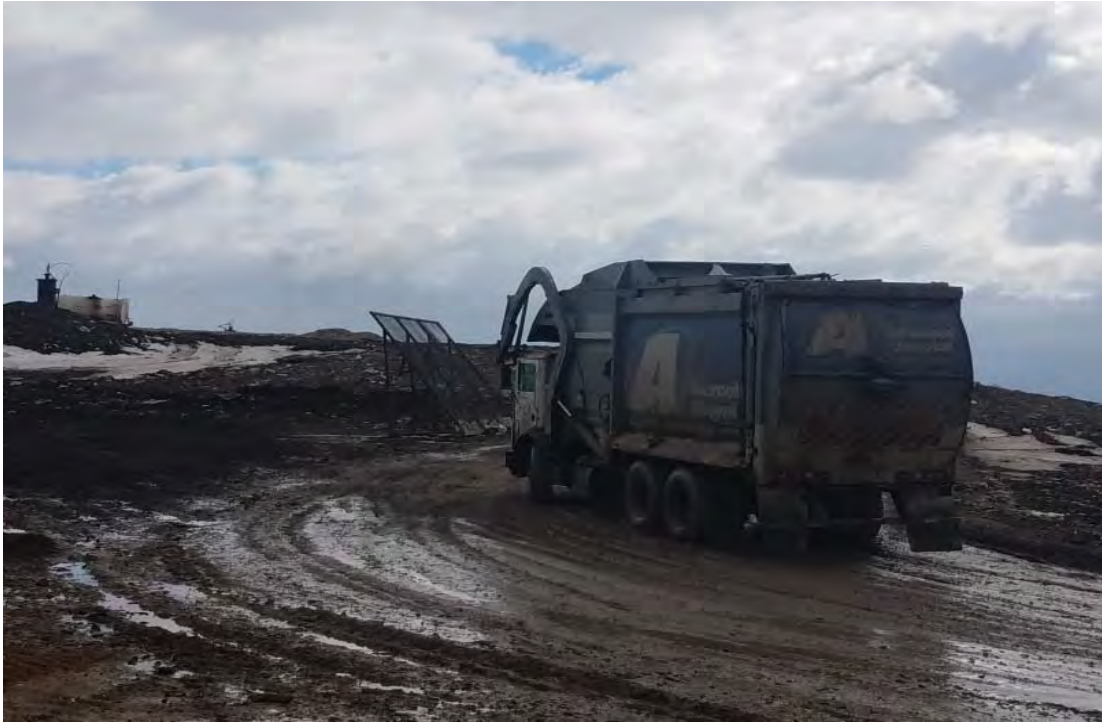
Access road about Phase 7

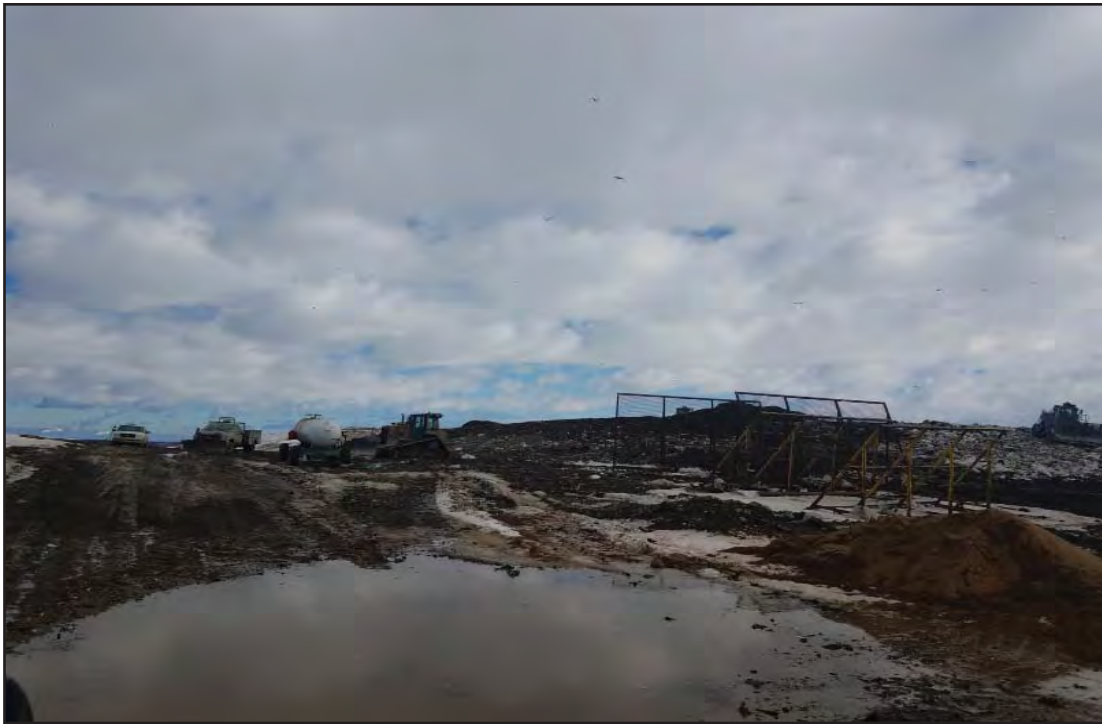
Thawing conditions in Phase 7

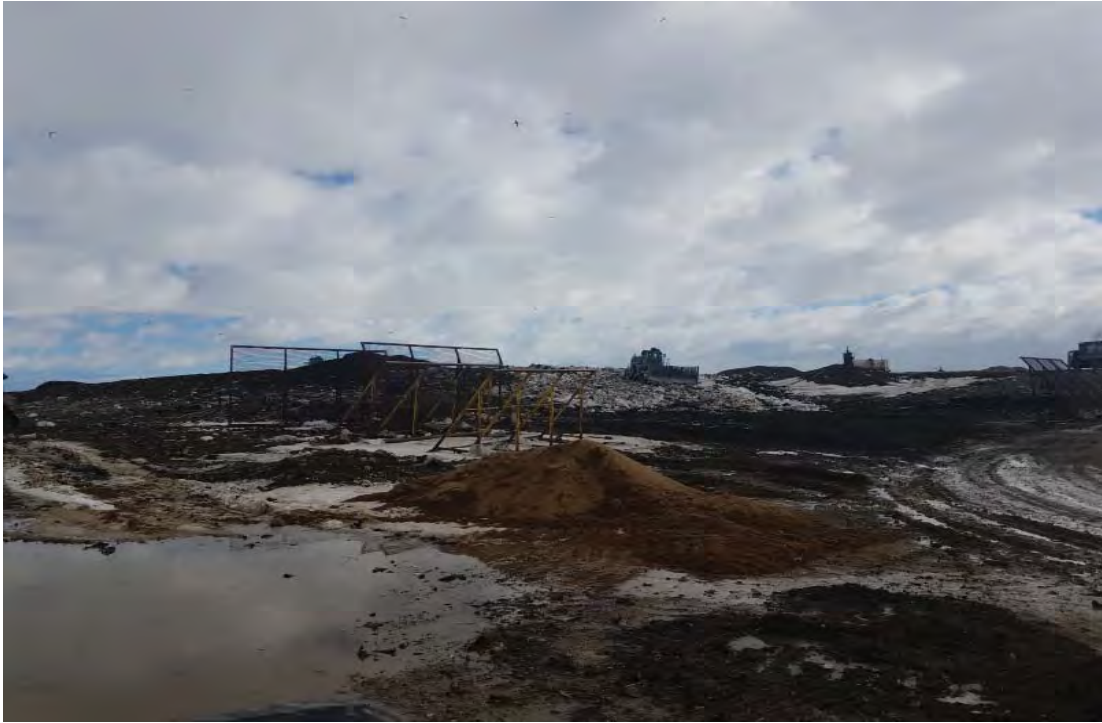
Phase 7, viewed from Phase access in Northwest. Active area rapidly thawing

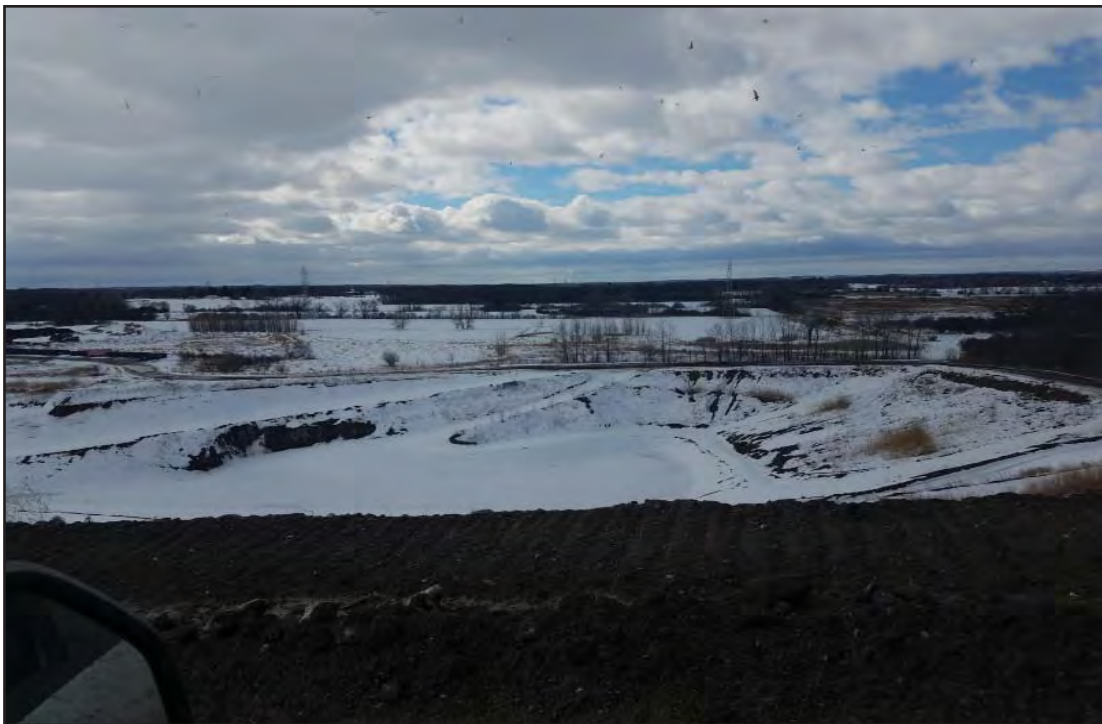
- Temp sed basin frozen, pumping not viable
 - One snow event since last audit, temperatures above freezing since 2/21/2021
 - Site conditions mucky
- E) Odor Control

East of Phase 7, temp sed basin and future cells. Well frozen

- Temp sed basin without pump; however pump is repaired and will be restored with thawing conditions.
