GFL Emerald Park Landfill Audit Summary

To: GFL Emerald Park Landfill Standing Committee, City of Muskego
FROM: Jo-Walter Spear, Jr., P.E.
COPIES: File
DATE: 7/27/2021
PROJECT NUMBER: 1012.10030

Attached is the audit report for activities at the GFL Emerald Park Landfill for the week of June 27, 2021. The audit was performed at 2:58 PM on **June 3, 2021** by Jo Spear, Jr.; in the presence of Daniel Otzelberger, the General Manager

**/ CITY OF MUSKEGO
AUDIT PHOTOS**

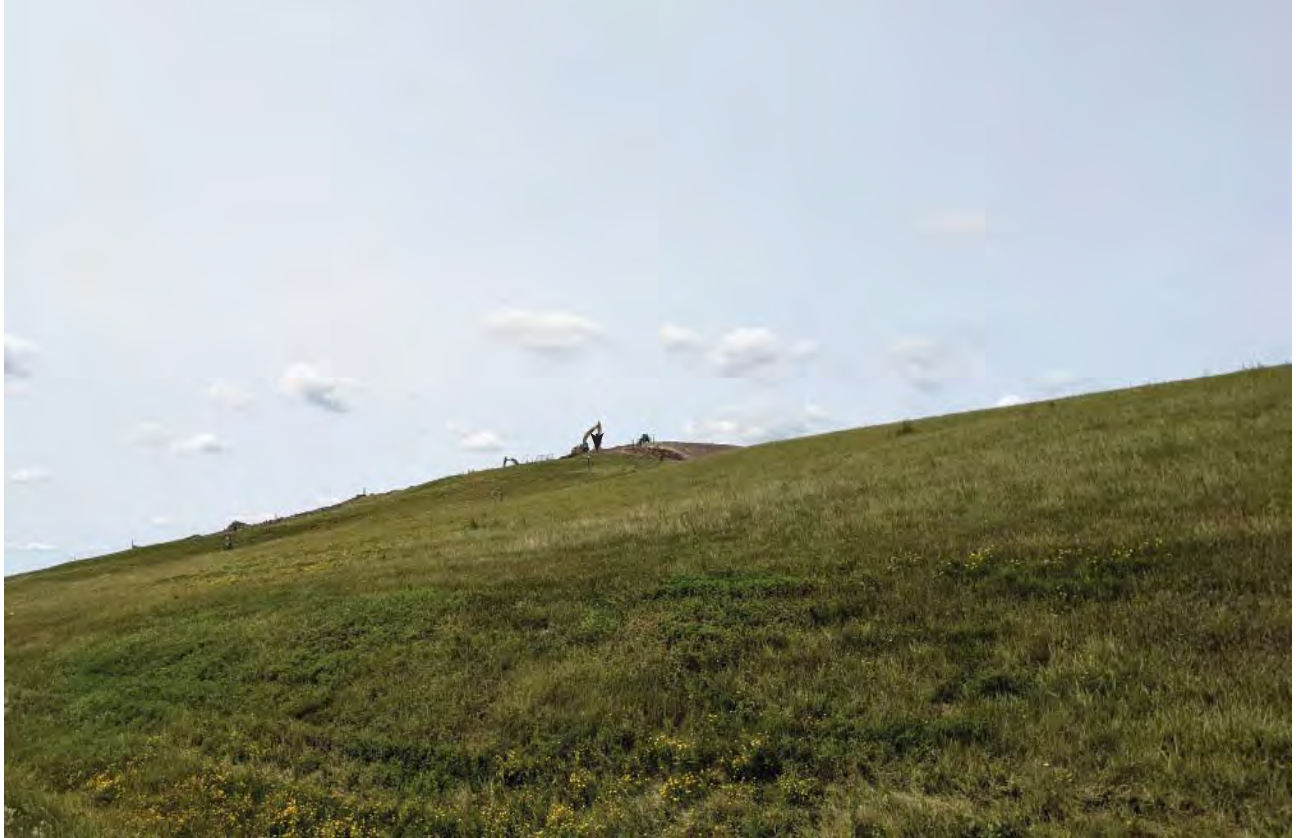
South slope of Phase 5 & 6, contractor at top of slope with excavator for connecting wells

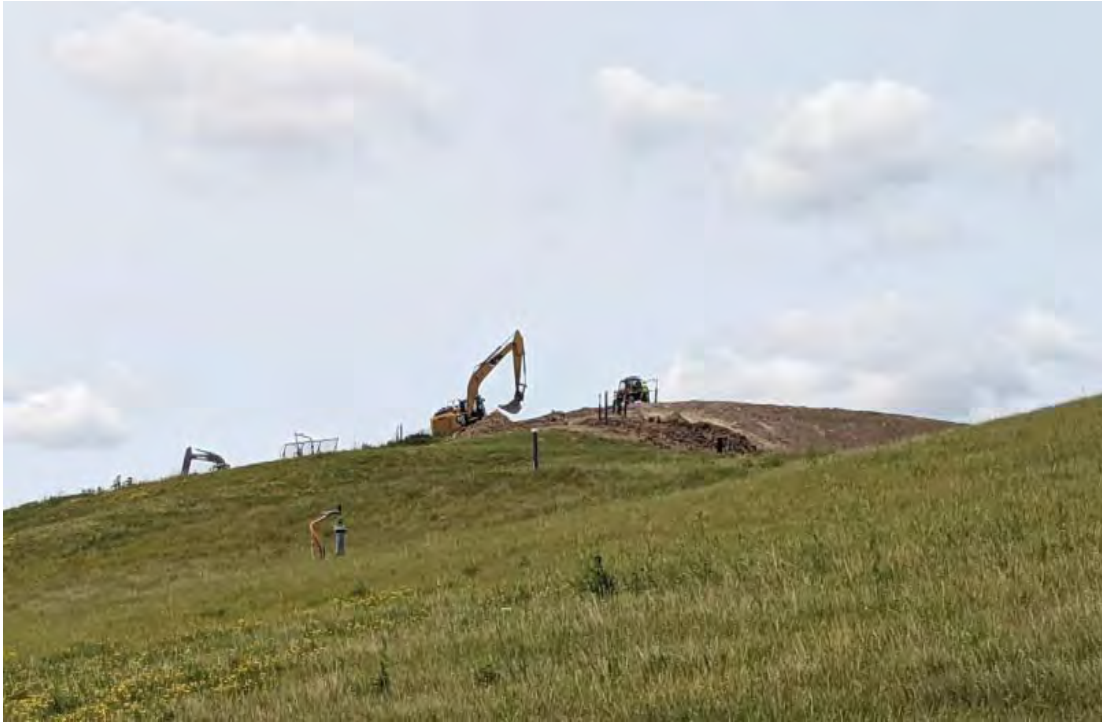
Contractor connecting new wells with HDPE piping

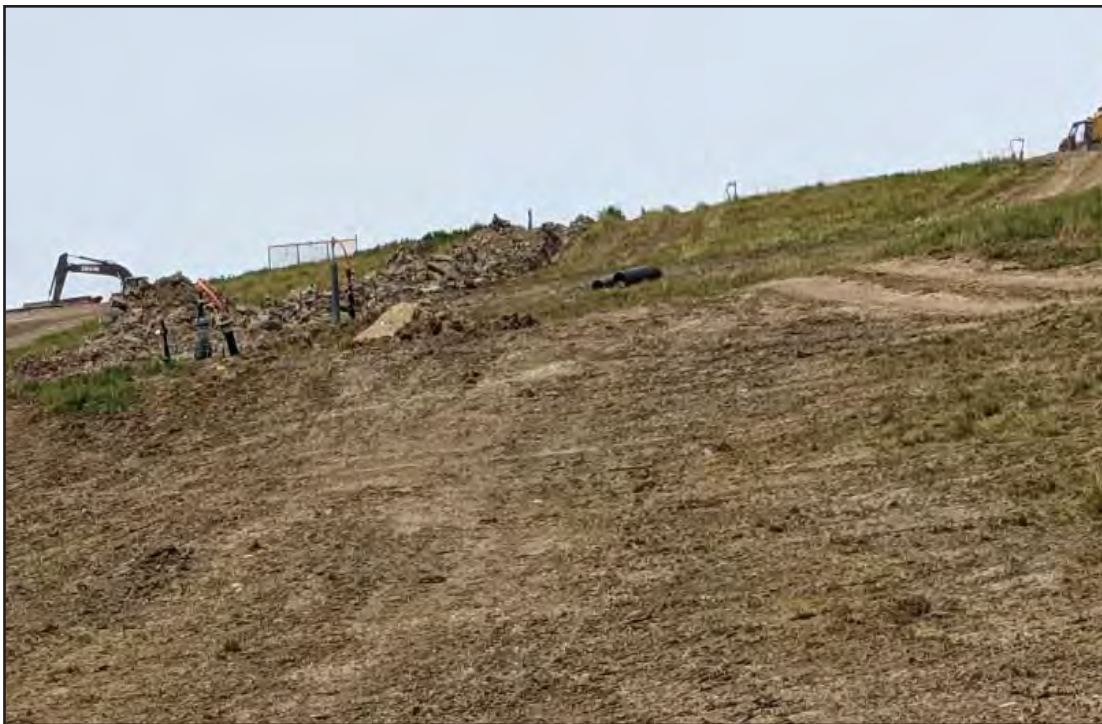
East slope of Phase 5, awaiting see

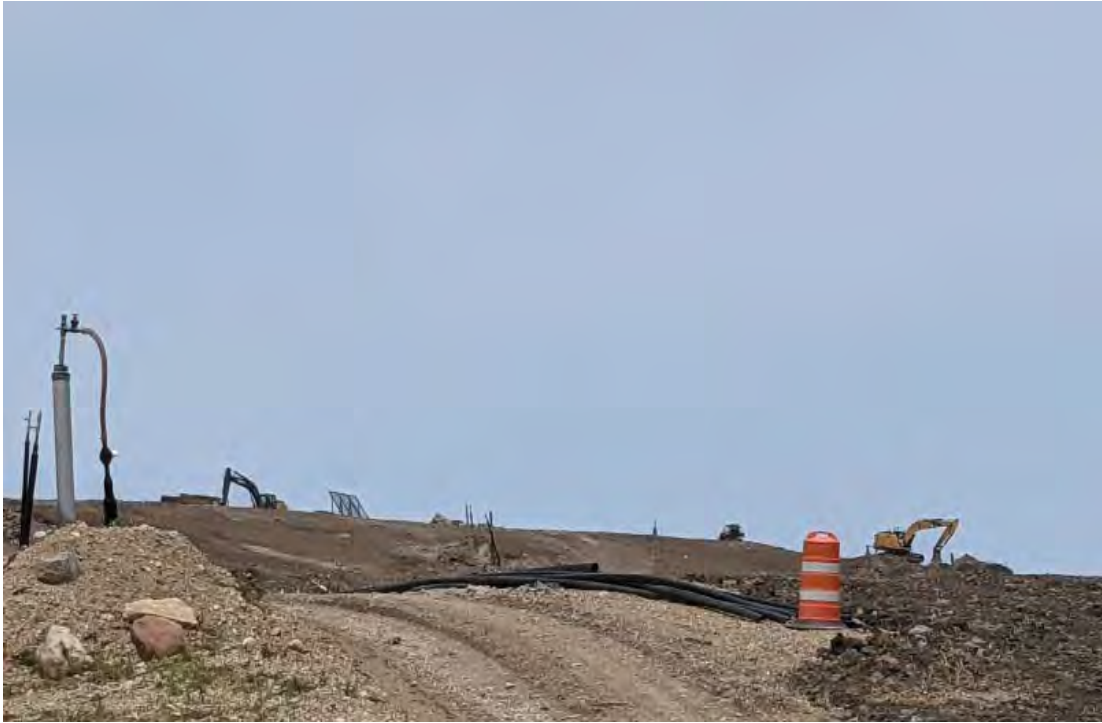
South slope of Emerald Park, top soil being spread

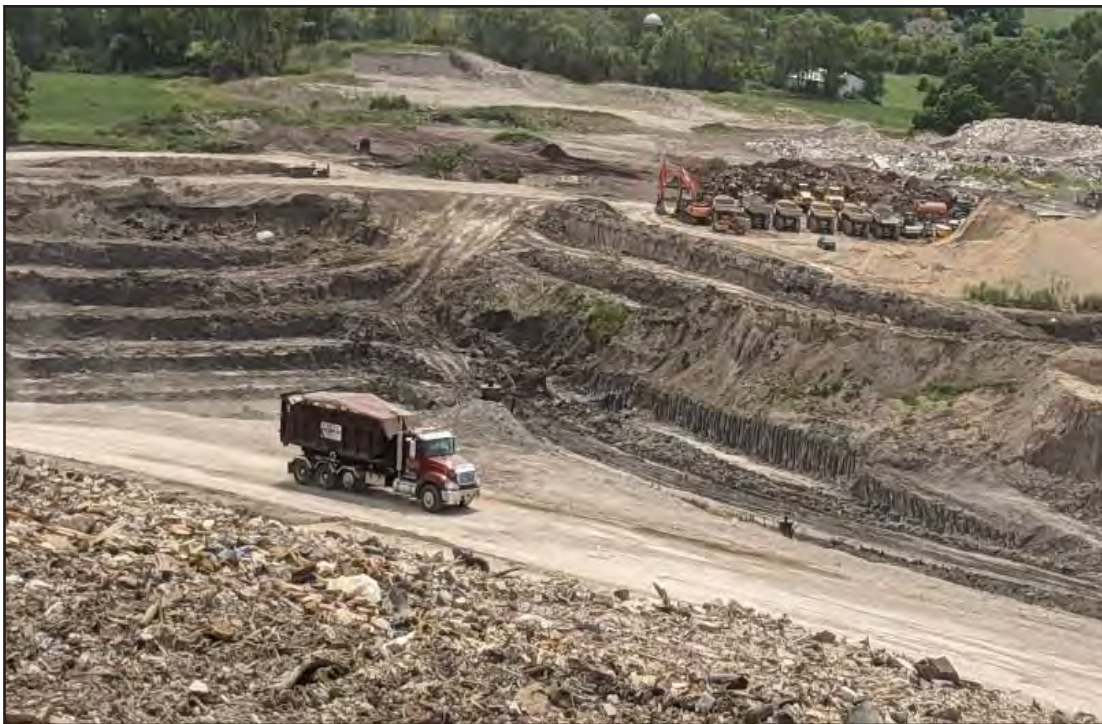
Overview of new cell

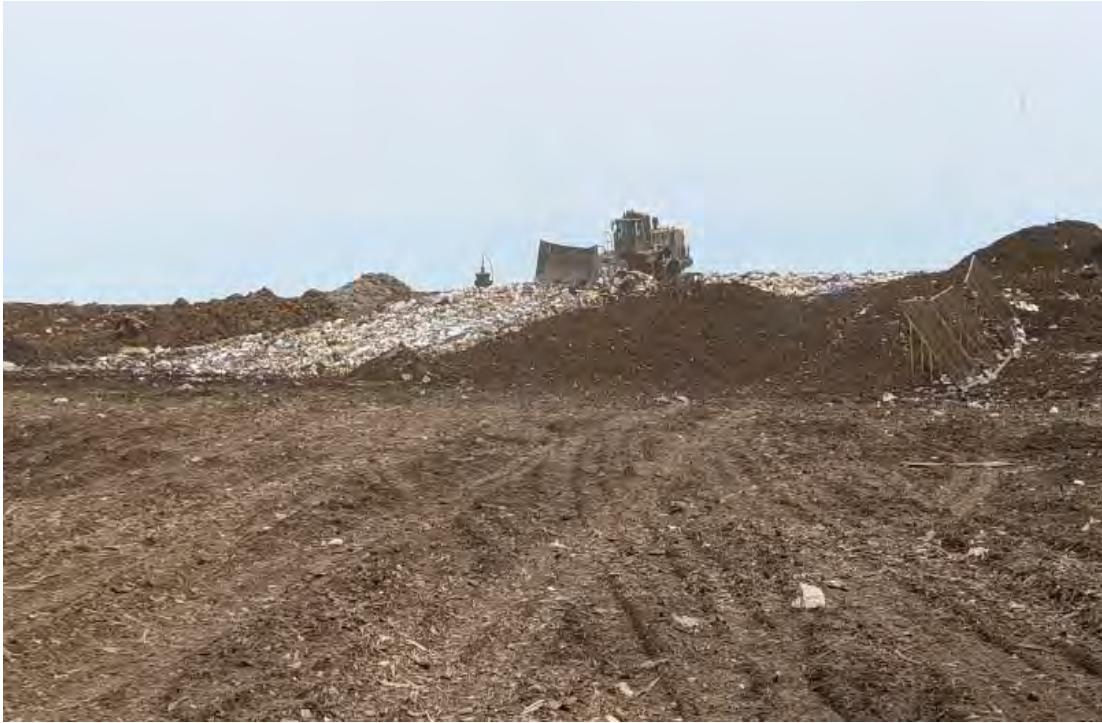
Working face in Southeast corner of Phase 6 at top of slope

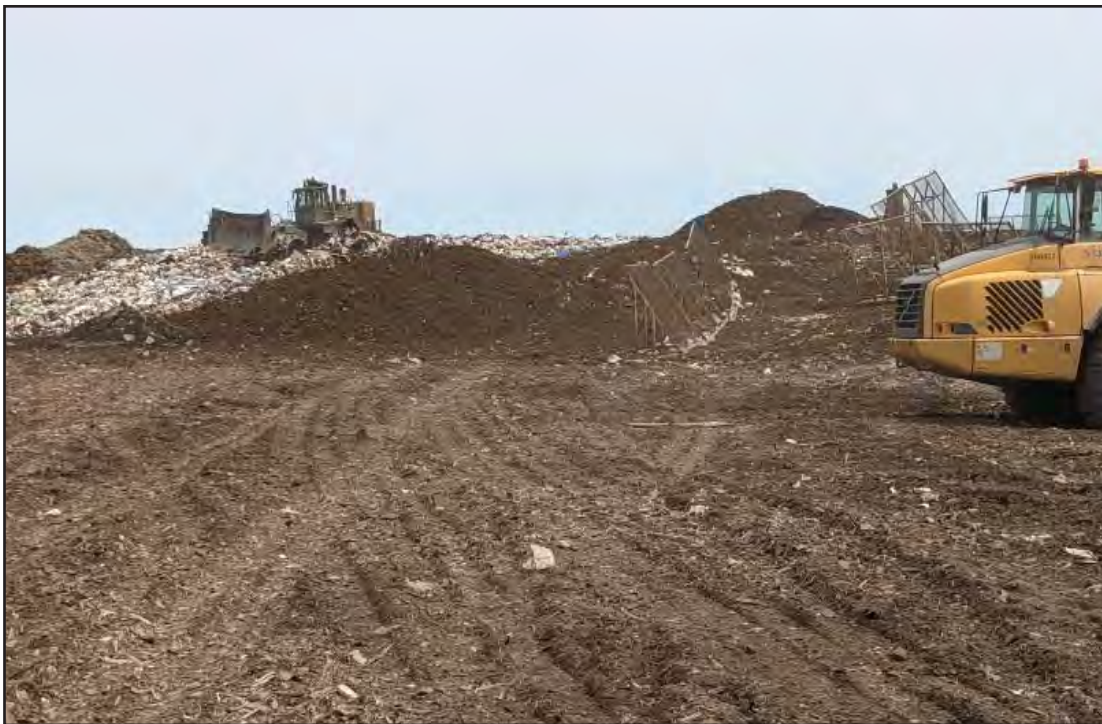
Working face in Southeast corner of Phase 6 at top of slope

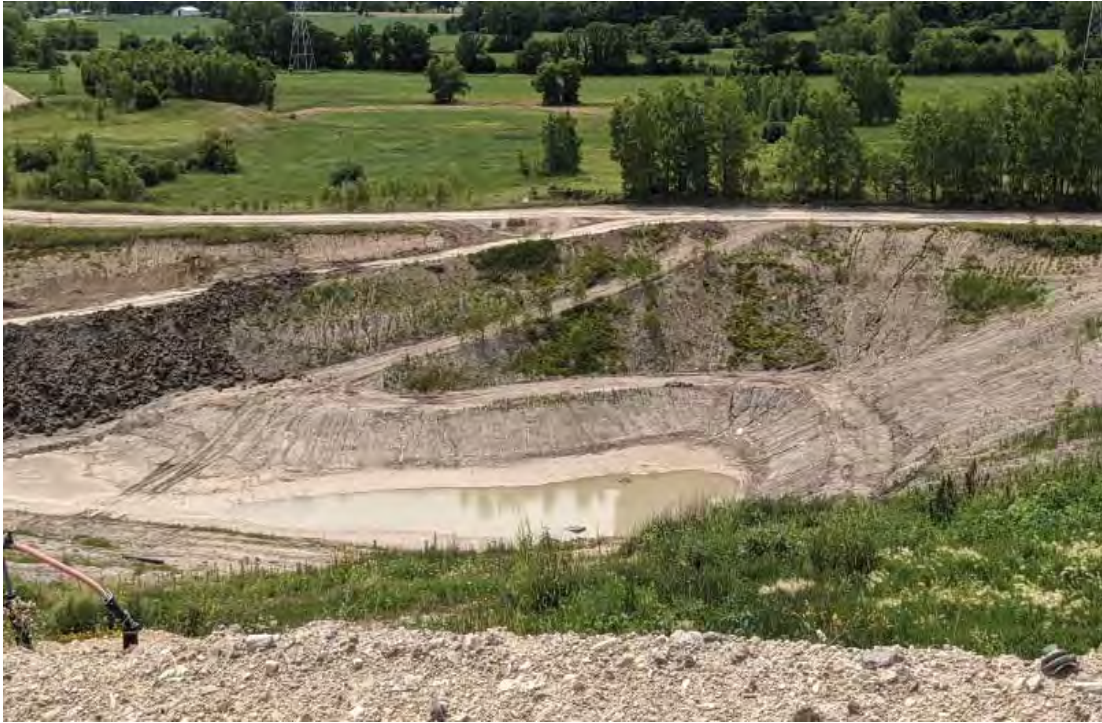
Temp Sed Basin, well pumped down

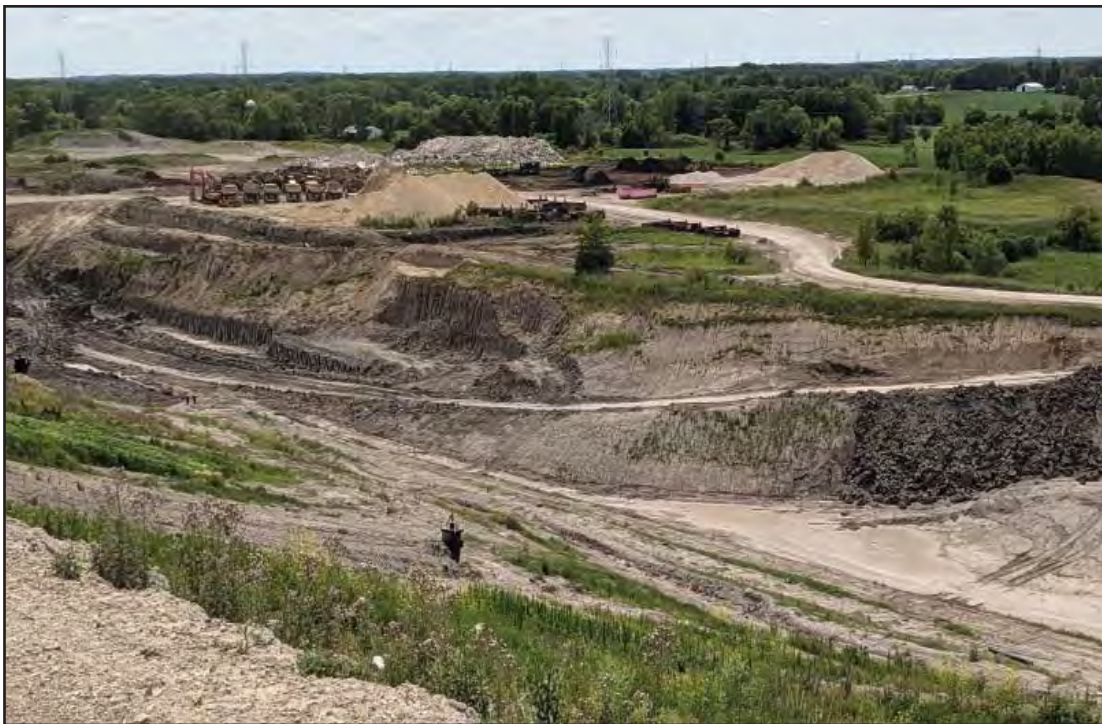
Temporary Sedimentation Basin transition

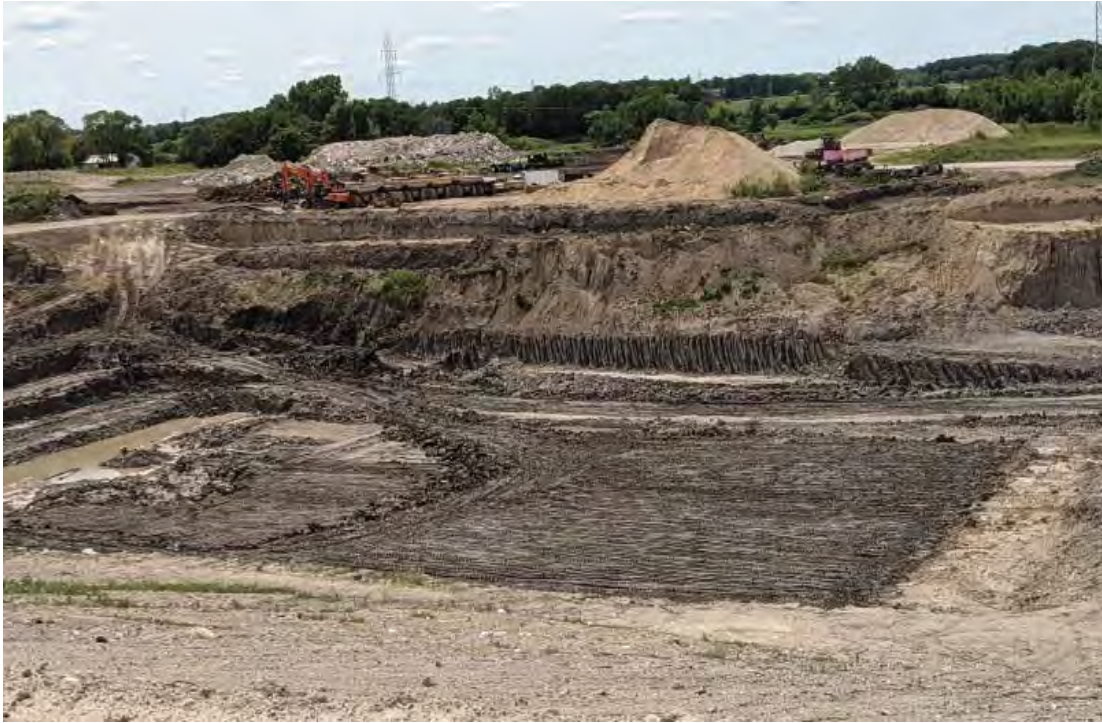
New cell construction, base nearly prepared for liner deployment

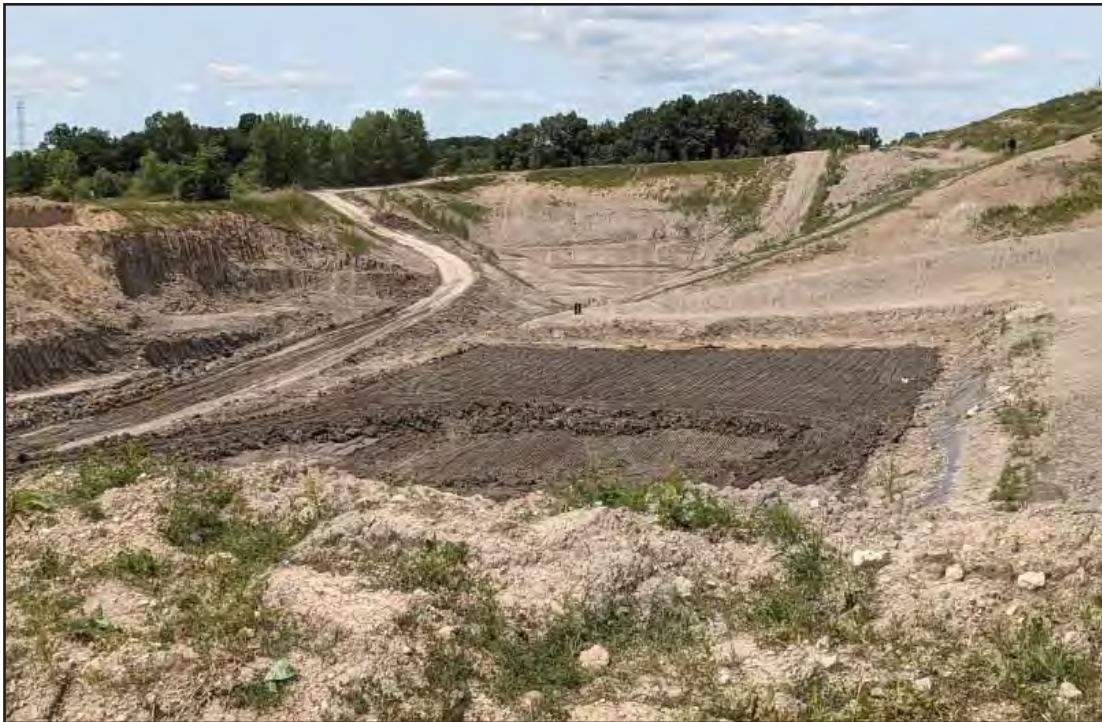
New cell construction, base nearly prepared for liner deployment

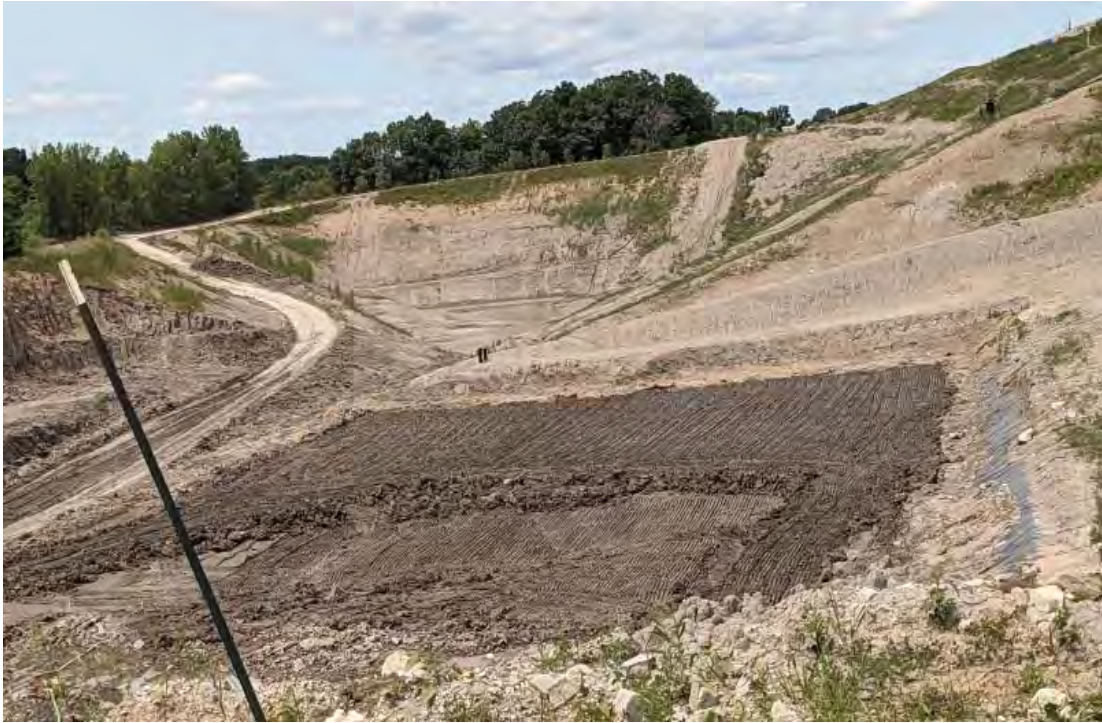
New cell construction, base nearly prepared for liner deployment
