GFL Emerald Park Landfill Audit Summary

TO: GFL Emerald Park Landfill Standing Committee, City of Muskego
FROM: Jo-Walter Spear, Jr., P.E.
COPIES: File
DATE: 7/27/2021
PROJECT NUMBER: 1012.10030

GREEN FOR LIFE ENVIRONMENTAL (GFL) EMERALD PARK LANDFILL
 LANDFILL OPERATIONS AUDIT FORM
 CITY OF MUSKEGO

**/ CITY OF MUSKEGO
AUDIT PHOTOS**

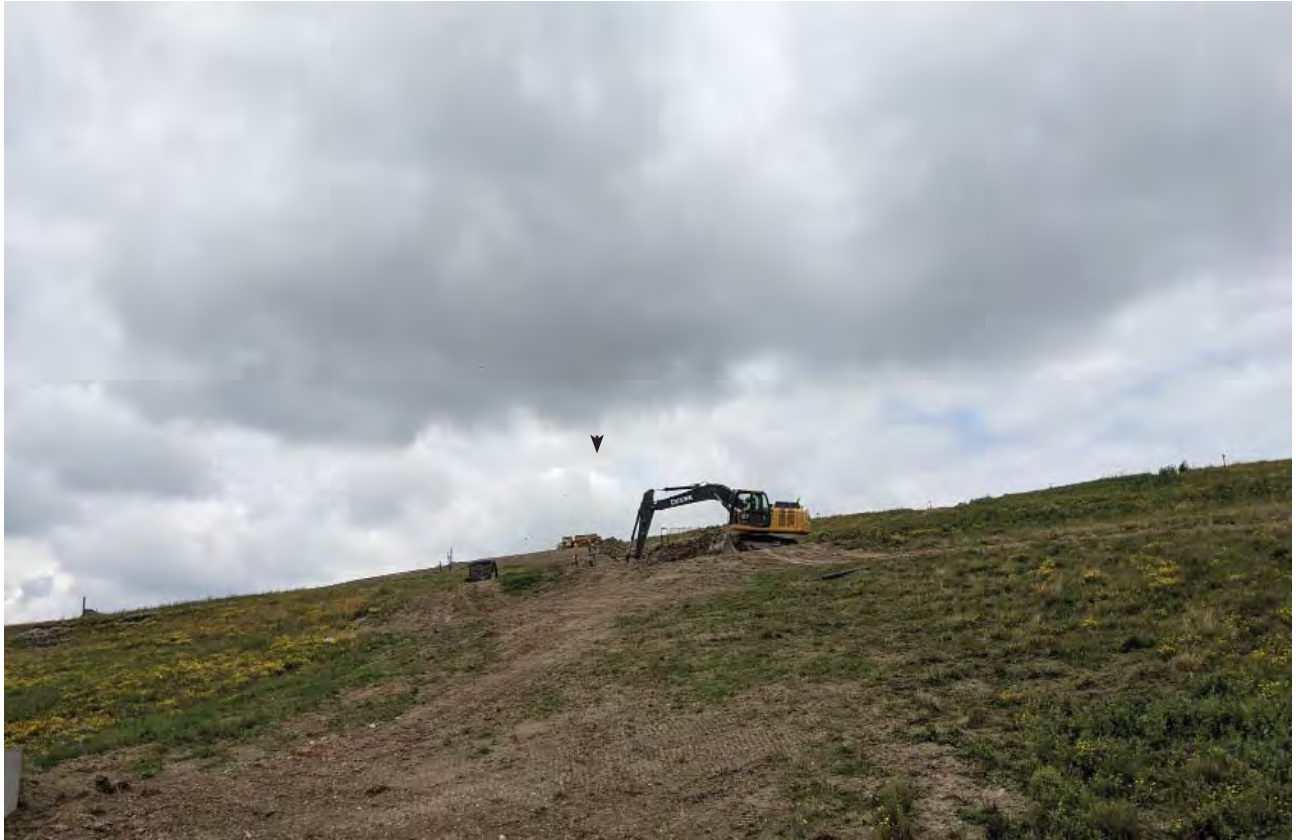
Contractor digging trenches for placement of gas collection piping

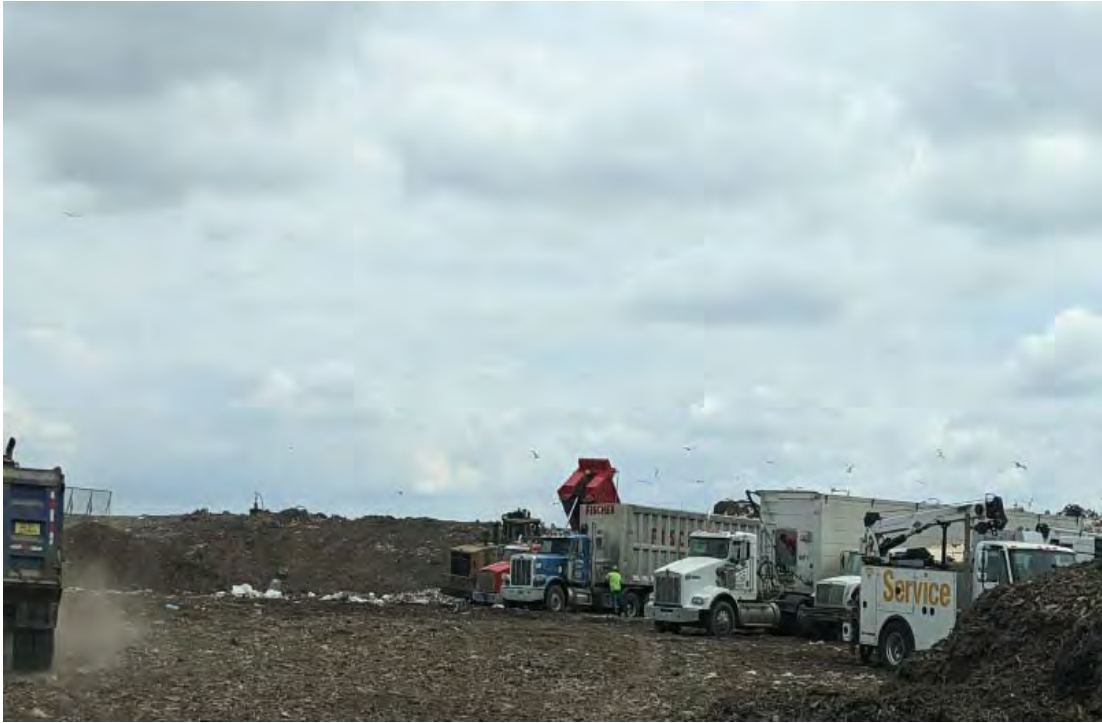
Previously placed waste acting as protective berm about Phase 6. Cover is autofluff ADC

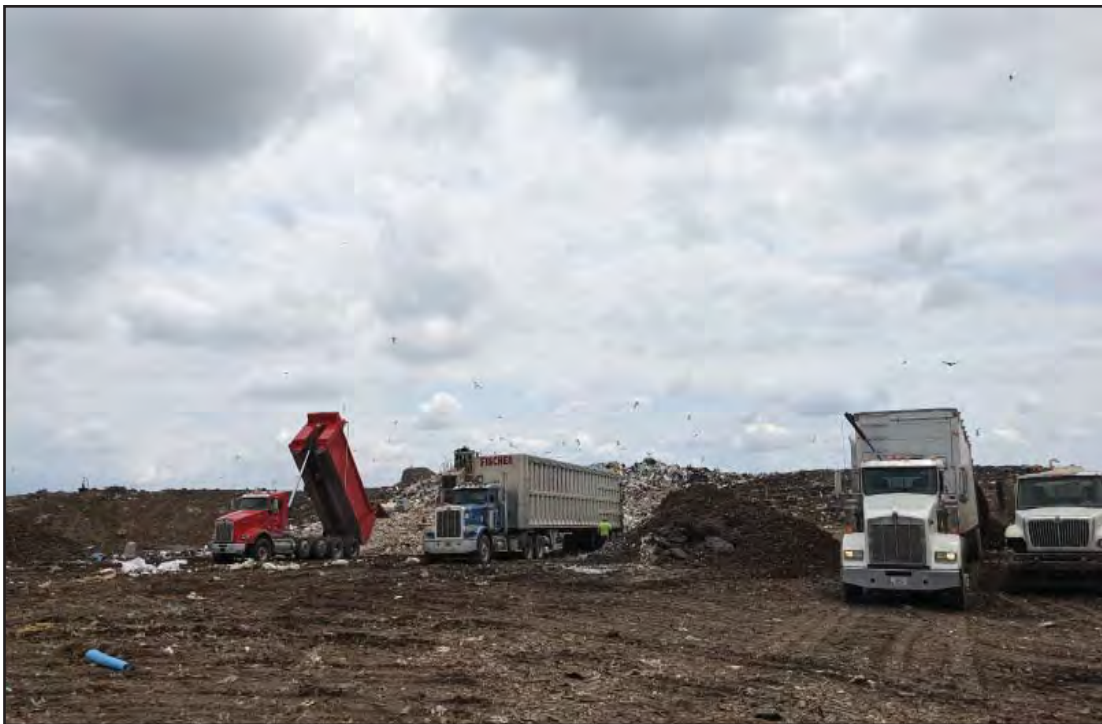
Working face moving along South end of Phases 6/7

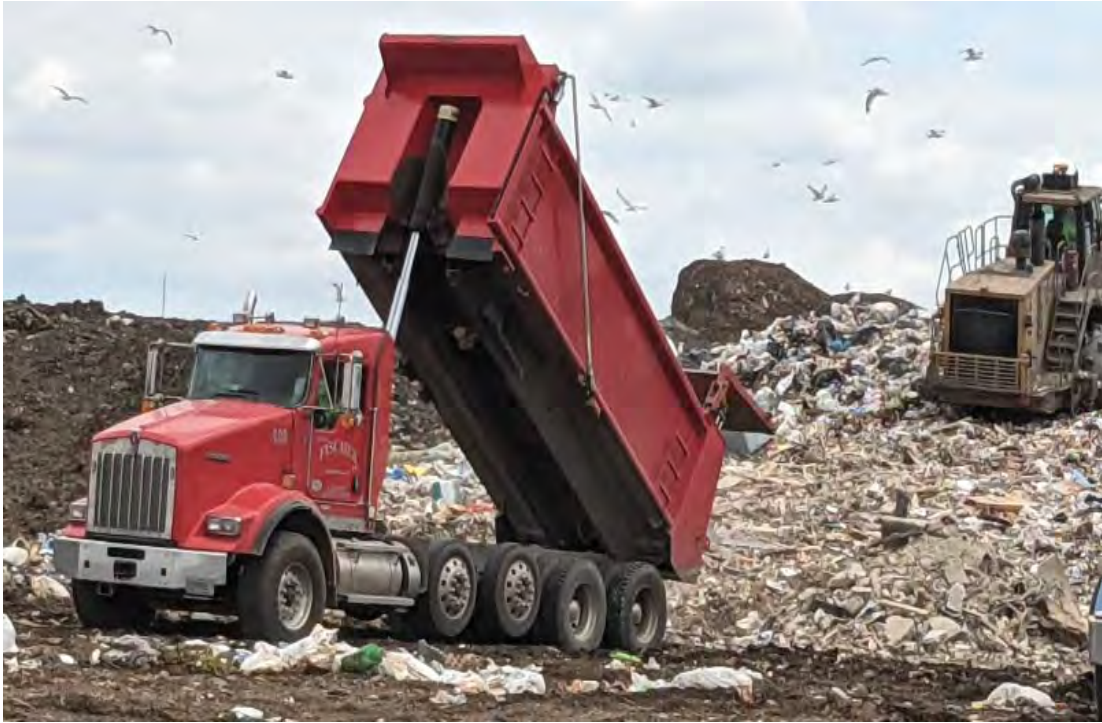
Tipping at working face

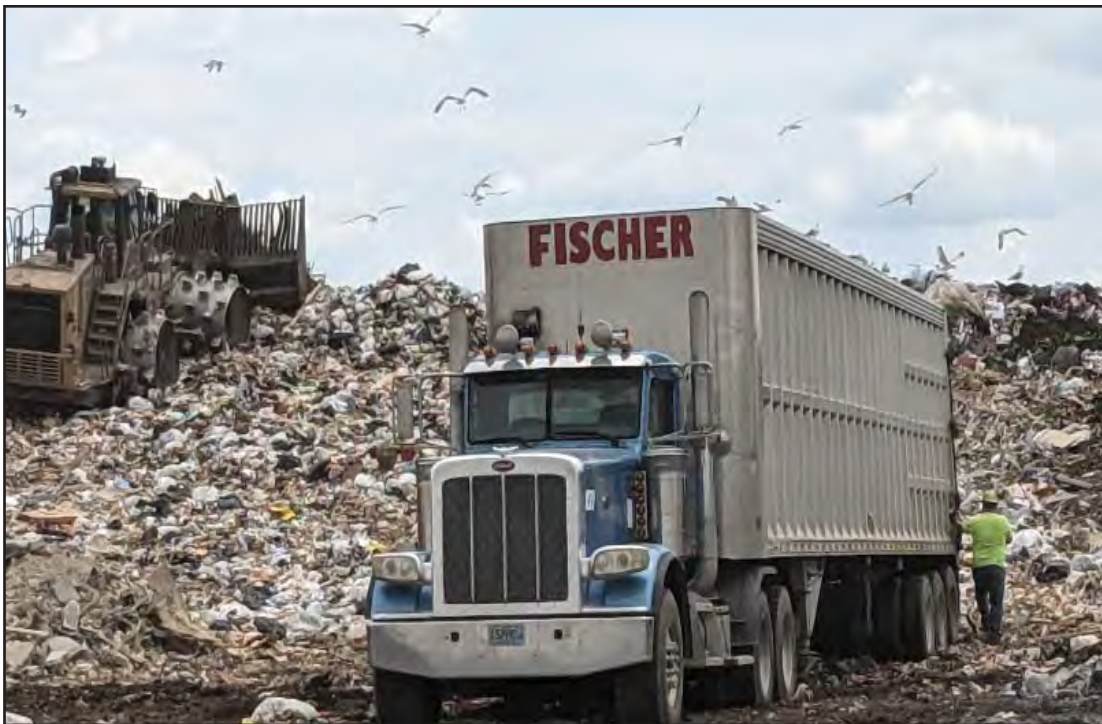
Working face in Phase 6/7

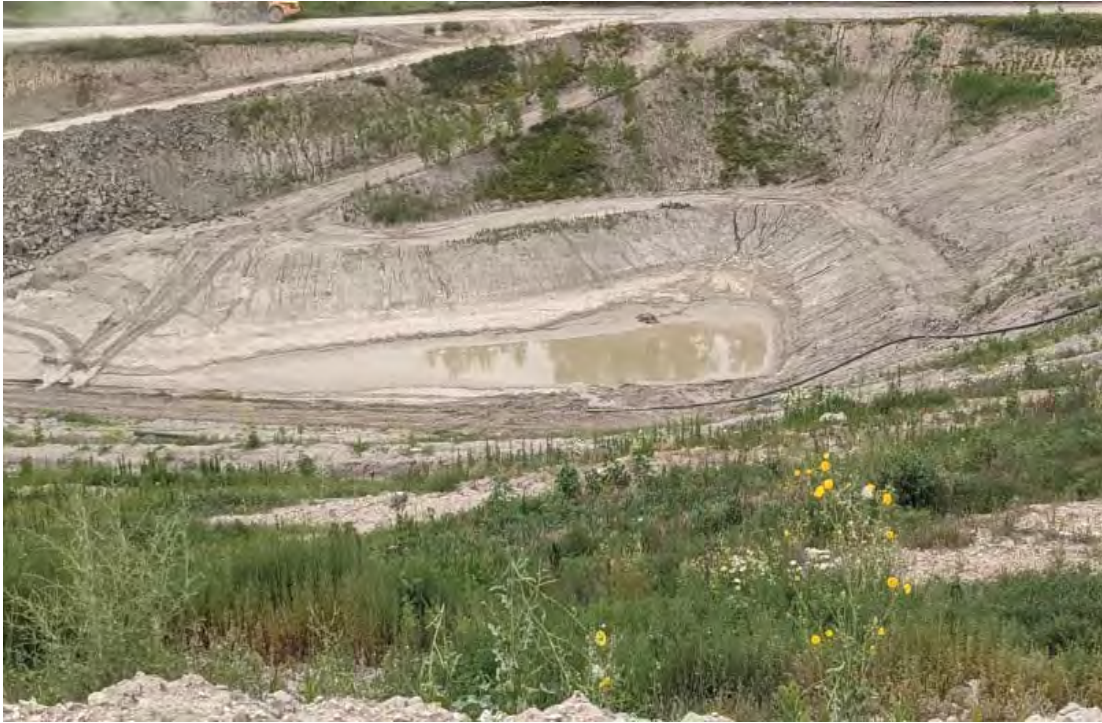
Temp sed basin, being maintained by pumping to Basin #1

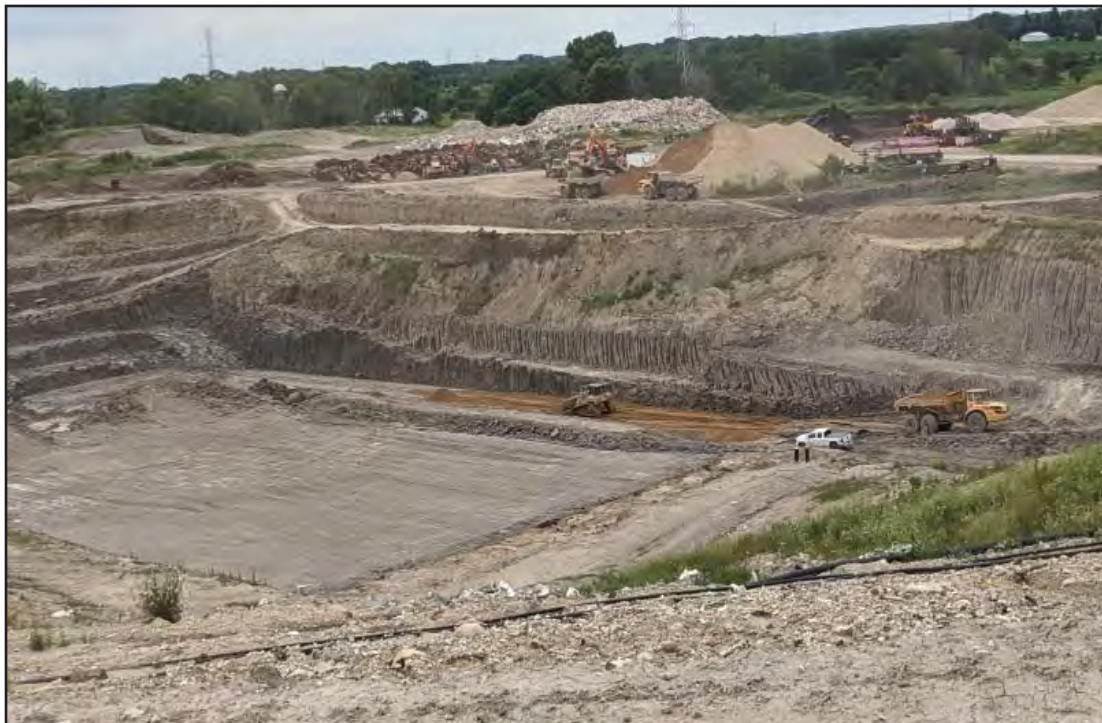
Overview of new cell construction

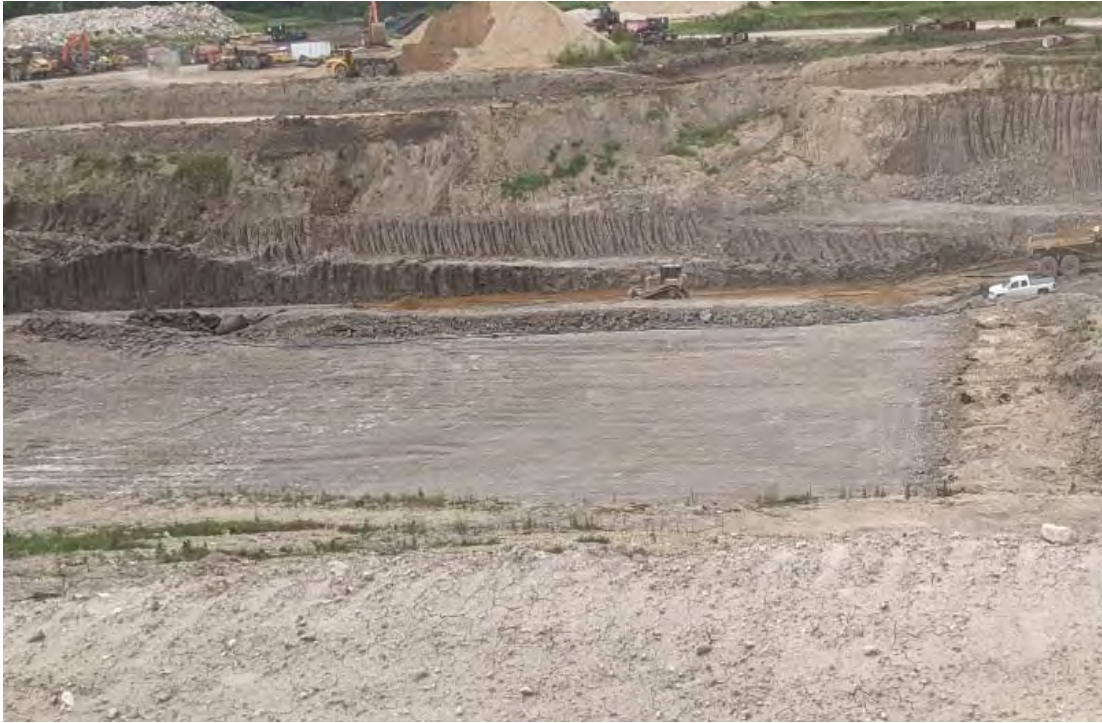
Overview of new cell

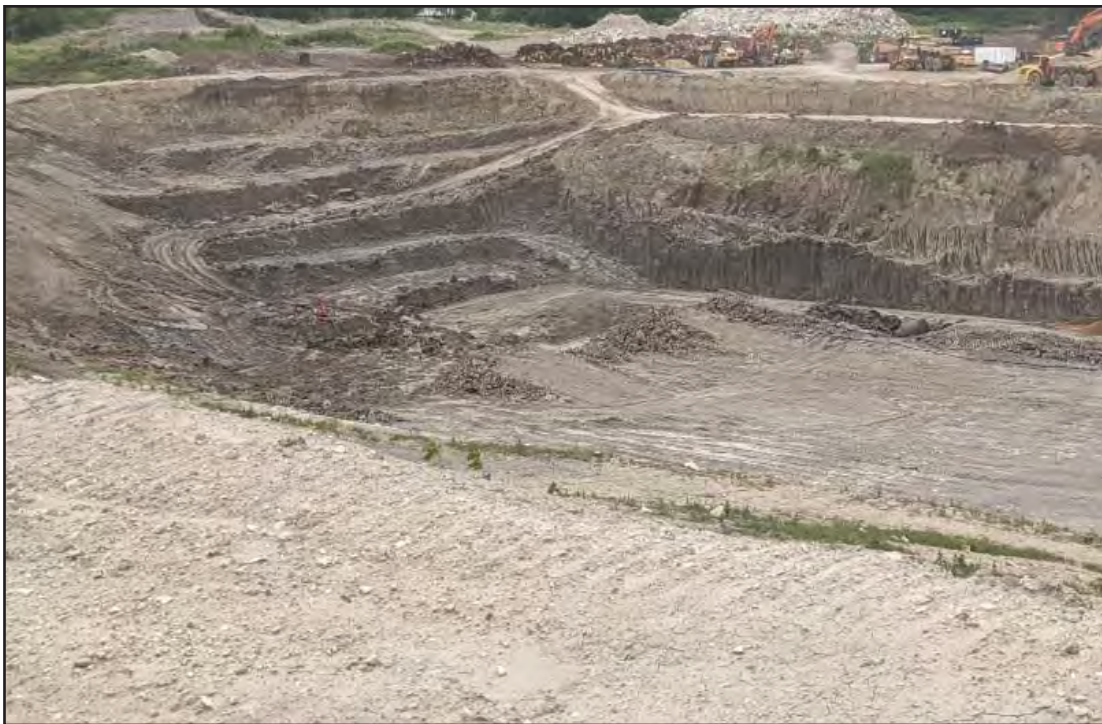
New cell South slope still being shaped

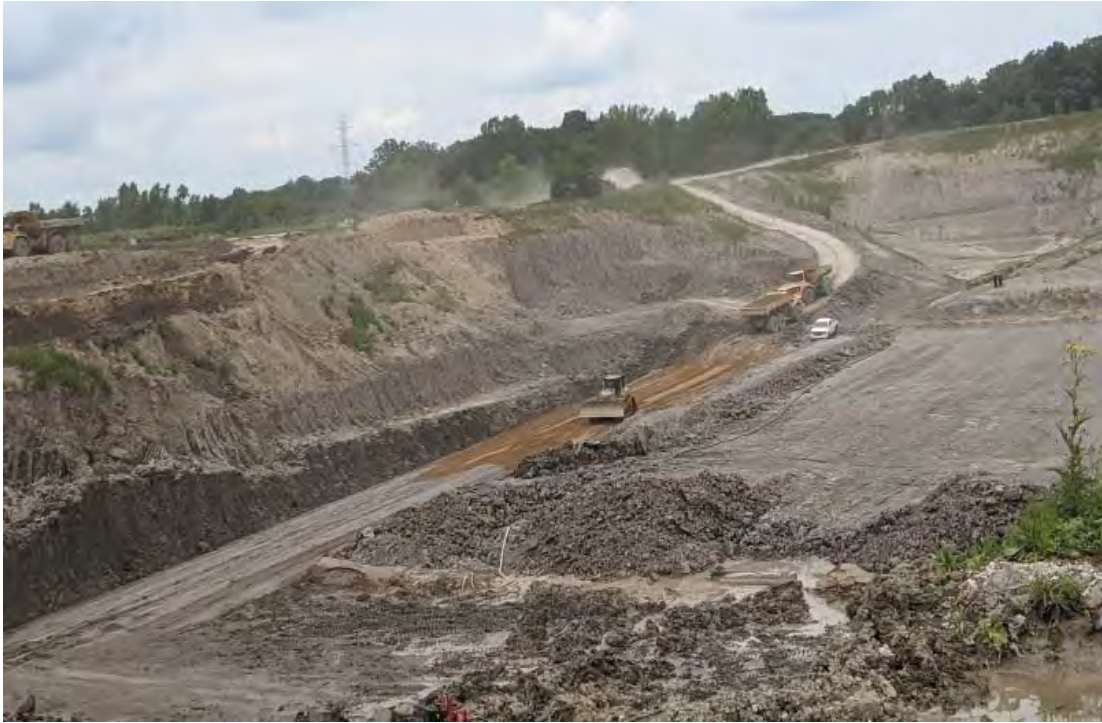
West side of the new cell, construction ongoing, placement of gradient layer

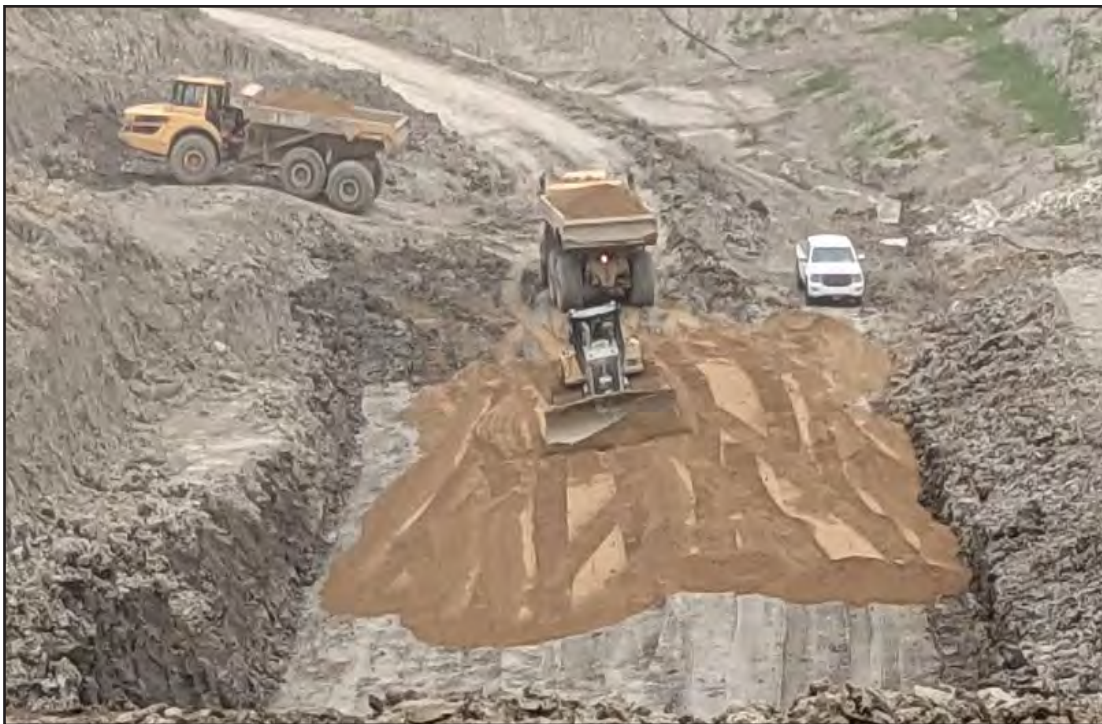
Placement of gradient layer below liner in new cell

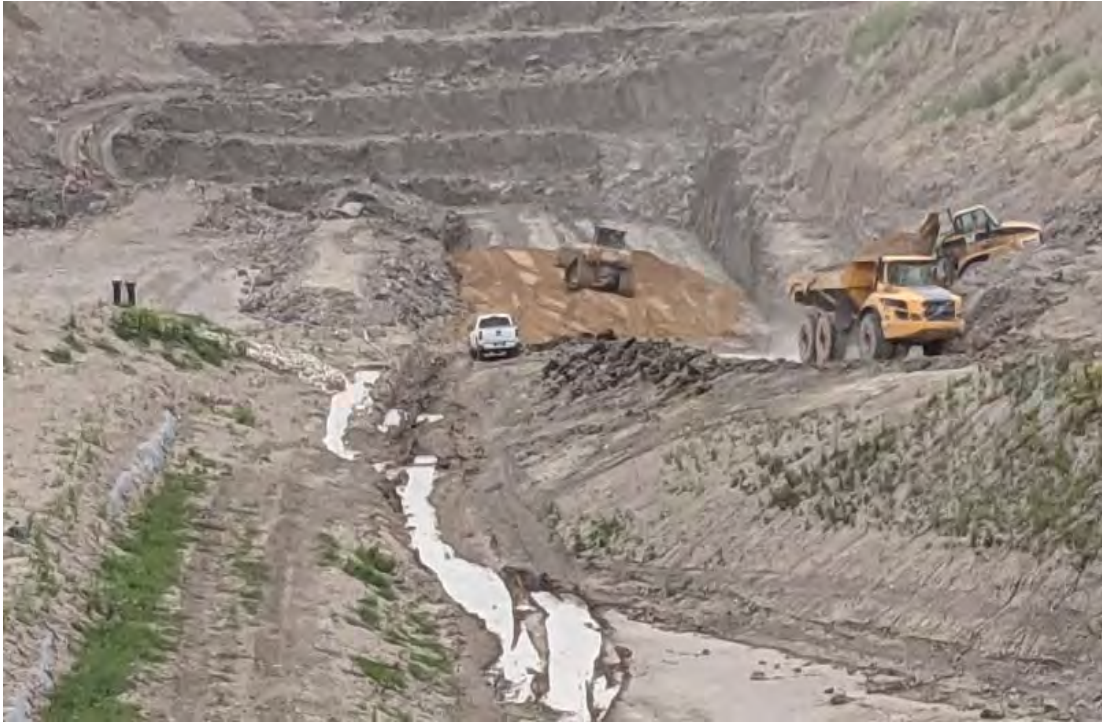
Placement of gradient layer on West side of new cell
