GREEN FOR LIFE ENVIRONMENTAL (GFL) EMERALD PARK LANDFILL
 LANDFILL OPERATIONS AUDIT FORM
 CITY OF MUSKEGO

PROJECT NO. 1020.10030

DATE December 20, 2021

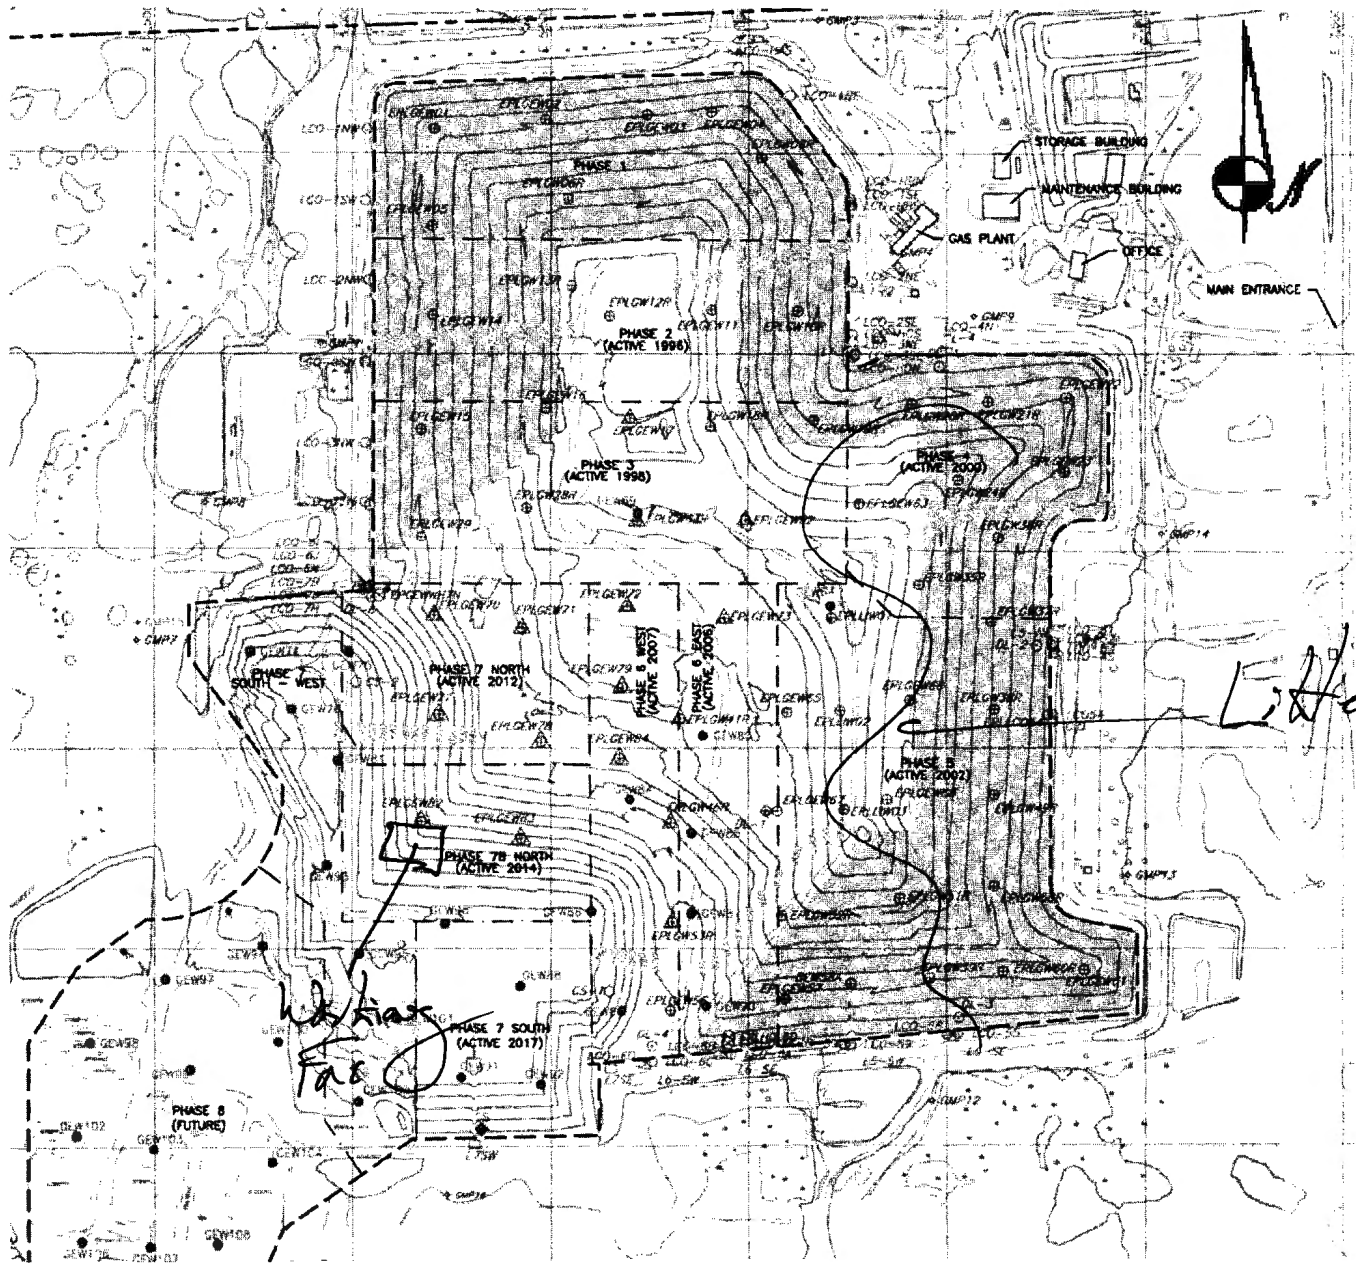
Green For Life Environmental (GFL) Emerald Park Landfill Audit Map

Working face in Southwest corner of Phase 2 South, right on outboard slope.

Working face wrapped in cover soil on slope to prevent waste from moving
