# VEOLIA Emerald Park Landfill Audit Summary

**TO:** Veolia Emerald Park Landfill Standing Committee, City of Muskego  
**FROM:** Anna Krajcik  
**COPIES:** File  
**DATE:** 02/25/13  
**PROJECT NUMBER:** 1012.10030

ADVANCED DISPOSAL SERVICES EMERALD PARK LANDFILL  
 LANDFILL OPERATIONS AUDIT FORM  
 CITY OF MUSKEGO

**ADVANCED DISPOSAL SERVICES  
EMERALD PARK LANDFILL  
AUDIT PHOTOS  
CITY OF MUSKEGO**

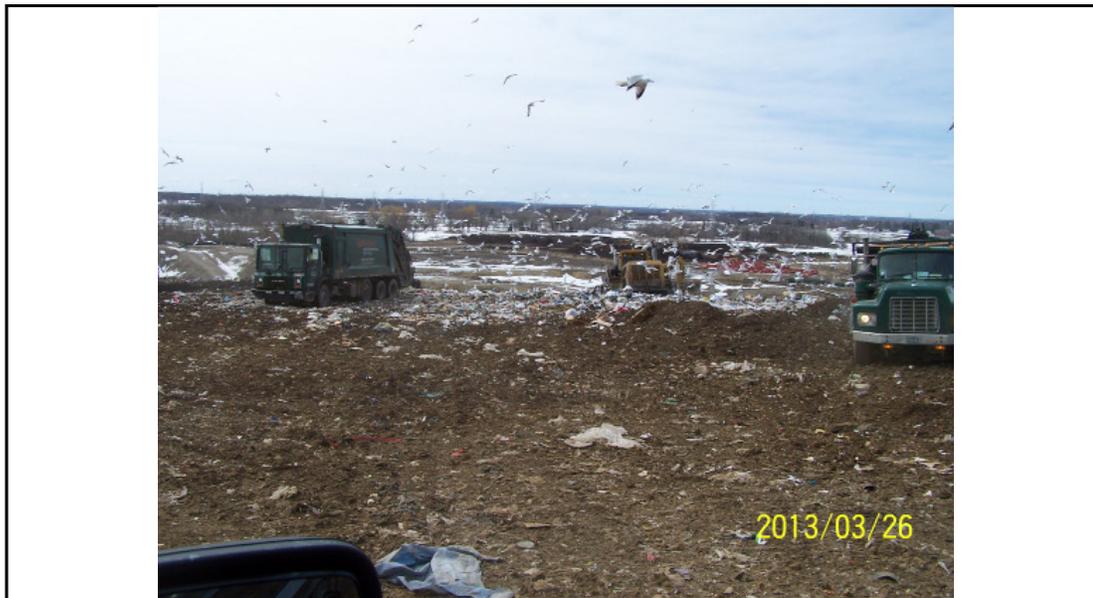
Working face progressing from Northeast corner. Access ramp being removed from lower end, new access from top where active area meets road grade. No soil loads or other working faces.

Working face viewed from access road (Northeast)

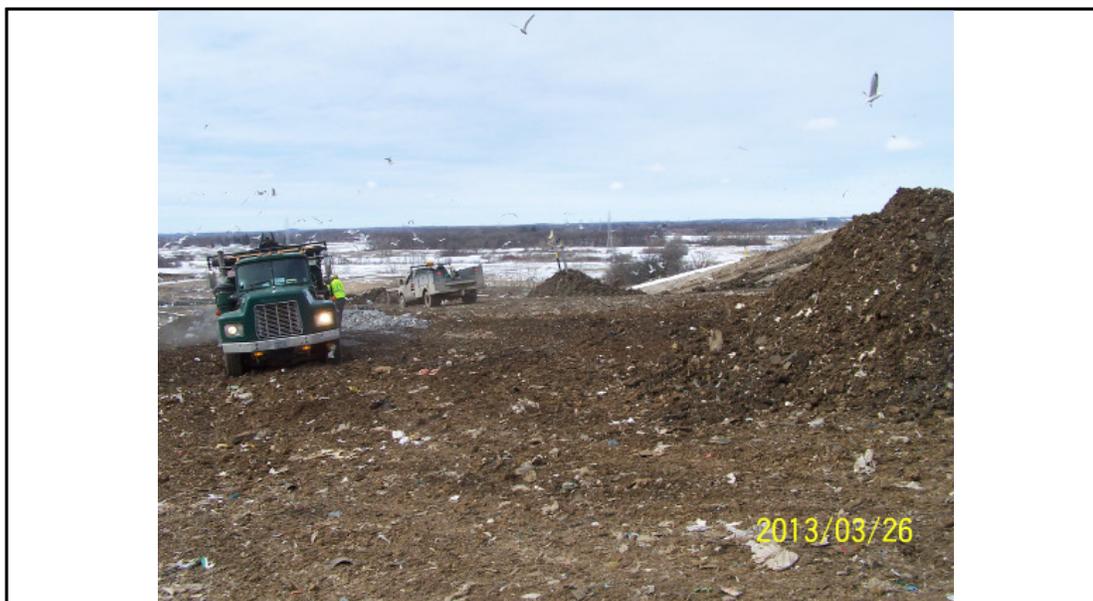
Autoglyf & CTD stockpiled

Autofluff stockpiles adjacent to working face

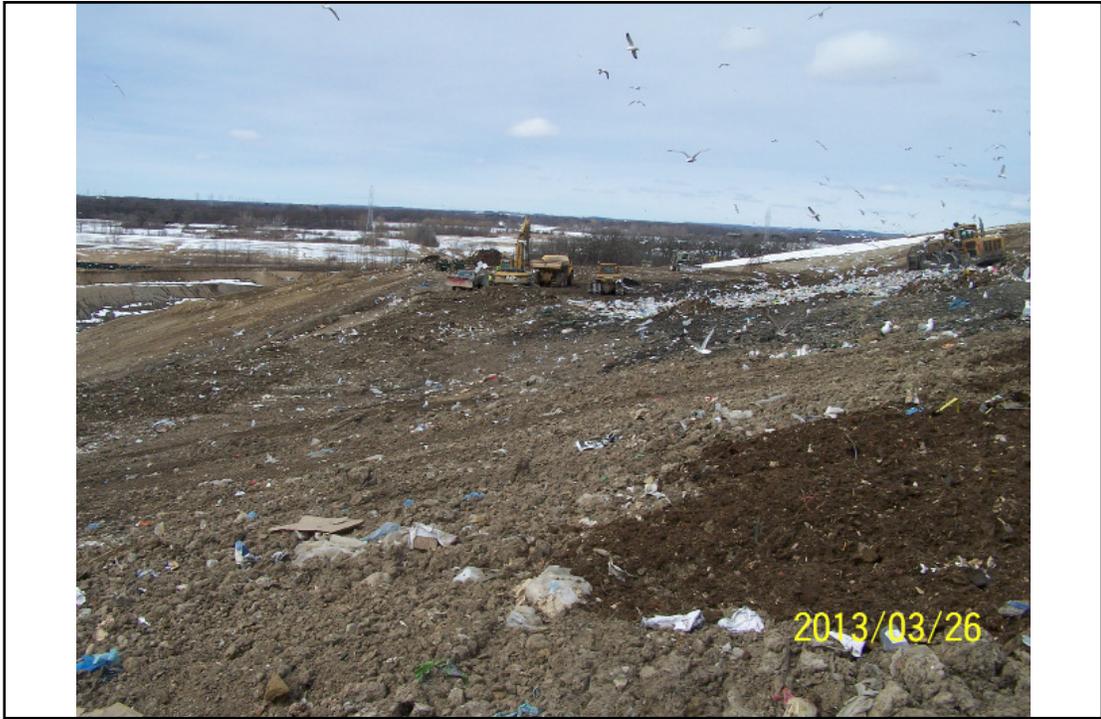
Compactor pushing waste down

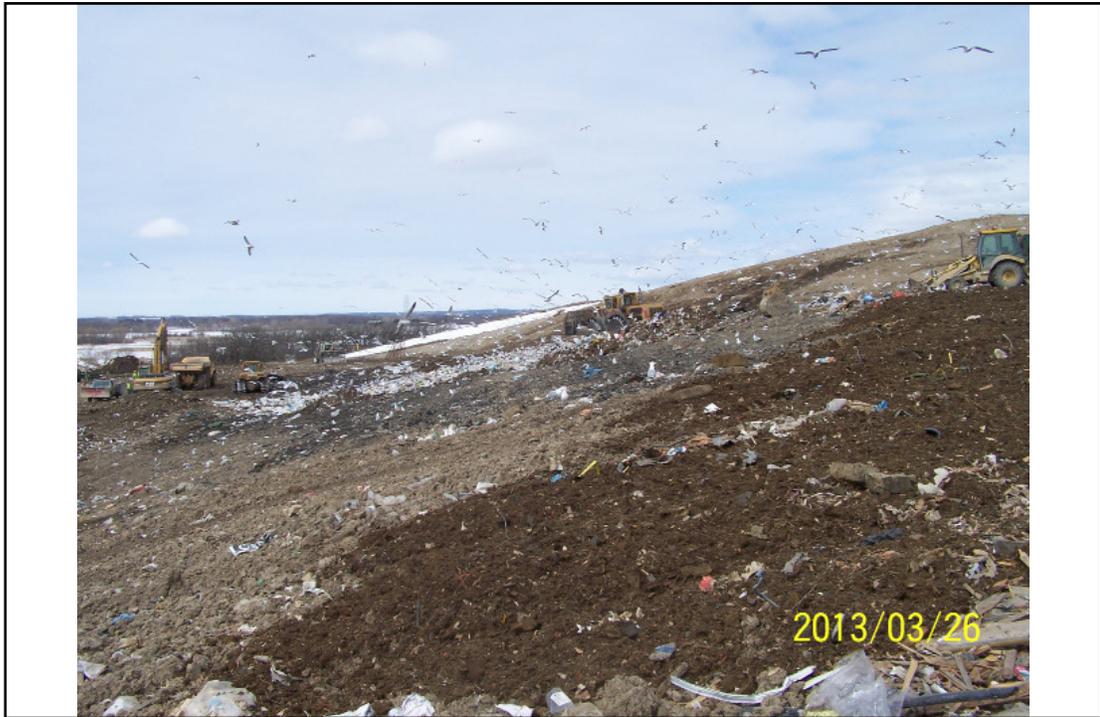
\* Ramp deconstruction & new construction  
in Phase 7. Ramp removal to prevent  
leaches & material used for cover  
\* Red Roads to be regraded today and  
ditch cleaning to commence

Ramp removal

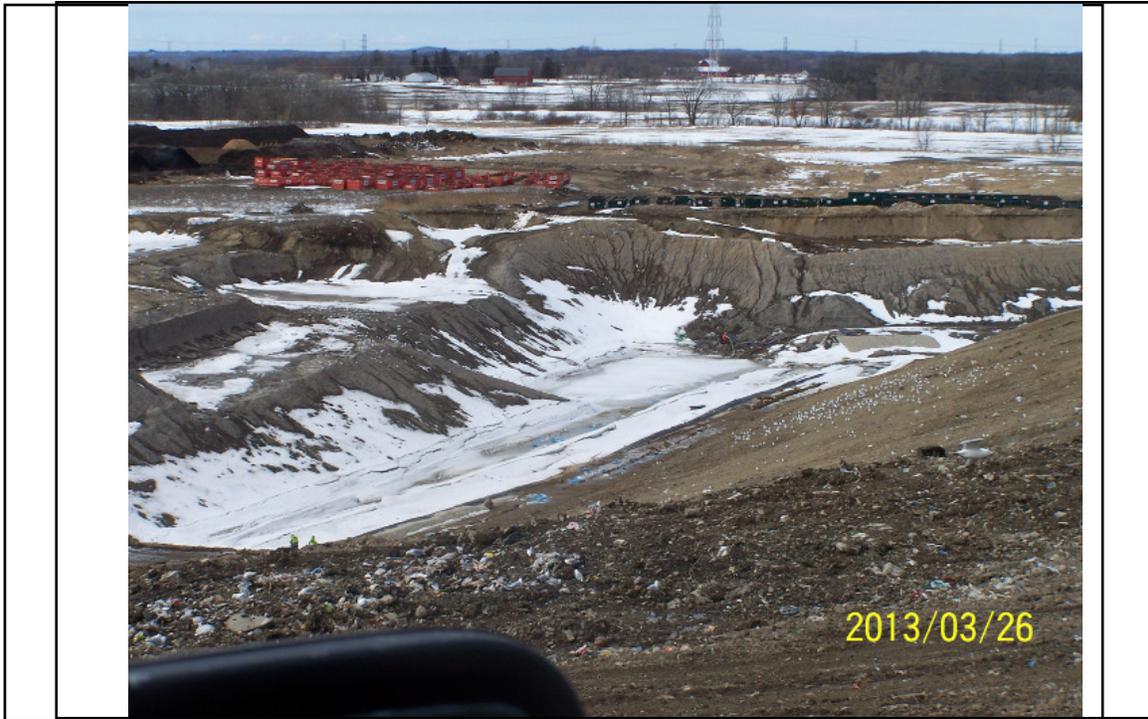
Temp Sed Basin drained, all basins surface frozen

Temp sed basin at toe of Phase 7 South slope

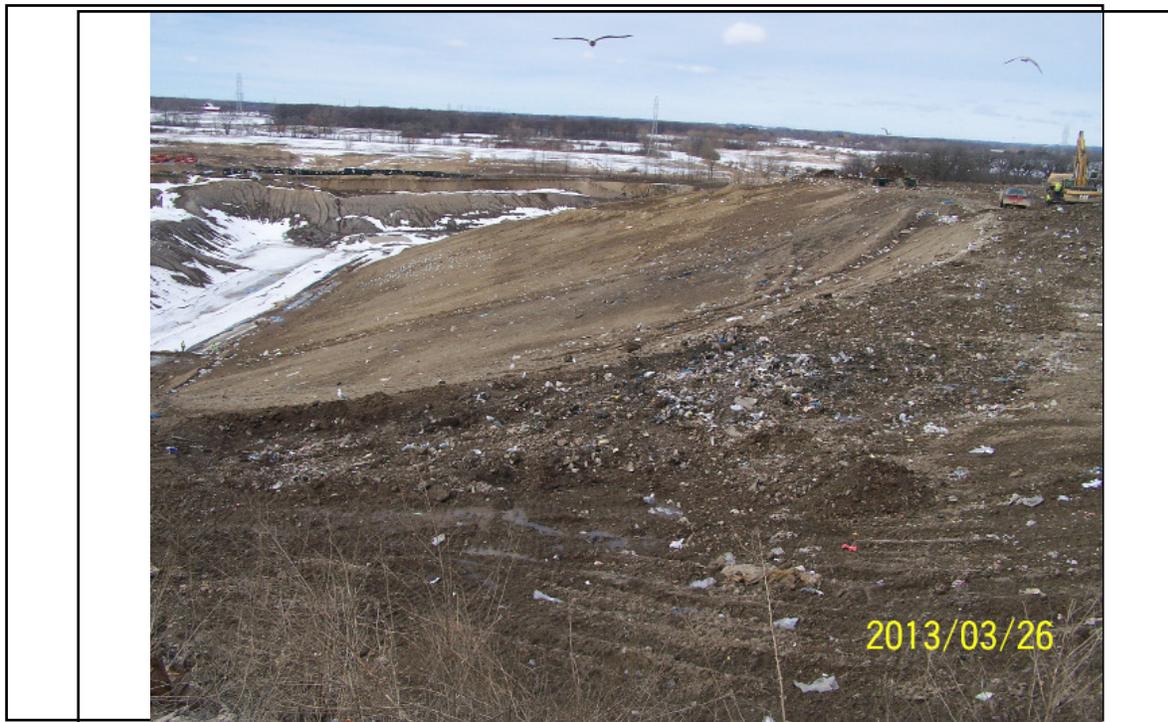
- Possible soil loads next week
- Residential Drop-Off clean, E-Waste box available
- Ramp deconstruction and new construction in Phase 7
- Ramp being deconstructed to improve leachate flow

Ramp/road into active area being removed to prevent lense development
