ADS Emerald Park Landfill Audit Summary

To: ADS Emerald Park Landfill Standing Committee, City of Muskego
FROM: Faith Spear.
COPIES: File
DATE: 01/08/15
PROJECT NUMBER: 1012.10030

Attached is the audit report for activities at the ADS Emerald Park Landfill for the week of December 15, 2014. The audit was performed at 3:15 PM on **December 17, 2014** by Jo Spear, Jr. in the presence of David Geier, Operations Manager.

**ADVANCED DISPOSAL SERVICES
EMERALD PARK LANDFILL / CITY OF MUSKEGO
AUDIT PHOTOS**

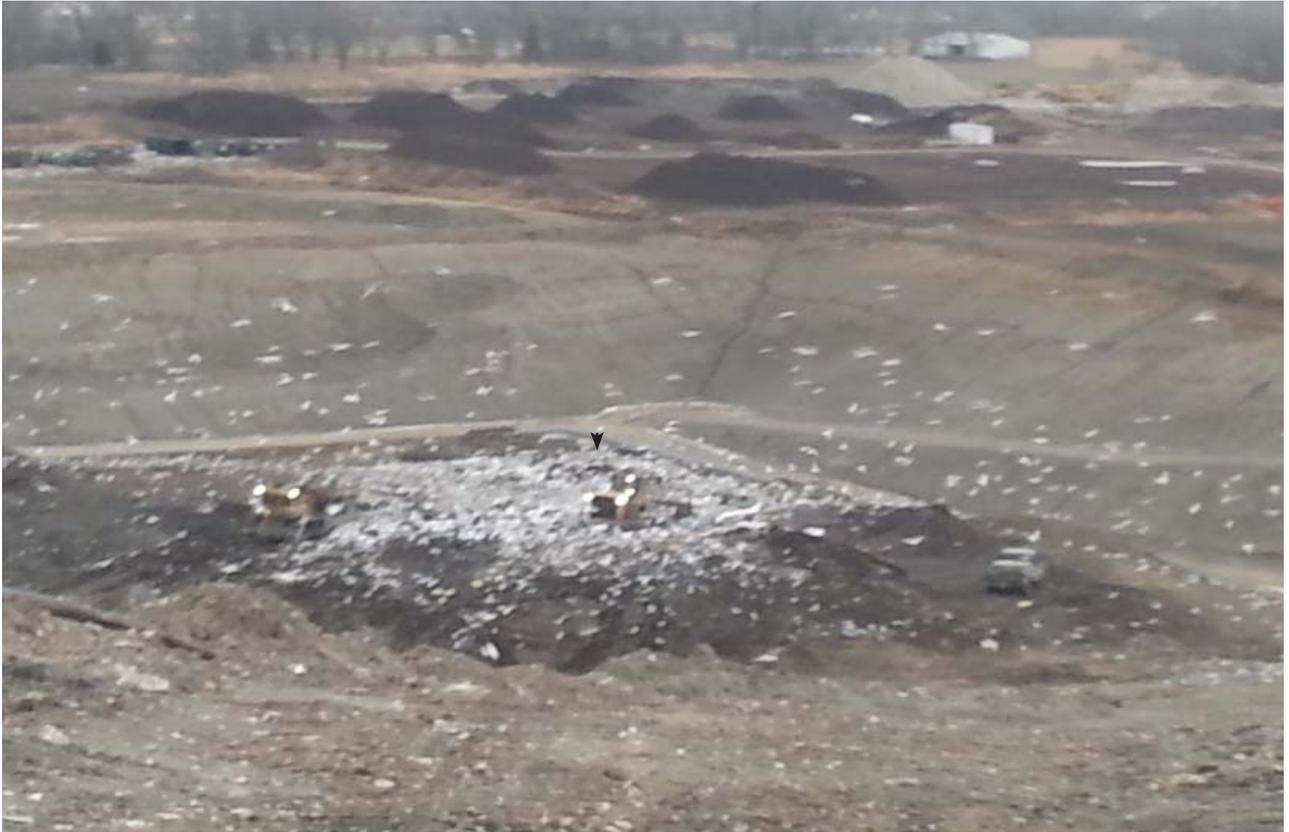
Working face in Southwest corner of
Phase 7B/7C West. Working face small and
some cover being placed at time of Audit
On load of biosoil was received, today,
In phase 3

Working face in Southwest corner of Phase 7B

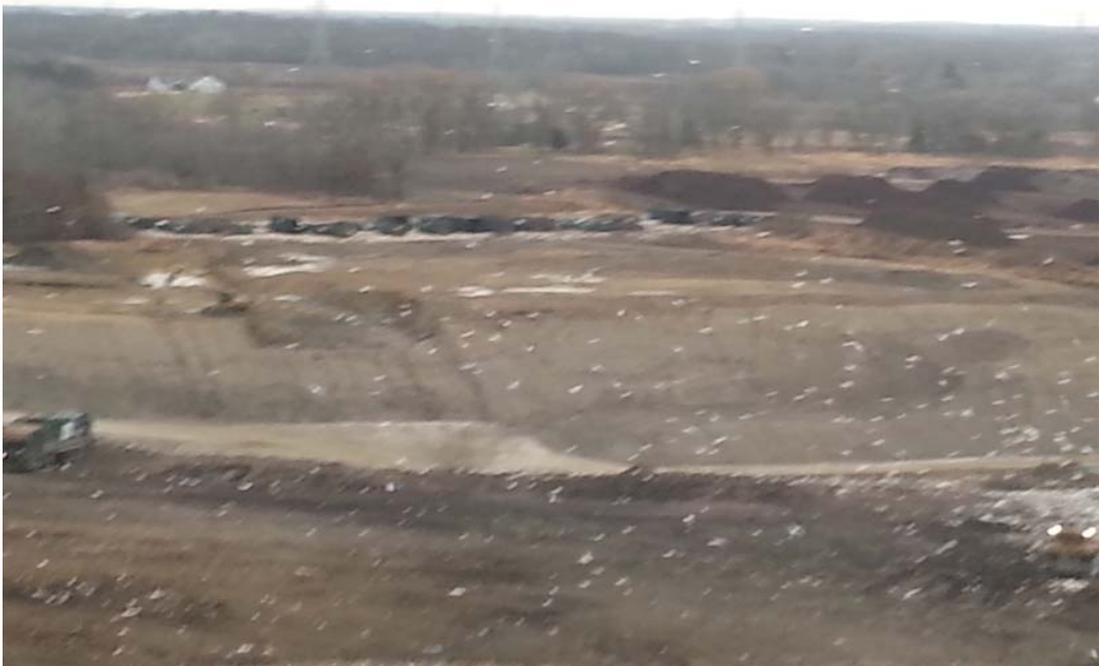
- Ongoing excavation in Phase 8 to develop site and provide cover materials

In the background, future Phase 8 being excavated for soil use on site
