# VEOLIA Emerald Park Landfill Audit Summary

**TO:** Veolia Emerald Park Landfill Standing Committee, City of Muskego  
**FROM:** Anna Krajcik  
**COPIES:** File  
**DATE:** 01/30/13  
**PROJECT NUMBER:** 1012.10030

VEOLIA EMERALD PARK LANDFILL  
LANDFILL OPERATIONS AUDIT FORM  
CITY OF MUSKEGO

**VEOLIA EMERALD PARK LANDFILL  
AUDIT PHOTOS  
CITY OF MUSKEGO**

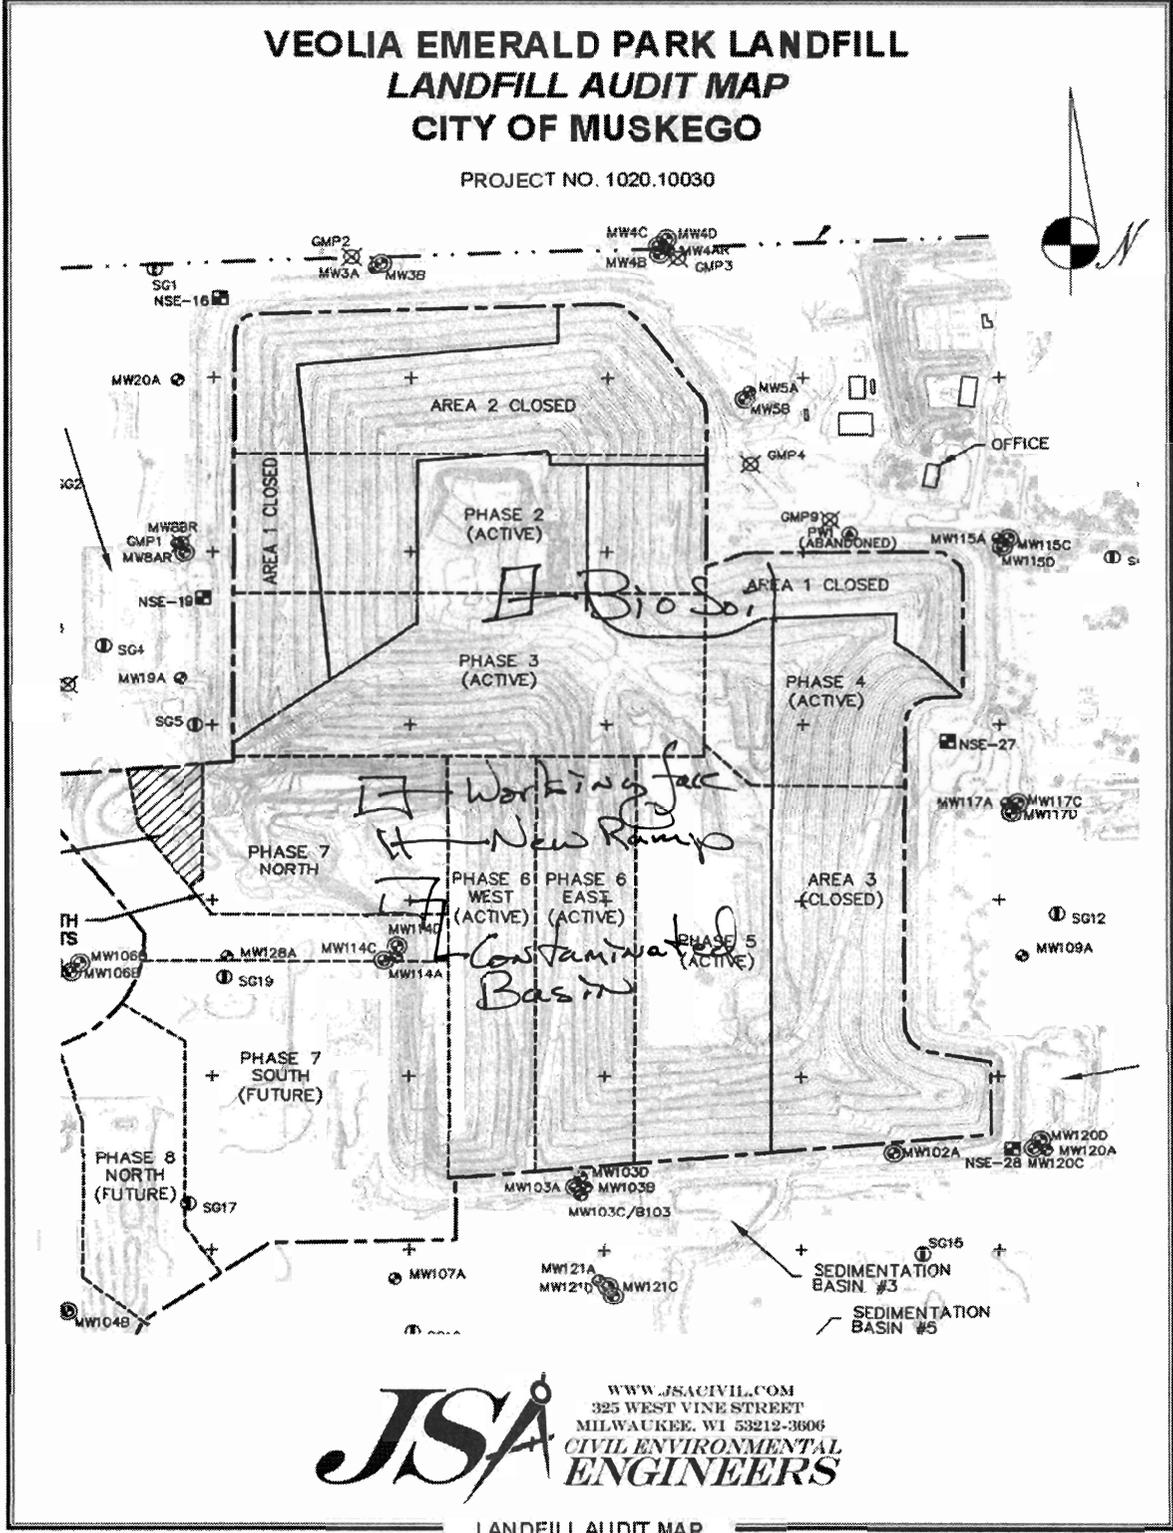
# VEOLIA EMERALD PARK LANDFILL LANDFILL AUDIT MAP CITY OF MUSKEGO

- Working face for MSW in Phase 7 Northeast corner
  - New access ramp in southeast corner as well
  - Biosoils being received in Phase 2 & 3
  - Autofluff in use for cover, previous covers of soil

- Leachate discharge to MMSD
- One flare and one blower in operation,
  - Currently not pushing gas to MMSD
- Three storm events since last audit, ~3"
  - Minor snowfall this week, heavy rains over weekend 1/28 causing runoff to enter temporary sediment pond.

\* Temp sed basin cleanup ongoing. frozen conditions slowed liquids removal, No threat to public. Temp Sed basin impacted is the Eastern most, Not hydraulically connected to larger basins.
