VEOLIA Emerald Park Landfill Audit Summary

TO: Veolia Emerald Park Landfill Standing Committee, City of Muskego
FROM: Anna Krajcik
COPIES: File
DATE: 02/11/13
PROJECT NUMBER: 1012.10030

VEOLIA EMERALD PARK LANDFILL
LANDFILL OPERATIONS AUDIT FORM
CITY OF MUSKEGO

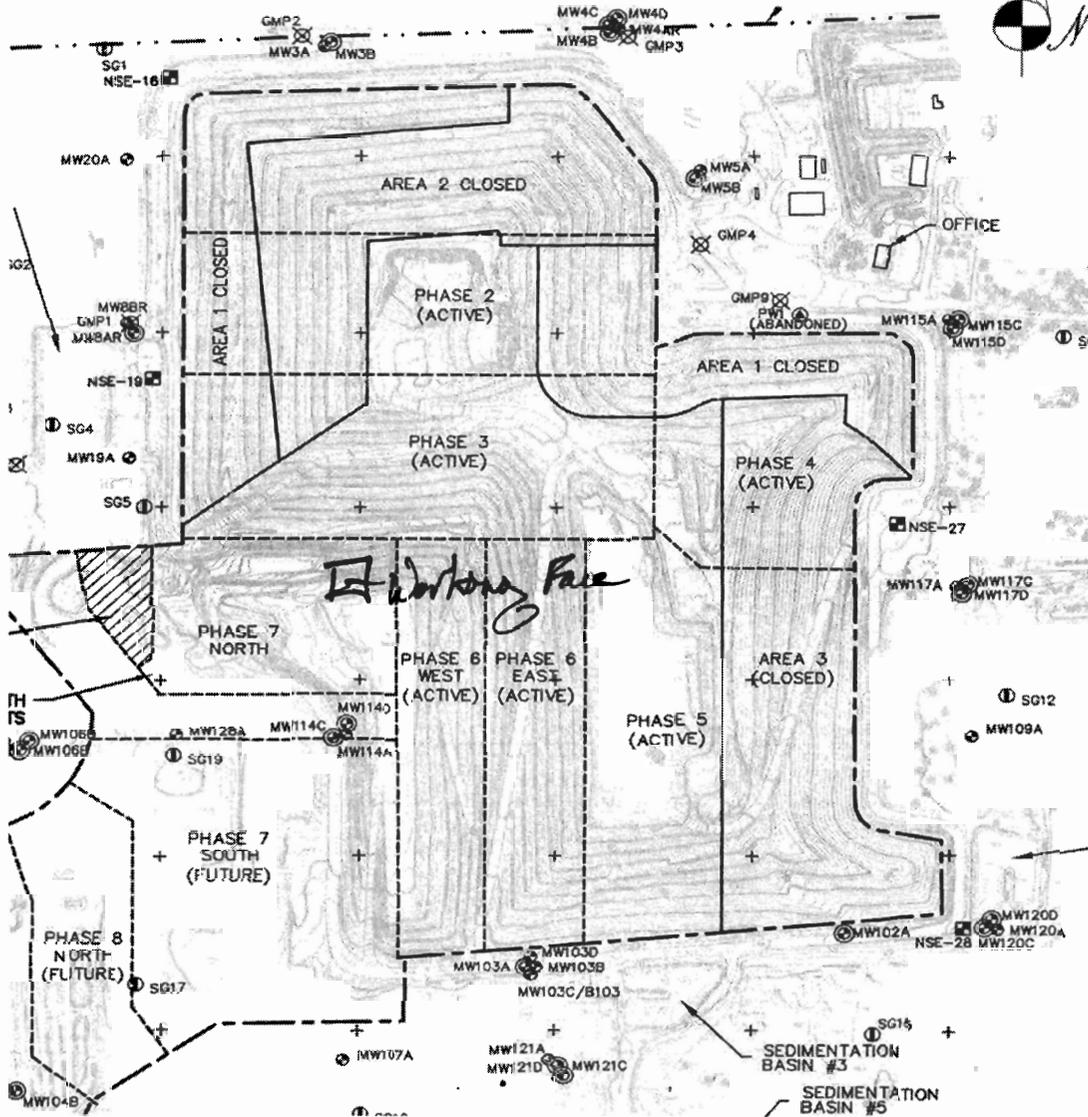
VEOLIA EMERALD PARK LANDFILL LANDFILL AUDIT MAP CITY OF MUSKEGO

- Working face in northeast corner of Phase 7, only working face during snow cover
 - Working face against slope allowing soil to be cut from slope for cover
 - Awaiting Autofluff today, new account provider, soils being used as well
- Leachate discharge to MMSD
- One flare and one blower in operation,
 - Flare running well, MMSD not taking receipt of gas yet
- One storm event since last audit, ~2"
 - Snow storm on 2/7 of approximately 8"
 - Site and basins snow covered, no flowing water
- No on or off site odors
- No special waste handling noted
- No litter on site, snow conditions reduce and cover litter
- US 45 and 8 Mile Road slushy, some ice and shoulders are snow covered
- Tipping scale camera and equipment operators inspecting waste
 - Random load date 02/08/2013, ~1200 tpd no soil jobs
- Snow limiting site access
- Ramp construction to begin after current lift is completed
