VEOLIA Emerald Park Landfill Audit Summary

TO: Veolia Emerald Park Landfill Standing Committee, City of Muskego
FROM: Anna Krajcik
COPIES: File
DATE: 02/25/13
PROJECT NUMBER: 1012.10030

VEOLIA EMERALD PARK LANDFILL
LANDFILL OPERATIONS AUDIT FORM
CITY OF MUSKEGO

VEOLIA EMERALD PARK LANDFILL AUDIT PHOTOS CITY OF MUSKEGO

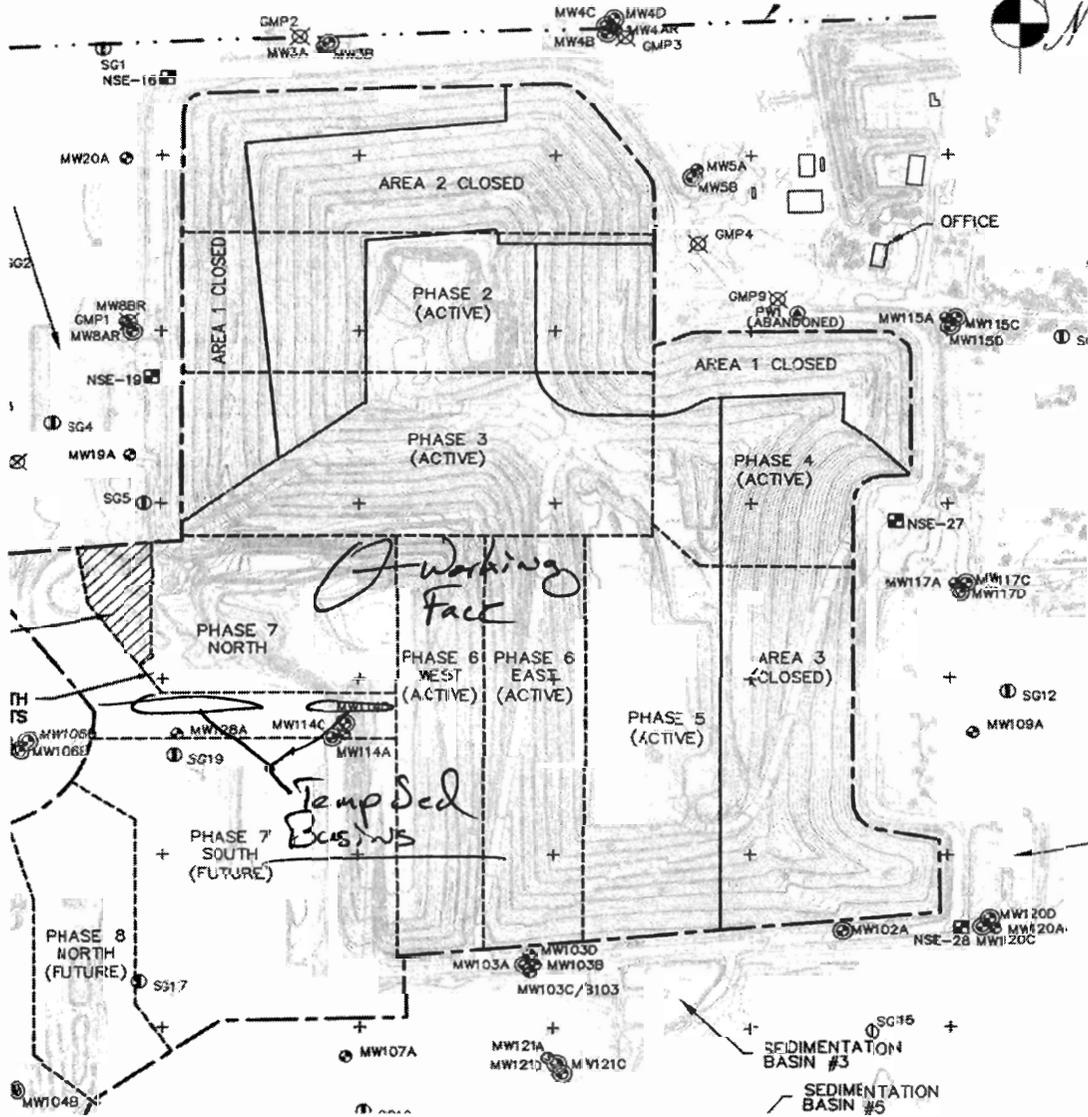
VEOLIA EMERALD PARK LANDFILL LANDFILL AUDIT MAP CITY OF MUSKEGO

Working face in Northeast corner of Phase 7
at top of access road. Conditions too wet
to come in from below. No soils or
other working faces
