Advanced Disposal Services Emerald Park Landfill Audit Summary

To: ADSEPL Standing Committee, City of Muskego
FROM: Anna Krajcik
COPIES: File
DATE: 04/03/13
PROJECT NUMBER: 1012.10030

ADVANCED DISPOSAL SERVICES EMERALD PARK LANDFILL
 LANDFILL OPERATIONS AUDIT FORM
 CITY OF MUSKEGO

**ADVANCED DISPOSAL SERVICES
EMERALD PARK LANDFILL
AUDIT PHOTOS
CITY OF MUSKEGO**

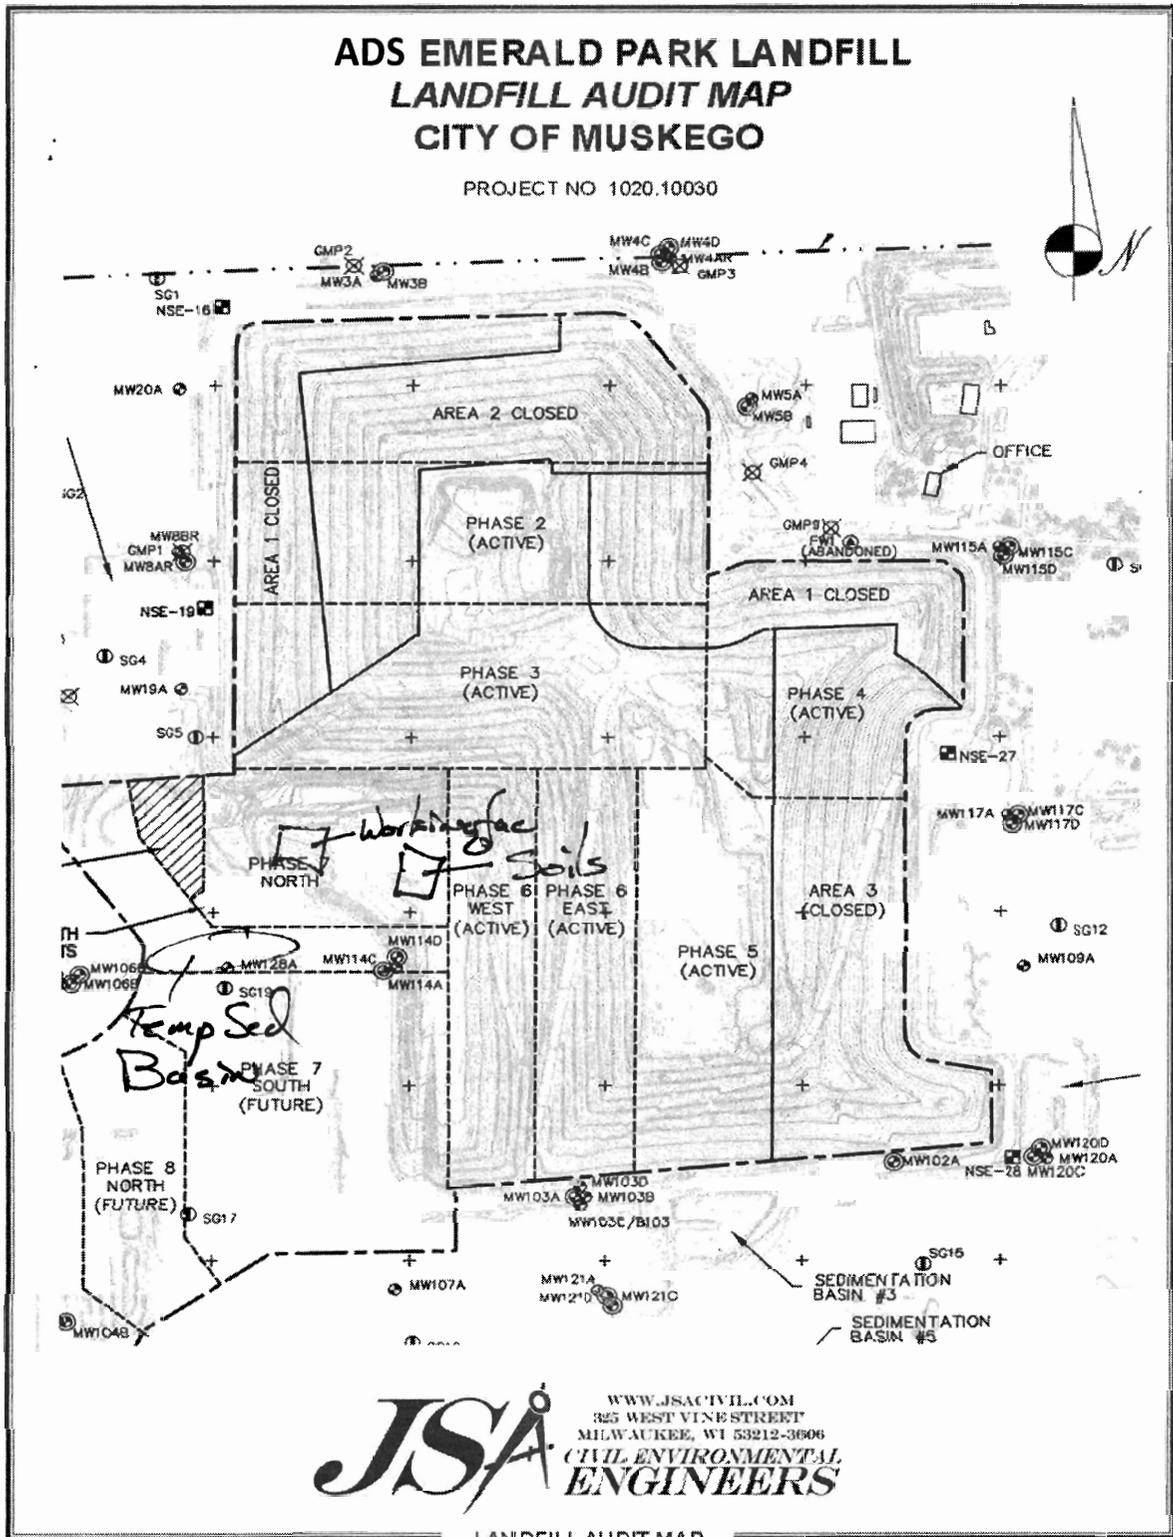
ADS EMERALD PARK LANDFILL LANDFILL AUDIT MAP CITY OF MUSKEGO

- Working face moving westward along south edge of Phase 7 at top of slope. Working face at approximately ½ the distance between North and South end.
 - Wet soils tipped at southeast corner of Phase 7 will be relocated when it dries out

- Basins about ½ full, no additional erosion
- Some garbage odor on site from active area
- No liquid loads received
- Litter in fences and about Phase 1-3 due to wind directions

- US 45 and 8 Mile Road dusty, left turn lanes dirty and dusty
- Tipping scale camera and equipment operators inspecting waste
 - Random load inspection date 4/26/13 ~1600 tpd
