MEMORANDUM

ADS Emerald Park Landfill Audit Summary

TO: ADS Emerald Park Landfill Standing Committee, City of Muskego
FROM: Jo-Walter Spear, Jr., P.E.
COPIES: File
DATE: 09/5/2013
PROJECT NUMBER: 1012.10030

**ADVANCED DISPOSAL SERVICES
EMERALD PARK LANDFILL / CITY OF MUSKEGO
AUDIT PHOTOS**

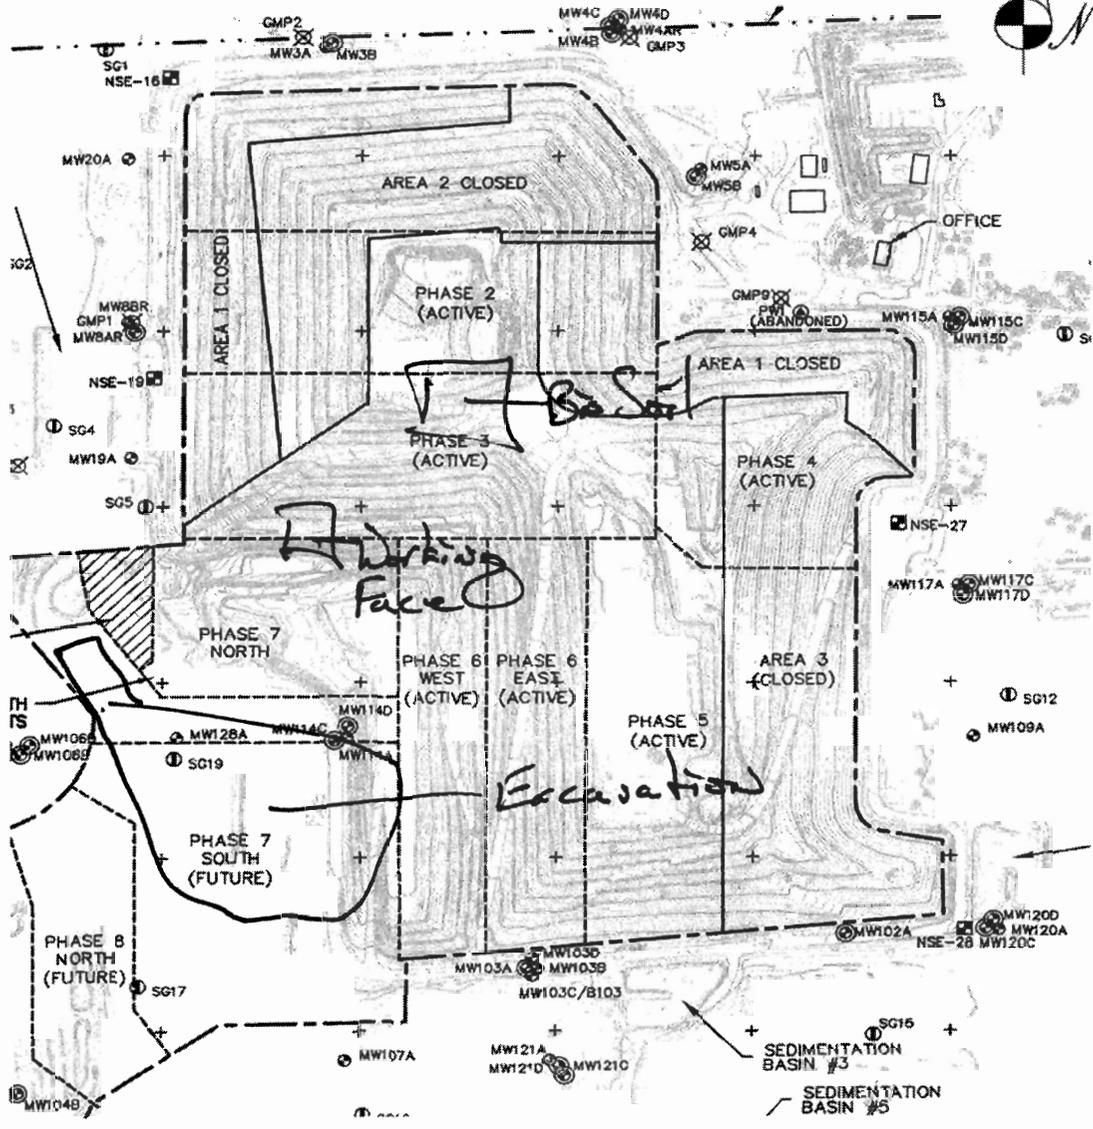
LANDFILL AUDIT MAP

- Working face at Eastern edge of Phase 7
 - Access road filling to begin tomorrow connecting Phase 7 and overlap of Phase 5
 - No other working face
 - C&D stockpiles and landfill soils used for cover
