ADS Emerald Park Landfill Audit Summary

PROJECT NUMBER: 1012.10030

**ADVANCED DISPOSAL SERVICES
EMERALD PARK LANDFILL / CITY OF MUSKEGO
AUDIT PHOTOS**

PROJECT NO. 1012.10030

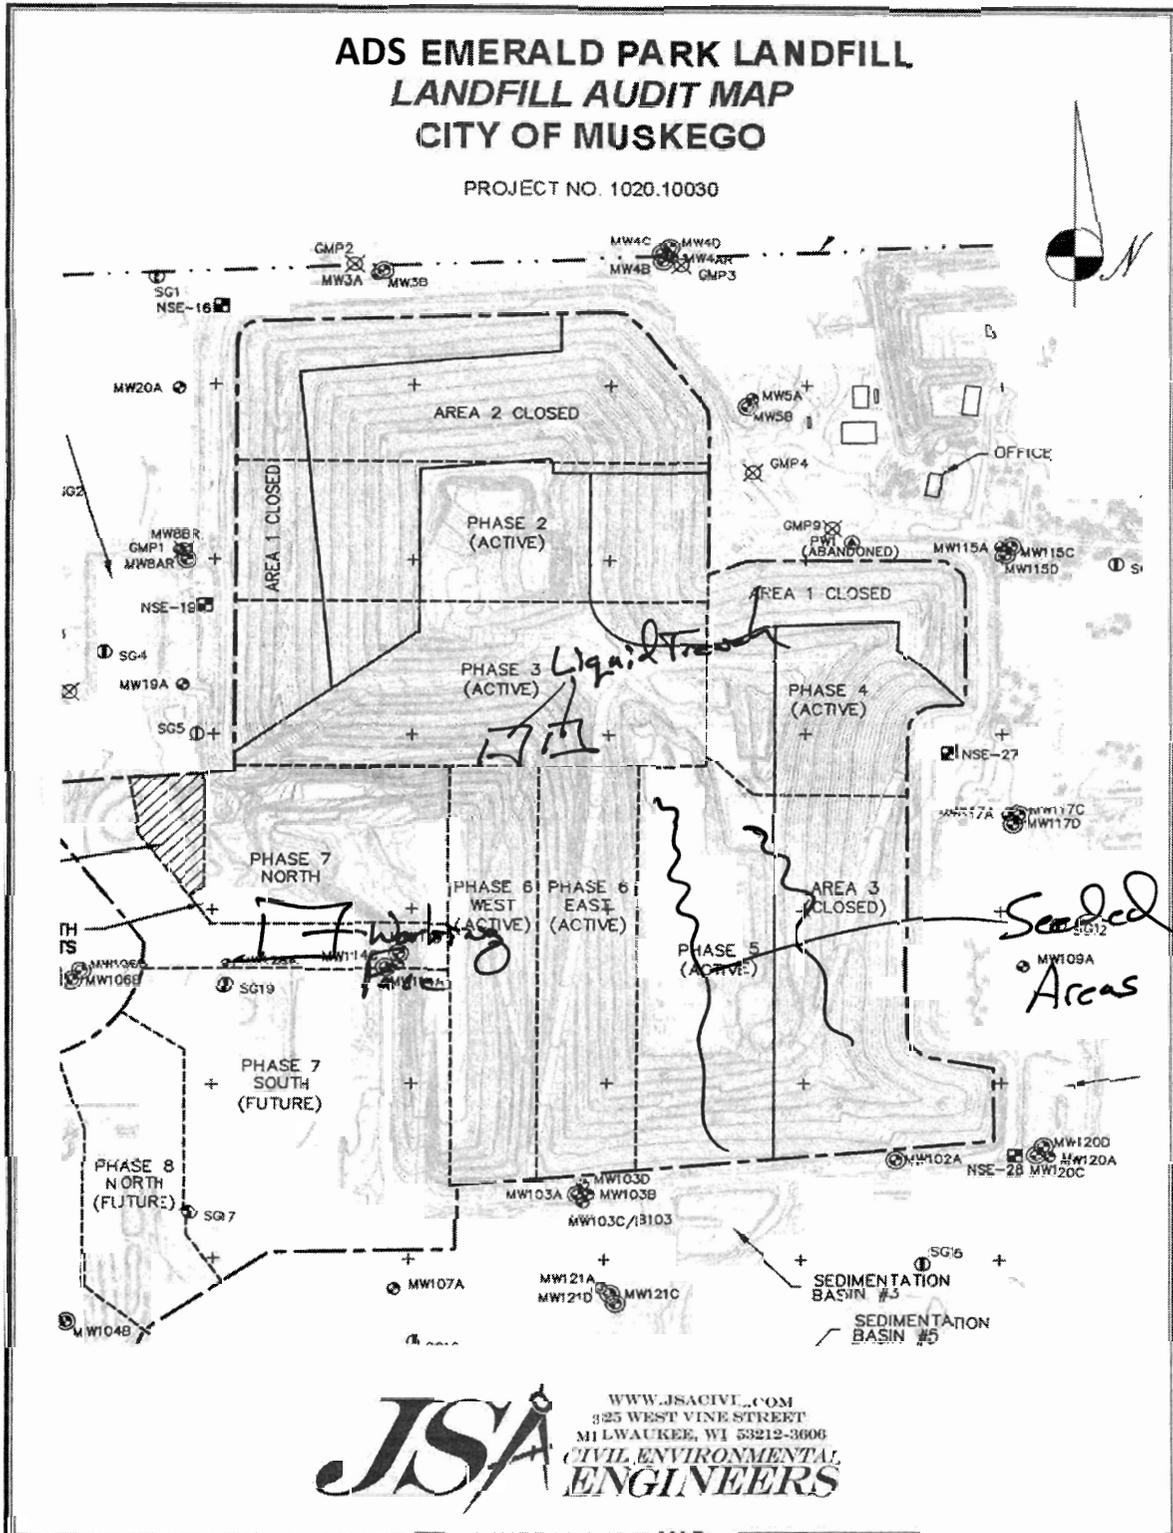
ADS EMERALD PARK LANDFILL LANDFILL AUDIT MAP CITY OF MUSKEGO

Slope repairs and sluce development on South slope of Phase 5.
