# ADS Emerald Park Landfill Audit Summary

**TO:** ADS Emerald Park Landfill Standing Committee, City of Muskego  
**FROM:** Faith Spear.  
**COPIES:** File  
**DATE:** 10/07/14  
**PROJECT NUMBER:** 1012.10030

**ADVANCED DISPOSAL SERVICES  
EMERALD PARK LANDFILL / CITY OF MUSKEGO  
AUDIT PHOTOS**

PROJECT NO. 1012.10030

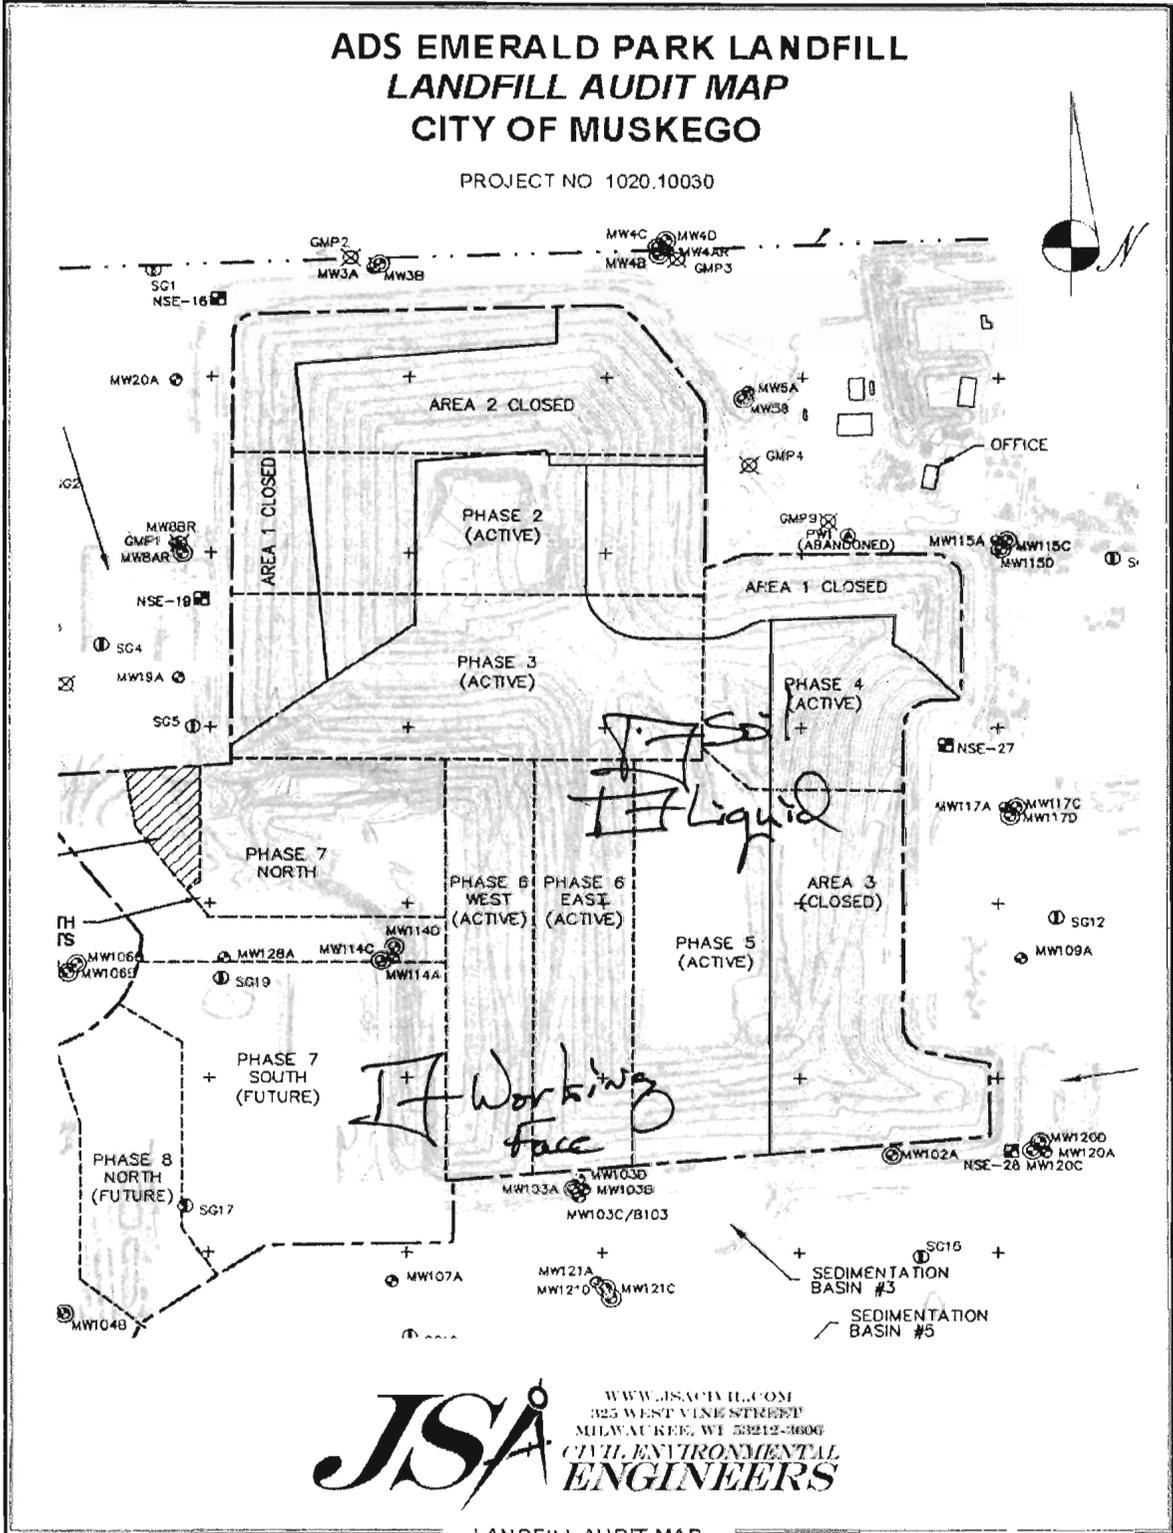
# ADS EMERALD PARK LANDFILL LANDFILL AUDIT MAP CITY OF MUSKEGO

- Repairs underway on South slope of Phase 5
  - Repairing soil erosion
  - Expected to seed this fall

\* Site addressing soil conditions on South  
slope of Phase 5, repairing soil  
erosion & expected to seed this year
