# ADS Emerald Park Landfill Audit Summary

**To:** ADS Emerald Park Landfill Standing Committee, City of Muskego  
**FROM:** Faith Spear.  
**COPIES:** File  
**DATE:** 11/21/14  
**PROJECT NUMBER:** 1012.10030

Attached is the audit report for activities at the ADS Emerald Park Landfill for the week of October 6, 2014. The audit was performed at 12:00 PM on **October 6, 2014** by Jo Spear, Jr. in the presence of David Greir, Operations Manager.

PROJECT NO. 1012.10030

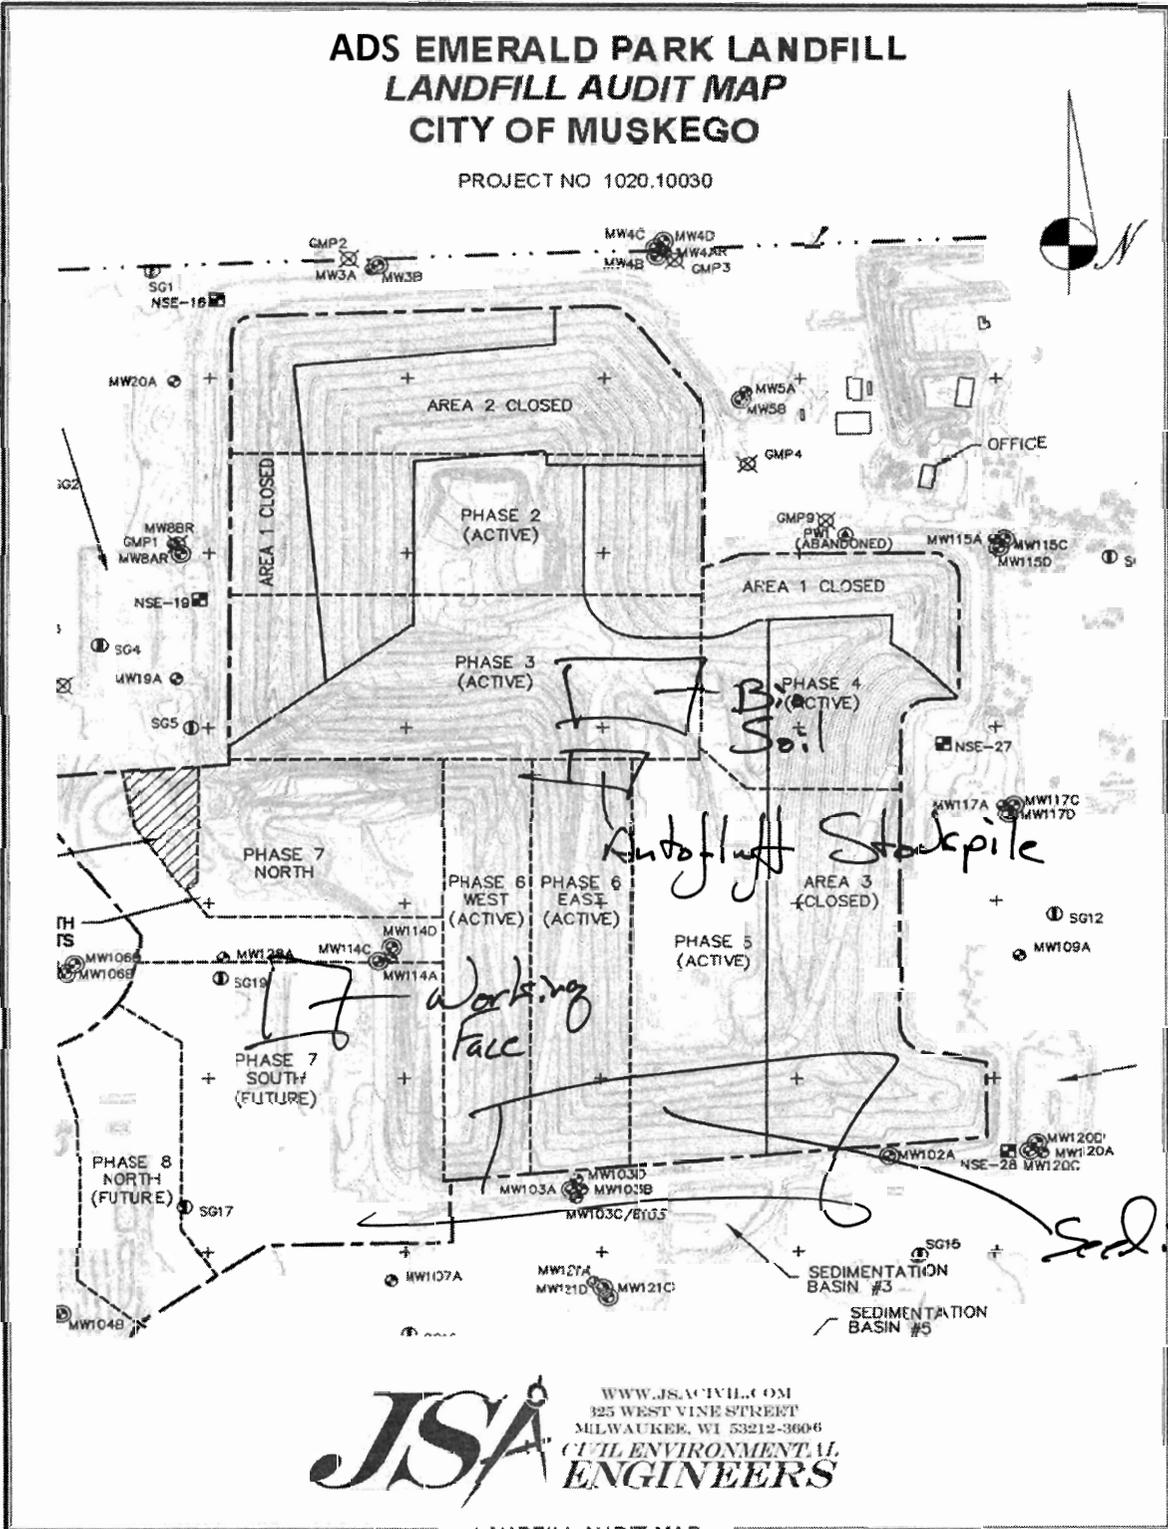
# ADS EMERALD PARK LANDFILL LANDFILL AUDIT MAP CITY OF MUSKEGO

Working face in middle of Phase 7B  
New ramp for access ~~is~~ in use.  
Operators spreading foundry sand  
for cover during Audit

Foundry sands  
Autofluff stock piled, but not in use

- \* Electricians working on Pneumatic building for pumping systems
- \* Fuel tanks inspected by Ag today
- \* Liner repair crew expected this week to repair West beam puncture of Phase 7B West
- \* Seeding of repair areas complete
