ADS Emerald Park Landfill Audit Summary

TO: ADS Emerald Park Landfill Standing Committee, City of Muskego
FROM: Faith Spear.
COPIES: File
DATE: 12/12/14
PROJECT NUMBER: 1012.10030

**ADVANCED DISPOSAL SERVICES
EMERALD PARK LANDFILL / CITY OF MUSKEGO
AUDIT PHOTOS**

PROJECT NO. 1012.10030

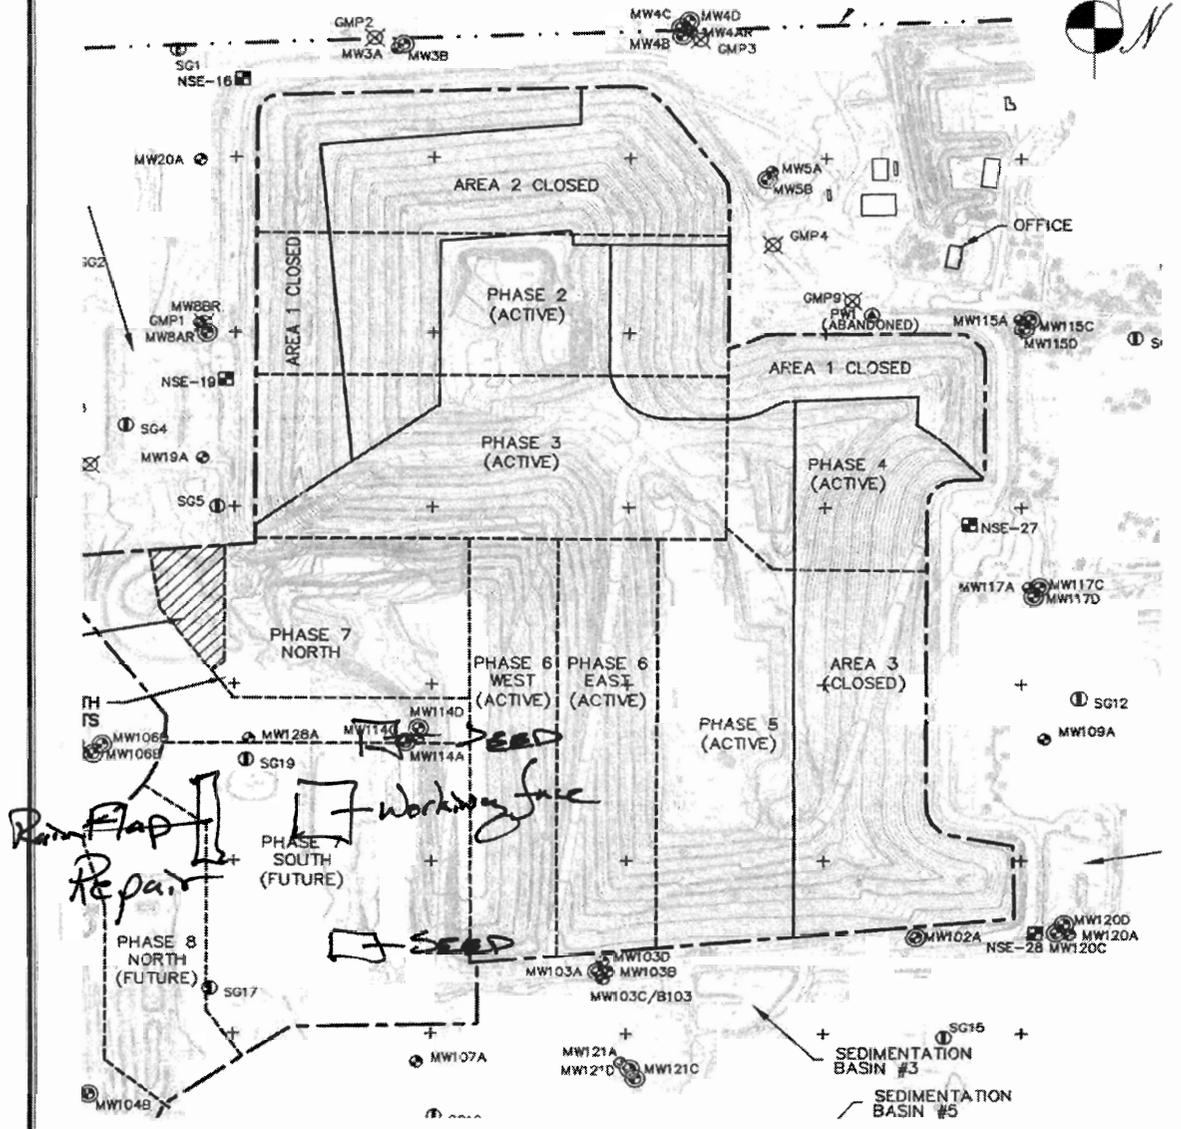
ADS EMERALD PARK LANDFILL LANDFILL AUDIT MAP CITY OF MUSKEGO

* Rain flap in Phase 7B West repaired
and waste covered with soil

* Small seeps repaired about Phase 7B
Both on North & South slopes
