Memorandum

ADS Emerald Park Landfill Audit Summary

To: ADS Emerald Park Landfill Standing Committee, City of Muskego
FROM: Faith Spear.
COPIES: File
DATE: 02/27/15
PROJECT NUMBER: 1012.10030

ADVANCED DISPOSAL SERVICES EMERALD PARK LANDFILL
 LANDFILL OPERATIONS AUDIT FORM
 CITY OF MUSKEGO

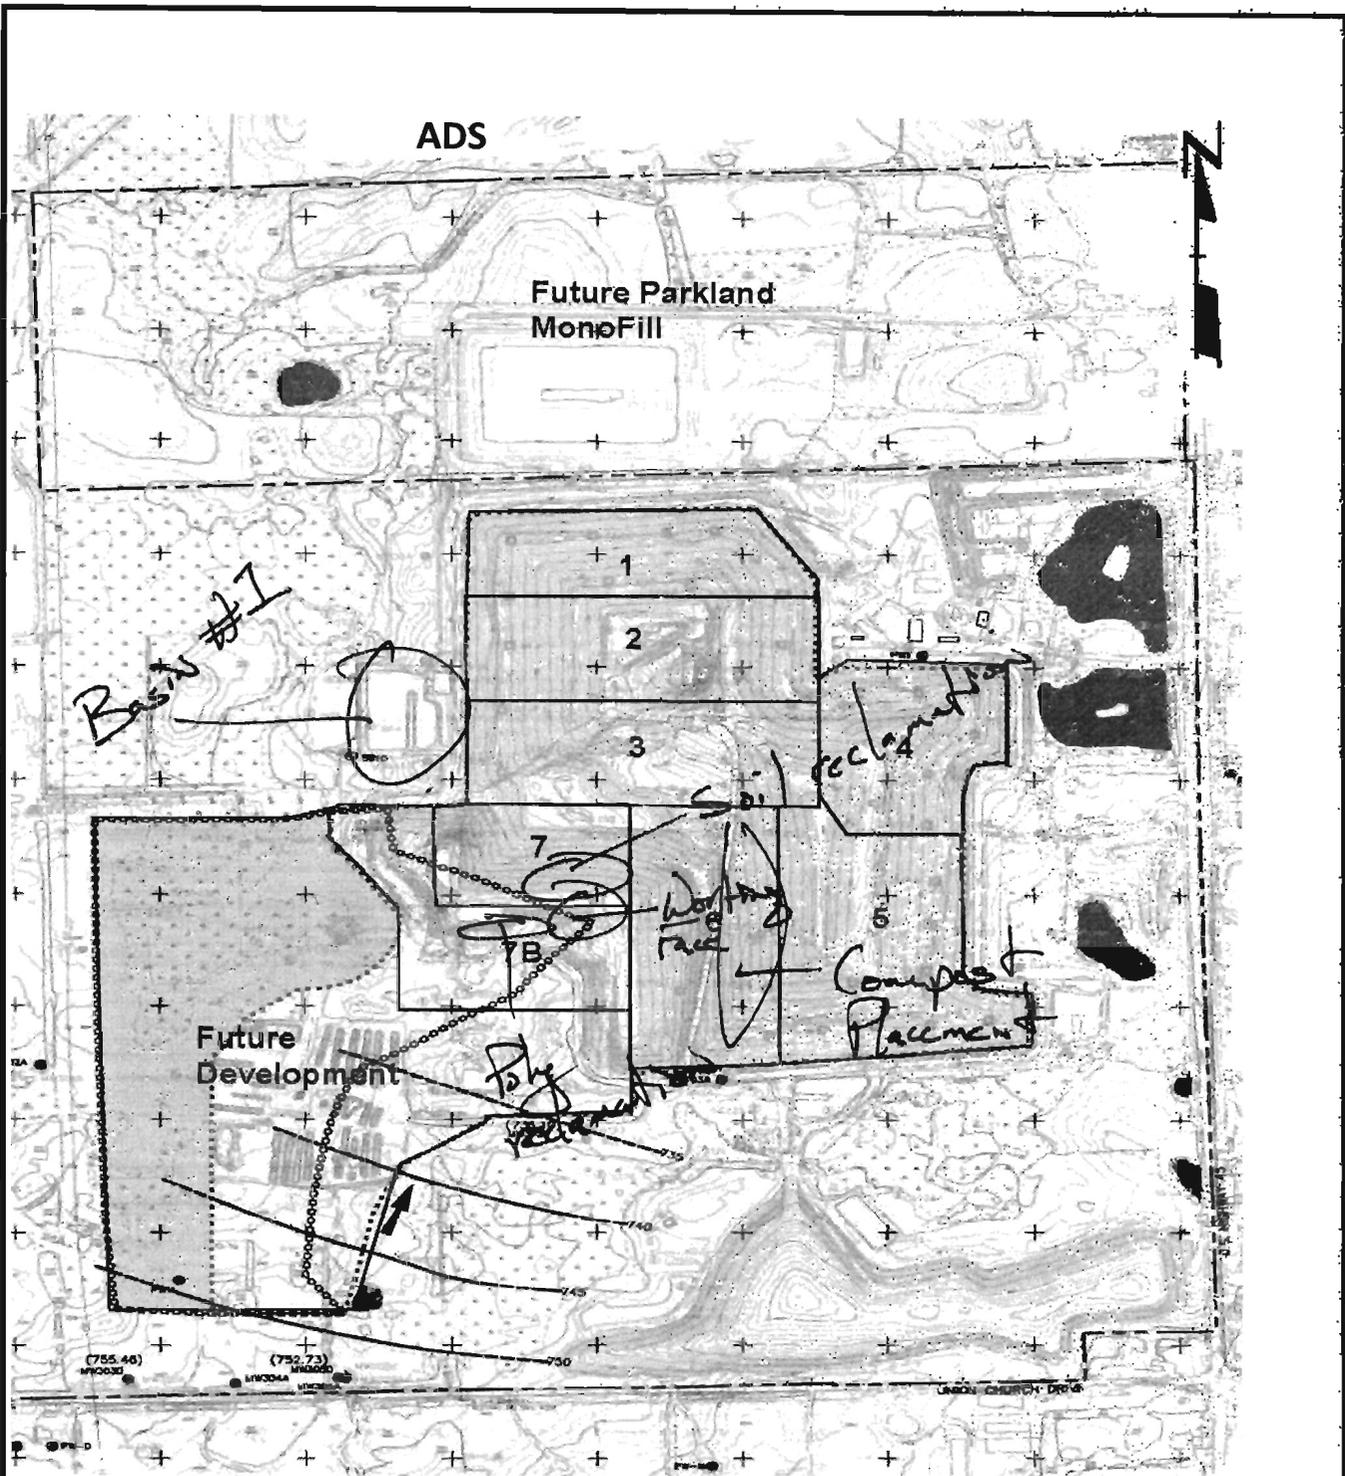
Advanced Disposal Services Emerald Park Landfill
 Landfill Audit Map
 City of Muskego
 Project No. 1020.10030

- Working face in Northeast corner of Phase 7B
 - Against South slope of Phases 3 and 7
 - Only one working face in operation
- Soil and polyfluff reclamation happening in Phase 7 above active working face
