Memorandum

ADS Emerald Park Landfill Audit Summary

To: ADS Emerald Park Landfill Standing Committee, City of Muskego
FROM: Faith Spear.
COPIES: File
DATE: 12/29/15
PROJECT NUMBER: 1012.10030

**ADVANCED DISPOSAL SERVICES
EMERALD PARK LANDFILL / CITY OF MUSKEGO
AUDIT PHOTOS**

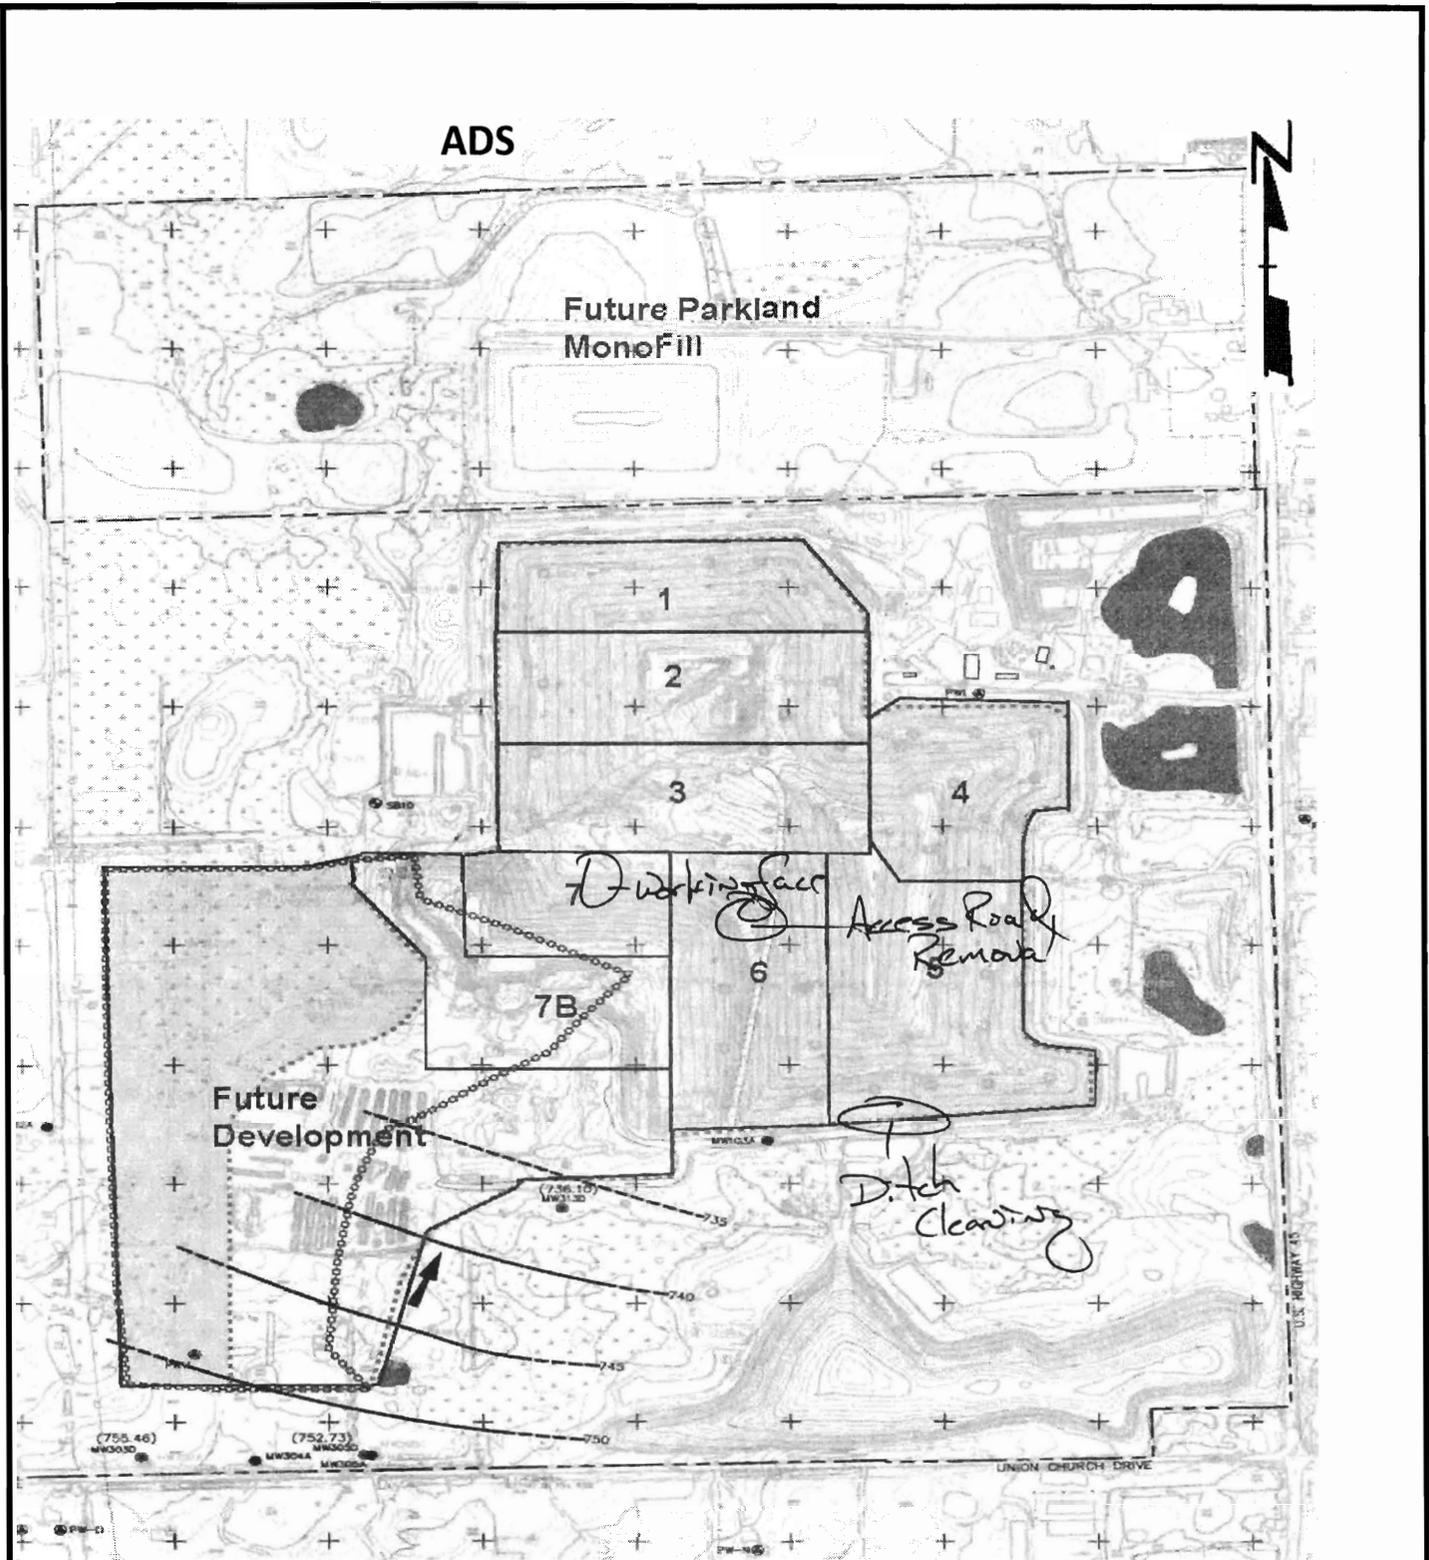
Advanced Disposal Services Emerald Park Landfill
 Landfill Audit Map
 City of Muskego
 Project No. 1020.10030

- Working face on North slope of Phase 7 where Phases 1,2 & 7 intersect
 - This is a protected area, sheltering tipping operations from winter weather conditions
 - Working face is small, about ¼ acre
 - No other working faces
- One compactor, one dozer, two excavators, one haul truck and one roll-off truck on site
- Site soils and previously tipped soils used for daily cover

- Removing access road into working face prior to waste placement
- Minor ditch cleaning underway about Phase 5
 - Additional repairs will be done after ground is dry or frozen
- Temporary sediment basin full, still some freeboard
 - Actively pumping during audit
