ADS Emerald Park Landfill Audit Summary

To: ADS Emerald Park Landfill Standing Committee, City of Muskego
FROM: Faith Spear.
COPIES: File
DATE: 01/29/16
PROJECT NUMBER: 1012.10030

Attached is the audit report for activities at the ADS Emerald Park Landfill for the week of January 11, 2016. The audit was performed at 10:41 AM on **January 14, 2016** by Jo Spear, Jr. in the presence of Michael Hackney, General Manager.

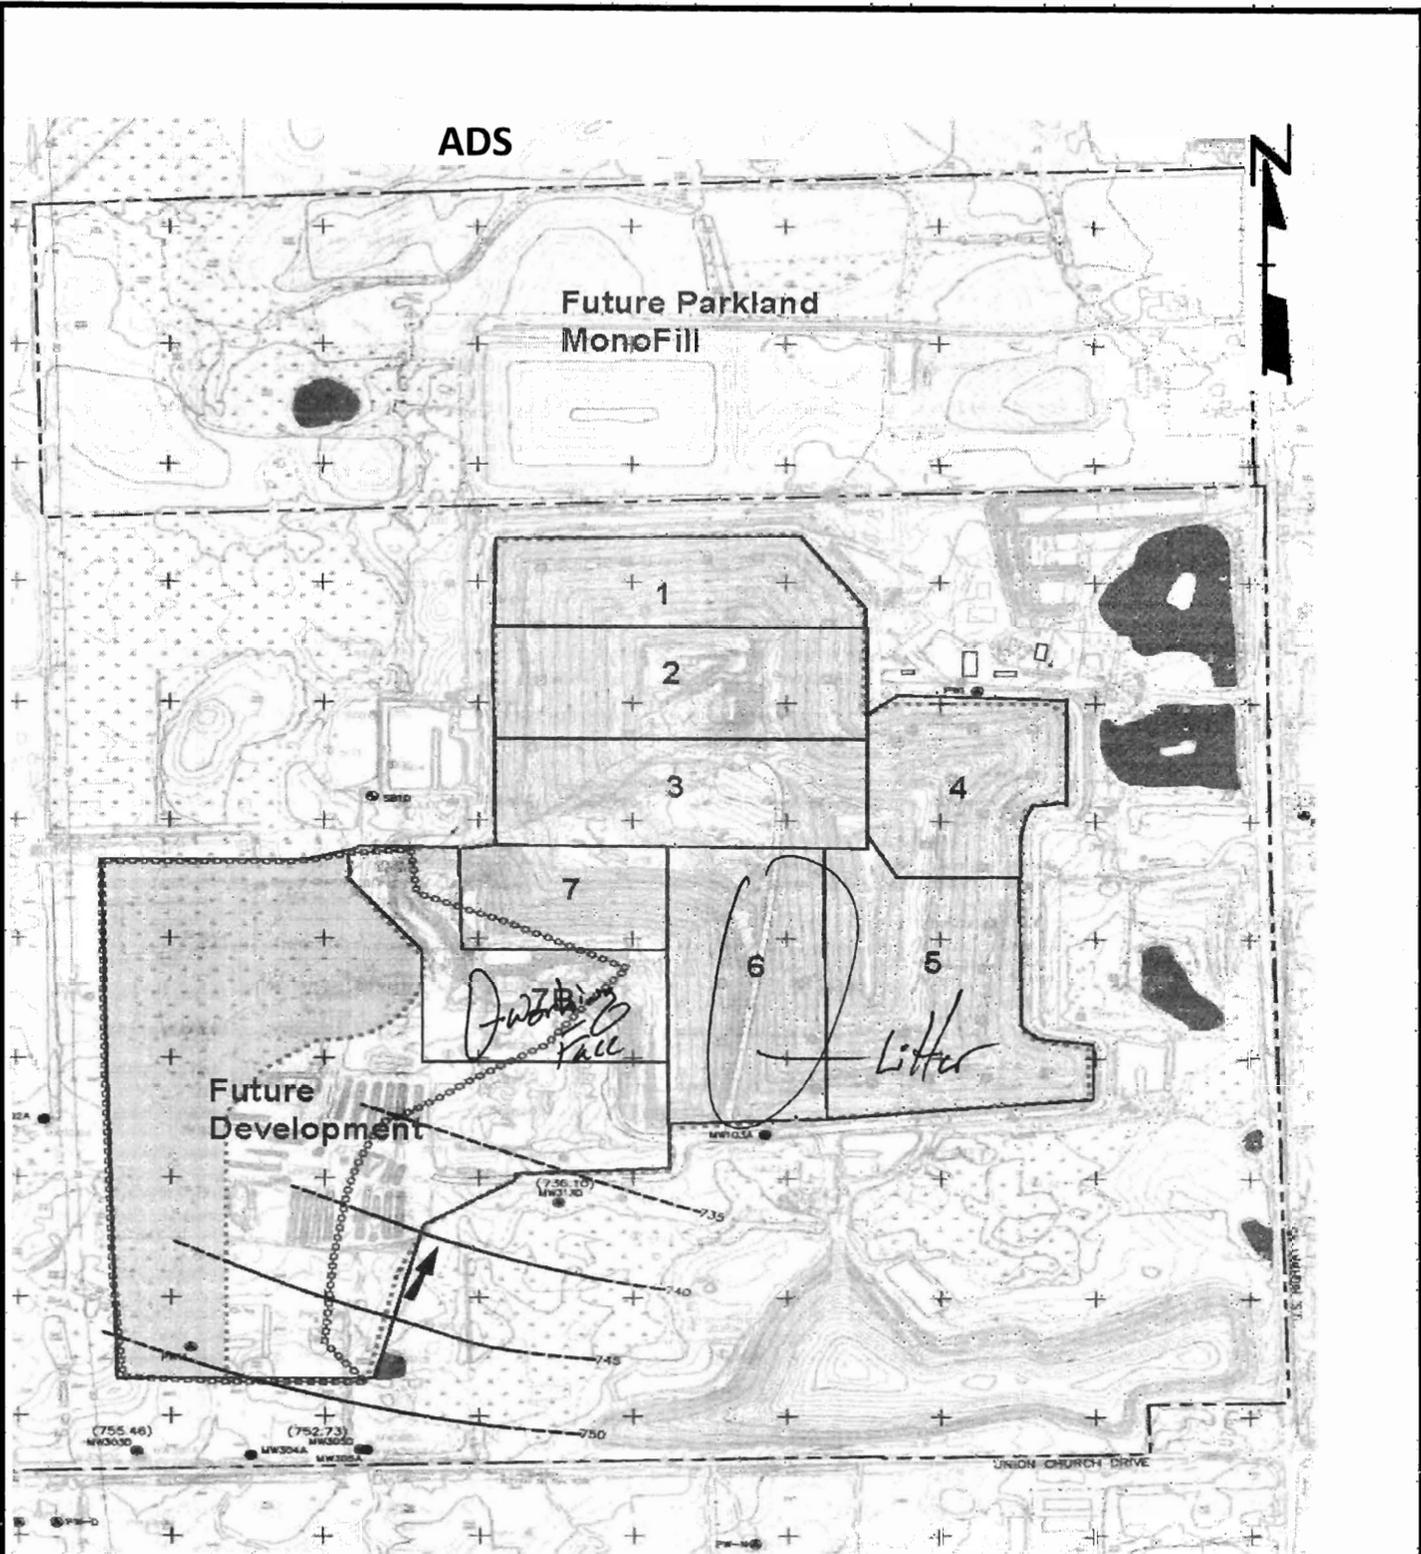
Advanced Disposal Services Emerald Park Landfill
 Landfill Audit Map
 City of Muskego
 Project No. 1020.10030

Large ril, previously observed and not increasing in size. Ril is on West slope above Temp Sed. Basin
