VEOLIA EMERALD PARK LANDFILL  
CITY OF MUSKEGO

## 2010 Veolia Emerald Park Landfill Year End Compliance Officer Report and Audit Summary

**TO:** Veolia Emerald Park Standing Committee  
**FROM:** Jo-Walter Spear, Jr., P.E.  
**COPIES:** File  
**DATE:** 01/20/11  
**PROJECT NUMBER:** 1012

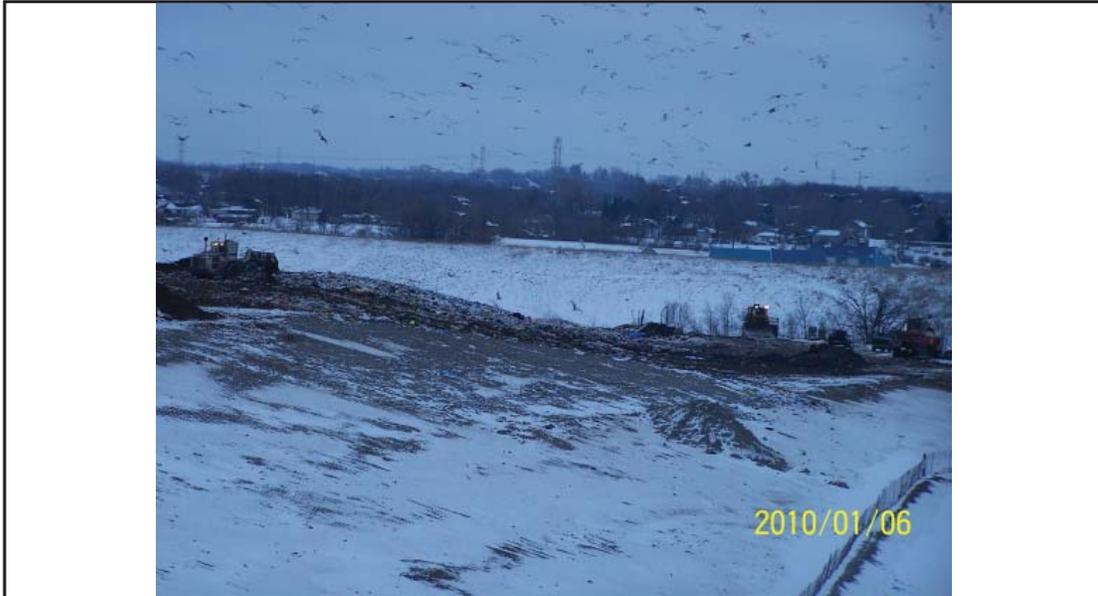
Working Face

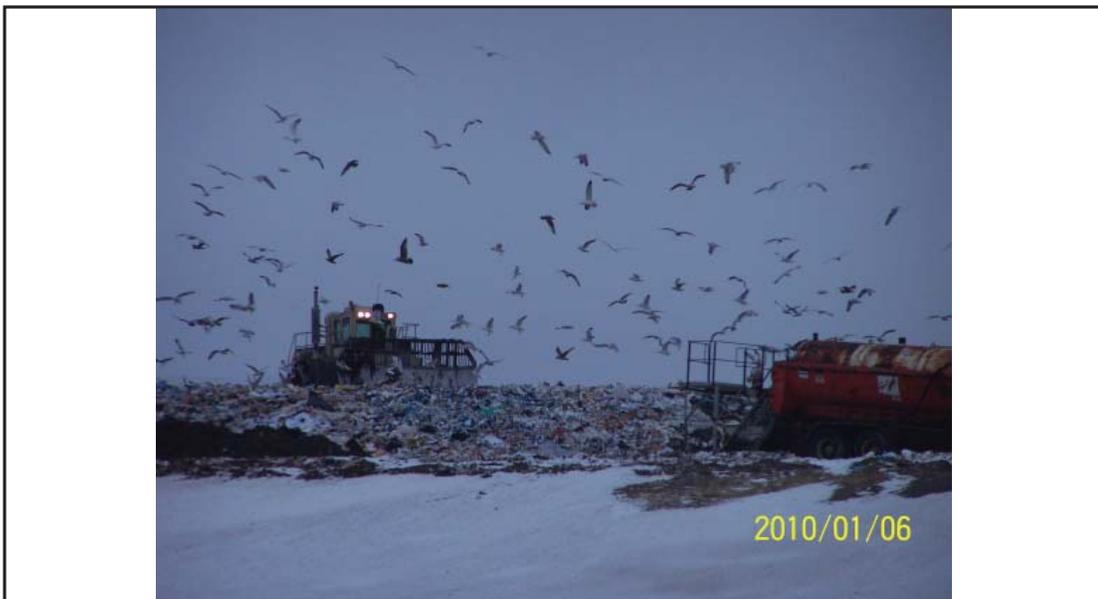
Active Area

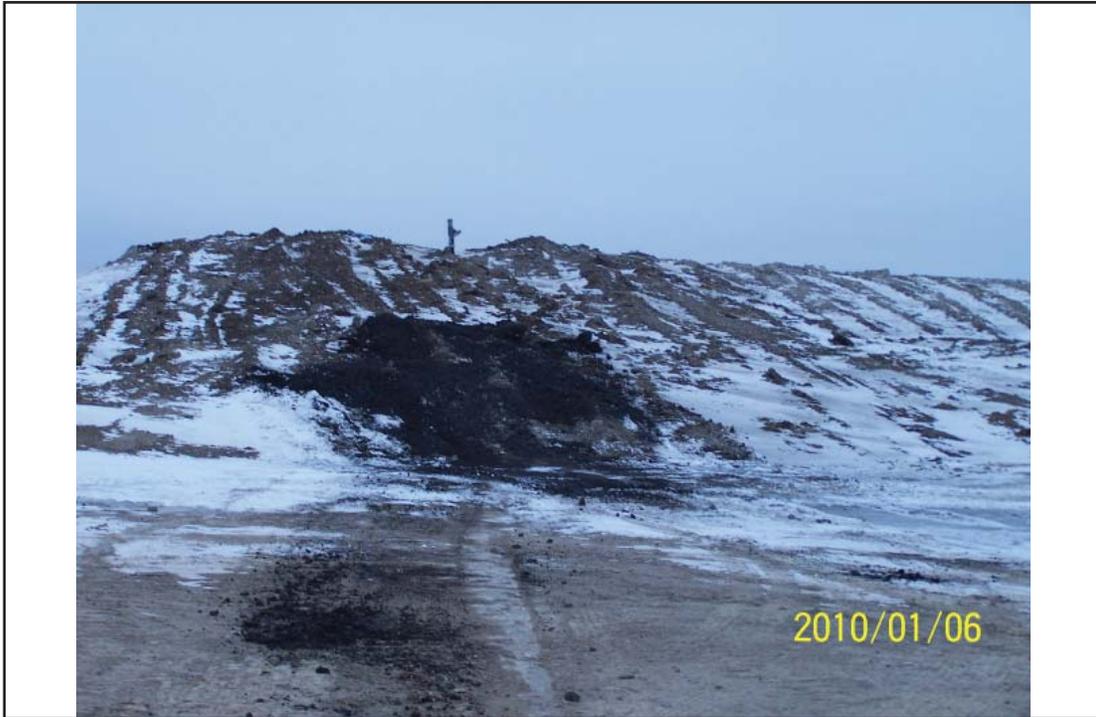
Soils tipped in Phase 2

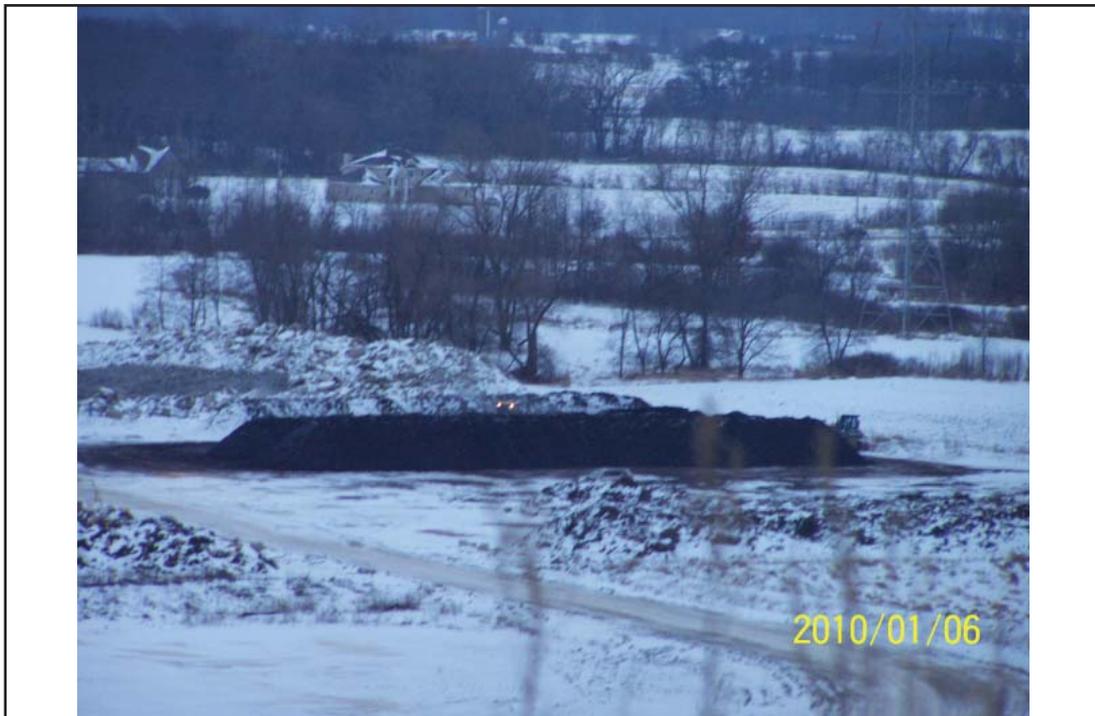
Compost

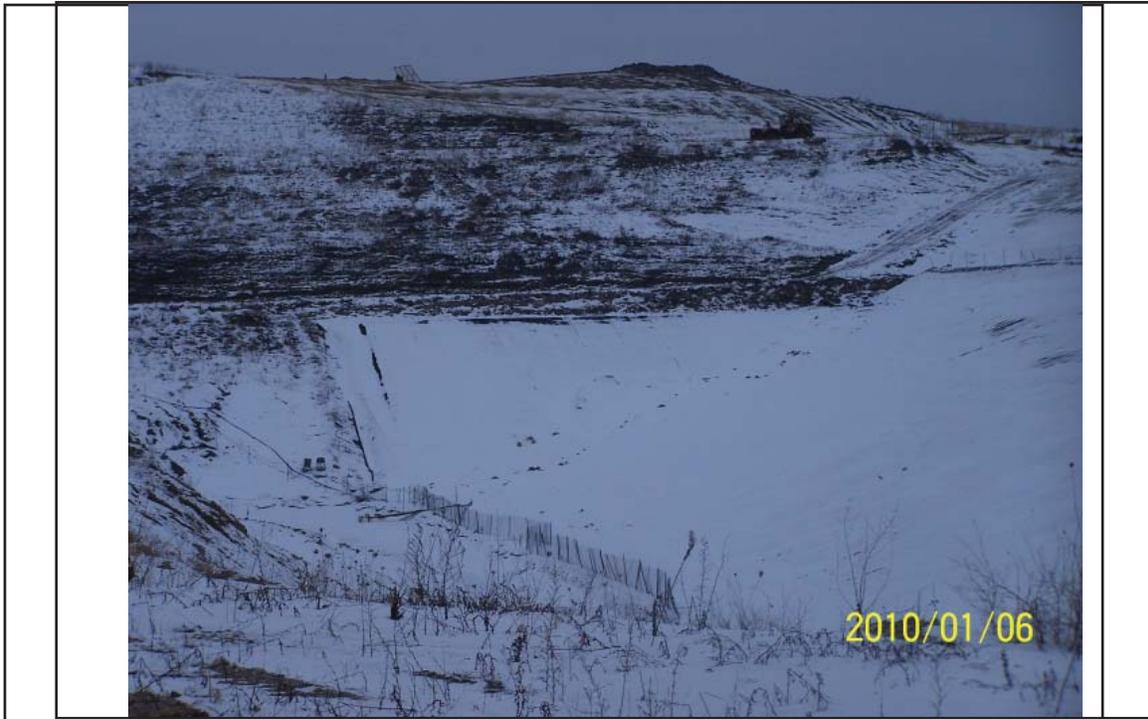
Fences relatively cleared of litter.

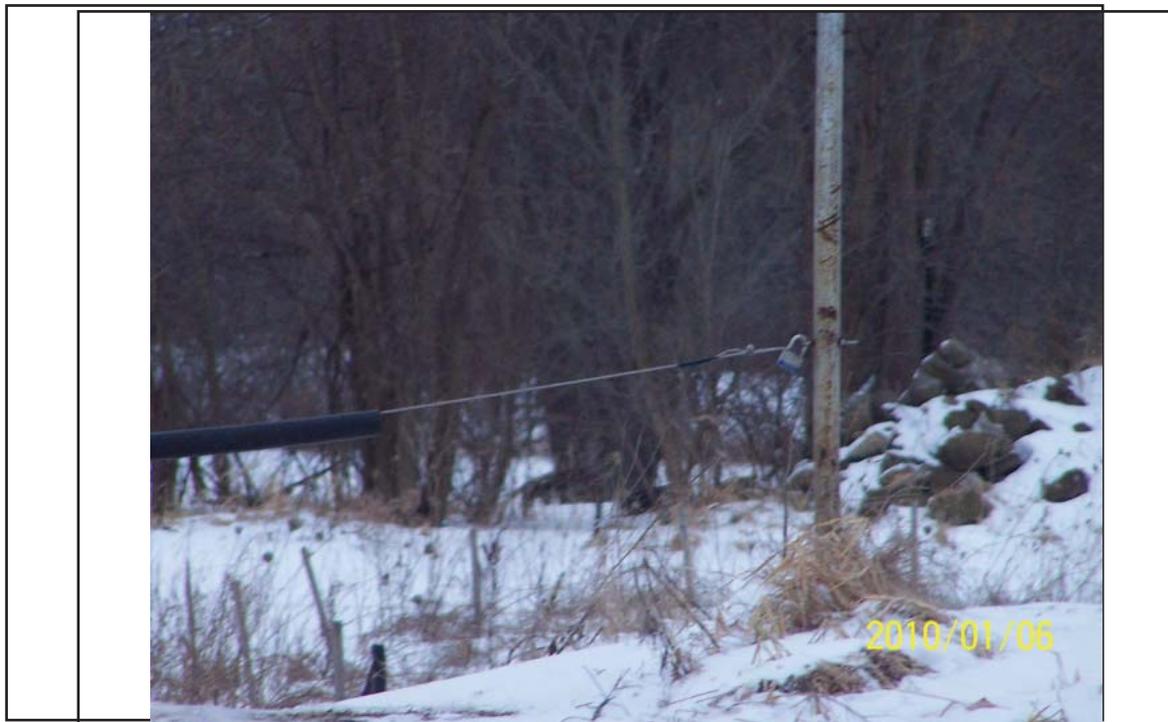
Compost Yard Gate secured

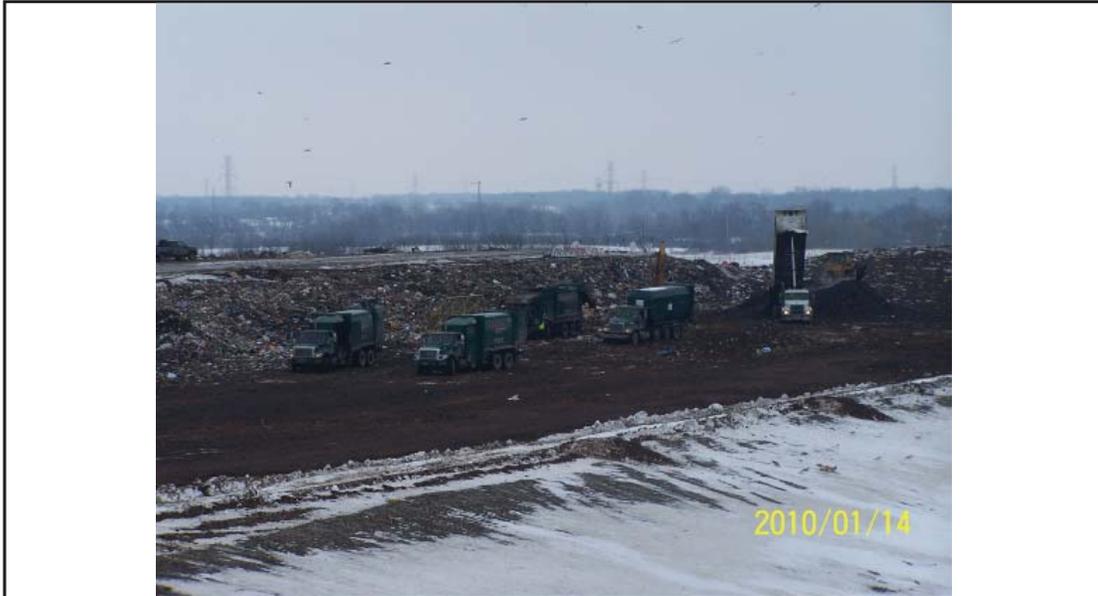
Active area

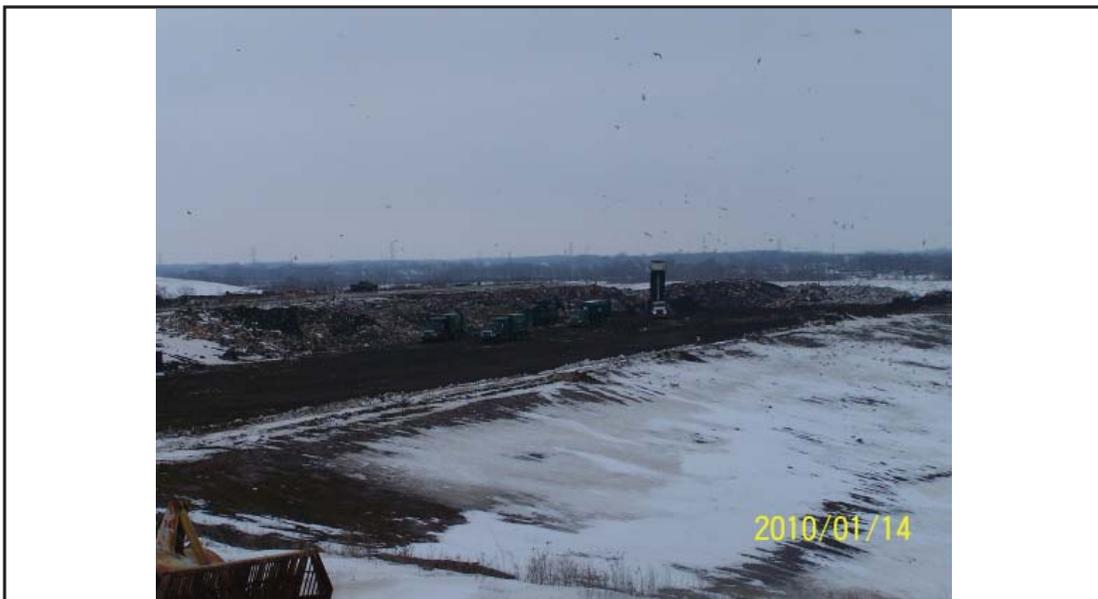
Working Face

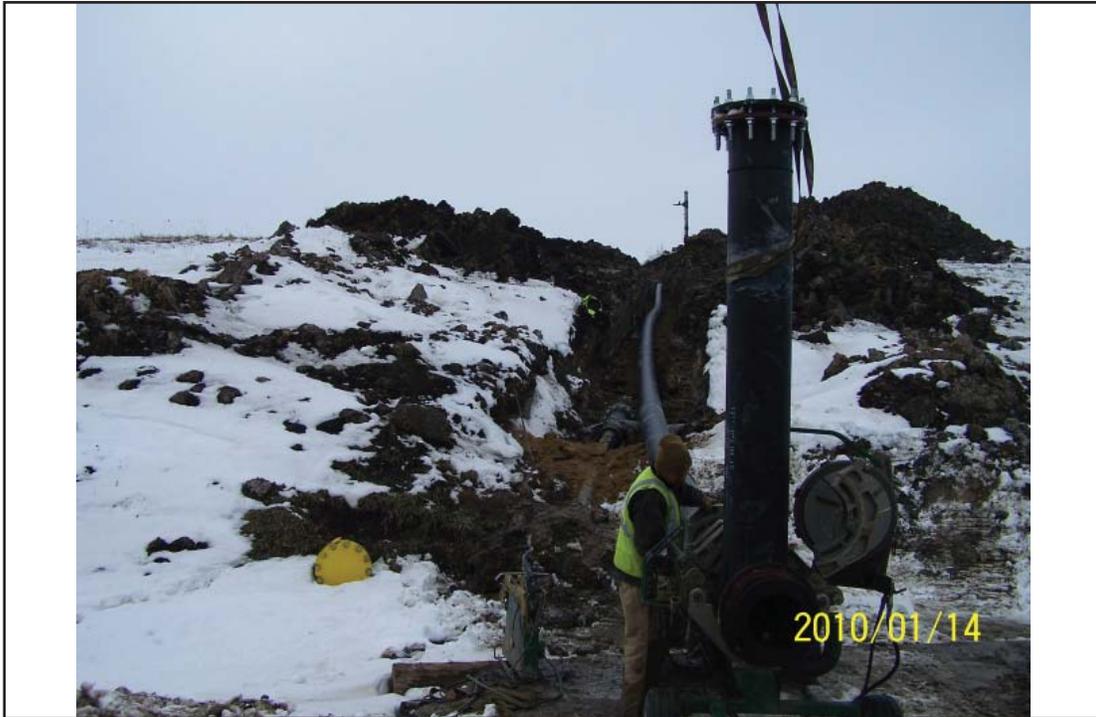
Header work progressing

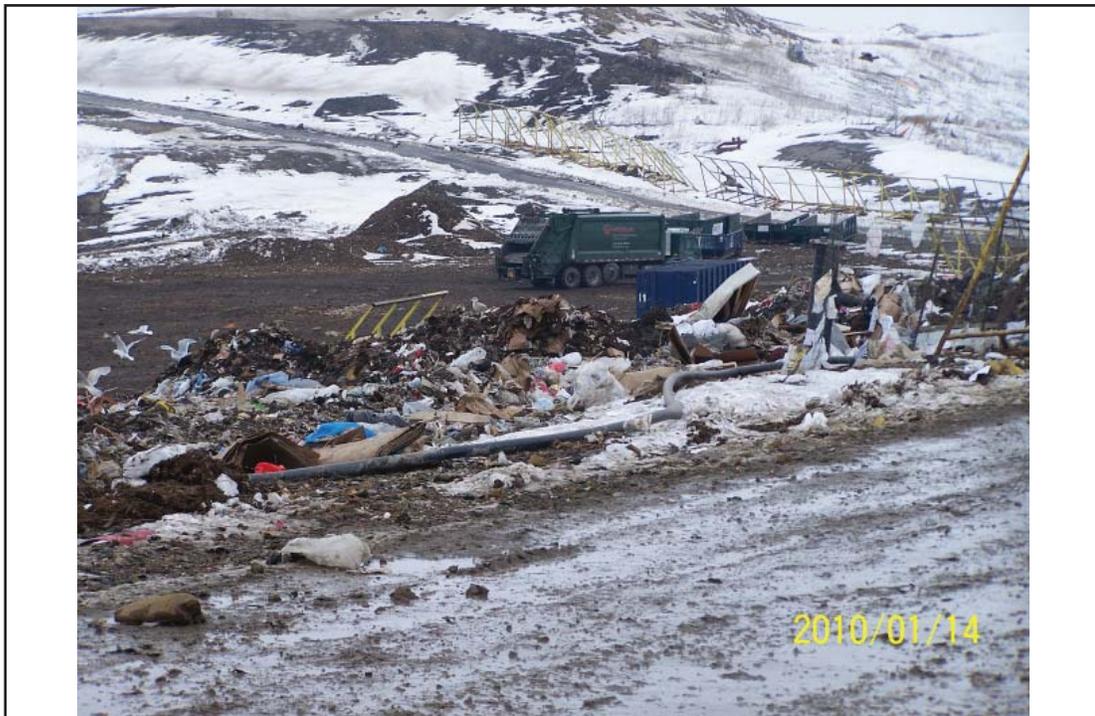
Dig out area on working face

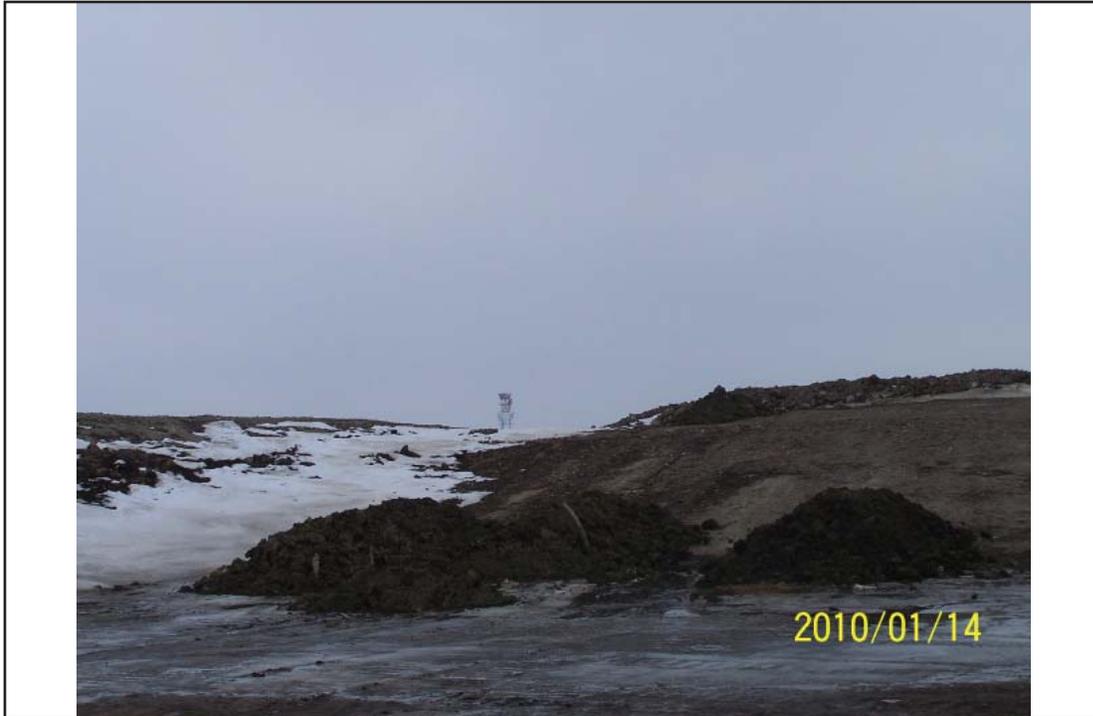
Autofluff and clay available for daily cover

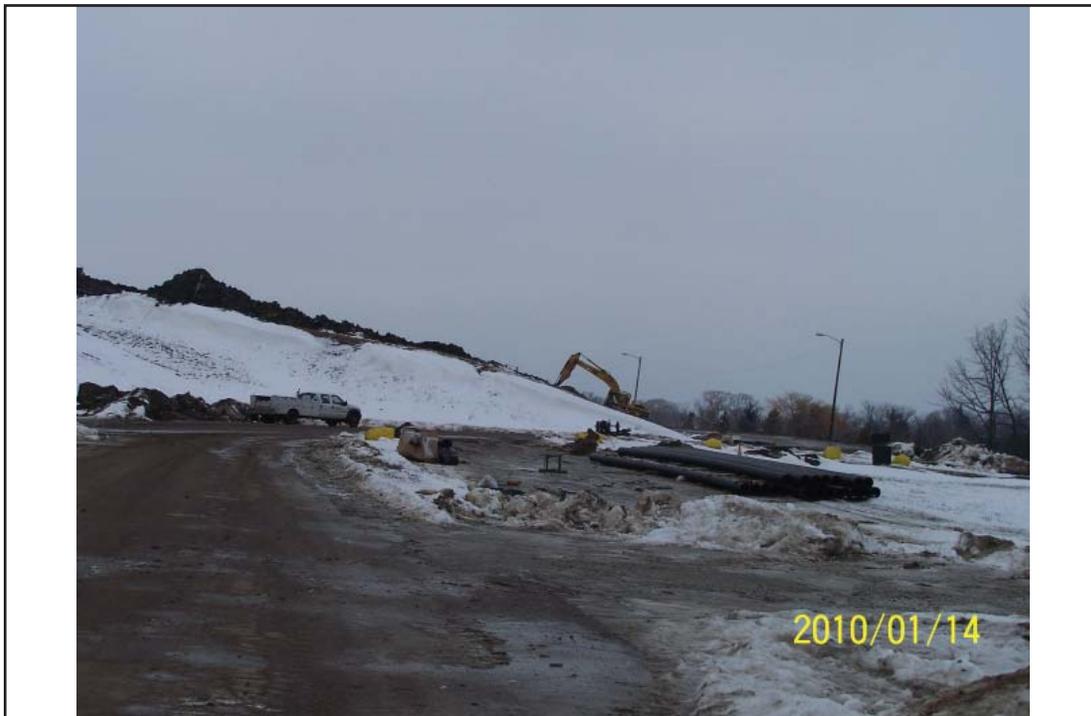
Special Services Active on site

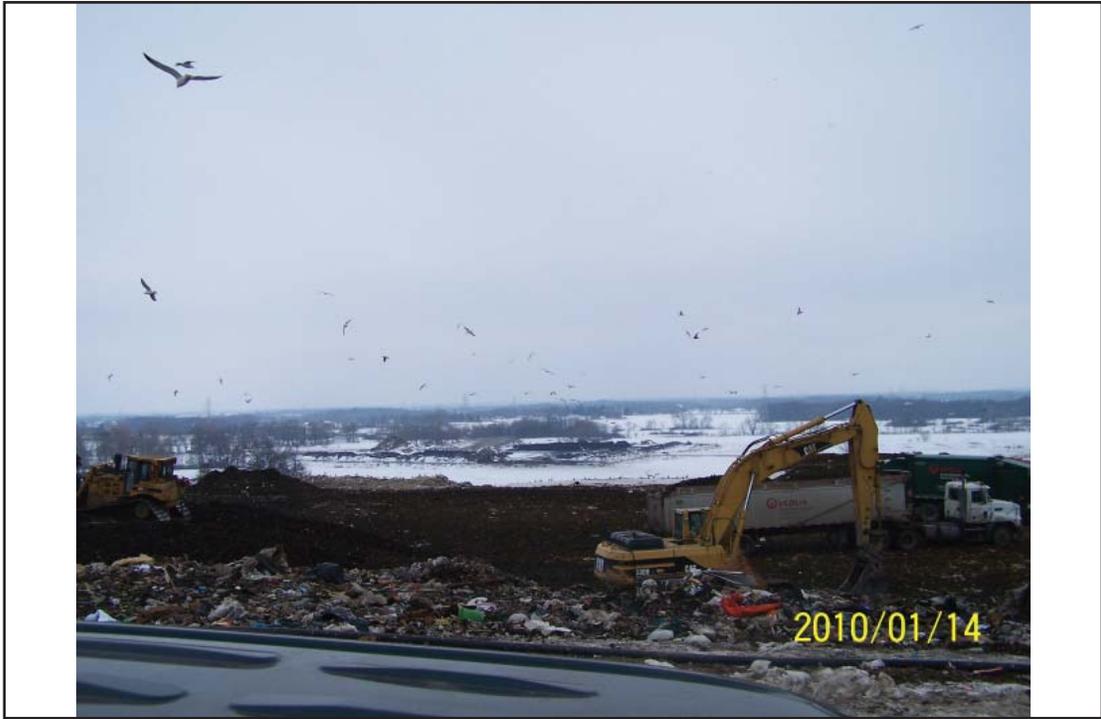
Dig out

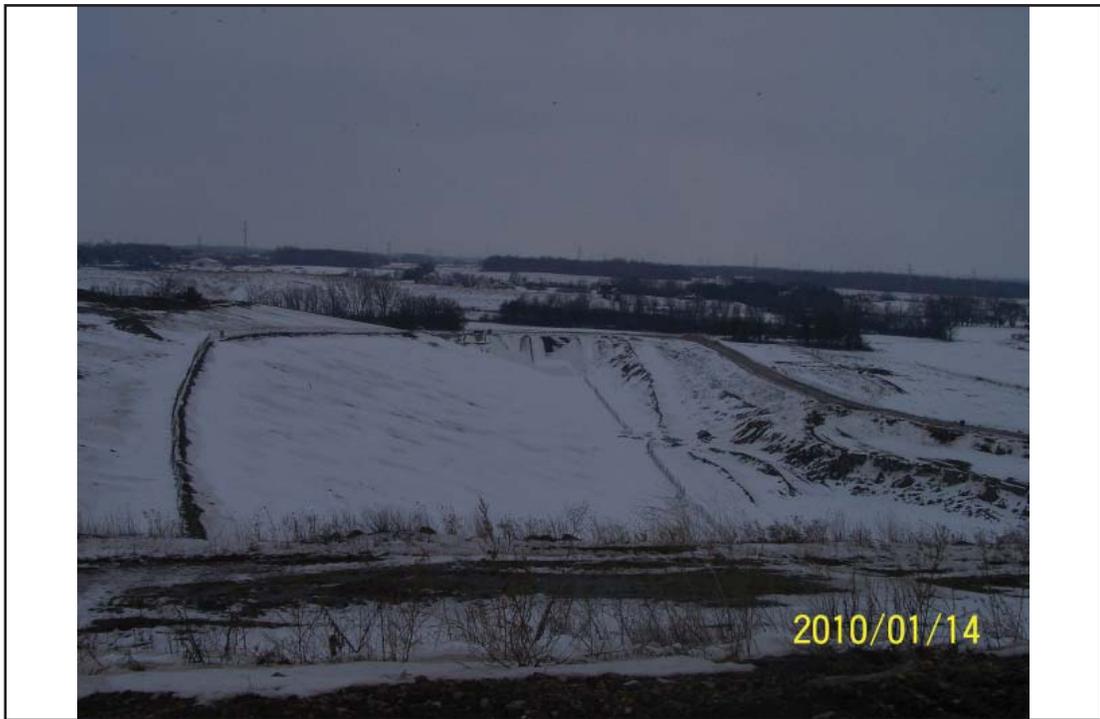
Site snow covered

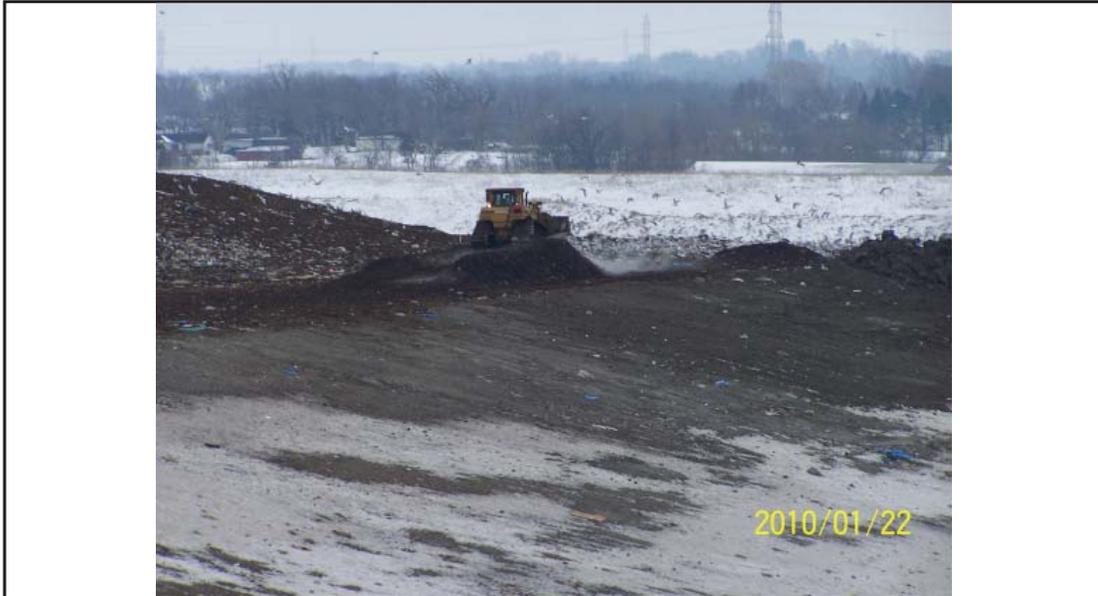
Active area

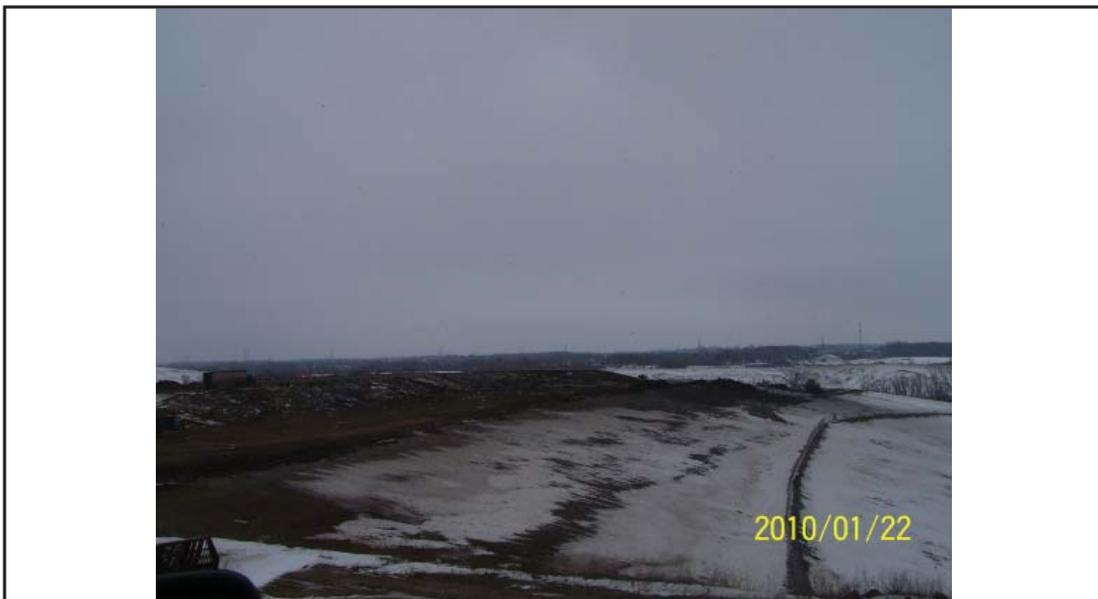
Working Face

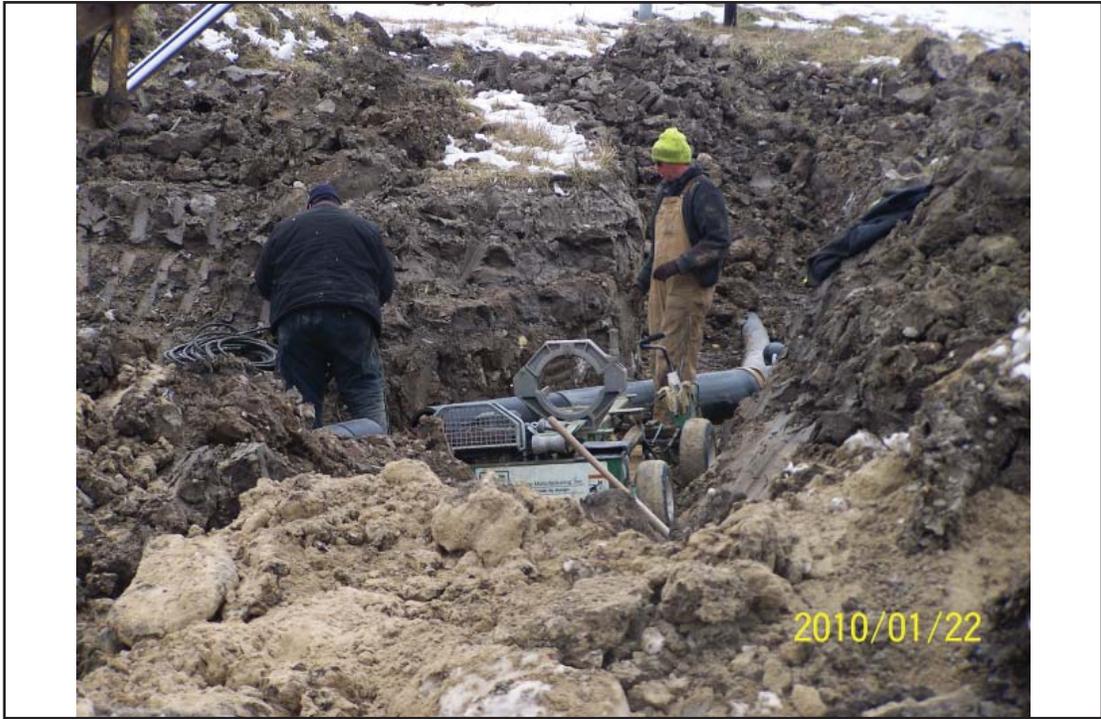
Header work progressing

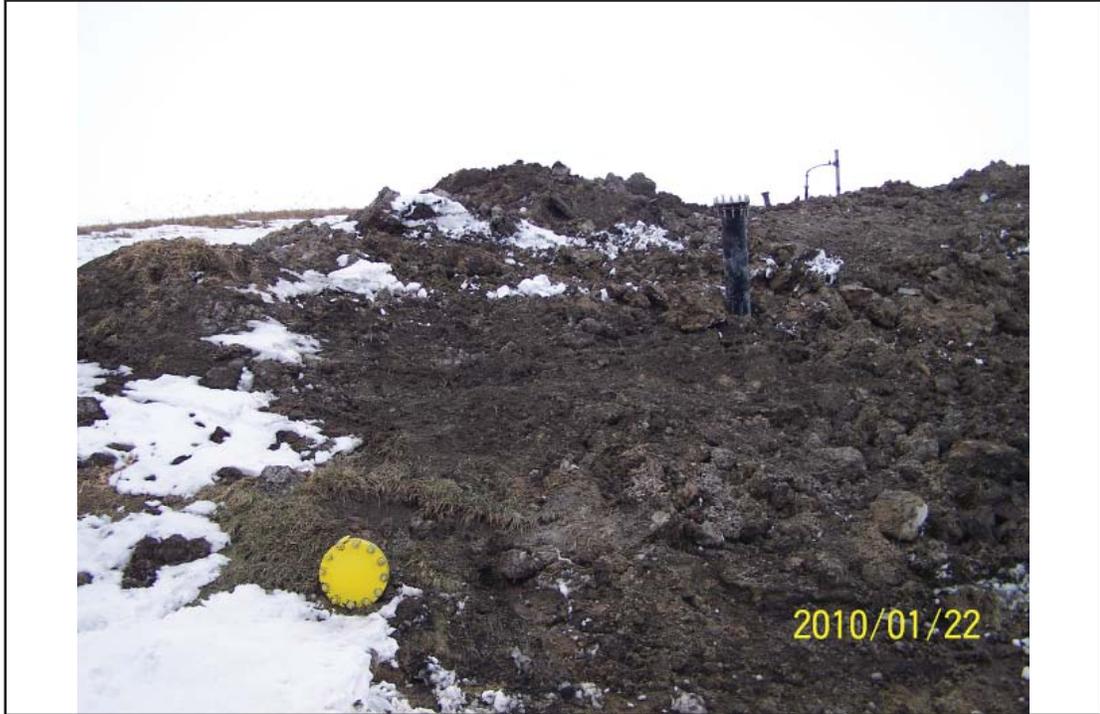
Lines buried

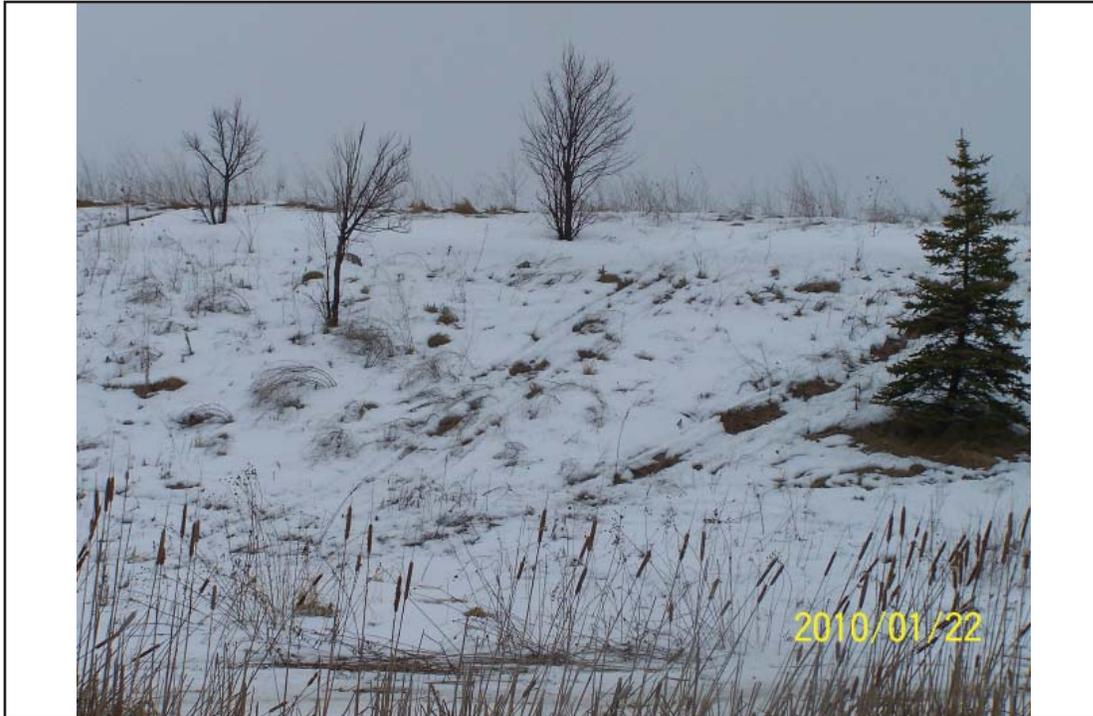
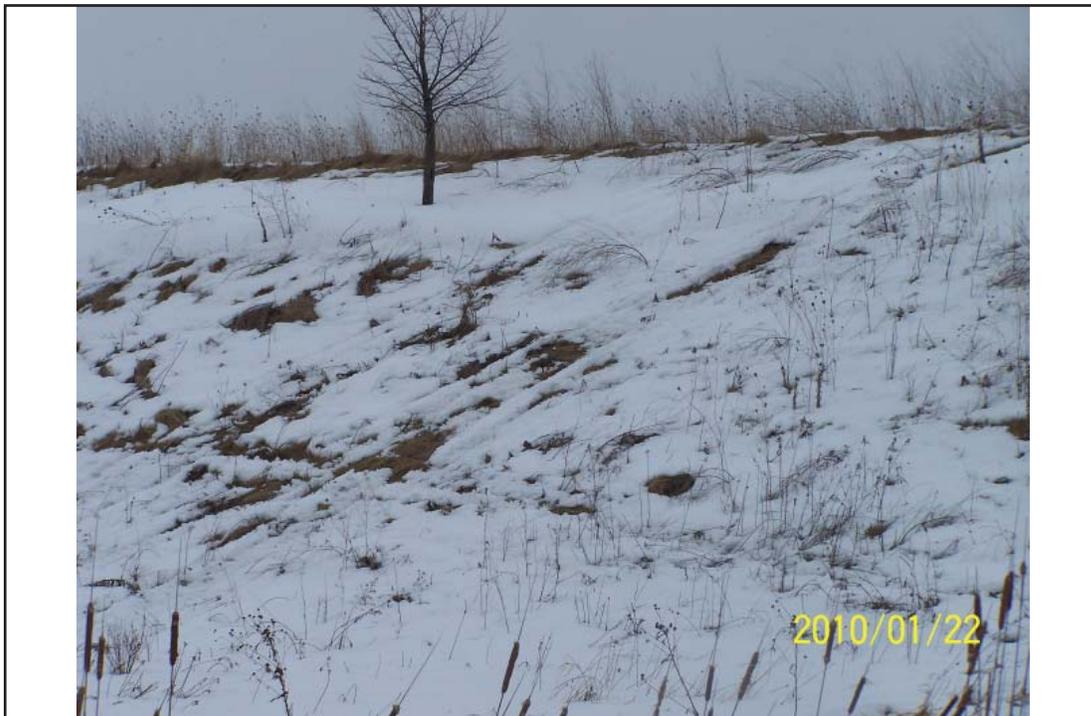
Snow machine tracks heading onto property

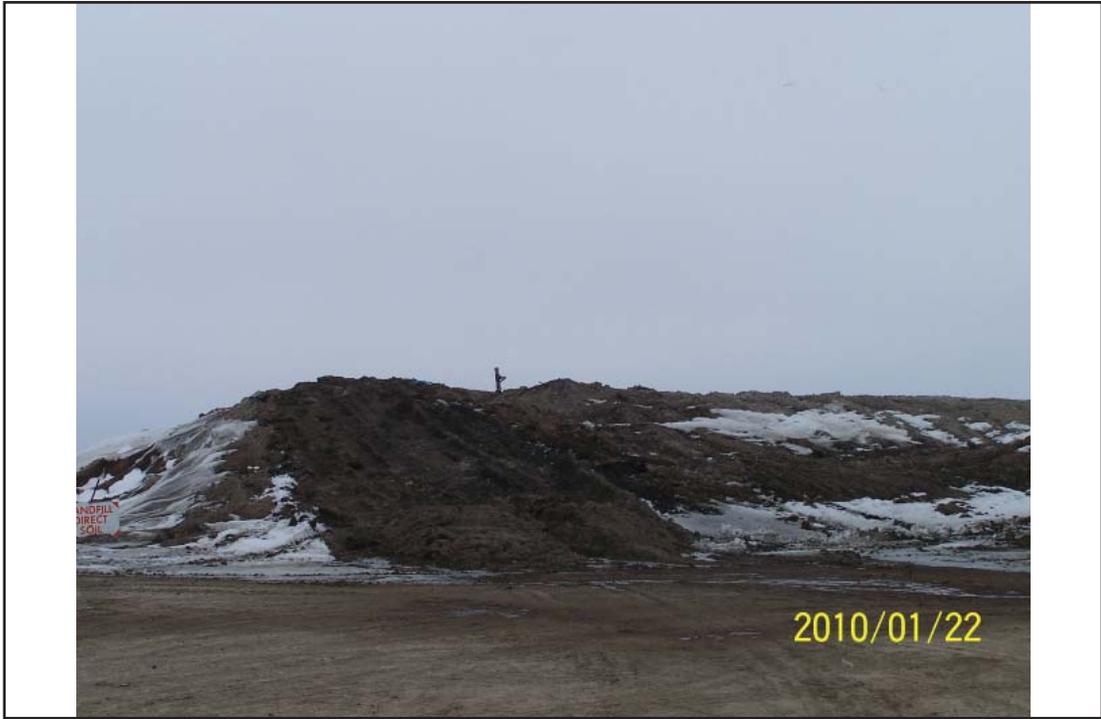
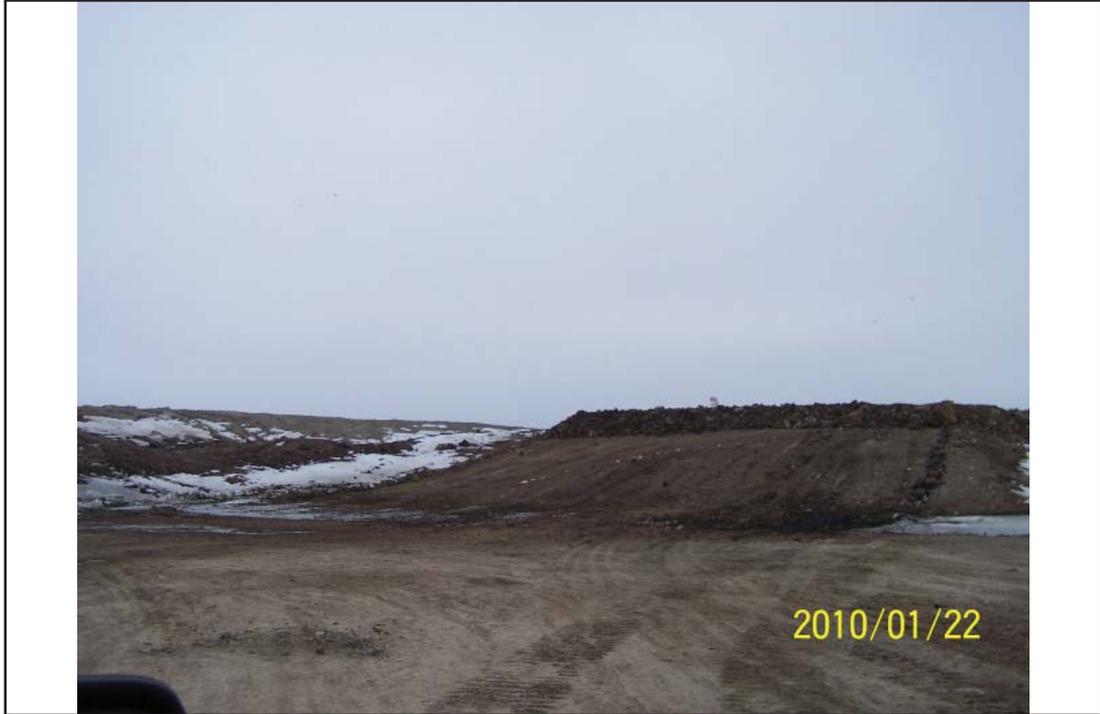
Soils tipped in Phase 2 & 3

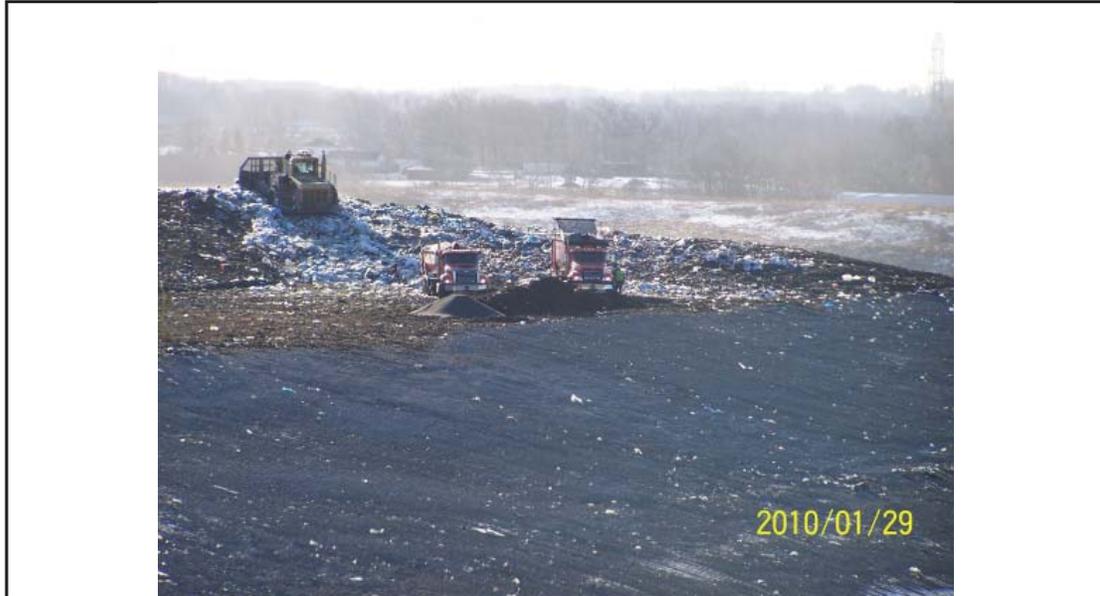
Active area

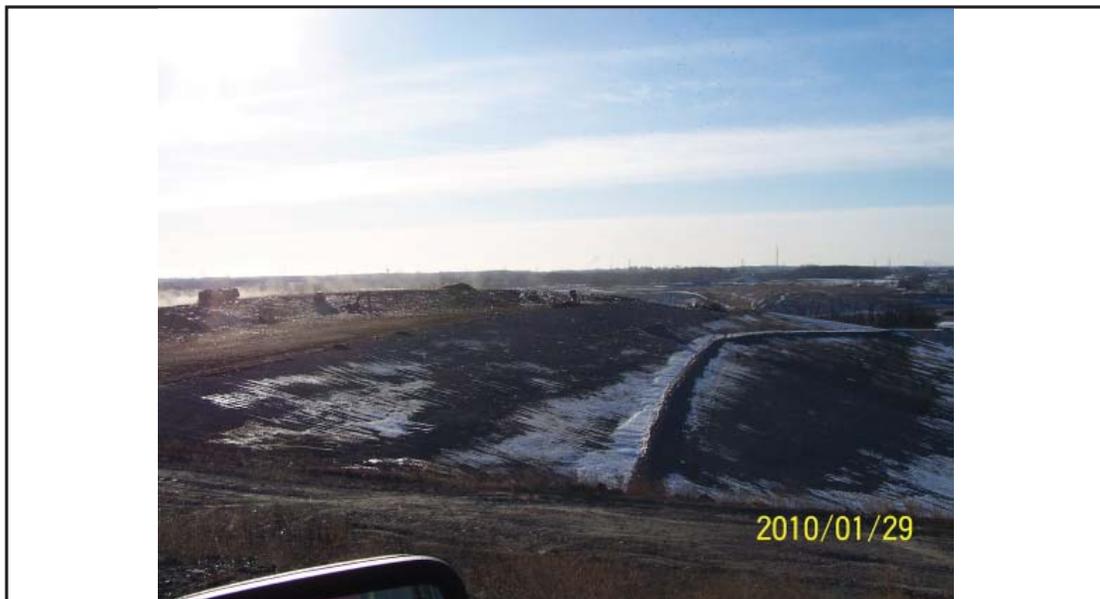
Working Face

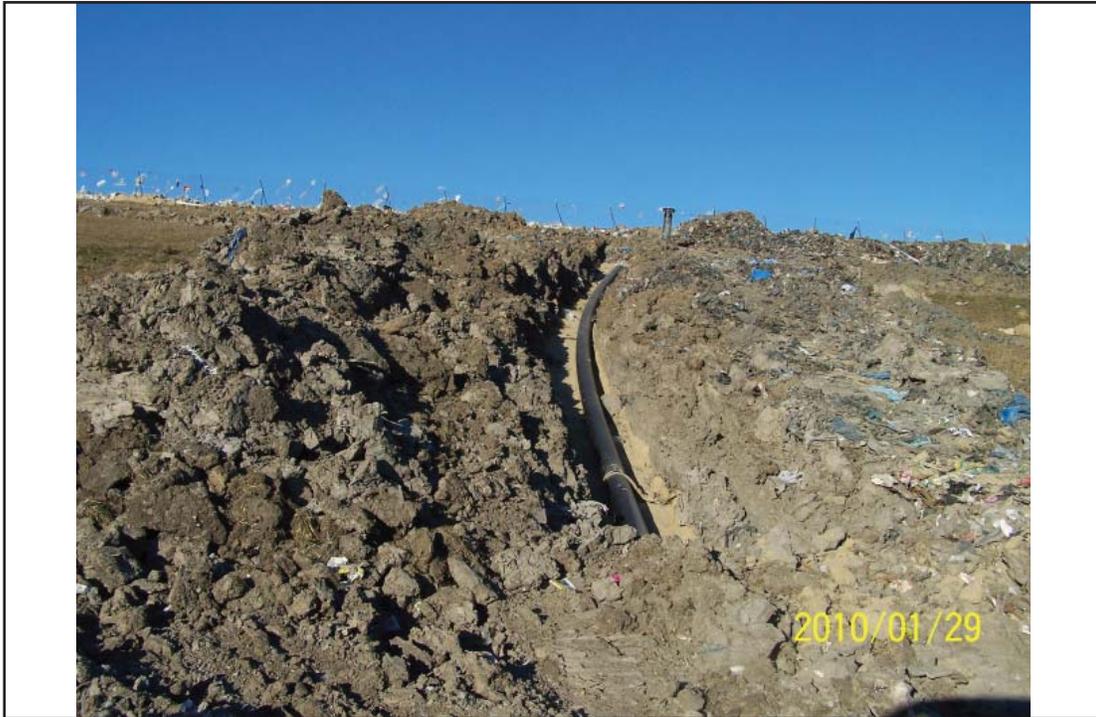
Header work progressing

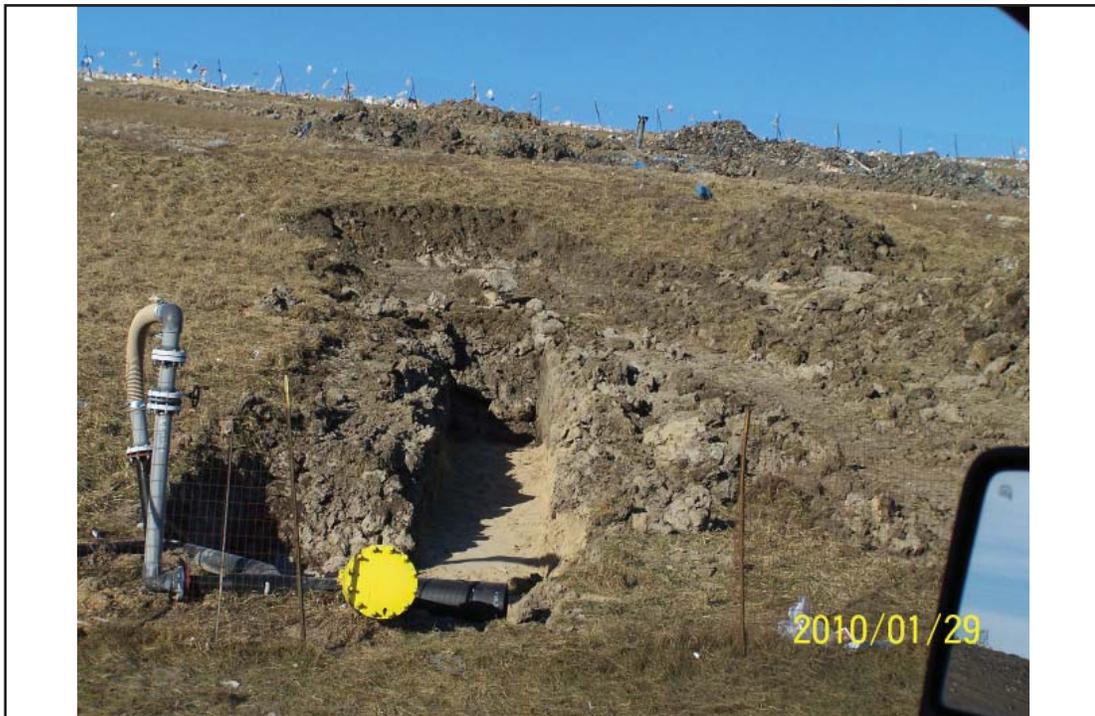
Lines buried

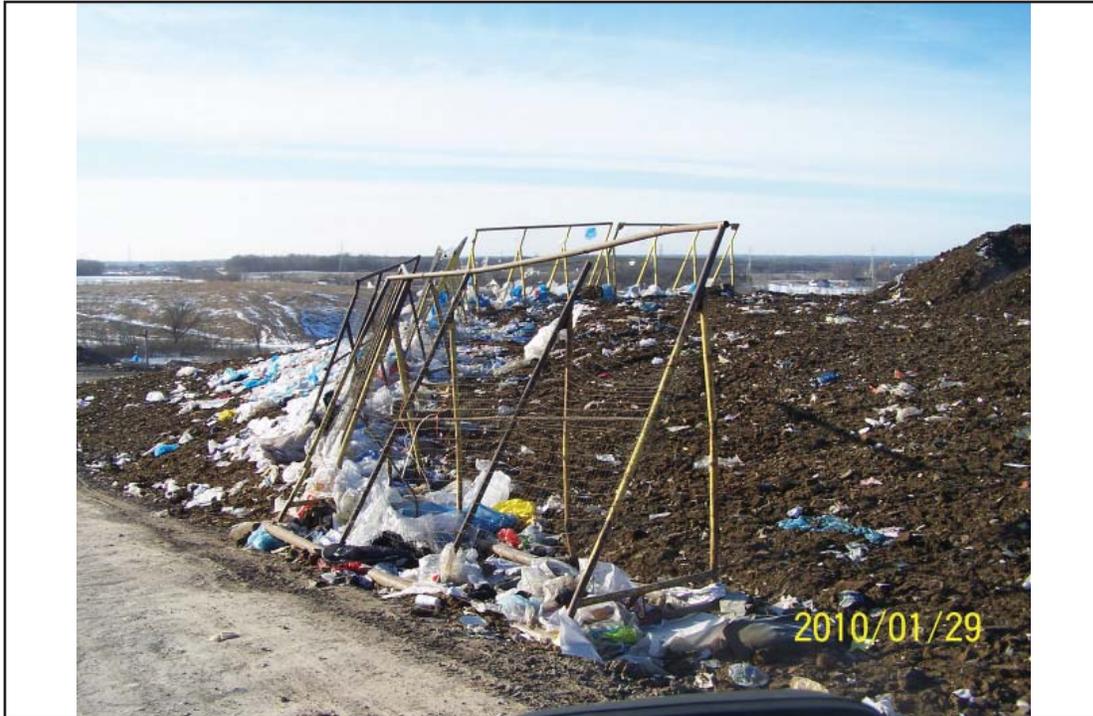
High winds causing lots of litter onsite, and minor litter off site

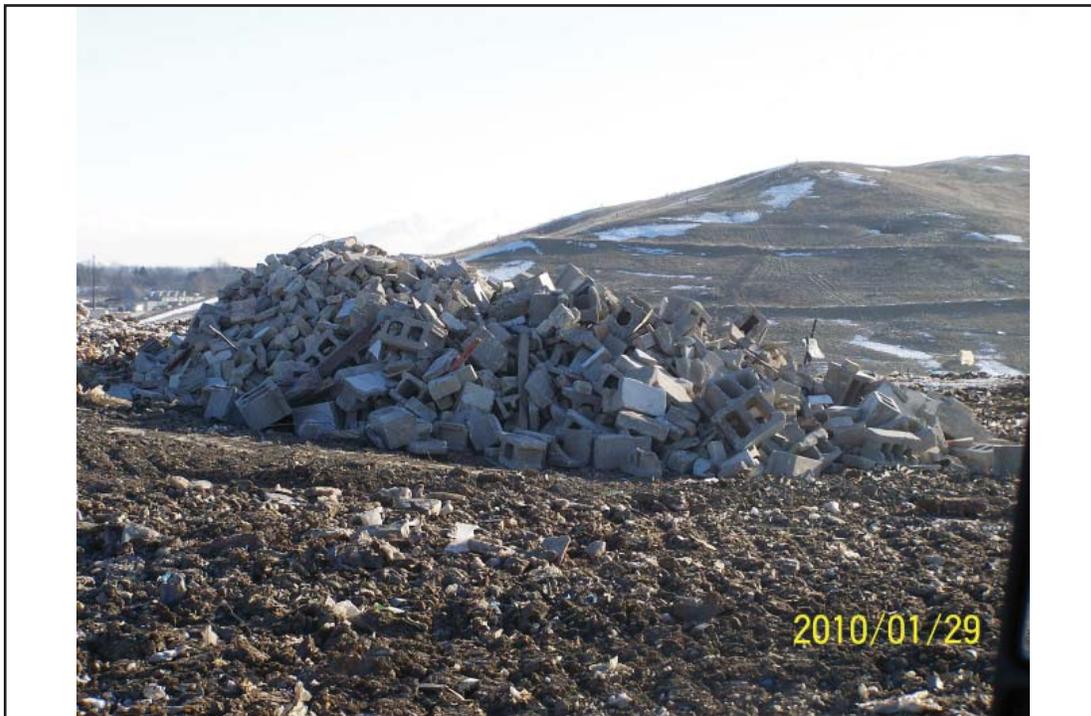
Concrete received in Phase 6

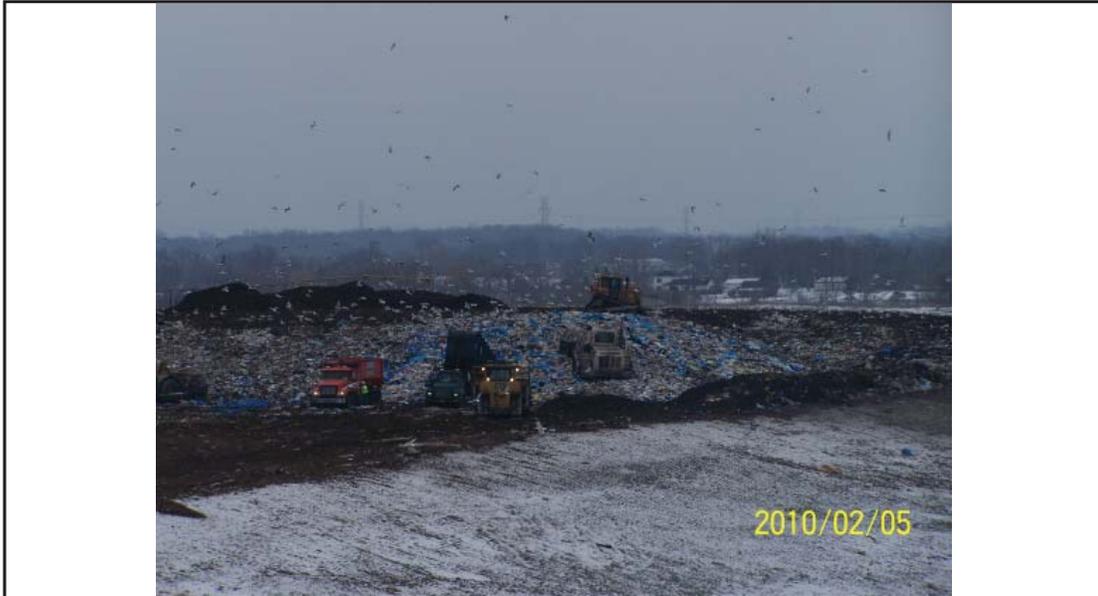
Active area

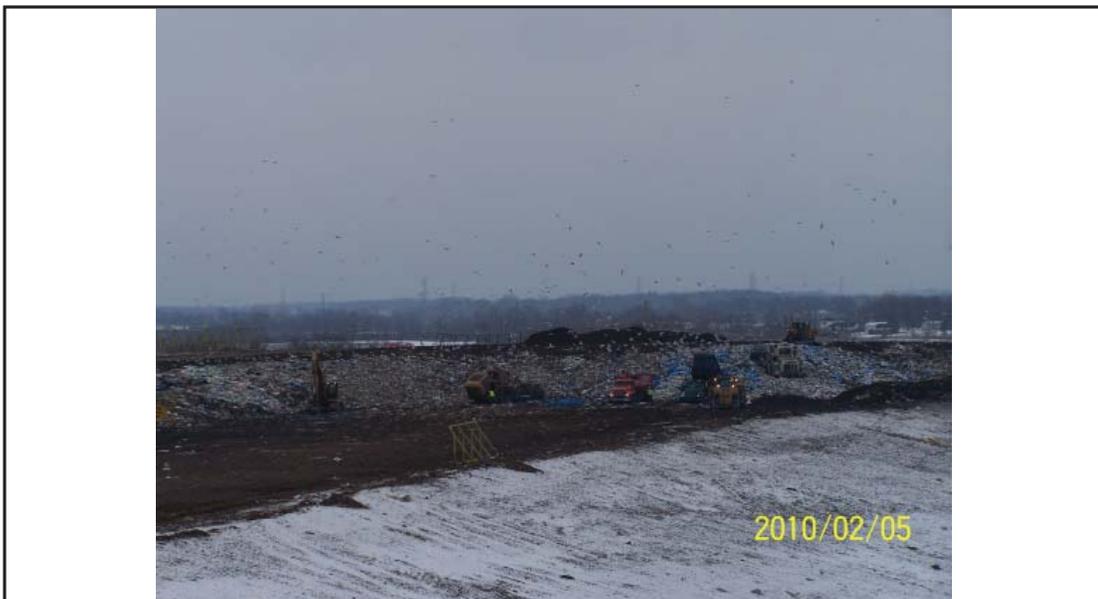
Working Face

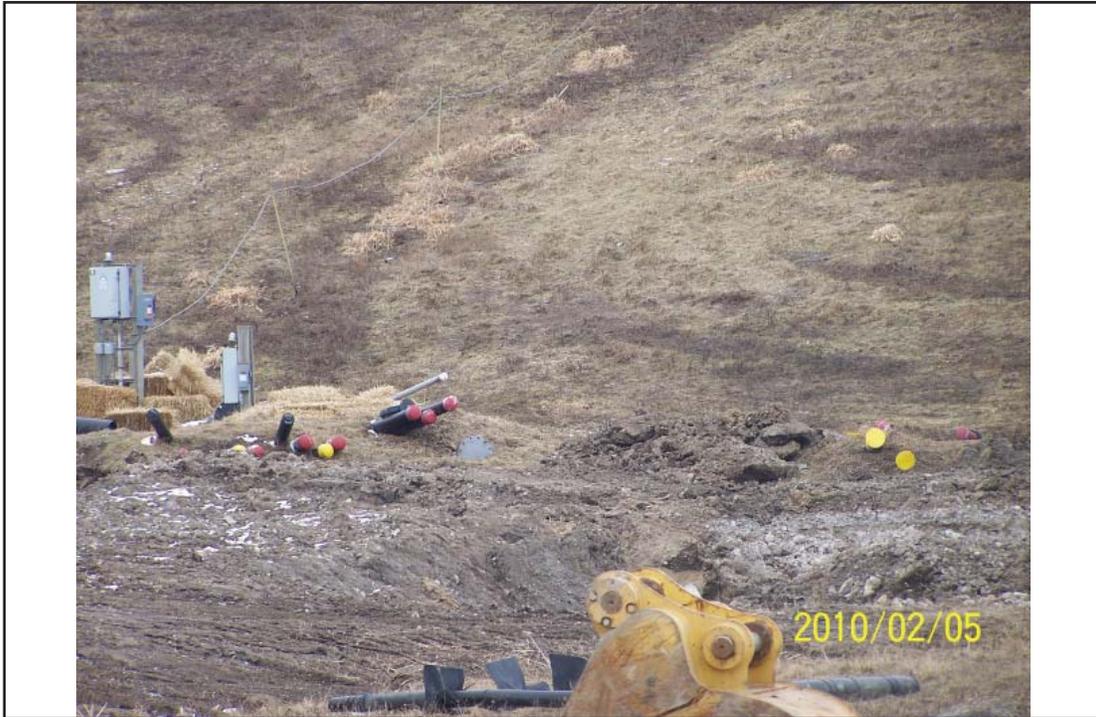
Header work progressing
