VEOLIA EMERALD PARK LANDFILL  
CITY OF MUSKEGO

## 2010 Veolia Emerald Park Landfill Year End Compliance Officer Report and Audit Summary

**TO:** Veolia Emerald Park Standing Committee  
**FROM:** Jo-Walter Spear, Jr., P.E.  
**COPIES:** File  
**DATE:** 01/20/11  
**PROJECT NUMBER:** 1012

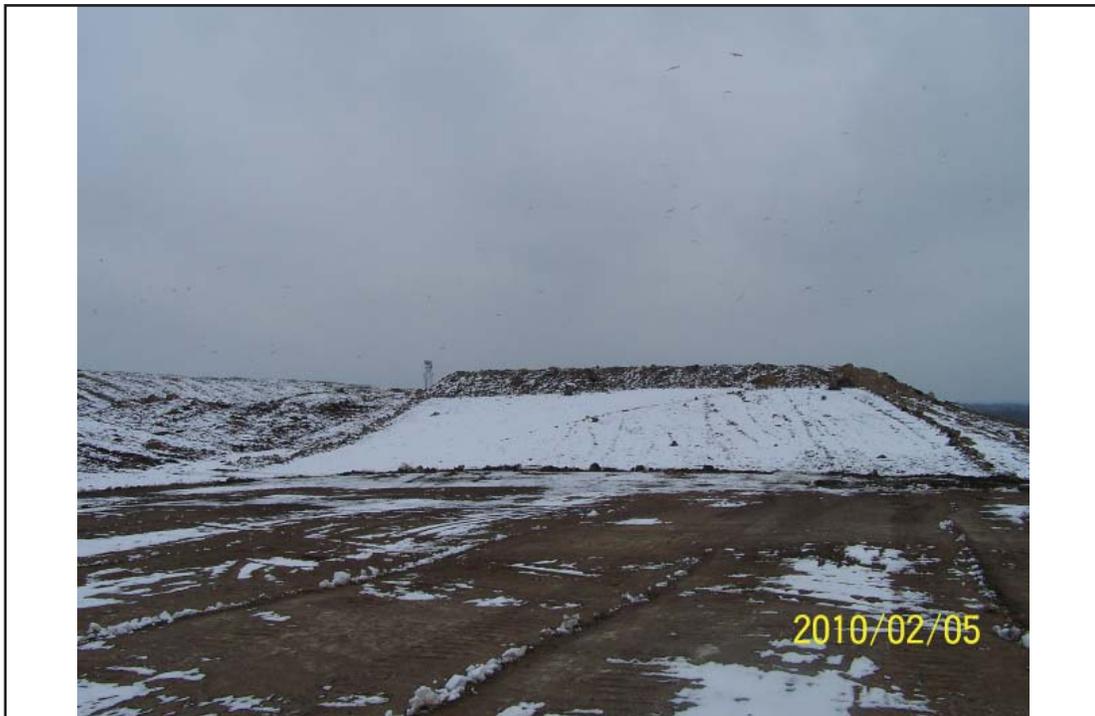
Soils in Phase 2 & 3

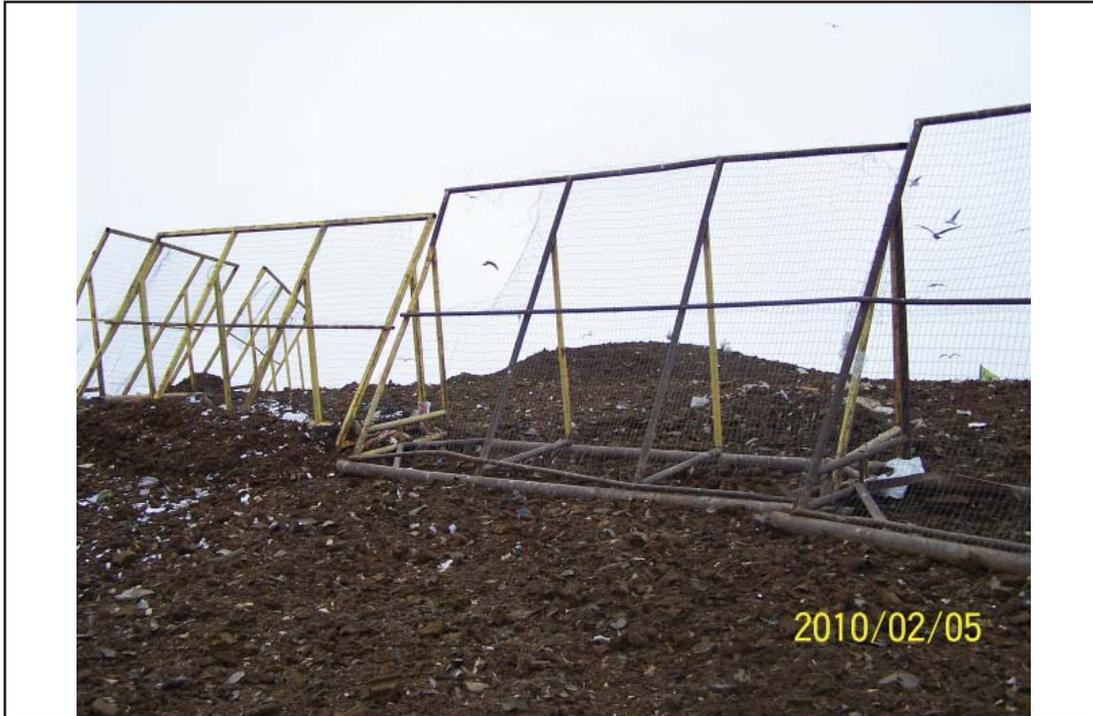
Litter fences cleared of blowing litter

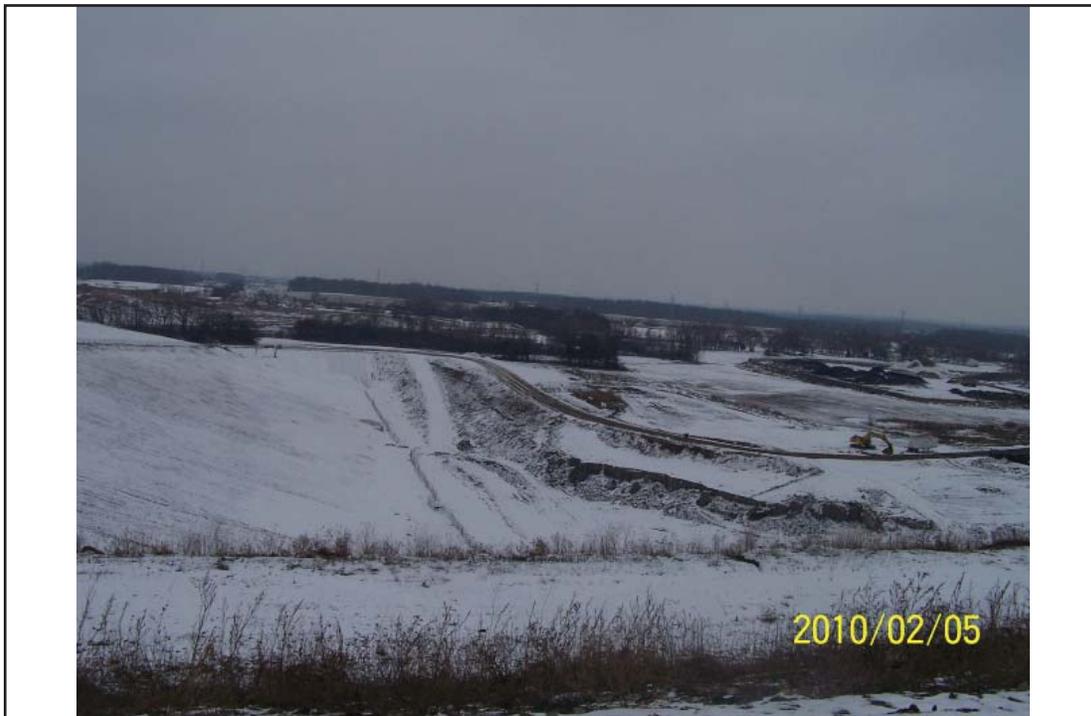
Snow covered site

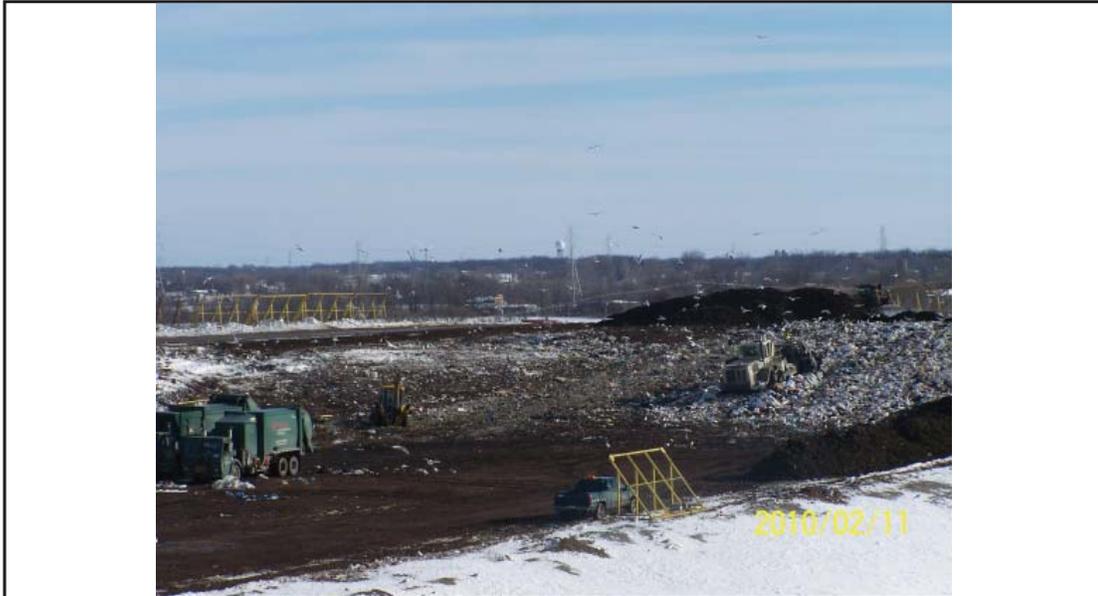
Active area

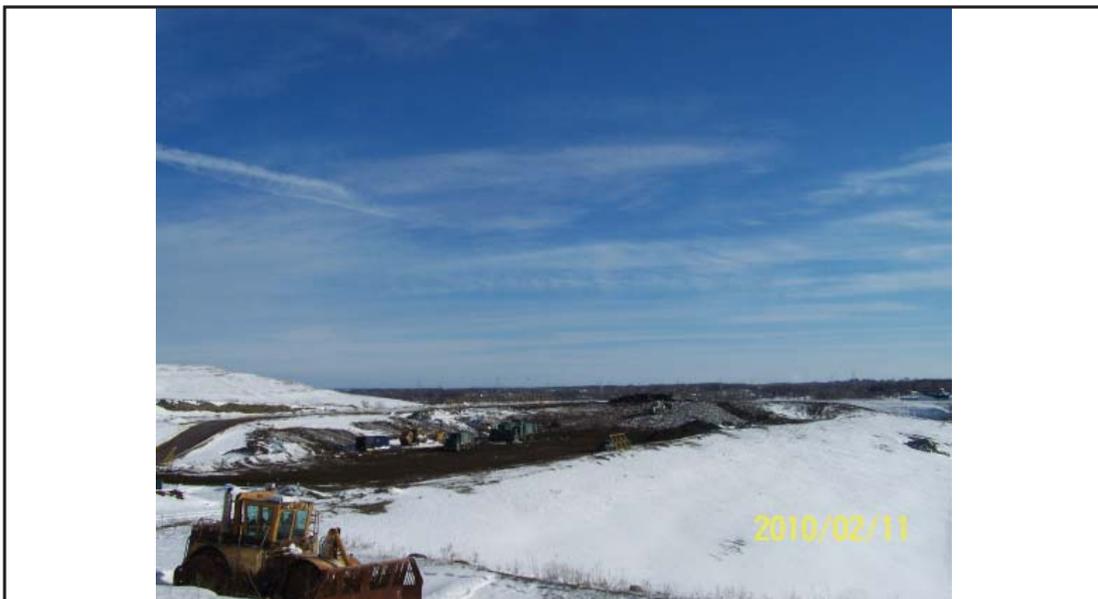
Working Face

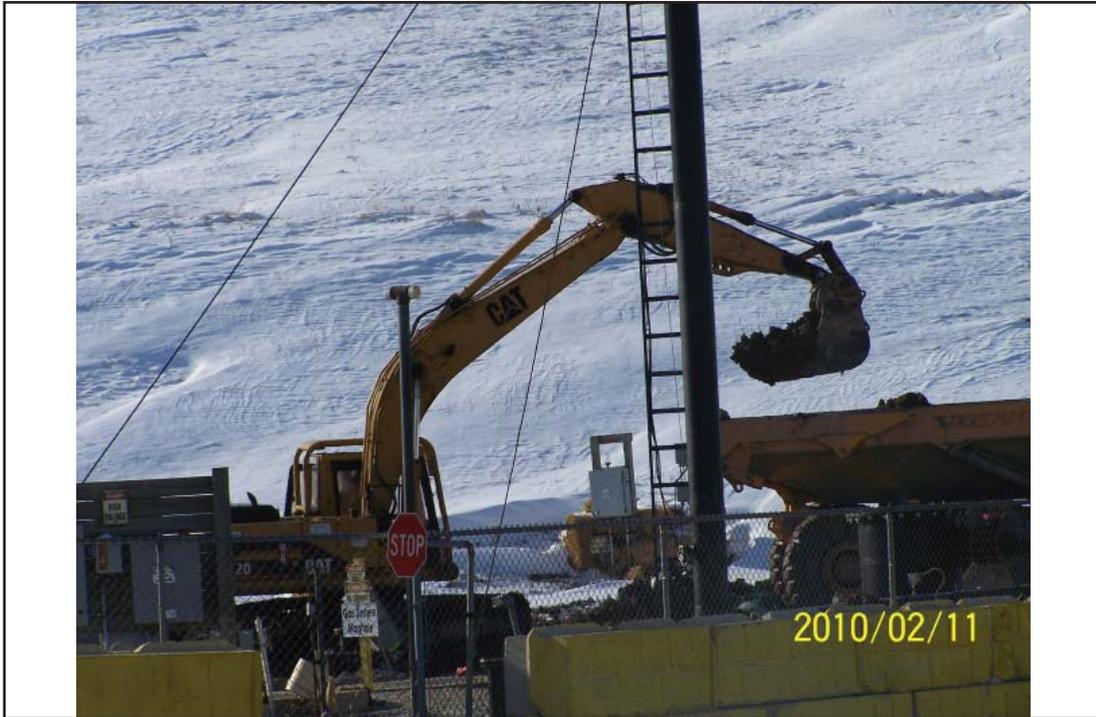
Header work progressing

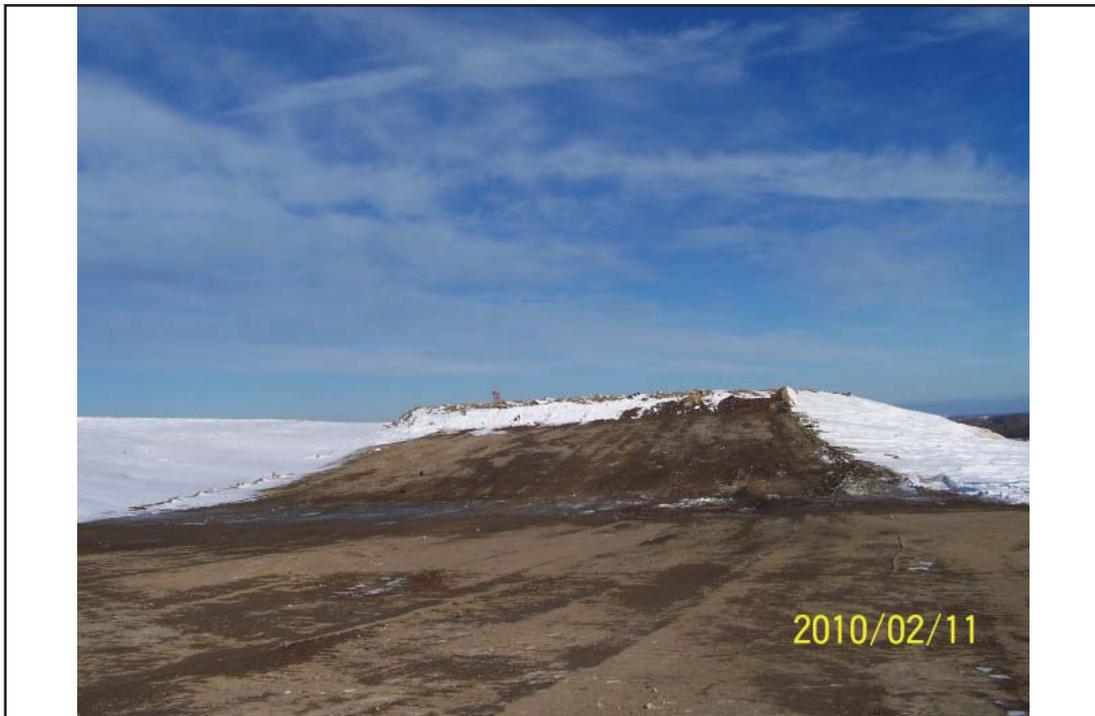
Soils in Phase 2 & 3

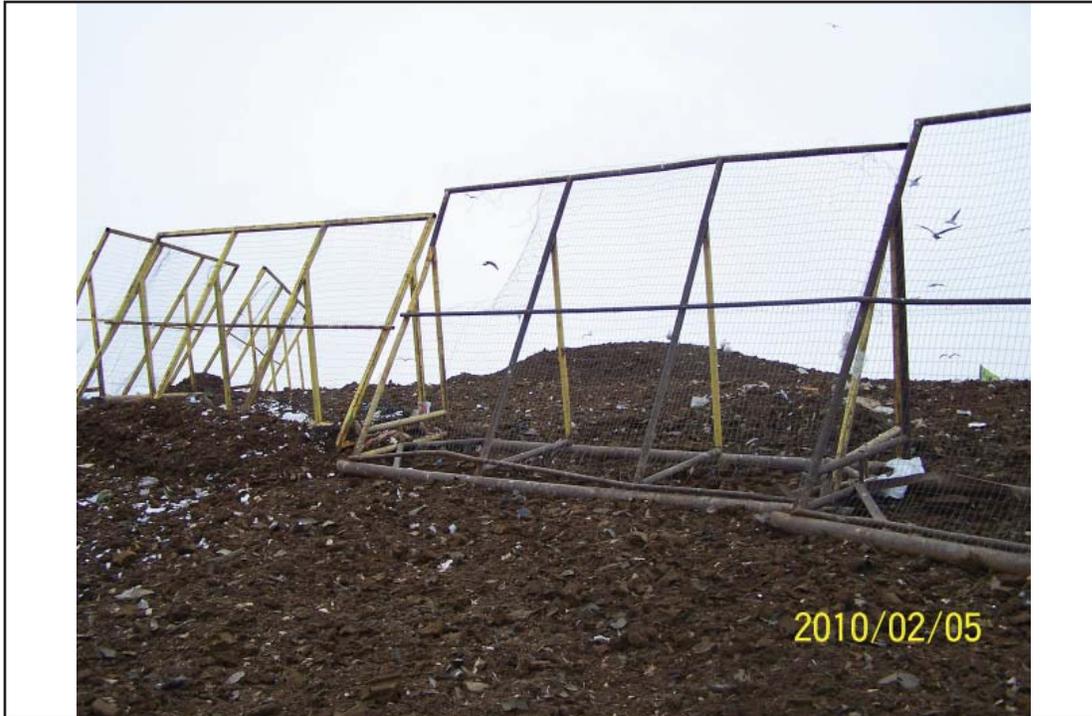
Litter fences cleared of blowing litter

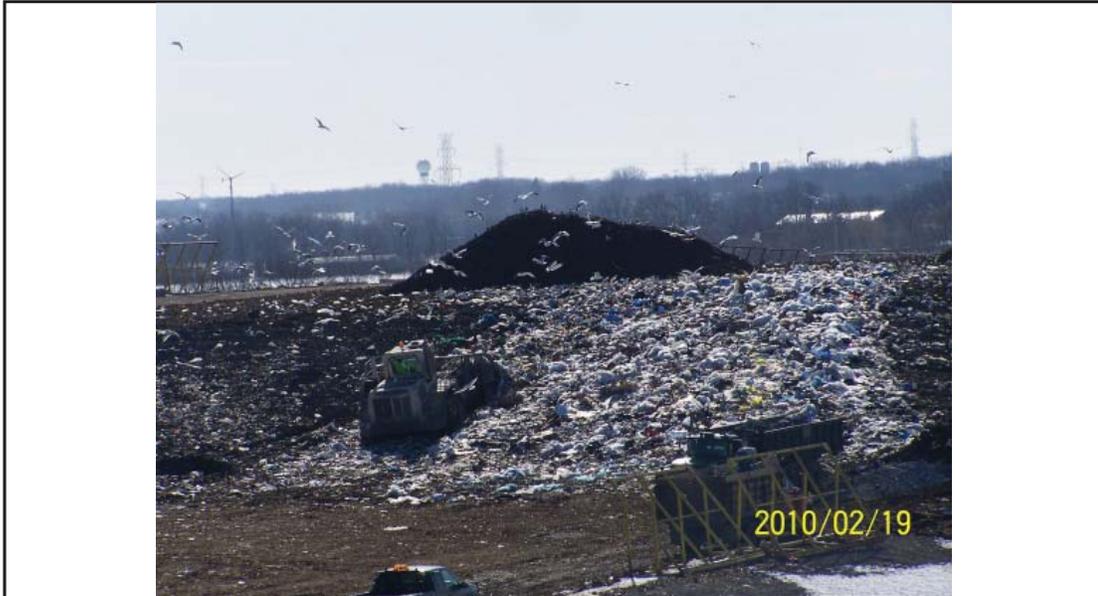
Active area

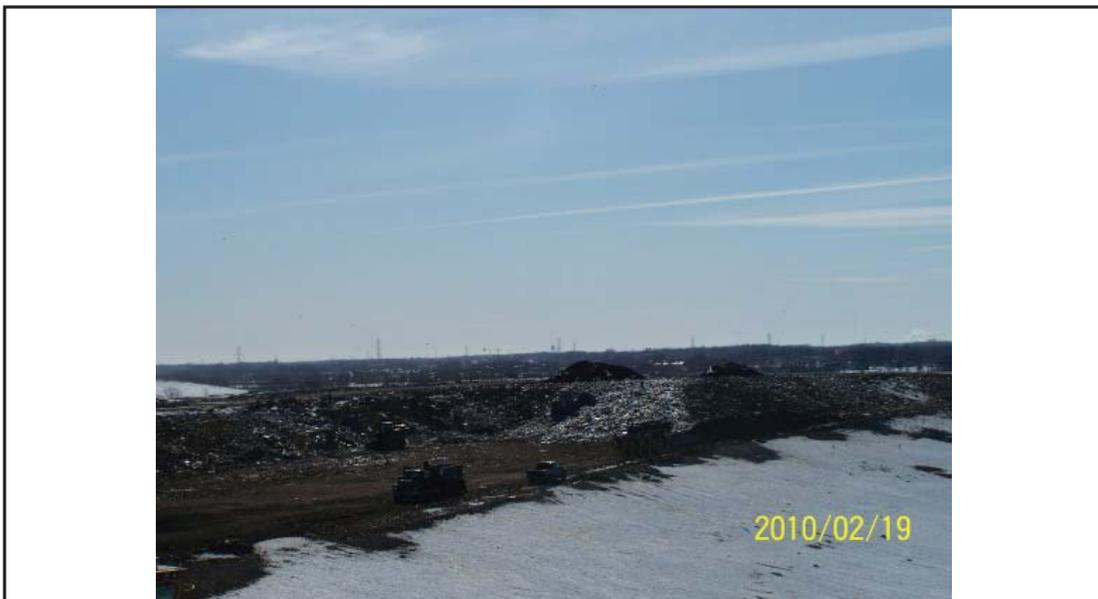
Working Face

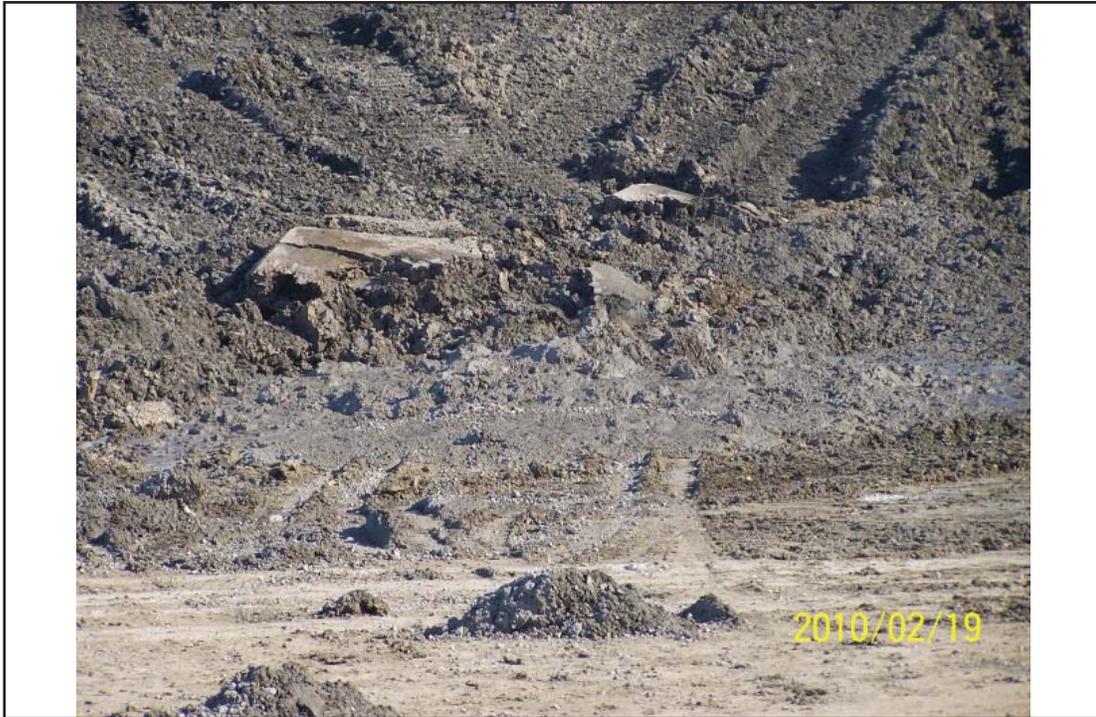
Sloppy load of soils recieved

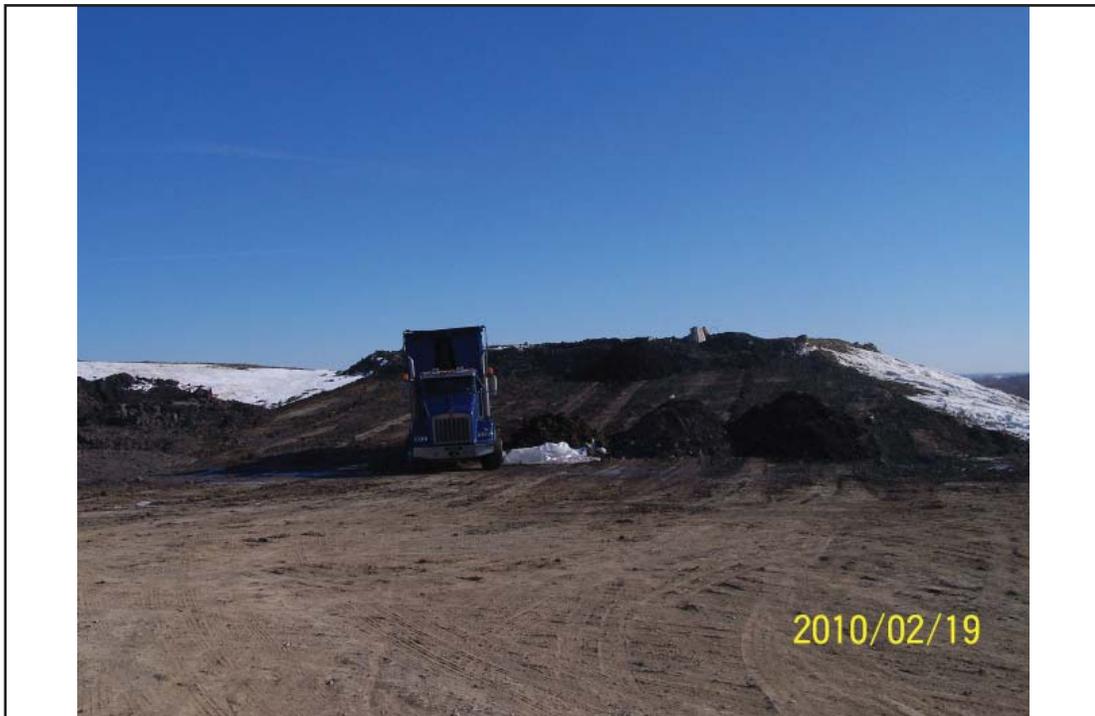
Soils in Phase 2 & 3

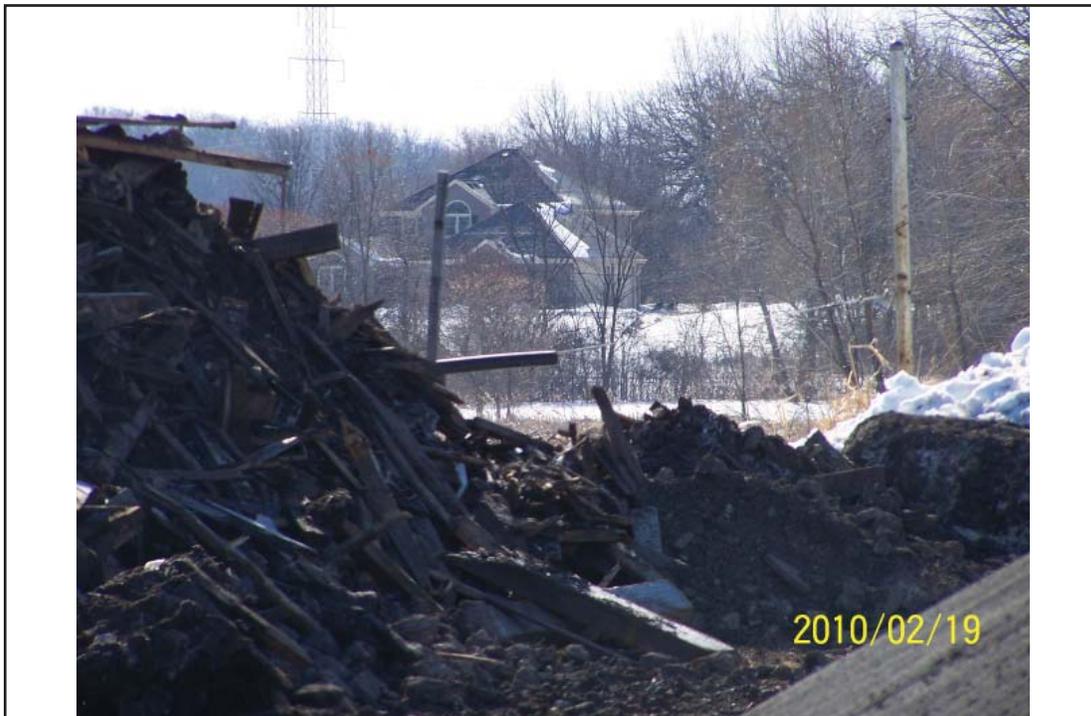
Compost yard secured and gate impassable

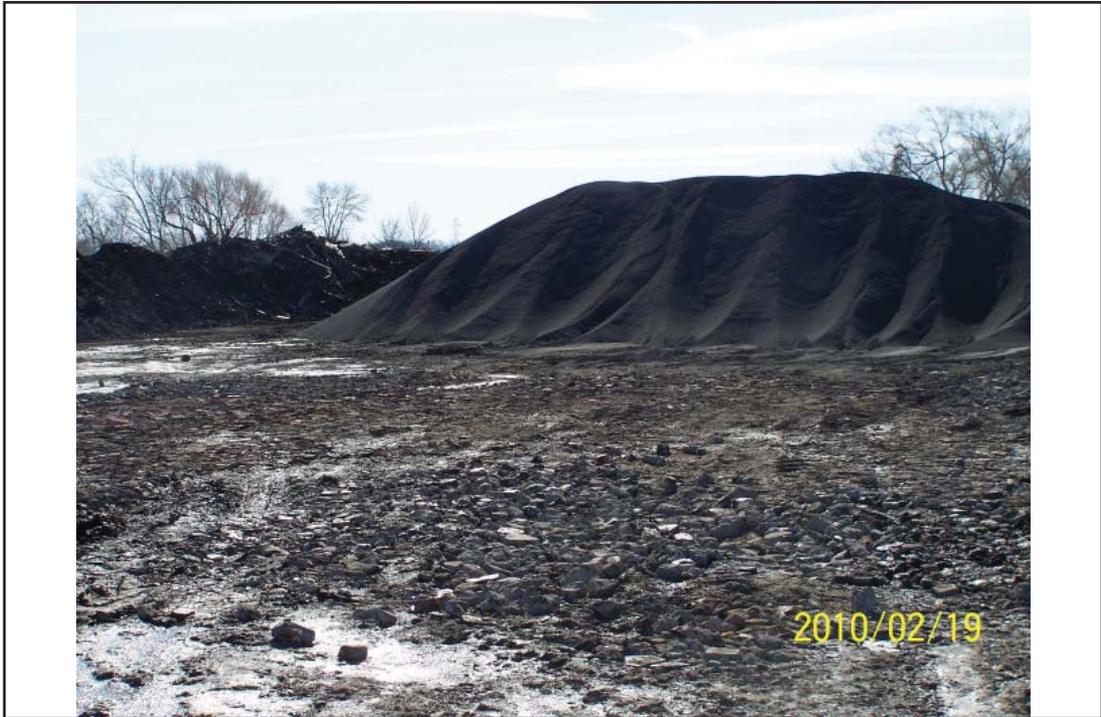
Loads of Milorganite being received in Compost Yard for use on site in spring.

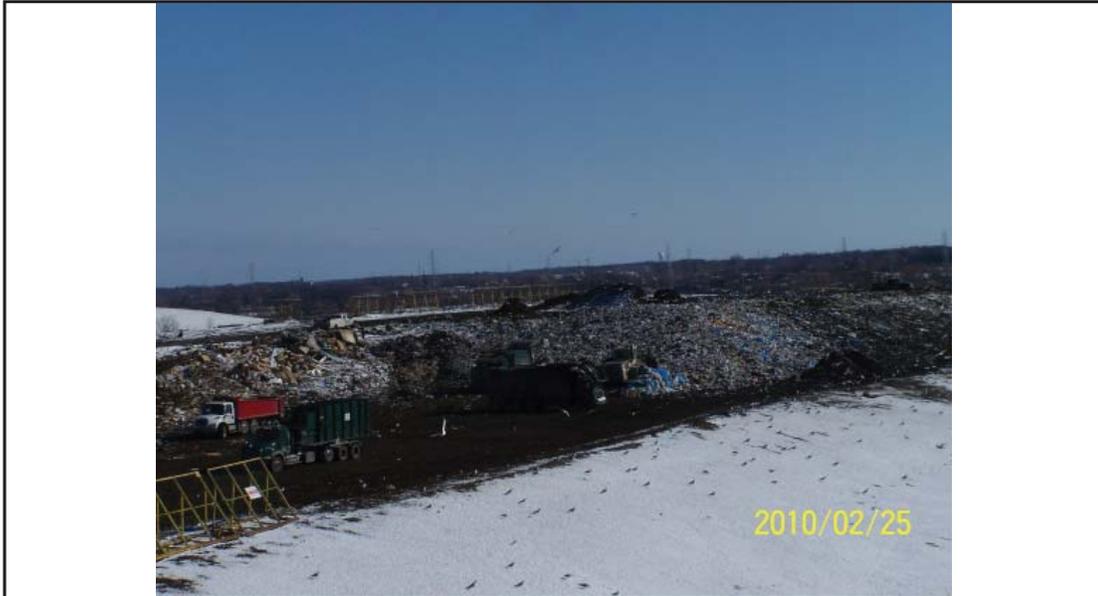
Active area

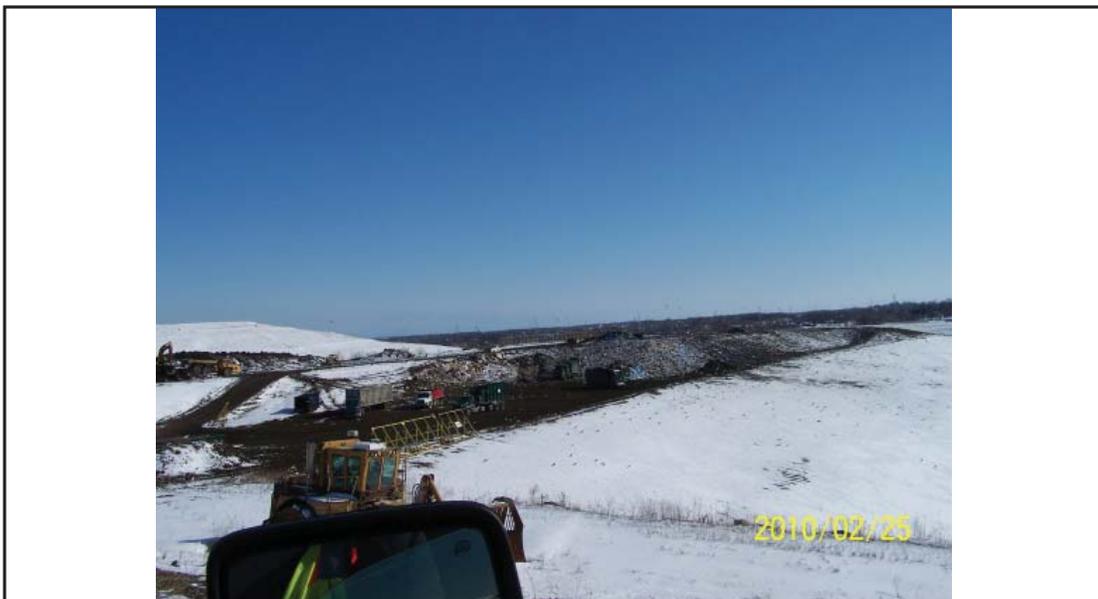
Working Face

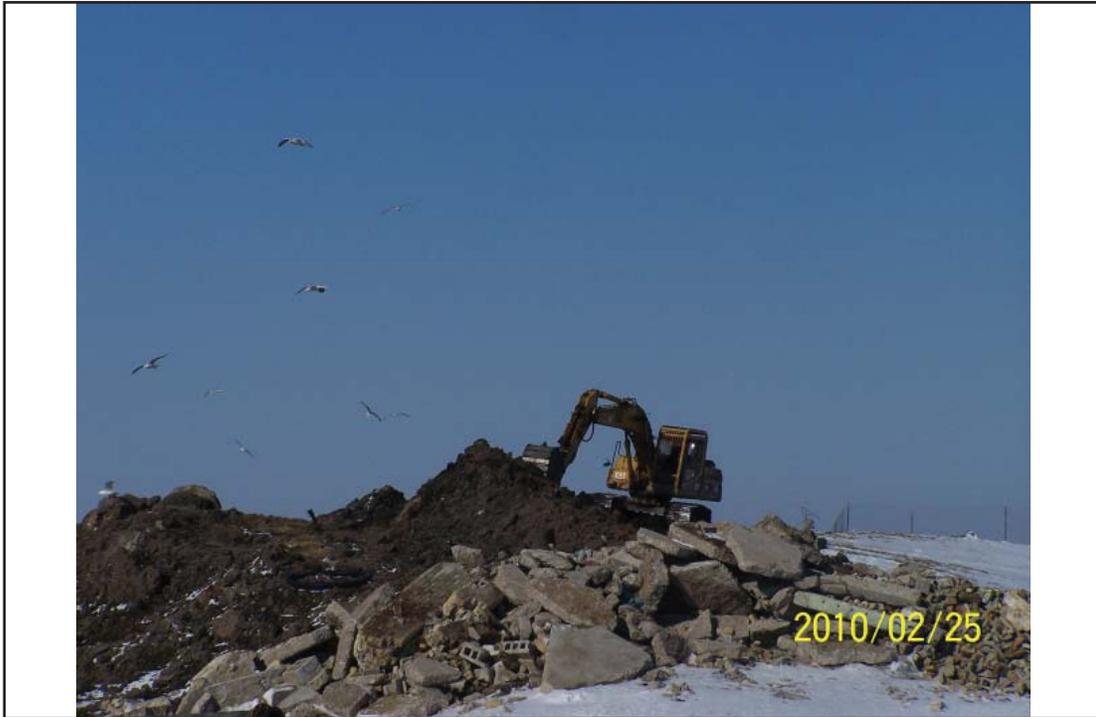
Digging trench in old Bio soils pile on Phase 5

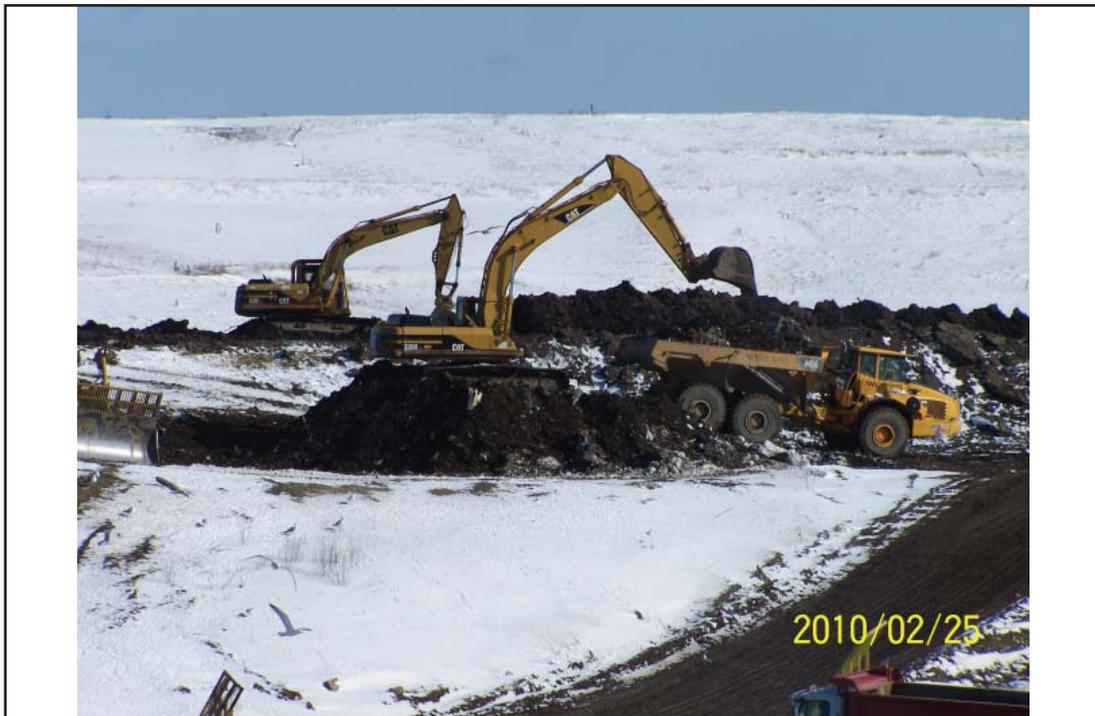
Trench in old bio soils pile

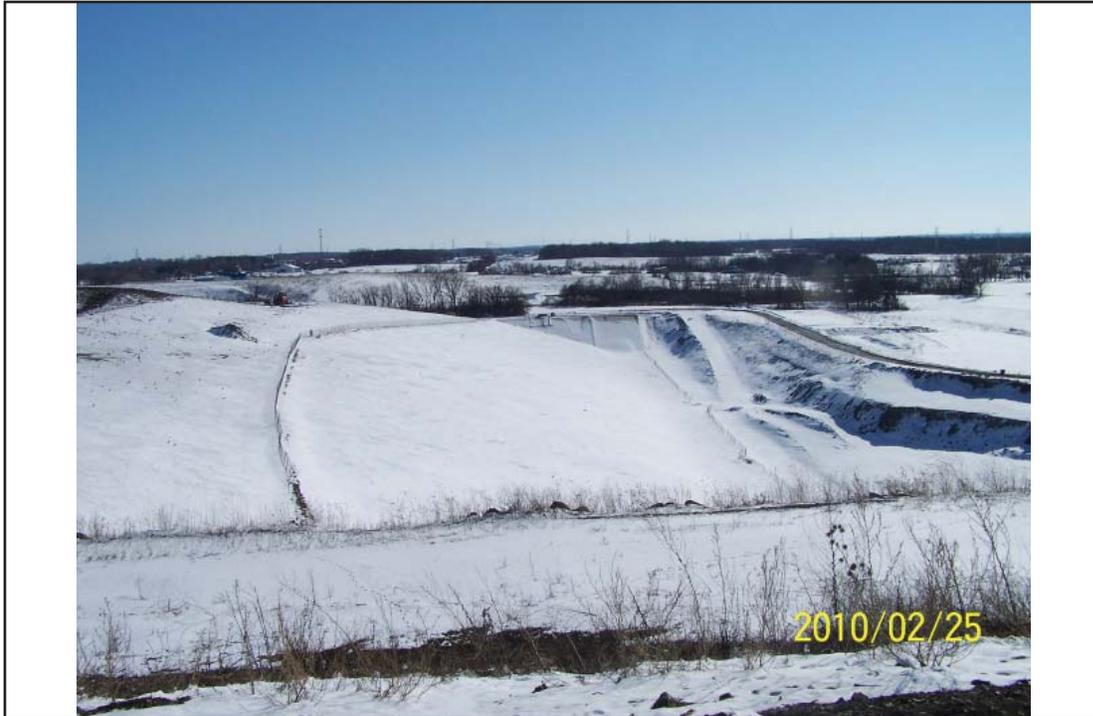
Site snow covered again.

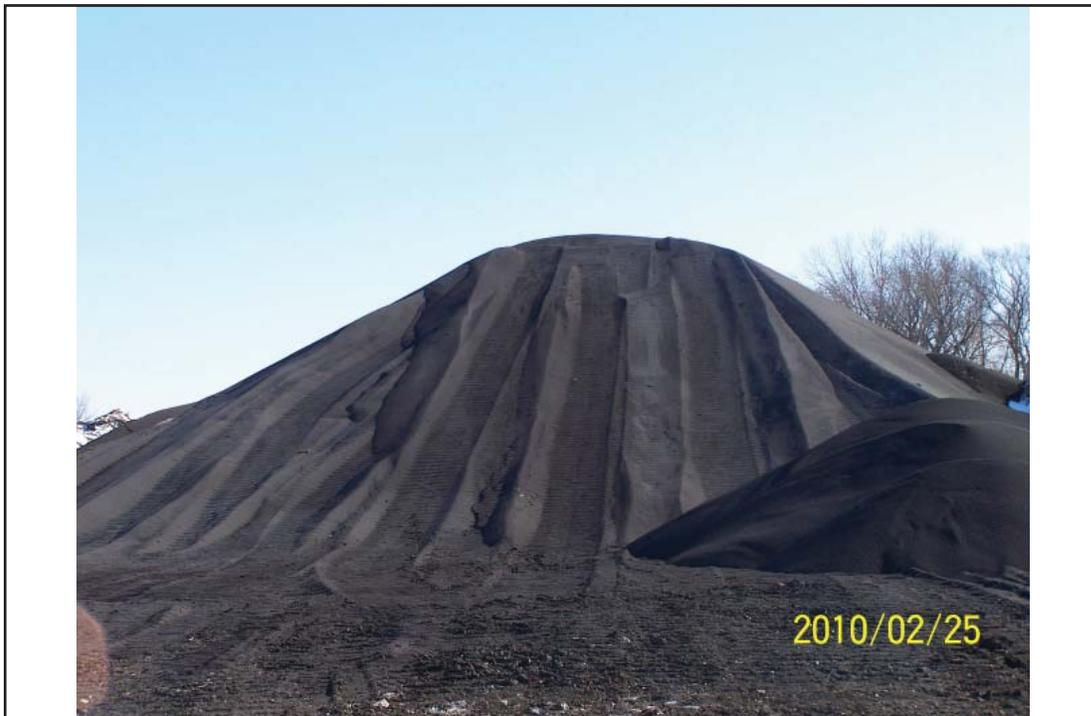
Milorganite loads delivered to compost yard

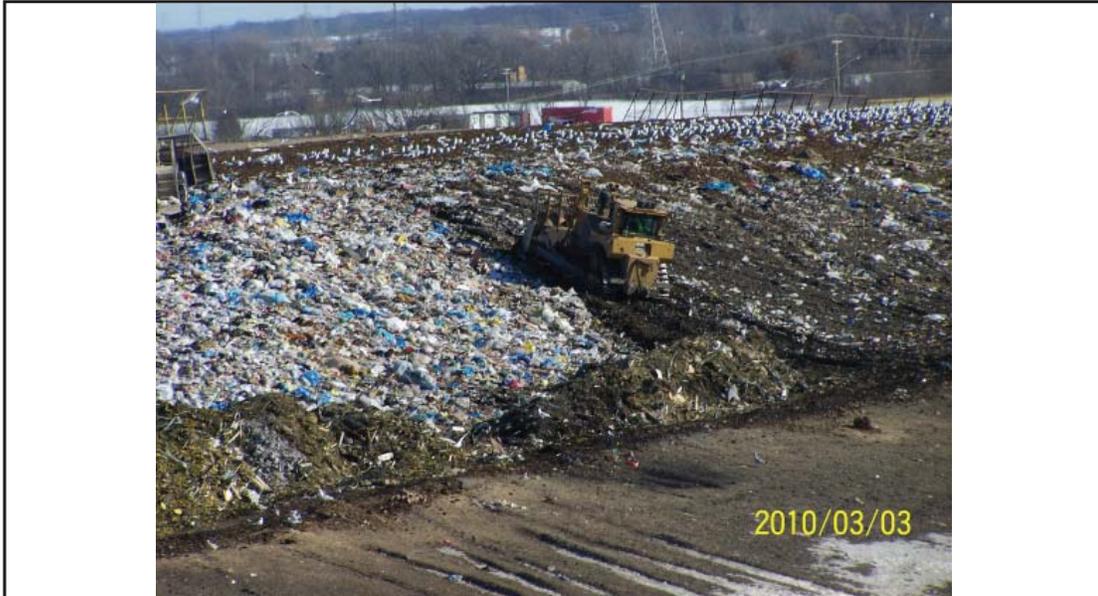
Active area

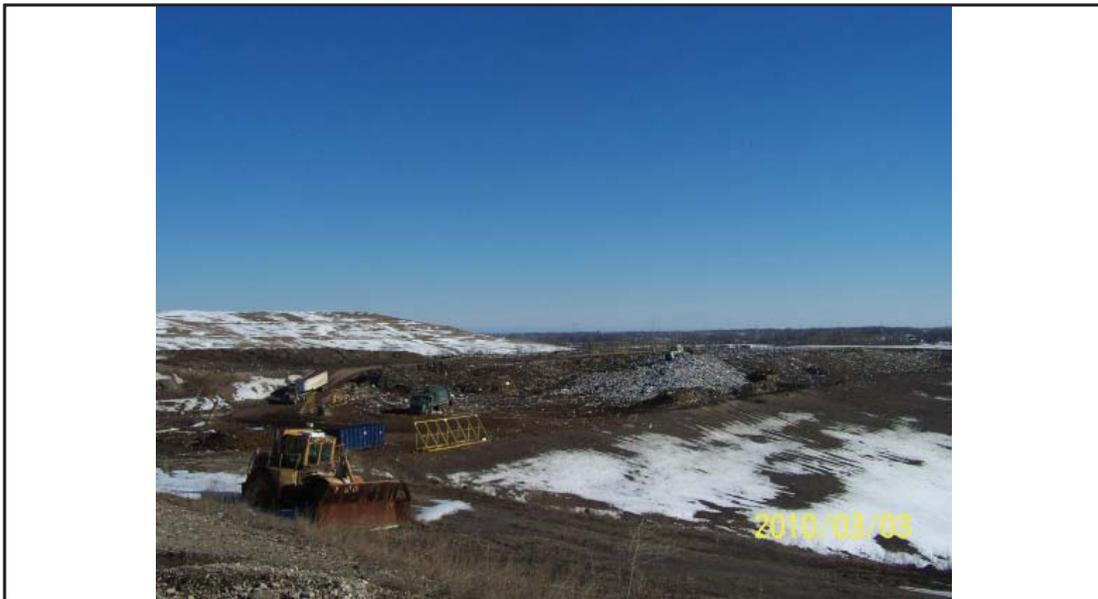
Working Face

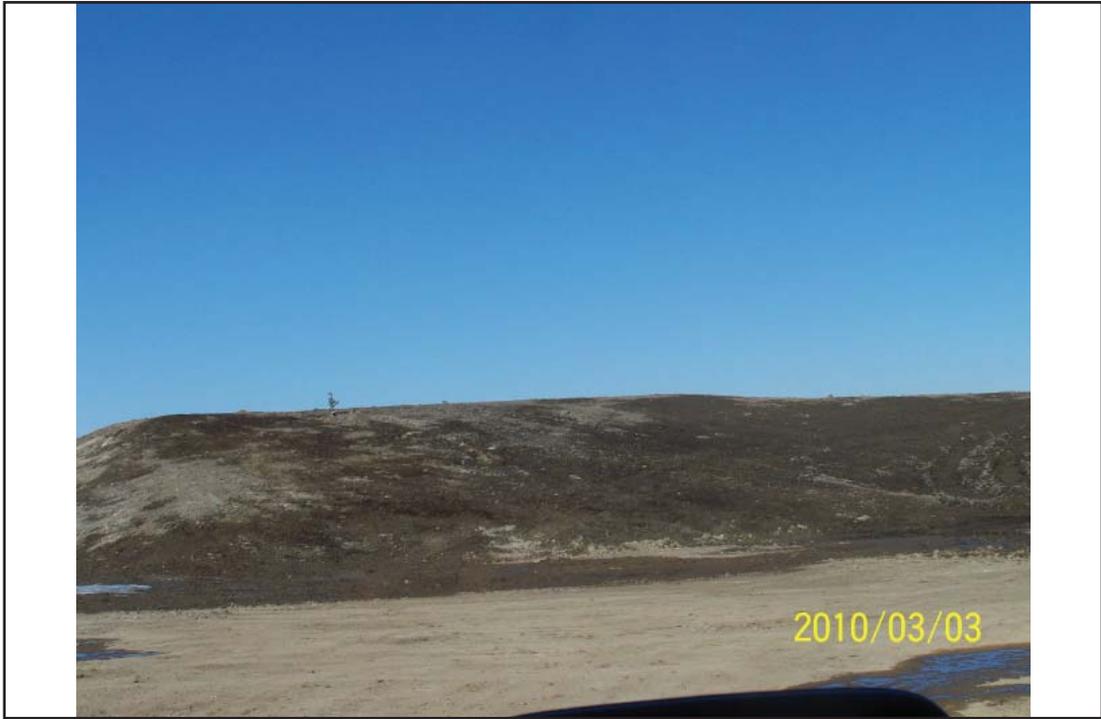
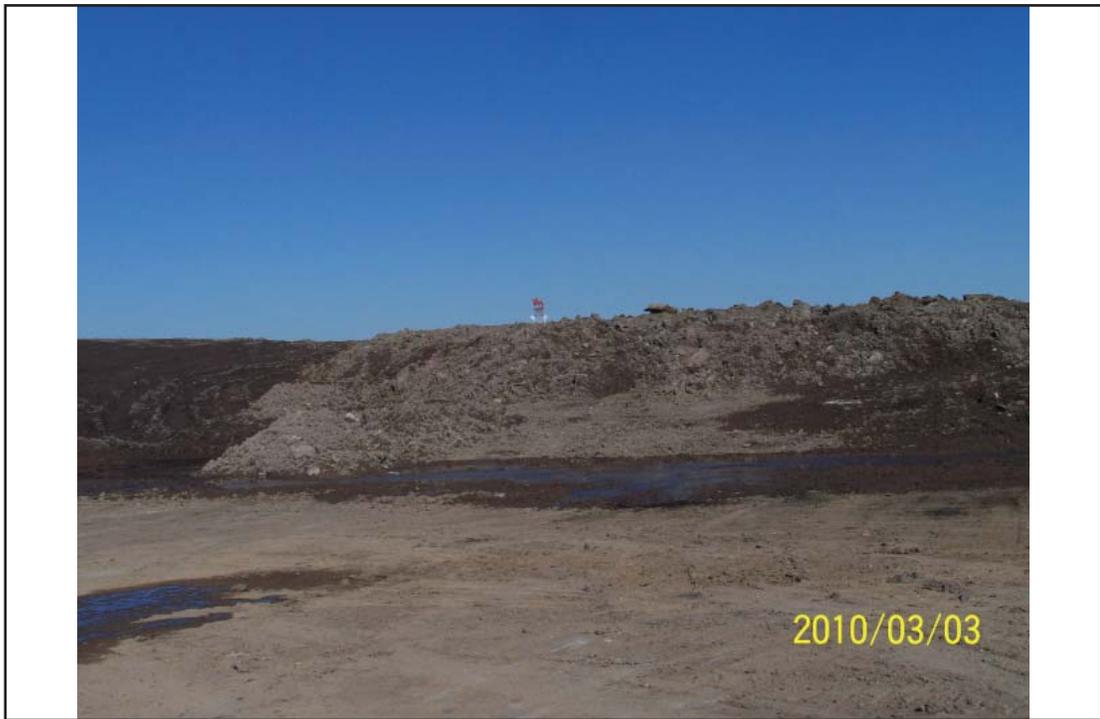
Soils delivered in Phase 2 and 3

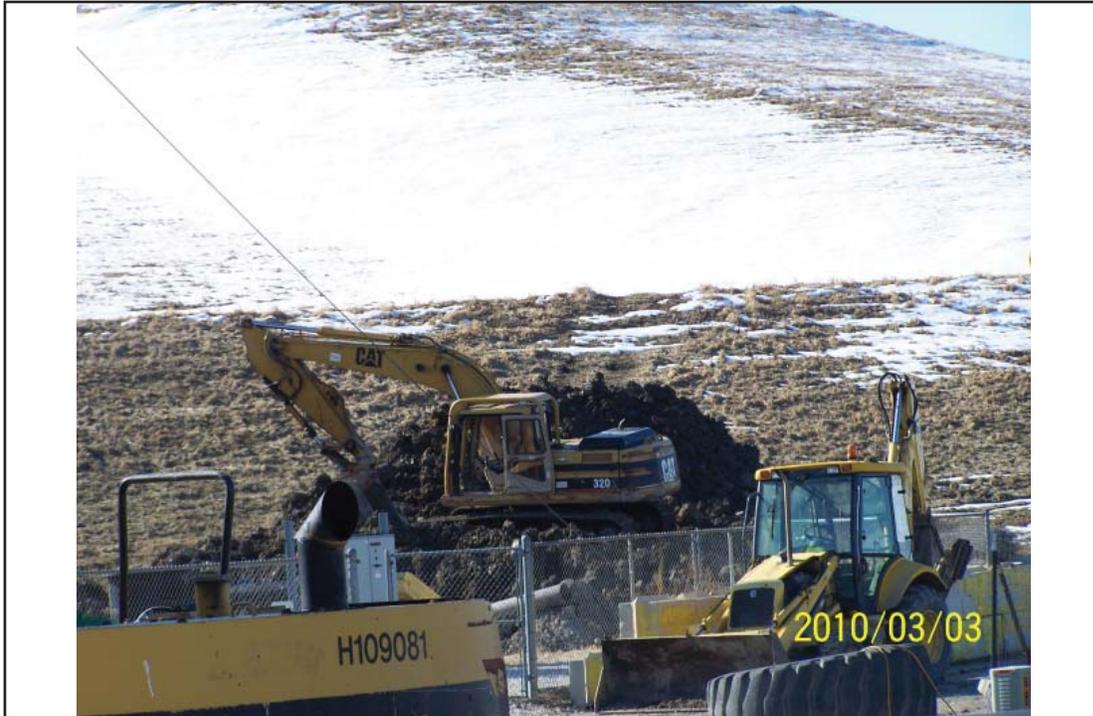
Header work

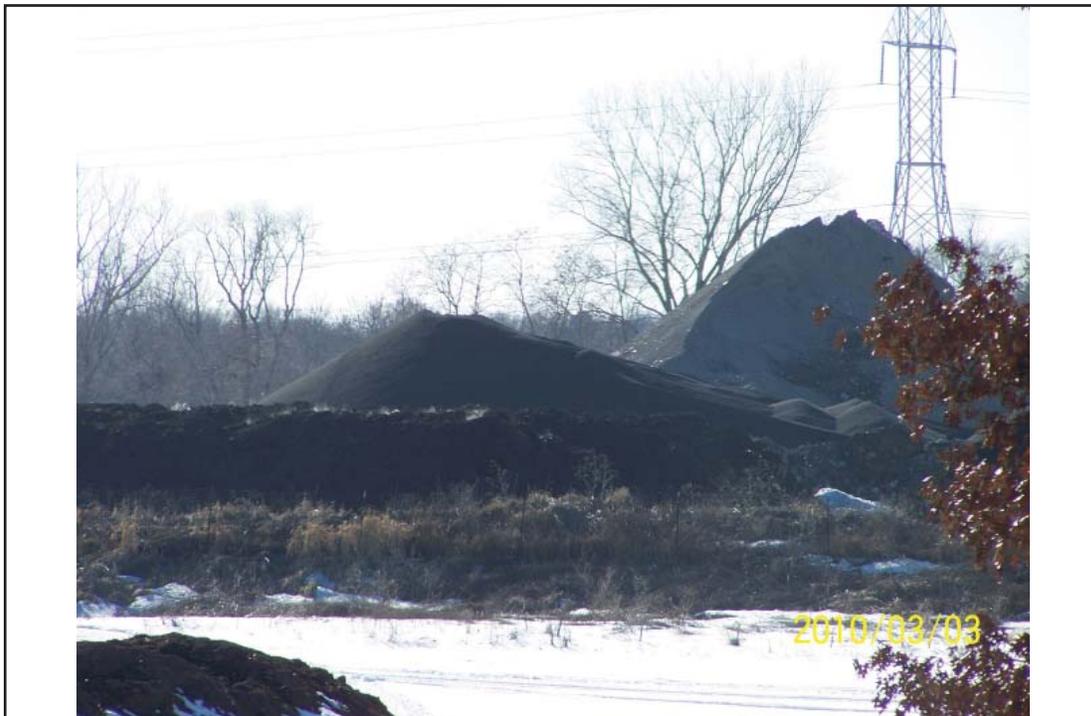
Milorganite loads delivered to compost yard

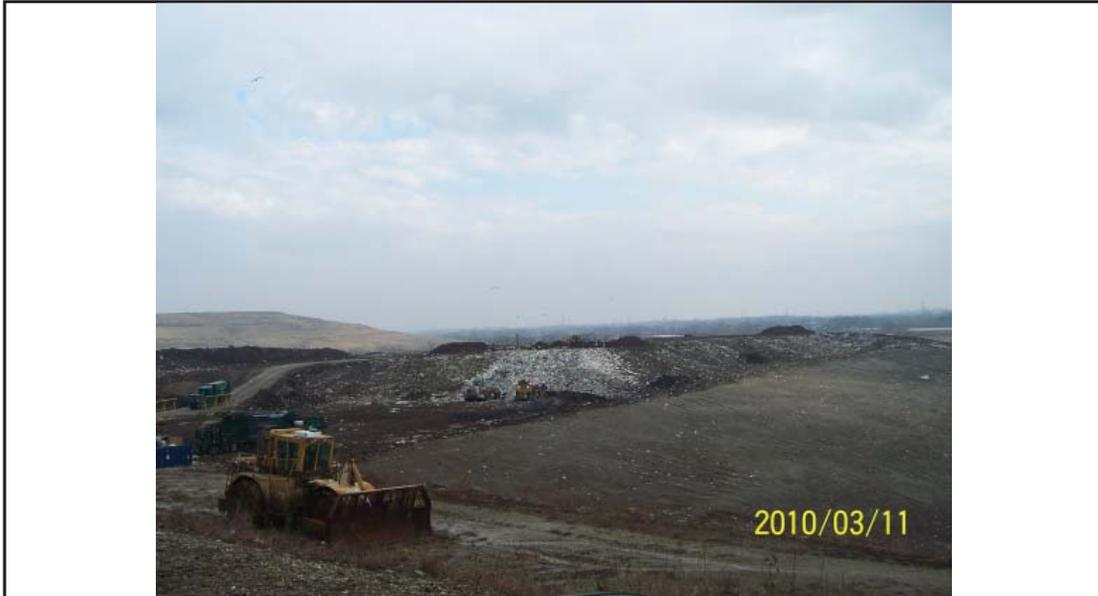
Active area

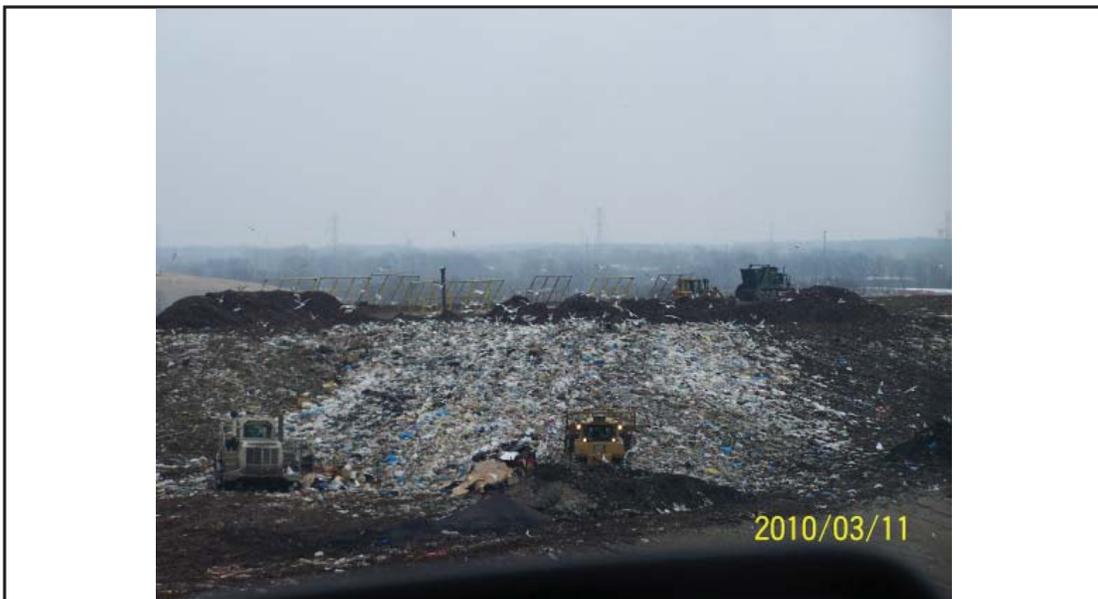
Working Face

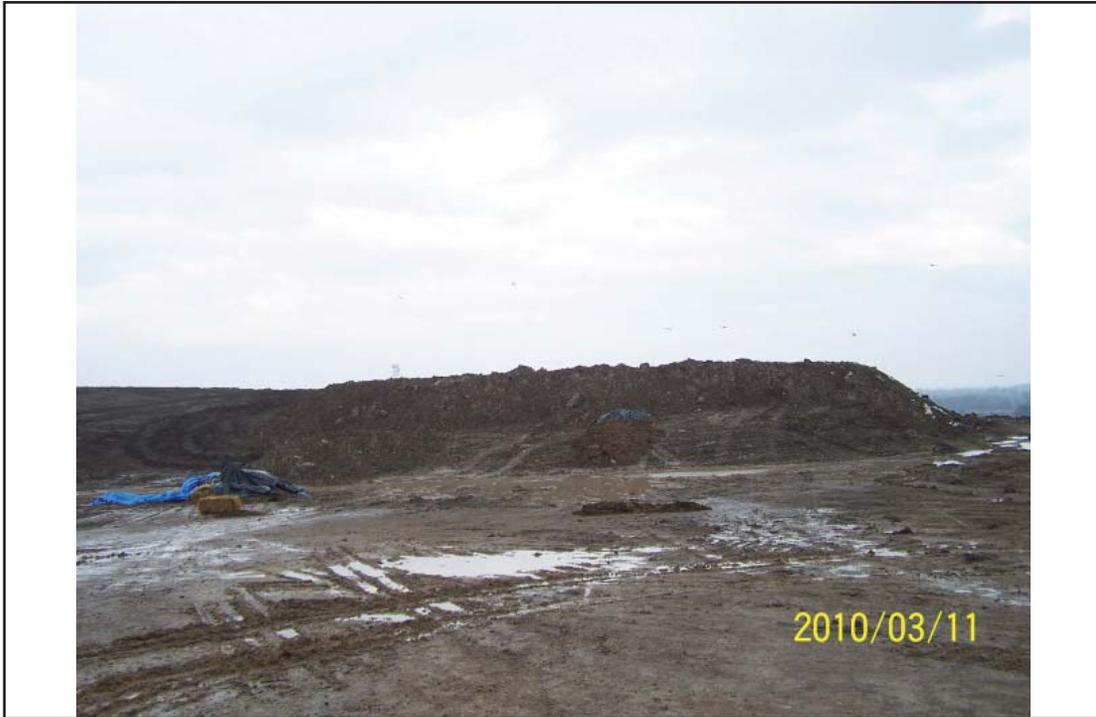
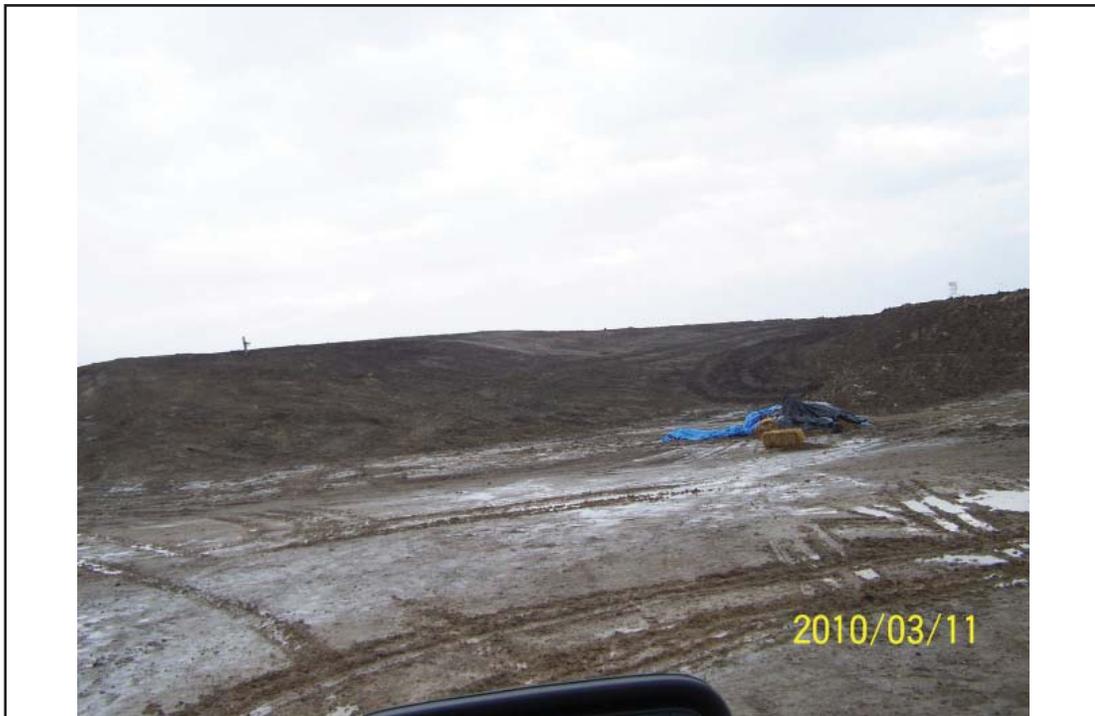
Soils delivered in Phase 2 and 3

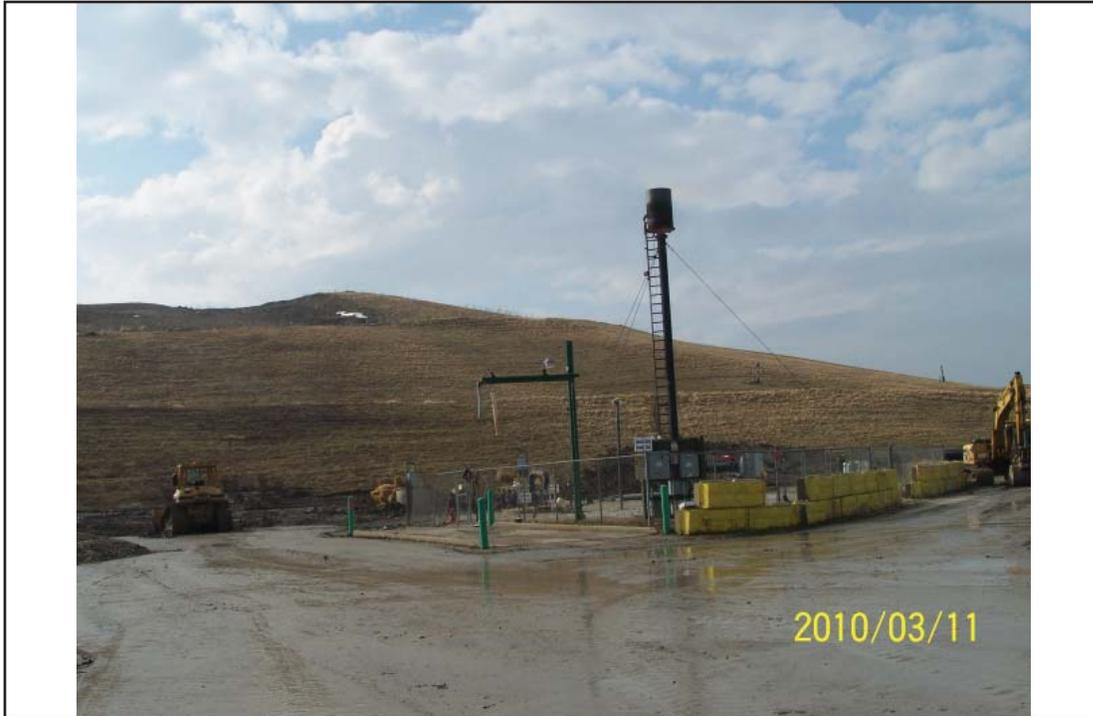
Header work
