VEOLIA EMERALD PARK LANDFILL  
CITY OF MUSKEGO

## 2010 Veolia Emerald Park Landfill Year End Compliance Officer Report and Audit Summary

**TO:** Veolia Emerald Park Standing Committee  
**FROM:** Jo-Walter Spear, Jr., P.E.  
**COPIES:** File  
**DATE:** 01/20/11  
**PROJECT NUMBER:** 1012

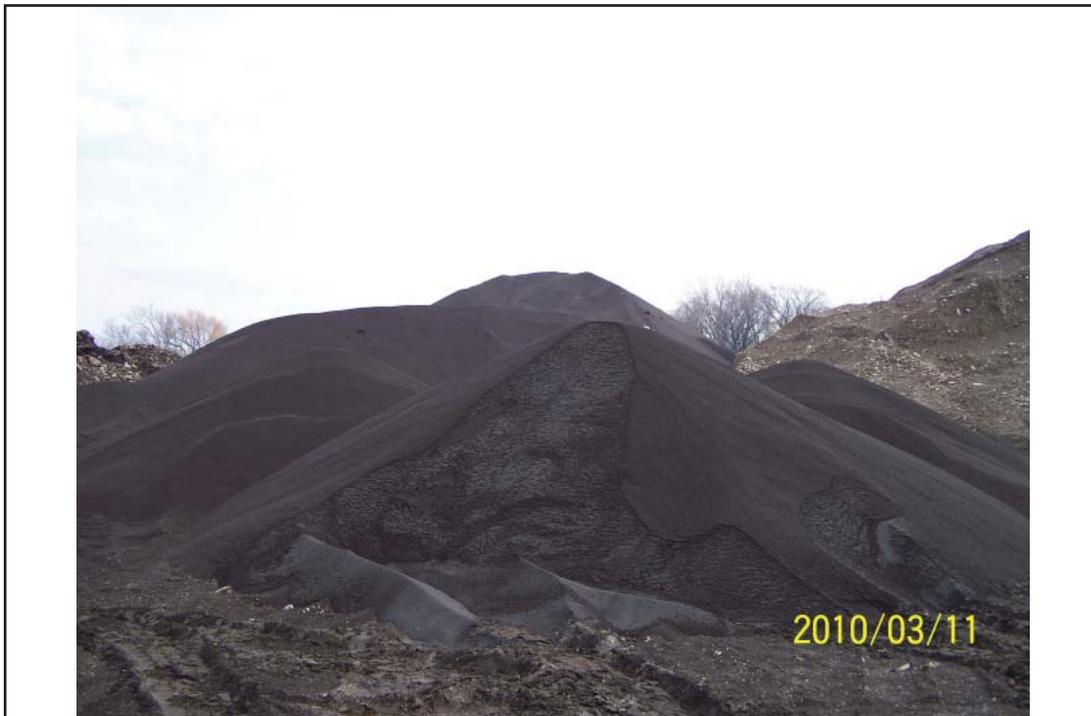
Milorganite loads delivered to compost yard

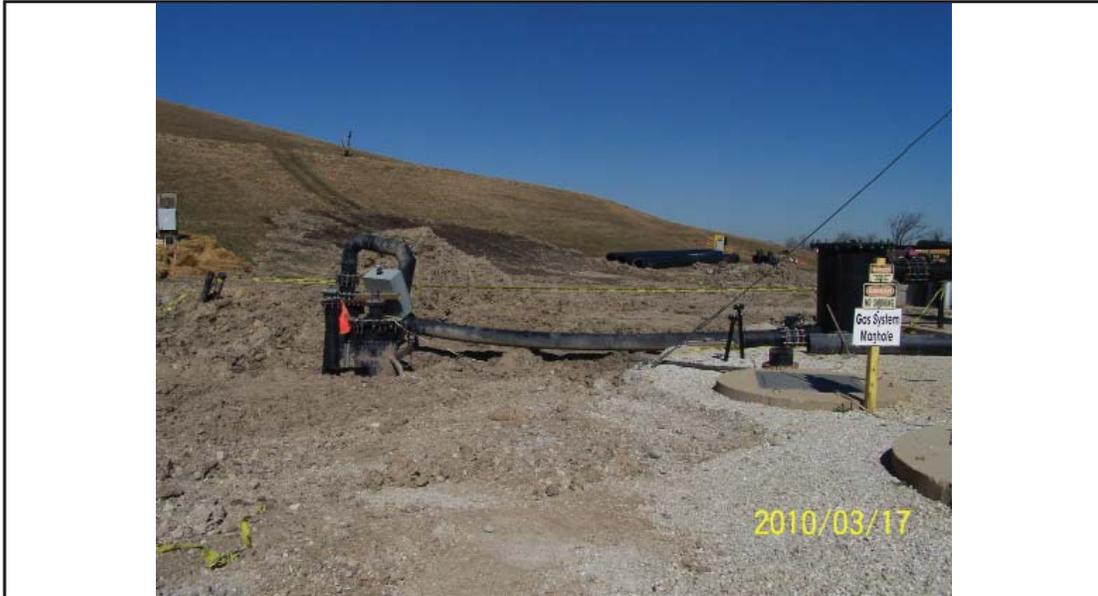
Connection to flare awaiting back fill

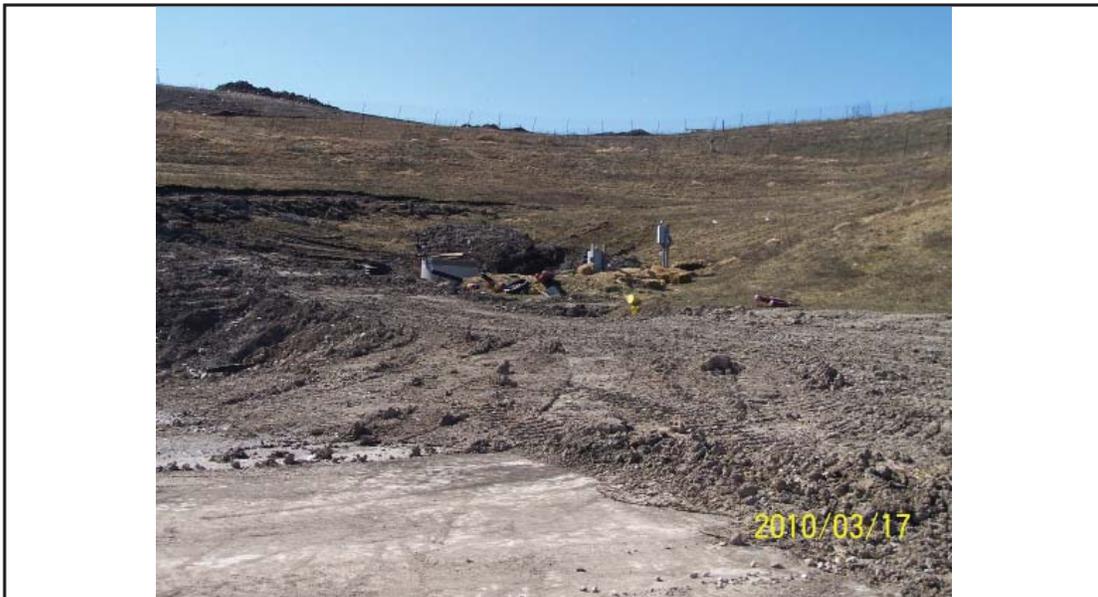
Header area backfilled

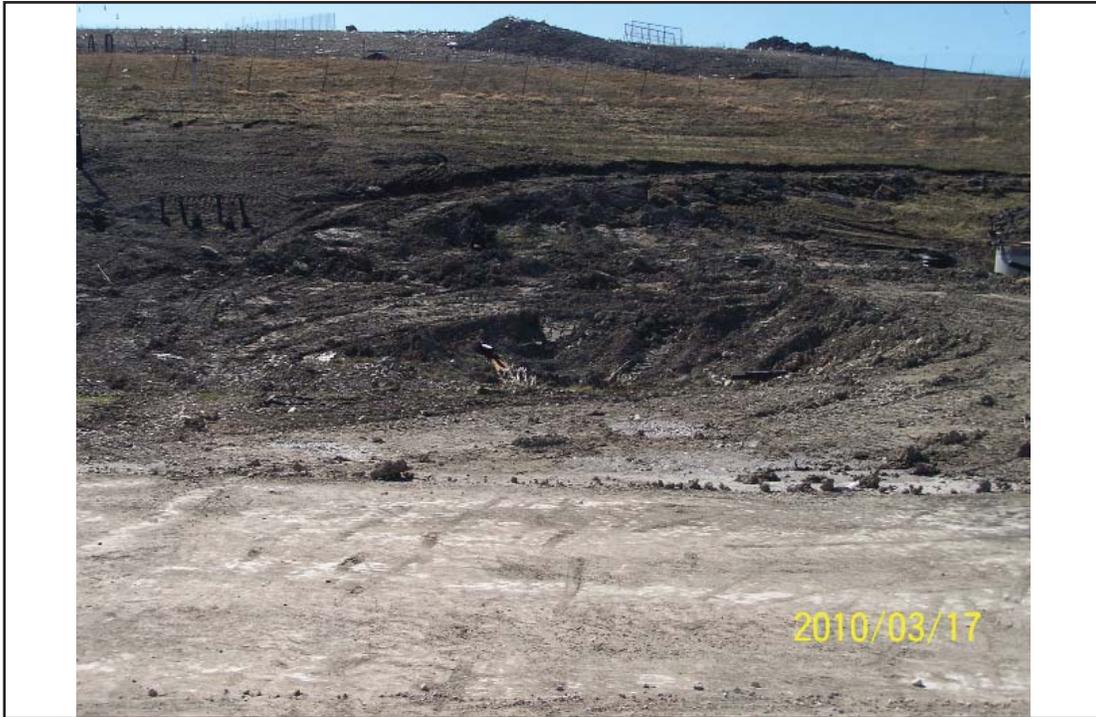
Backfilled area at Phase 3&4, grading, topsoil placement, and seeding to be done

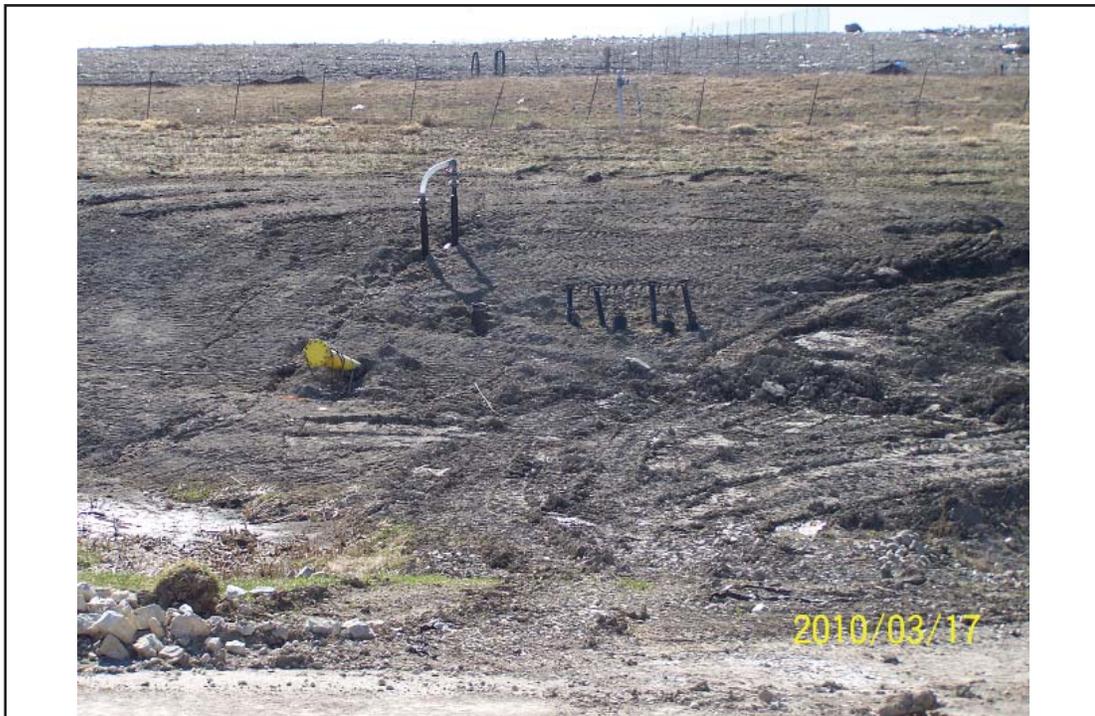
Phase 4 slope

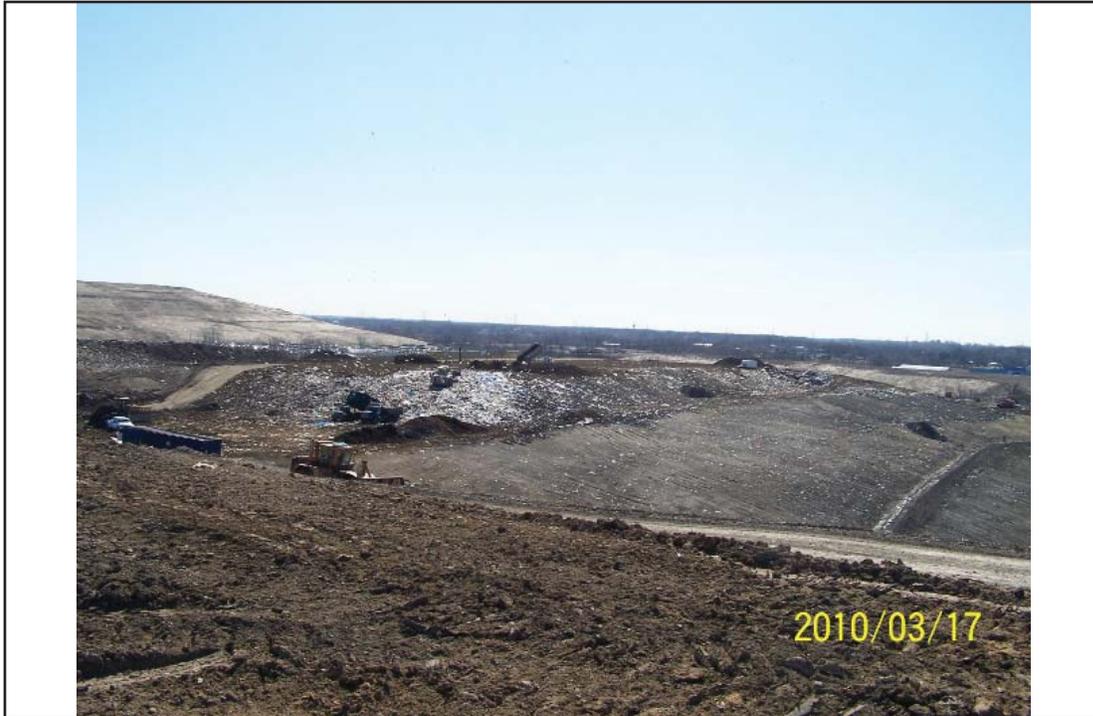
Active Area

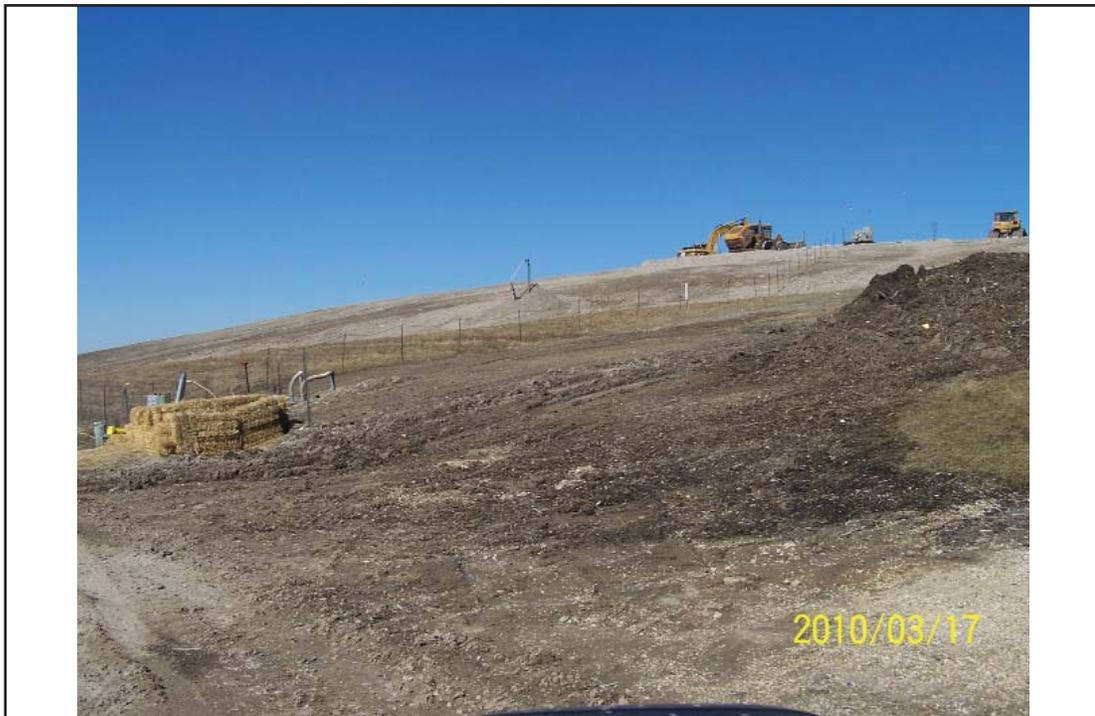
South end of Phase 6E/6W to be recovered this summer

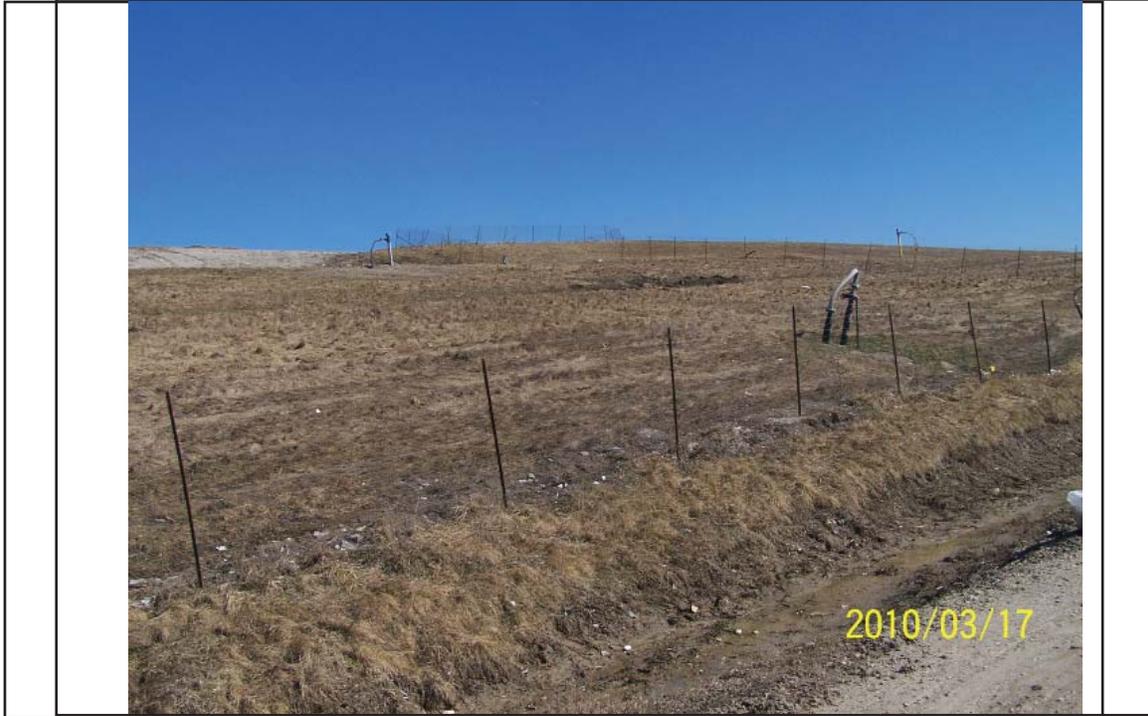
South end of Phase 5/6E to be recovered this summer

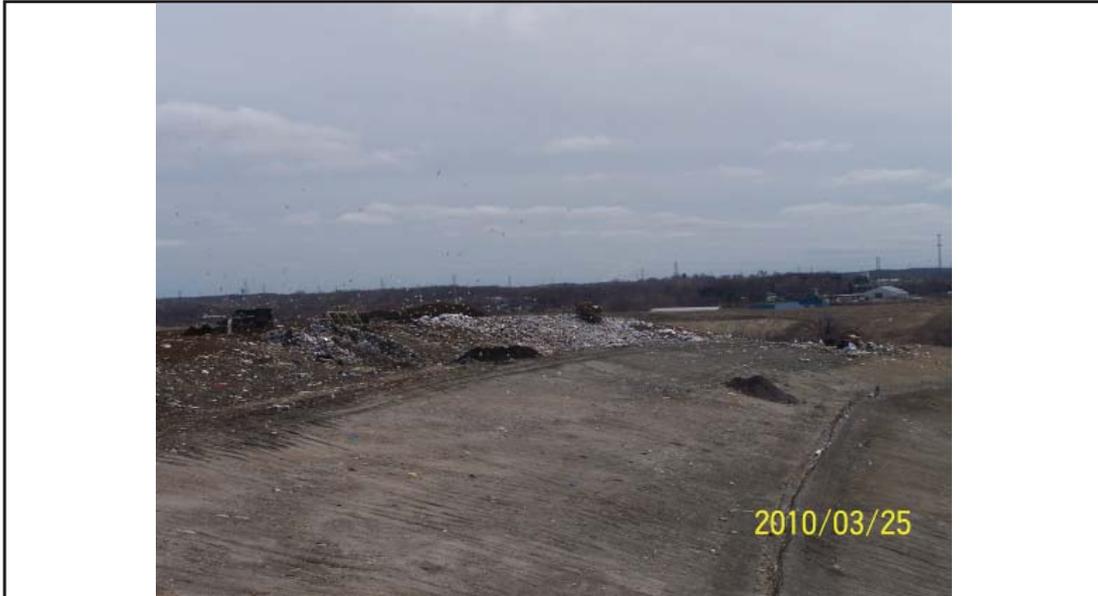
Active area

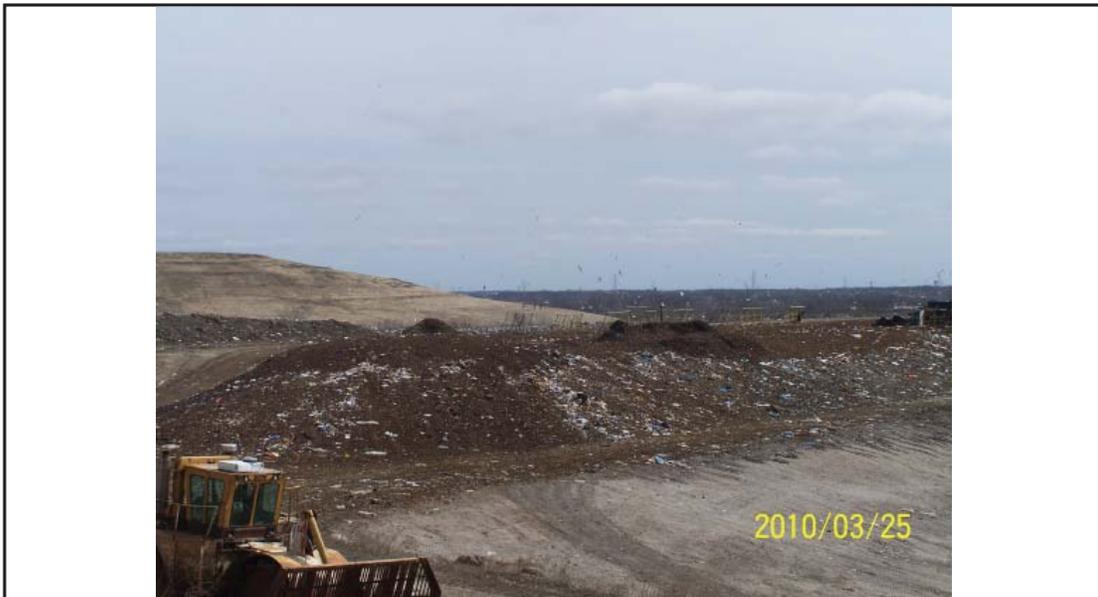
Working Face

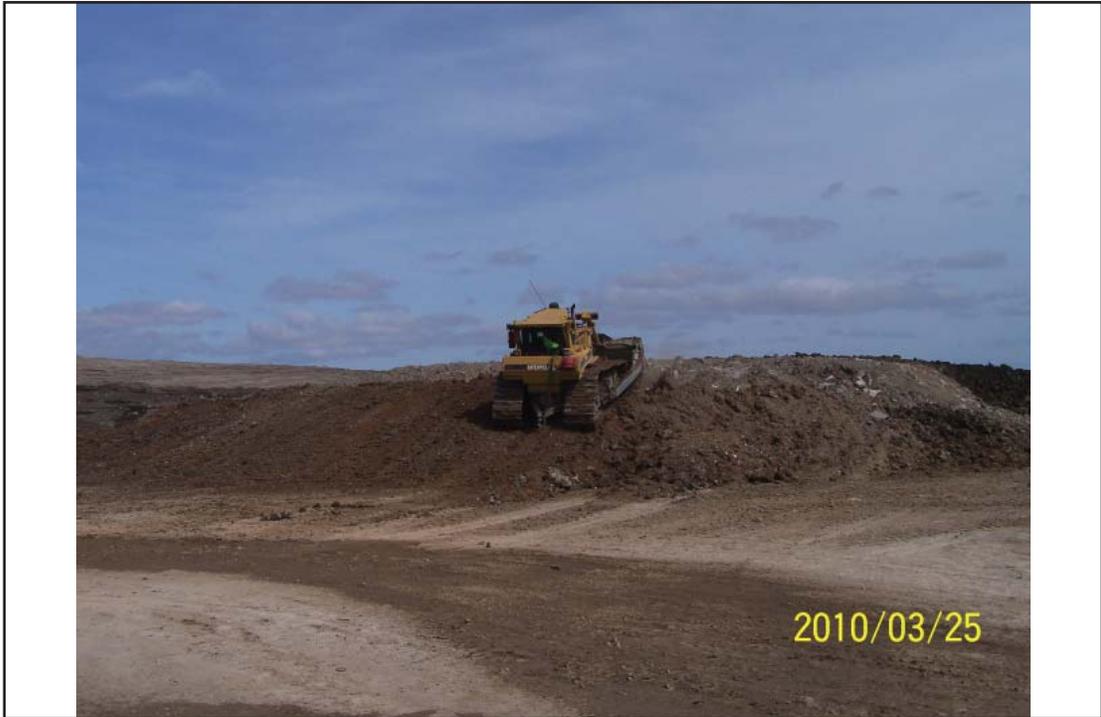
Soils in Phase 2 and 3 being moved for testing

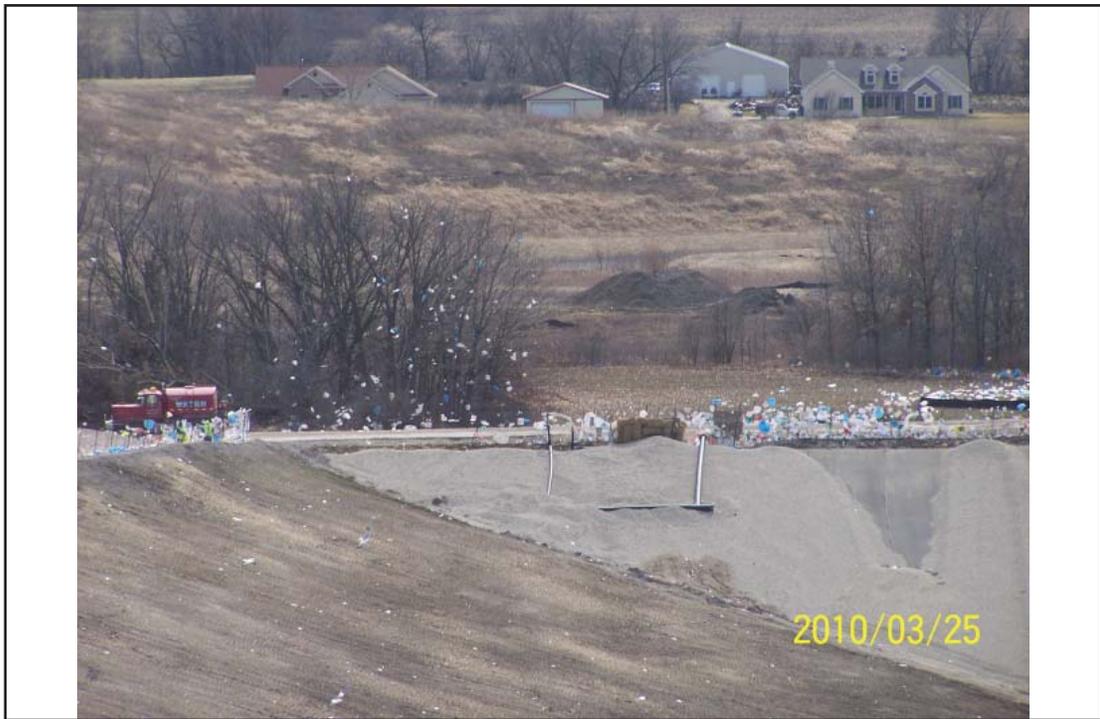
Litter extremely high due to strong winds

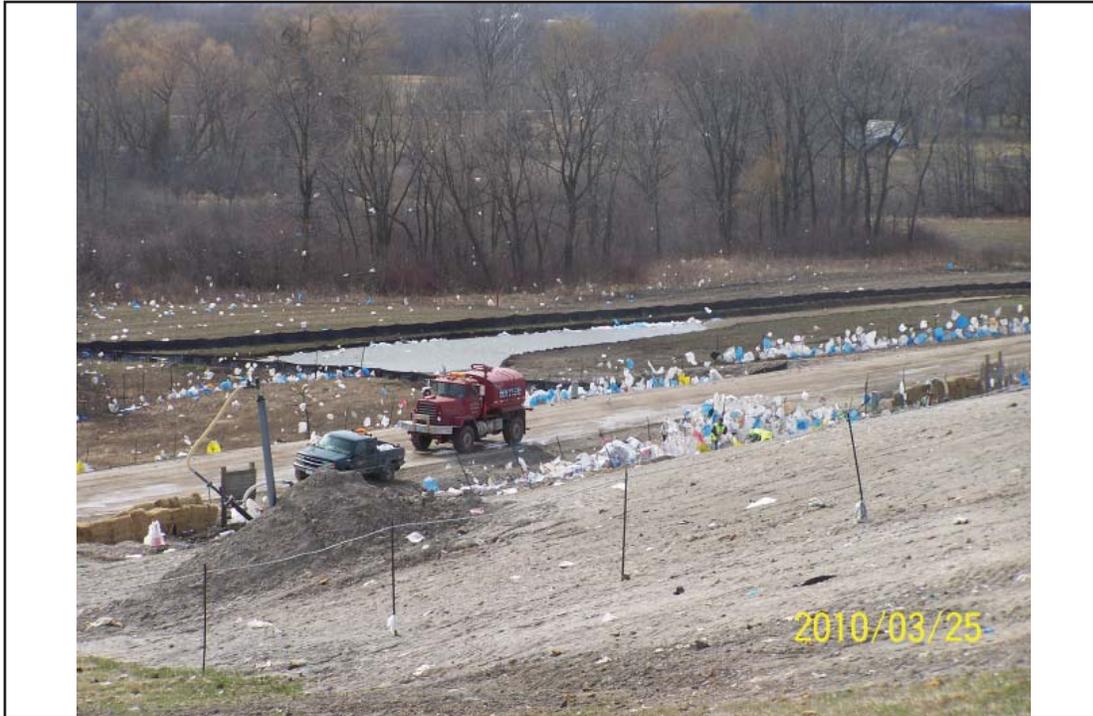
Header work

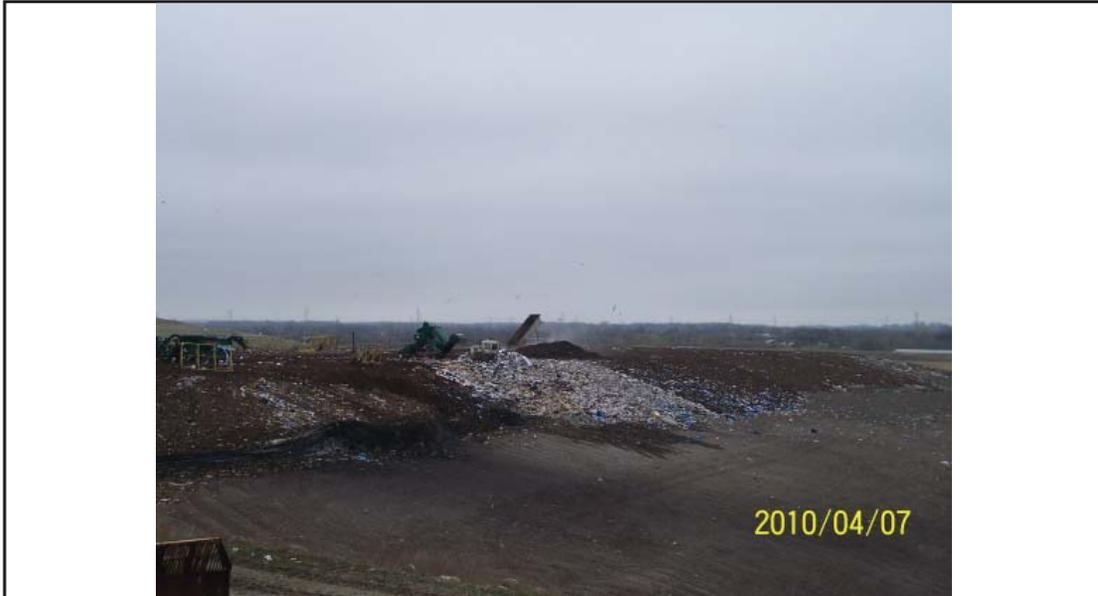
Working Face

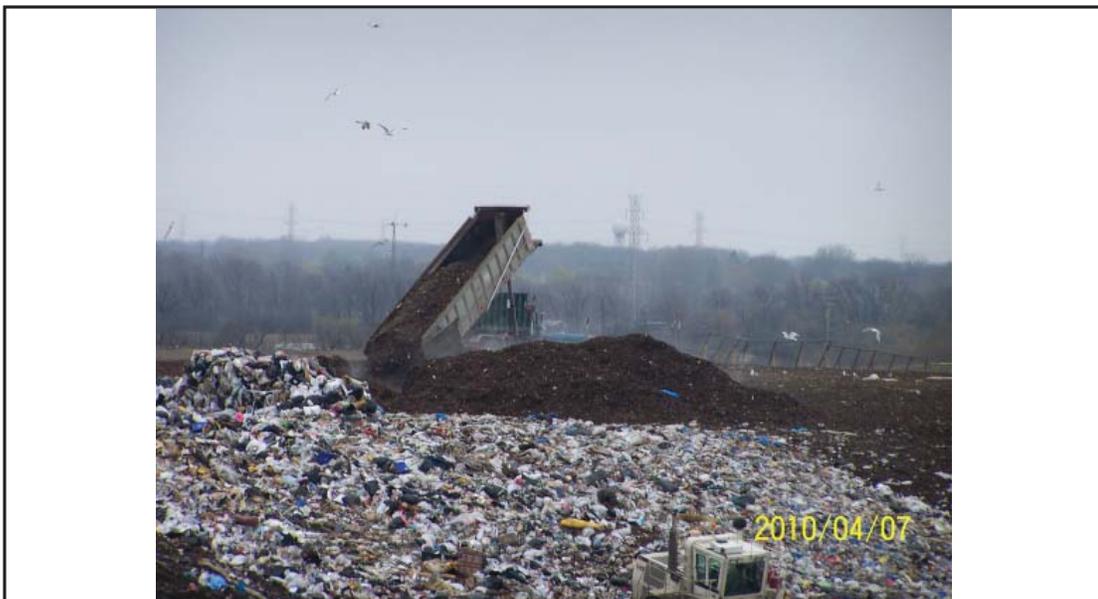
Active area

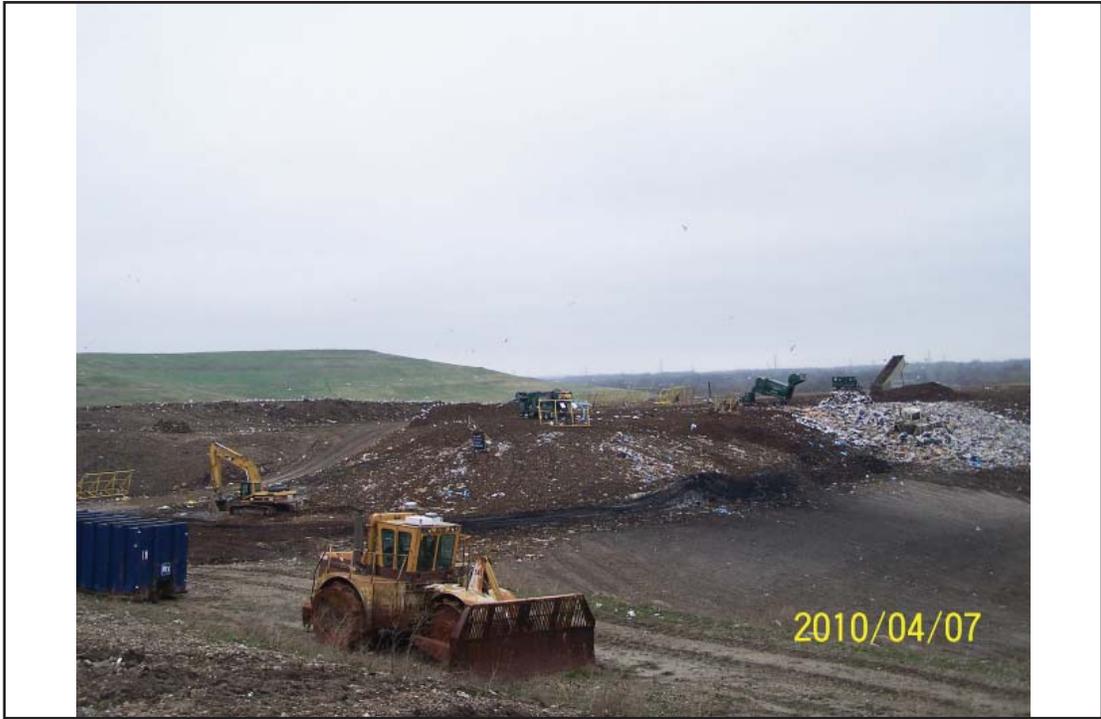
Working Face

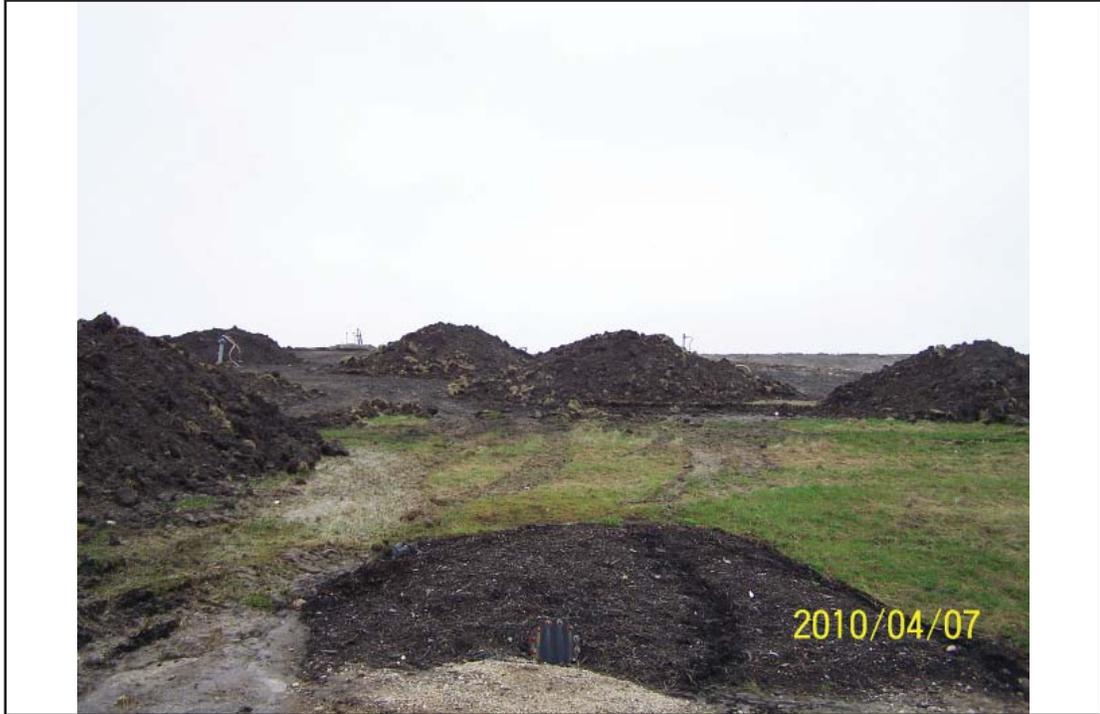
Soils

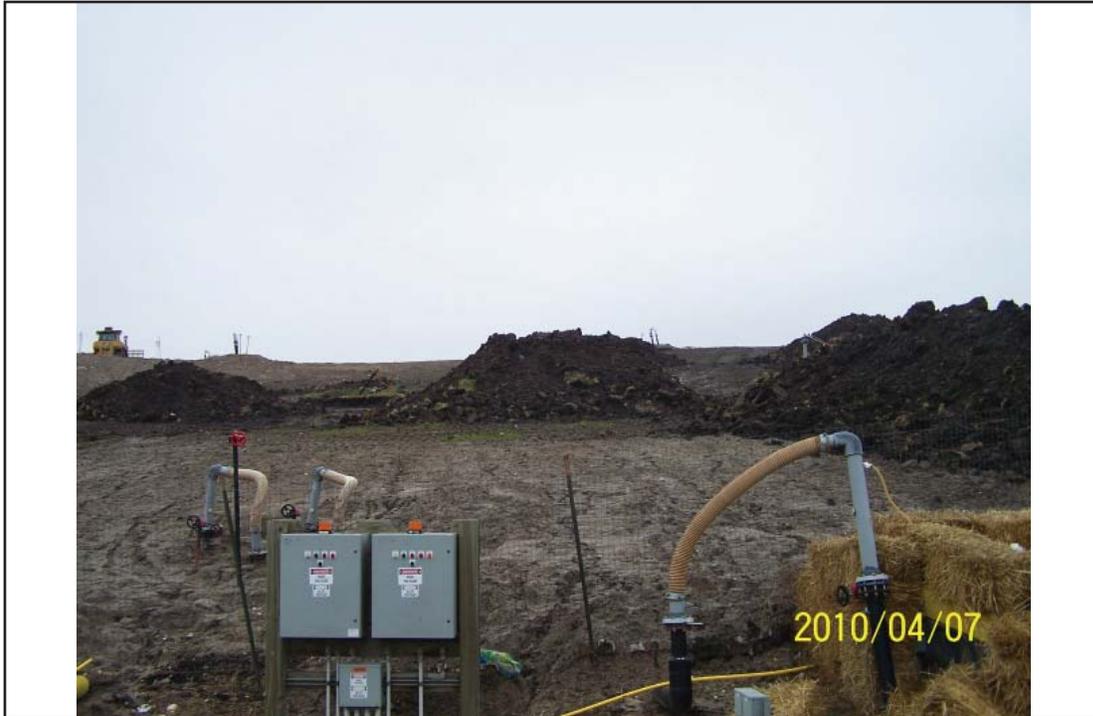
Header work

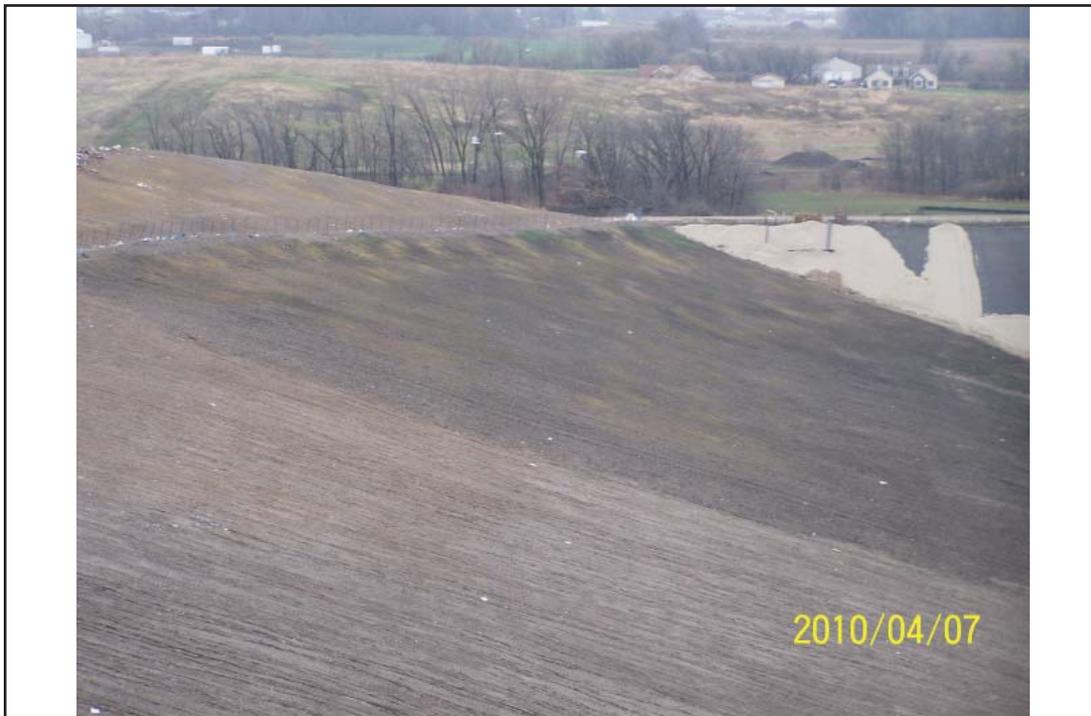
West Slope

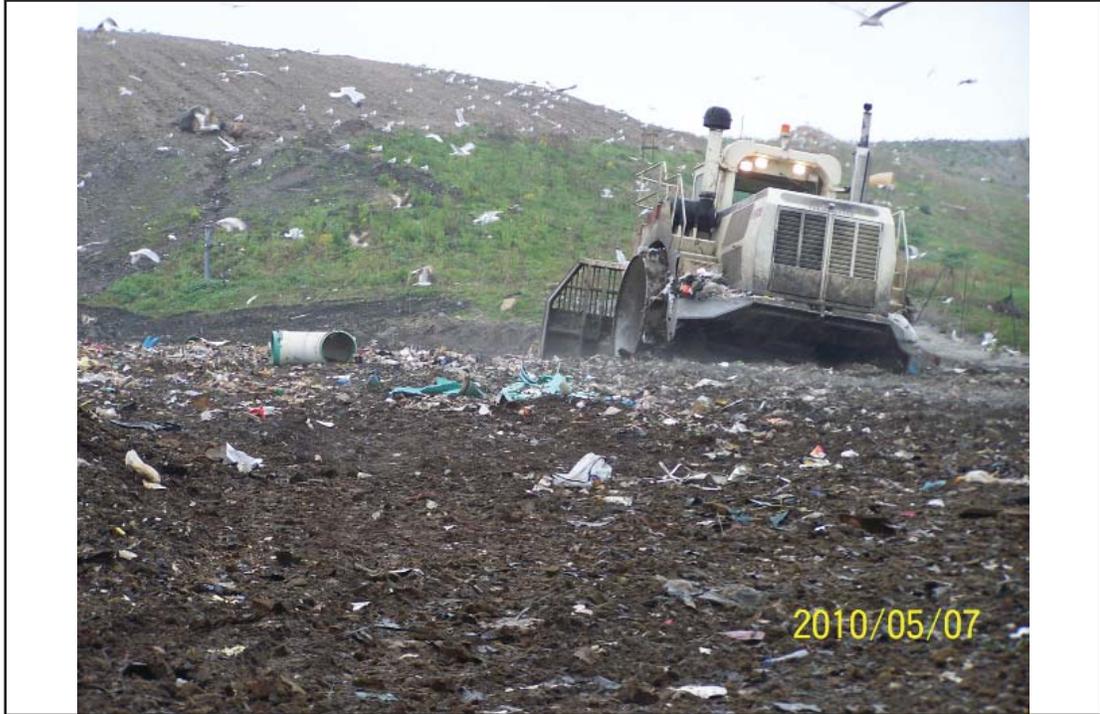
Compactor above waste

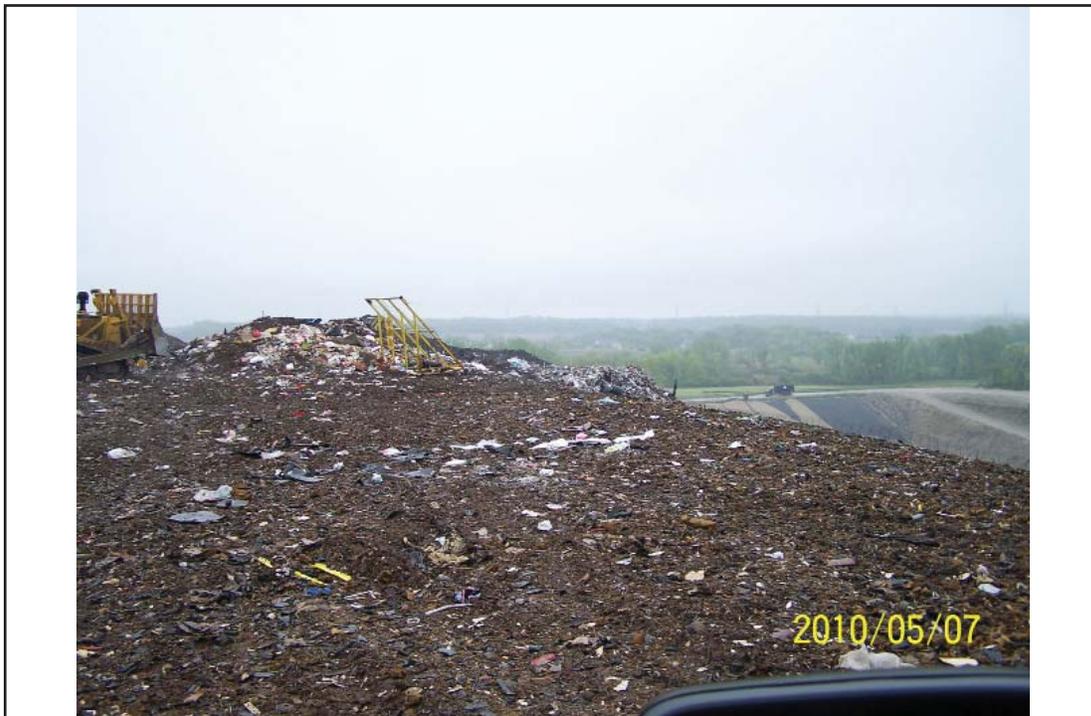
Current conditions in active area and clean out

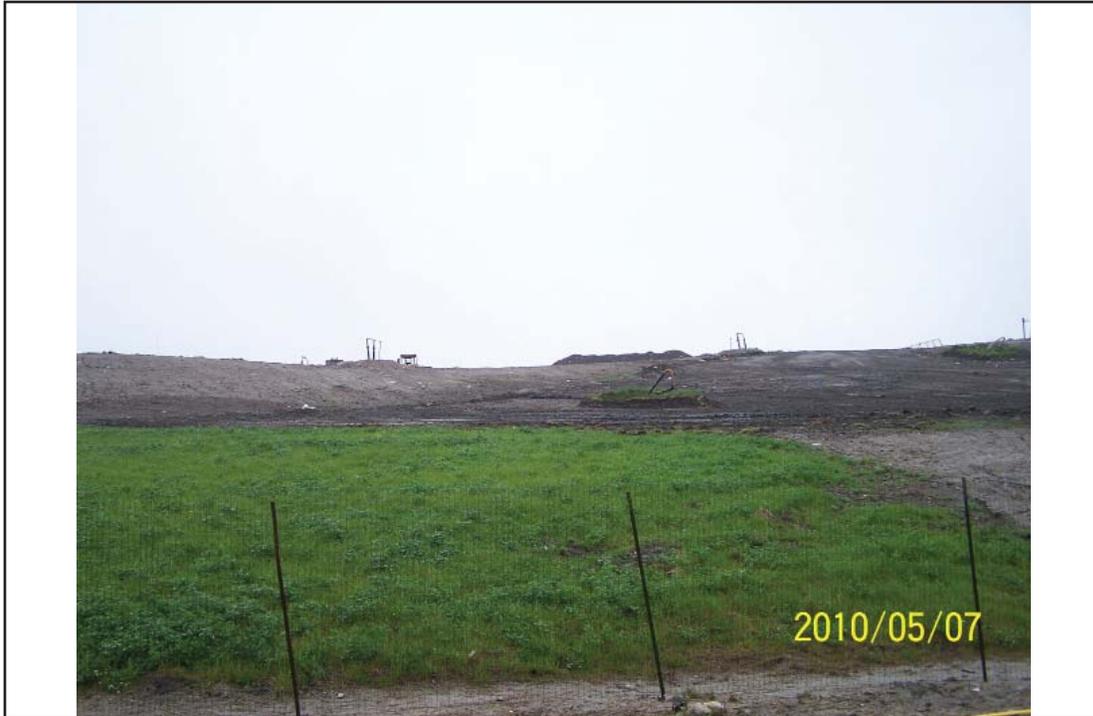
South slope of Phase 5/6

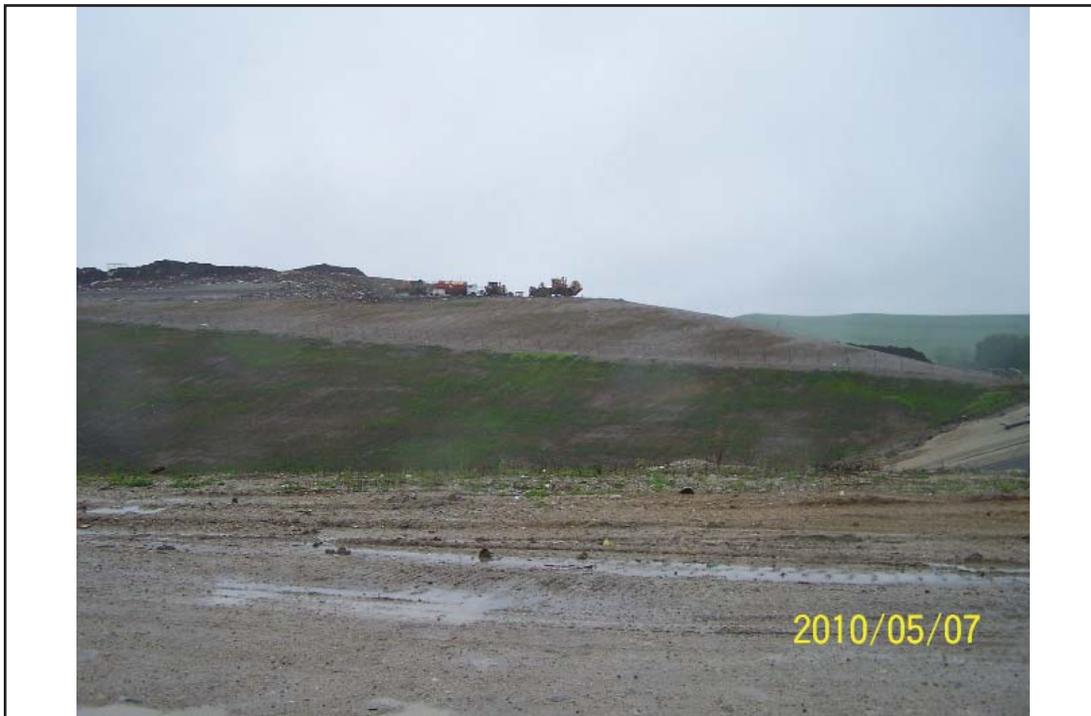
West slope of Phase 6, at South end

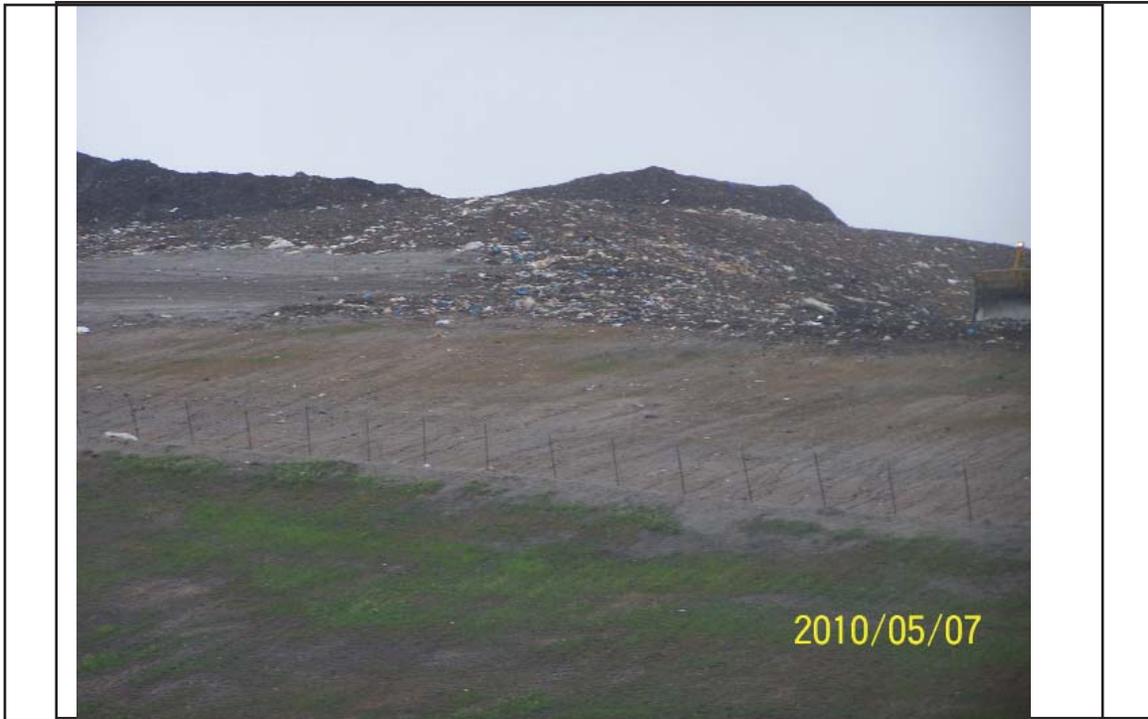
Poorly covered waste from previous days activities

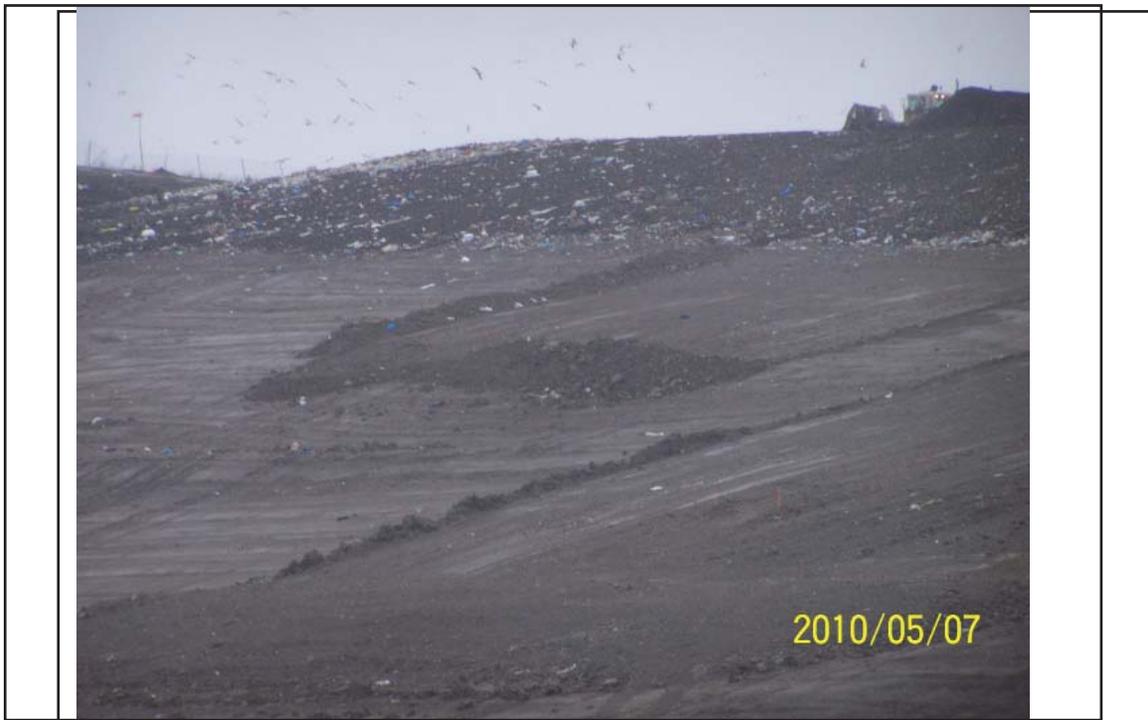
Poorly covered waste from previous days activities

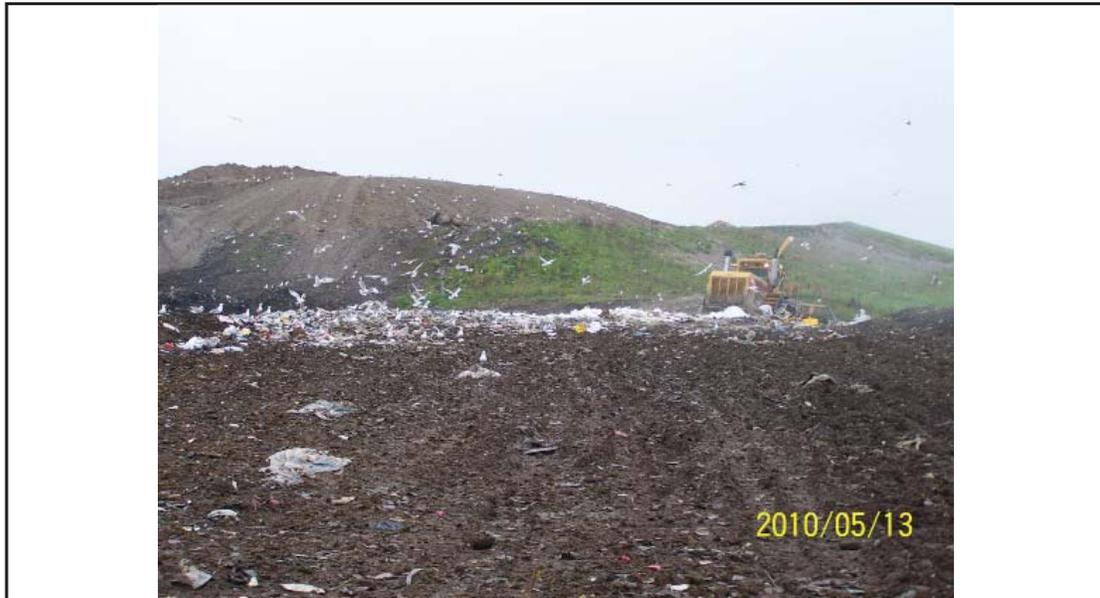
Working face at Northwest corner of Phase 6E, very small

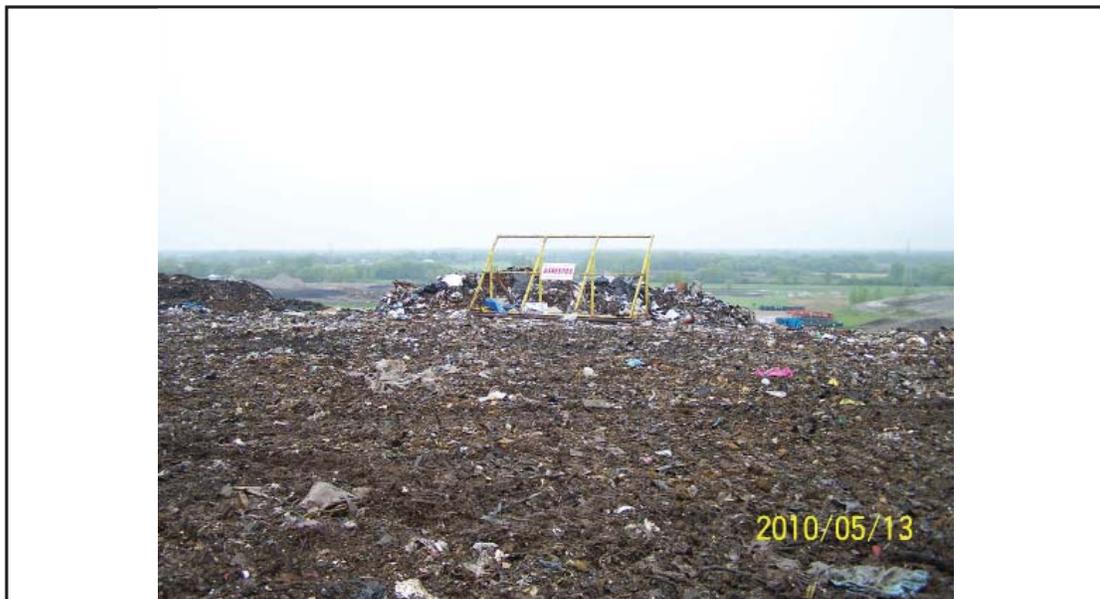
Clean out area and asbestos area

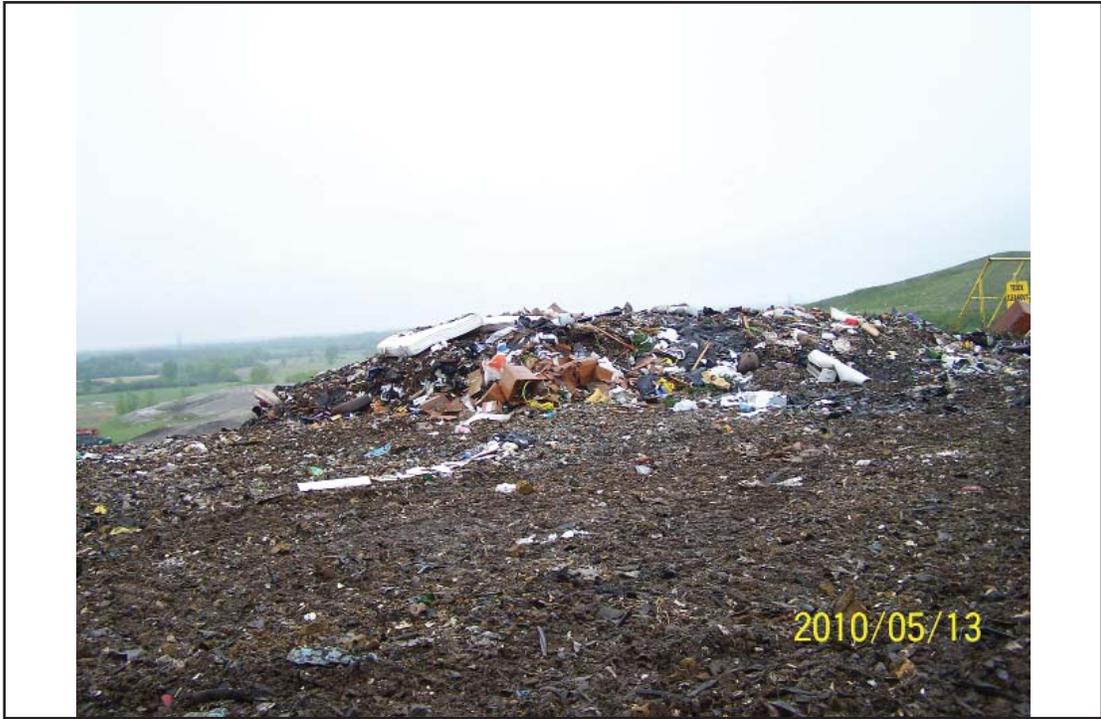
Older clean out area

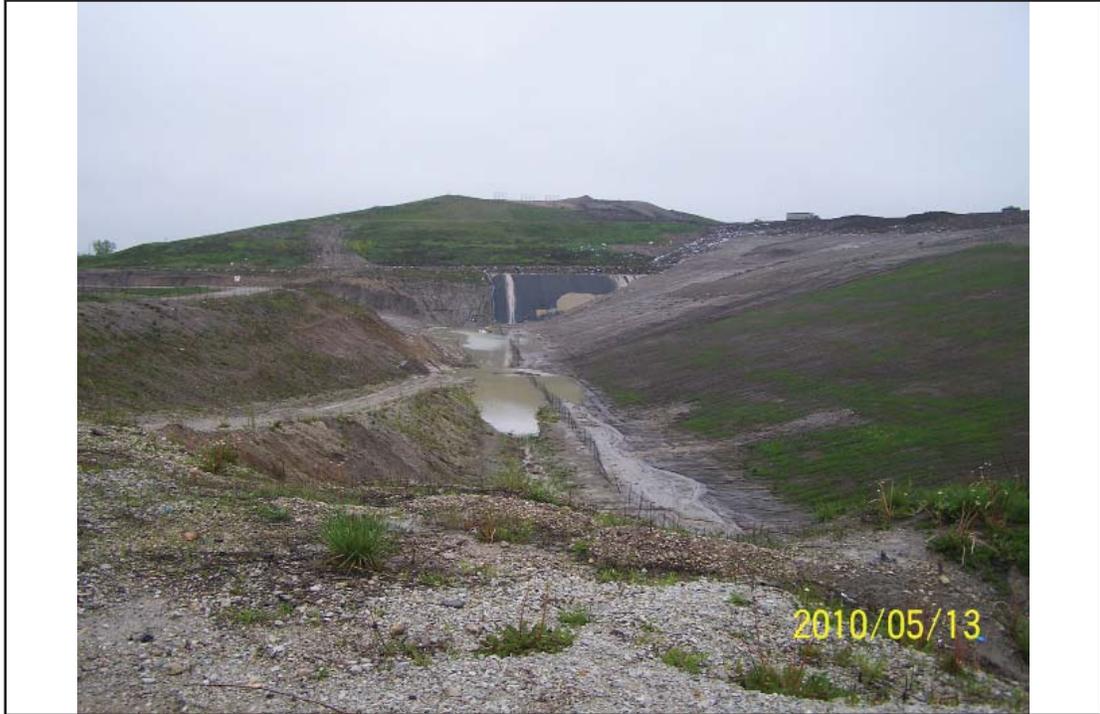
Temporary sed basin, over filled

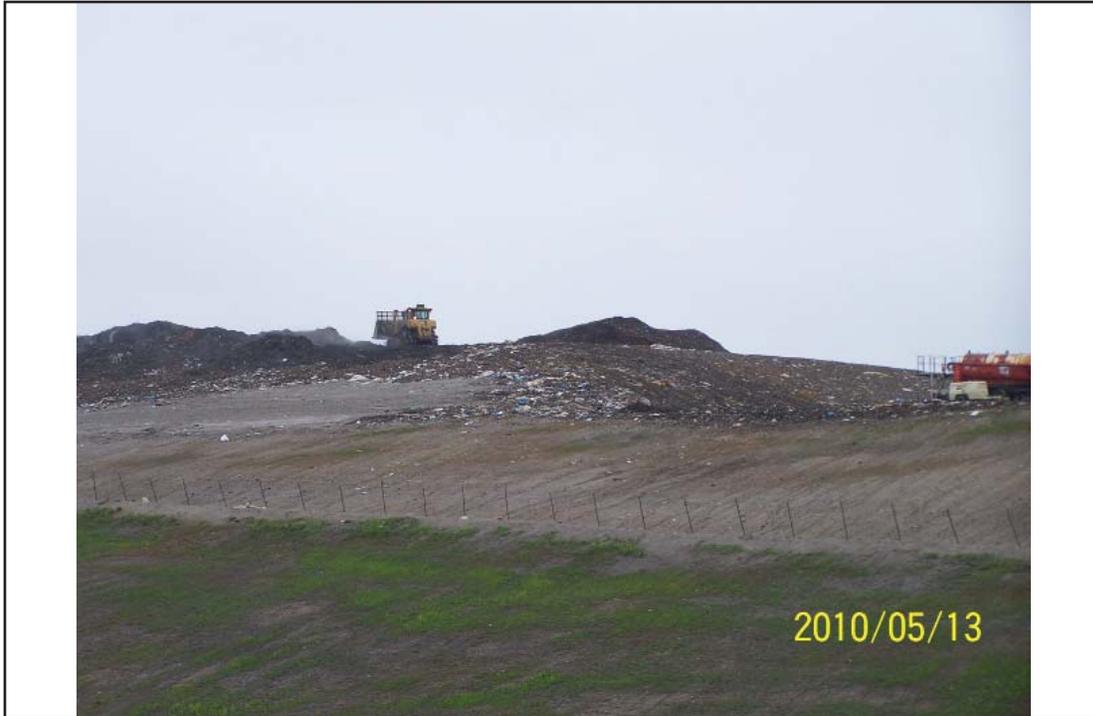
Area of poor cover
