VEOLIA EMERALD PARK LANDFILL  
CITY OF MUSKEGO

## 2010 Veolia Emerald Park Landfill Year End Compliance Officer Report and Audit Summary

**TO:** Veolia Emerald Park Standing Committee  
**FROM:** Jo-Walter Spear, Jr., P.E.  
**COPIES:** File  
**DATE:** 01/20/11  
**PROJECT NUMBER:** 1012

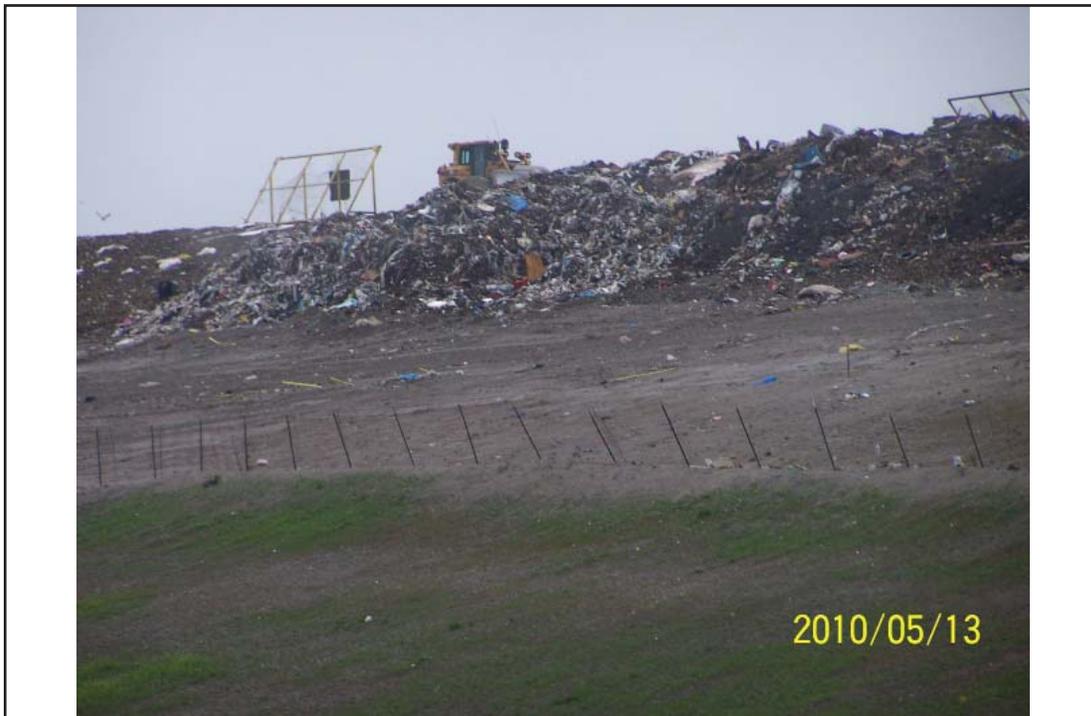
Area of poor cover

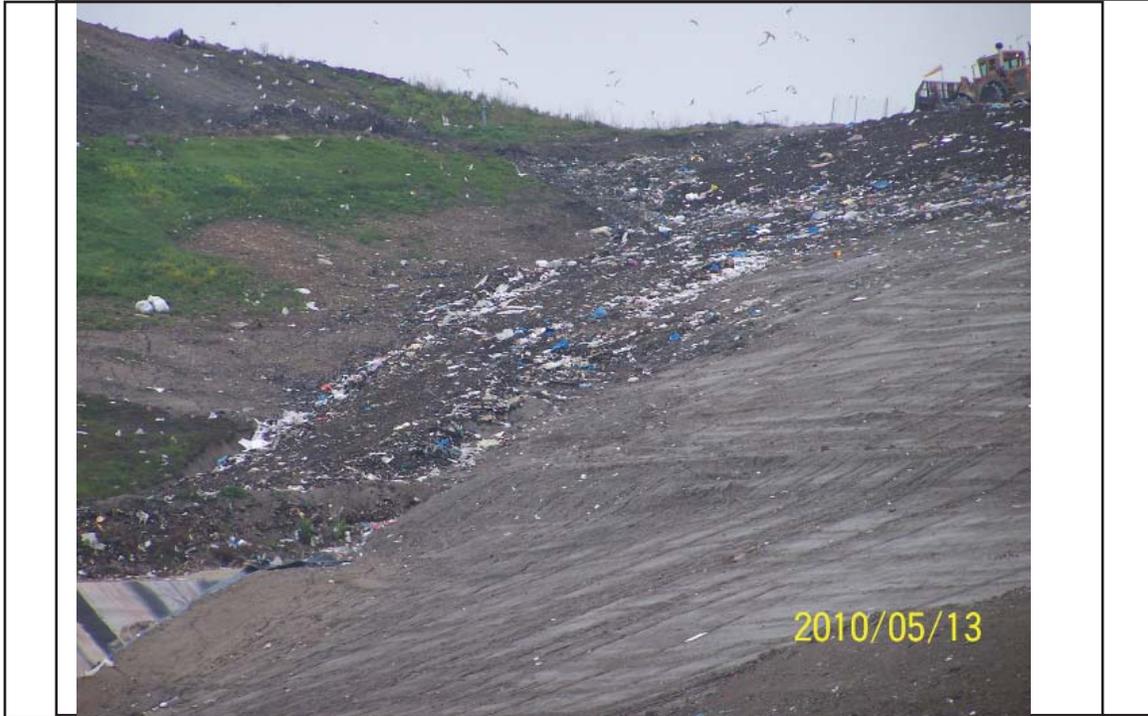
Heavy litter and some erosion at Phase juncture

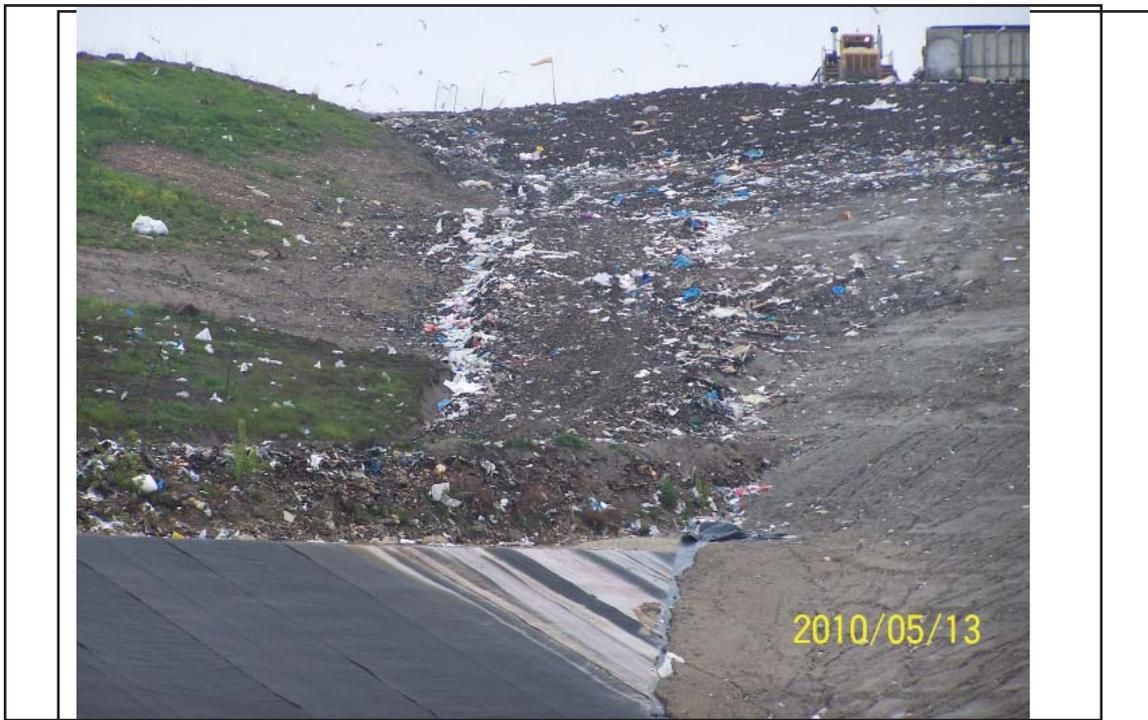
Expanded view of litter

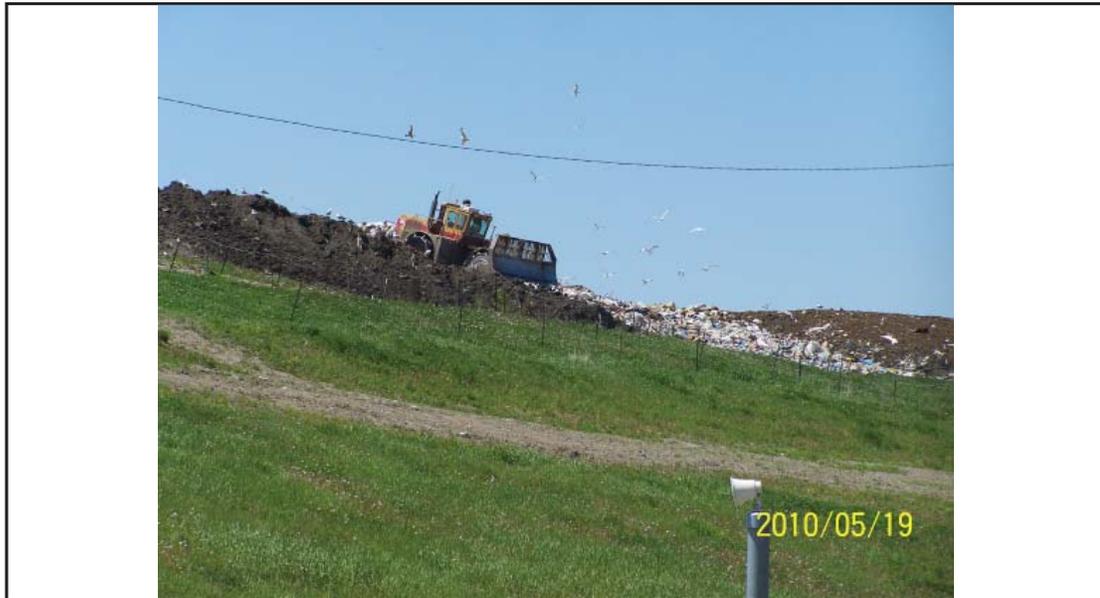
Working face in Phase 5, viewed from office parking lot

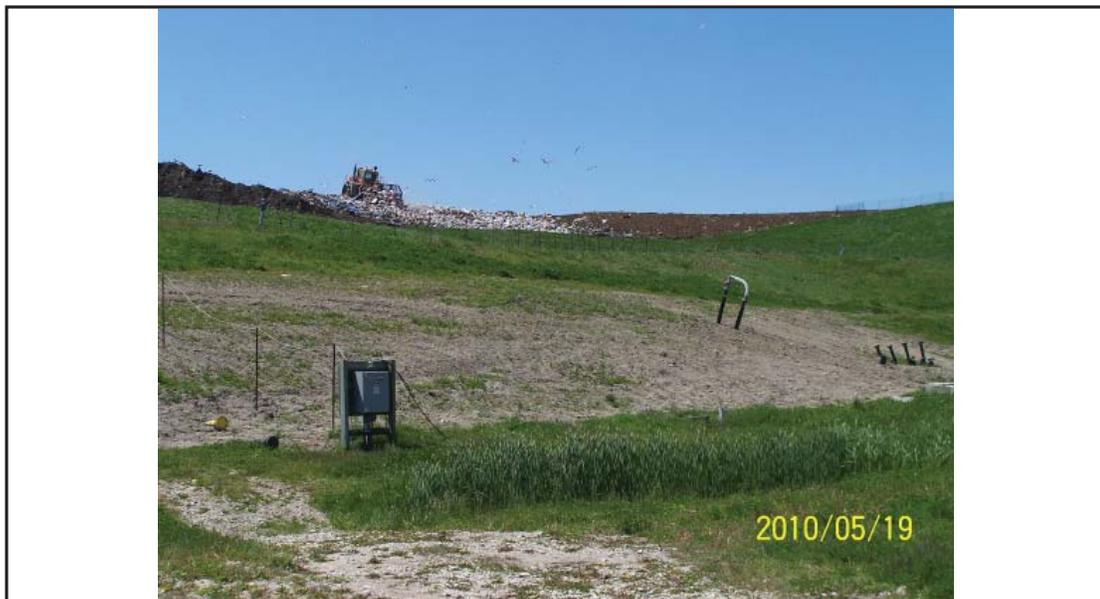
Area of header placement growing volunteer grasses

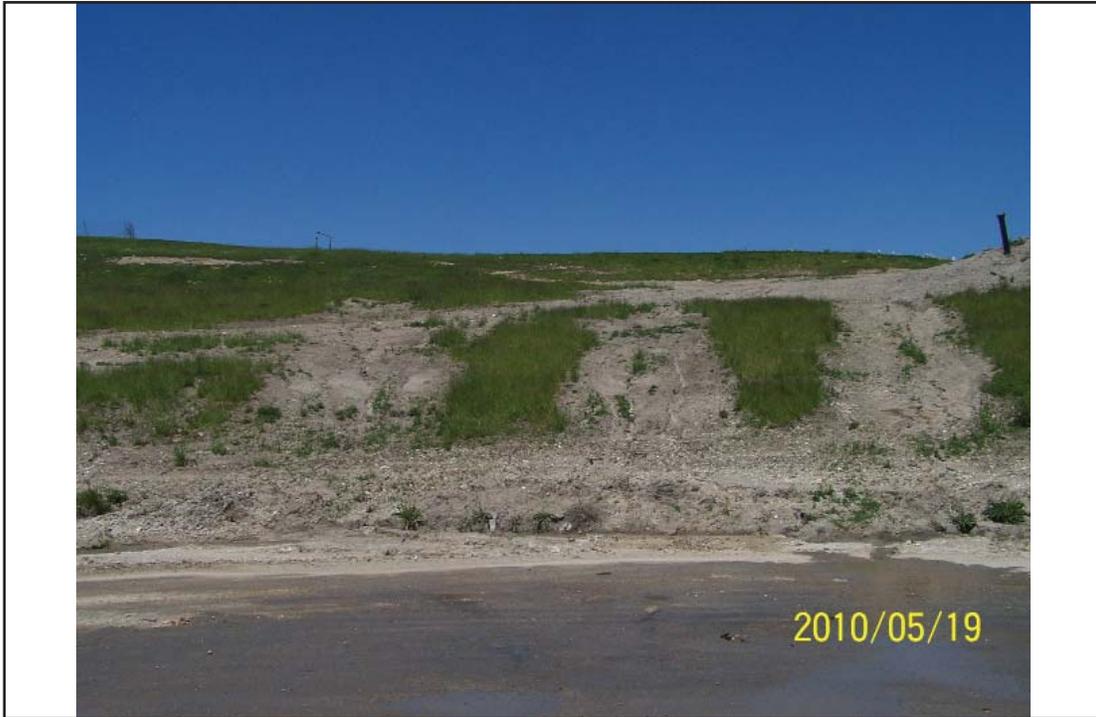
Areas of erosion on Phase 4, South slope

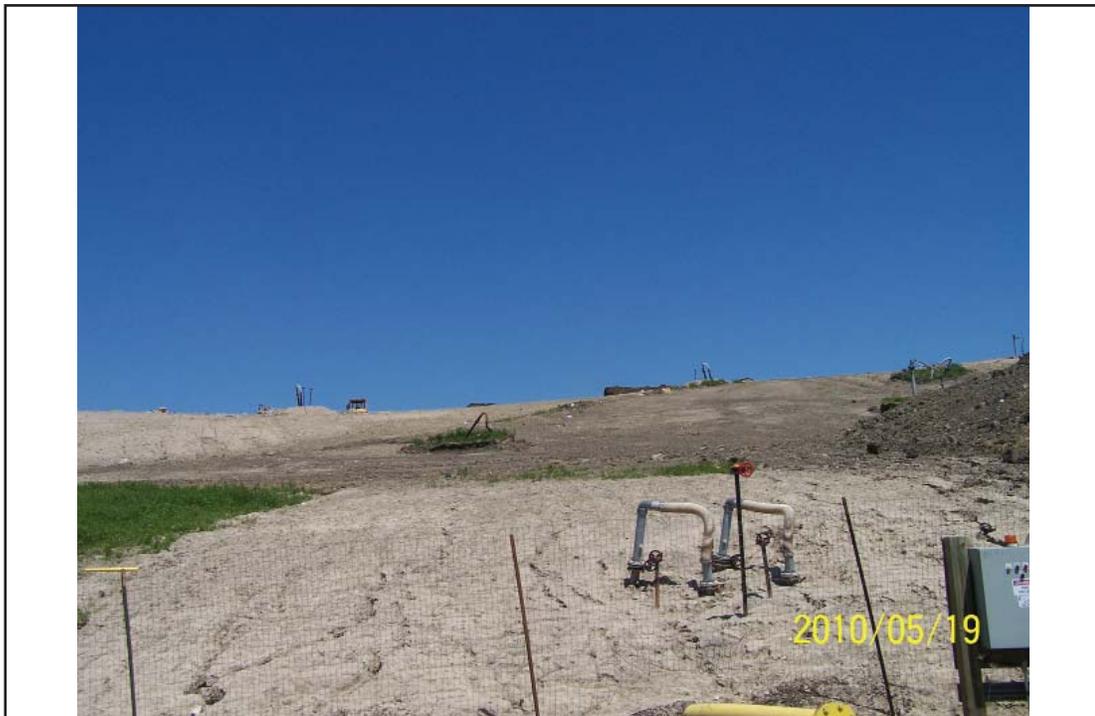
Areas of air-space recovery, South of Phase 5

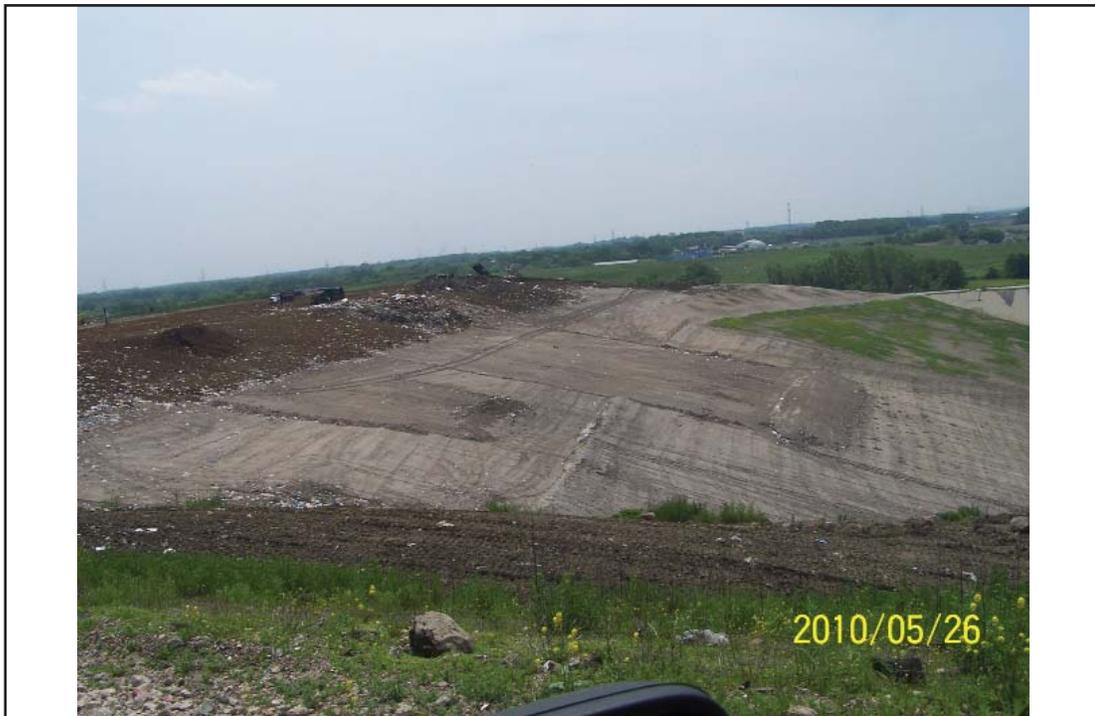
Autofluff on outboard slope, used as cover until airspace recovery can be initiated

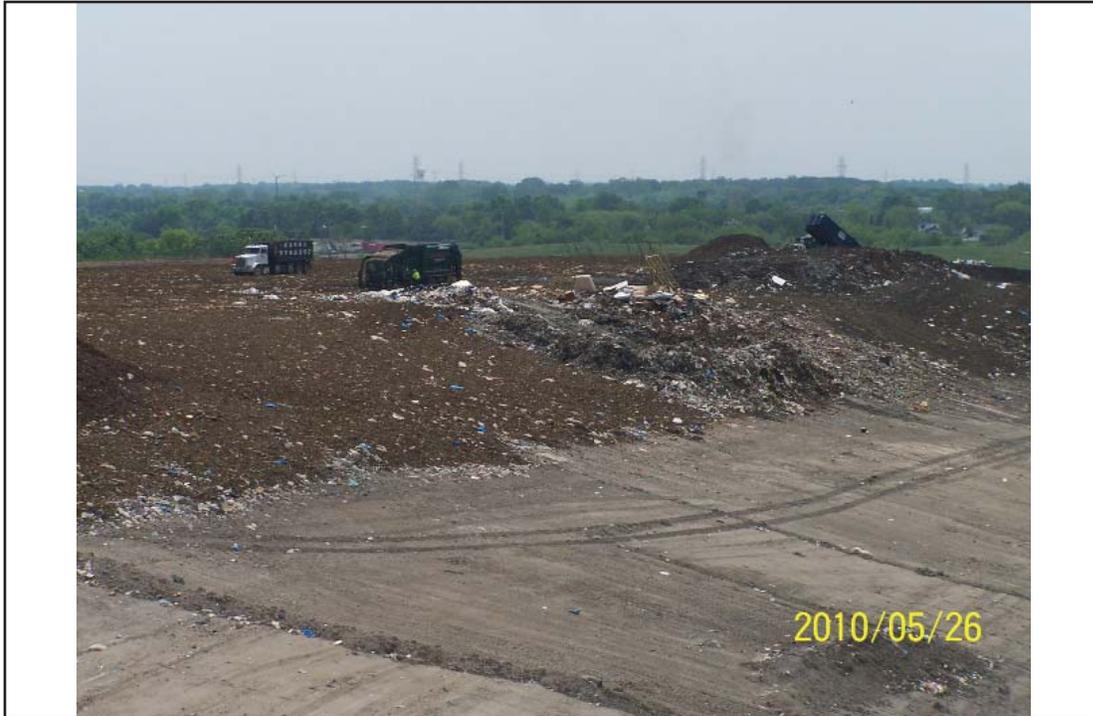
Pit excavated to take putrid loads today

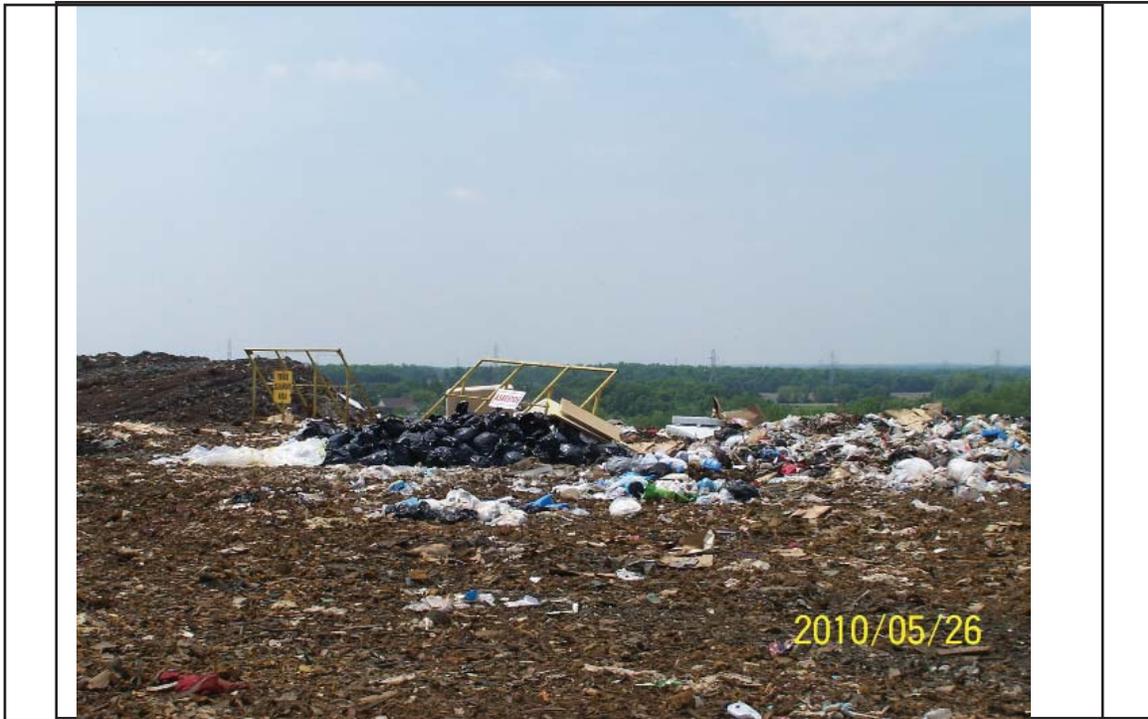
Asbestos Pit

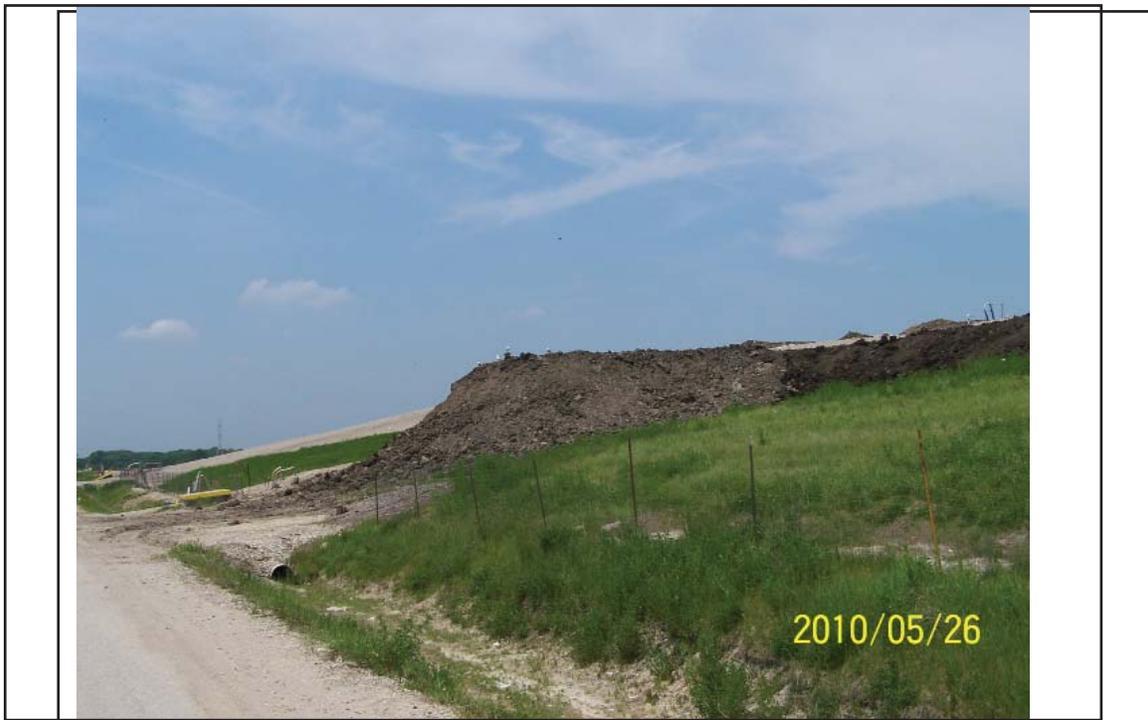
Phase 6/5 South slope, collected top soil to be removed and then restored after filling

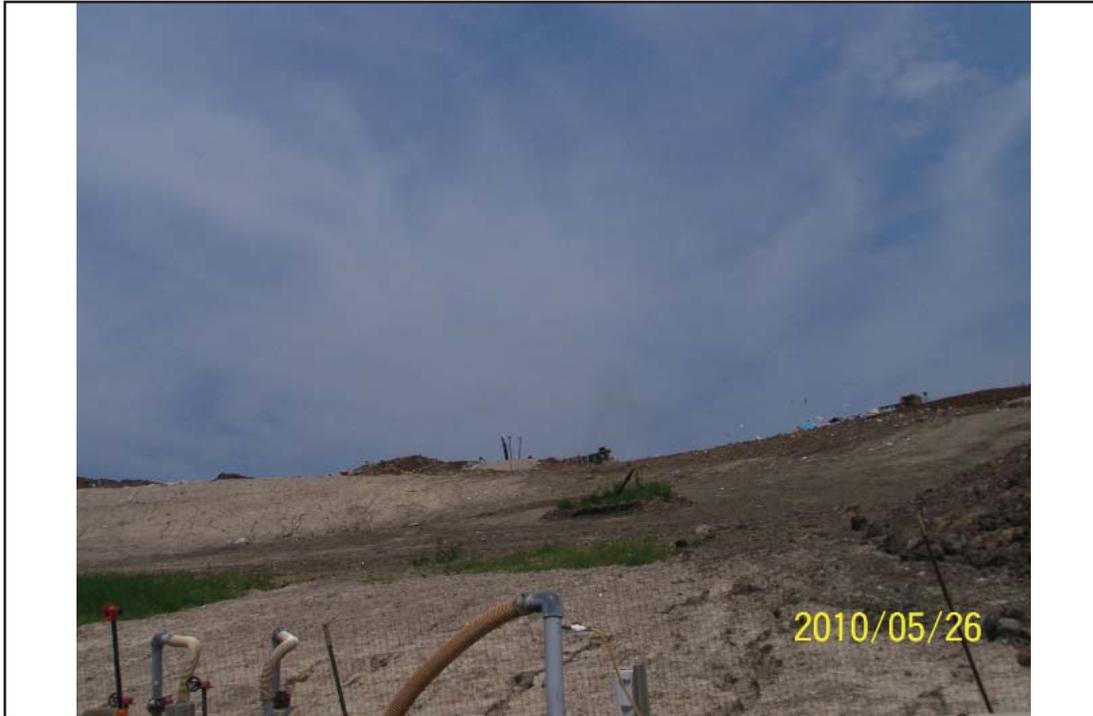
Phase 6/5 South slope clay cover only

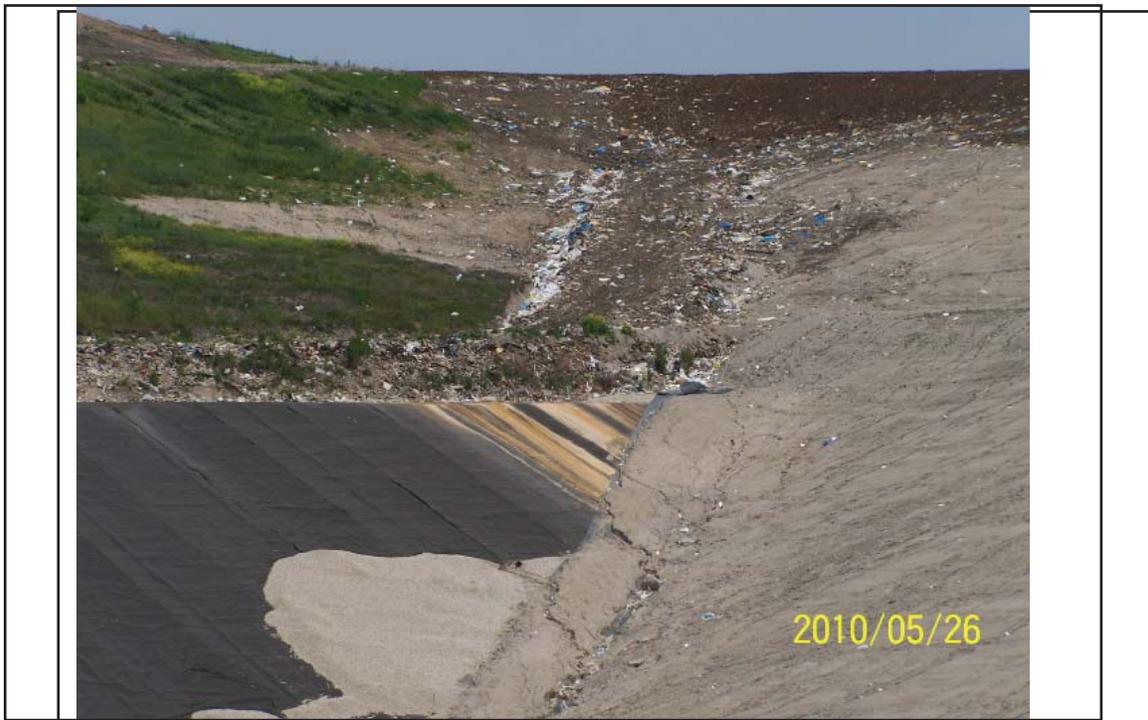
Northwest corner of Phase 6E, captured litter on slope.

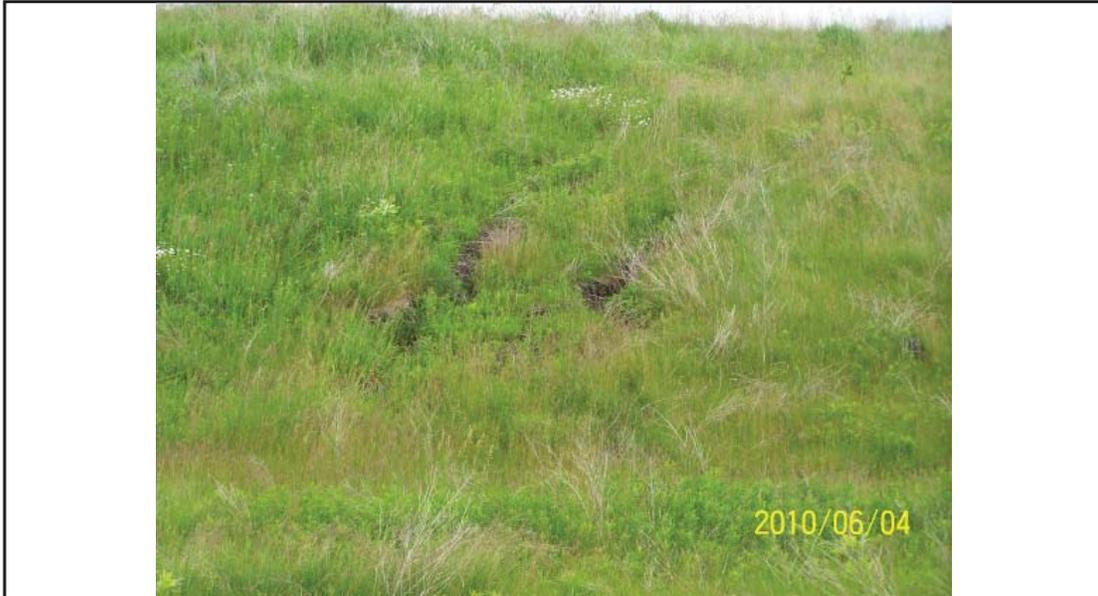
Rills in South stockpile on Union Church/ 8 mile Road

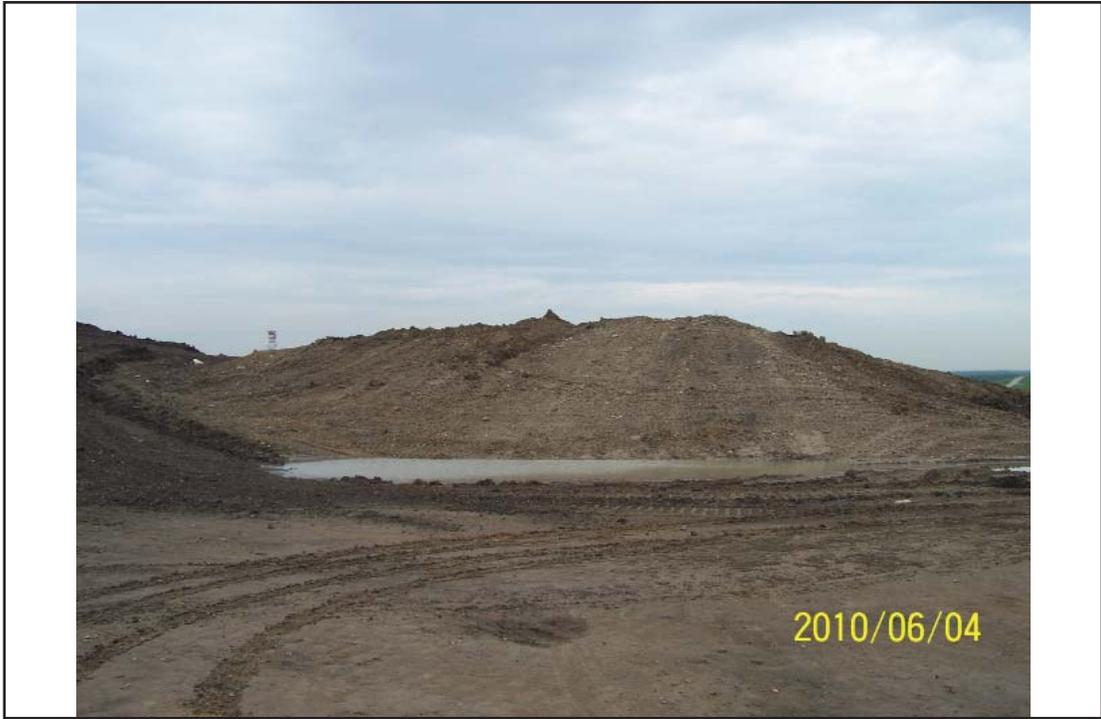
Bio soil pile with some ponding before it

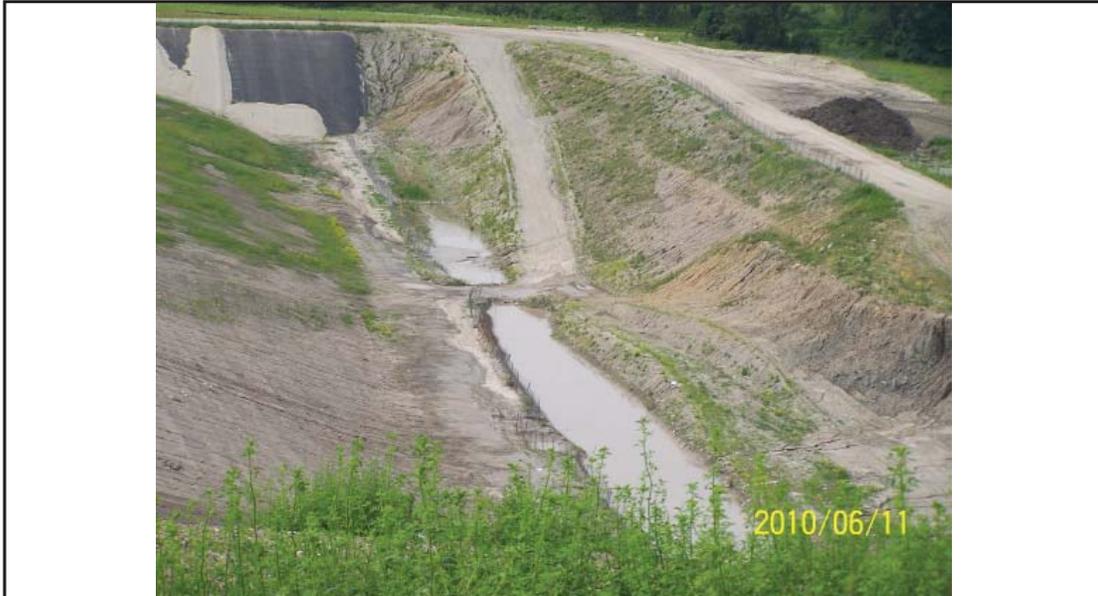
Temp Sed Basin pumped down to its boundaries

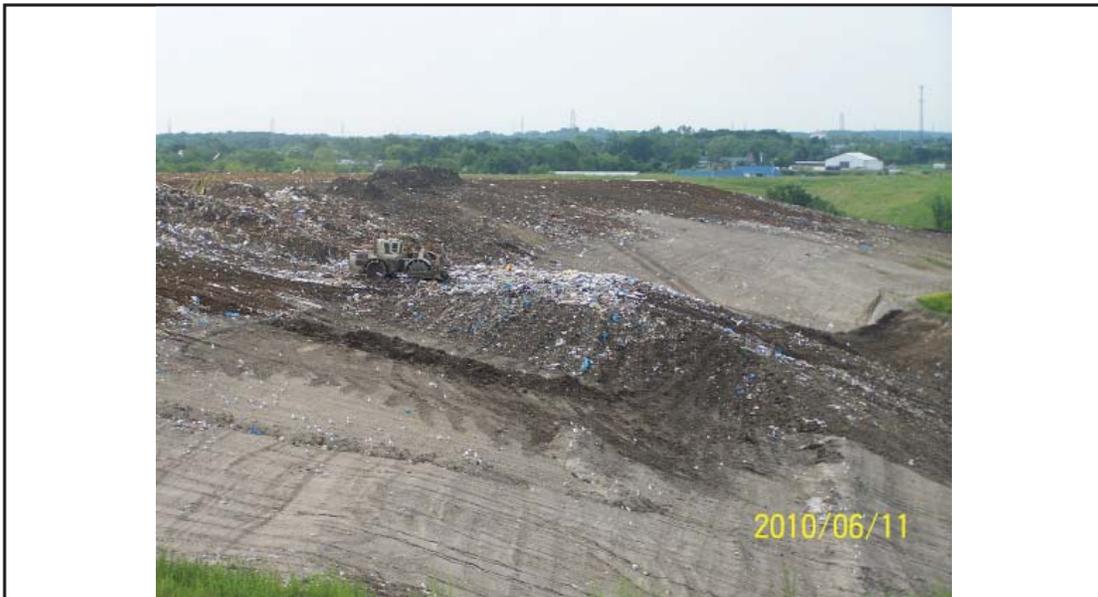
Waste grades being recovered after too shallow a slope was developed for Phase 6E, outboard slope (West)

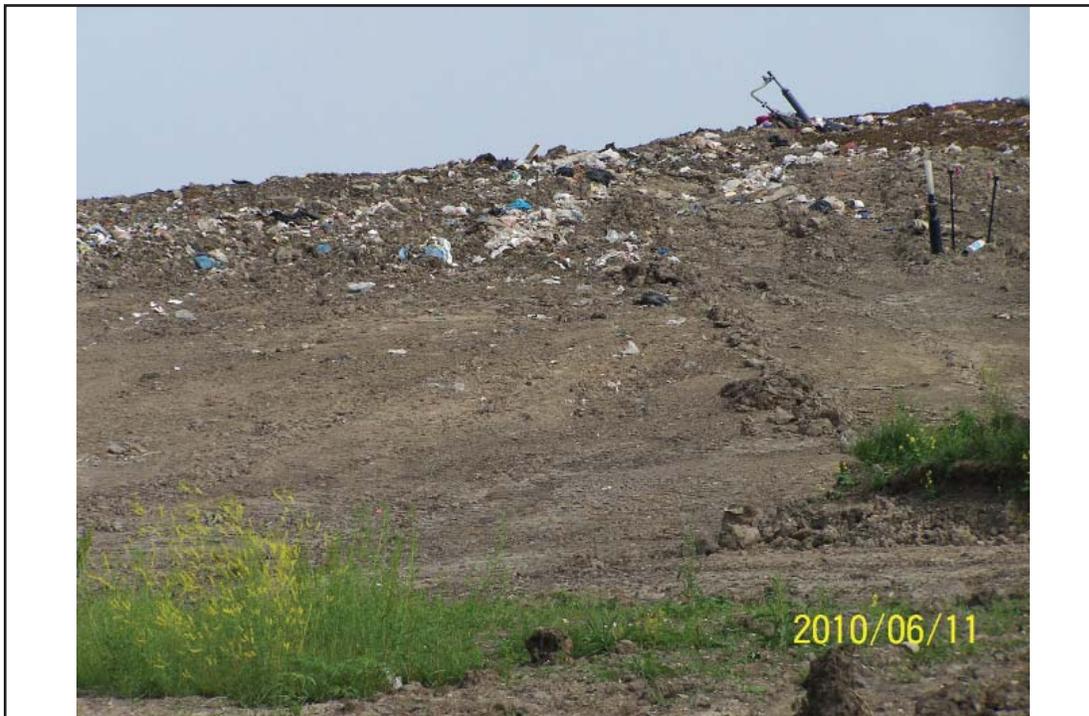
Area of exposed waste and flagging at Southwest corner of Phase 6E

- Jordan is ending employment with Veolia on July 2<sup>nd</sup>, 2010; no replacement at this time
- Continue action item of exposed waste

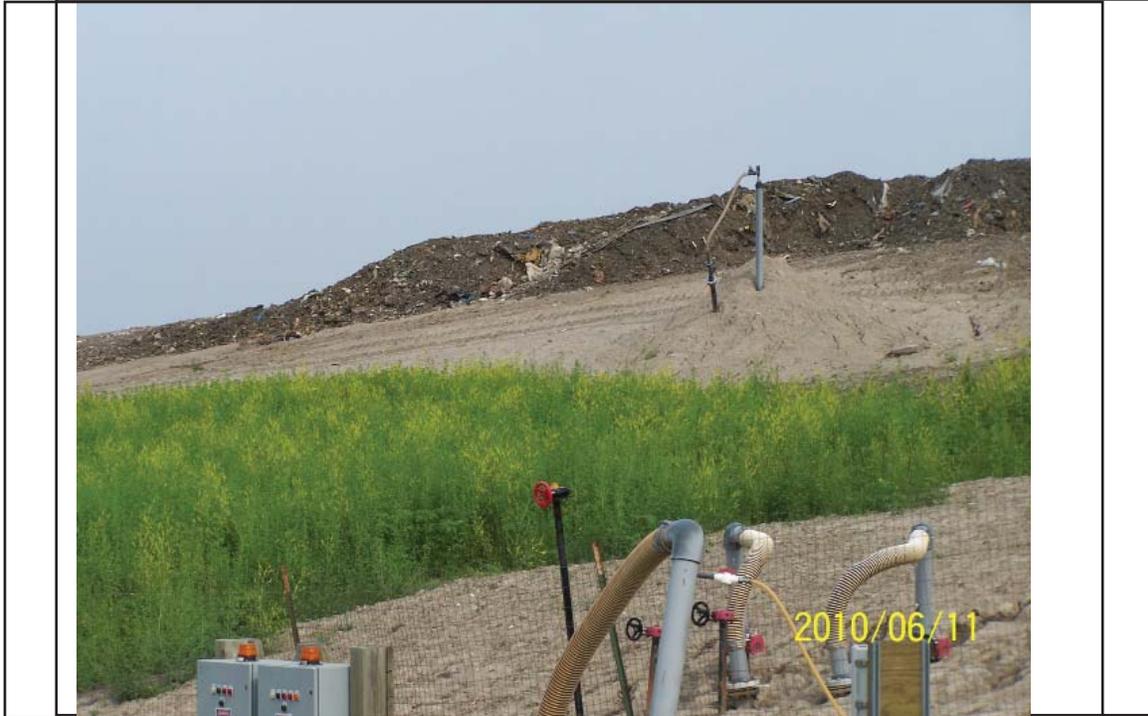
South slope recovery

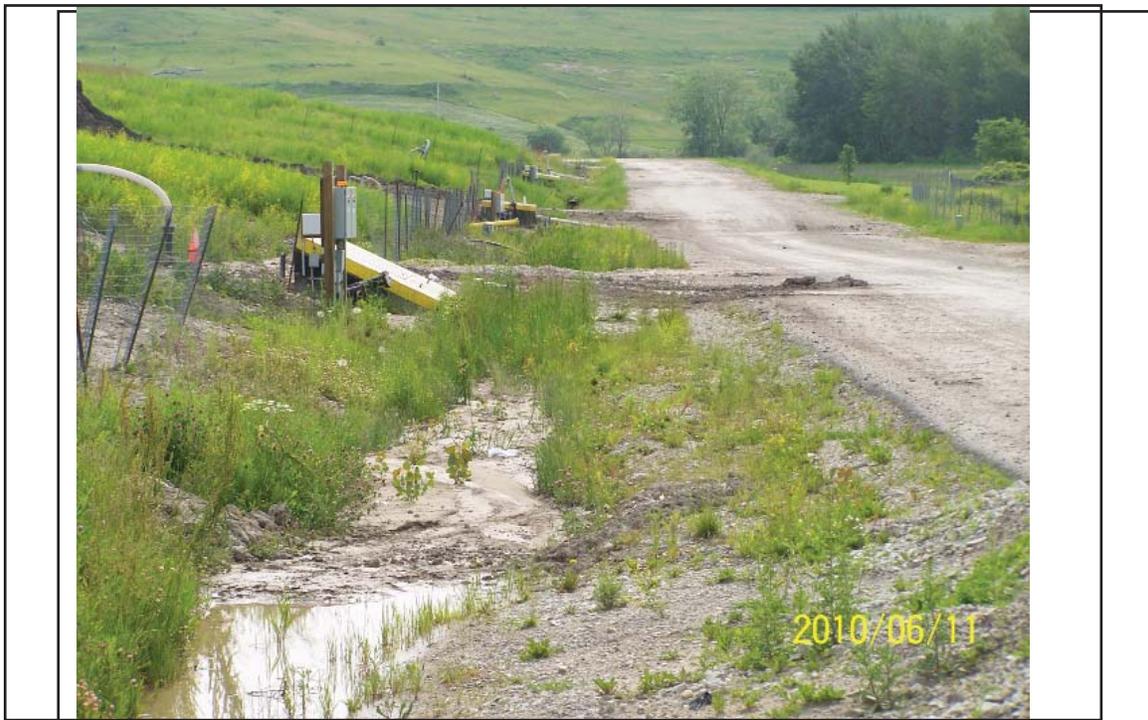
Ditch channels becoming ecluded by silt.

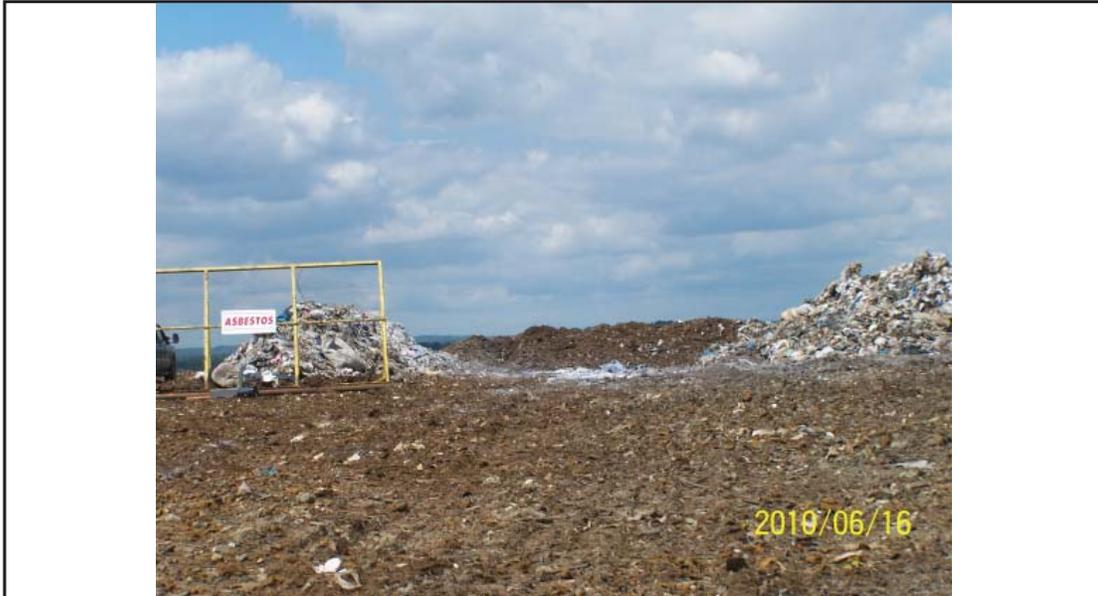
New asbestos pit location in Northeast corner of active area

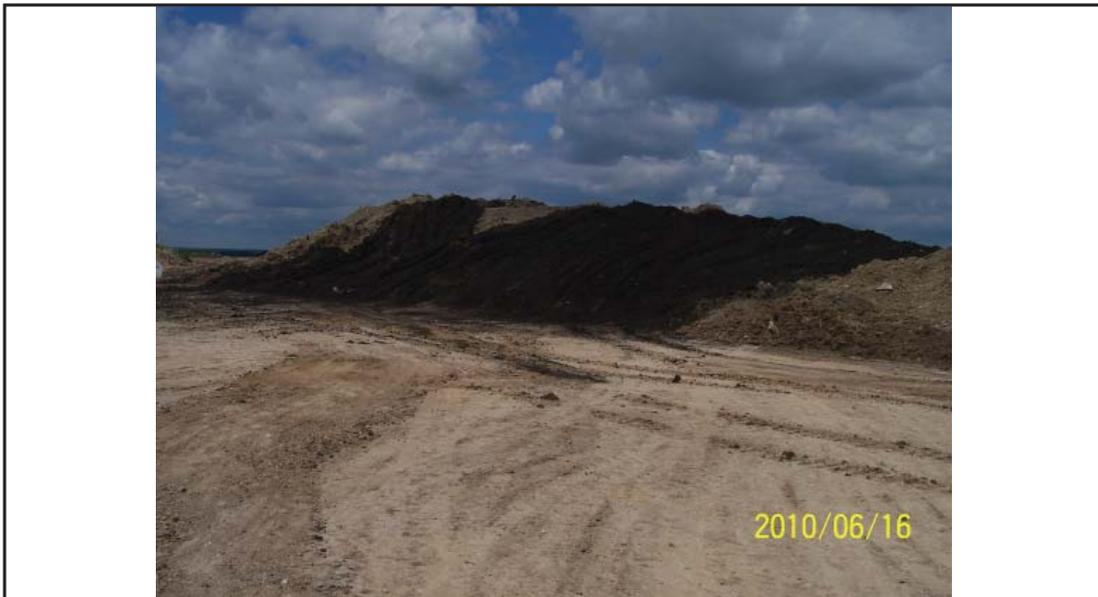
Increased volume of landfill direct soils. Soil placement crude due to use of D8 dozer instead of the D6, which is in the shop

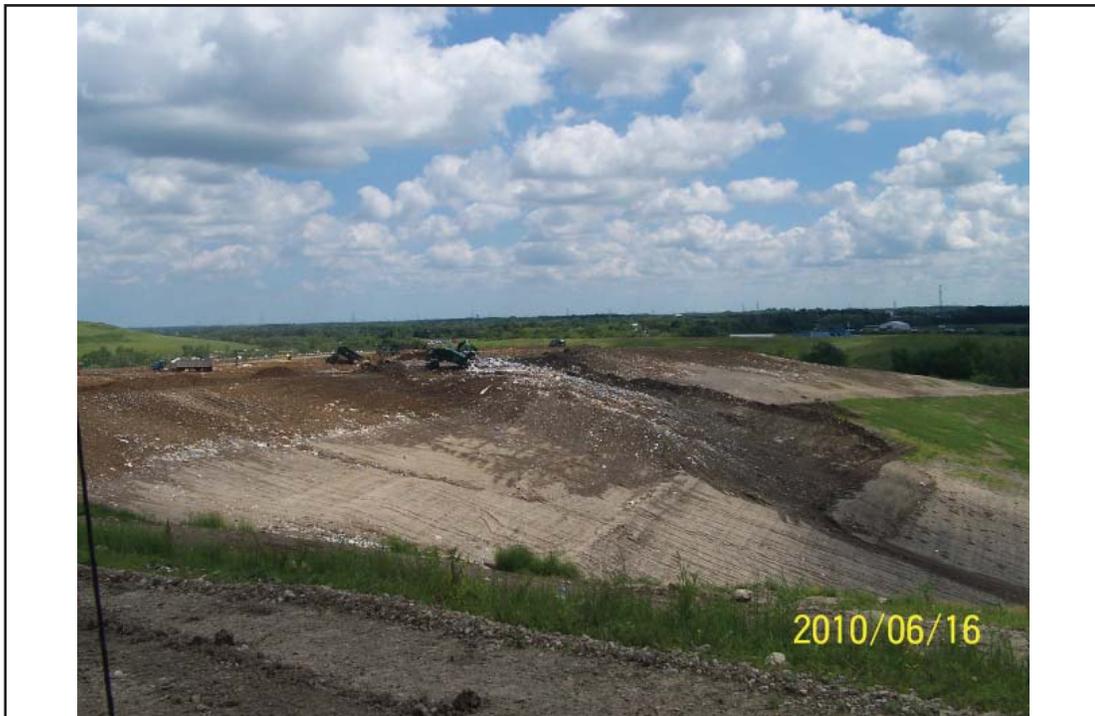
Active area (West slope of Phase 6). Cut beyond working face is location for next working face

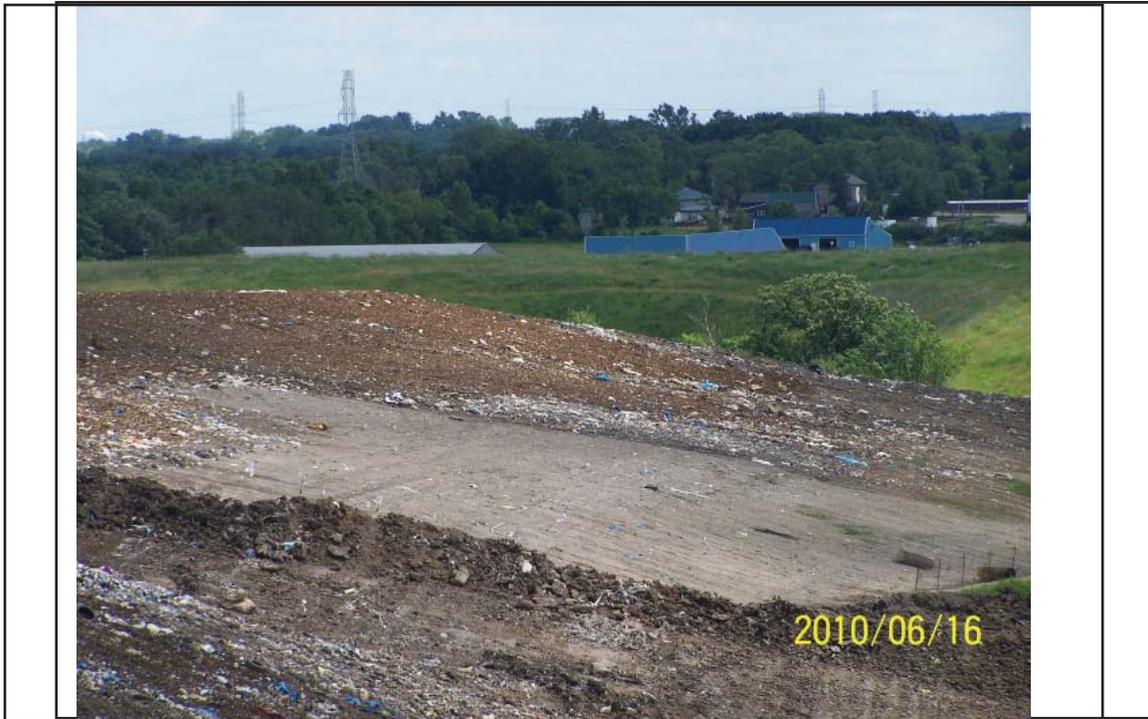
Exposed waste outside of working face

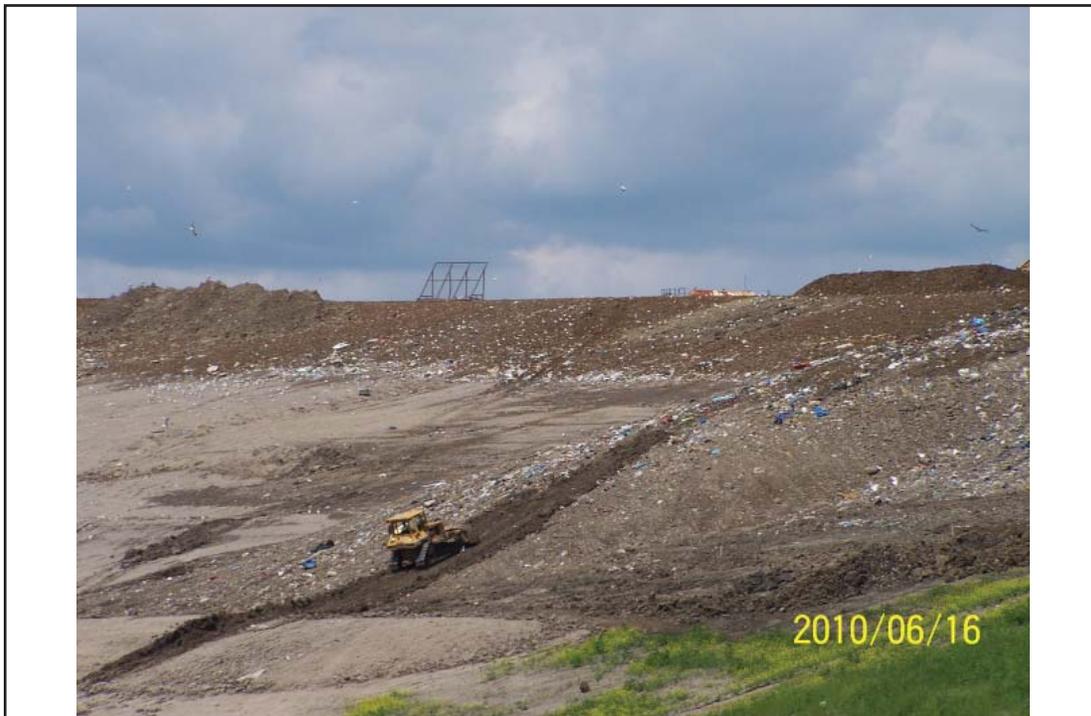
D5 Dozer (borrowed) fighting to move clay over working face

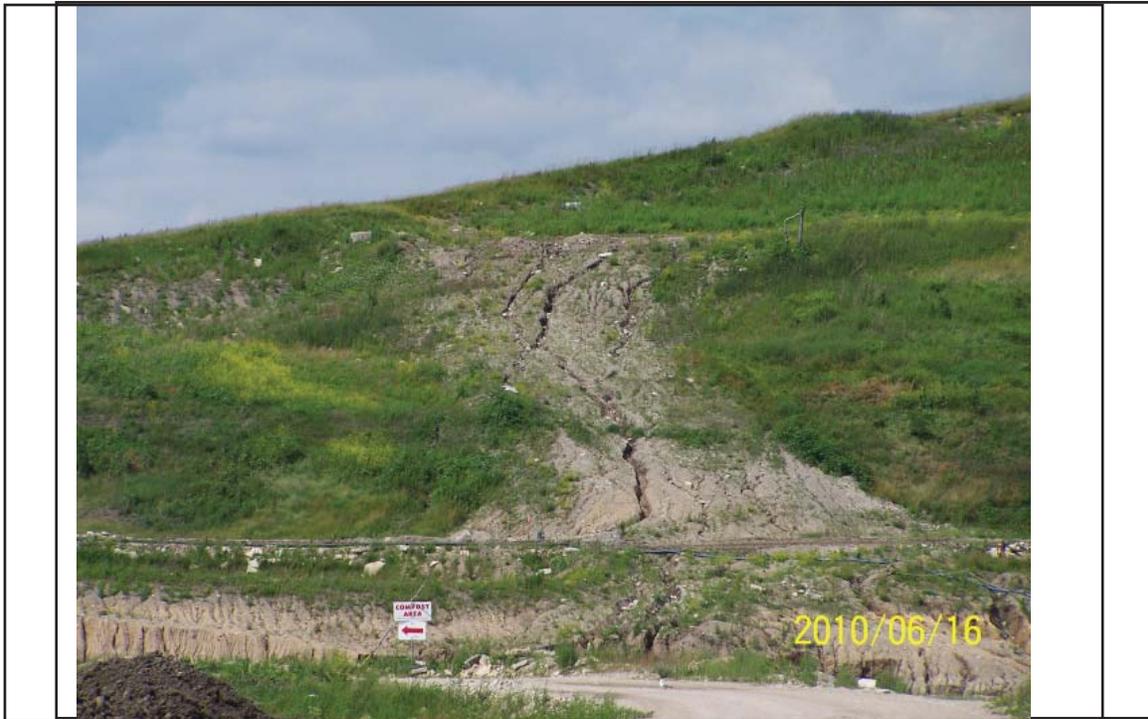
Severe rills in the old access road from Phase 6W to Phase 3

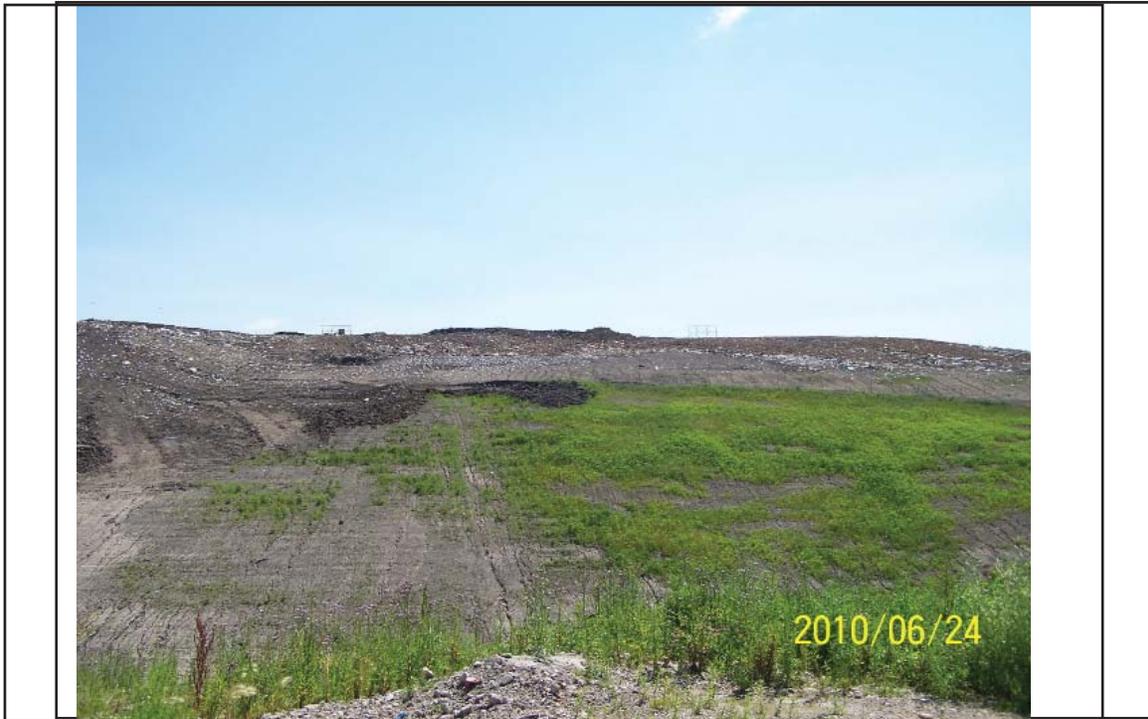
Phase 5, East slope, some rills

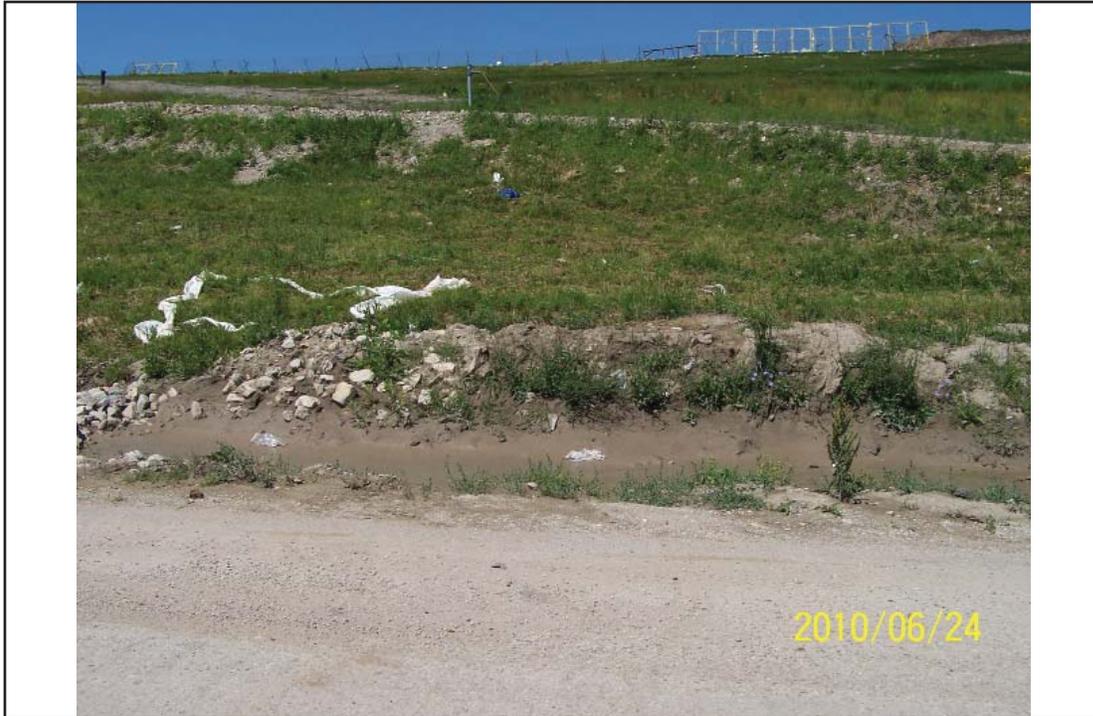
Silt in road side ditches

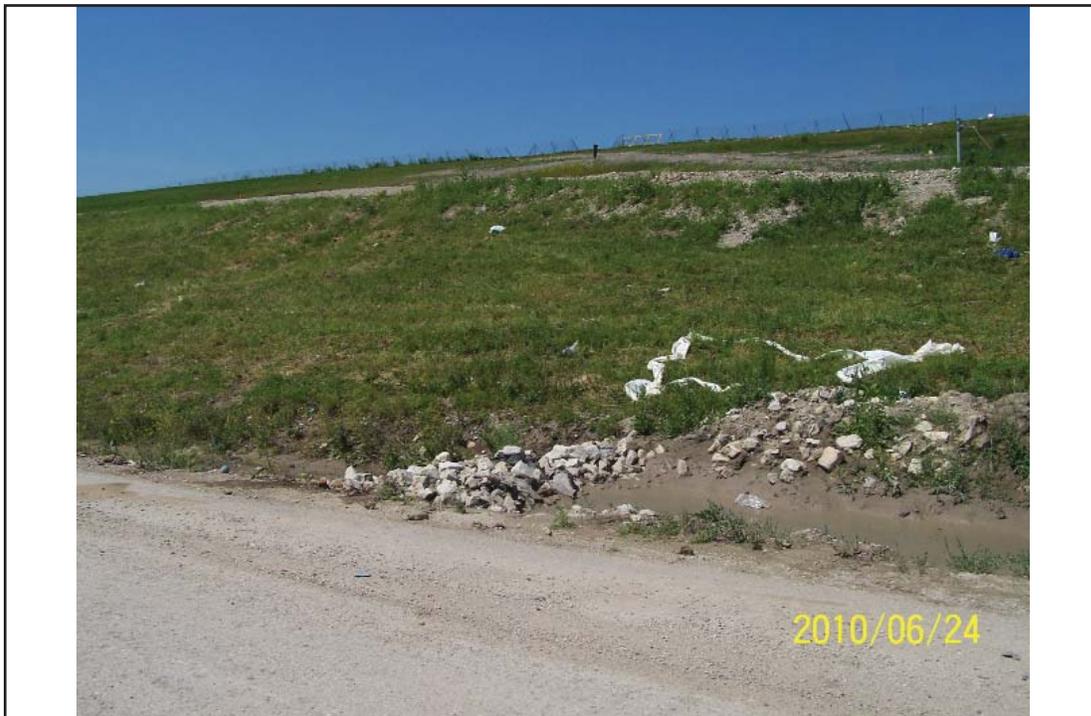
Silt in ditches reaching near top of check dams
