VEOLIA EMERALD PARK LANDFILL  
CITY OF MUSKEGO

## 2010 Veolia Emerald Park Landfill Year End Compliance Officer Report and Audit Summary

**TO:** Veolia Emerald Park Standing Committee  
**FROM:** Jo-Walter Spear, Jr., P.E.  
**COPIES:** File  
**DATE:** 01/20/11  
**PROJECT NUMBER:** 1012

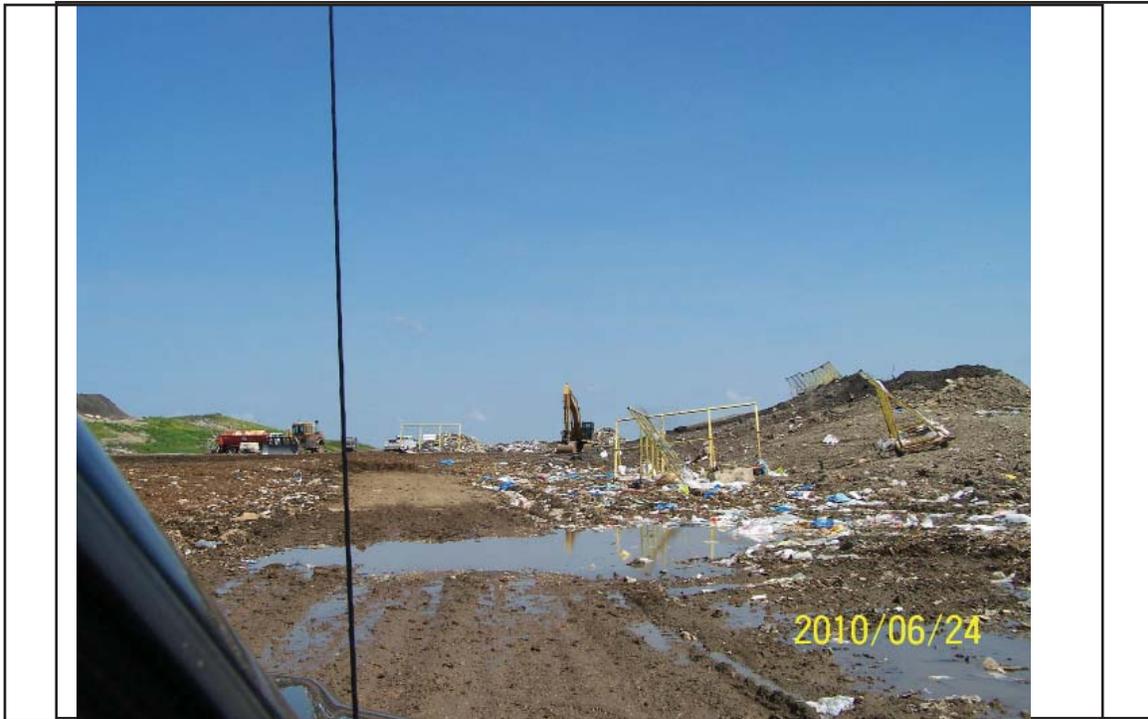
Top of Phase 5/6 very wet

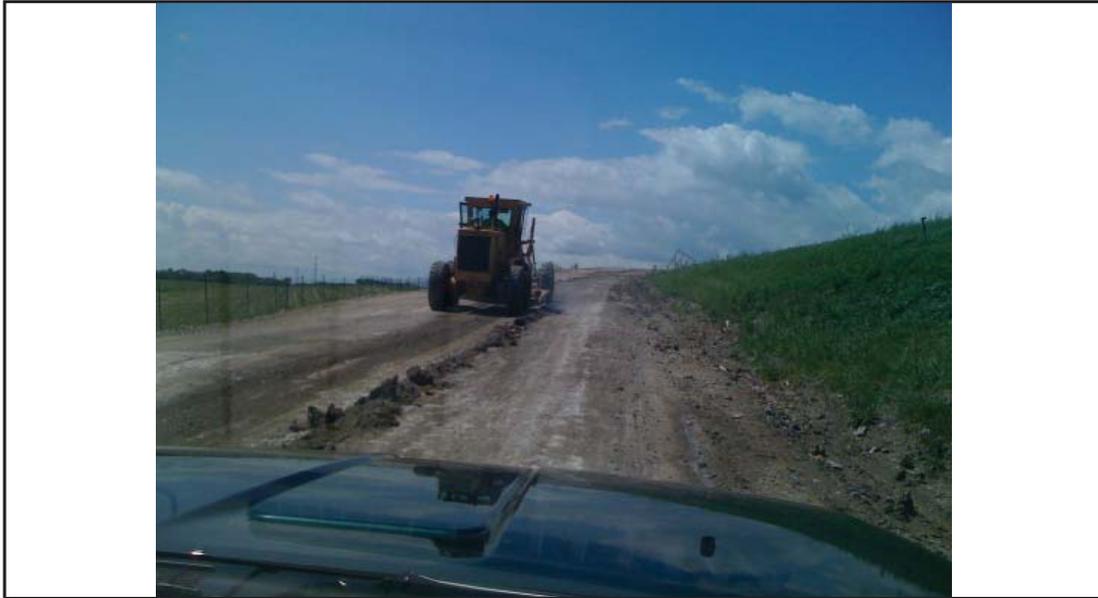
Regrading of Active Area access road

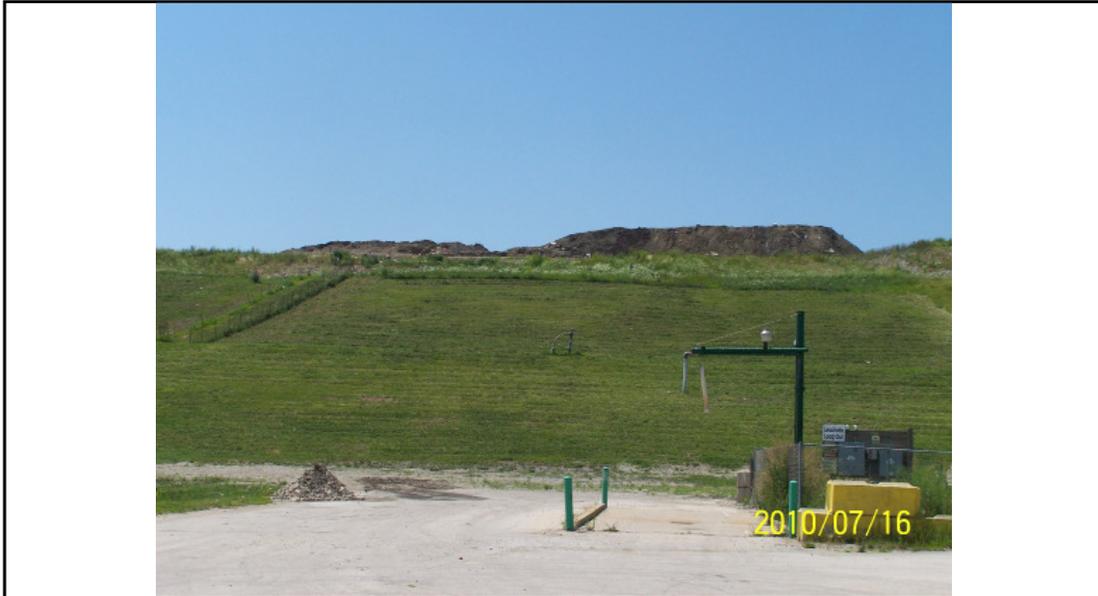
Slope about flare area

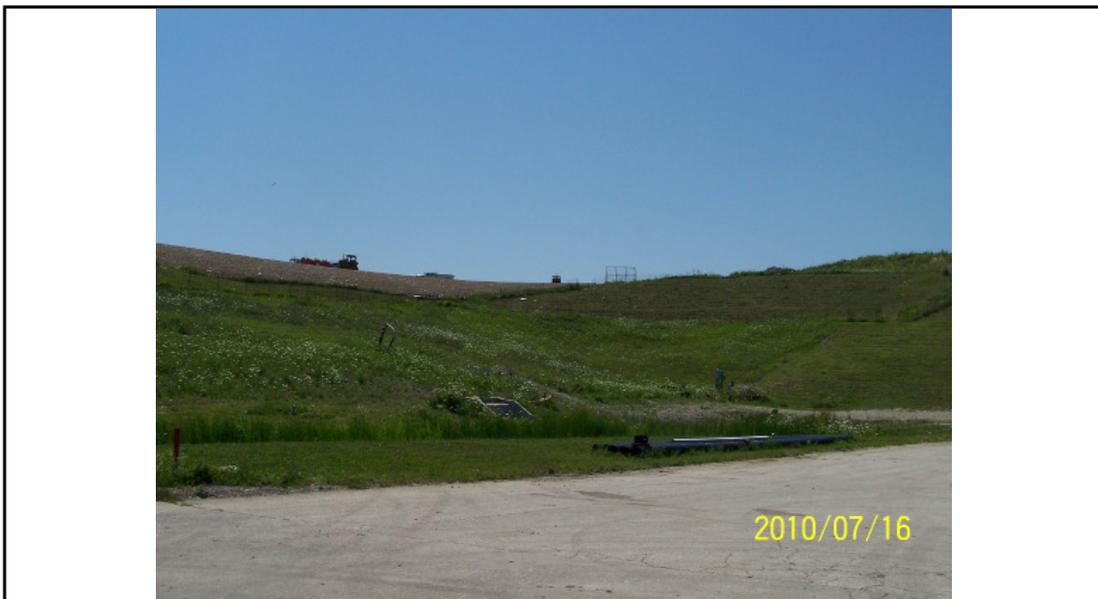
Slope about flare area

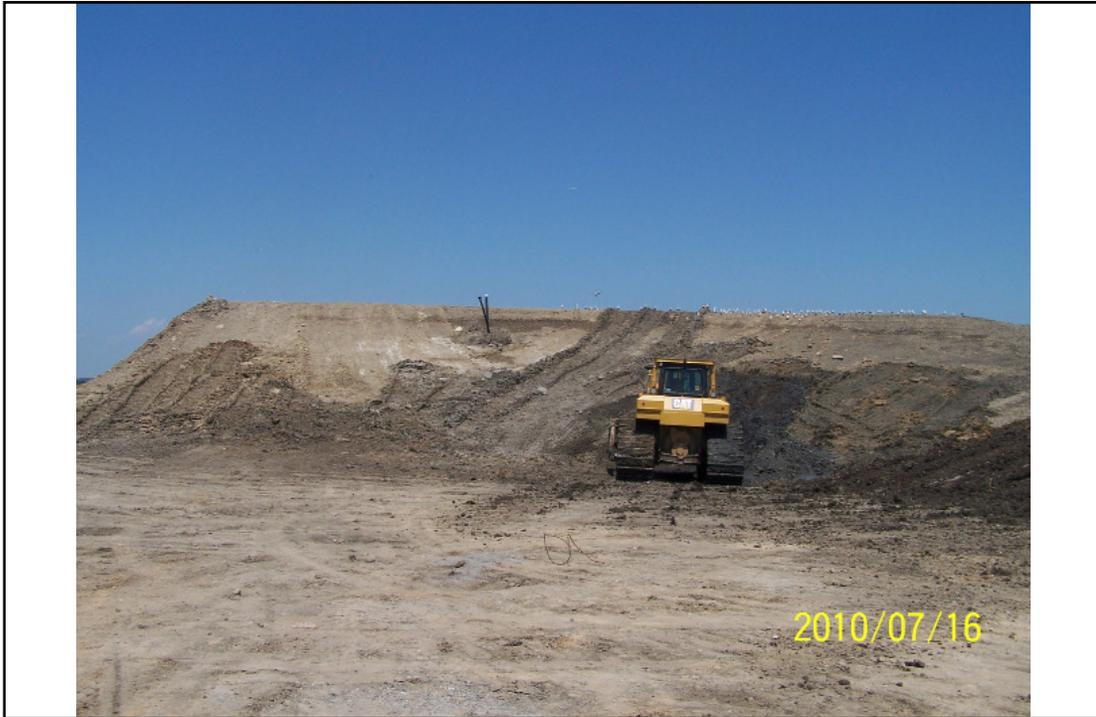
Landfill direct soils on Phase 2 & 3

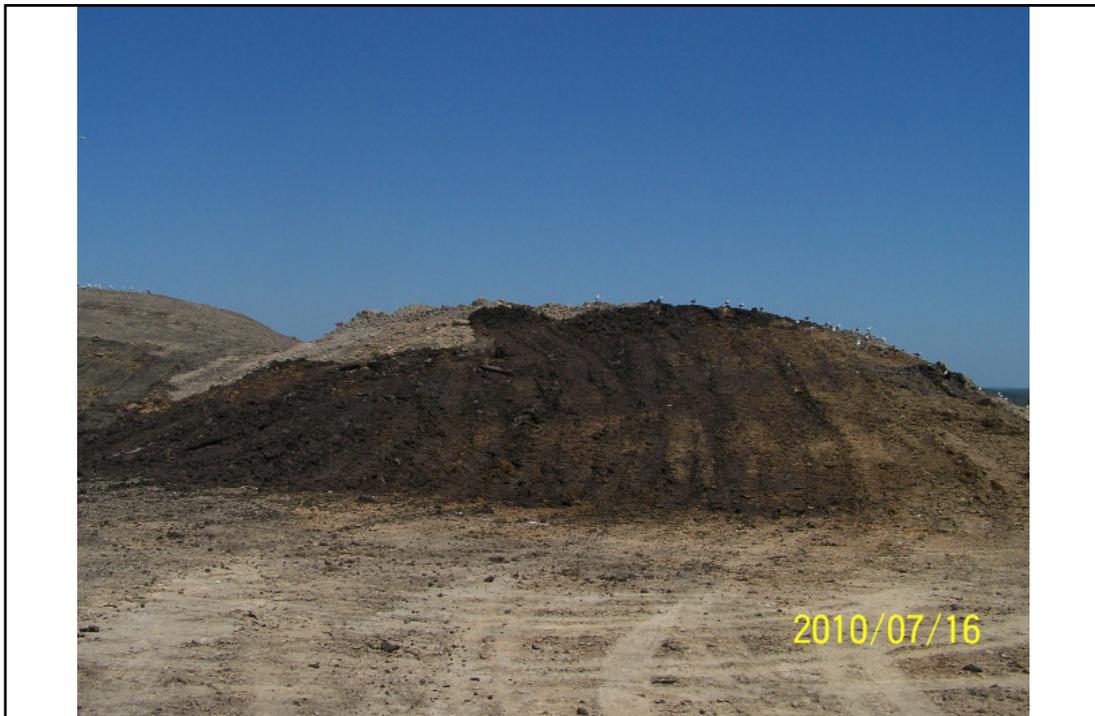
Bio Soils over Phase 2

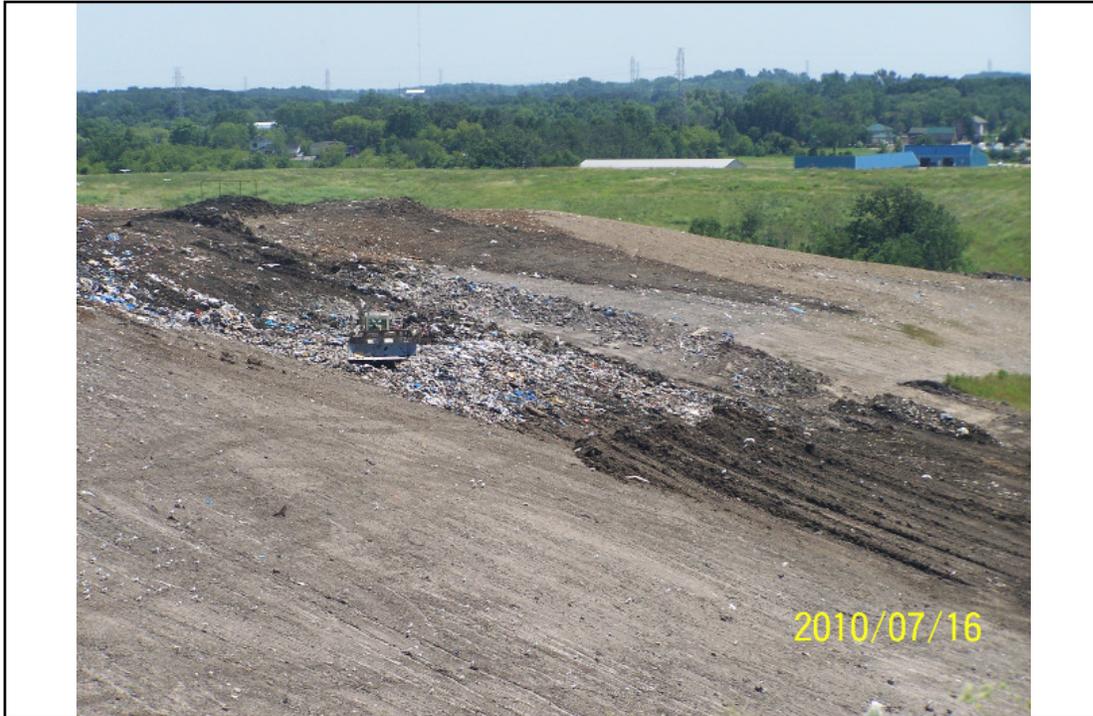
Working face, deep in Phase 6E's Western slope recovering air space

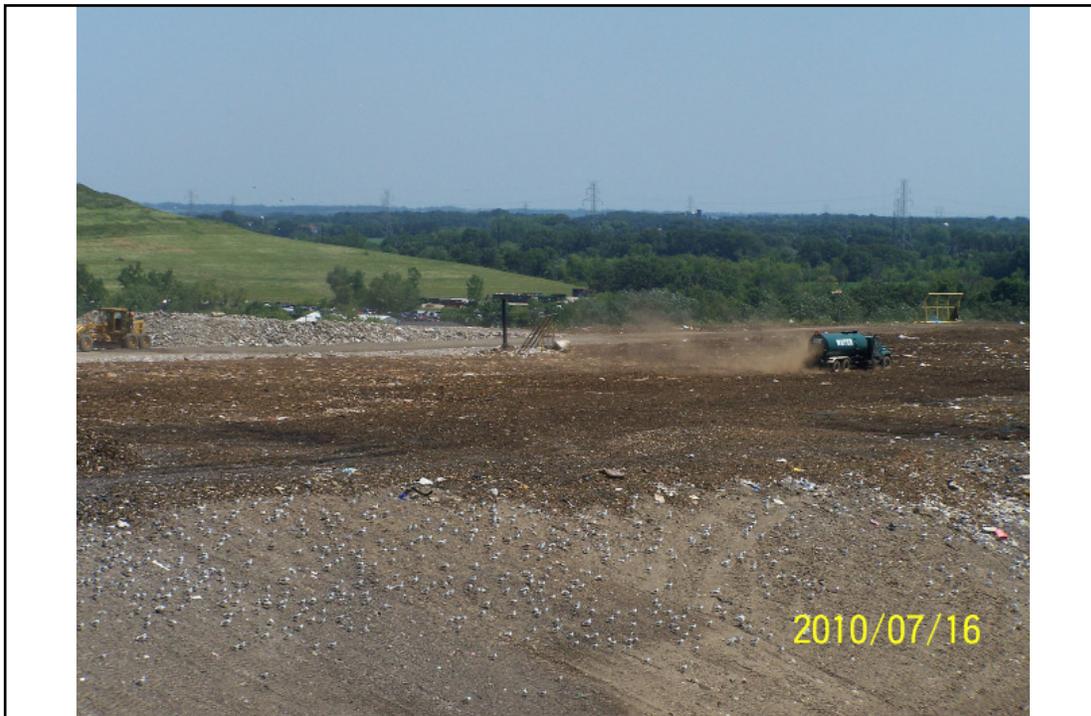
Top of Phase 5 & 6

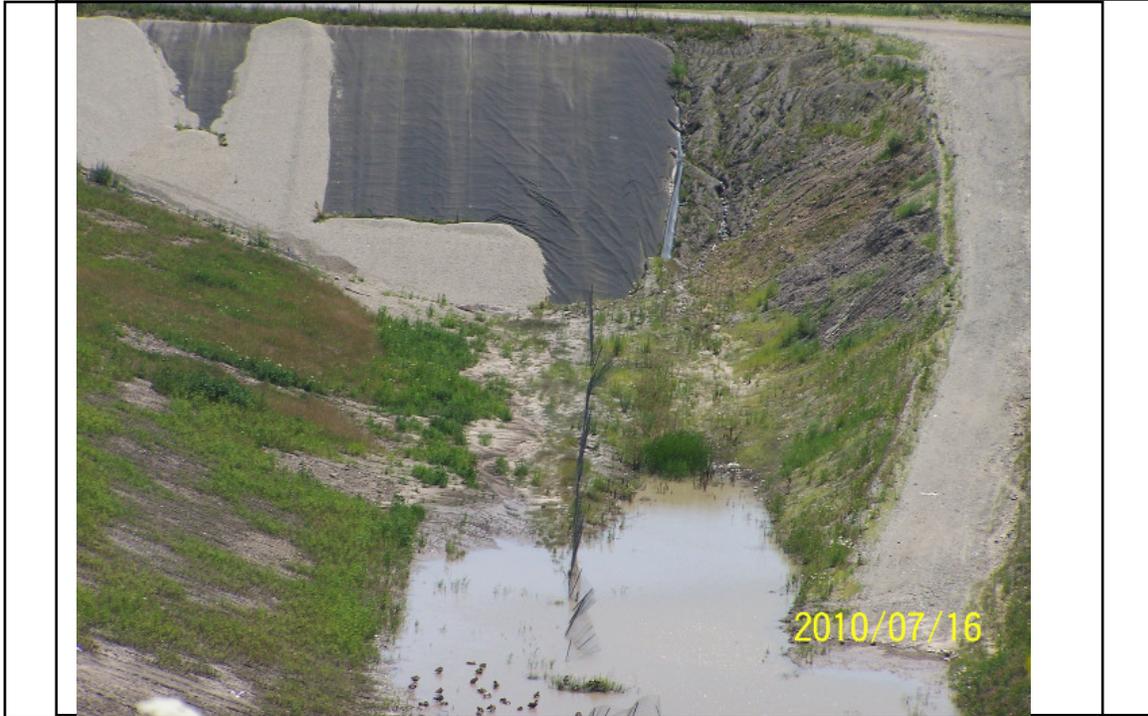
Temporary sed basin, overflowing due to rain events

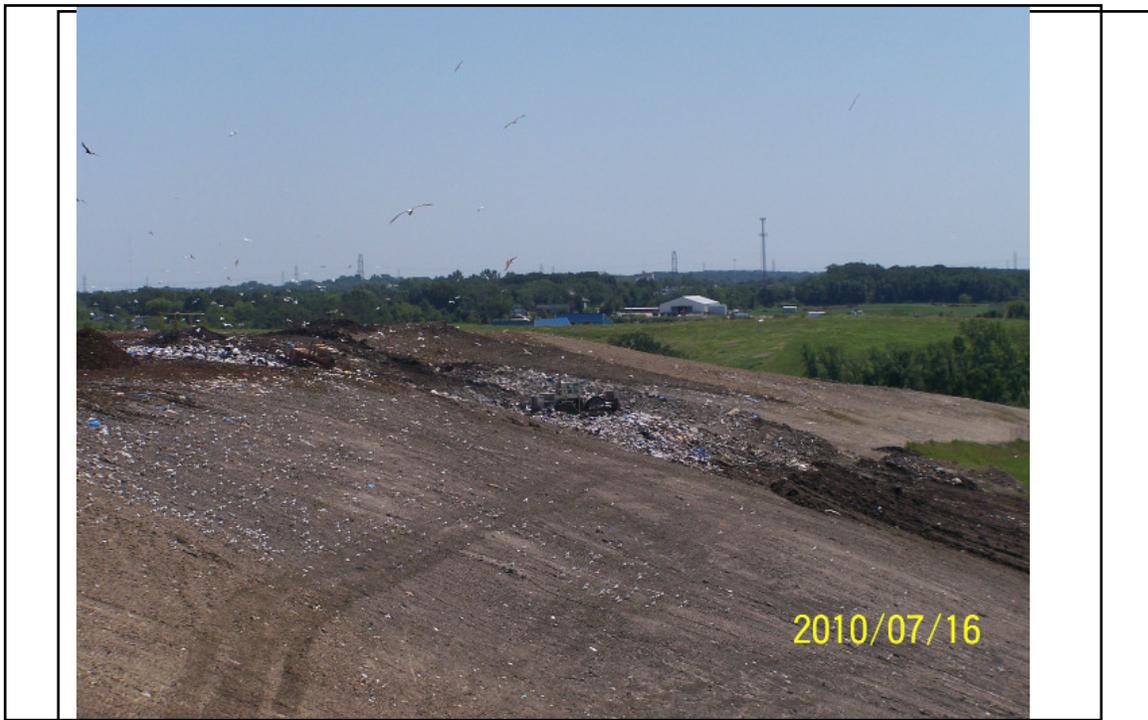
West slope of Phase 6

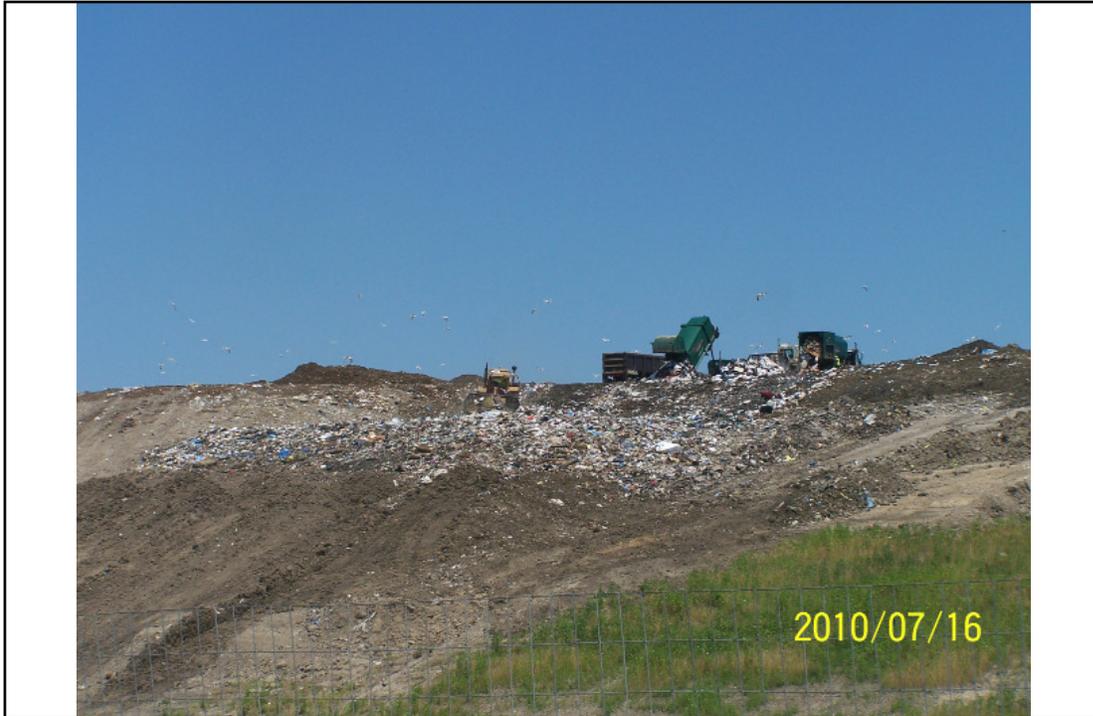
Working face viewed from Southwest

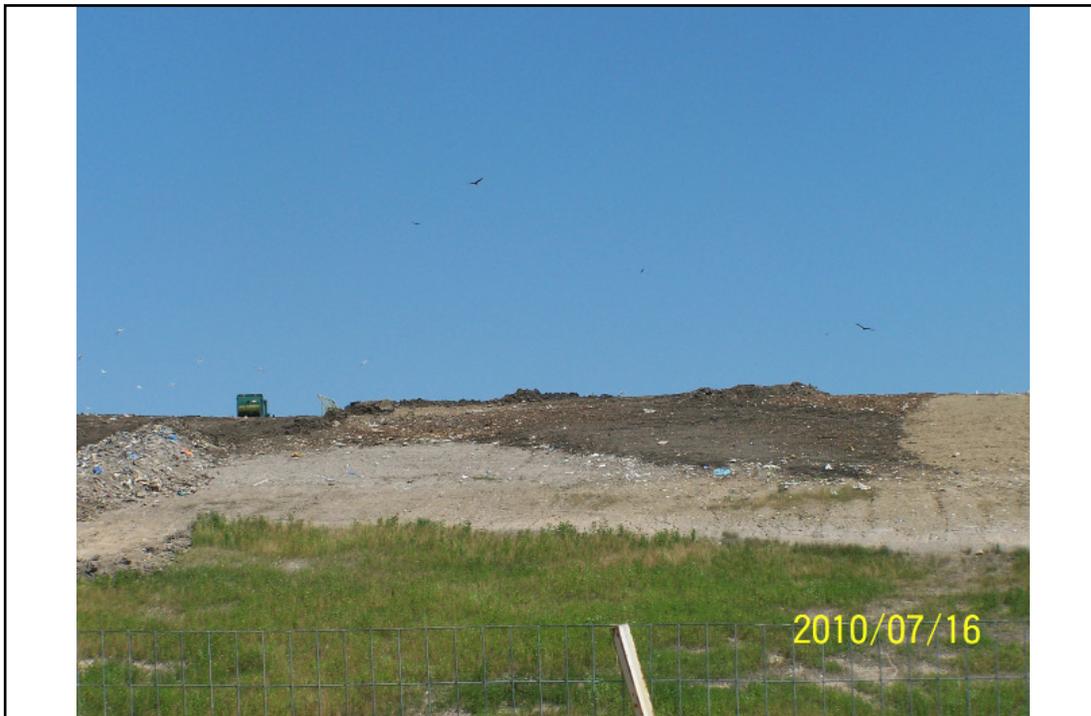
Areas of newly placed intermediate cover

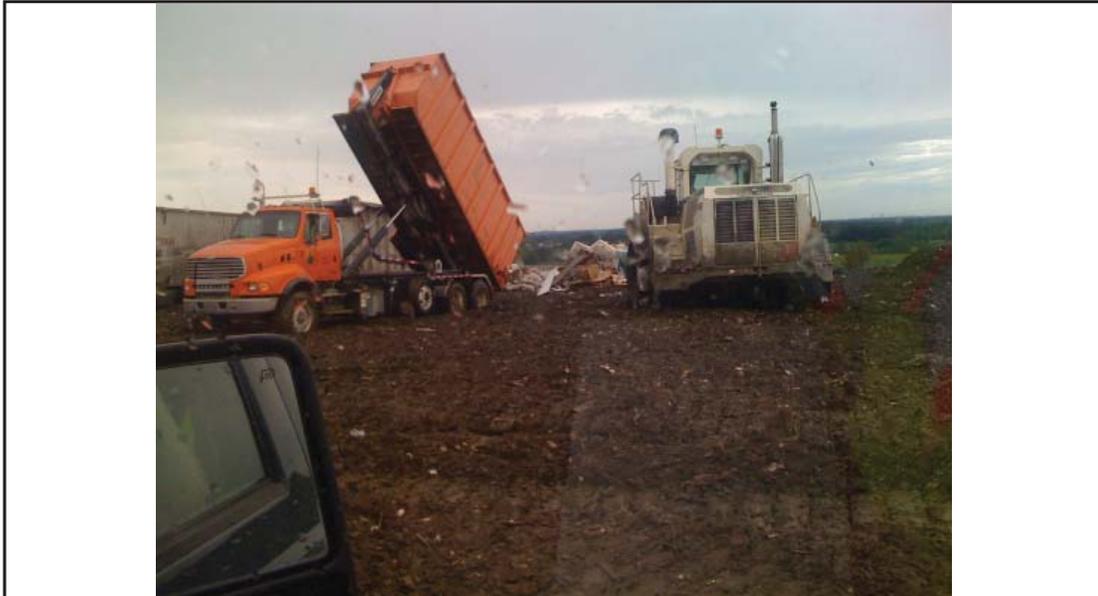
Tipping in active area

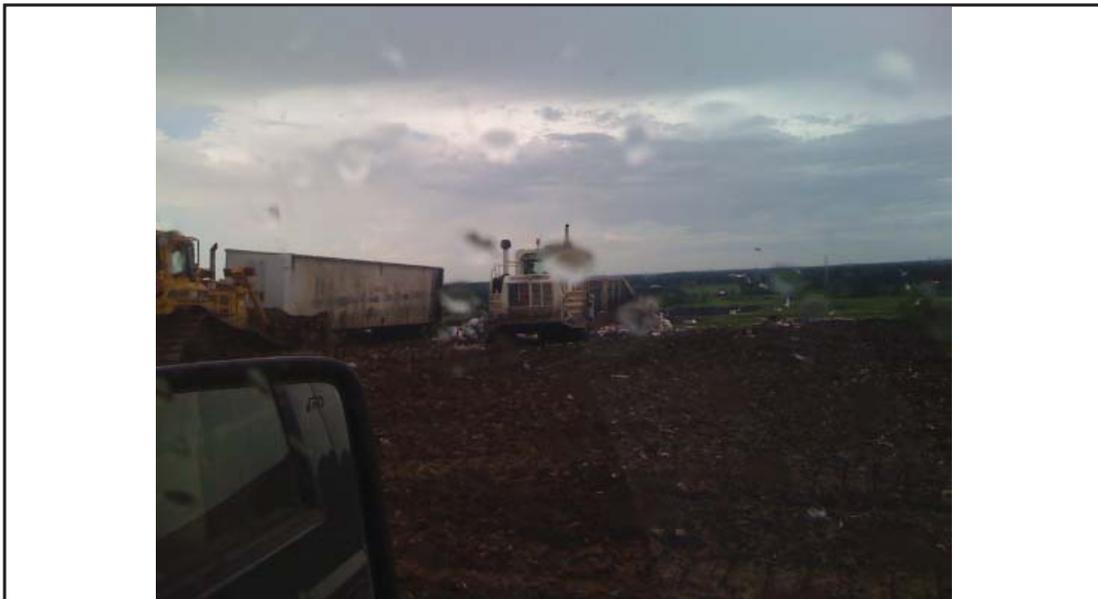
Tipping in active area

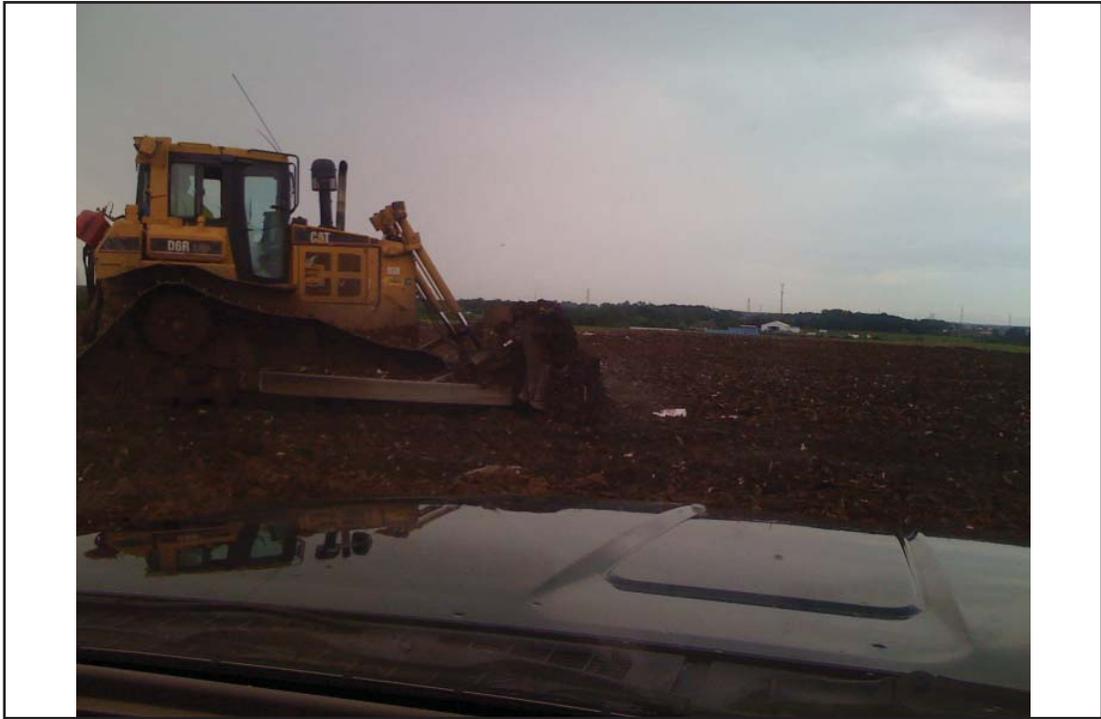
Active area

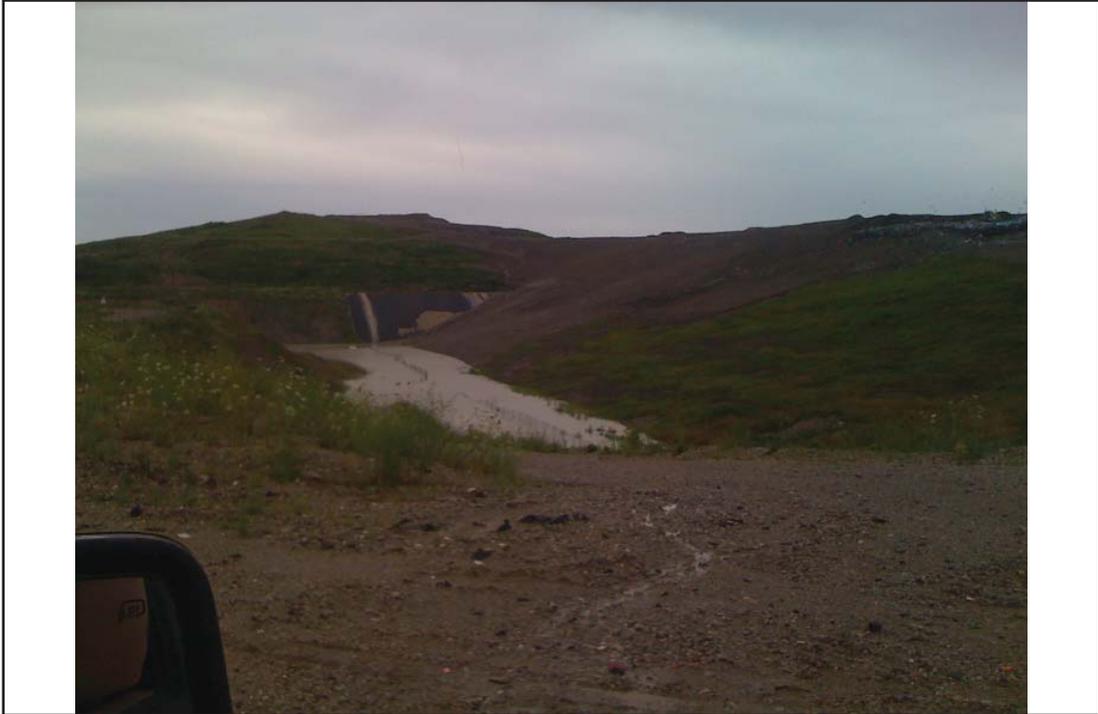
Catch basin

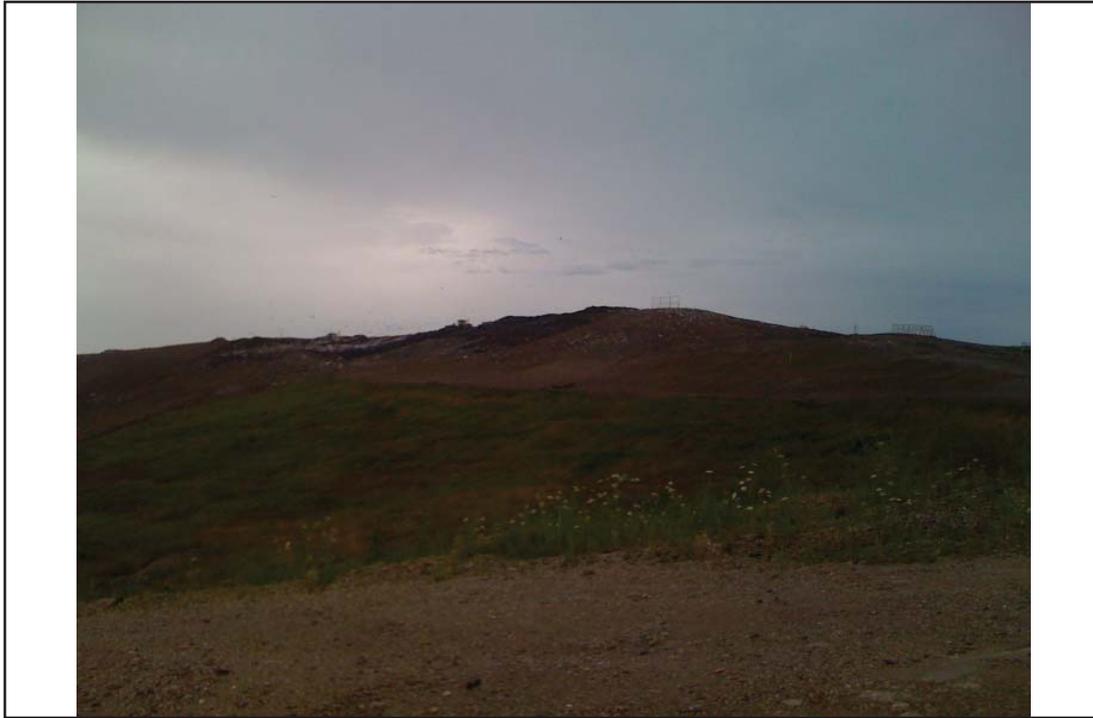
Working face

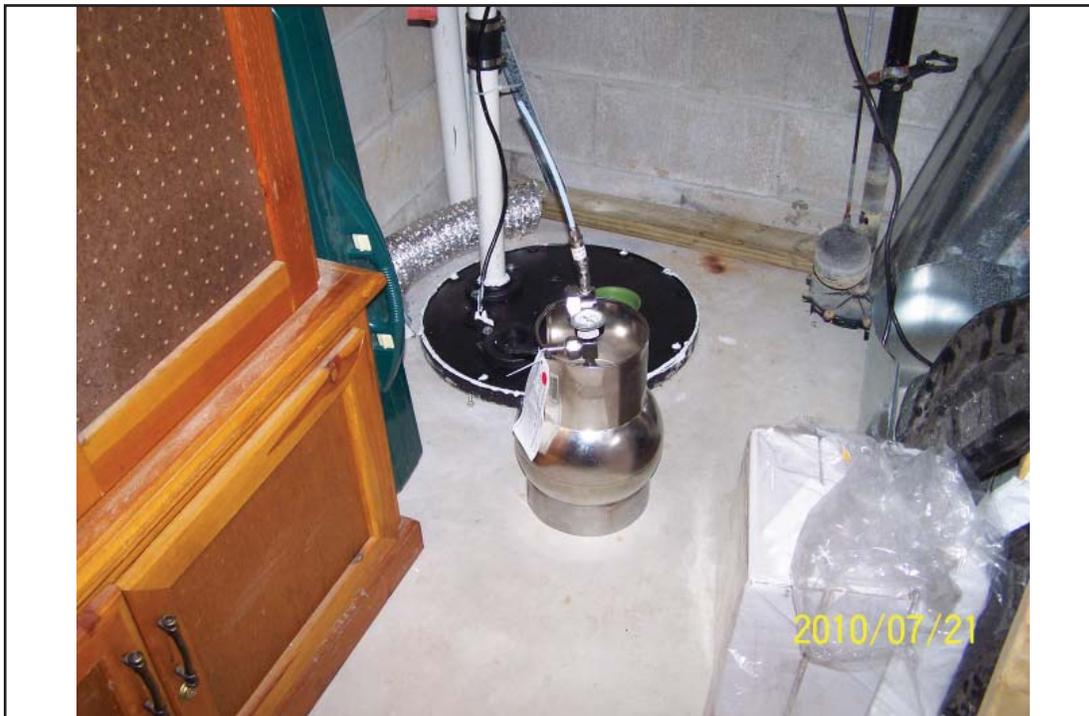
Summa Canister doing air sampling

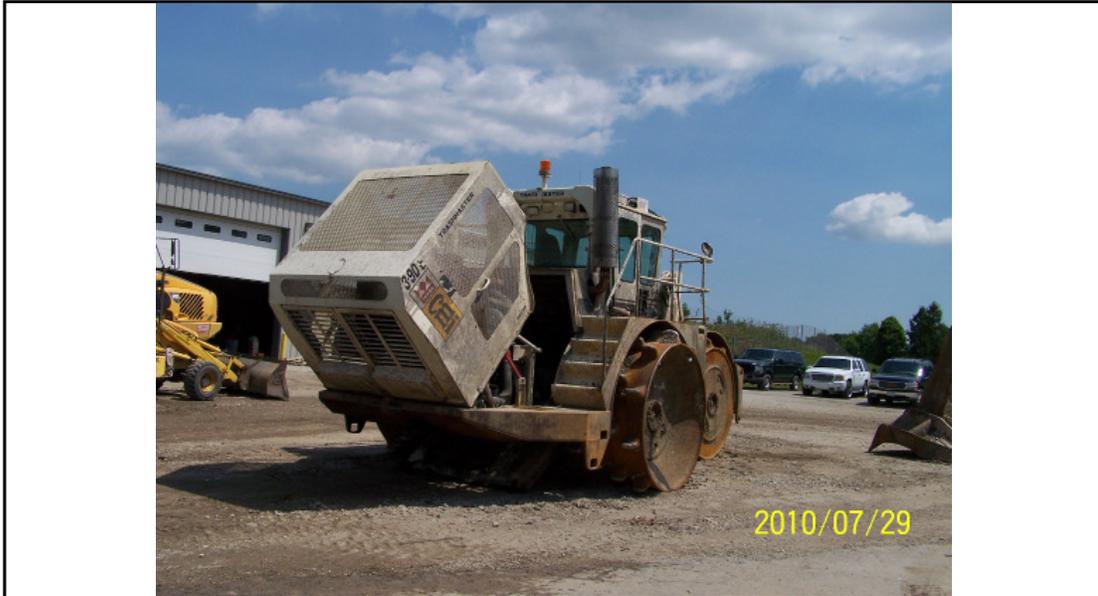
New compactor for Site

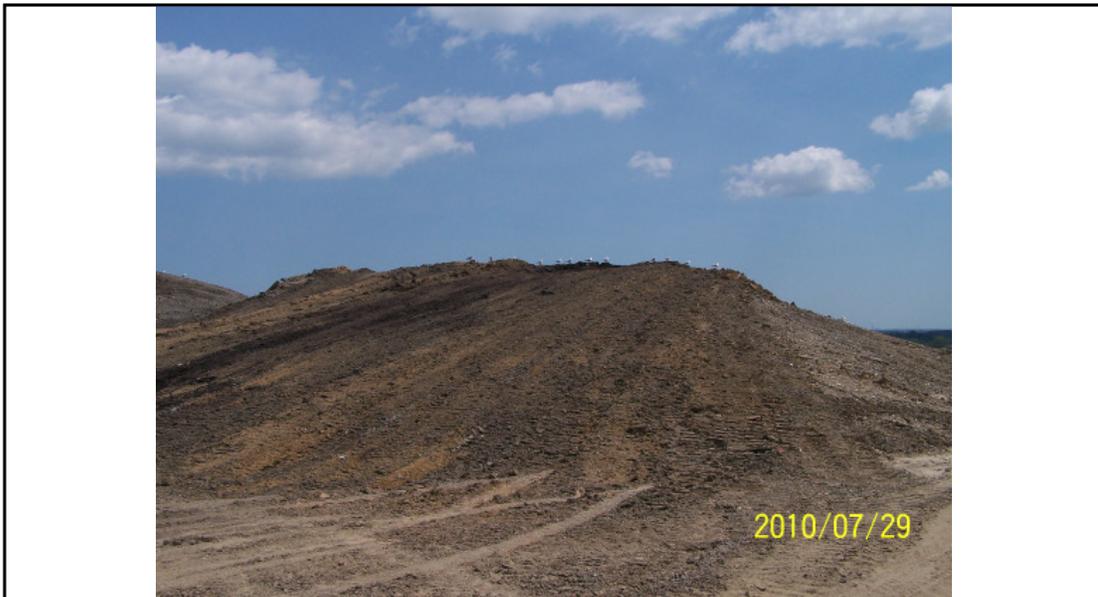
Bio soil stock piled on Phase 1 & 2

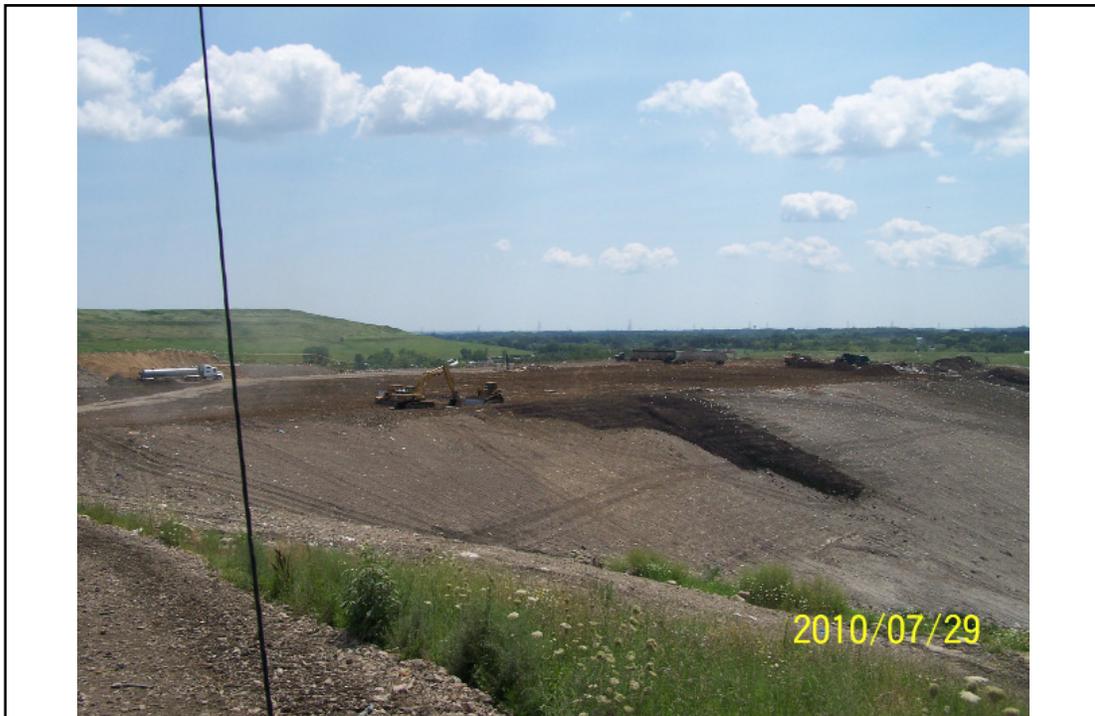
Active area viewed from the Northeast

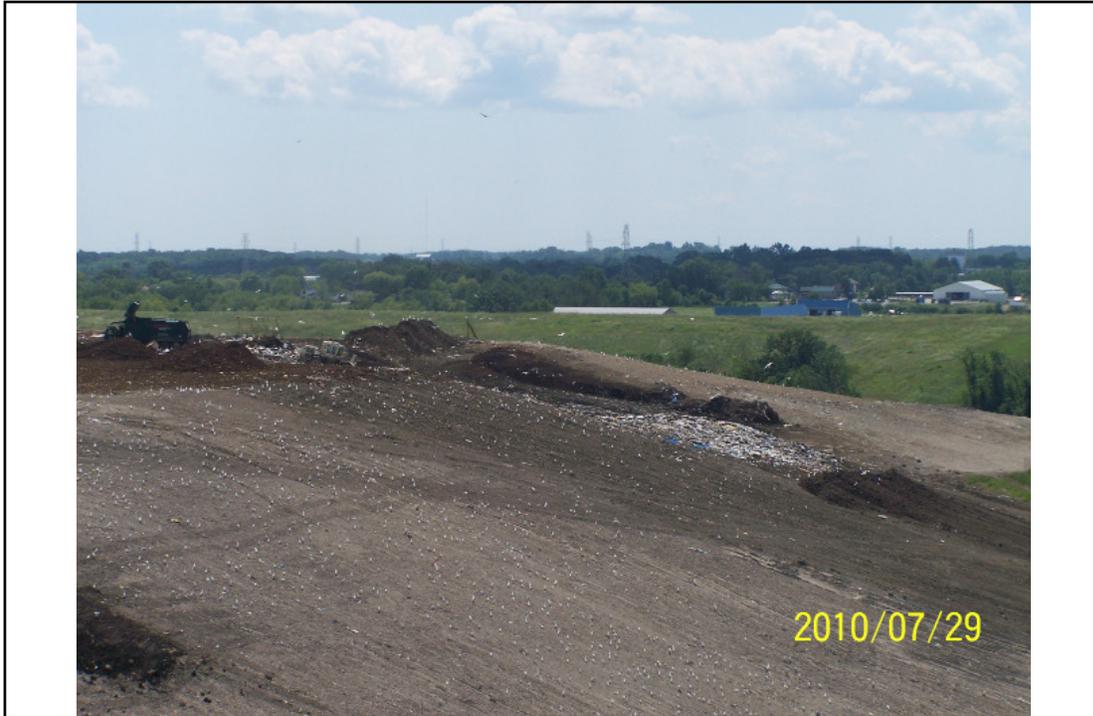
Working face

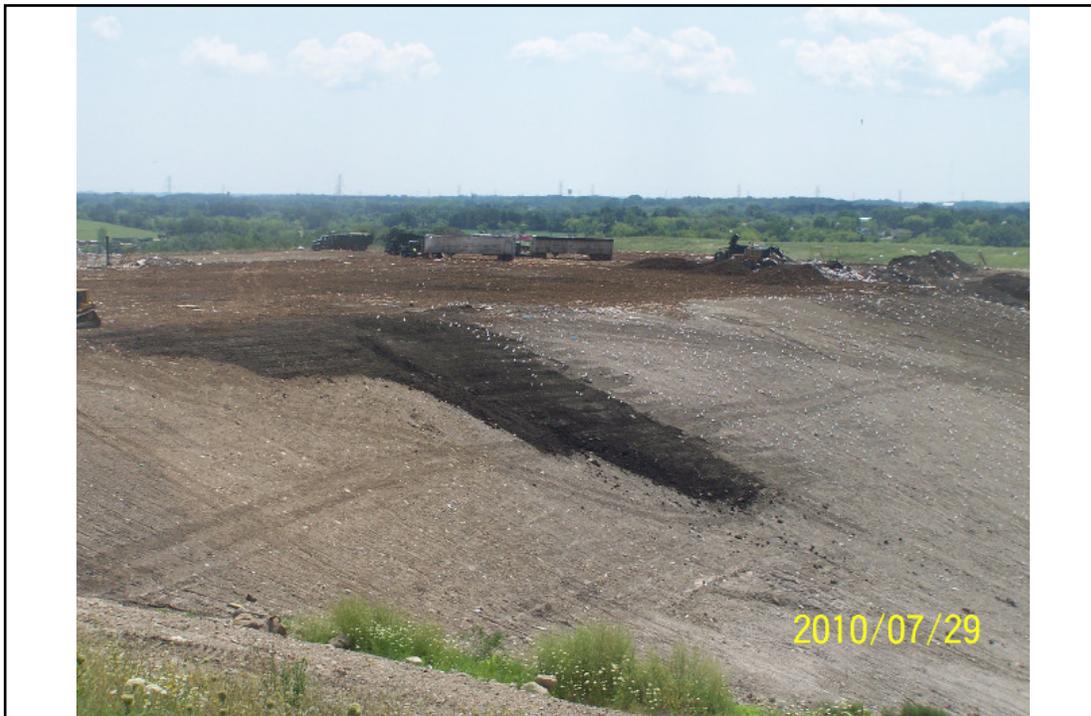
Side slope regraded after waste placement

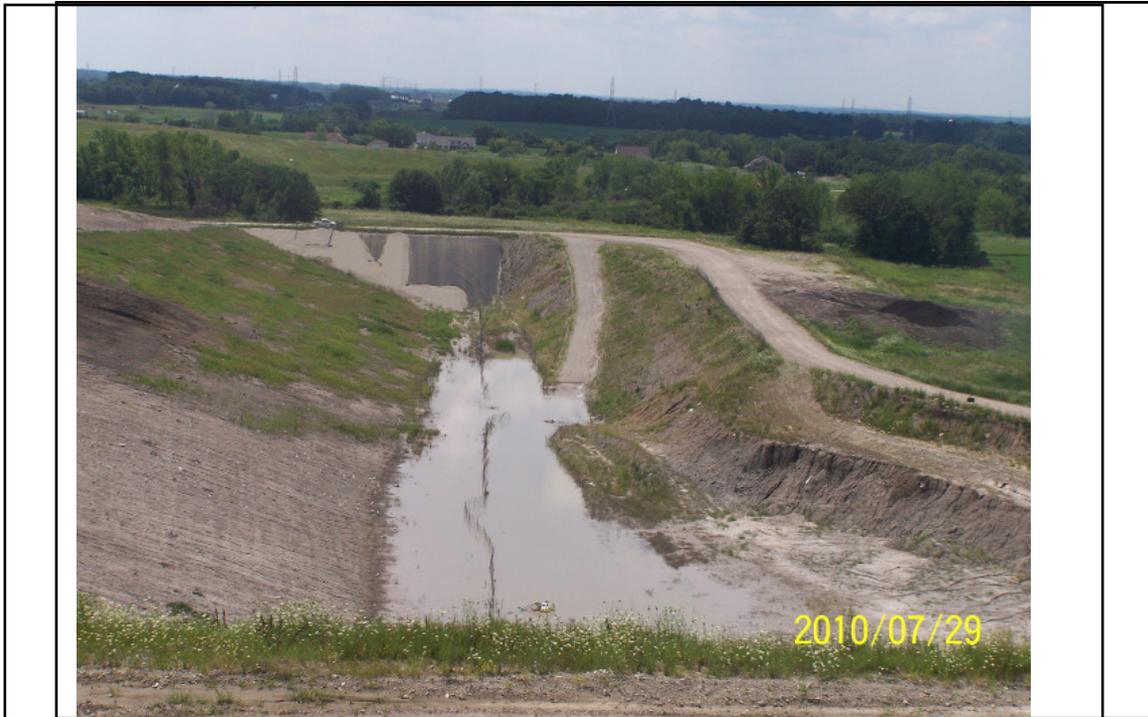
Temp Sed basin pumped down some since previous Audit

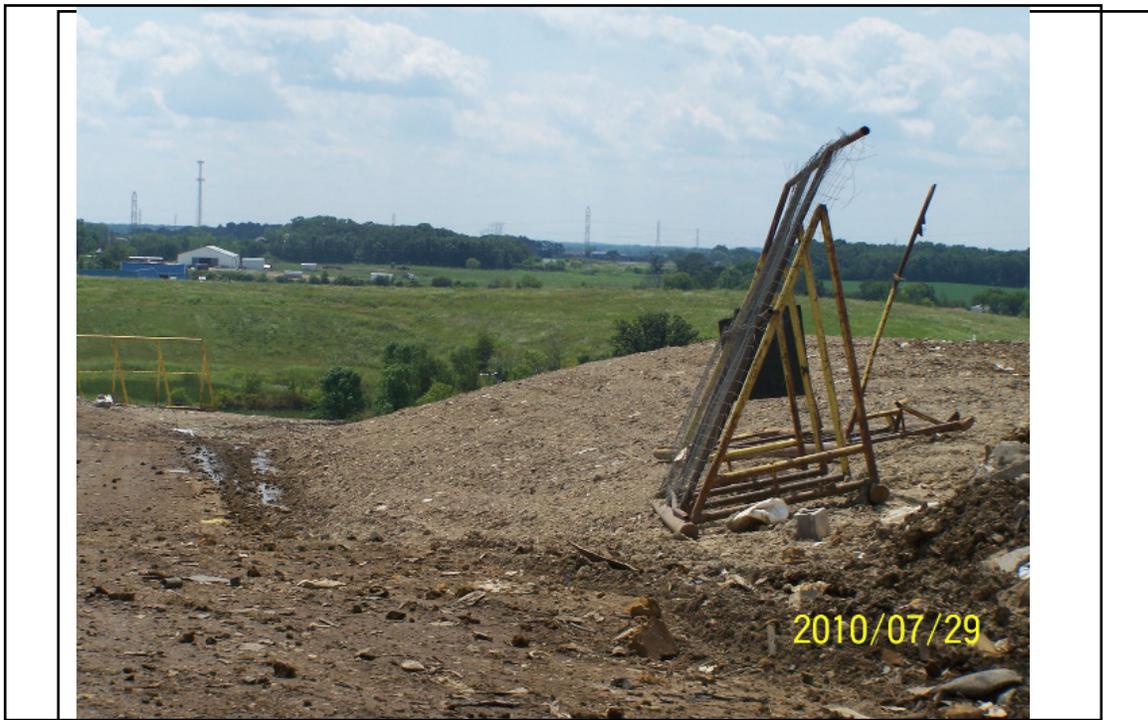
Slope cover now soil instead of auto fluff

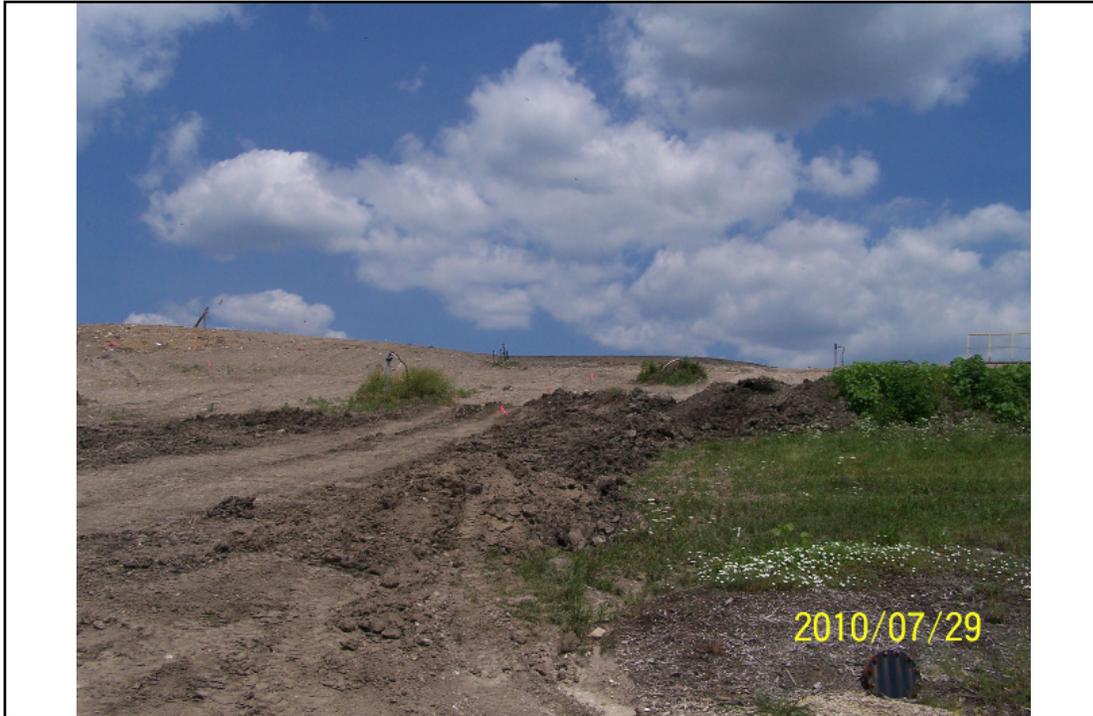
South slope of Phase 5, awaiting silt fence

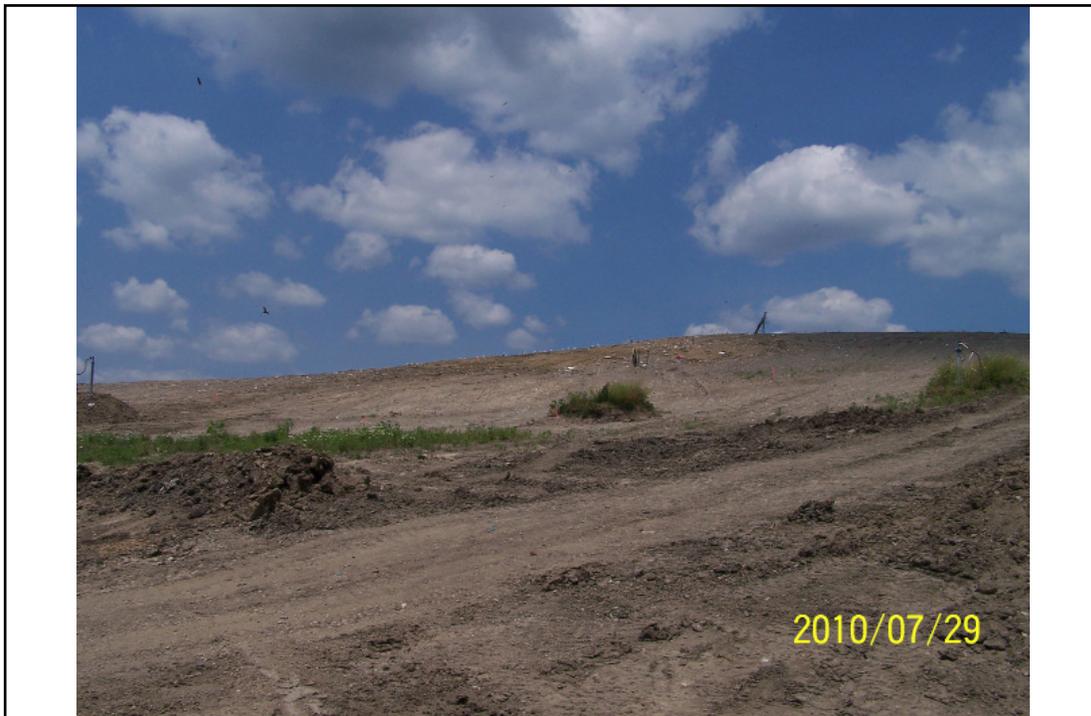
South slope of Phase 6

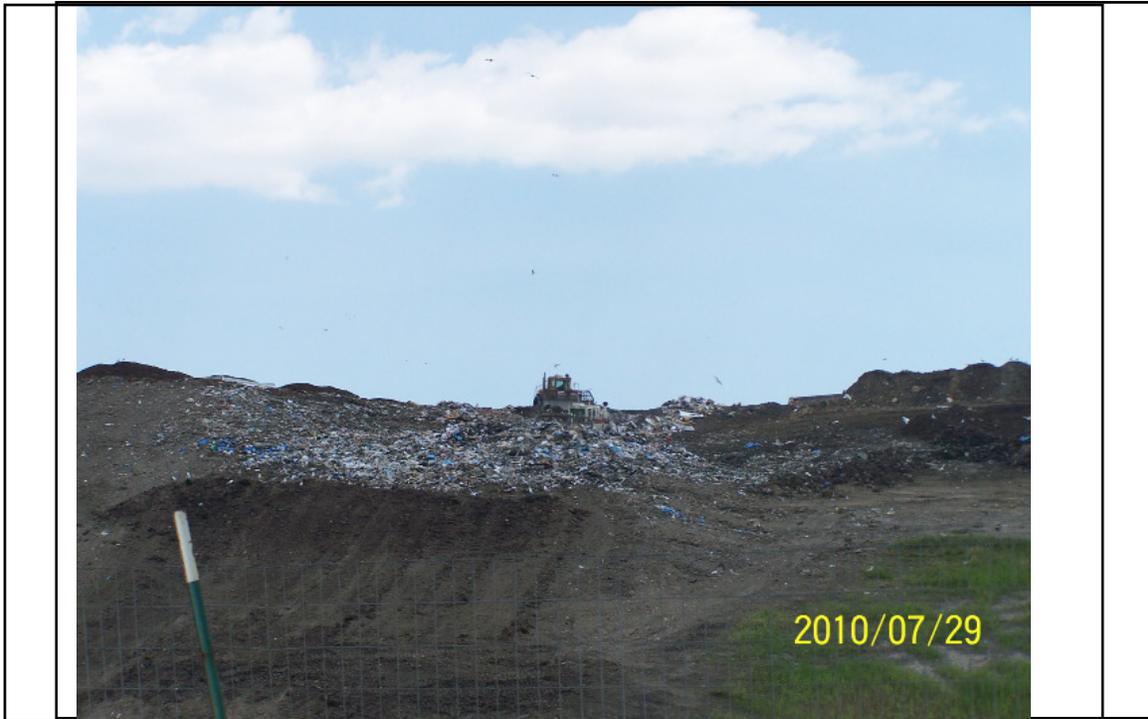
Working Face viewed from the West

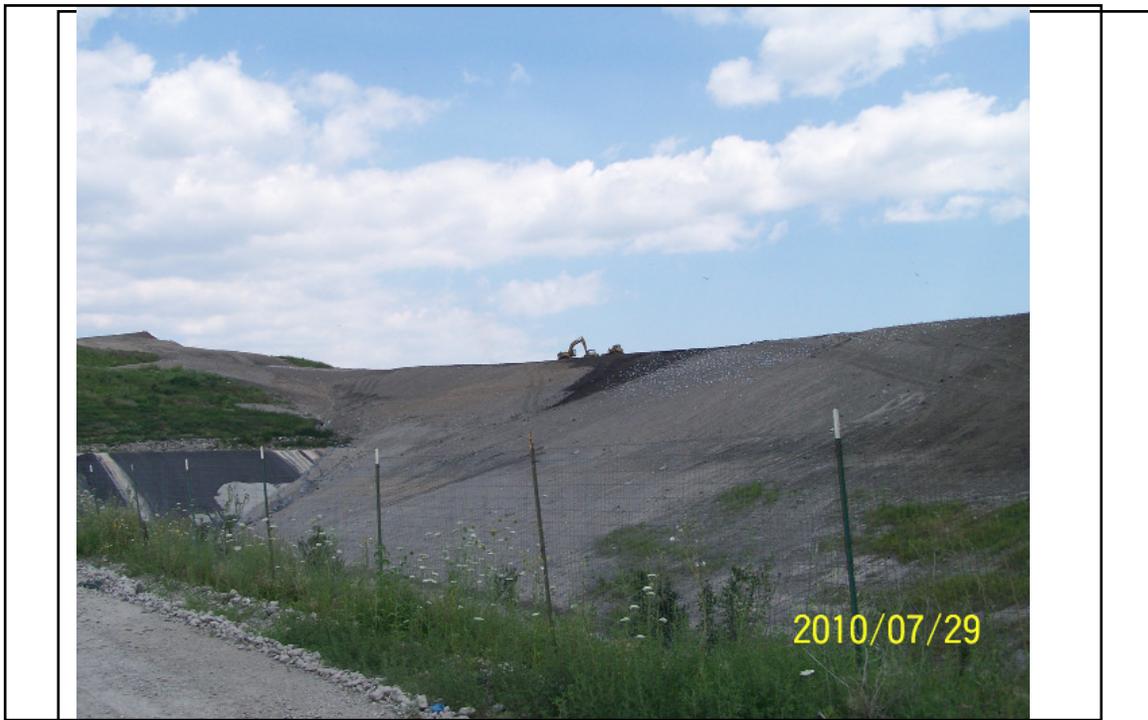
West Slope of Phase 6

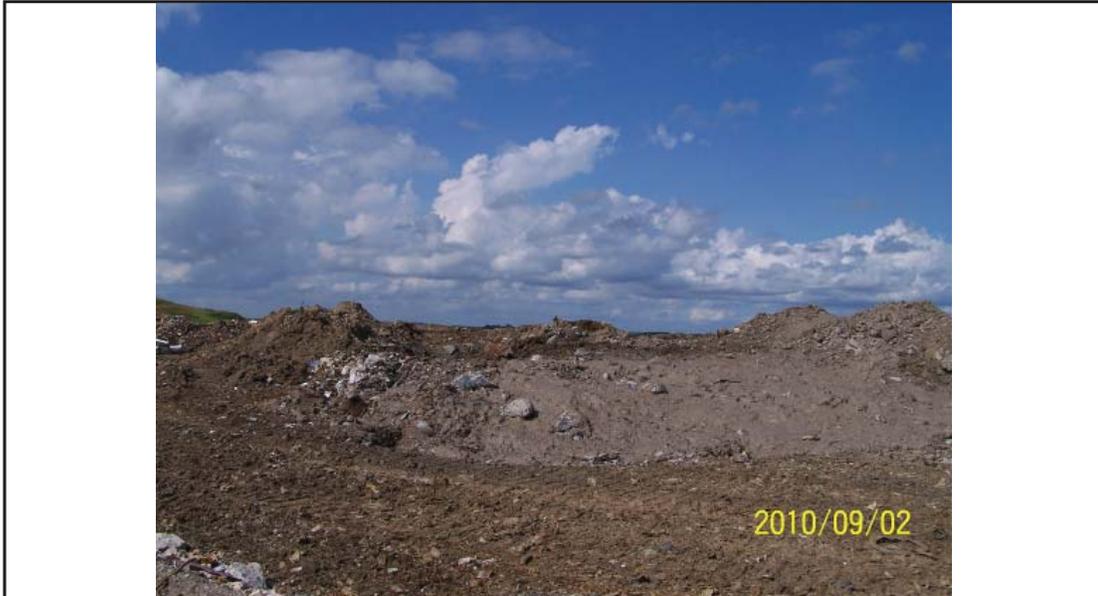
Covered asbestos pit
