VEOLIA EMERALD PARK LANDFILL  
CITY OF MUSKEGO

## 2010 Veolia Emerald Park Landfill Year End Compliance Officer Report and Audit Summary

**TO:** Veolia Emerald Park Standing Committee  
**FROM:** Jo-Walter Spear, Jr., P.E.  
**COPIES:** File  
**DATE:** 01/20/11  
**PROJECT NUMBER:** 1012

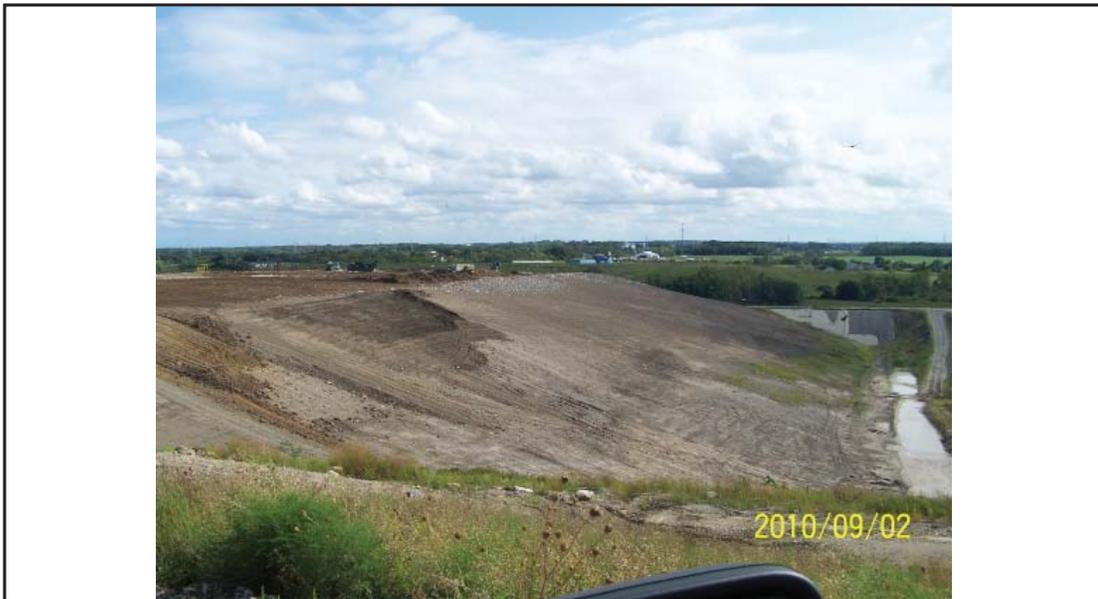
West slope of Phase 6, after slope reclamation completed

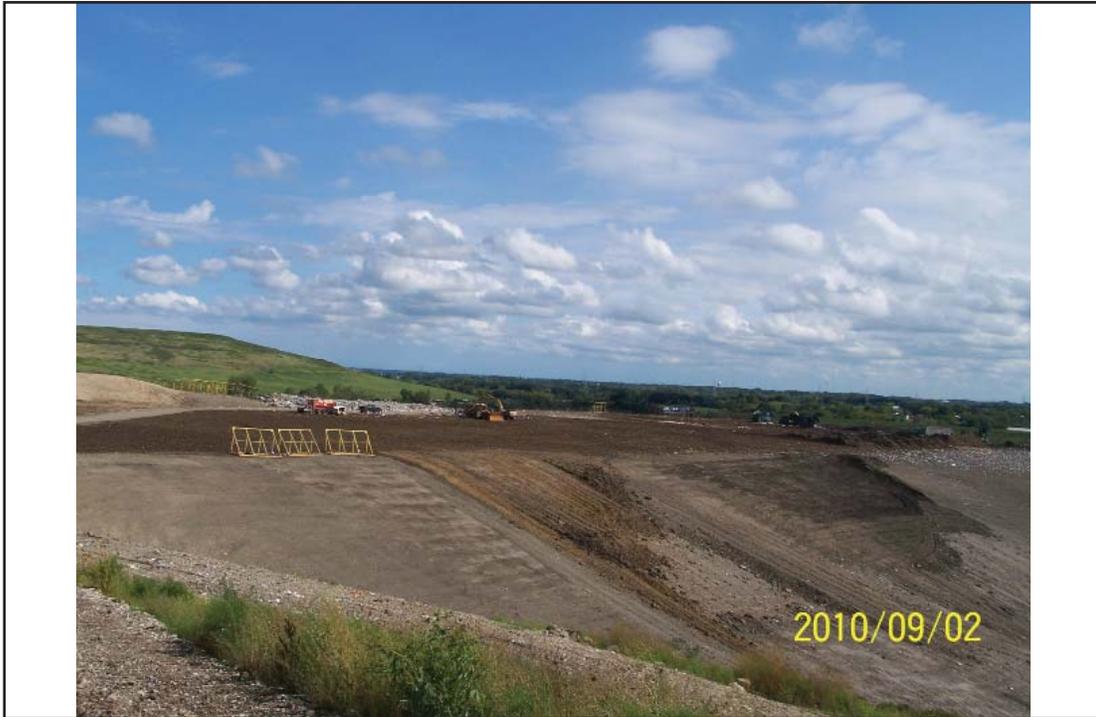
Active Area

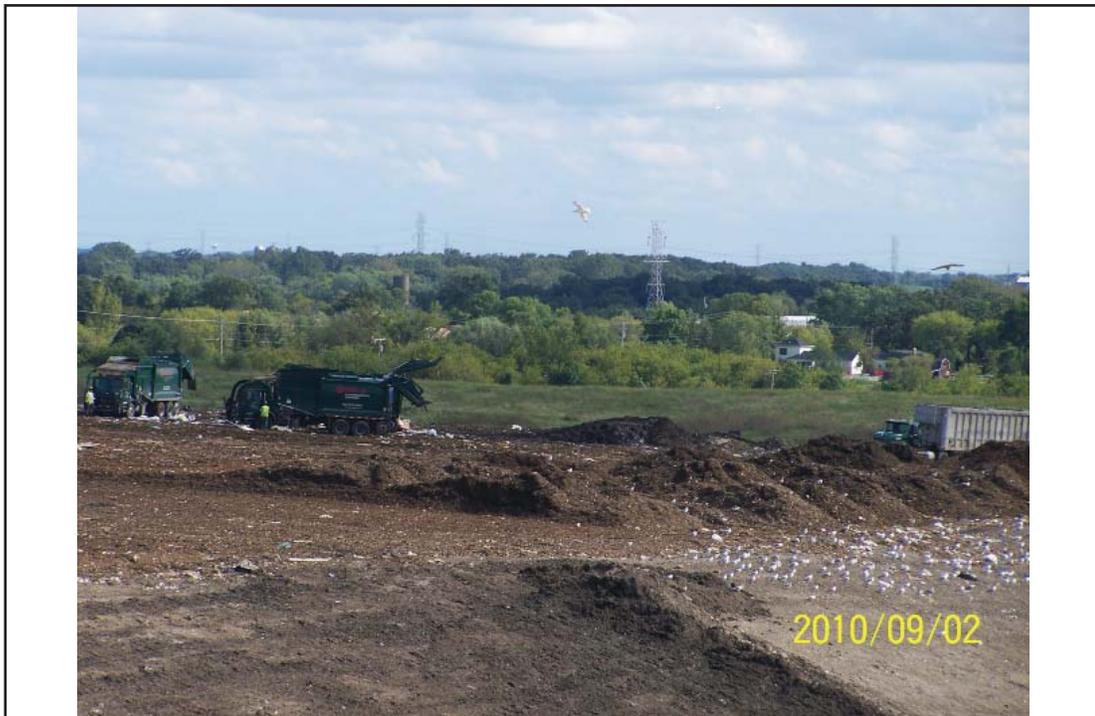
Autofluff stockpiled and being used on top of active area only, soils on slopes

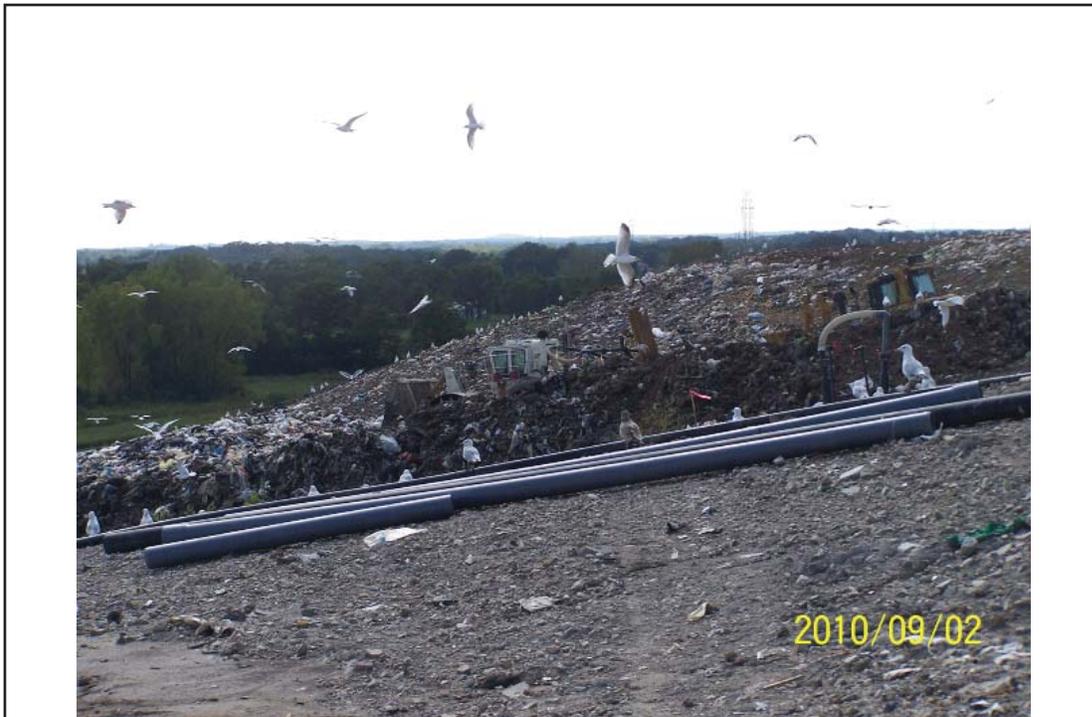
Piping prepared to extend wells on slopes

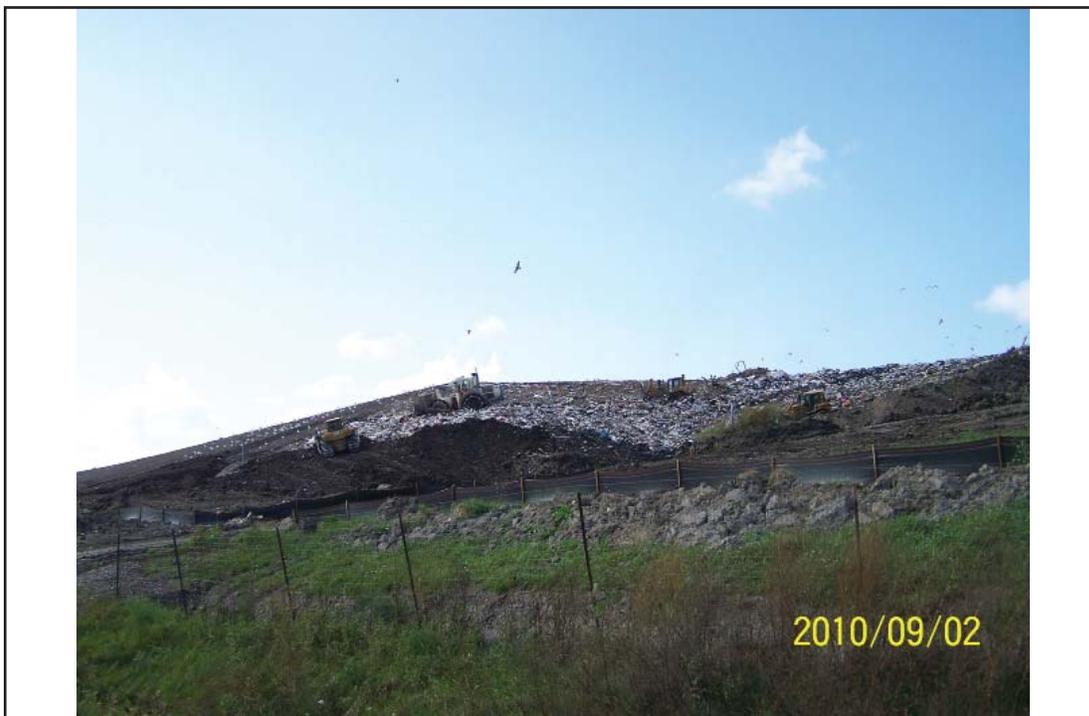
South slope undergoing filling

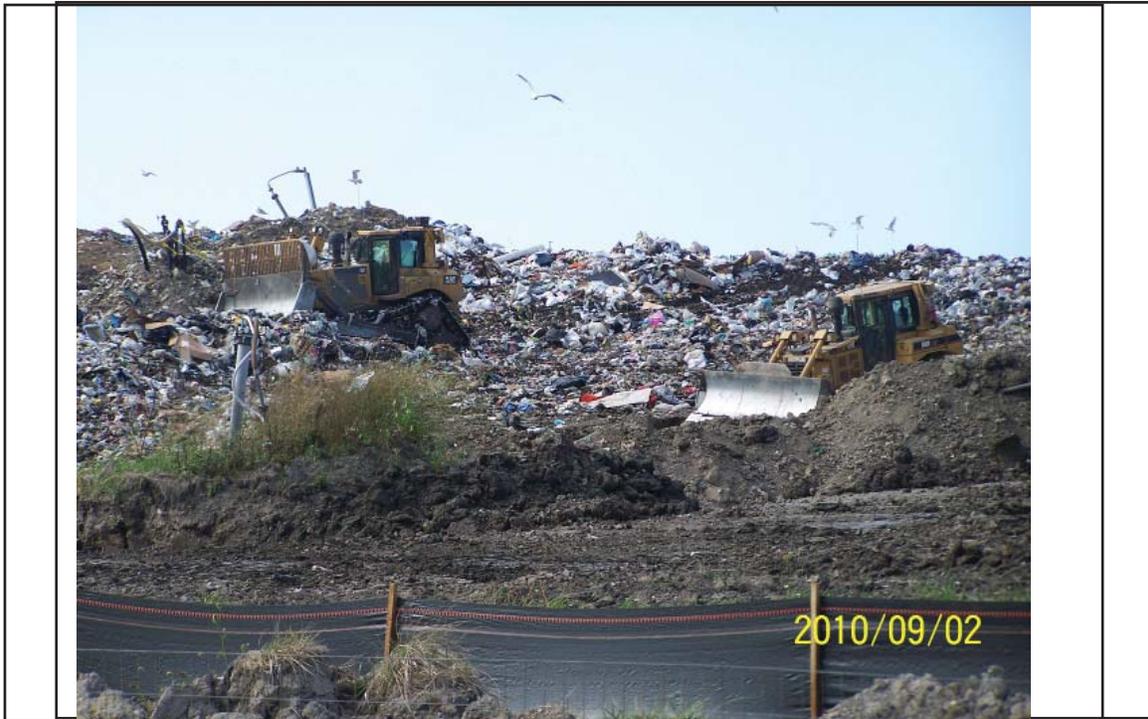
Working face on South slope

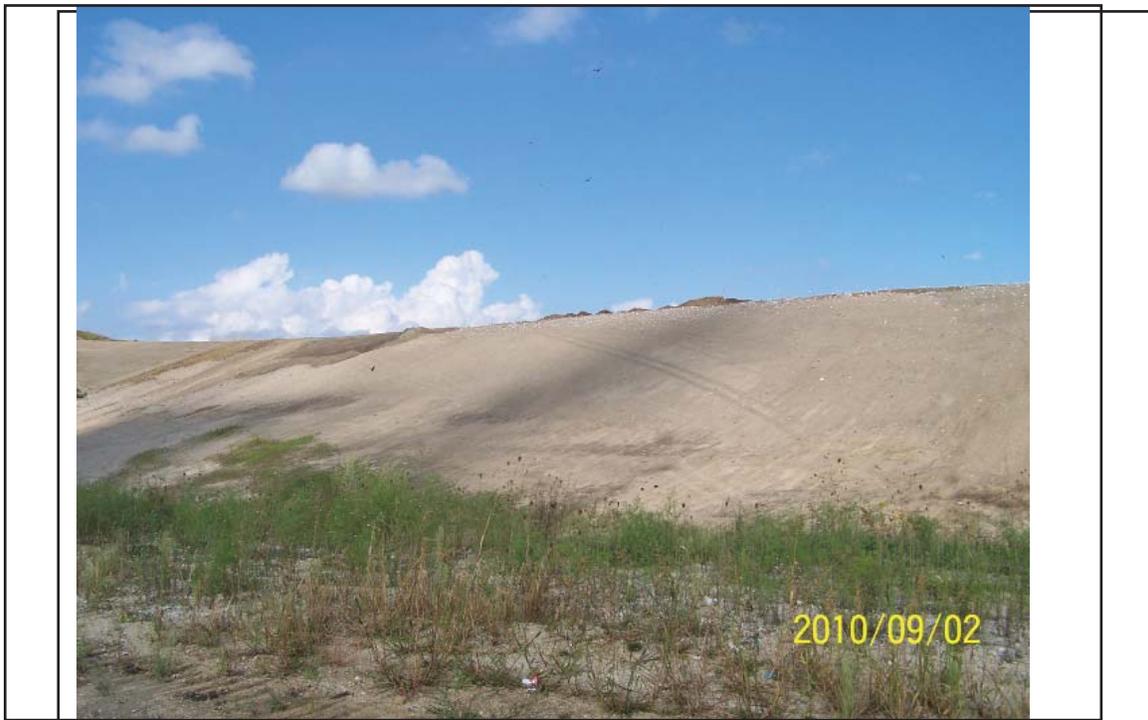
West slope of Phase 6

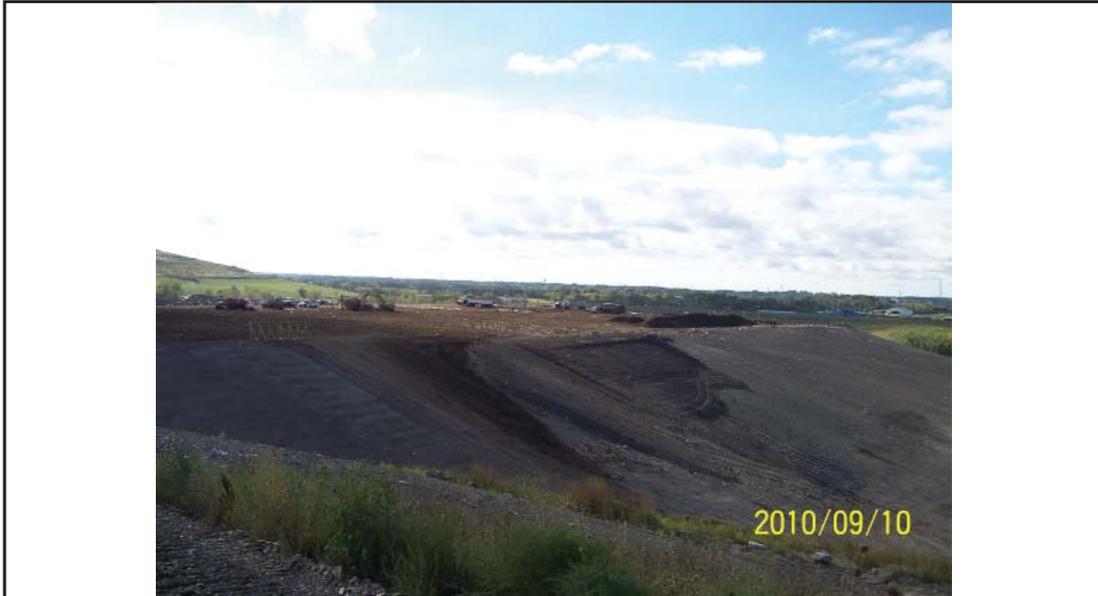
West slope of Phase 6

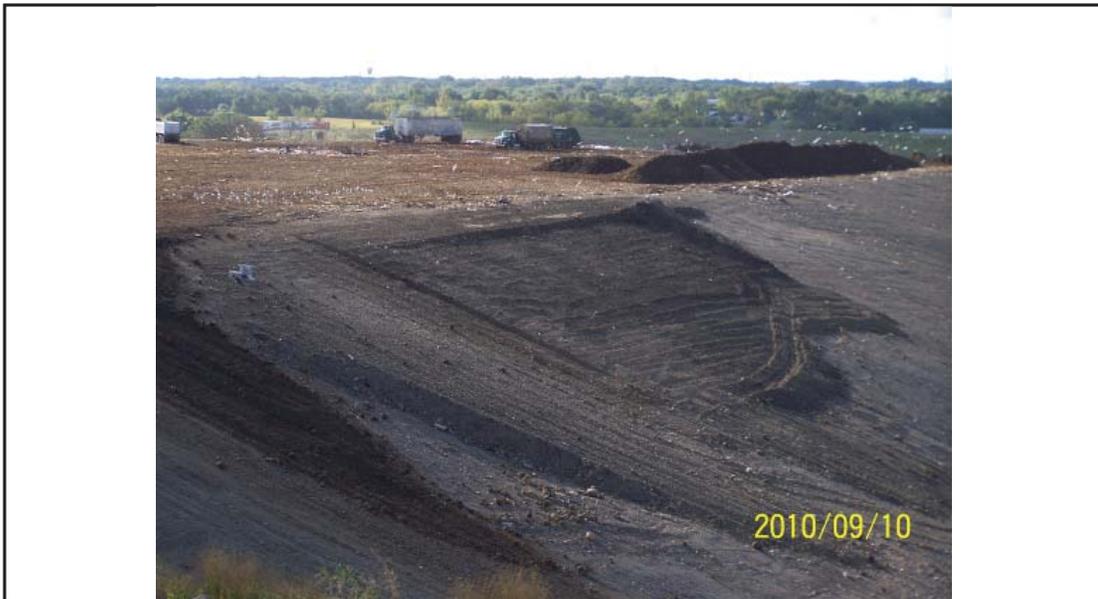
West slope of Phase 6, after slope reclamation completed

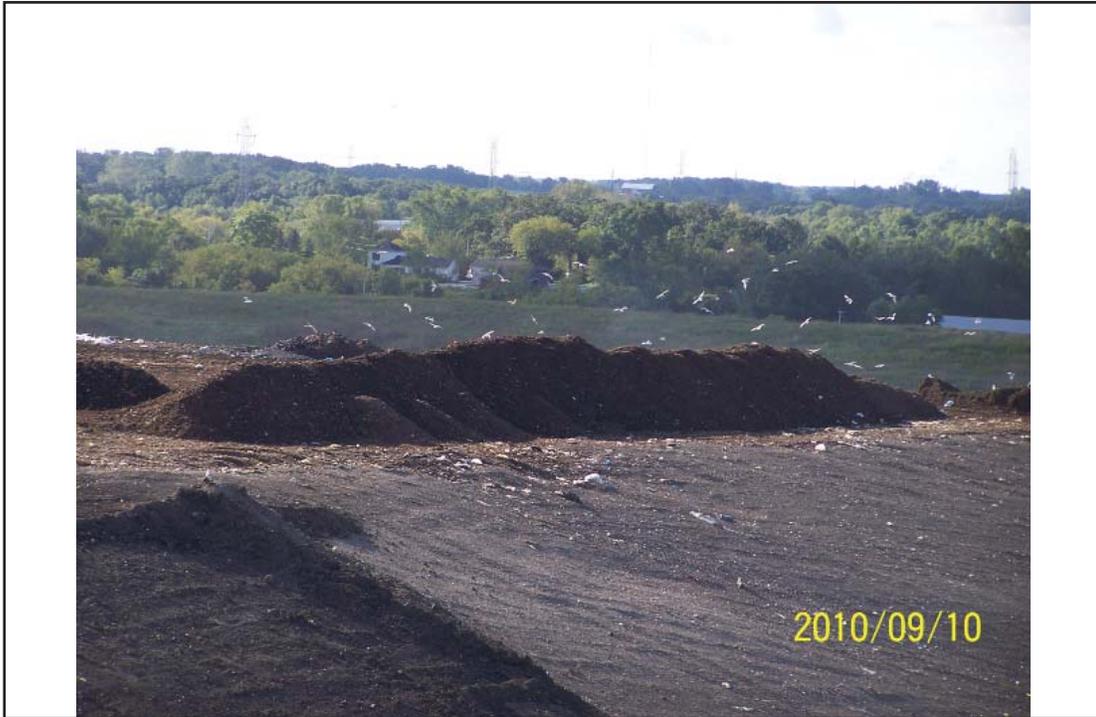
Active Area, more than adequate stockpiles of auto fluff

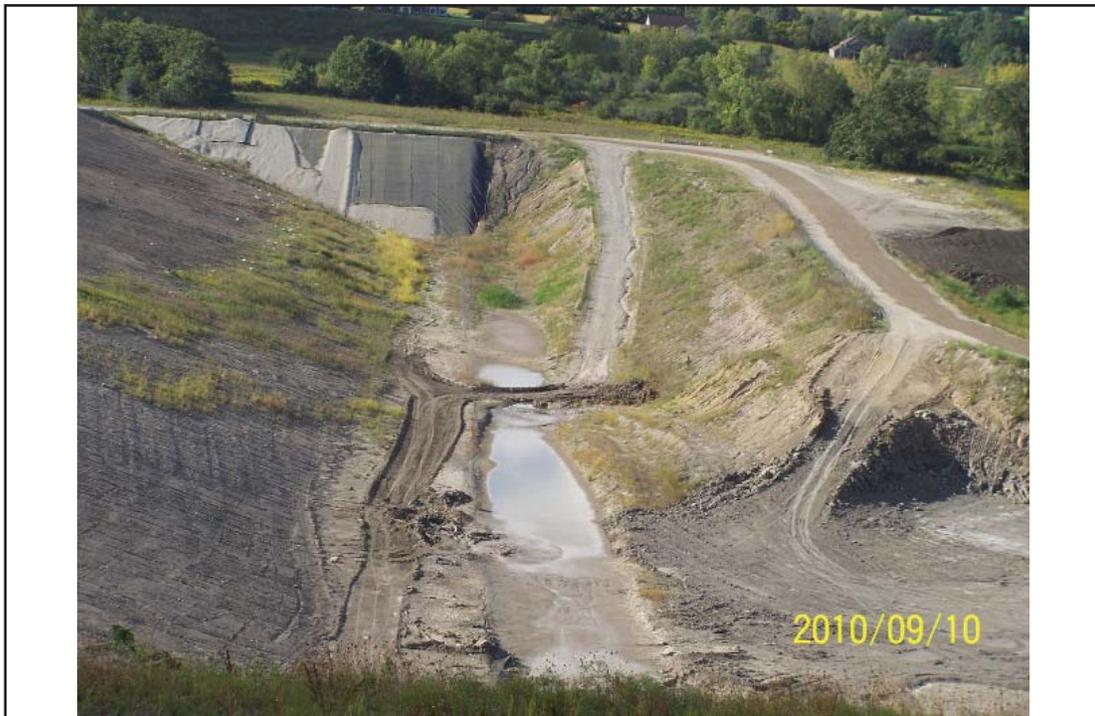
Temporary Sed Basin

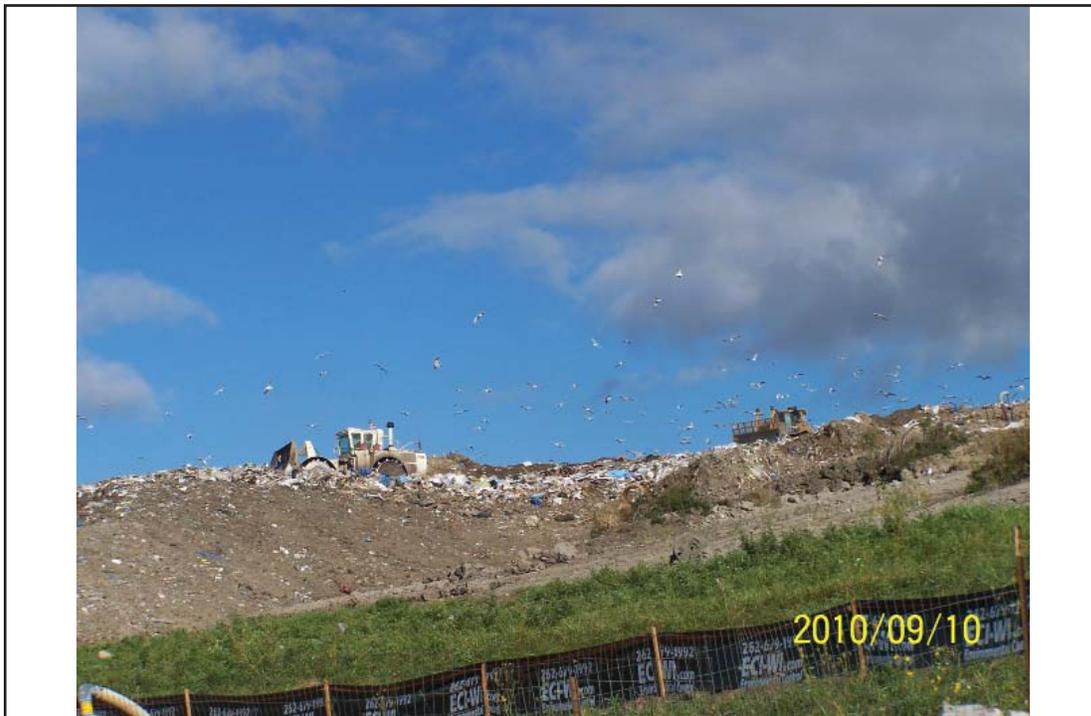
South slope undergoing filling

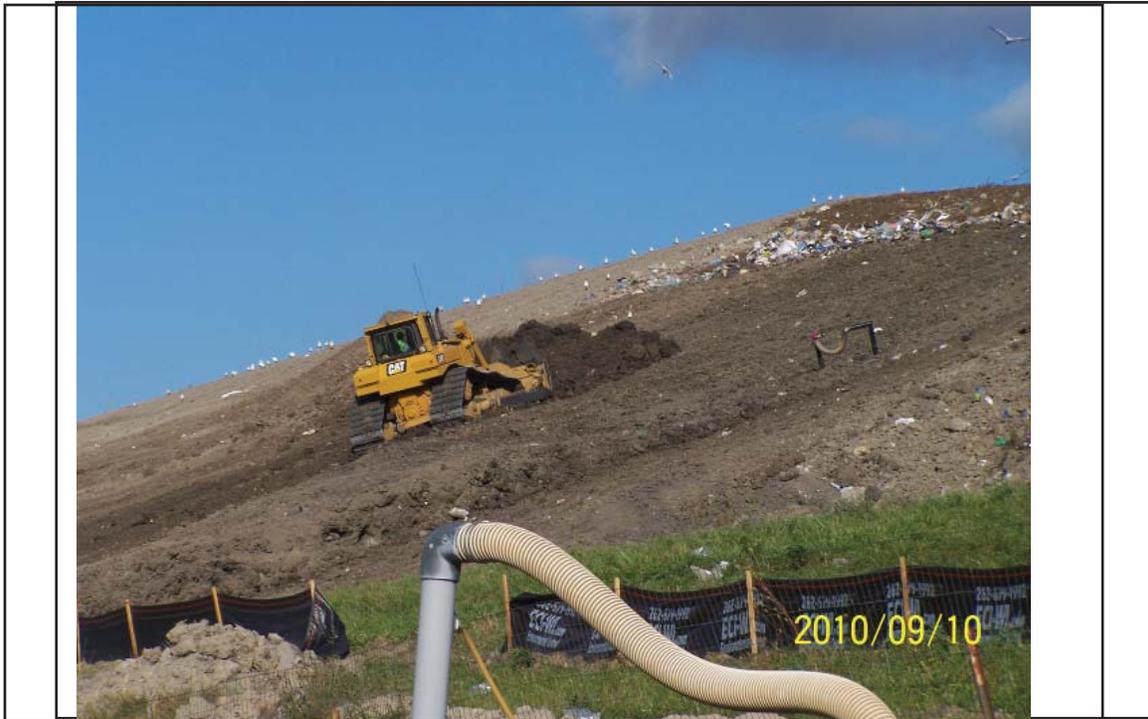
Dozer recovering intermediate cover for higher on slope

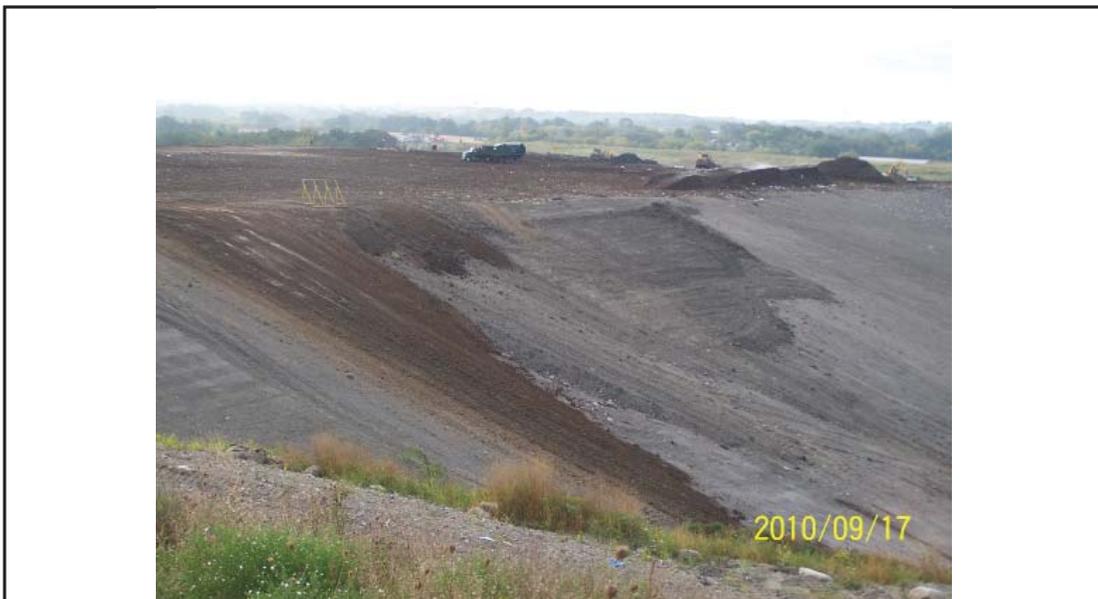
West Slope of Phase 6, additional soils from MMSD pipeline project

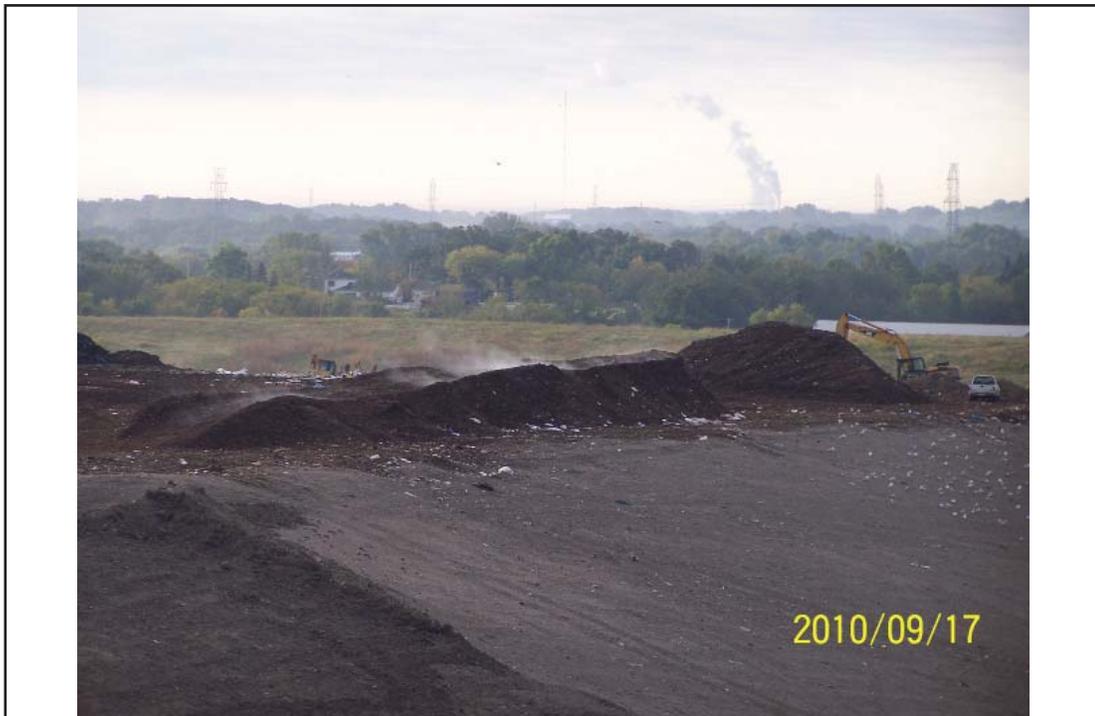
Working face at West slope edge

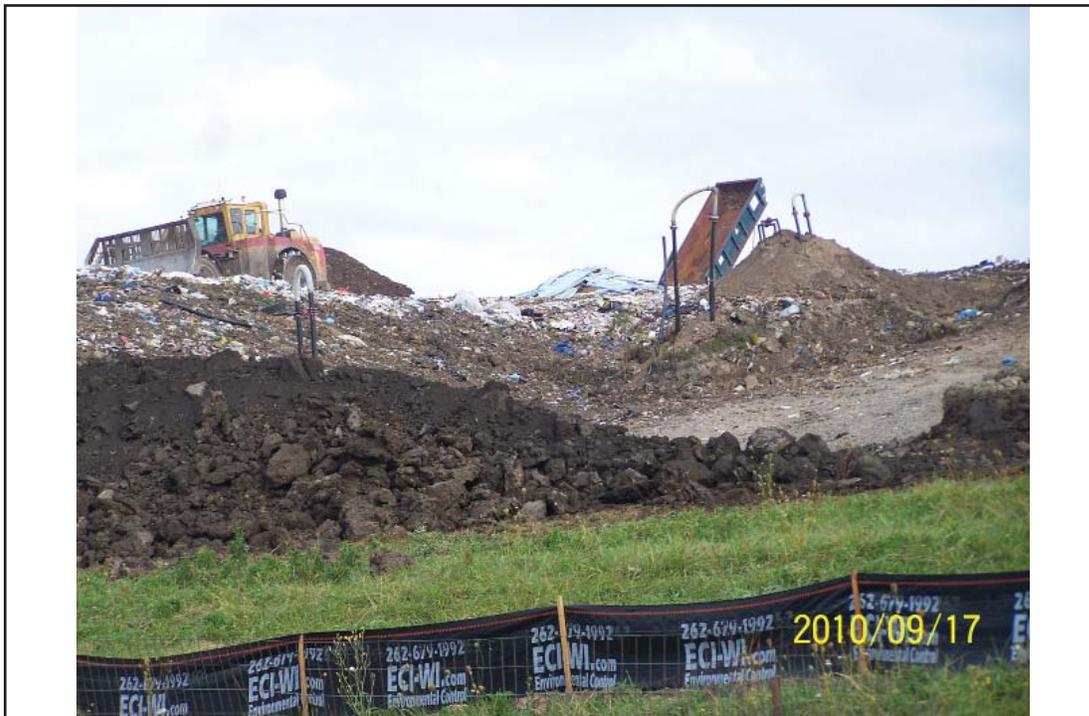
South slope undergoing filling

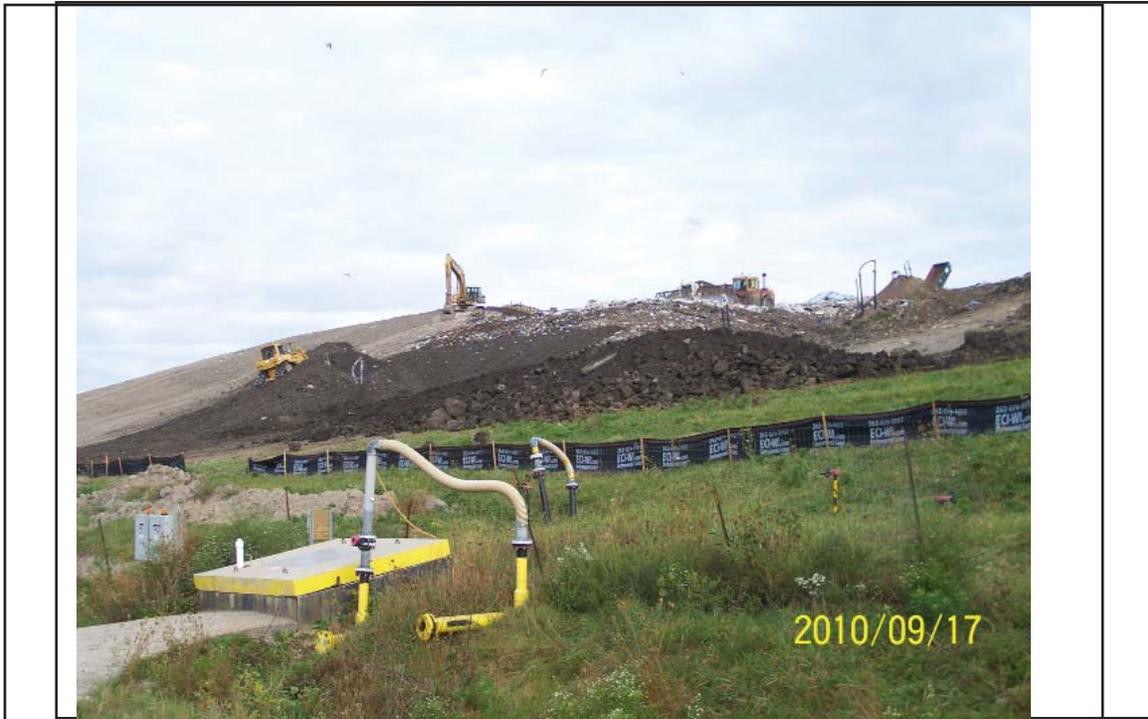
Slope recovery activities

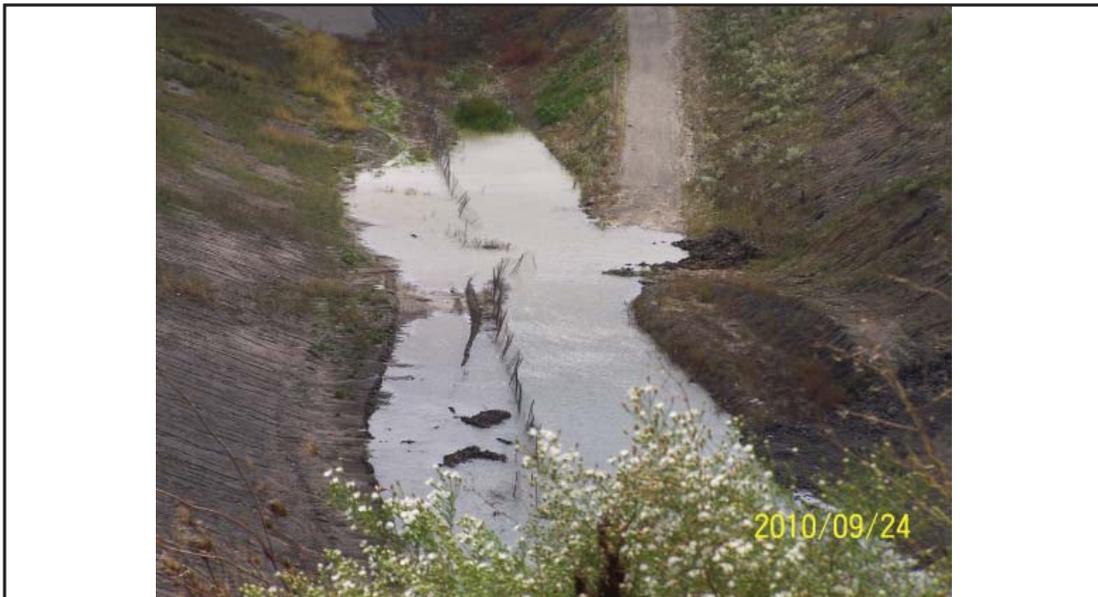
Temp Sed Basin

Pump in Temp Sed Basin needs to be repaired

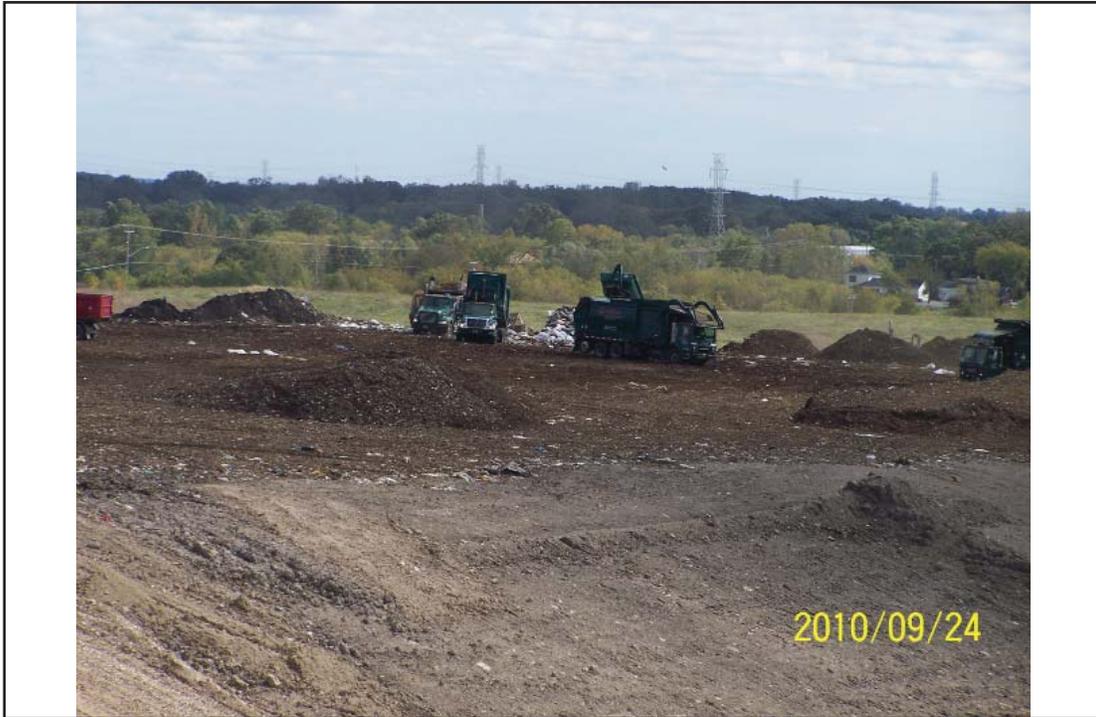
Active Area, more than adequate stockpiles of auto fluff

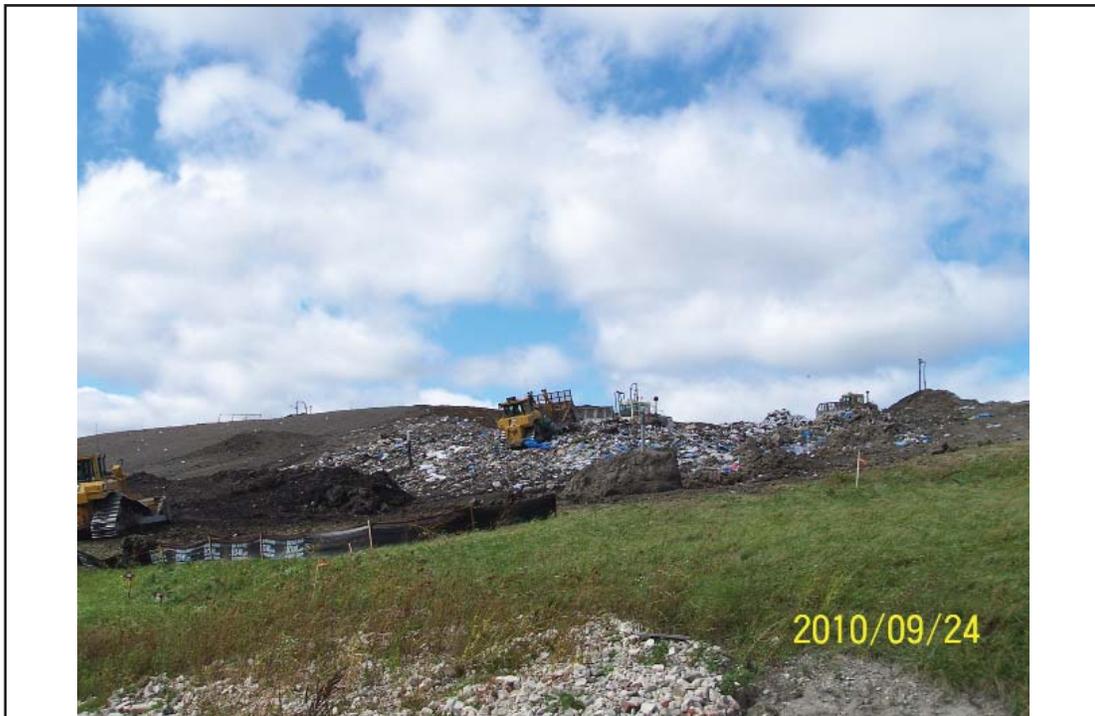
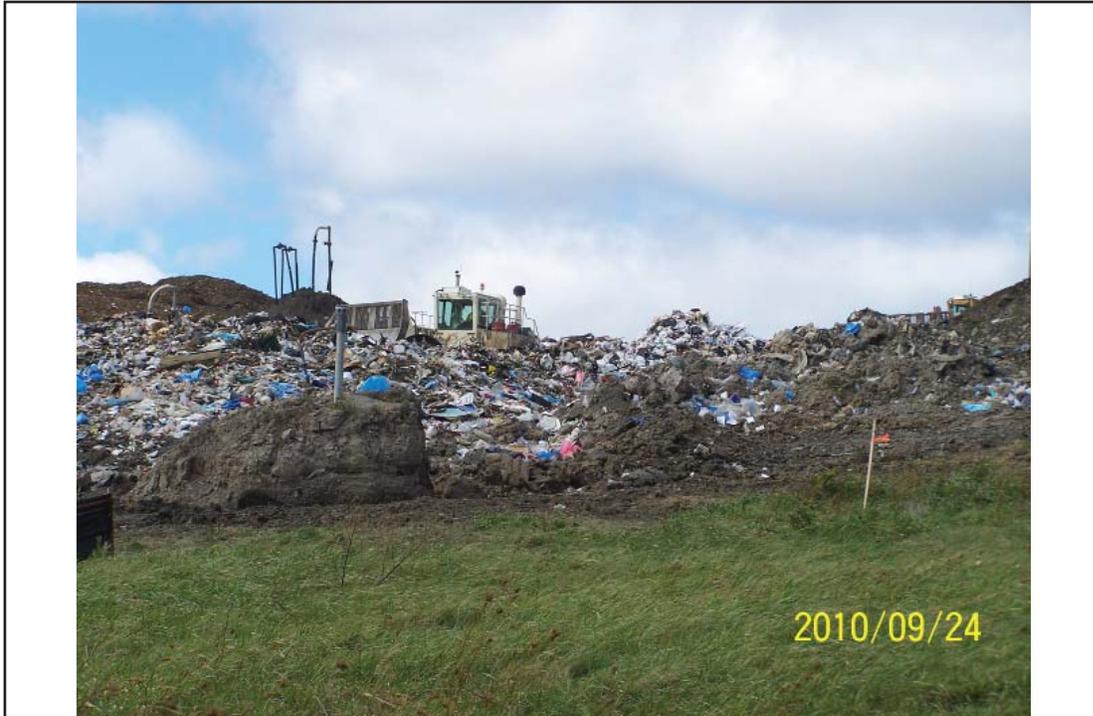
Waste being placed on South Slope of Phase 5

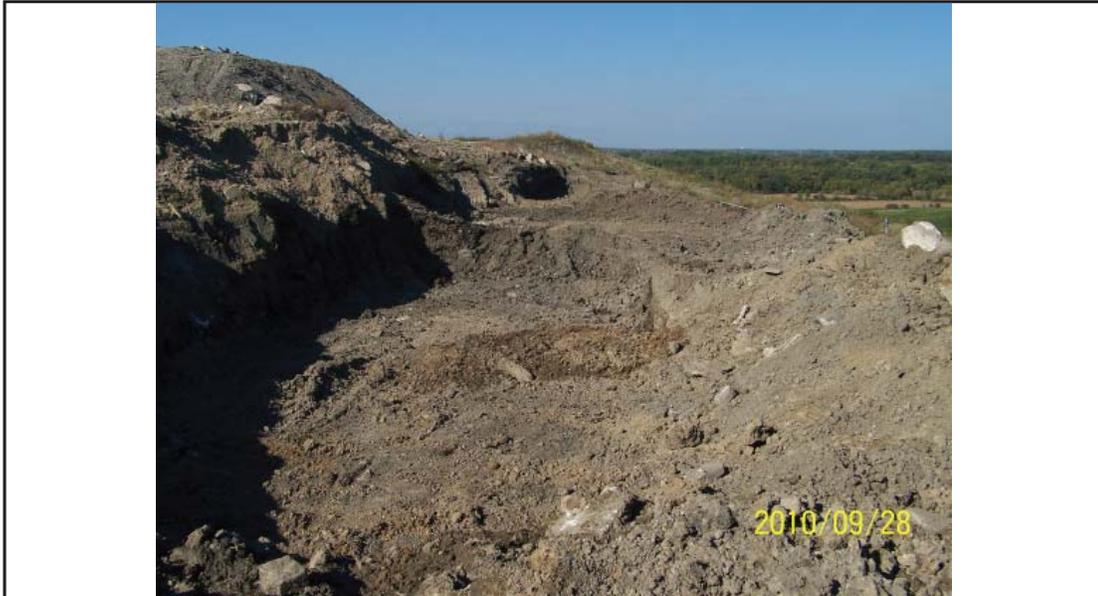
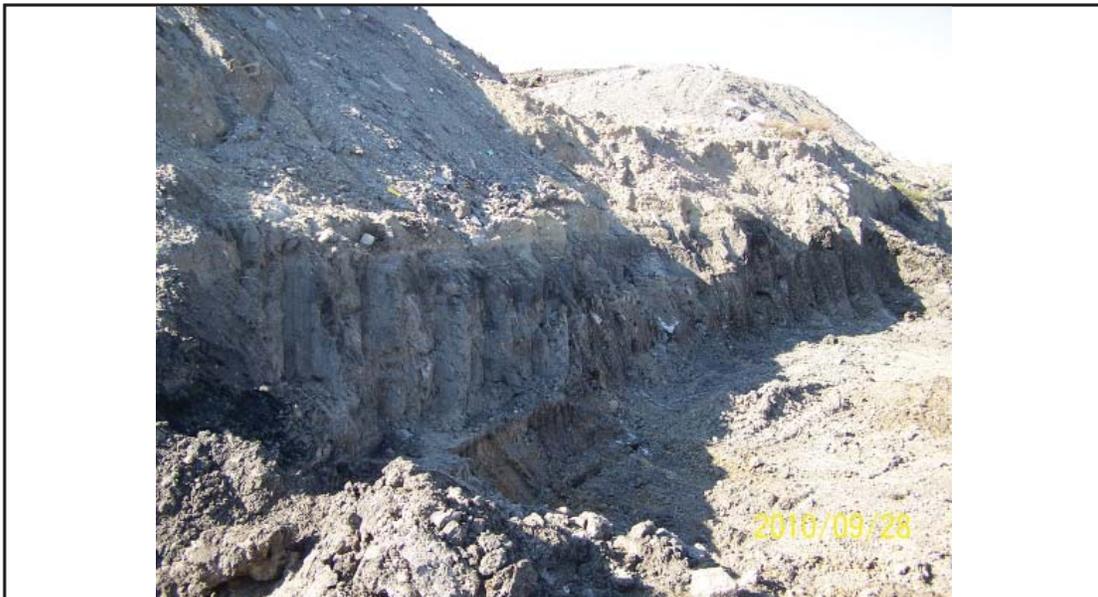
Excavation of cured bio-soil

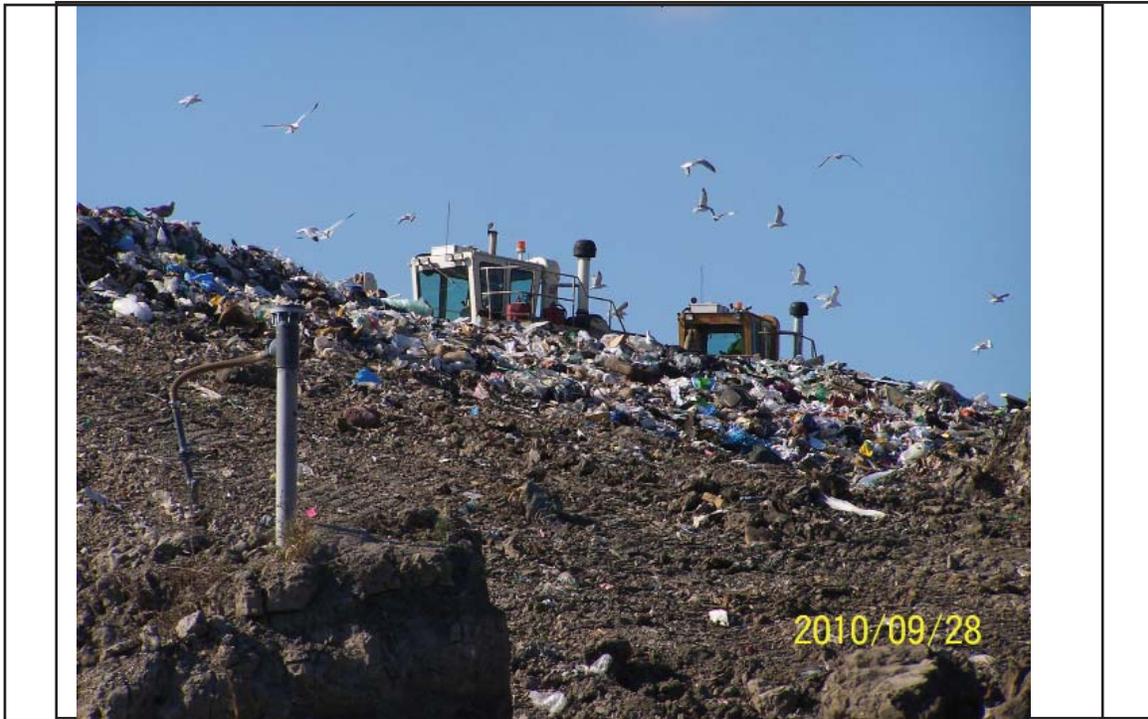
Waste placement in South Slope

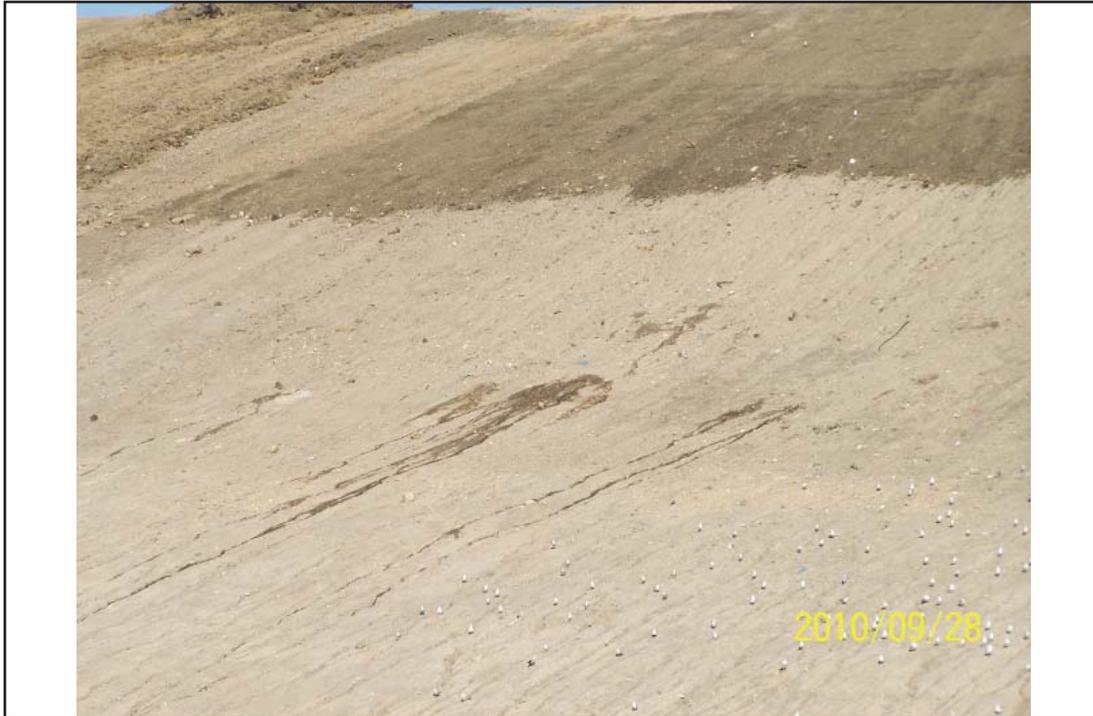
Very minor seep on West slope of Phase 6

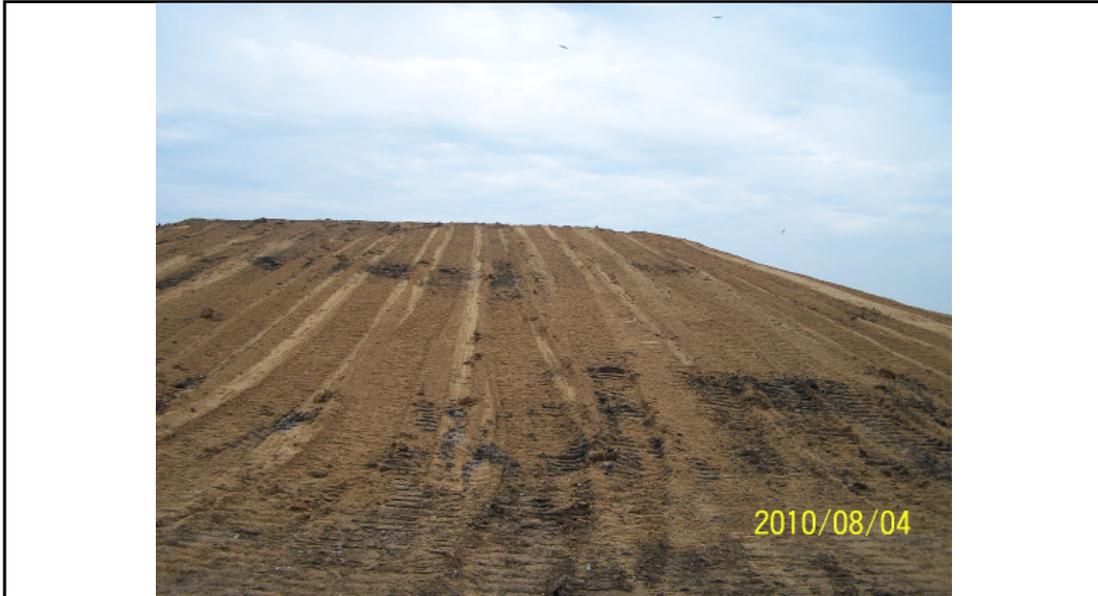
Bio Soil regraded for future relocation

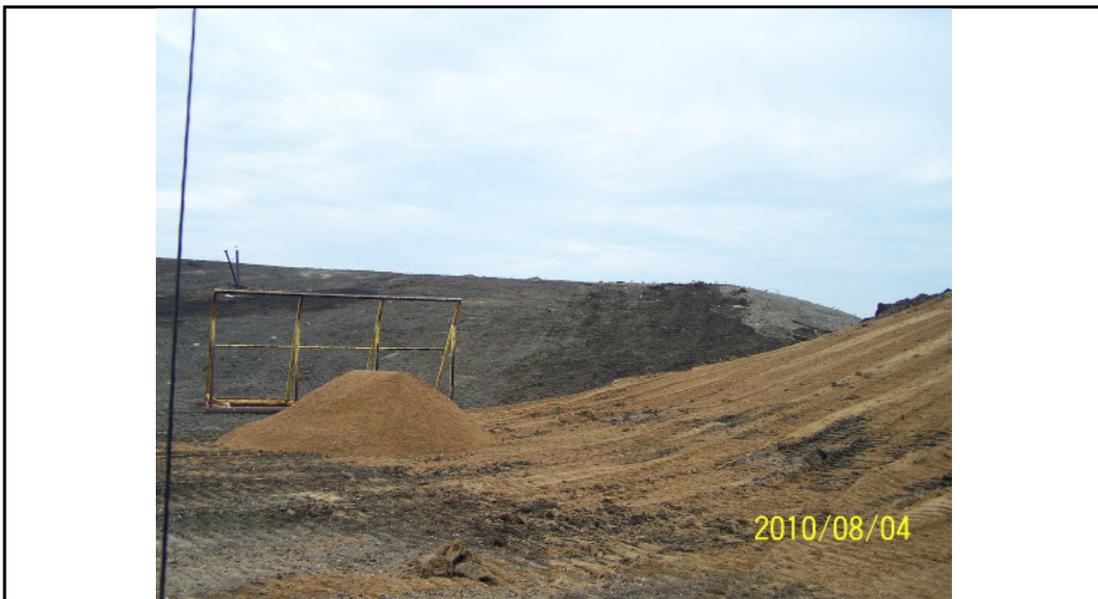
Soil stockpiles

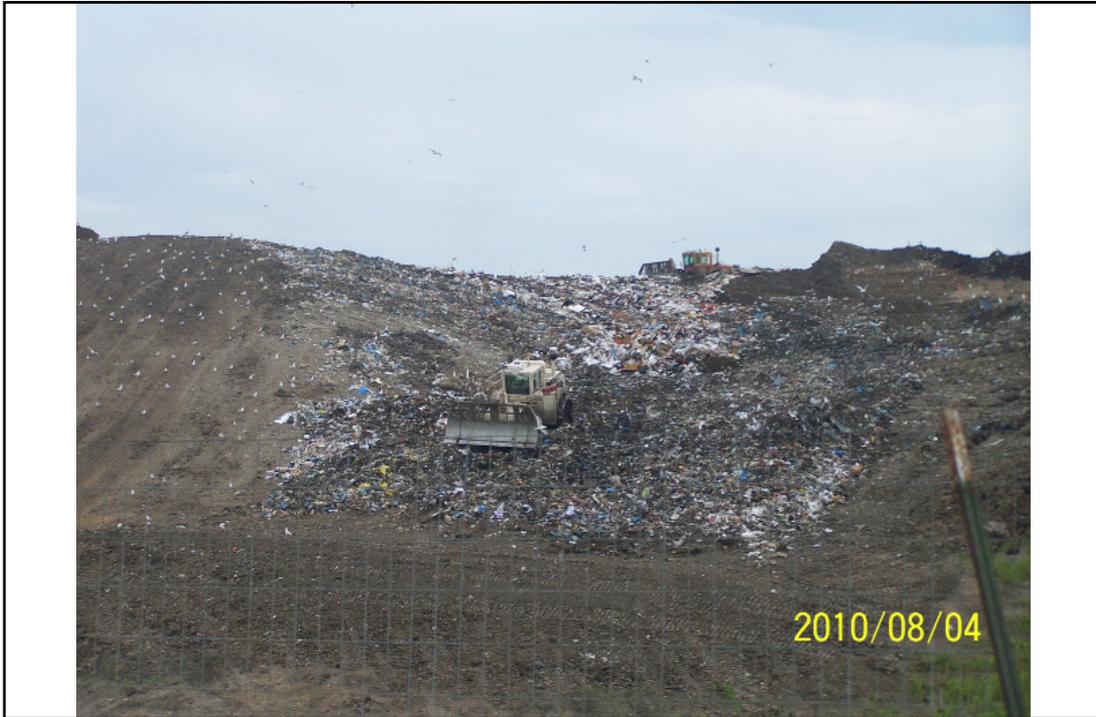
Working Face

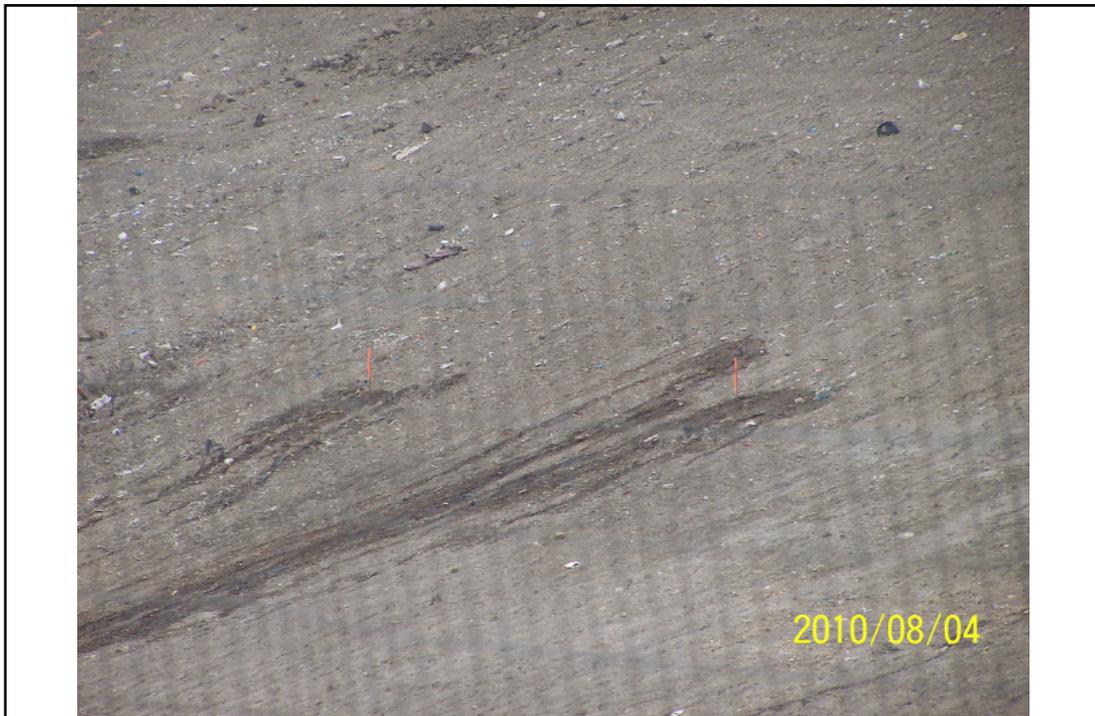
Minor Seeps in Phase 6, West slope

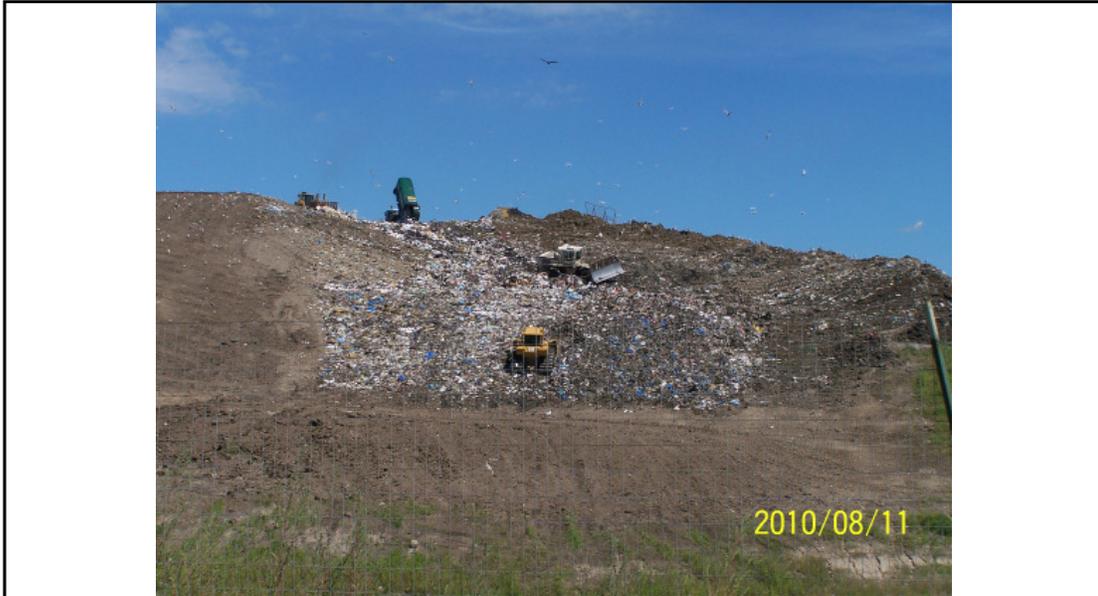
Working face at South end of Phase 6 West Slope
