VEOLIA EMERALD PARK LANDFILL  
CITY OF MUSKEGO

## 2010 Veolia Emerald Park Landfill Year End Compliance Officer Report and Audit Summary

**TO:** Veolia Emerald Park Standing Committee  
**FROM:** Jo-Walter Spear, Jr., P.E.  
**COPIES:** File  
**DATE:** 01/20/11  
**PROJECT NUMBER:** 1012

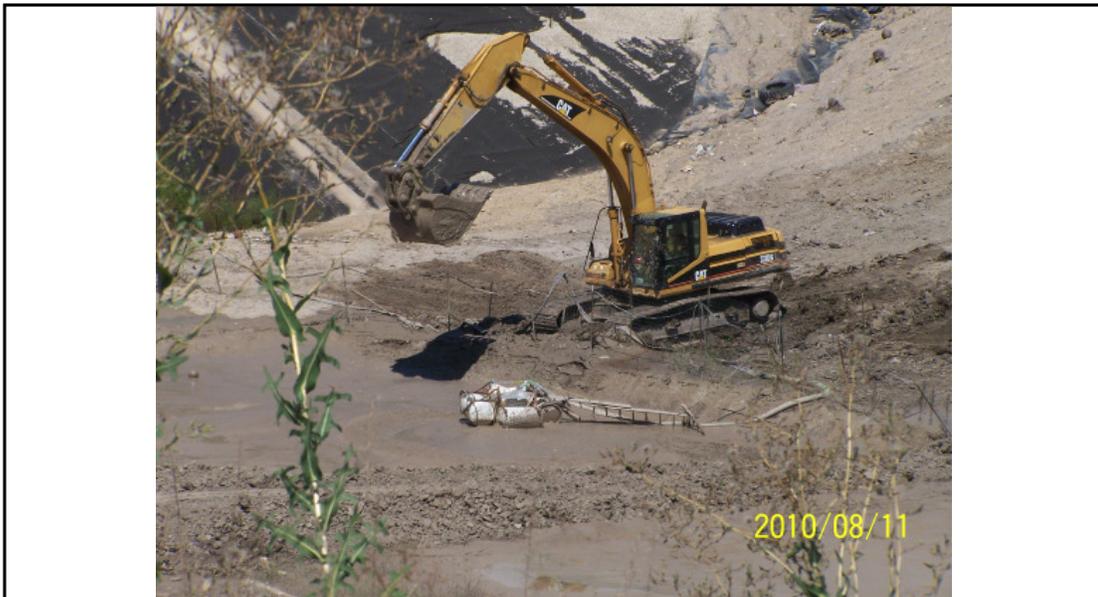
Excavator removing material from activated charcoal spill in temp sed basin

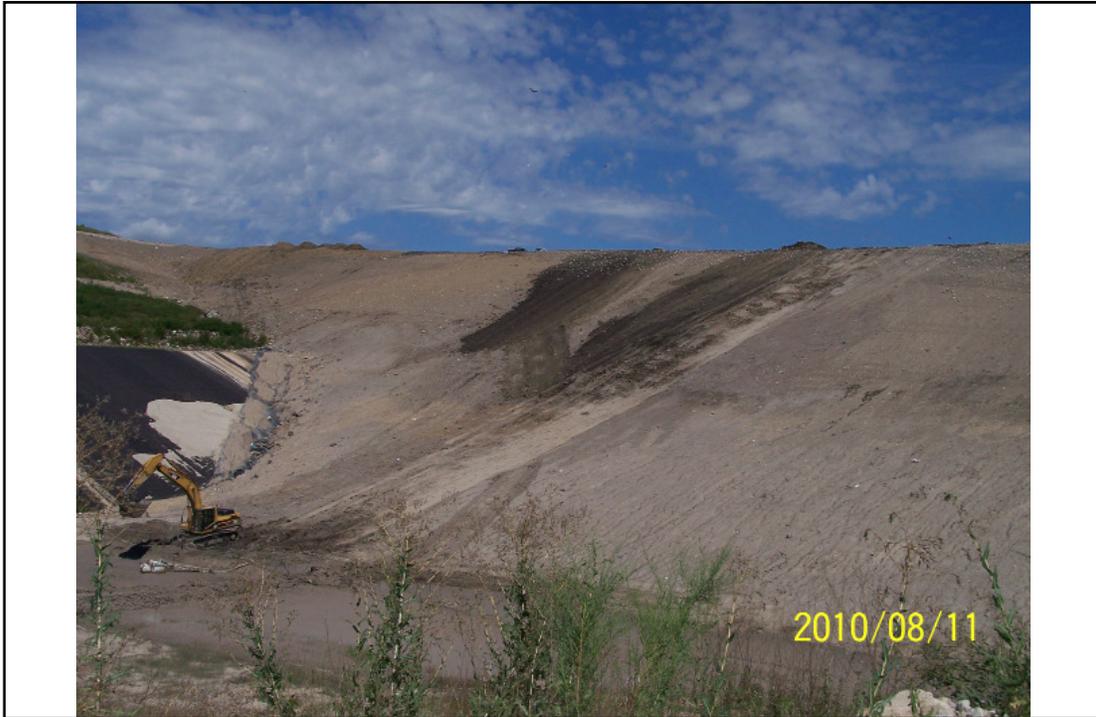
Area of traffic for cleaning up spill

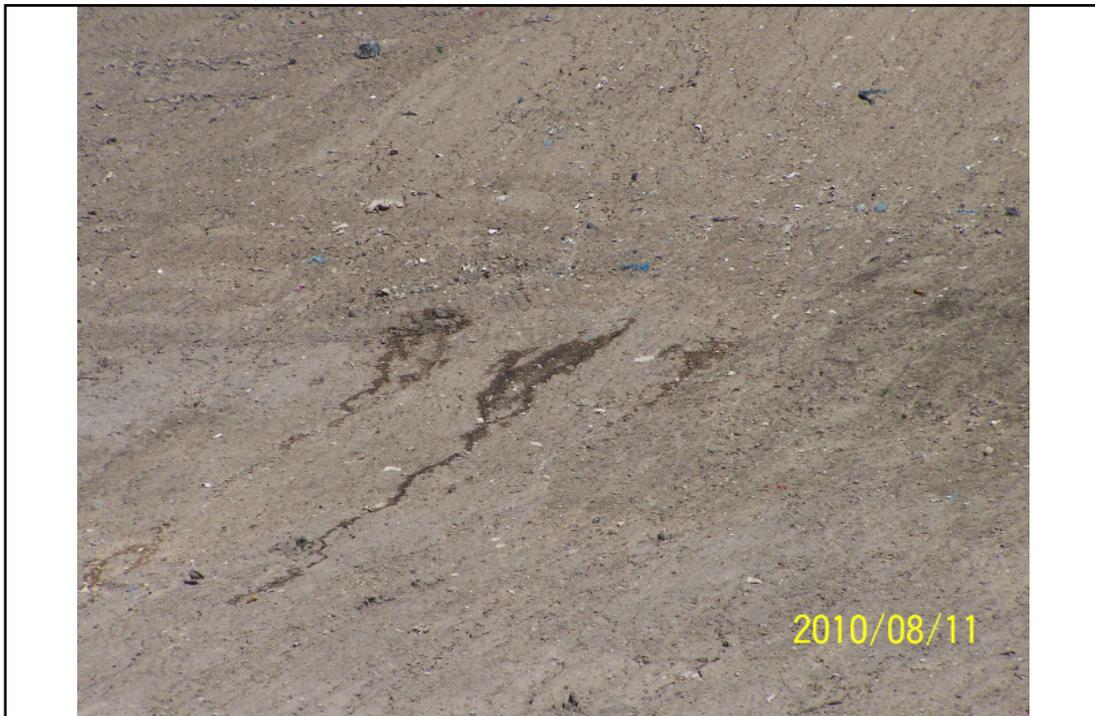
Seeps in Phase 6 West Slope smaller

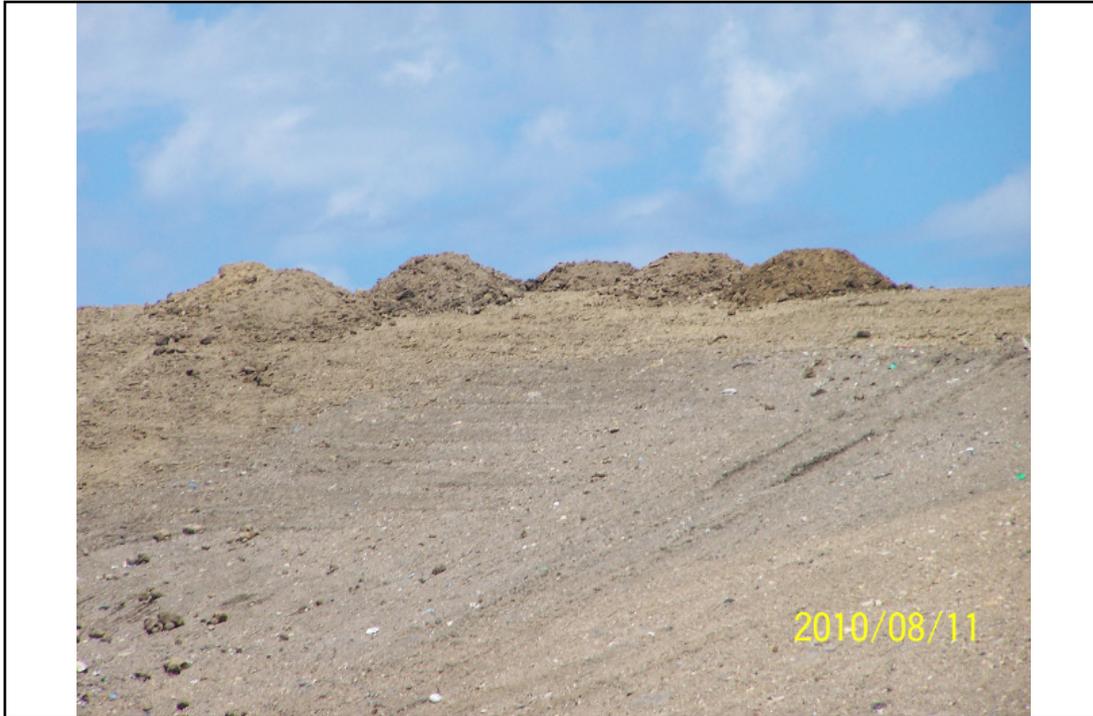
MMSD Pipeline soils to be used for cover

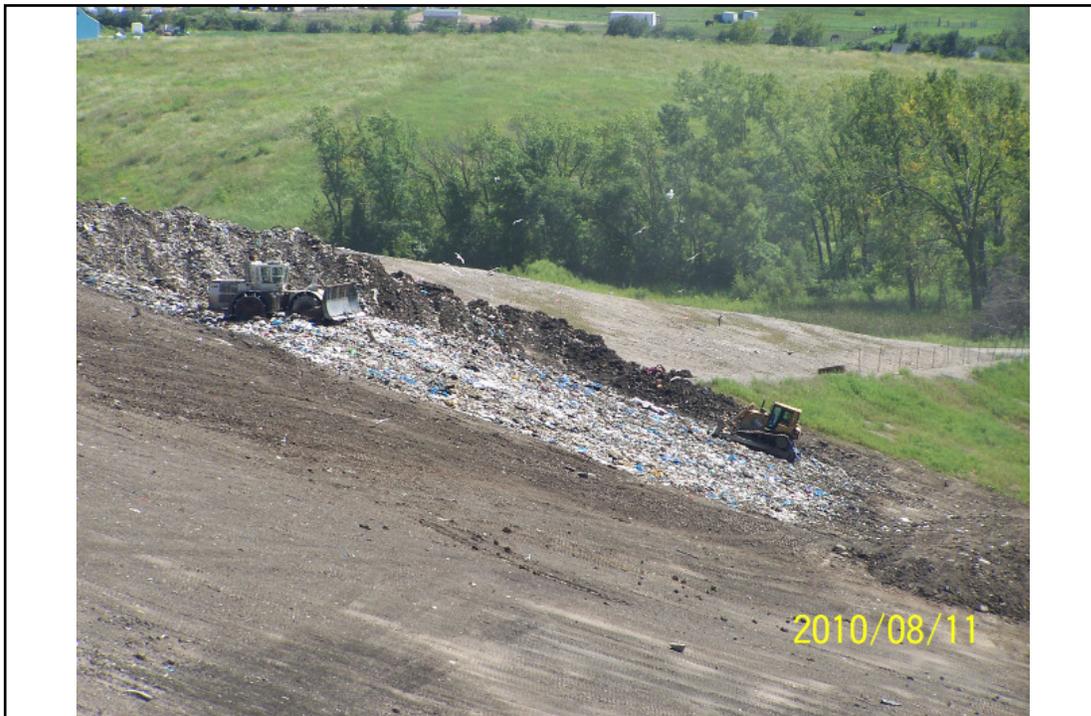
Working Face nearly at Southwest corner of Phase 6

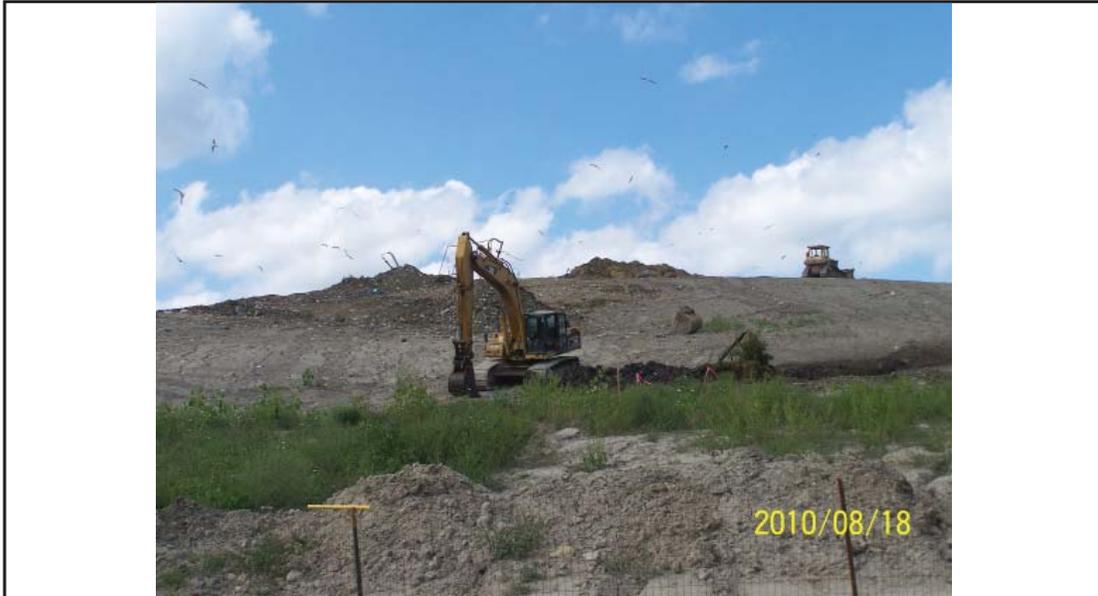
Excavator pulling back clays and top soil

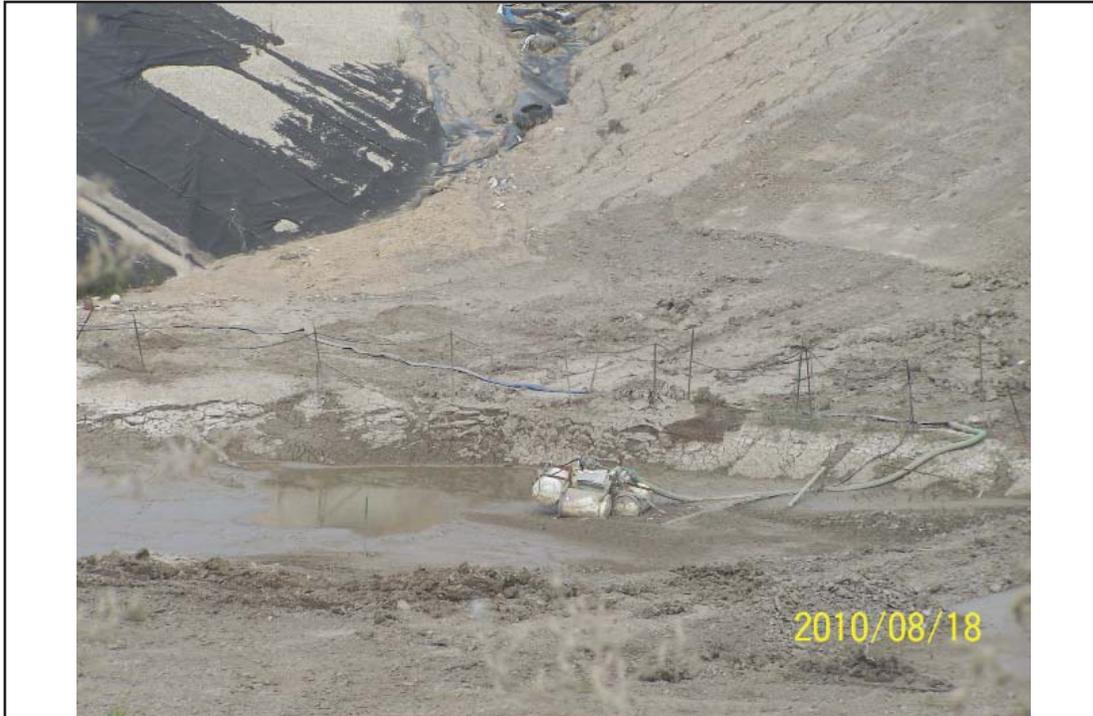
Current asbestos pit

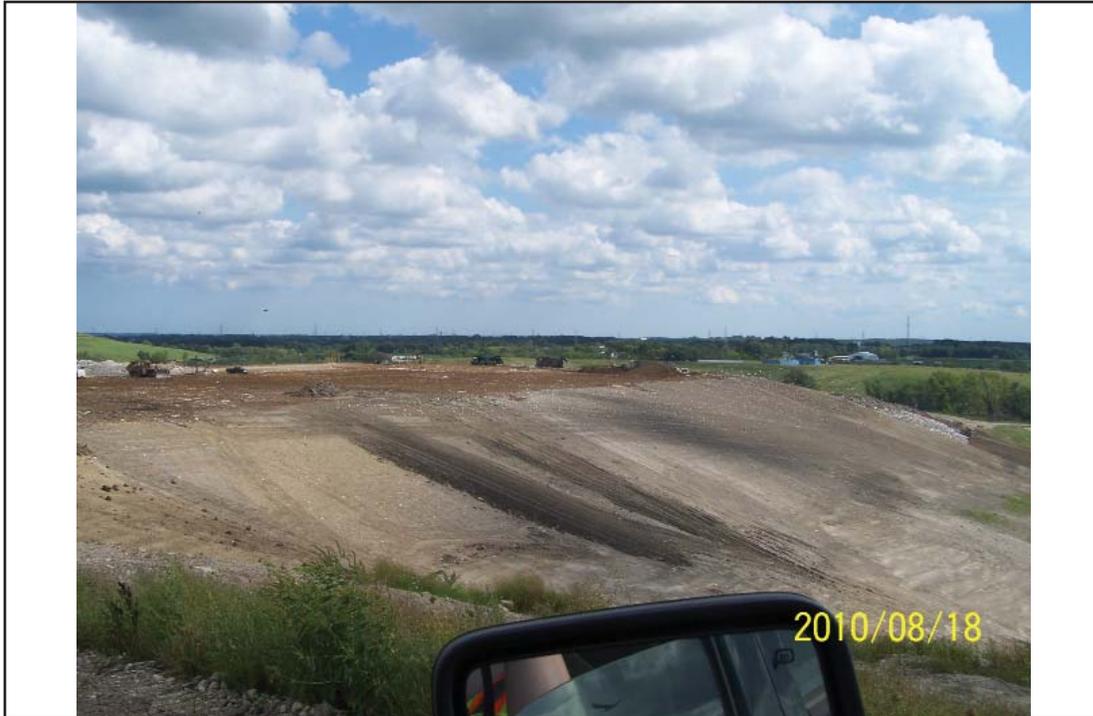
West Slope of Phase 6, additional soils placed from MMSD pipeline project

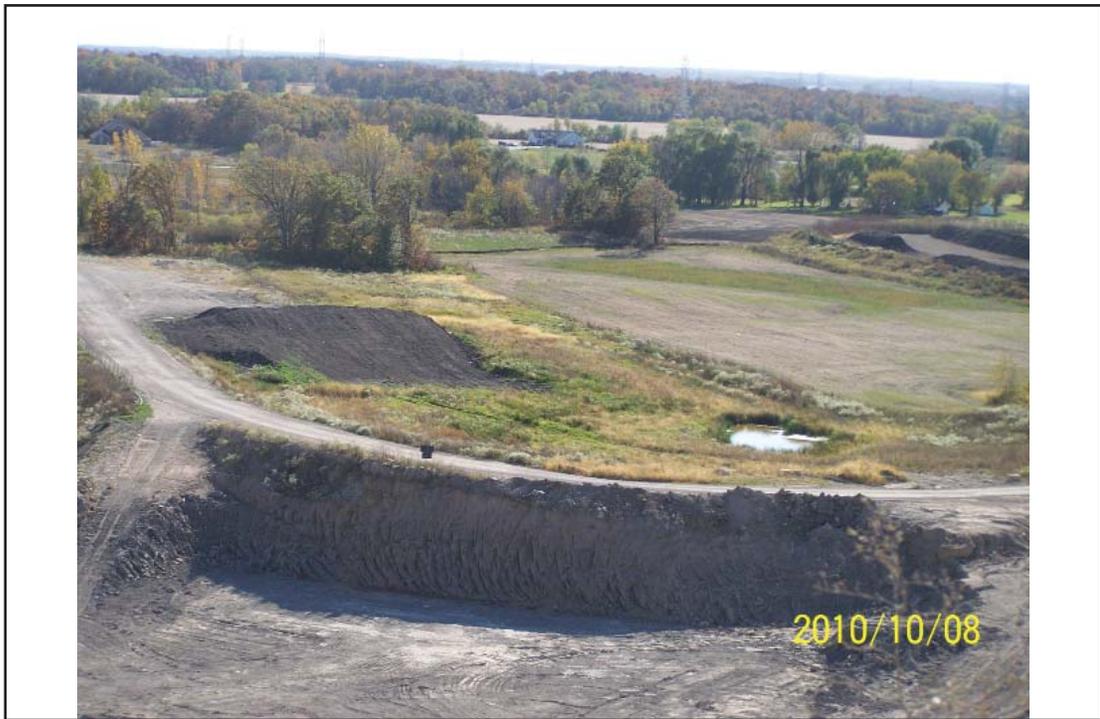
Excavation area, topsoil stockpile and wetland

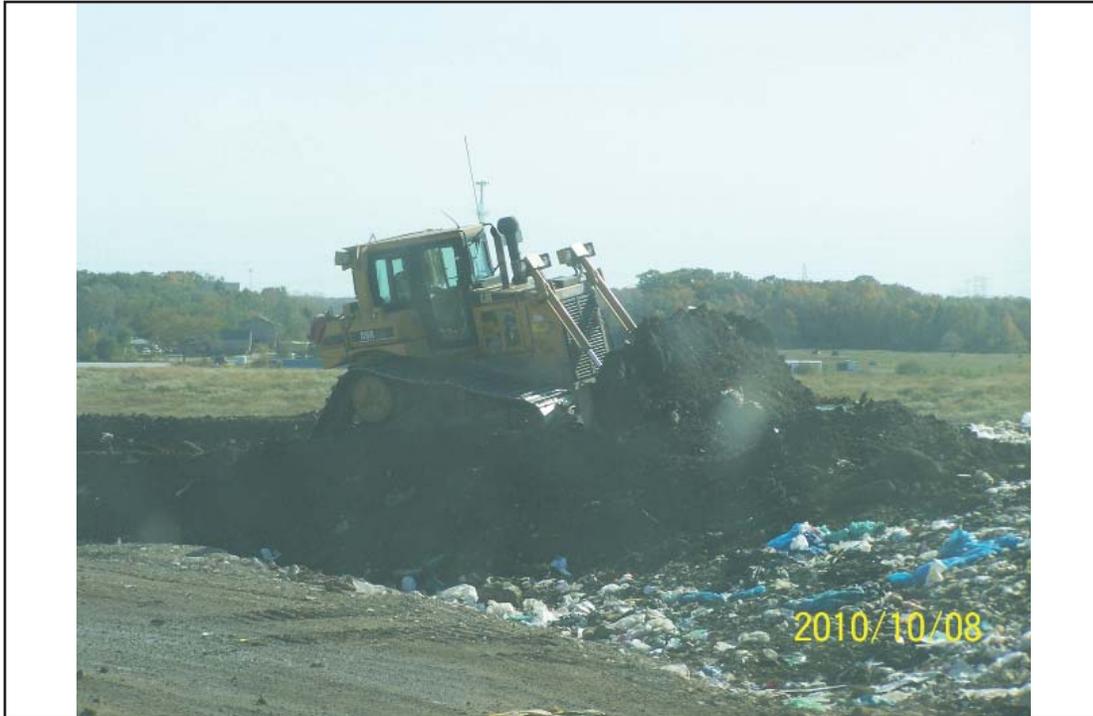
Covering waste along access road to Phase 5

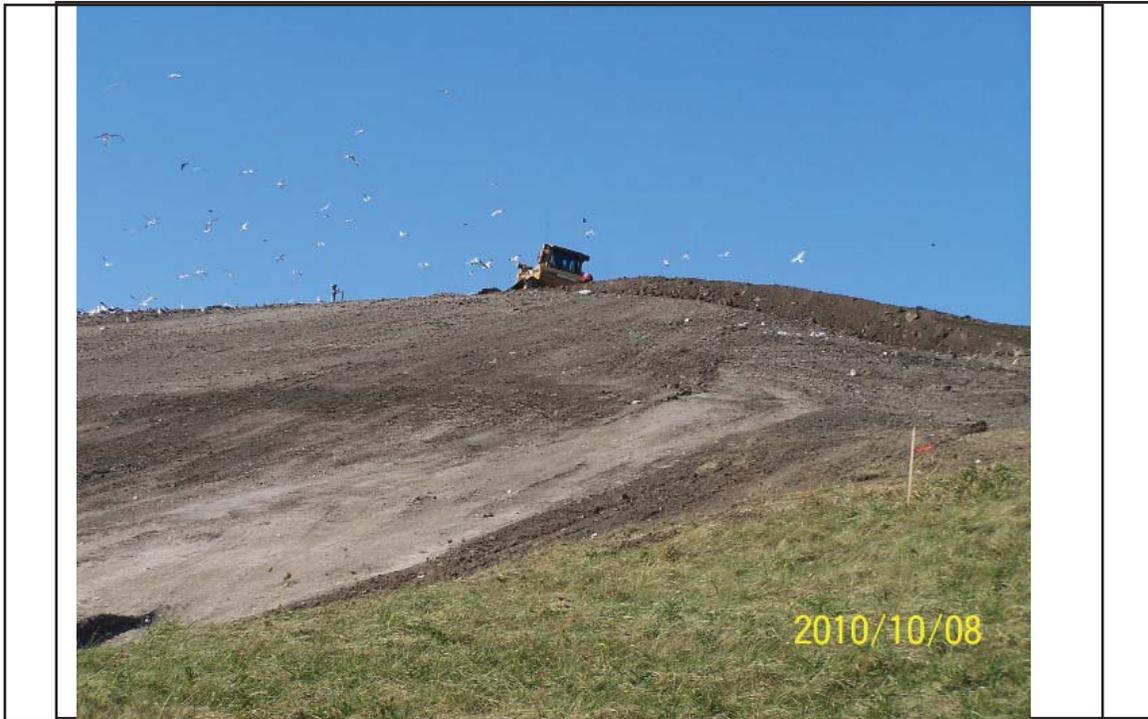
Cover placement and waste at top of Southwest corner of Phase 6

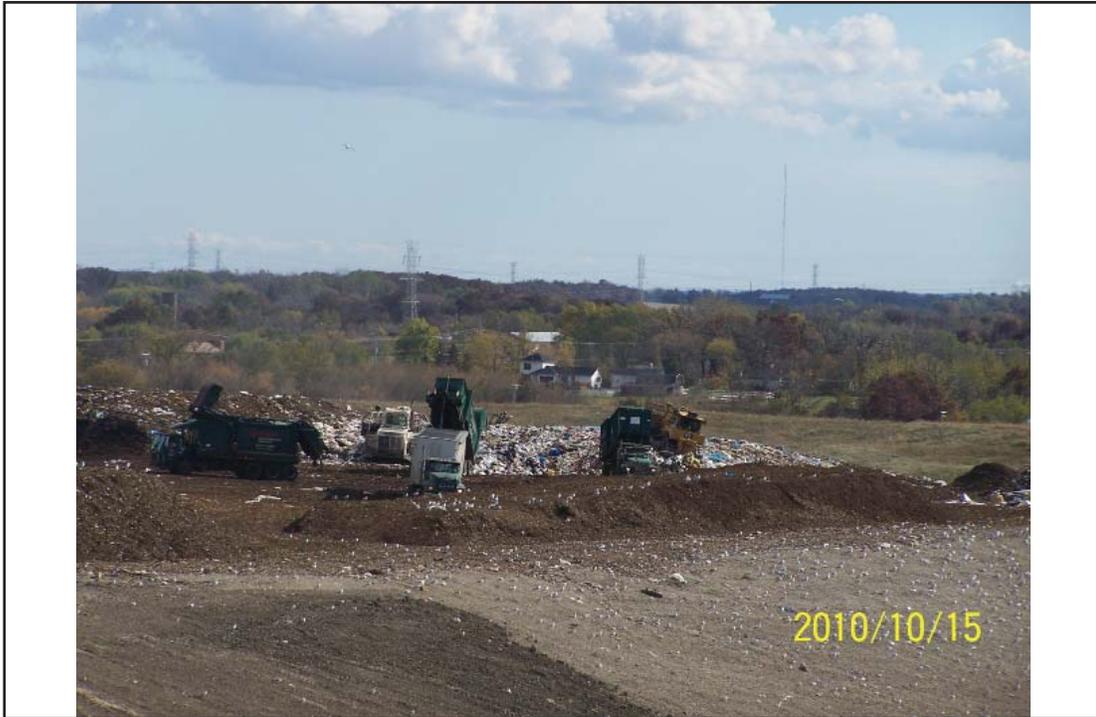
New lift starting at South end of Phase 6

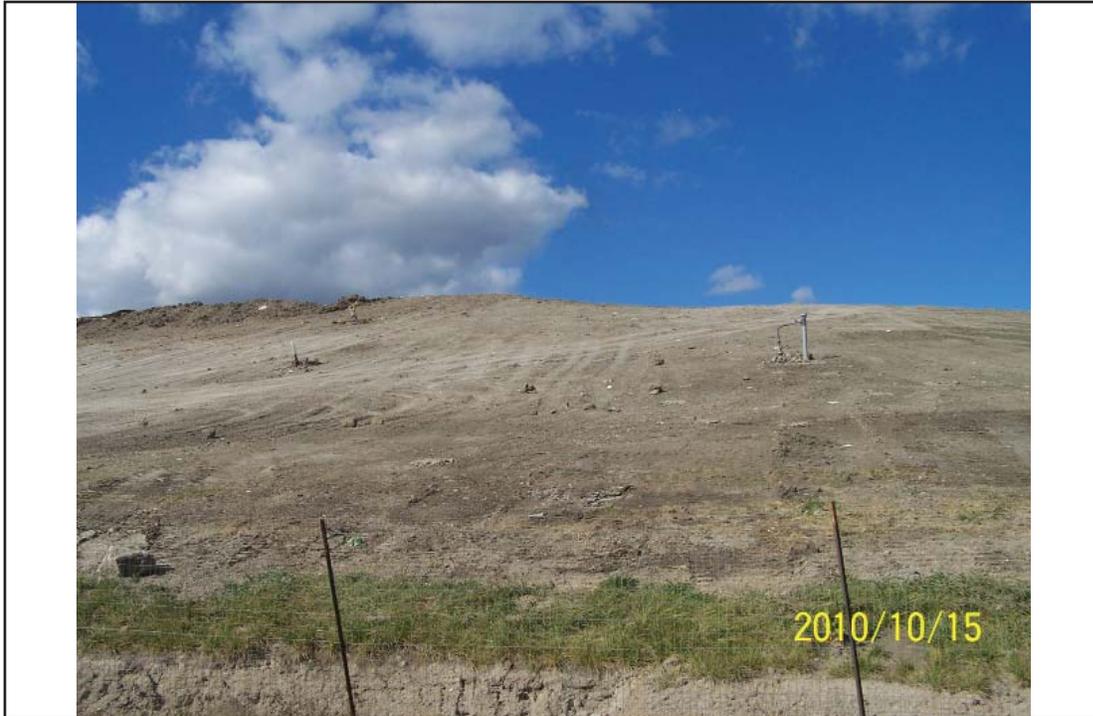
South slope awaiting clay, topsoil, and seeding

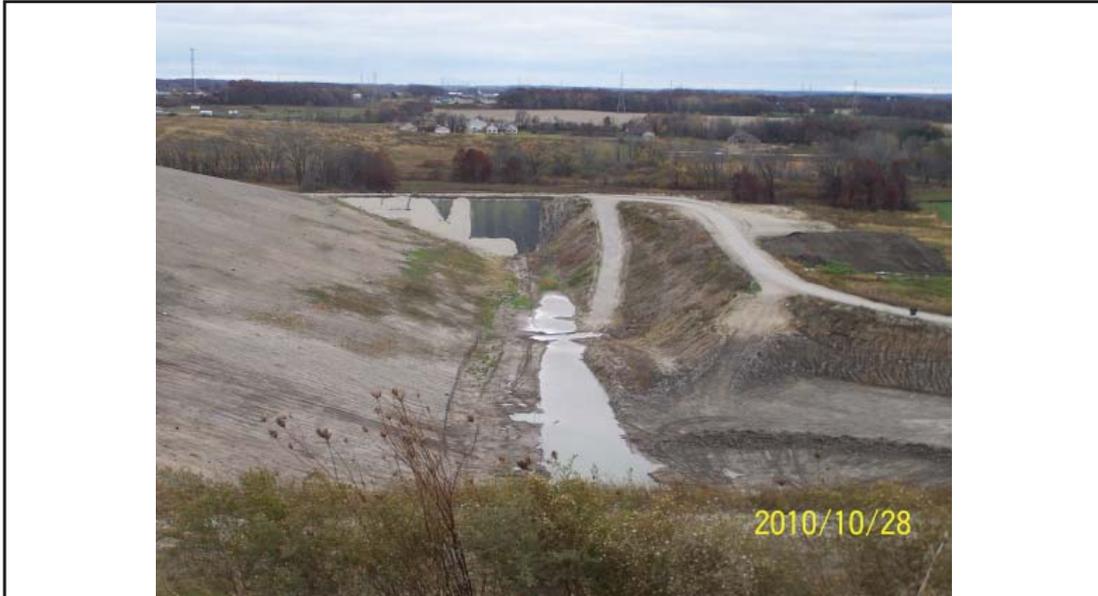
Temp Sed. Basin

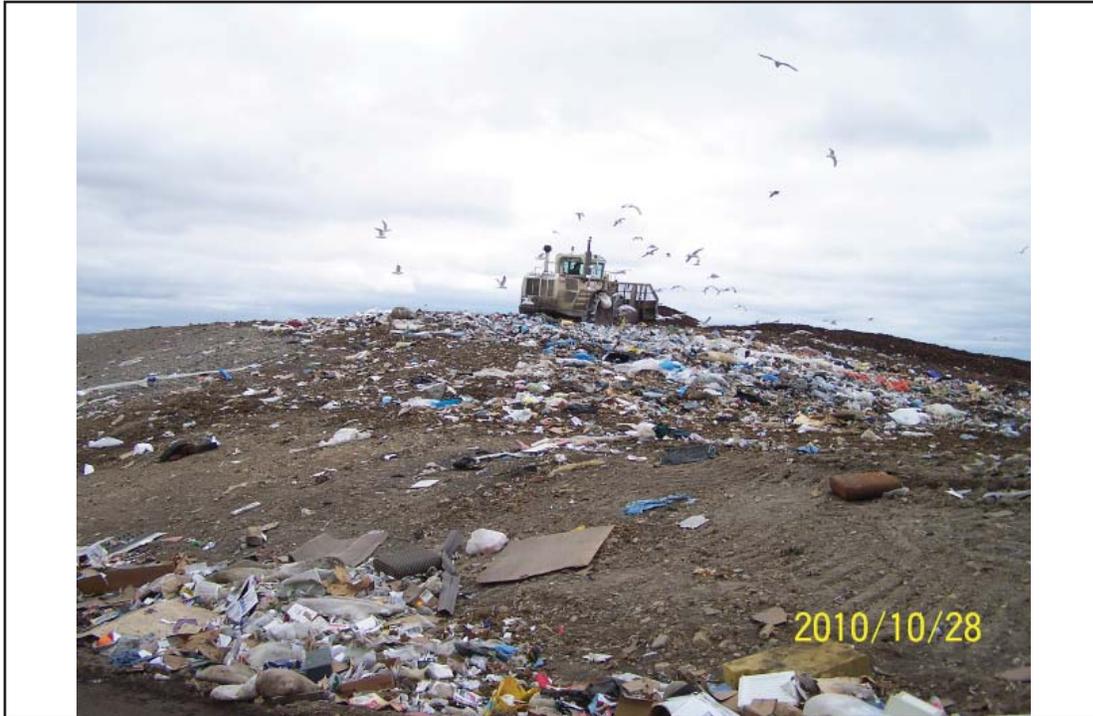
Wind blown litter below working face

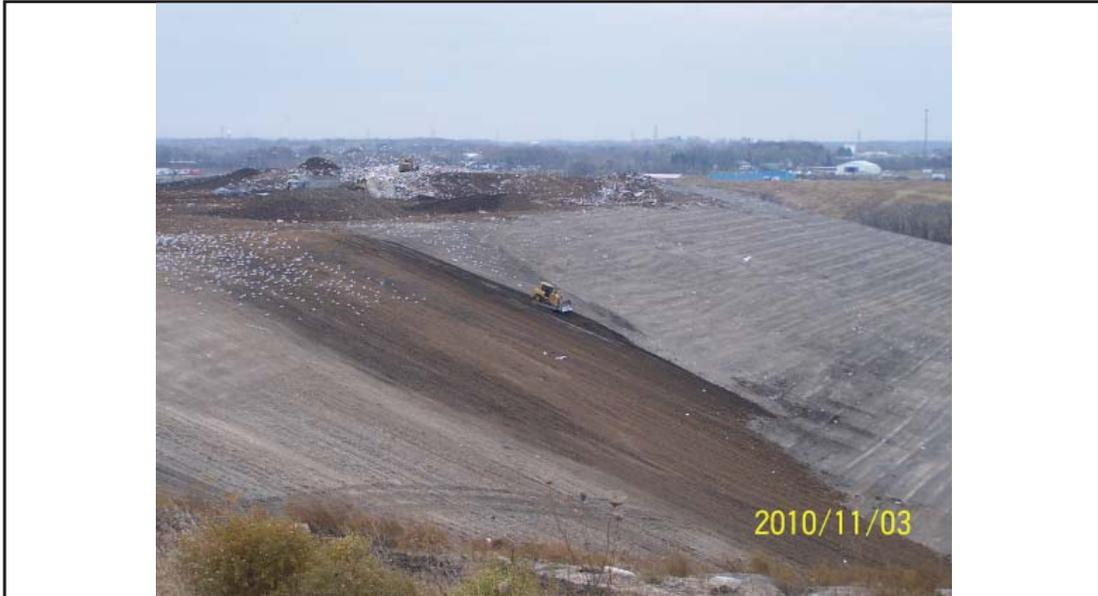
West slope of Phase 6, backdragged and being improved with soils from pipeline project

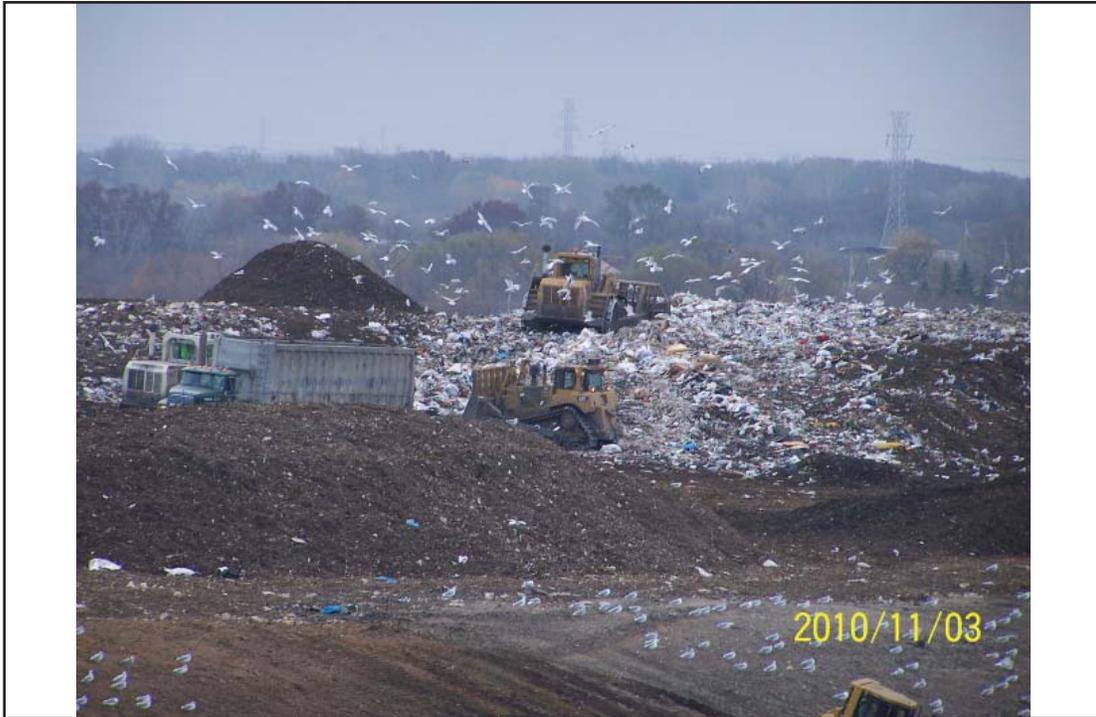
Working face at South end of Active area

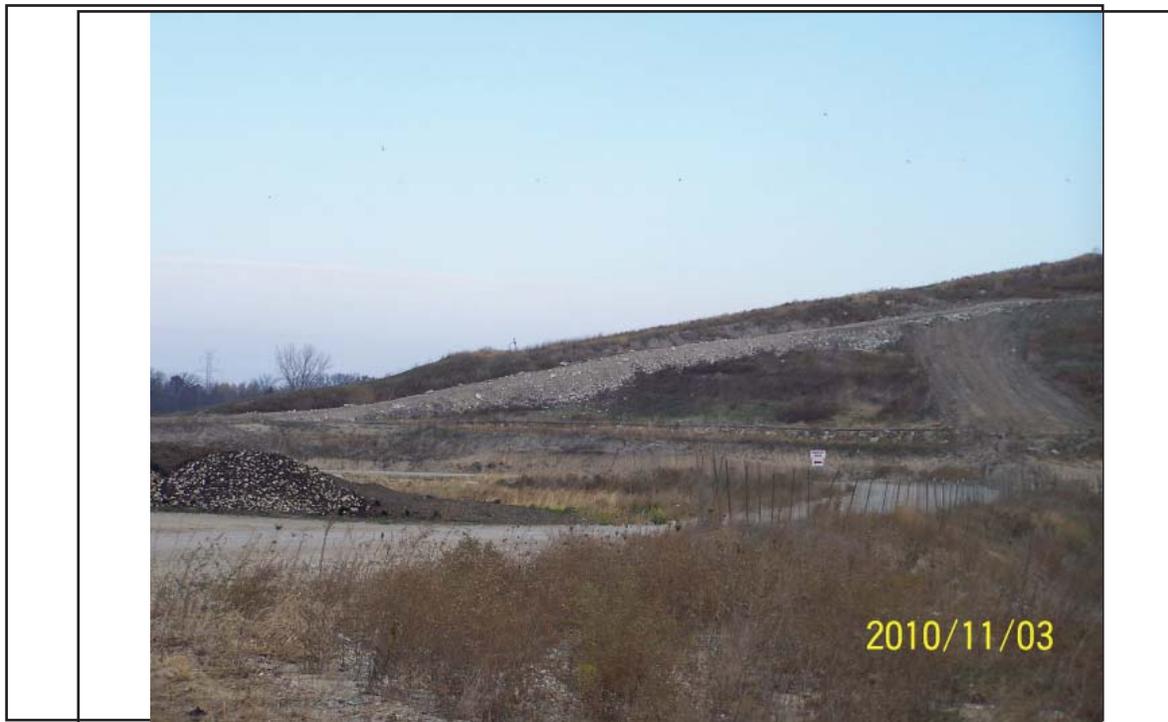
Equipment access road on South slope of Phase 3

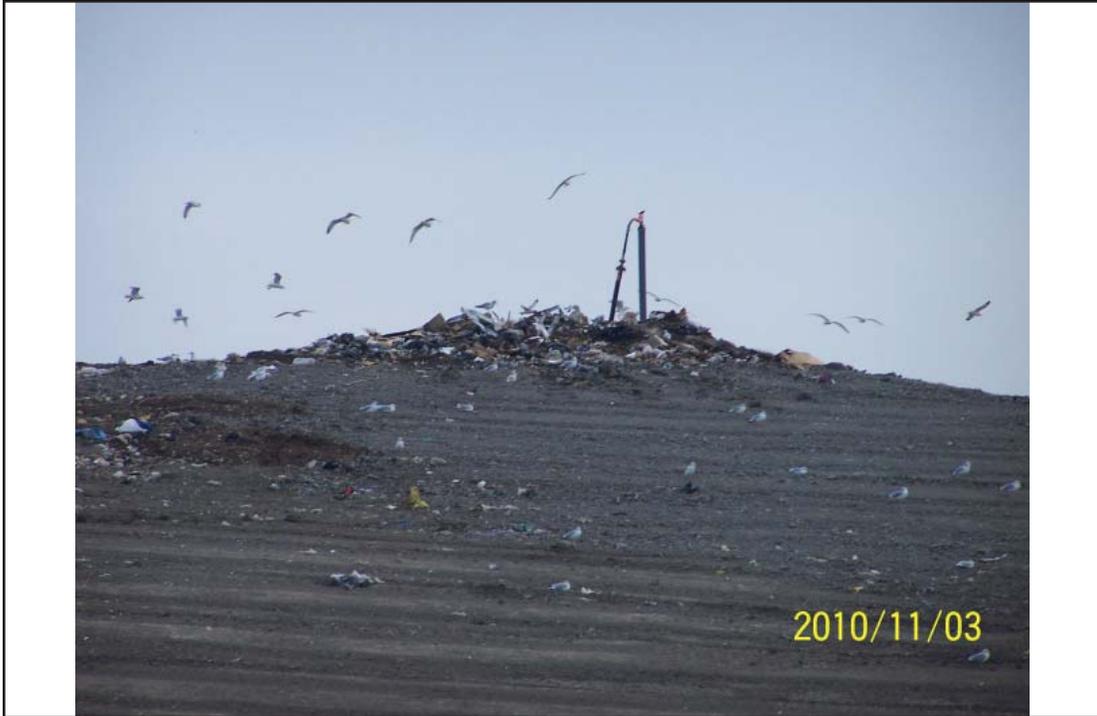
Raised gas collection well in Phase 6

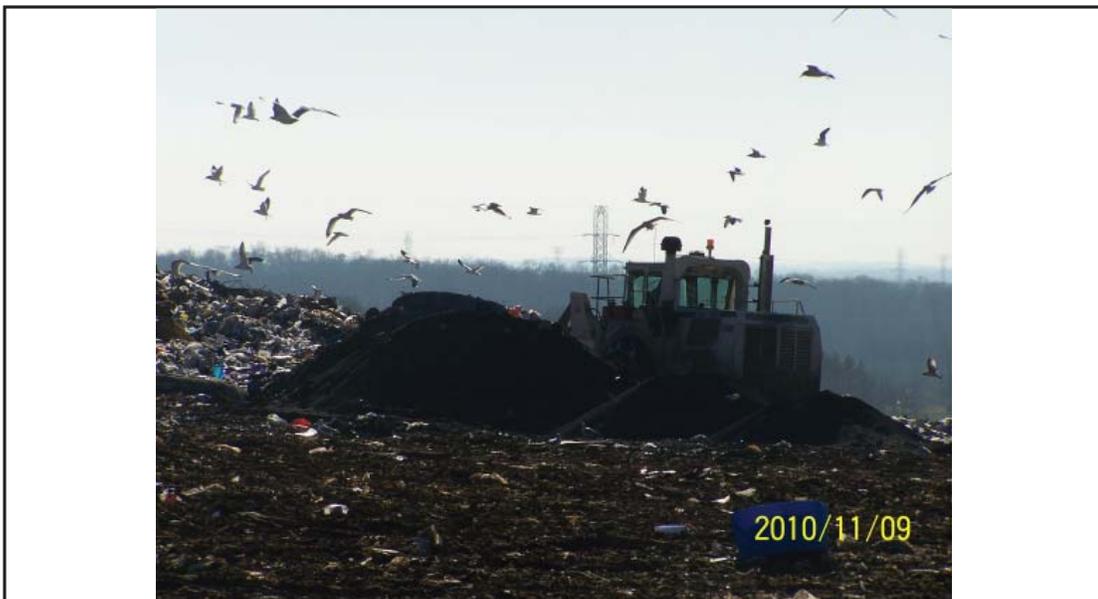
Foundry sands and autofluff stock piled for daily cover

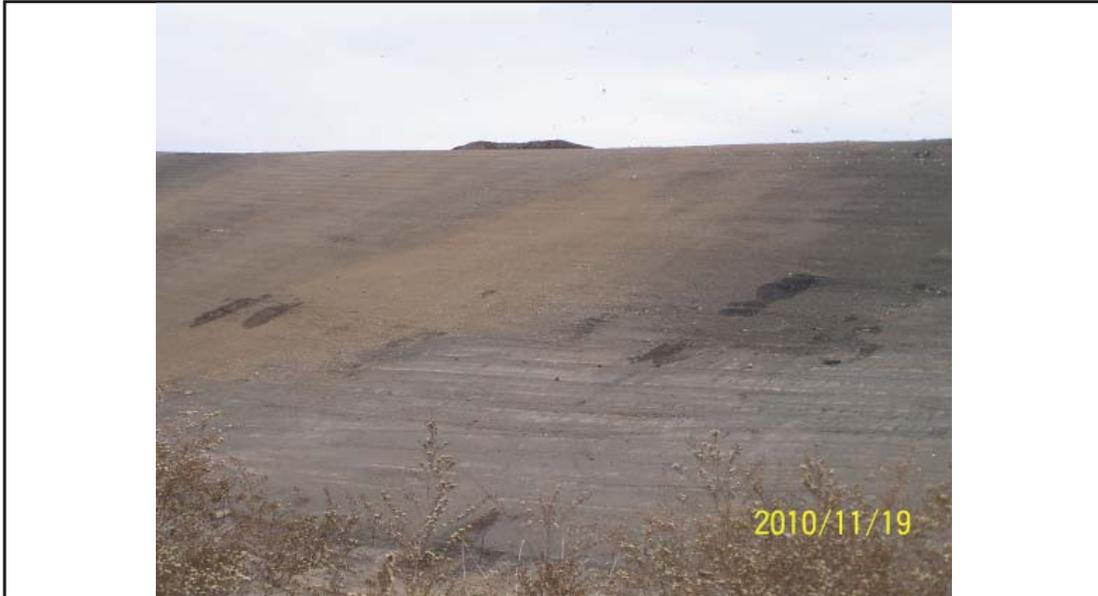
West slope of Phase 6W, no flowing seeps

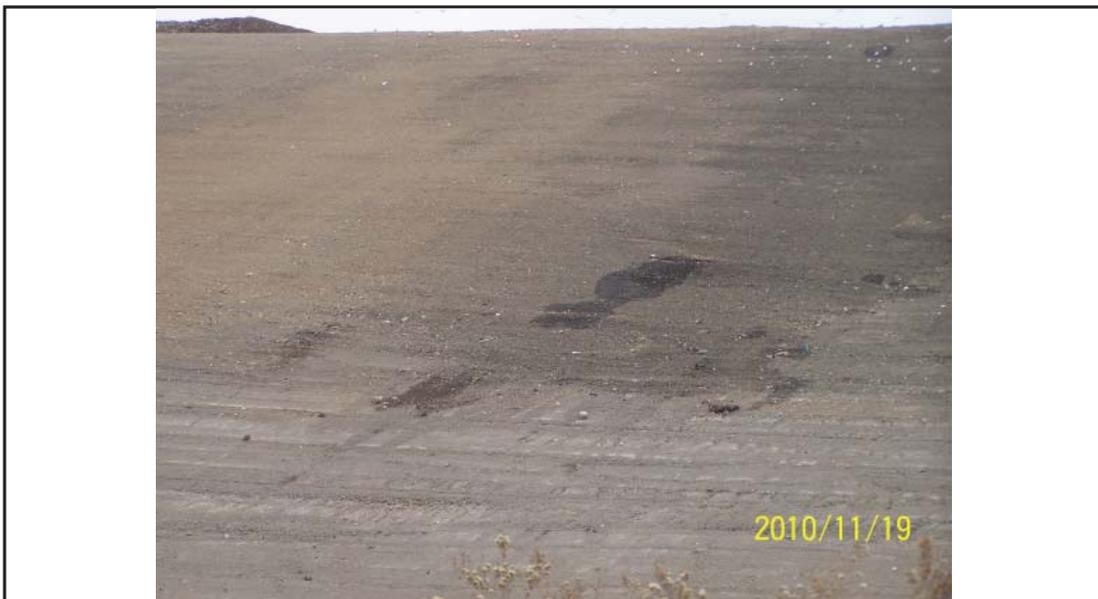
Close up of seeps

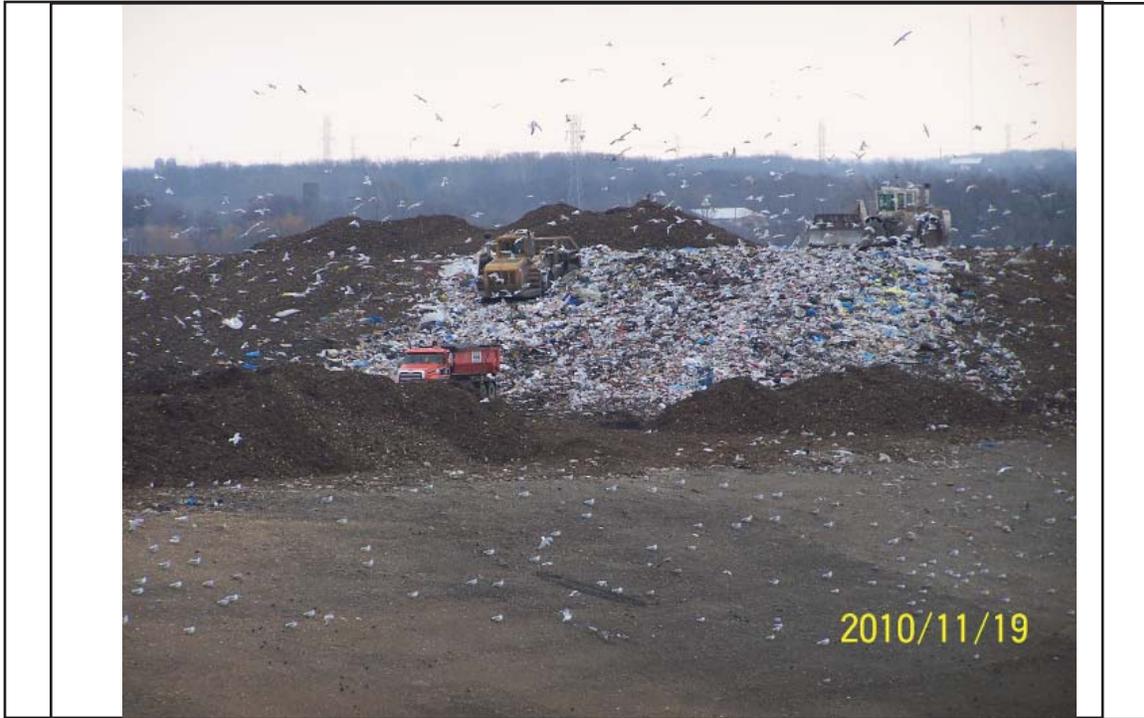
Working face at South end of Phase 6

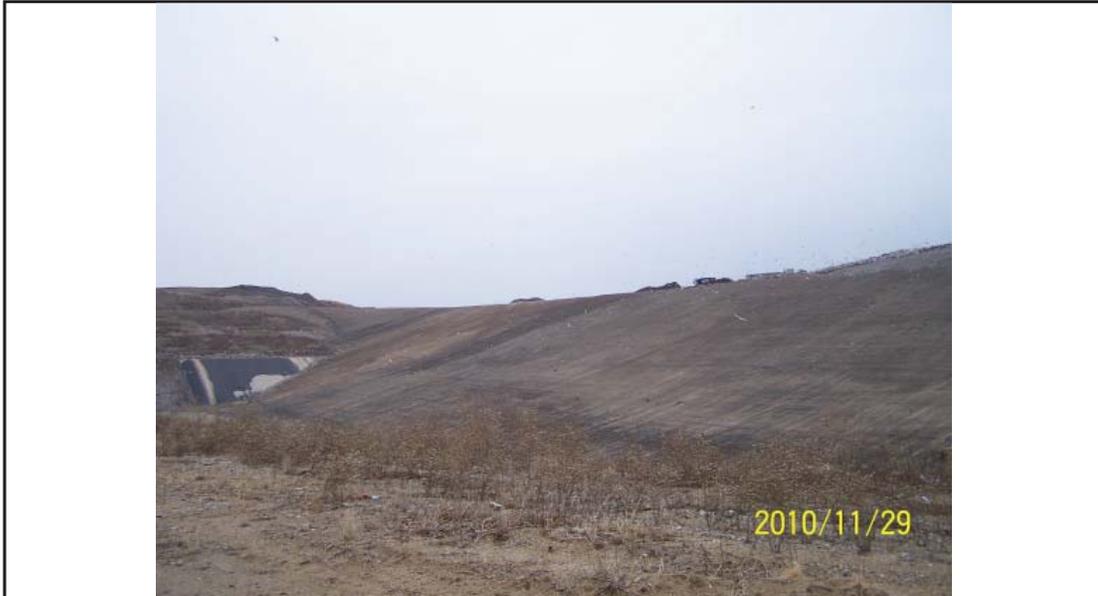
West slope of Phase 6, no seeps evident

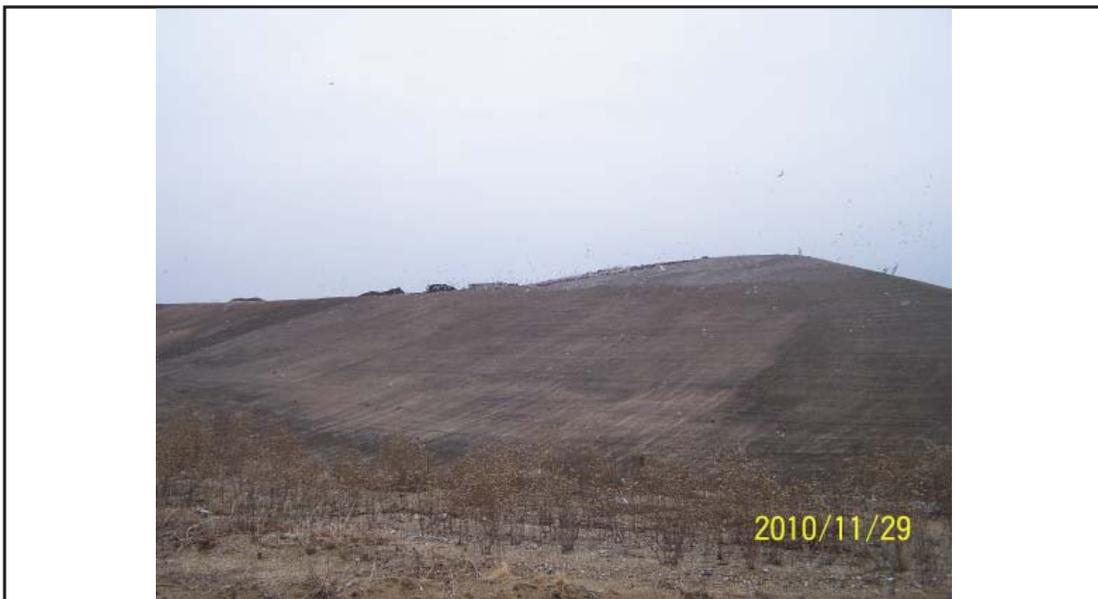
West slope of Phase 6 at Southwest corner

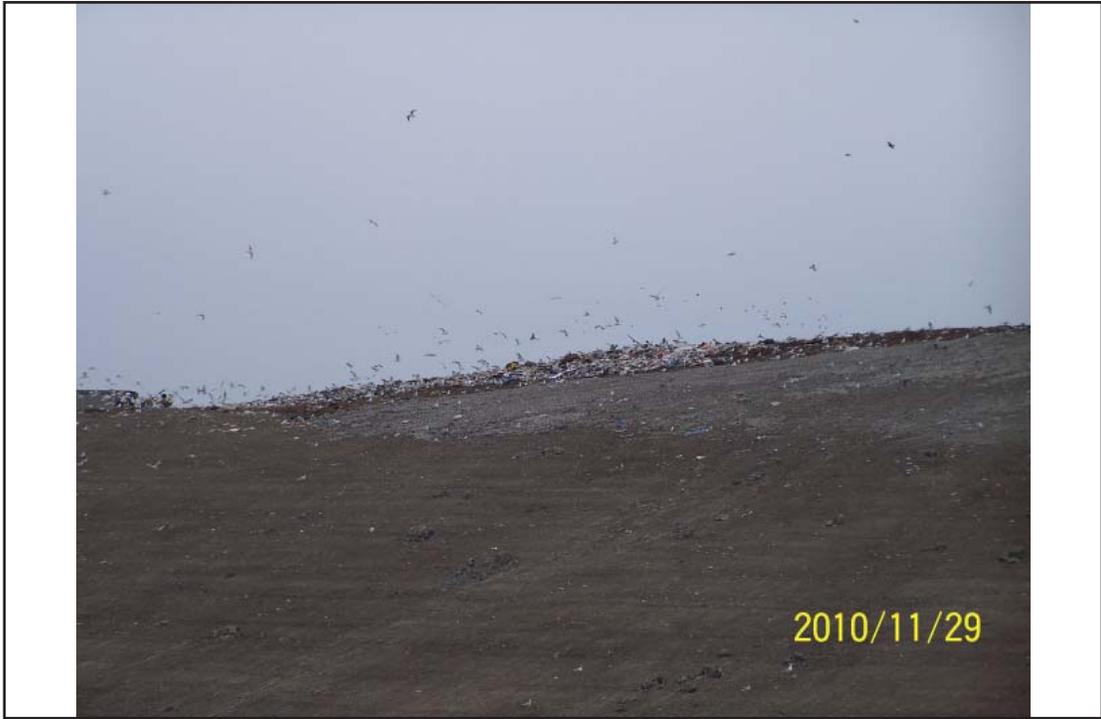
Working face at edge of West slope, Phase 6

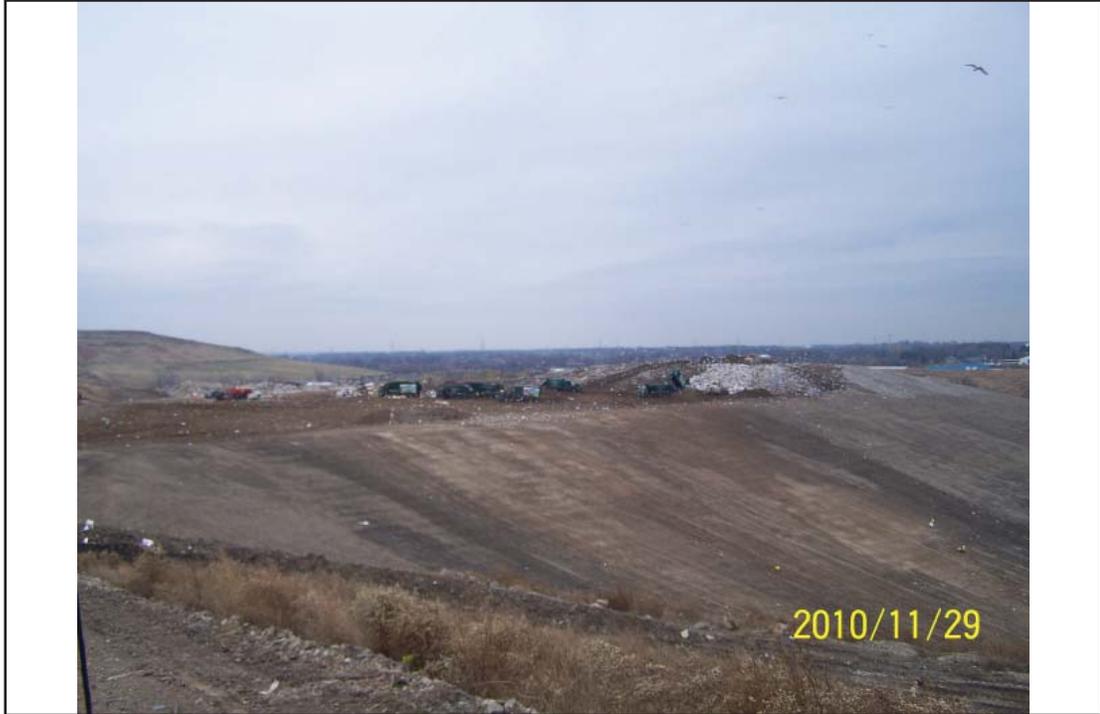
Active area

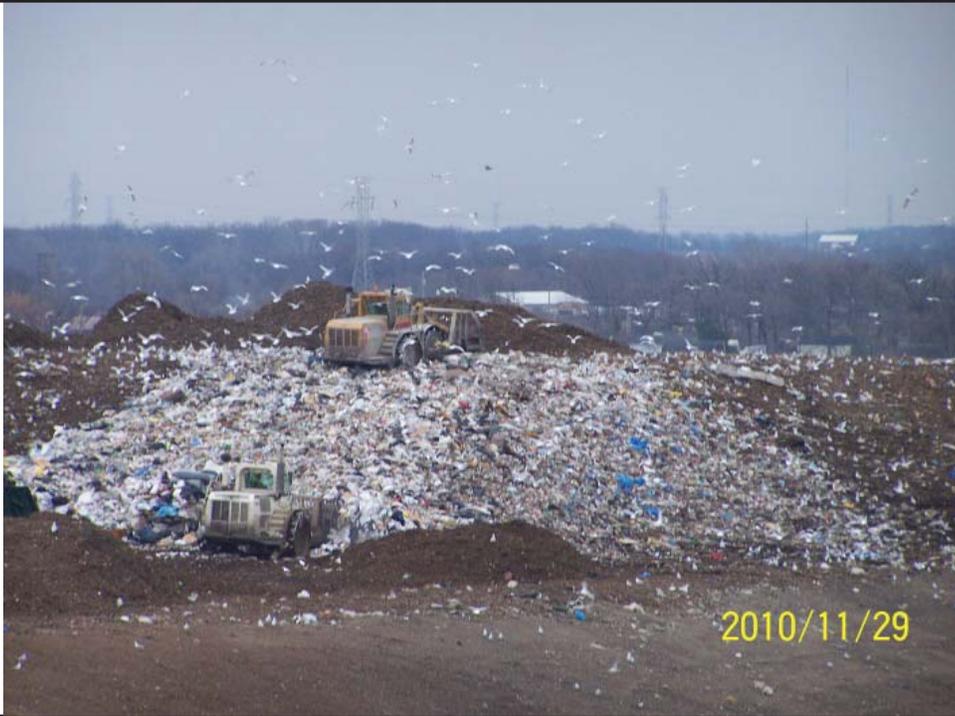
Working face

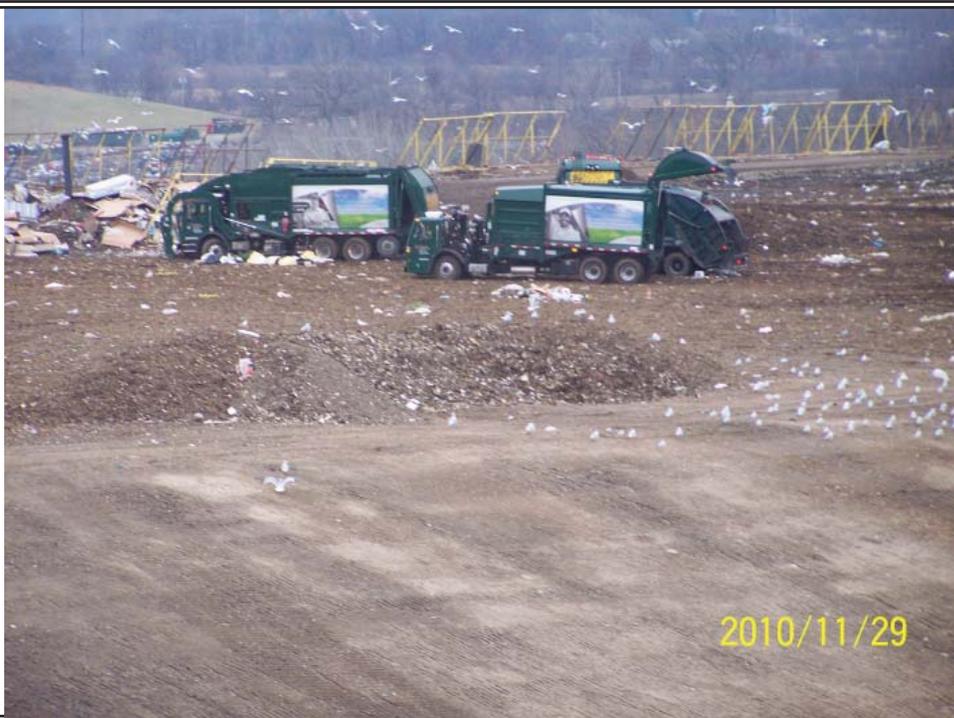
Trucks queuing for clean out

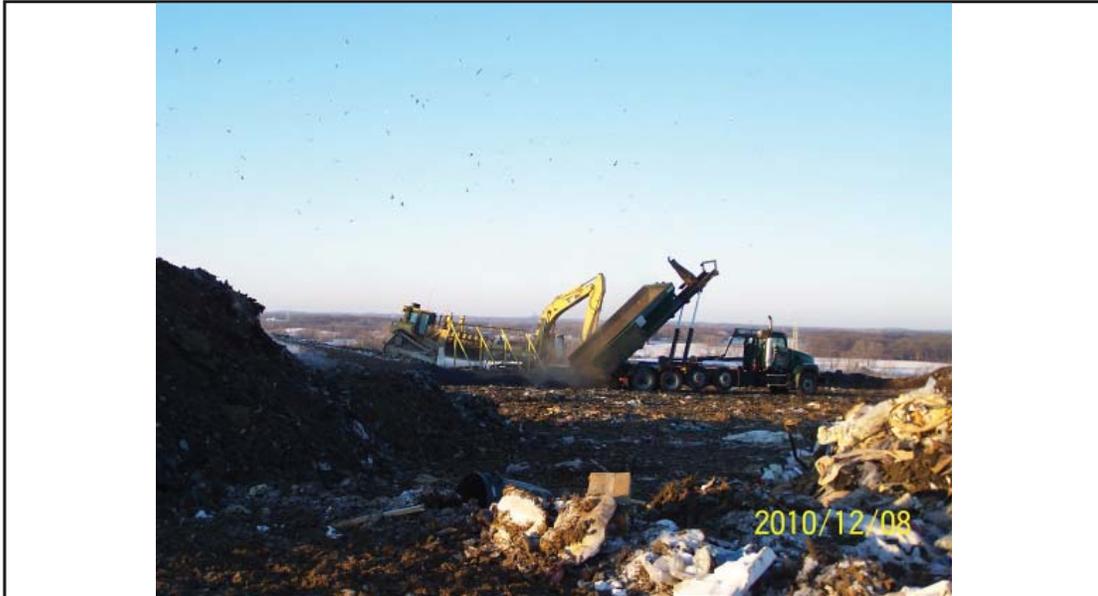
Frozen load being dug out by excavator

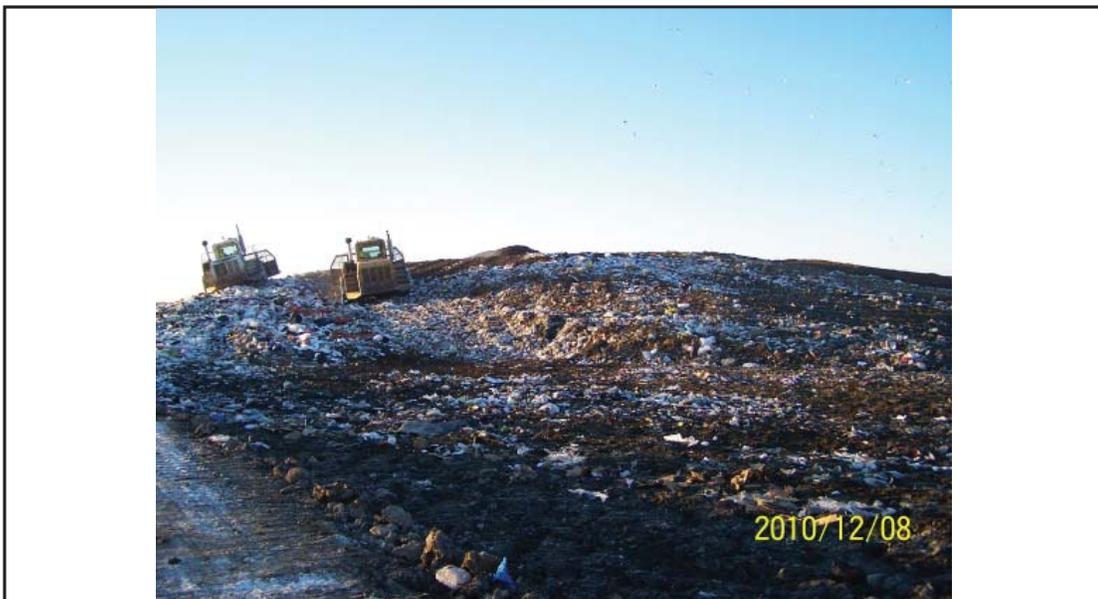
Working face
