VEOLIA EMERALD PARK LANDFILL  
CITY OF MUSKEGO

## 2010 Veolia Emerald Park Landfill Year End Compliance Officer Report and Audit Summary

**TO:** Veolia Emerald Park Standing Committee  
**FROM:** Jo-Walter Spear, Jr., P.E.  
**COPIES:** File  
**DATE:** 01/20/11  
**PROJECT NUMBER:** 1012

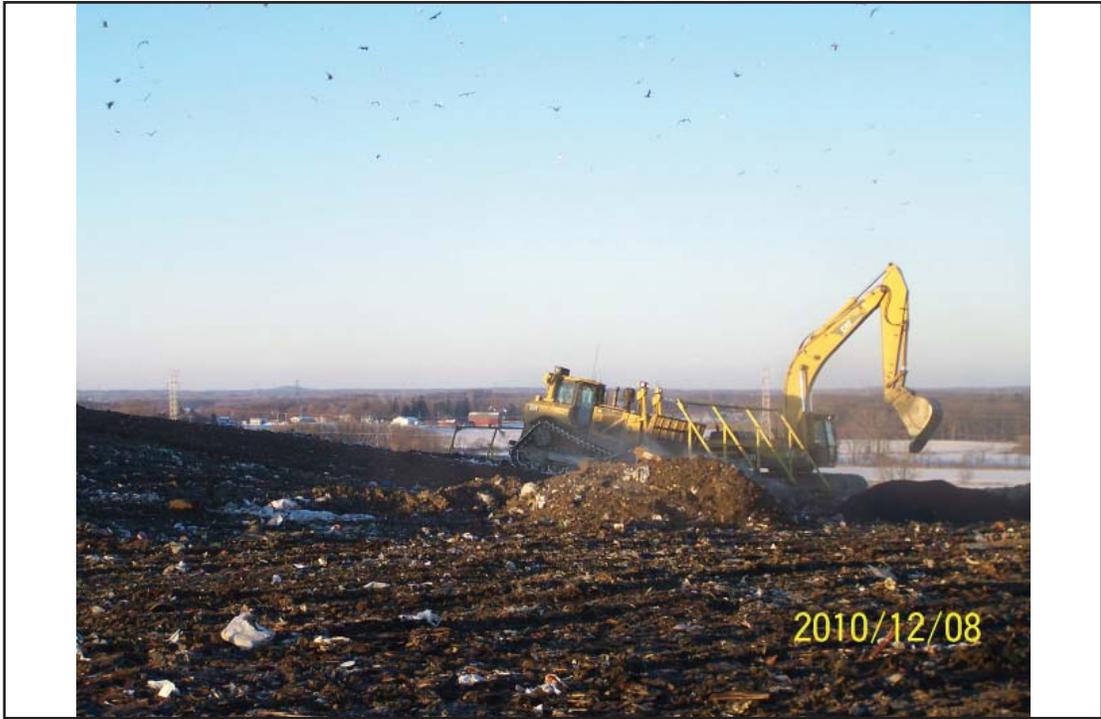
previous daily cover

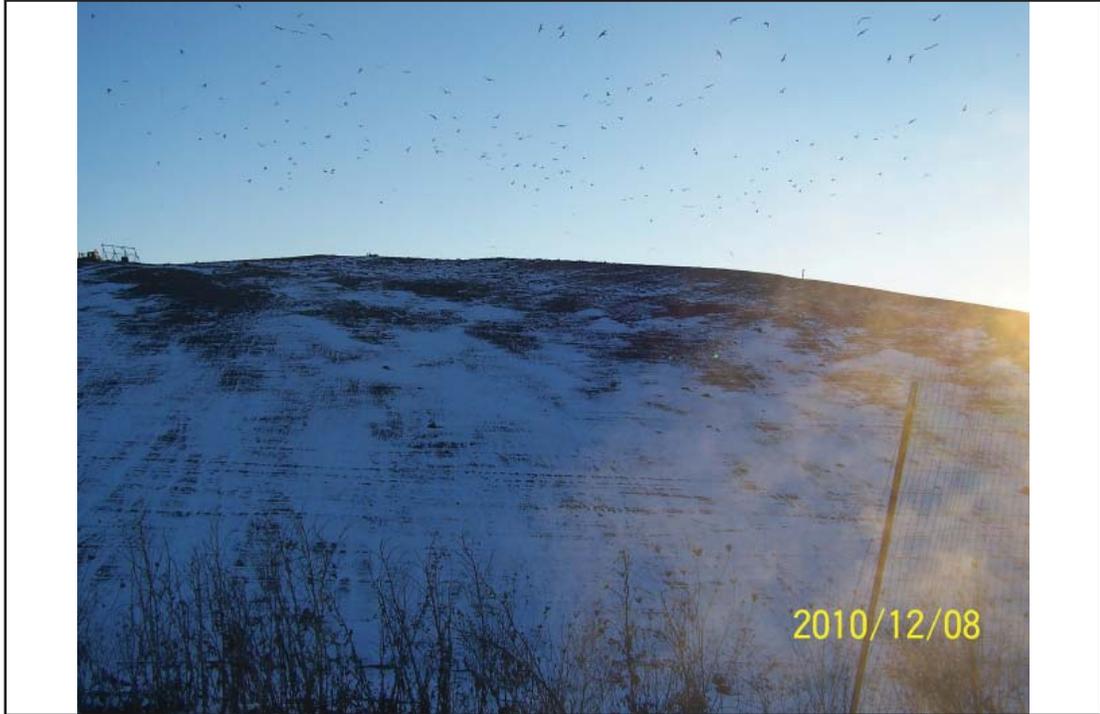
West slope at South most end

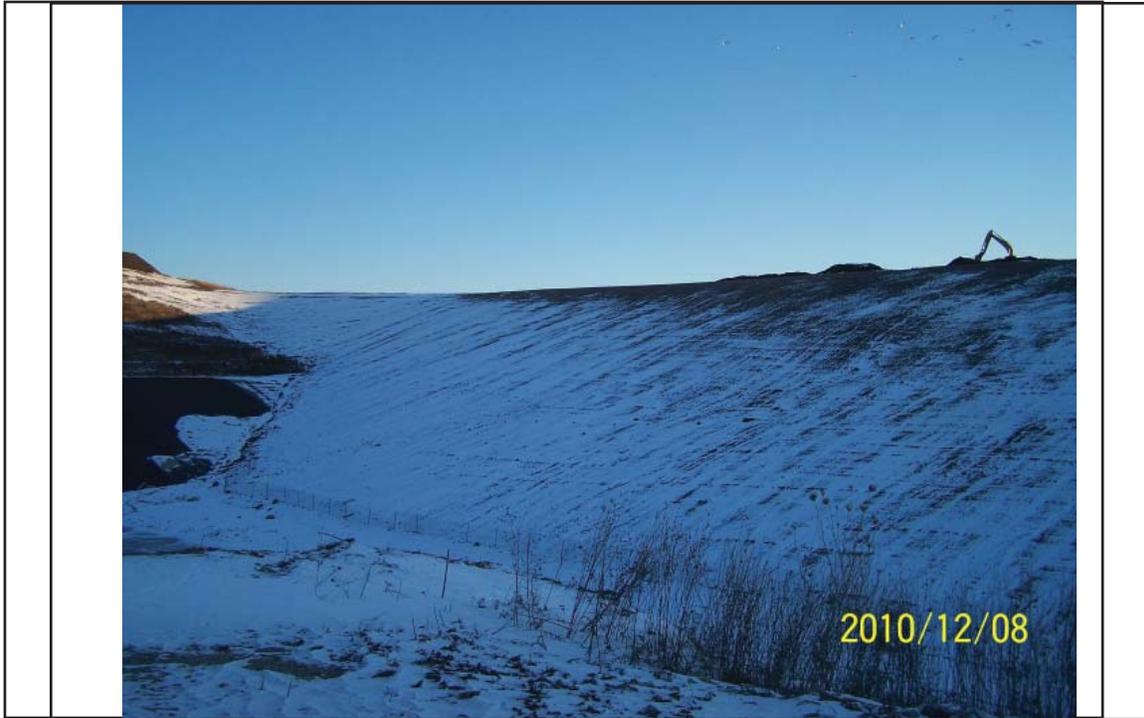
West sope, no seeps

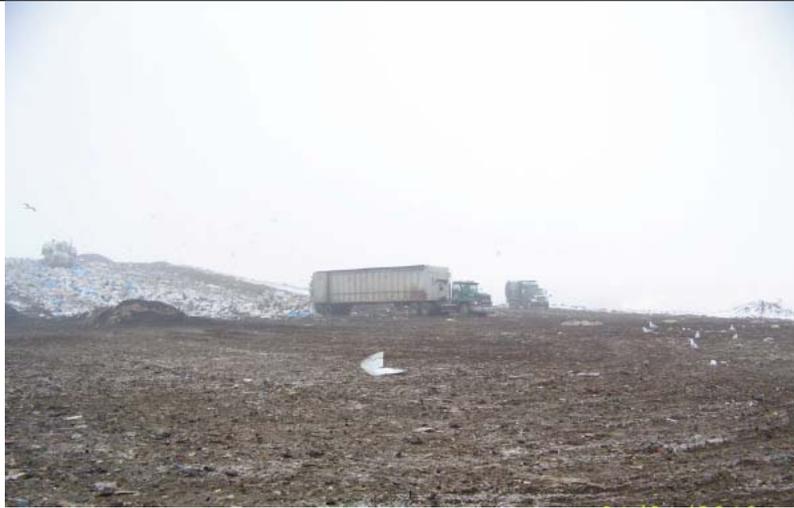
Active Area

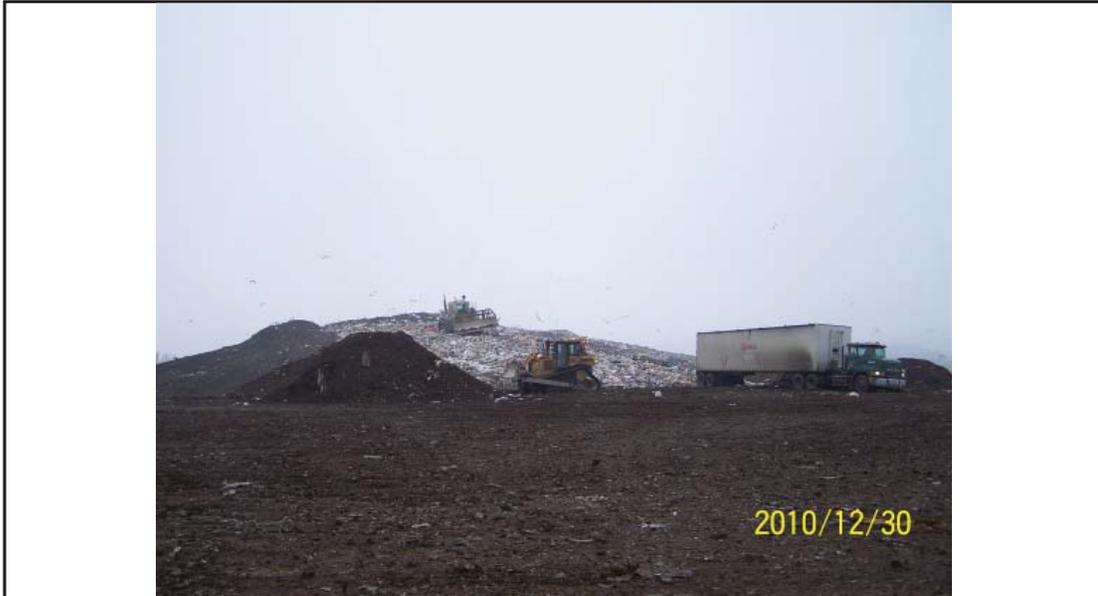
Working face

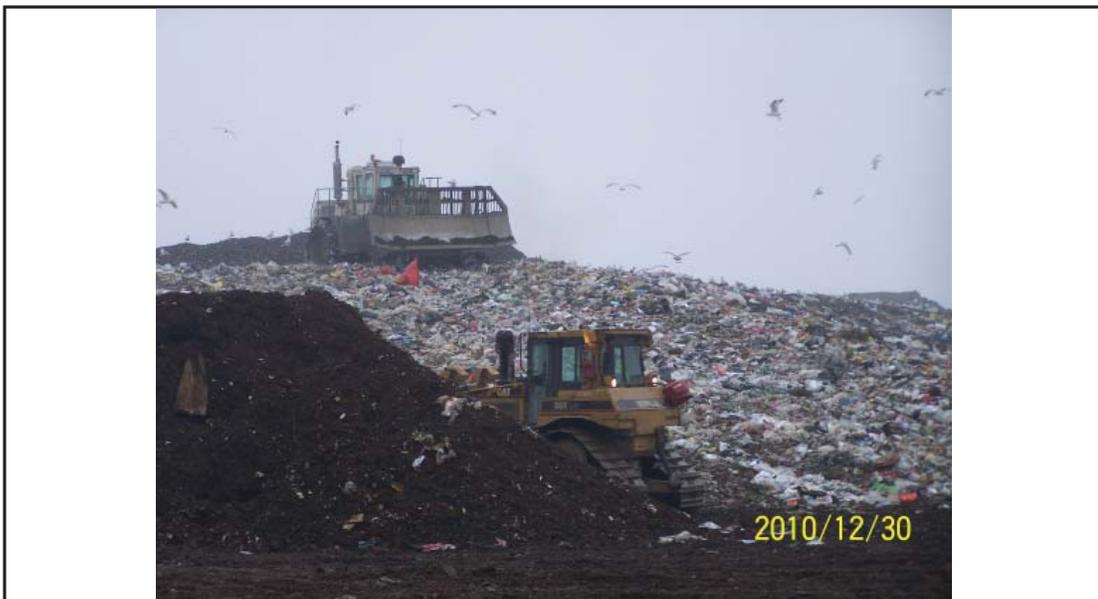
Compactor and dozer working face of waste

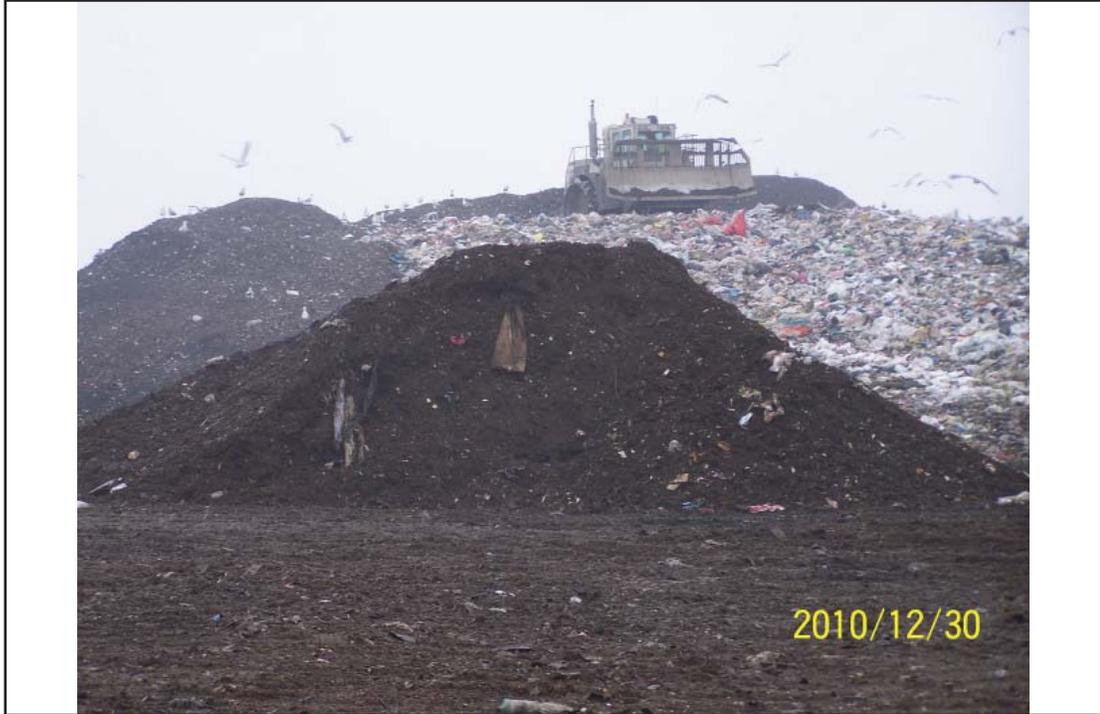
Additional autofluff stockpile

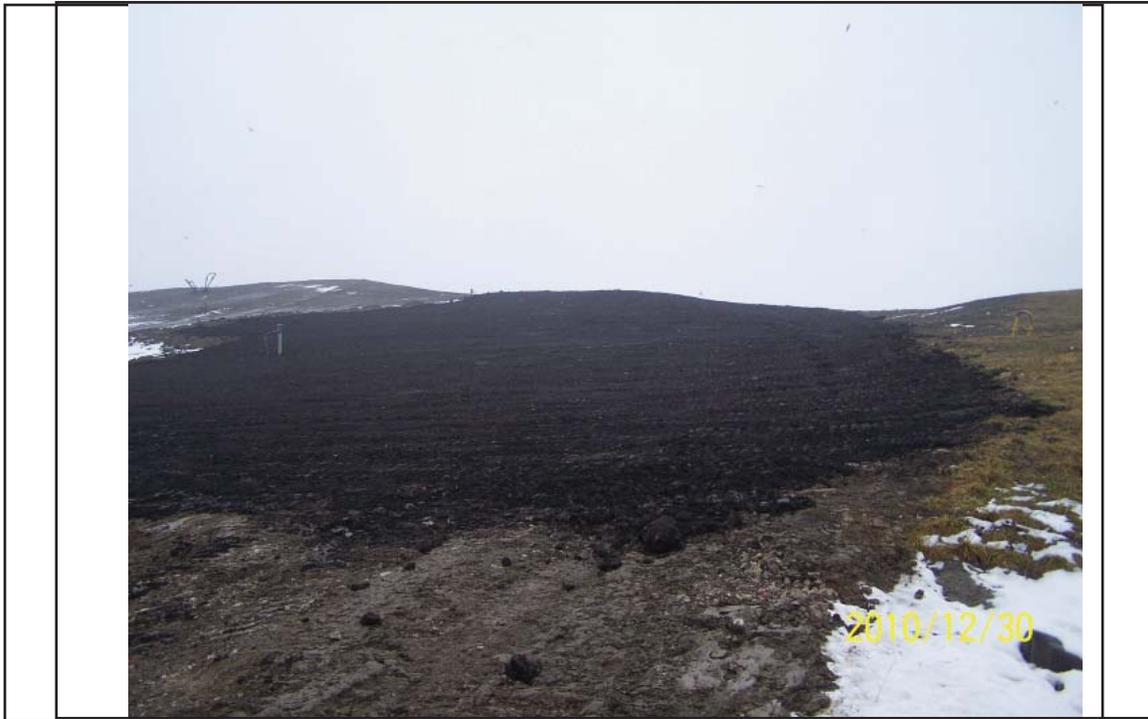
Topsoil, spread over clay on South slope of Phase 5/6

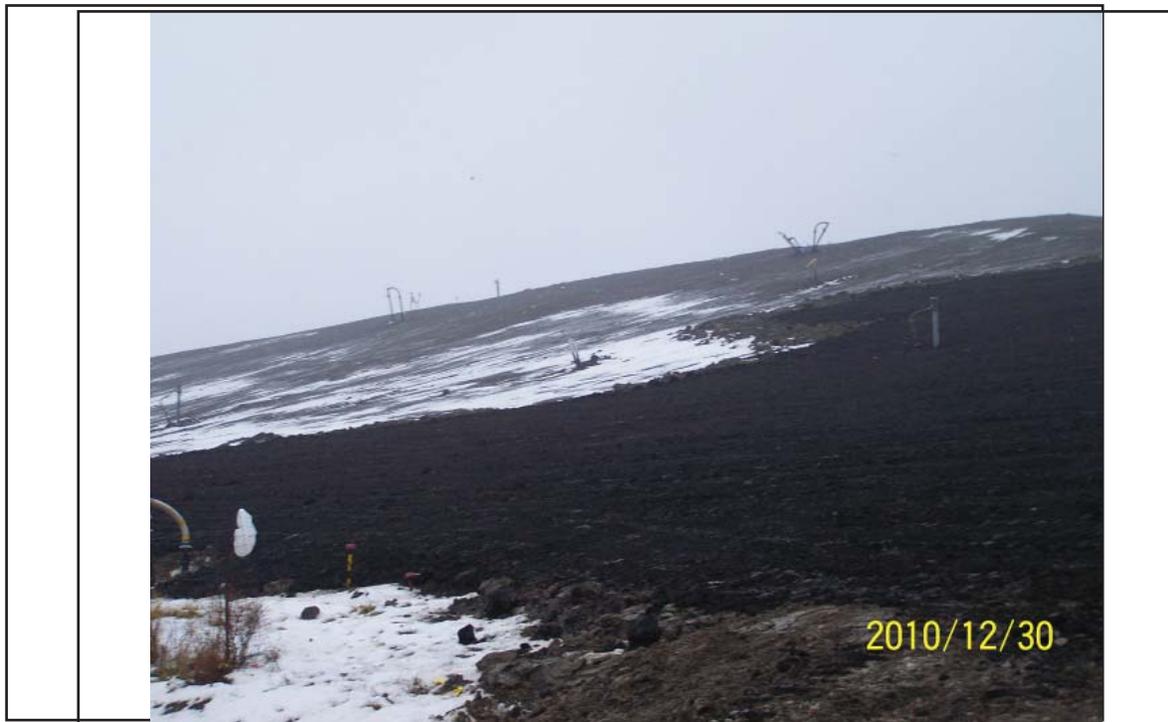
Extents of Top soil placement to date.

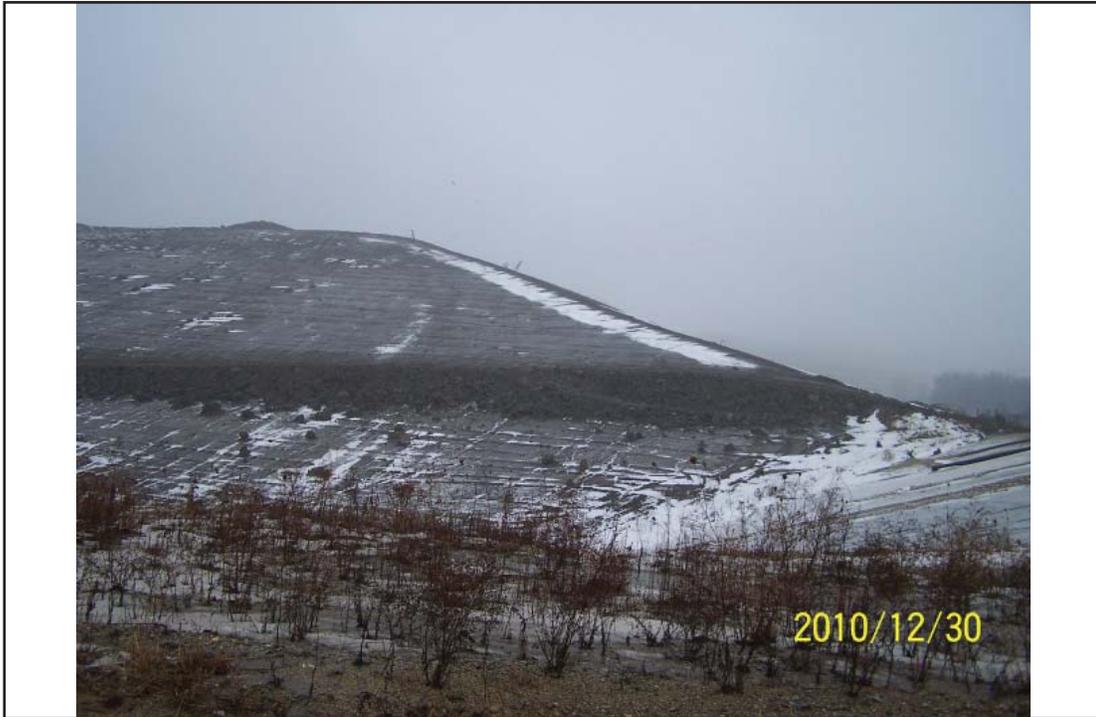
New access road for future waste placement in Phase 6W

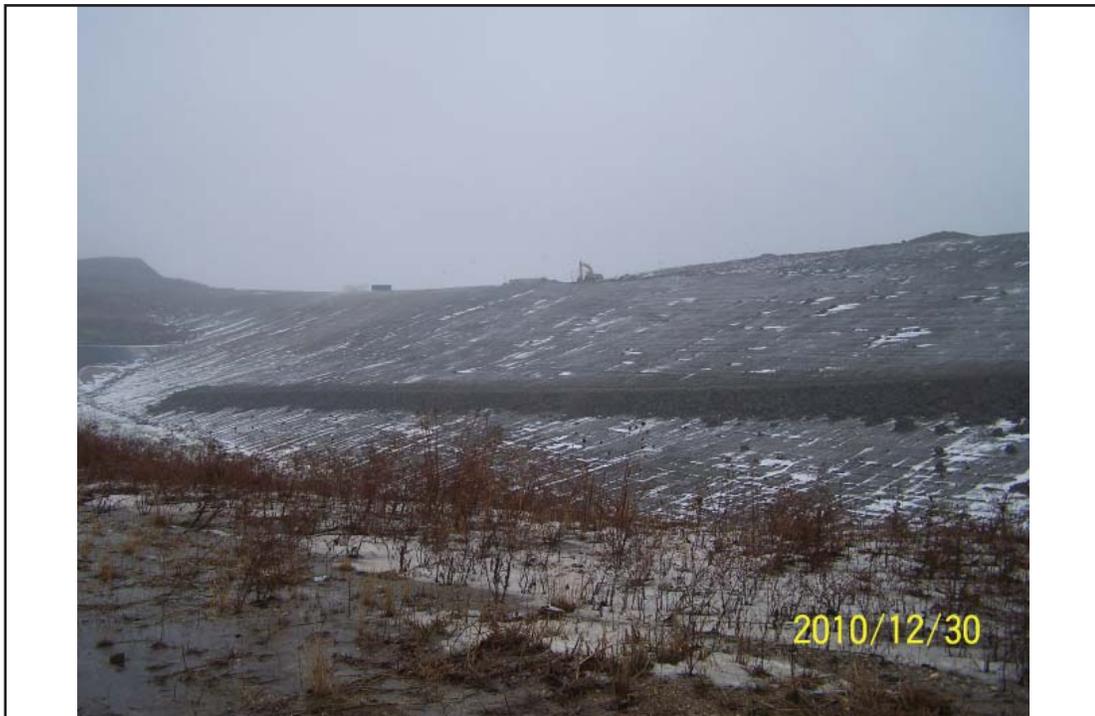
Reach of new access road.

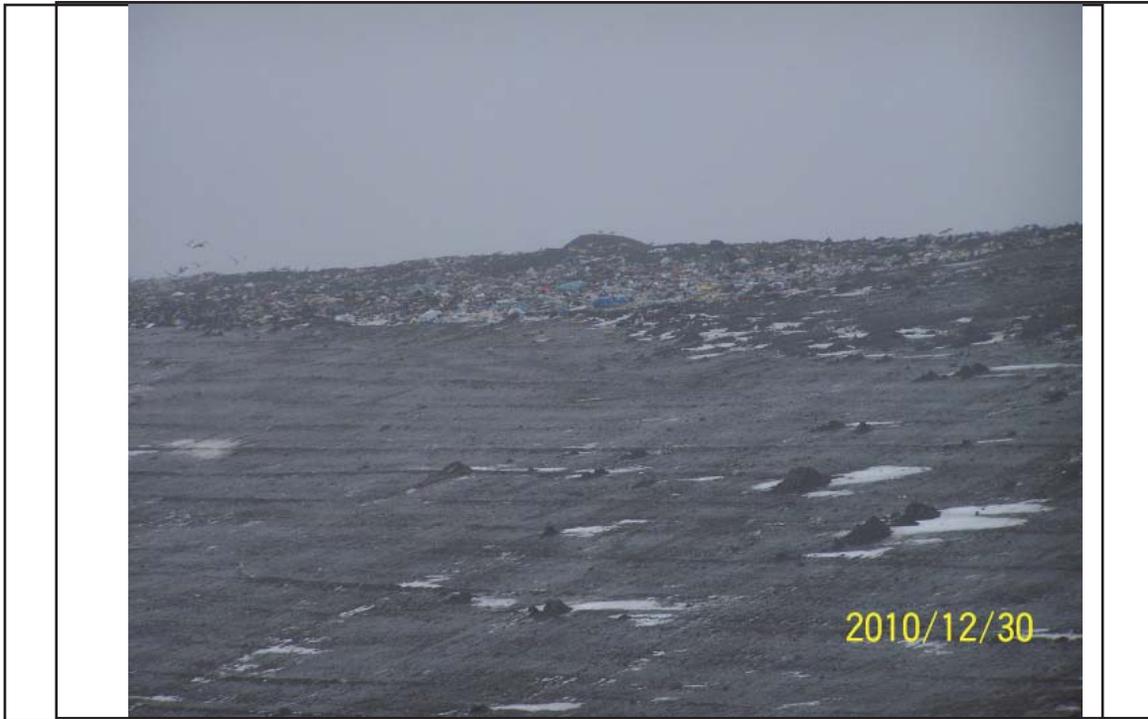
Poor soil cover placement on West slope. Flagging waste visible.
