Veolia Emerald Park Landfill
City of Muskego

2011 Veolia Emerald Park Landfill Year End Compliance Officer Report and Audit Summary

TO: Veolia Emerald Park Standing Committee
FROM: Jo-Walter Spear, Jr., P.E.
COPIES: File
DATE: 04/02/2012
PROJECT NUMBER: 1012.10030

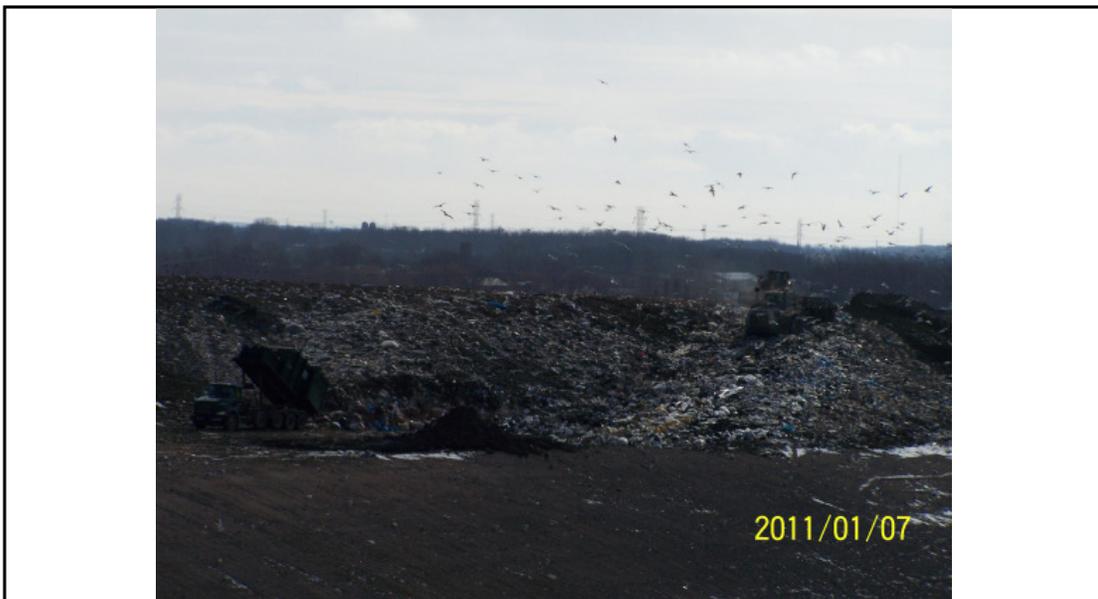
Working face viewed from the South

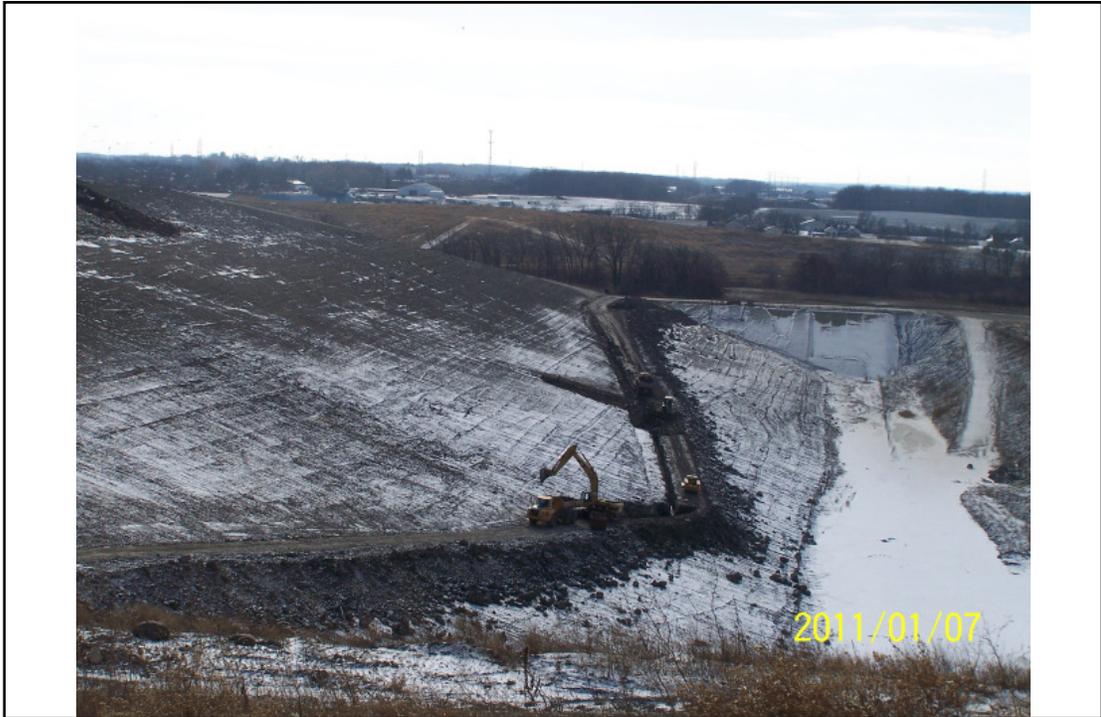
Access road construction on West slope of Phase 6

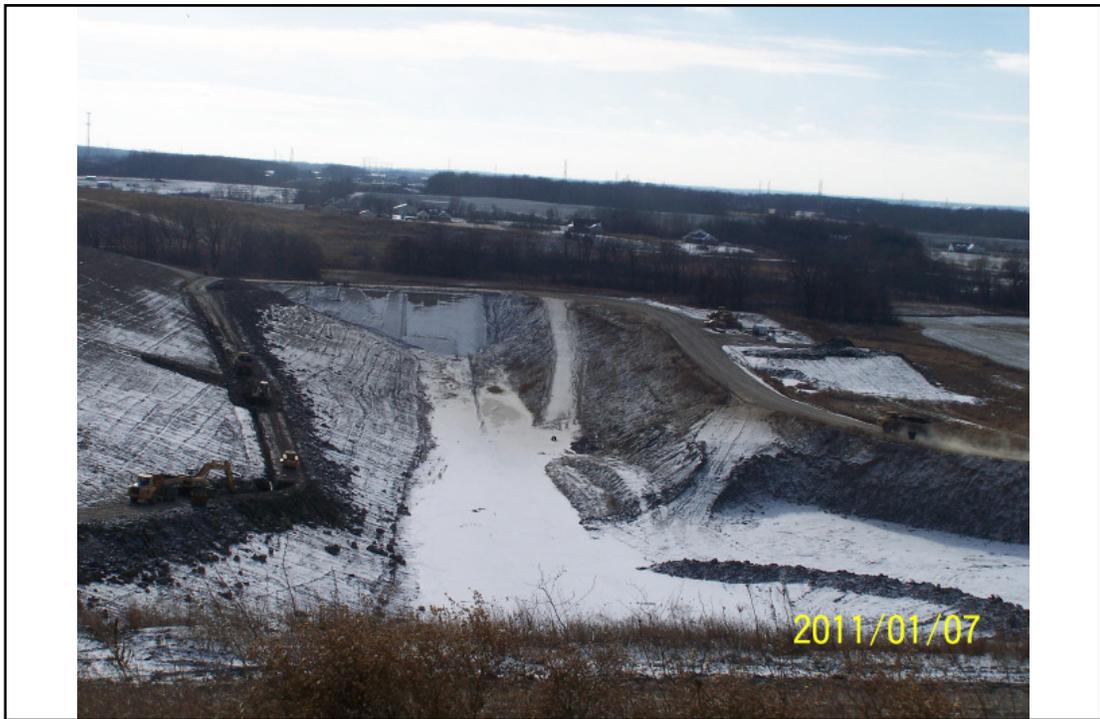
Temp sed basin and future foot print

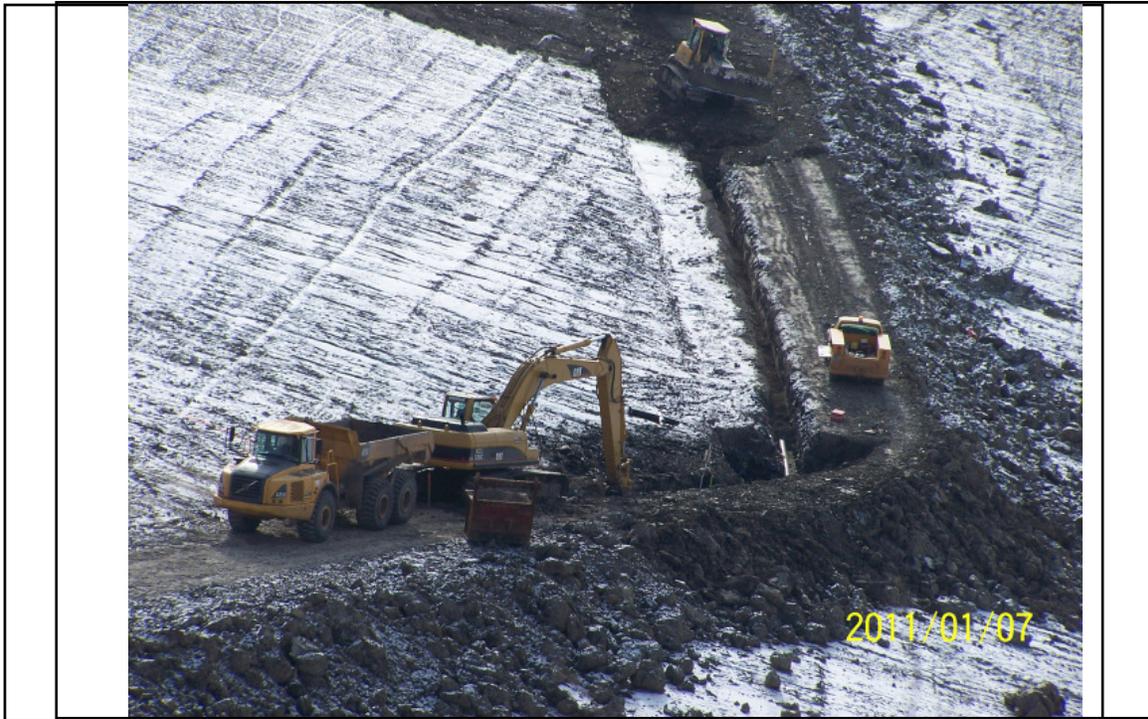
Gas line placement in West Slope

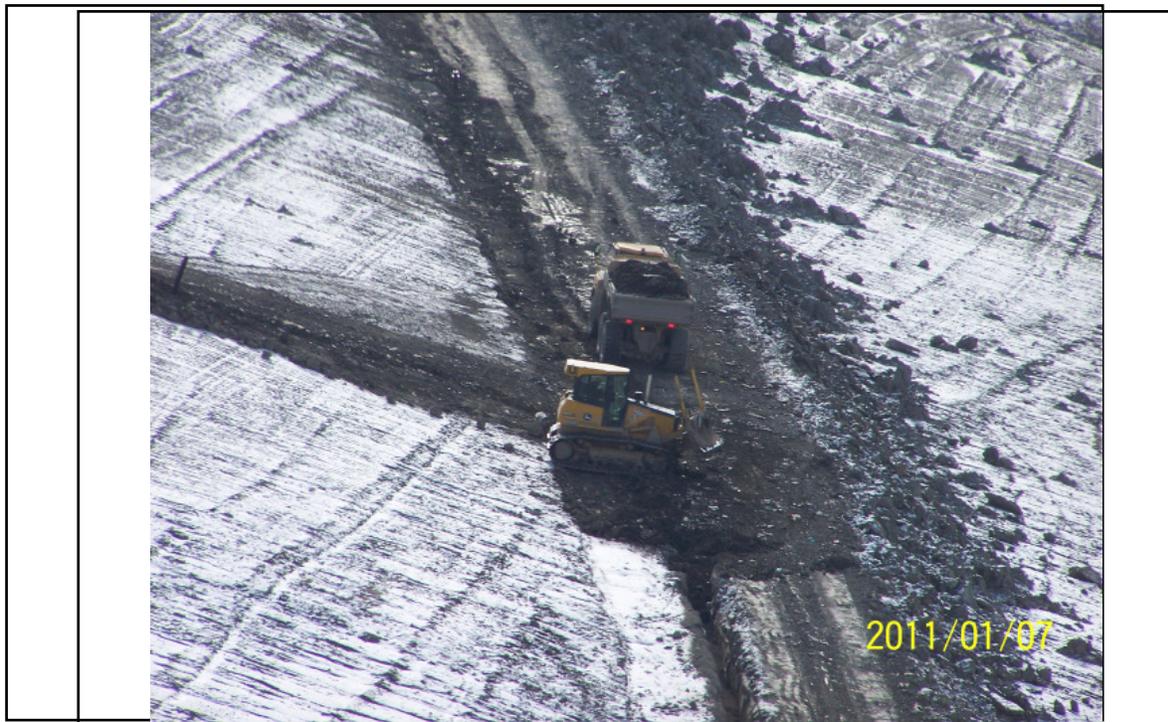
Access road construction

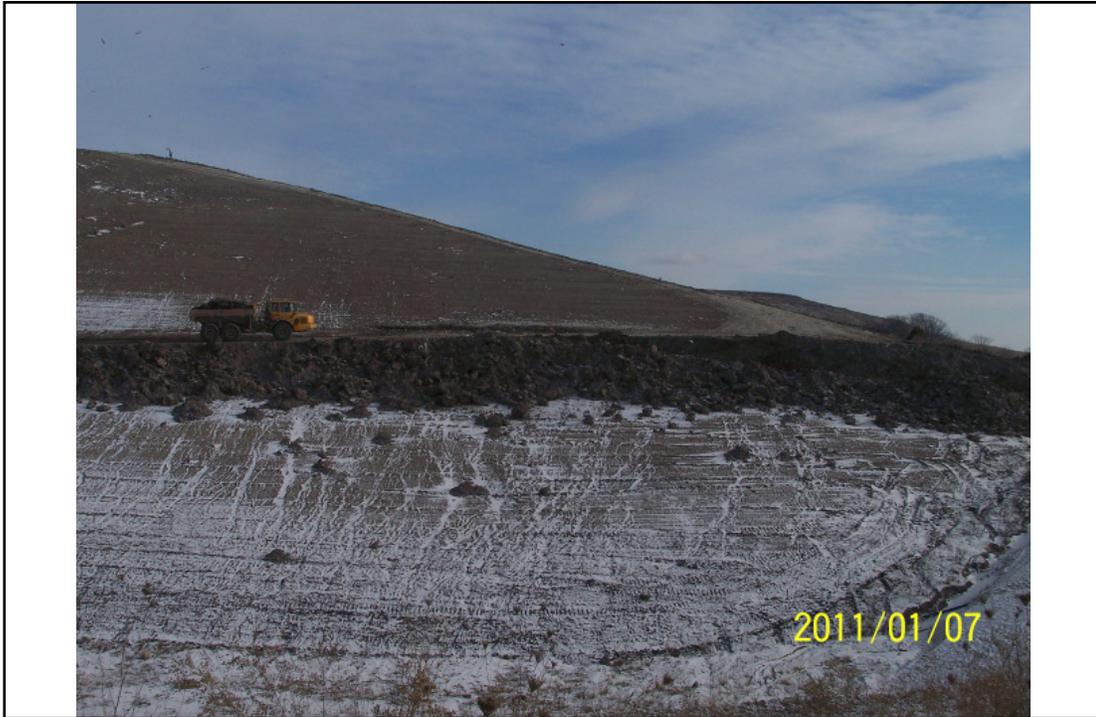
New access road for future waste placement in Phase 6W

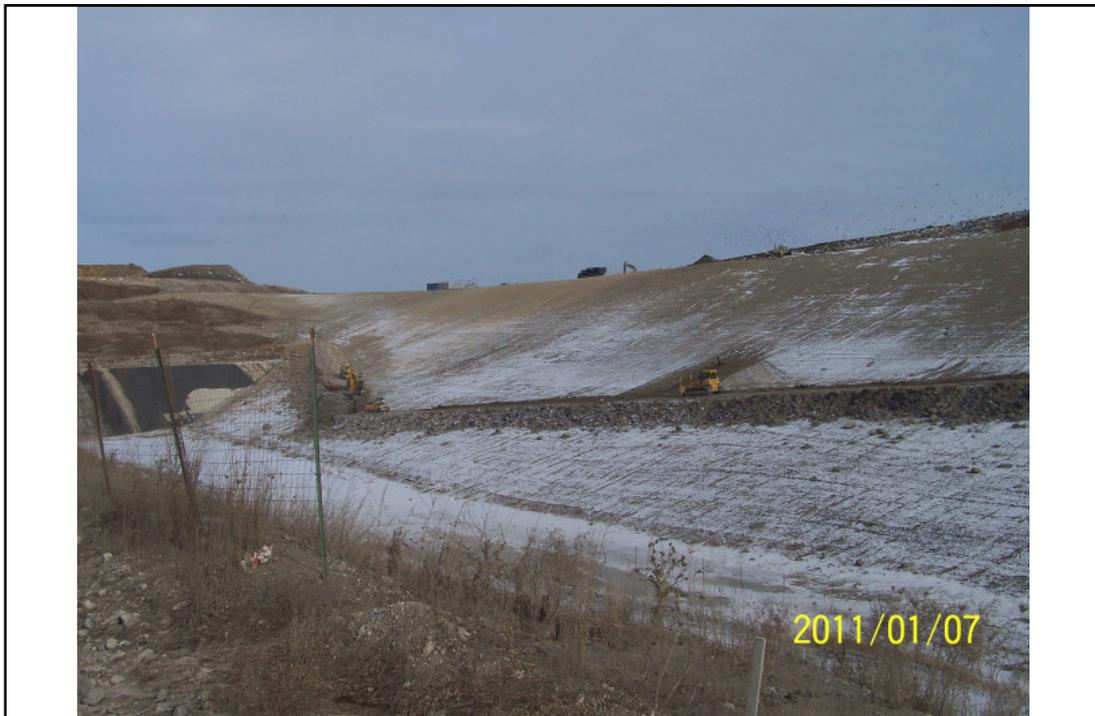
Reach of new access road.

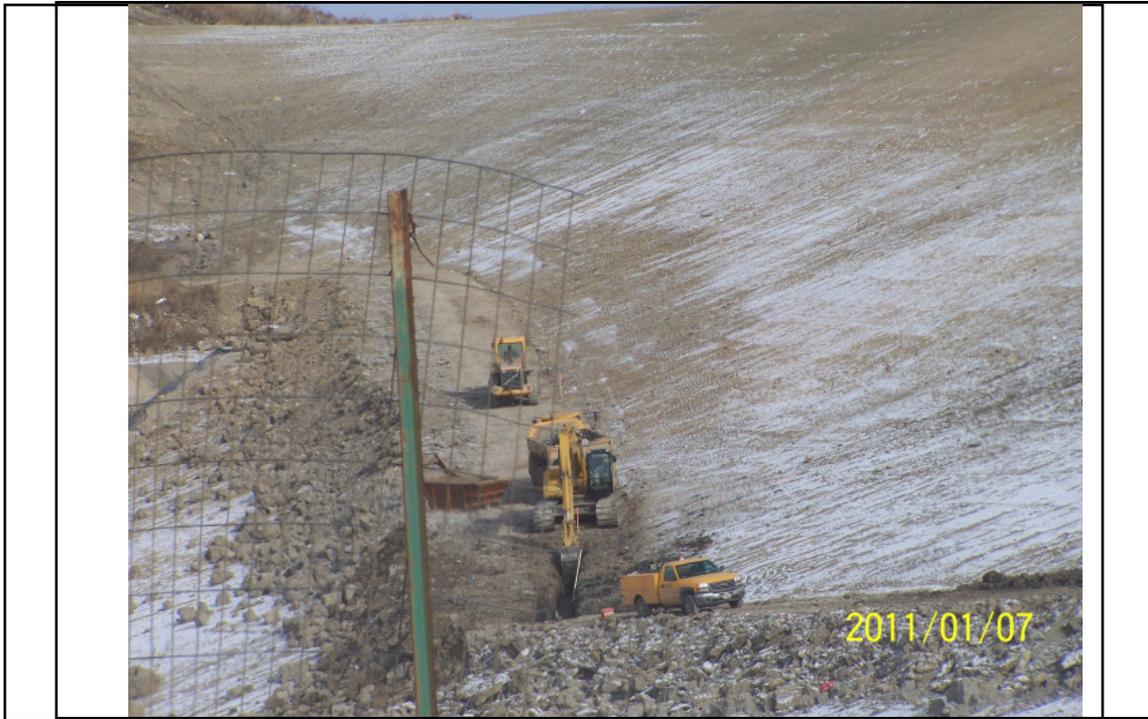
New access road for future waste placement in Phase 6W

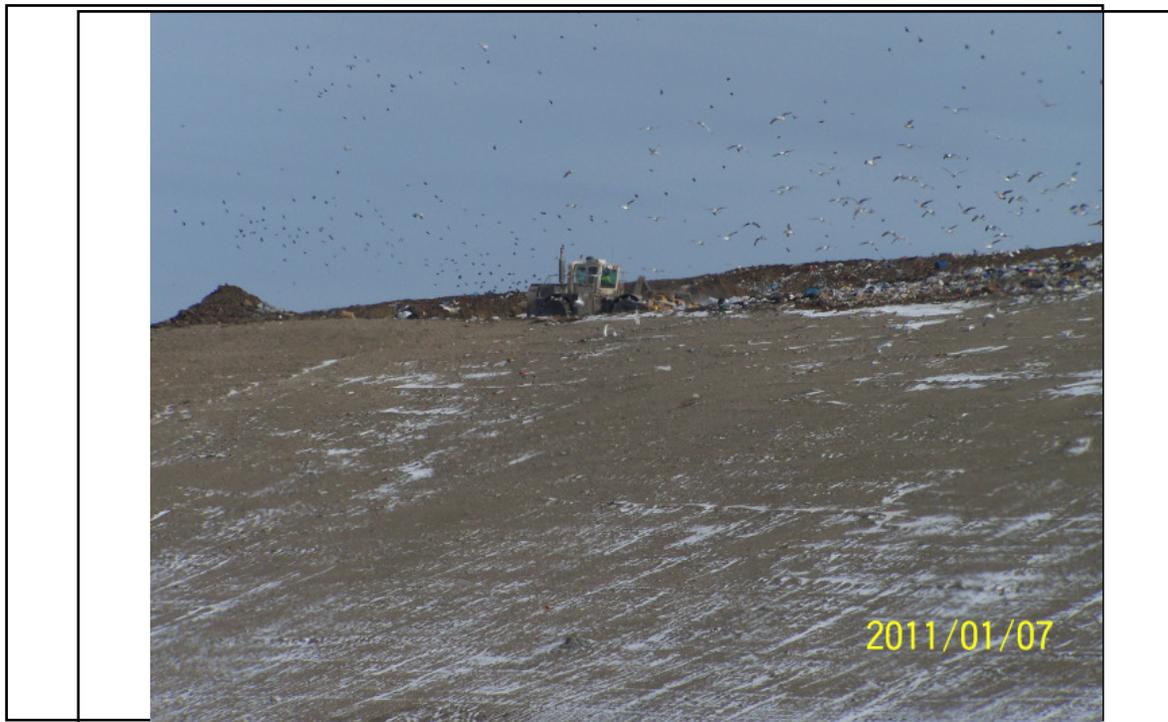
Reach of new access road.

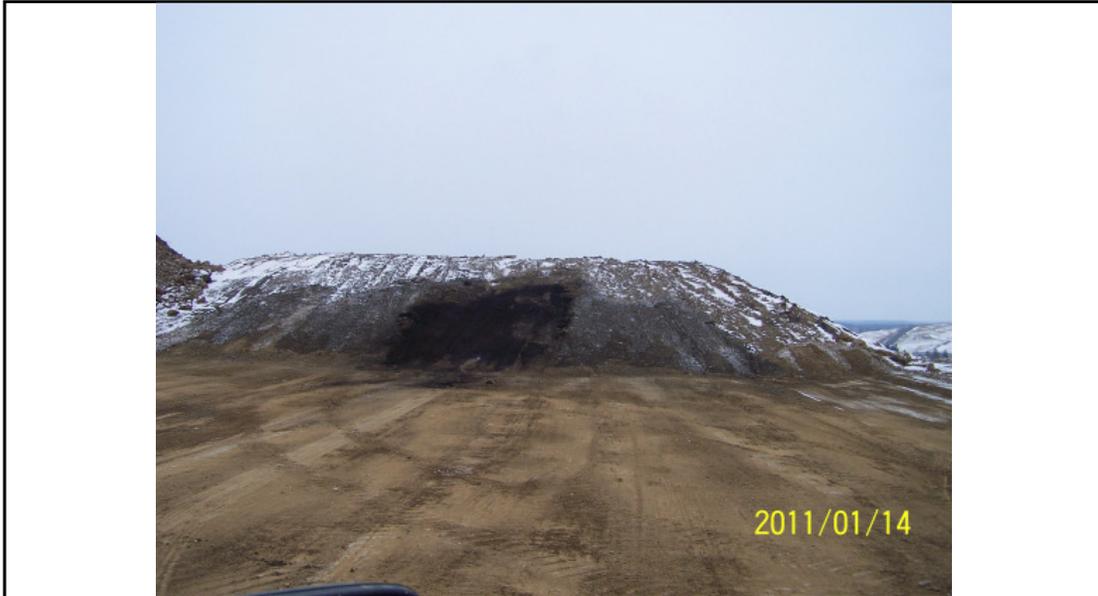
Bio Soil Pile

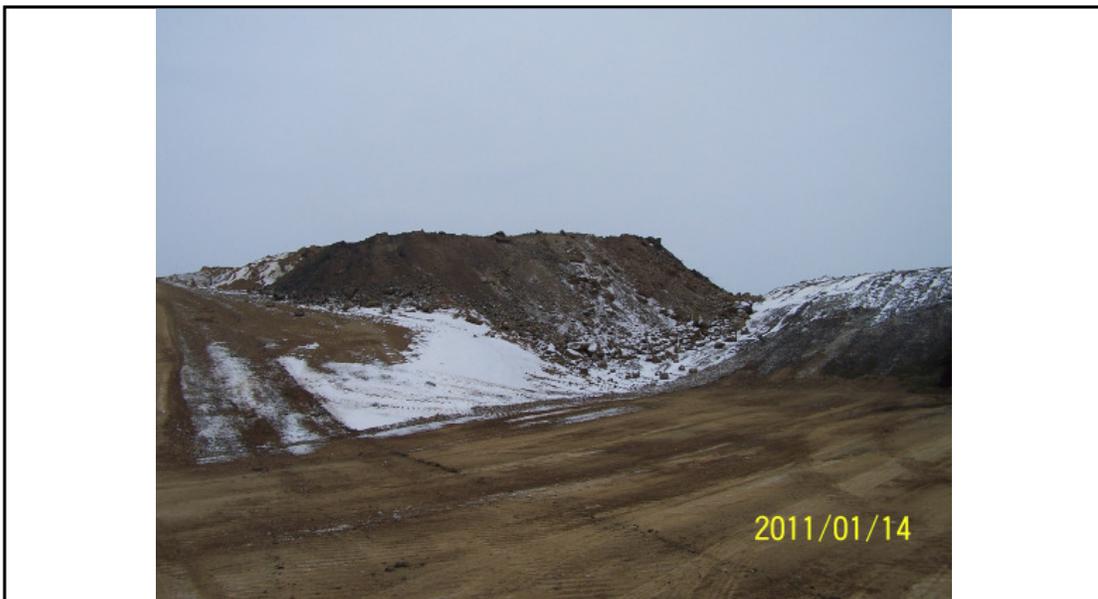
Landfill Direct Soil Pile

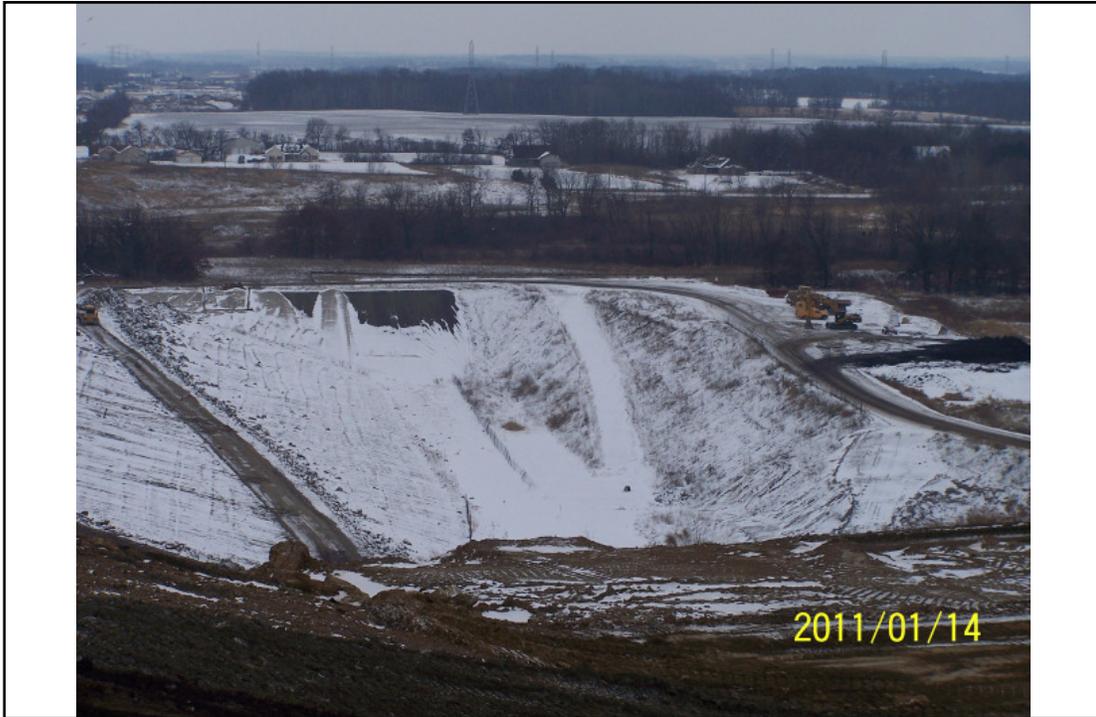
Temp sed basi nand new road construction

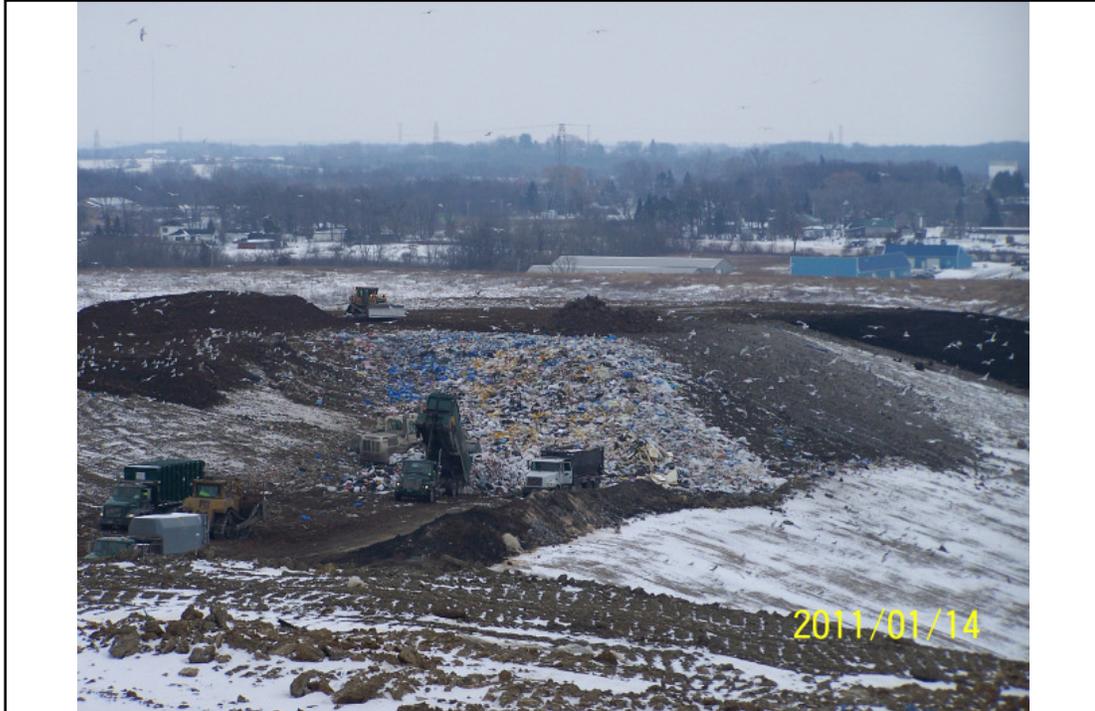
Working face

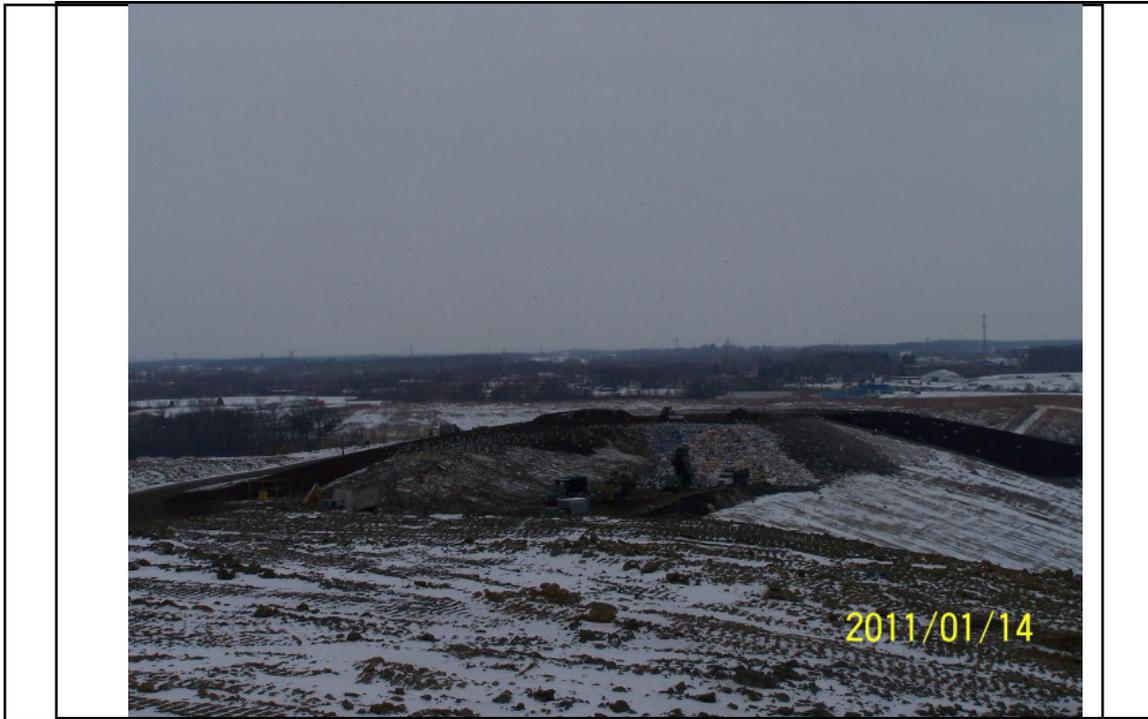
Active Area viewed from the North

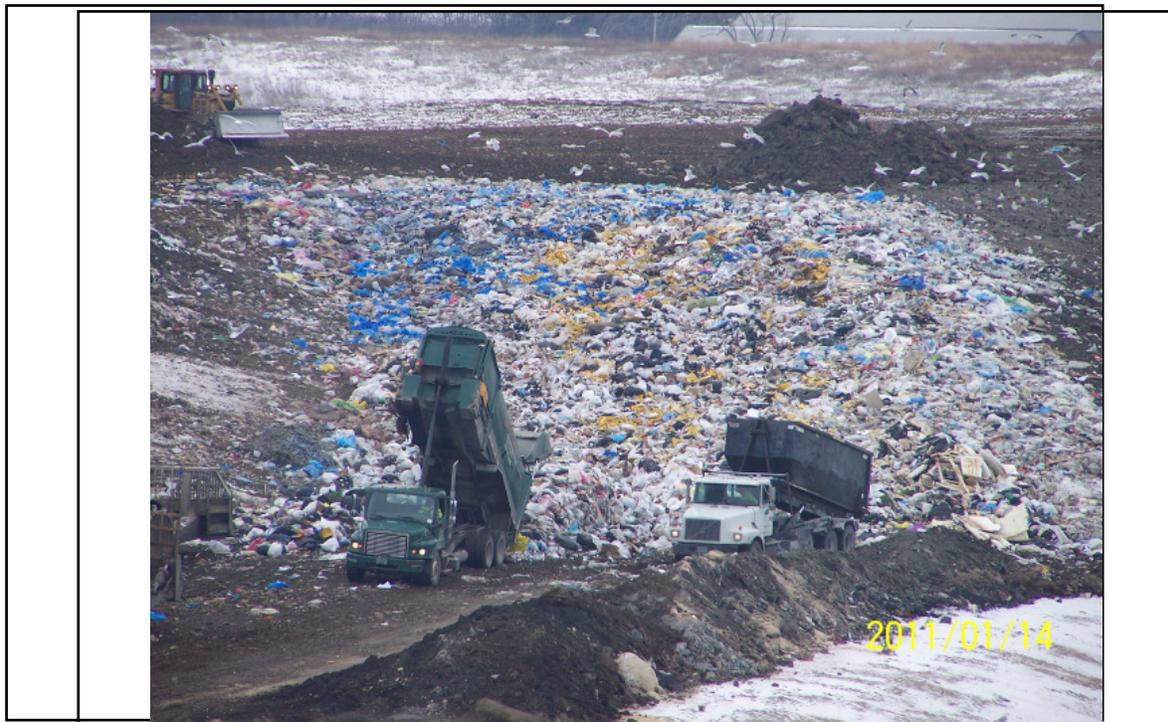
Working face along West top of slope, South end of Phase 6

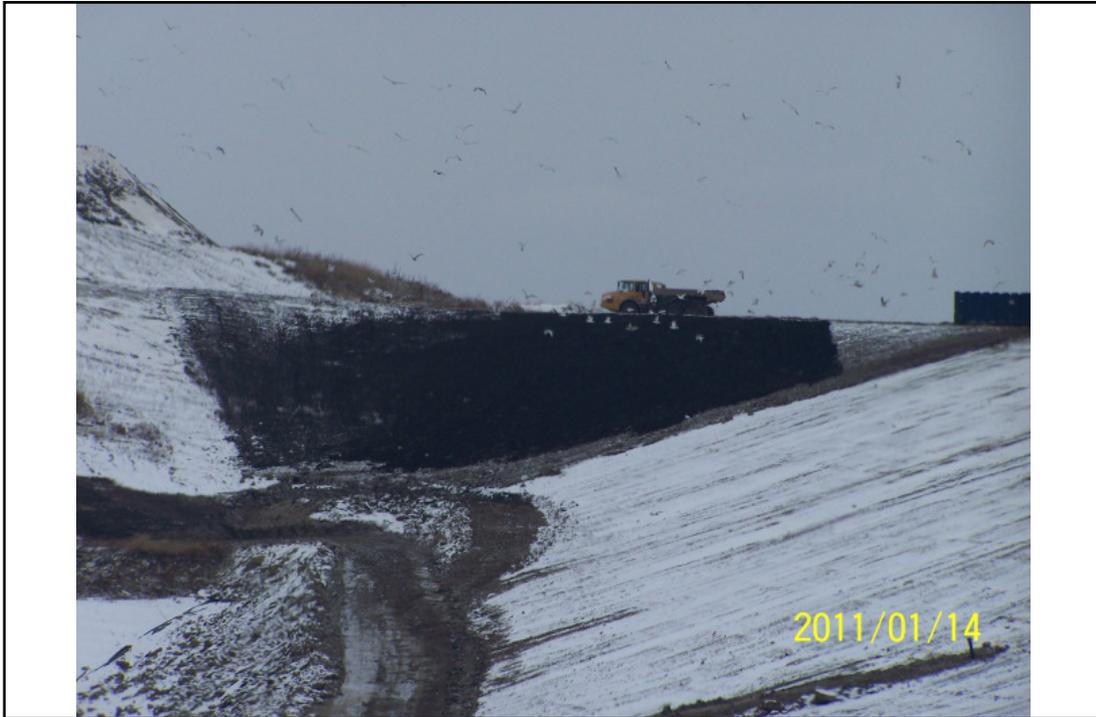
Haul truck moving soils for cover and road construction

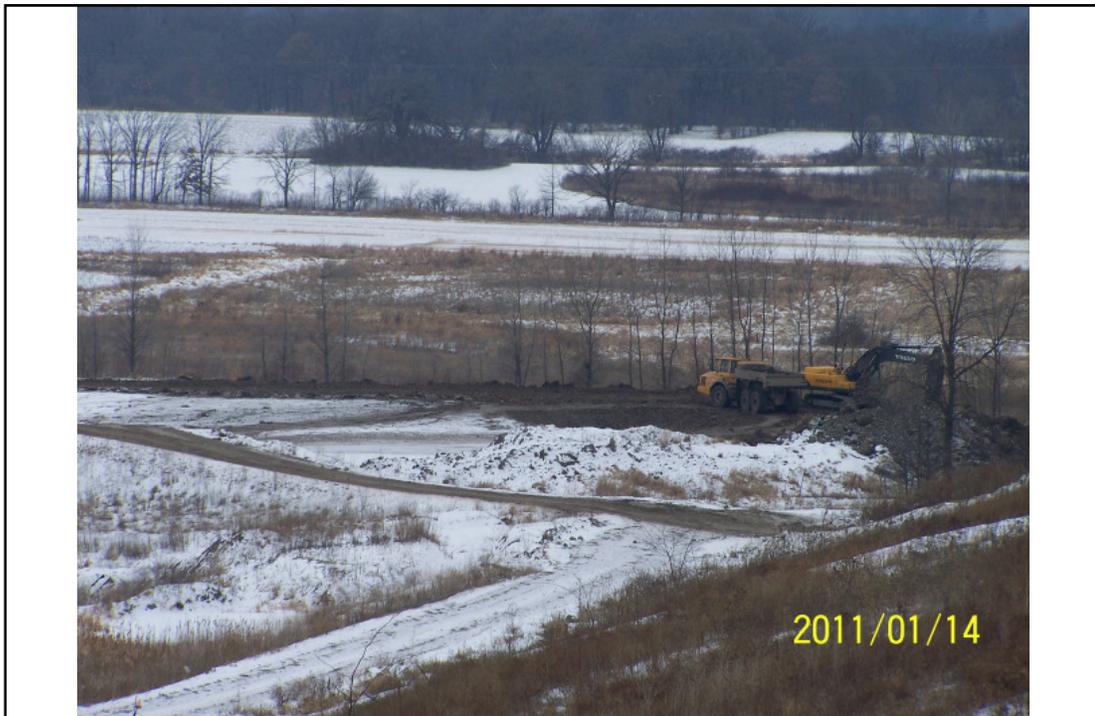
Soils being excavated from stock pile

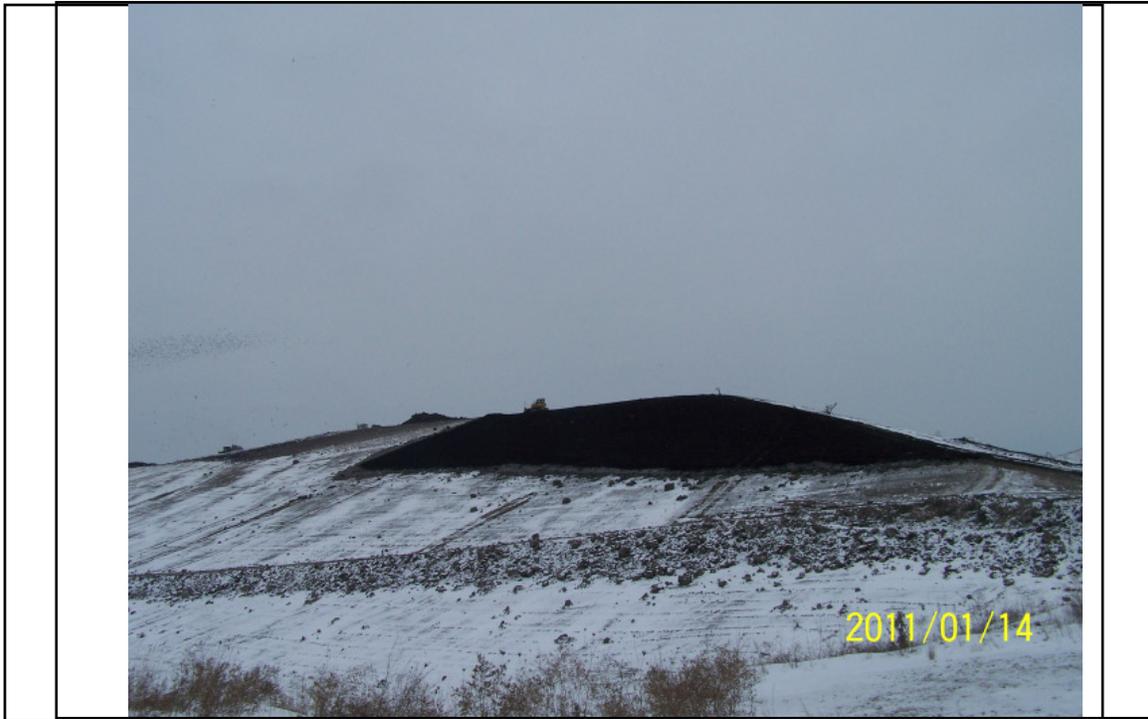
Previously placed intermediate cover

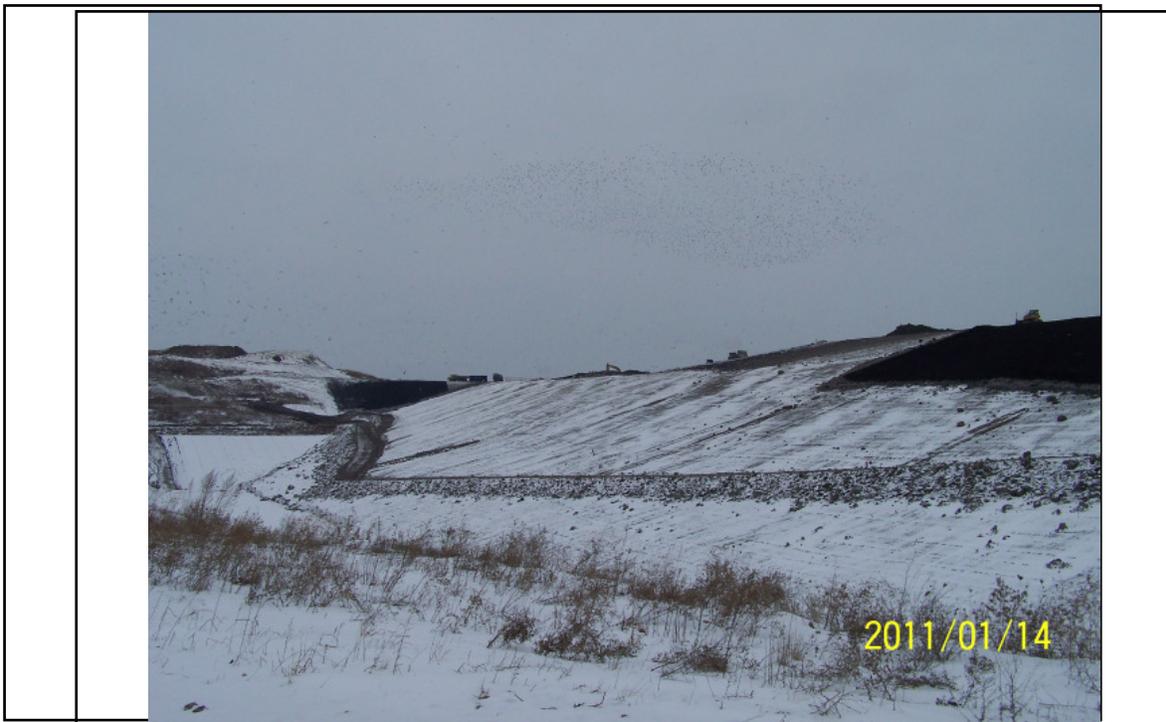
Reach of new access road.

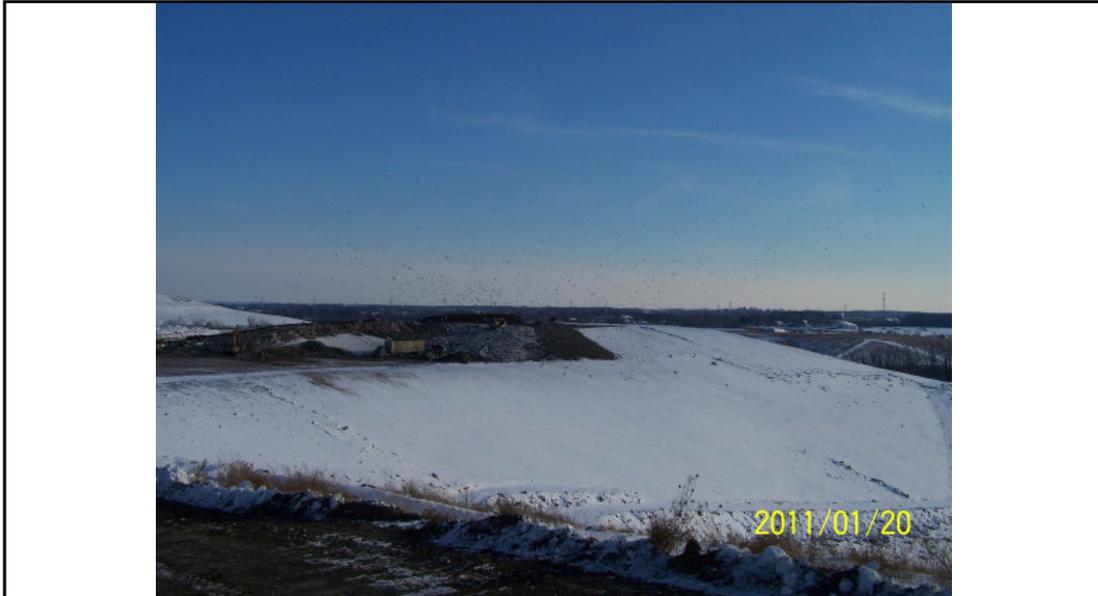
South end of active area

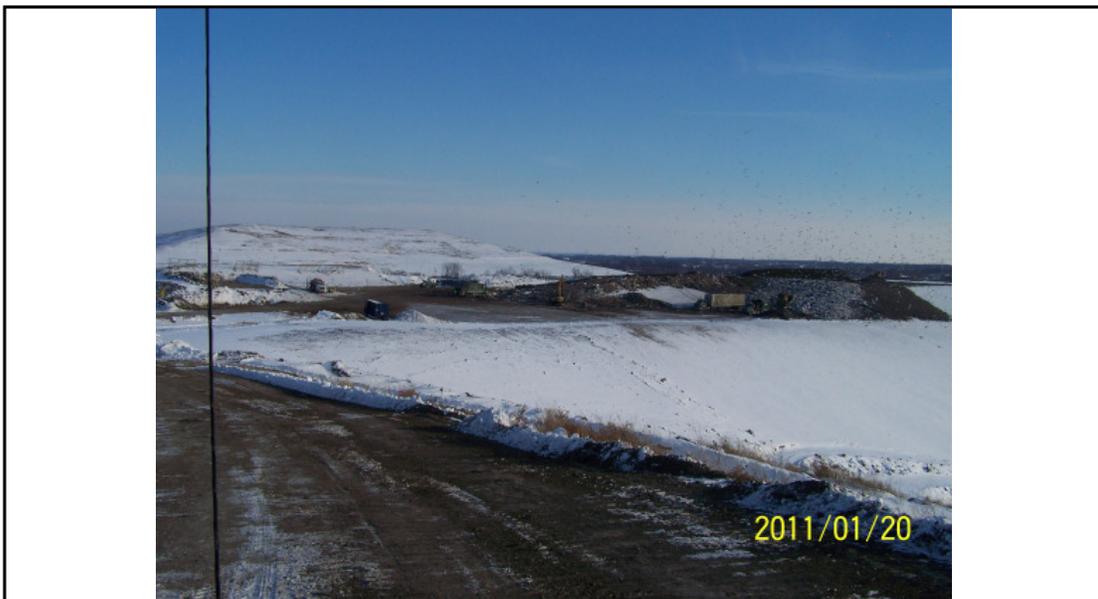
North end of active area

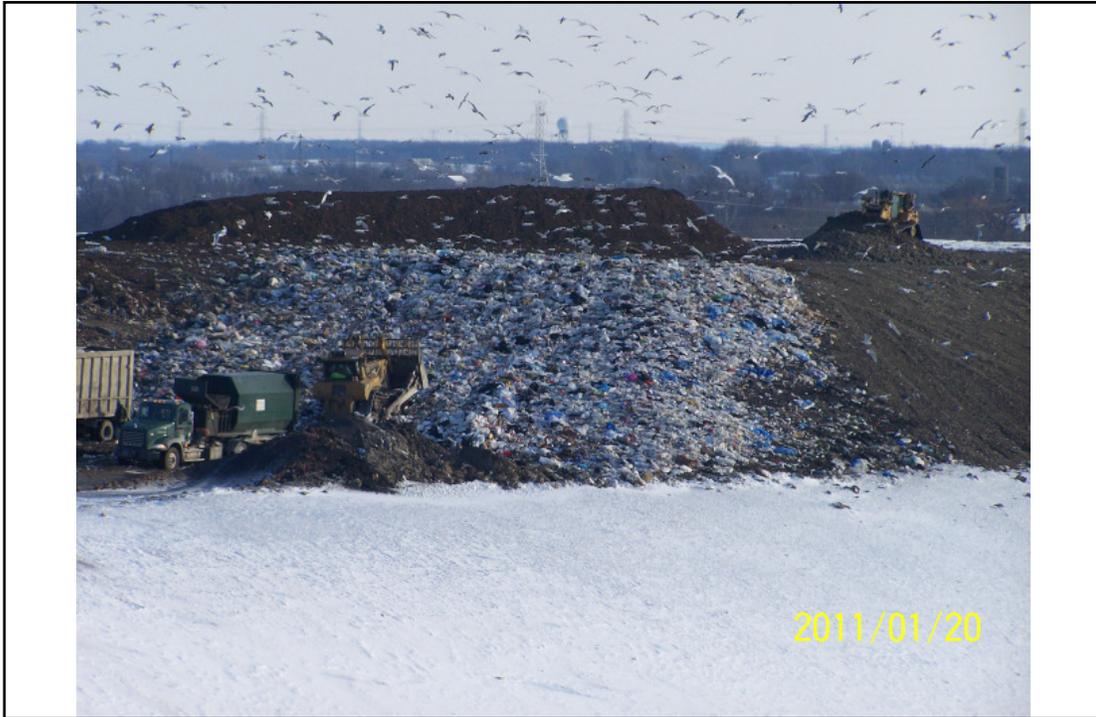
Working face

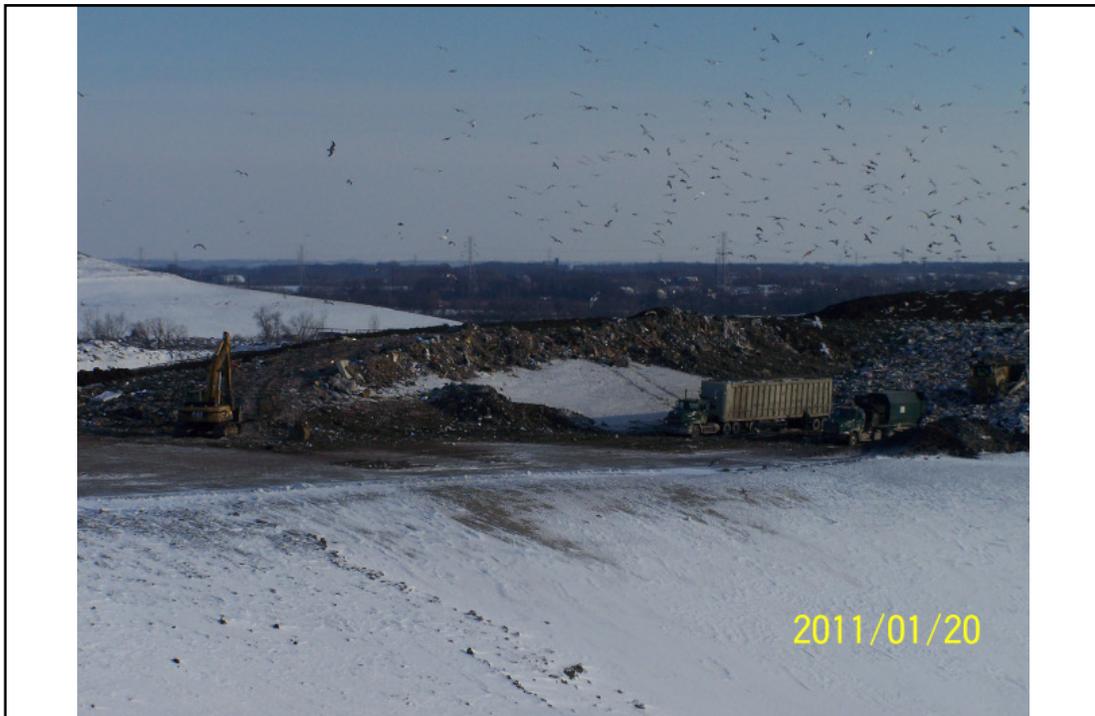
Previous working faces, with some rough cover

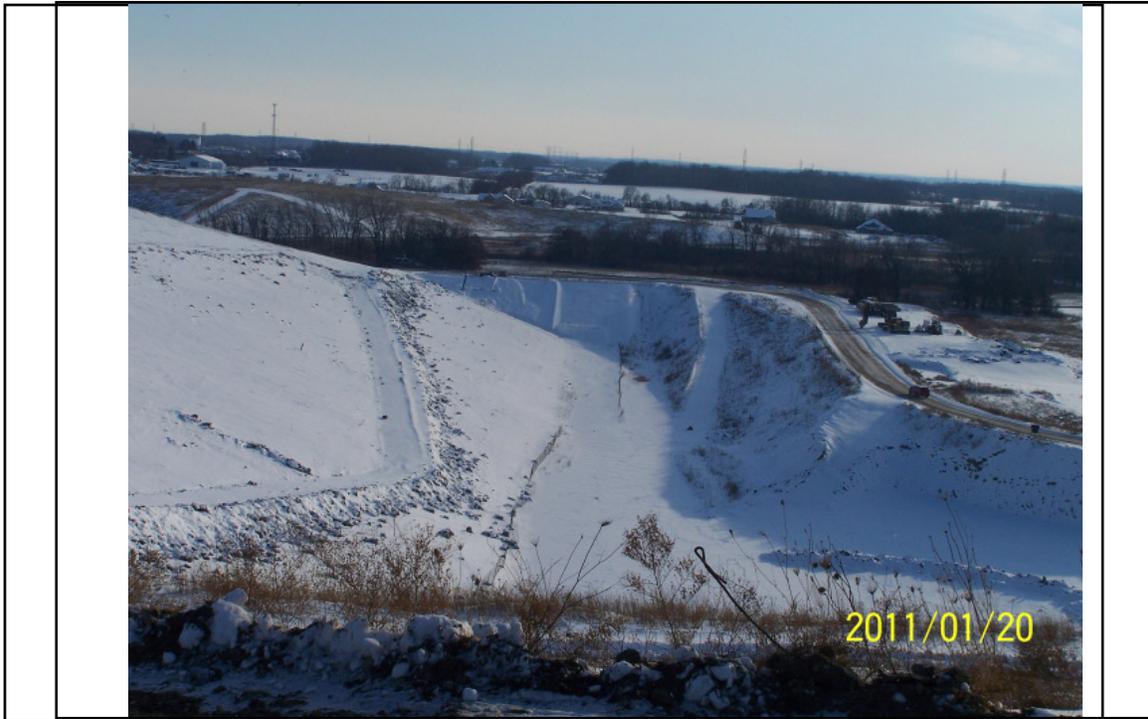
West of active area

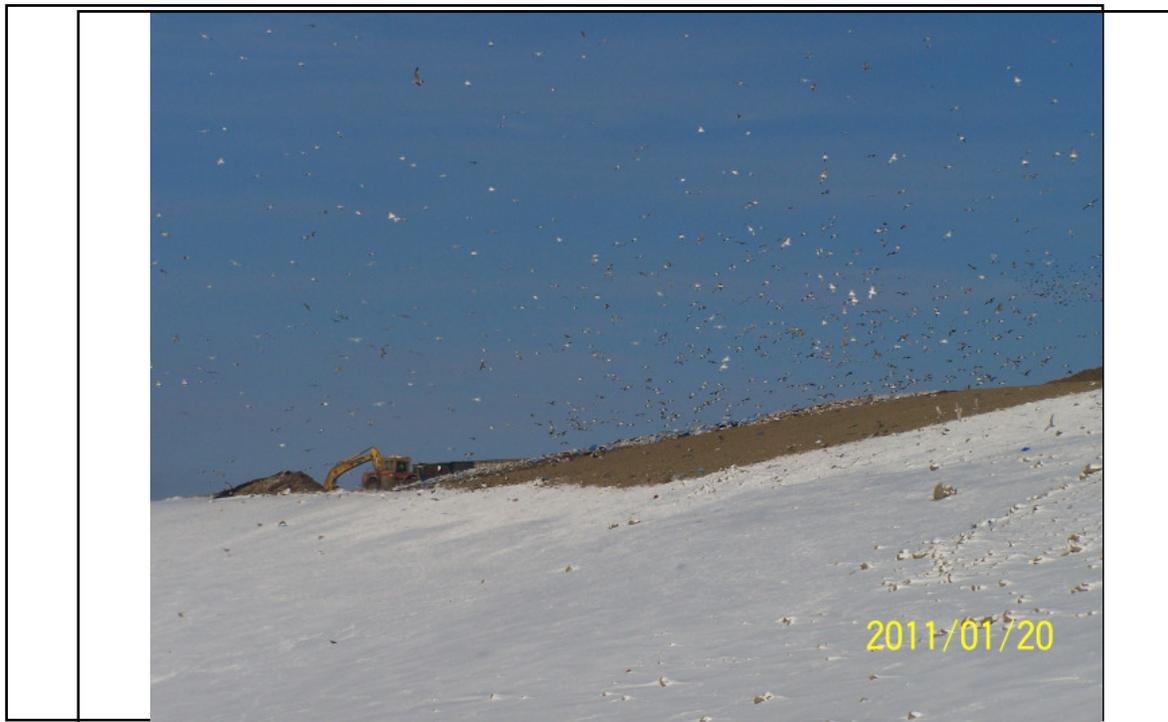
Intermediate cover of soil placed on West slope

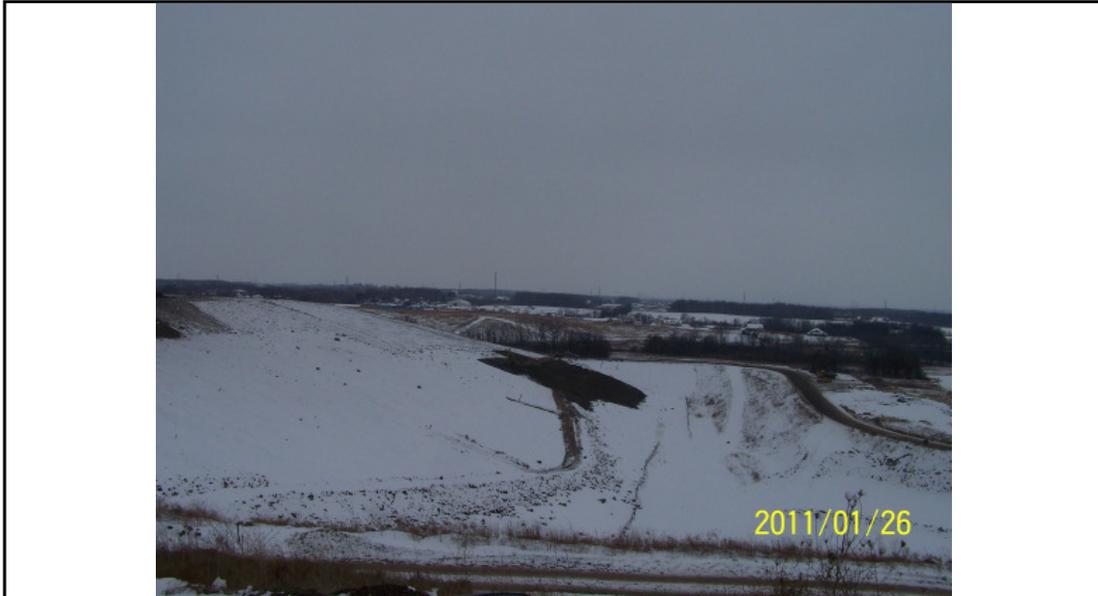
Road construction on West Slope

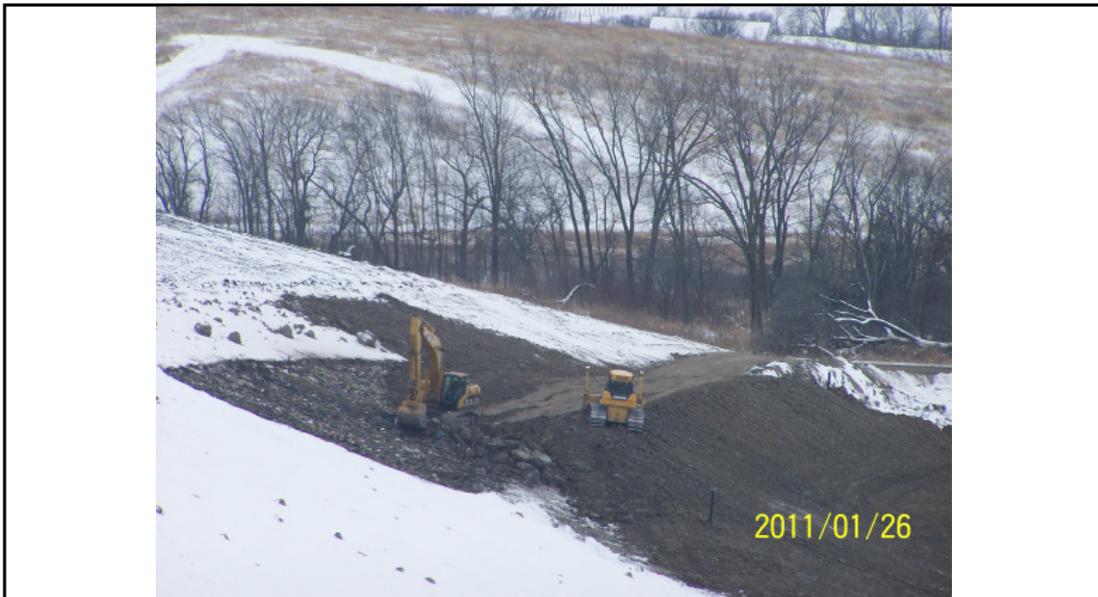
Cutting into waste for road placement

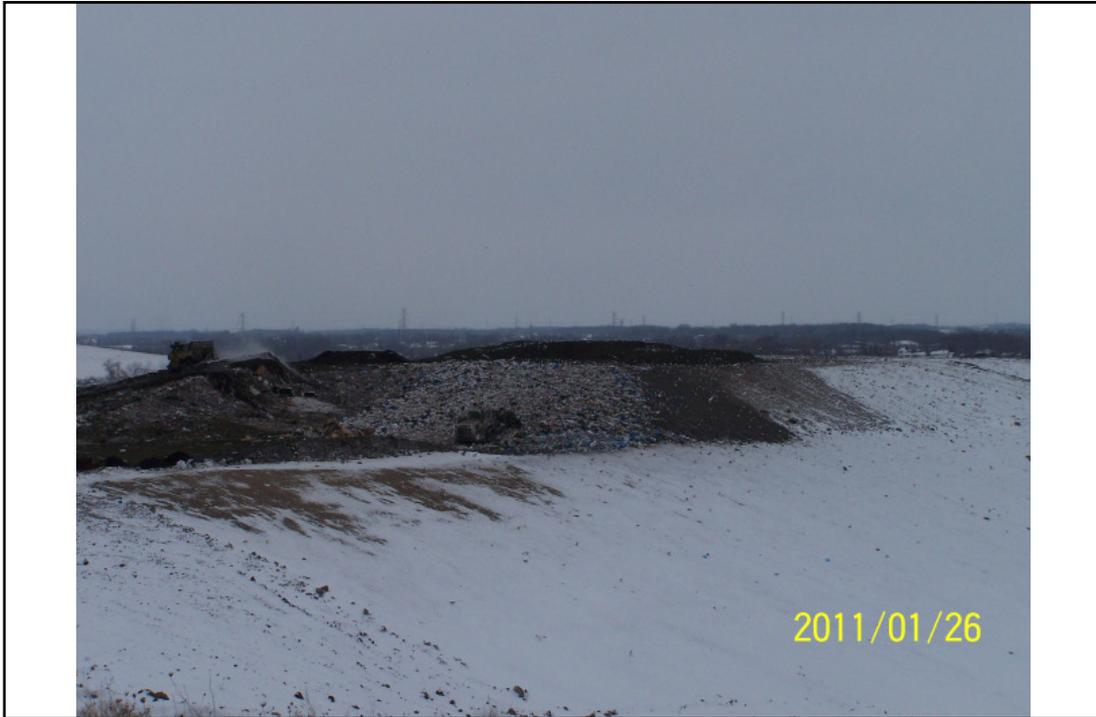
Working face

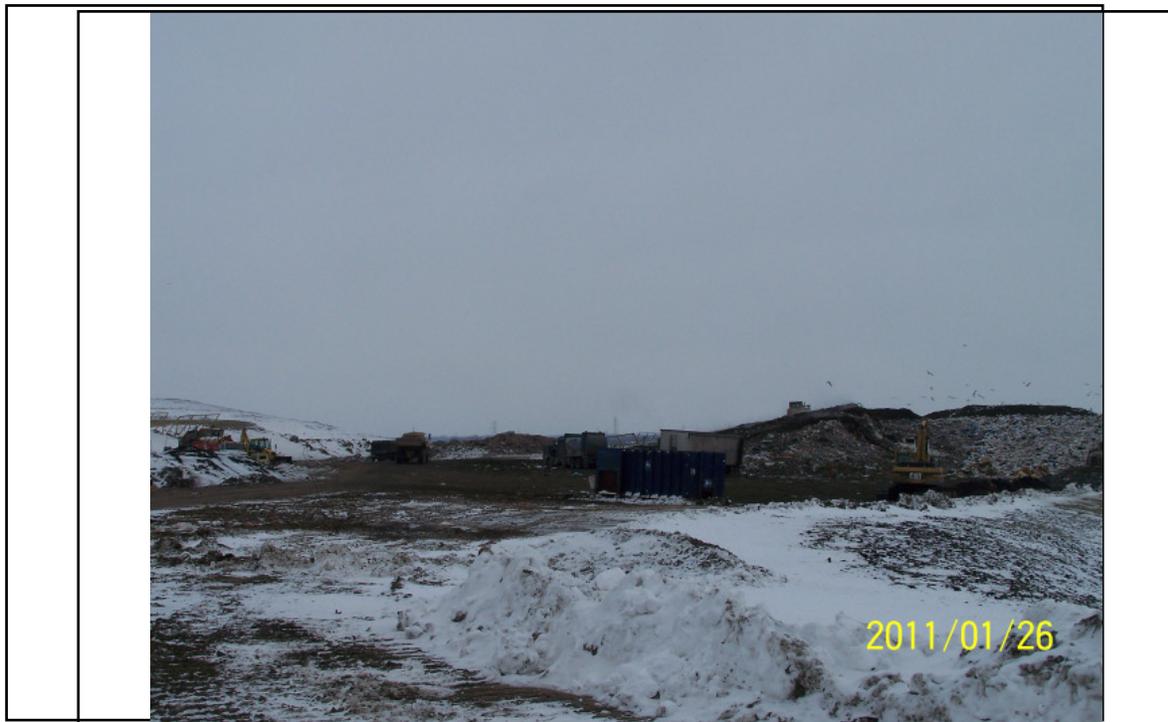
Active area with autofluff being spread over previous days cover
