Veolia Emerald Park Landfill
City of Muskego

2011 Veolia Emerald Park Landfill Year End Compliance Officer Report and Audit Summary

TO: Veolia Emerald Park Standing Committee
FROM: Jo-Walter Spear, Jr., P.E.
COPIES: File
DATE: 04/02/2012
PROJECT NUMBER: 1012.10030

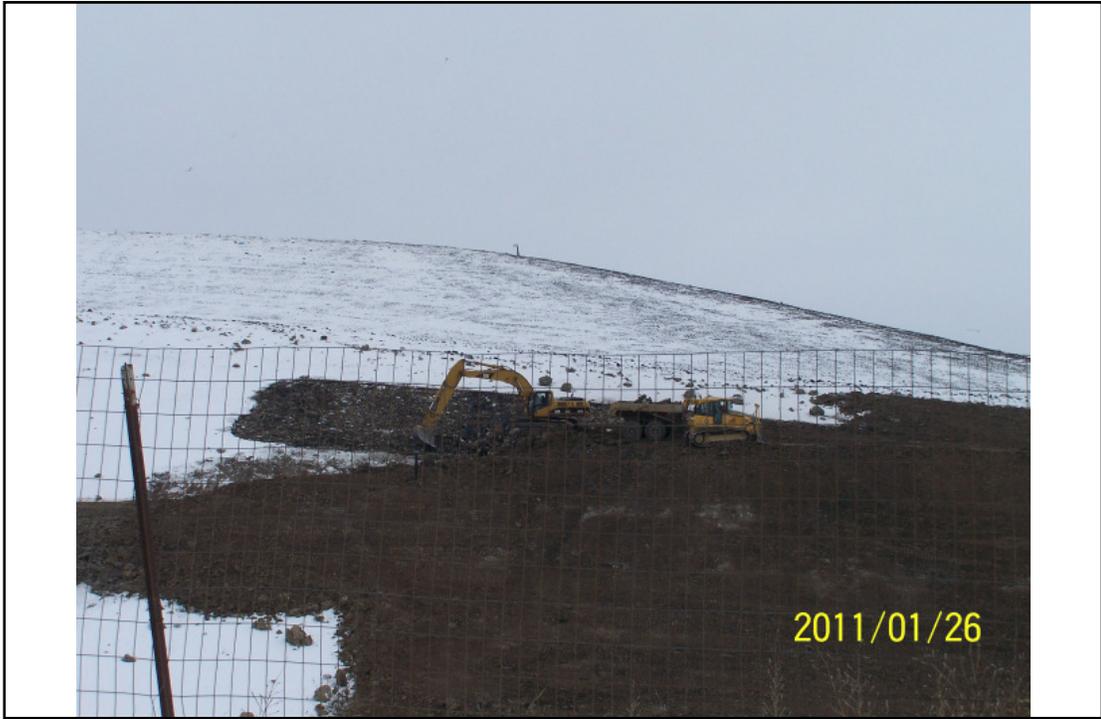
Road construction on West Slope

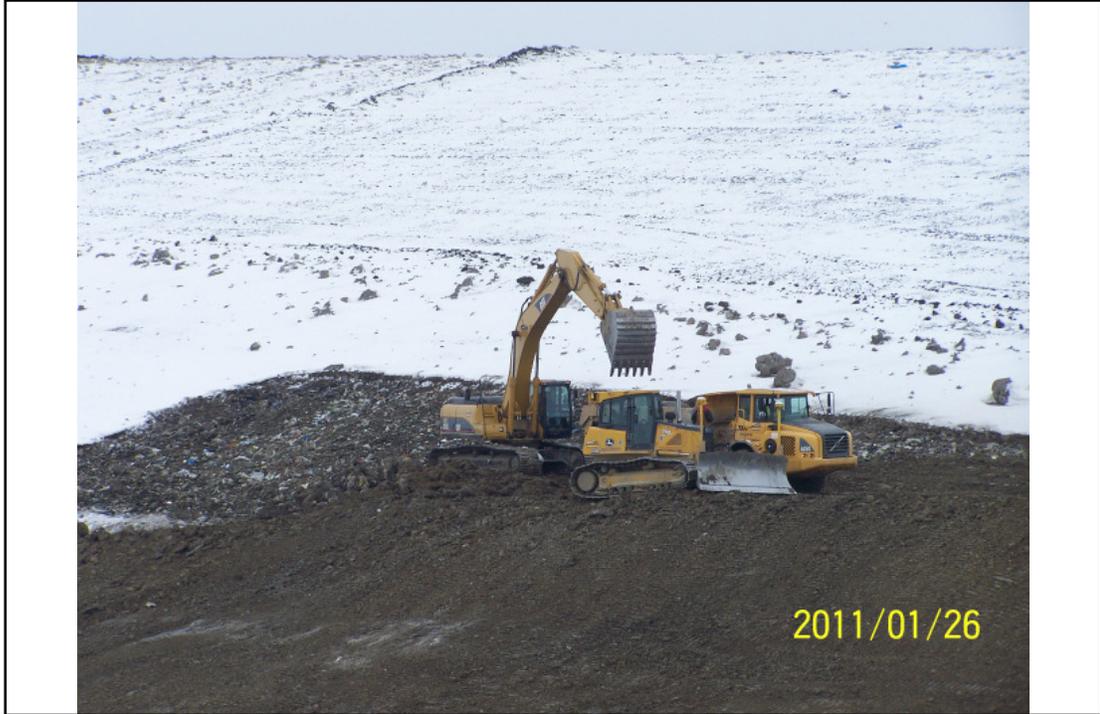
West access road construction

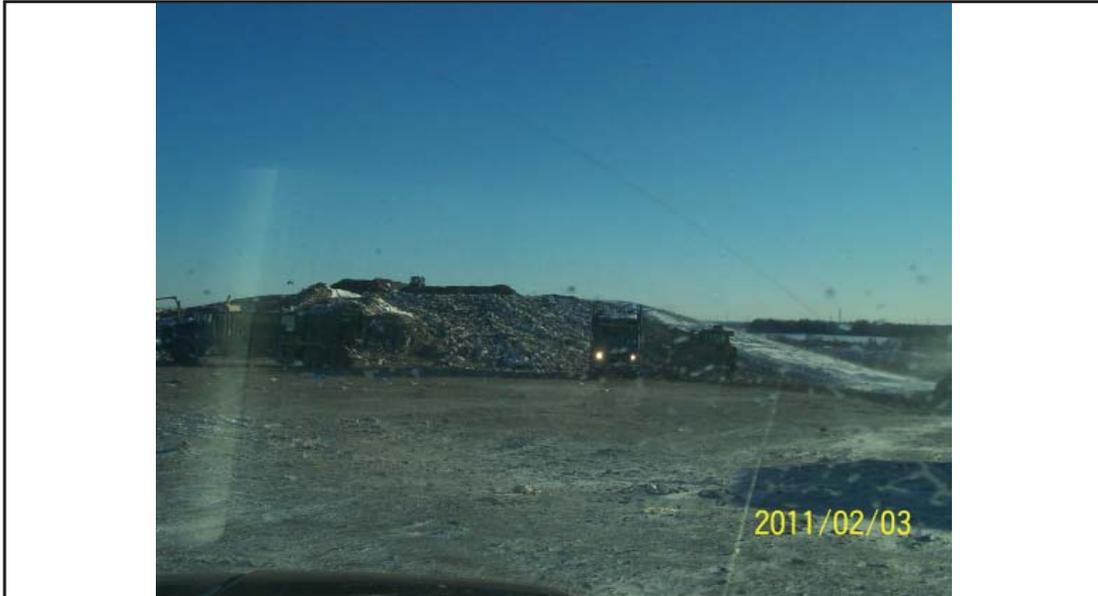
Working face

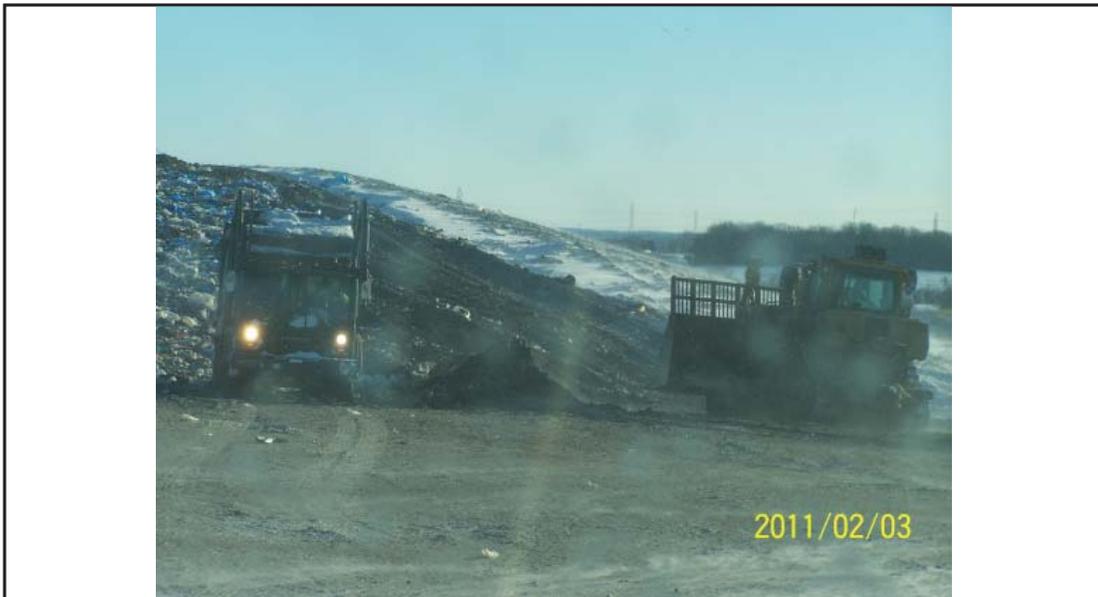
Dozer spreading daily cover

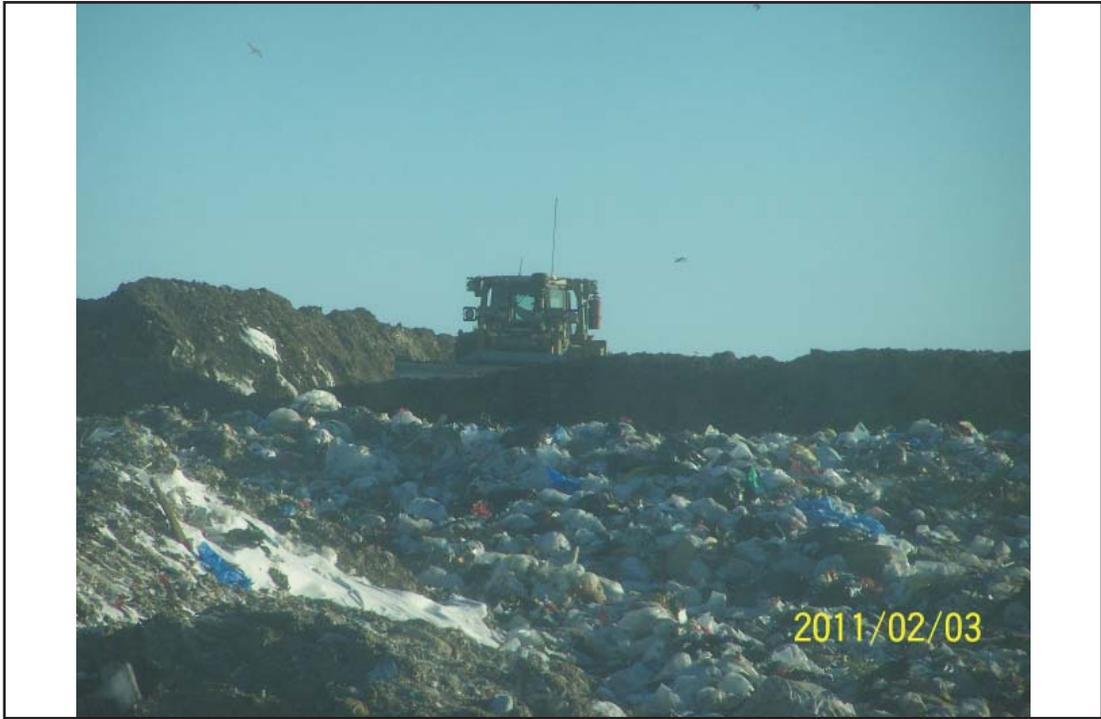
Dozer spreading cover from top of working face

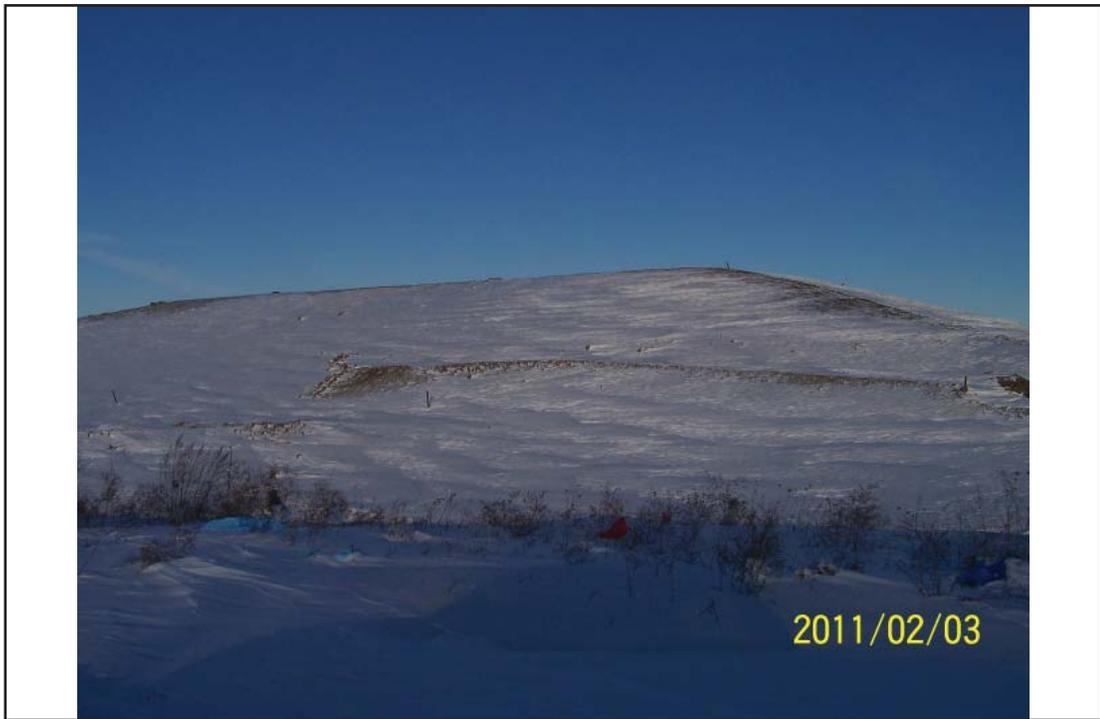
Southwest corner of Phase 6

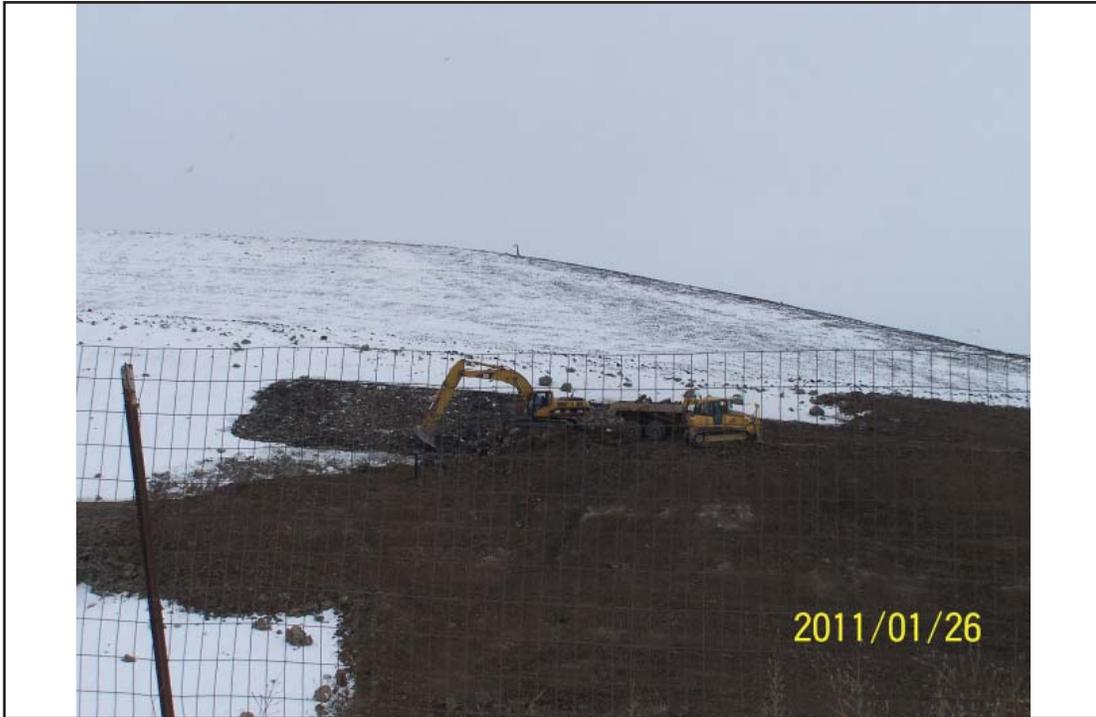
Road construction on West Slope

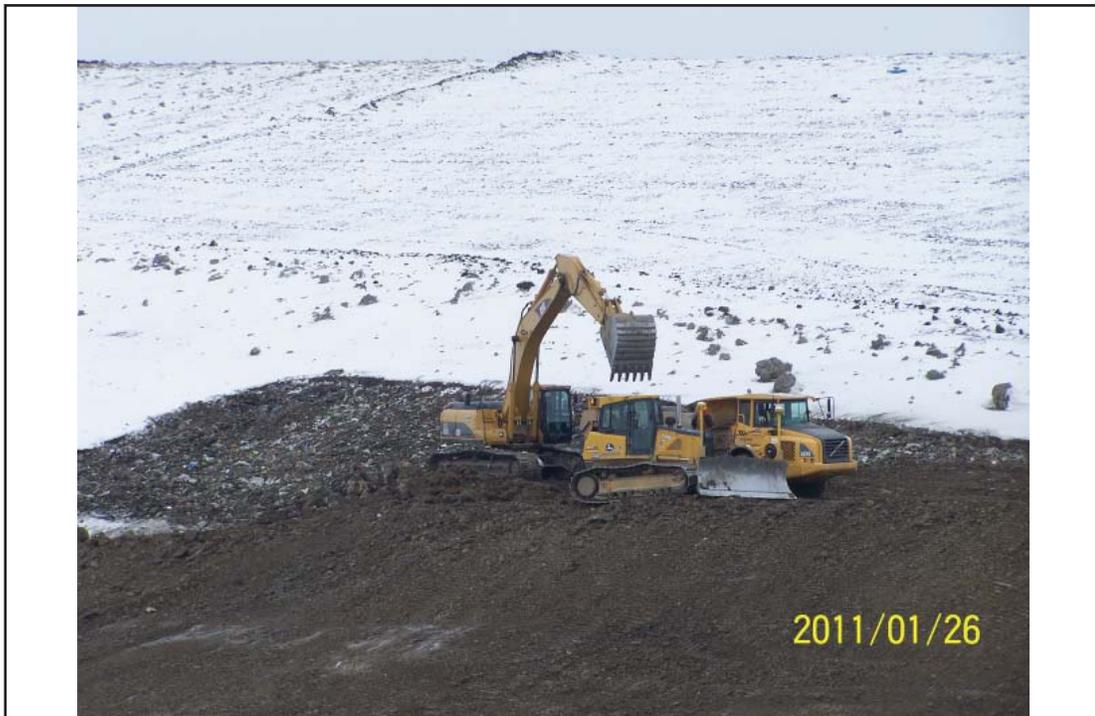
West access road construction

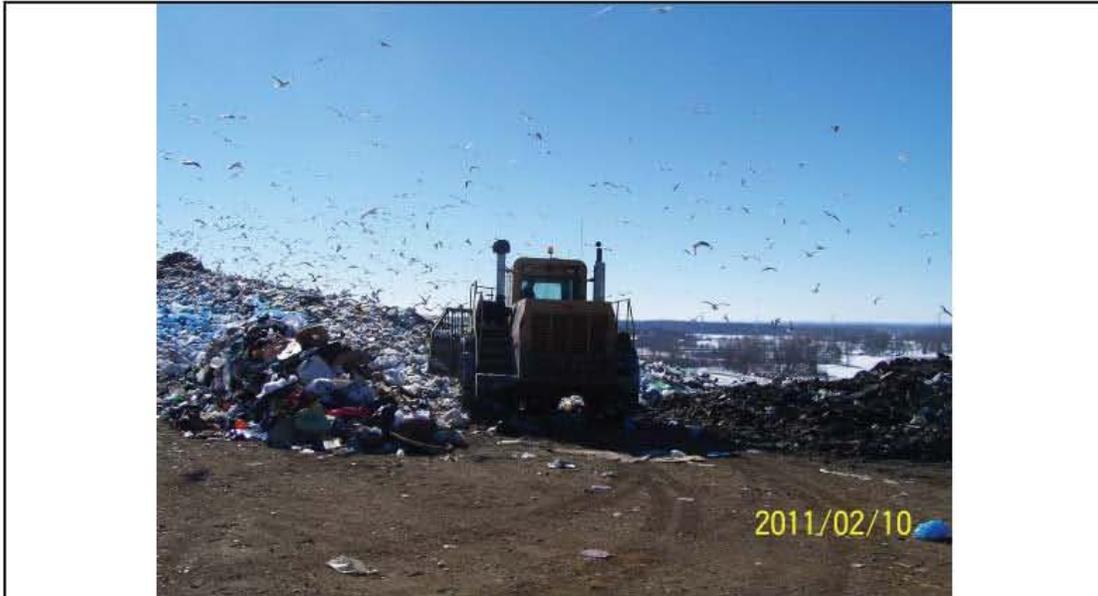
Compactor pushing waste into face

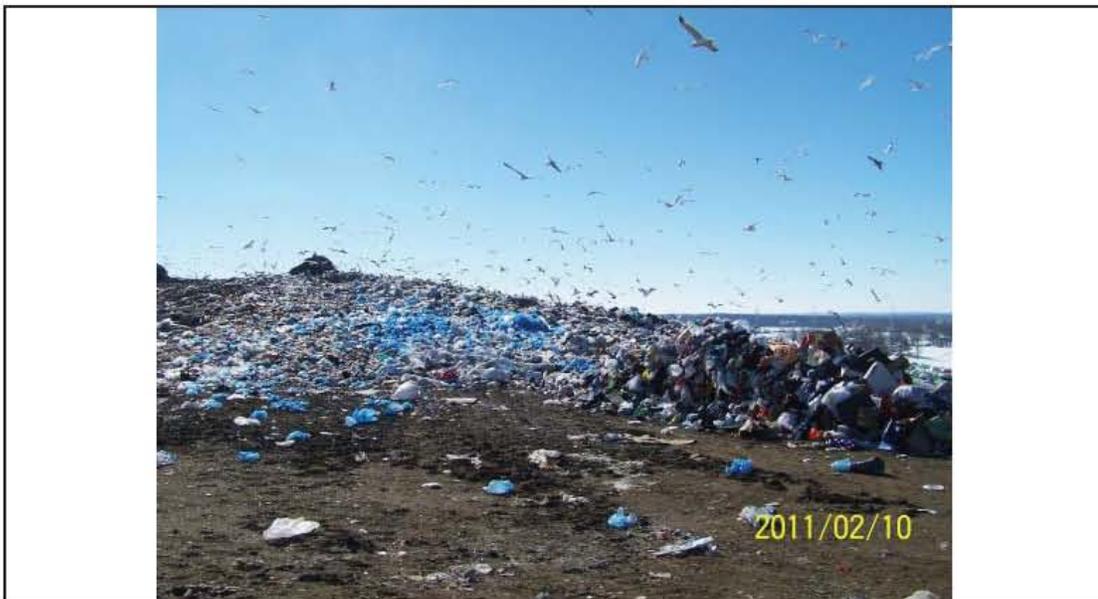
Working face with tipped load at base

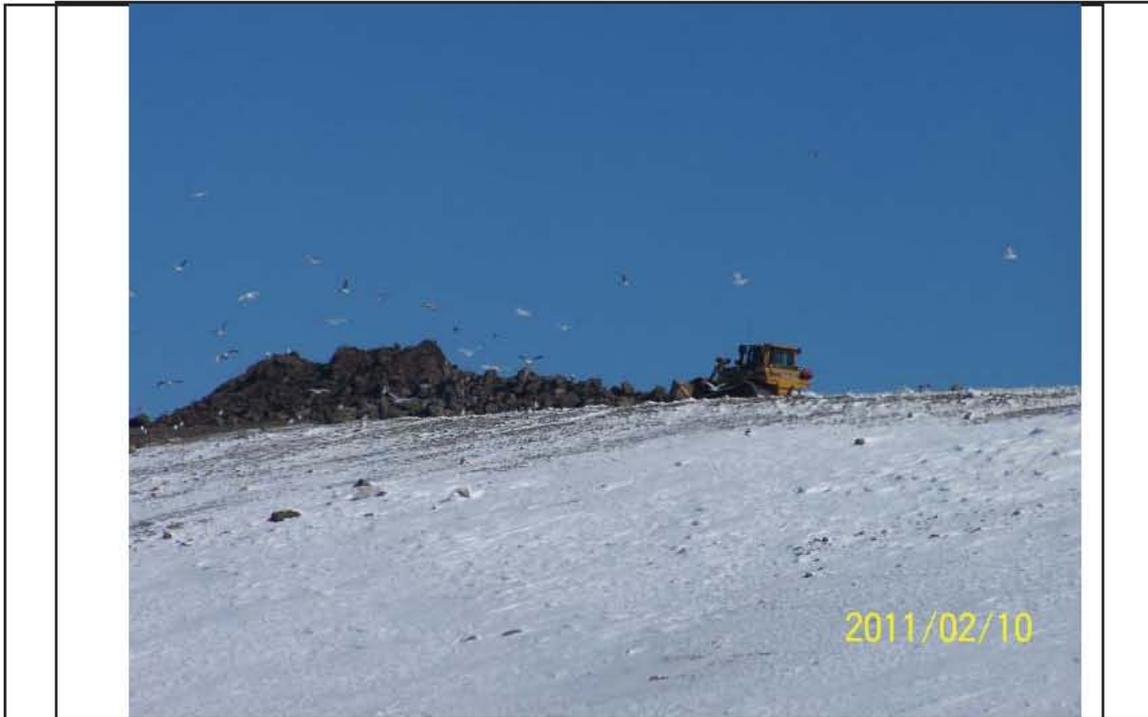
Dozer at top of working face pushing soils for later cover

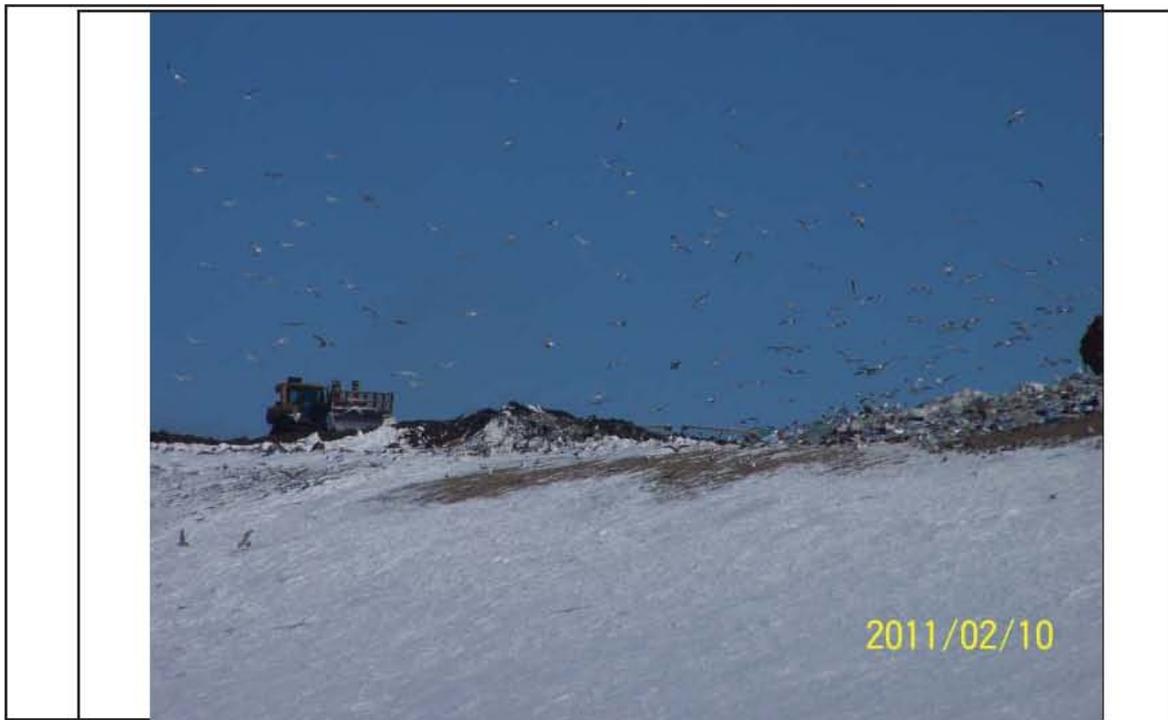
Compactor at base of working face pushing waste

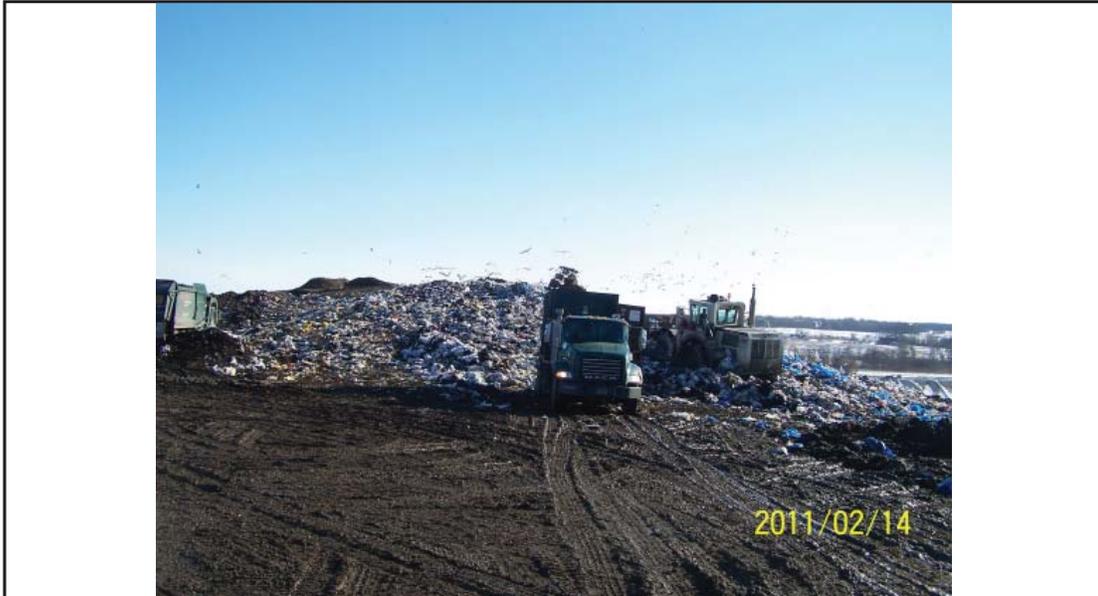
Typing area of working face

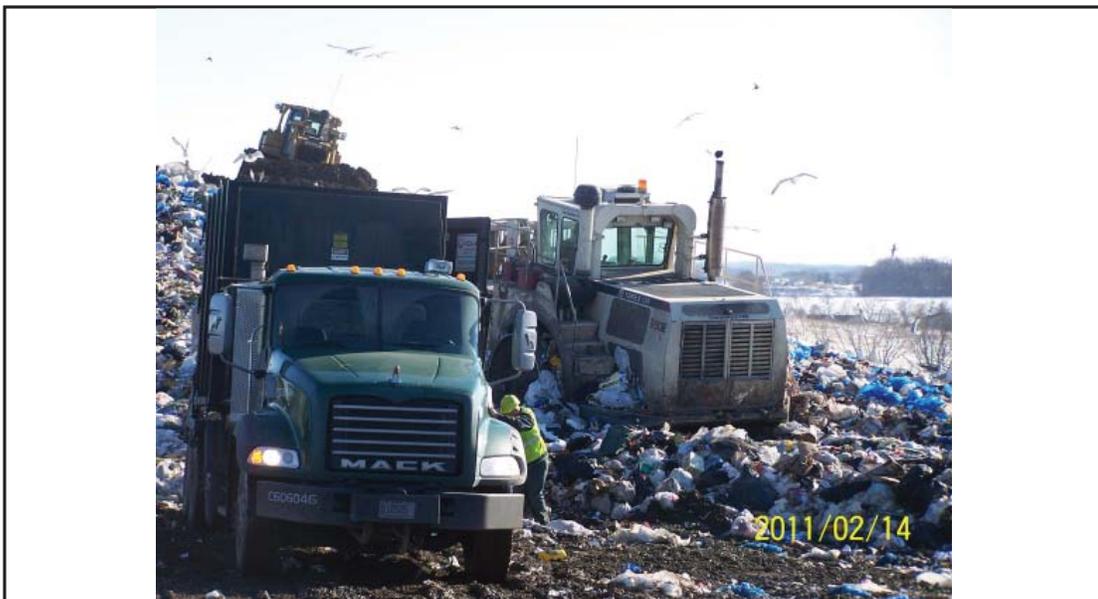
Active compactor in working face

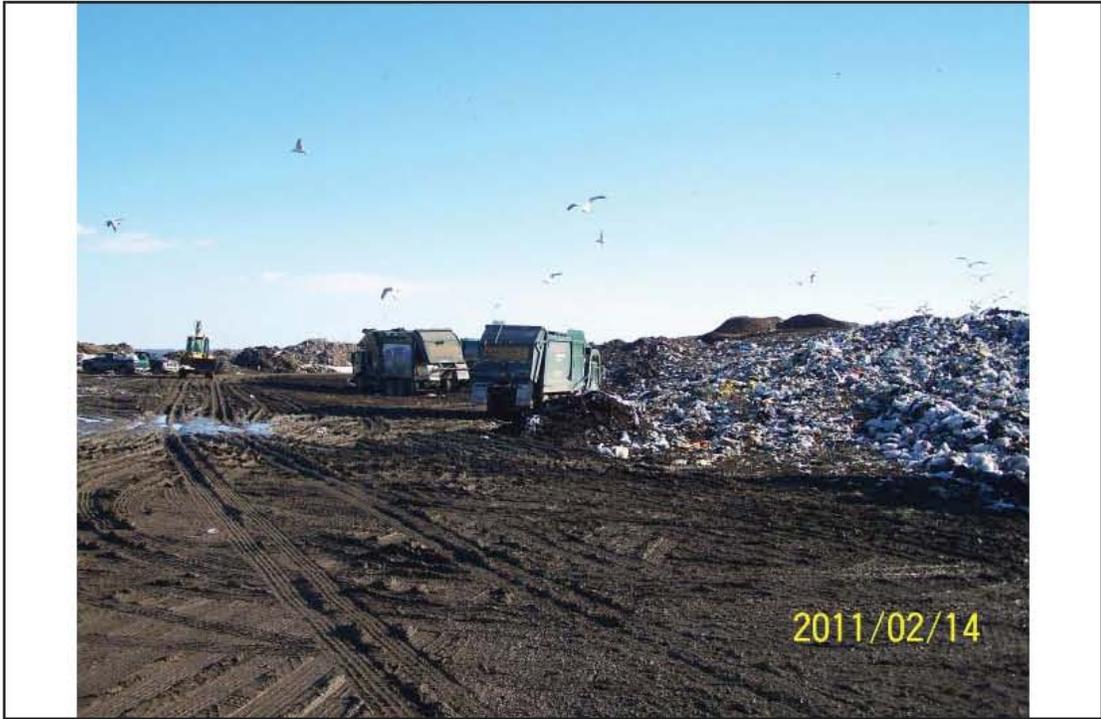
Active area viewing South

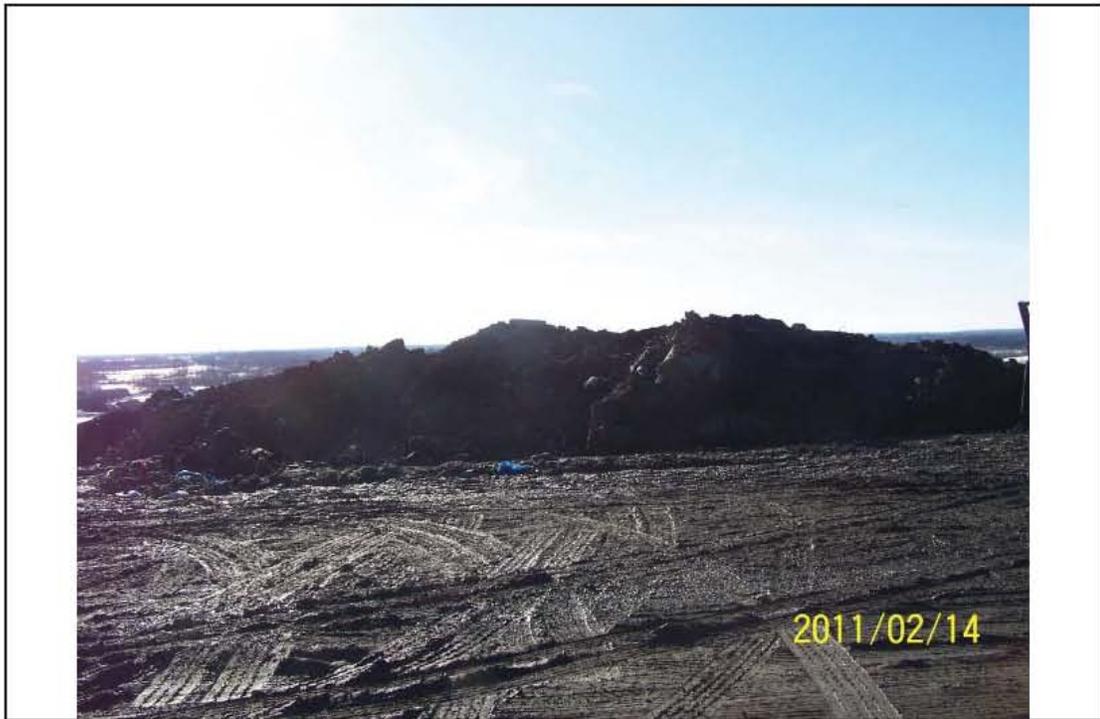
Recovered intermediate cover, stockpiled for future use

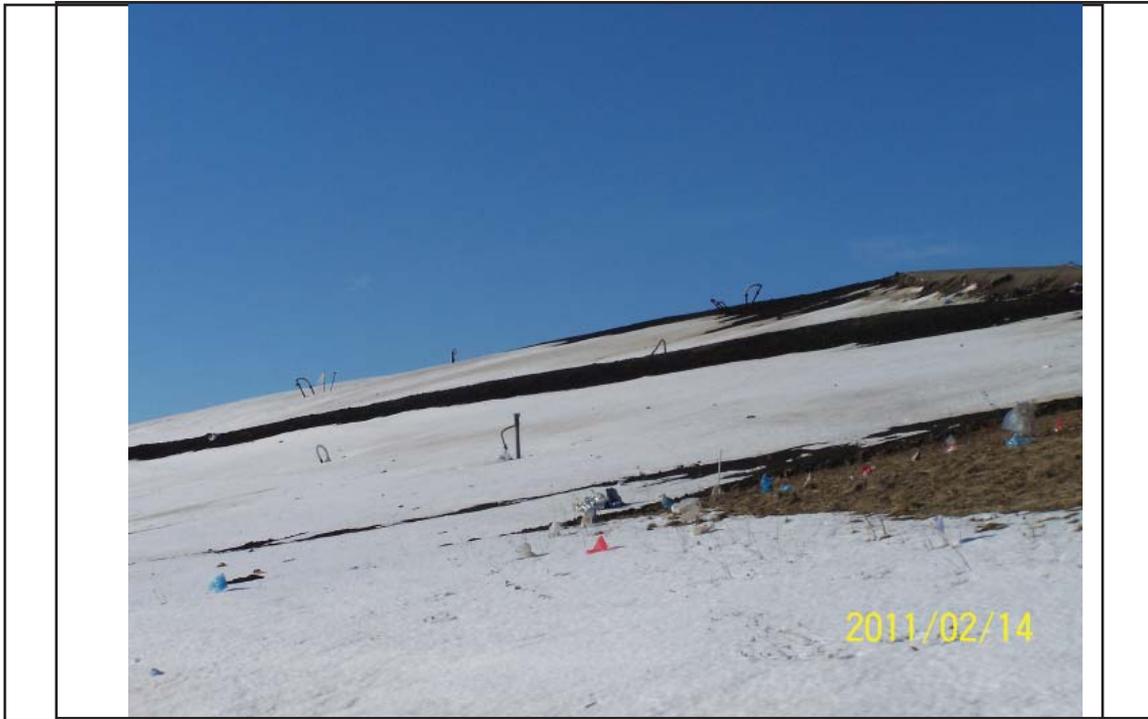
South slope of Phases 5 & 6 slowly exposed by melt

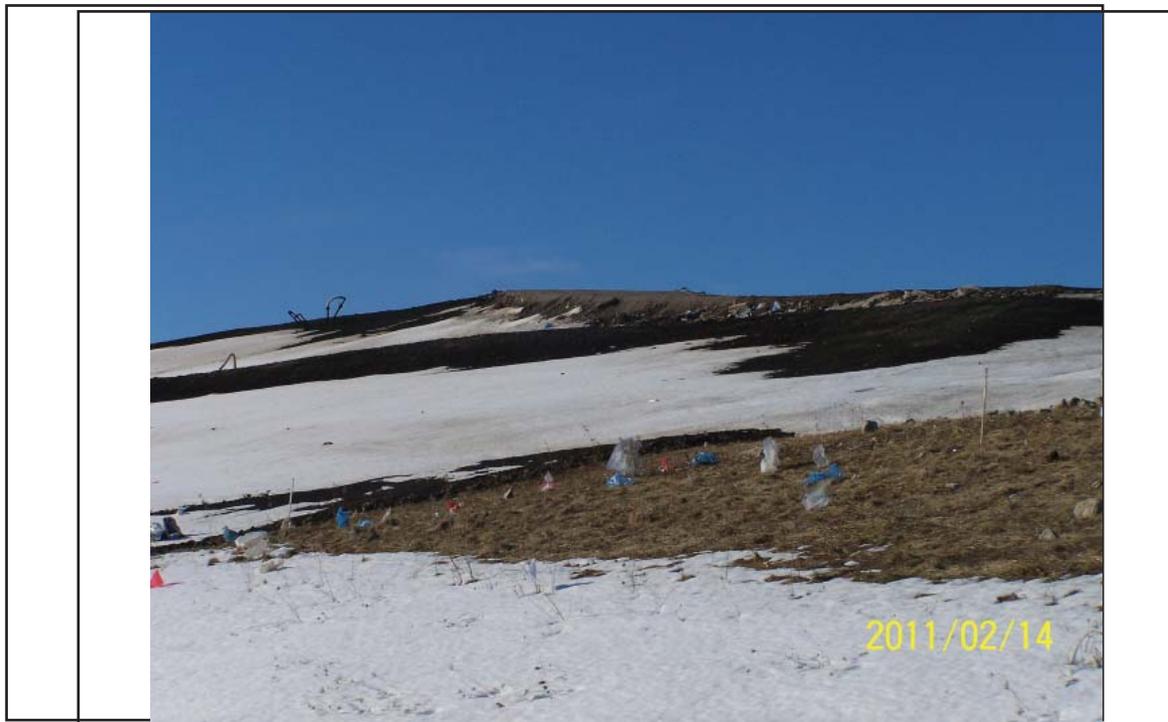
Southeast corner of Phase 5, dark soil is top soil and berm

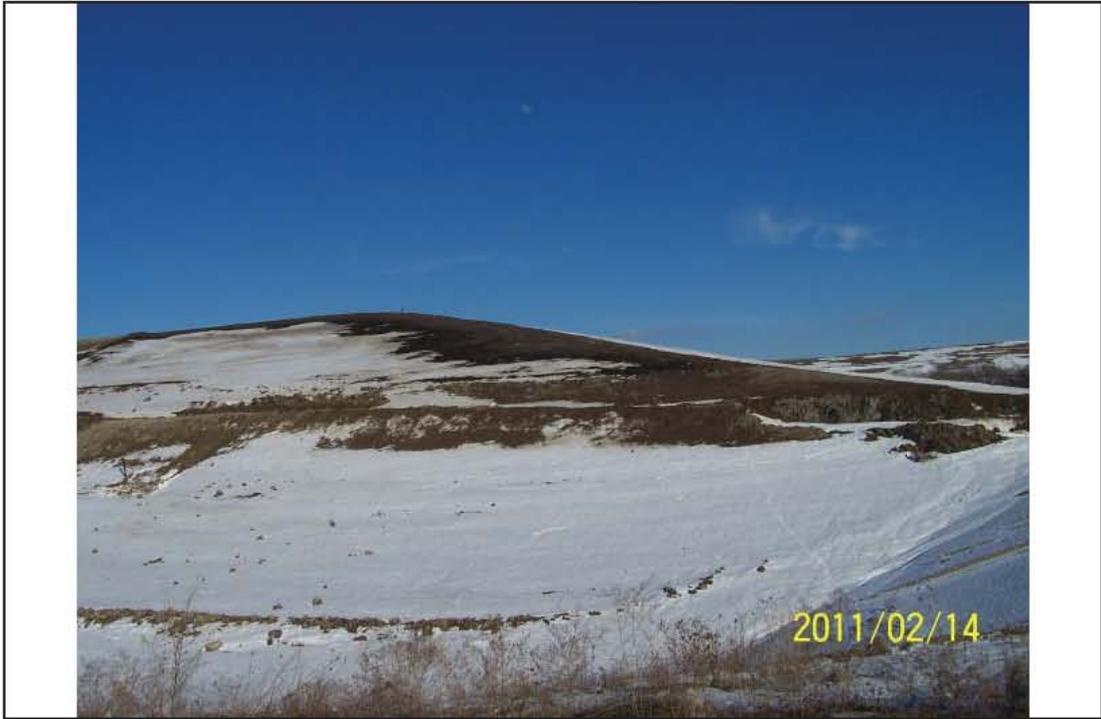
Southwest corner of Phase 6

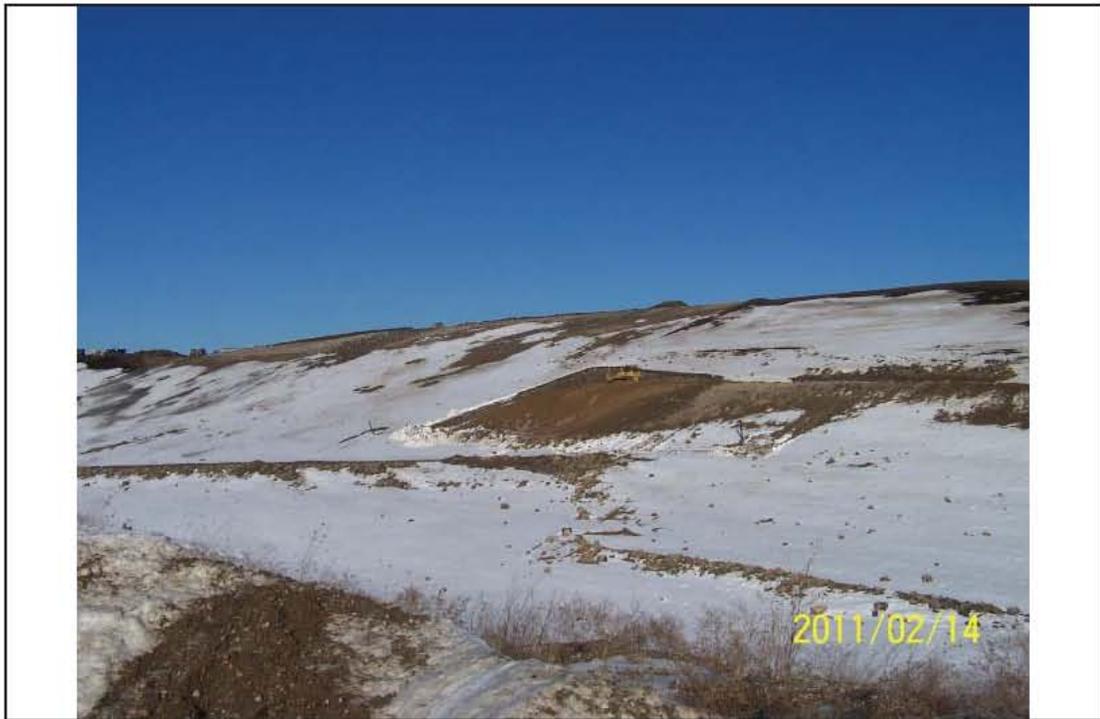
West slope

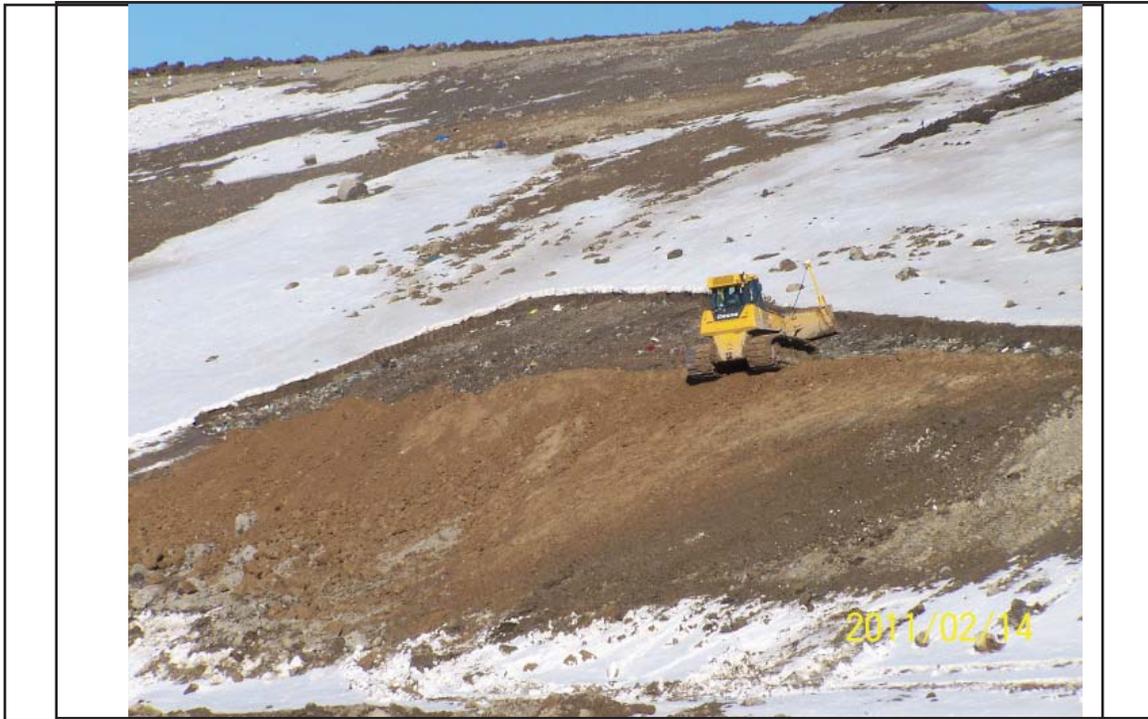
Road construction on West slope of Phase 6

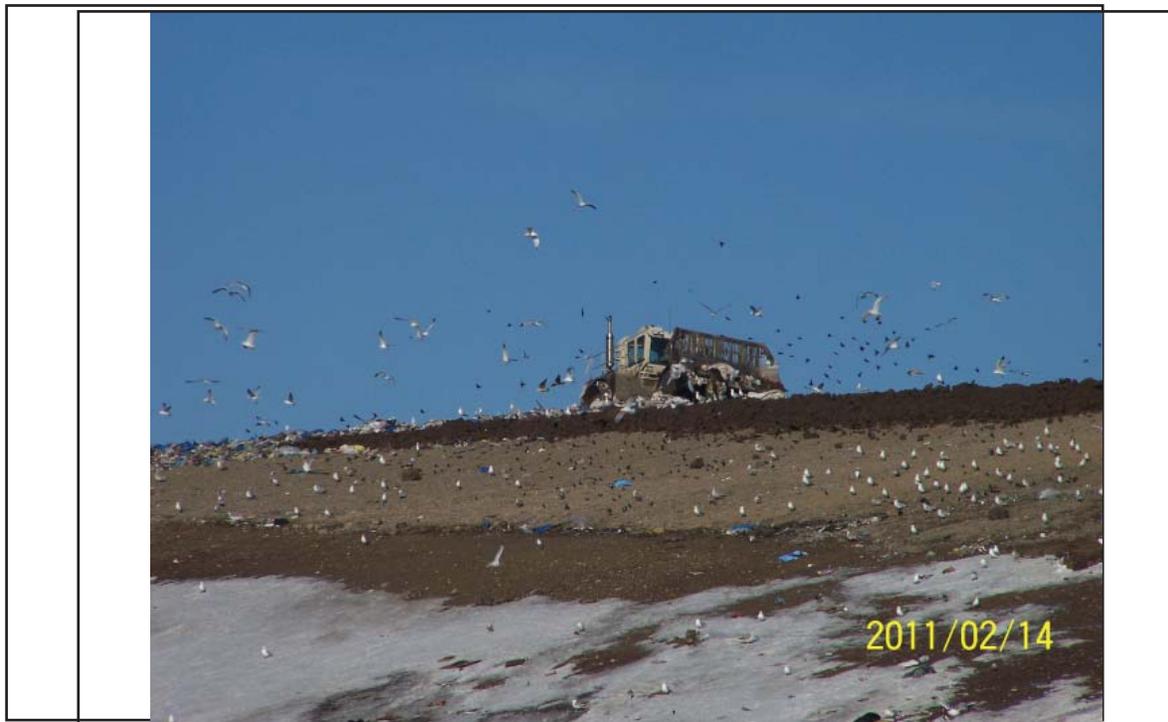
Active compactor viewed from the West

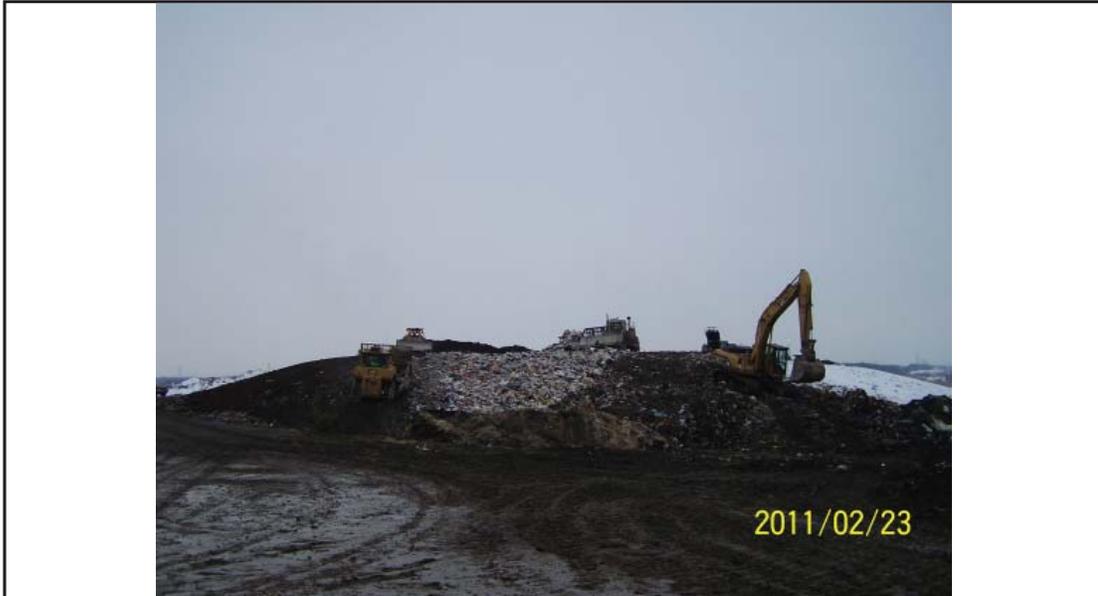
Working face

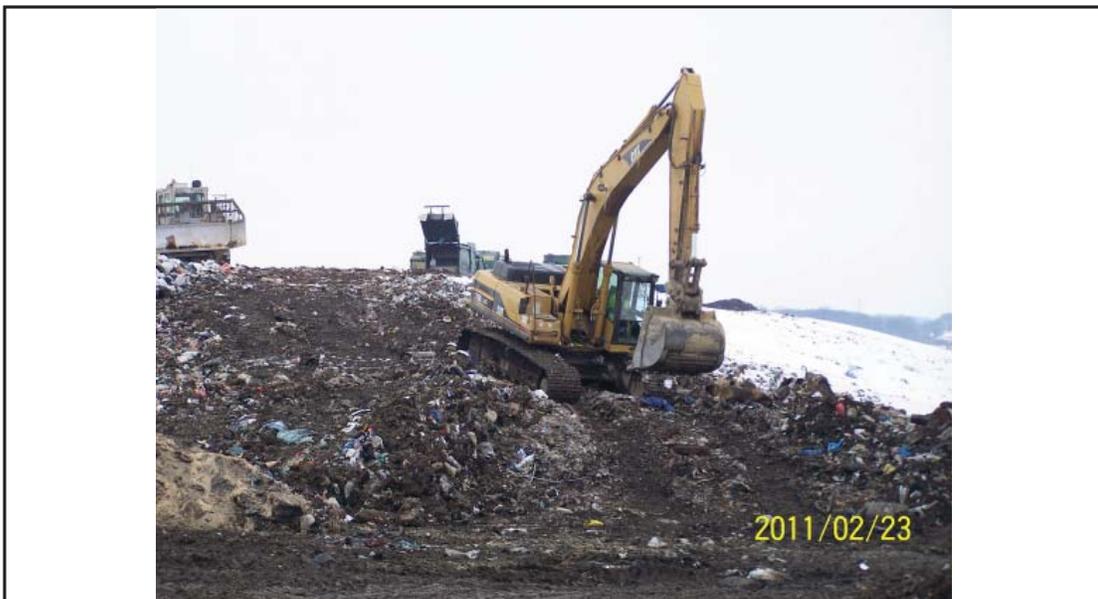
Excavator being relocated for the night

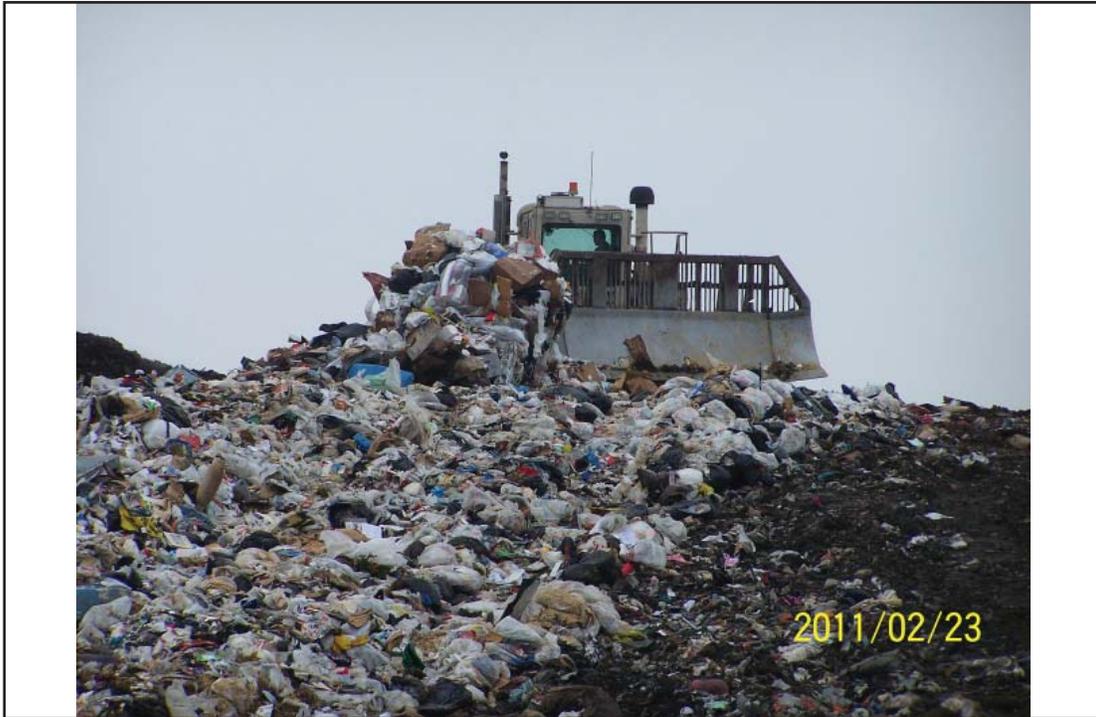
Compactor pushing final waste load of the day

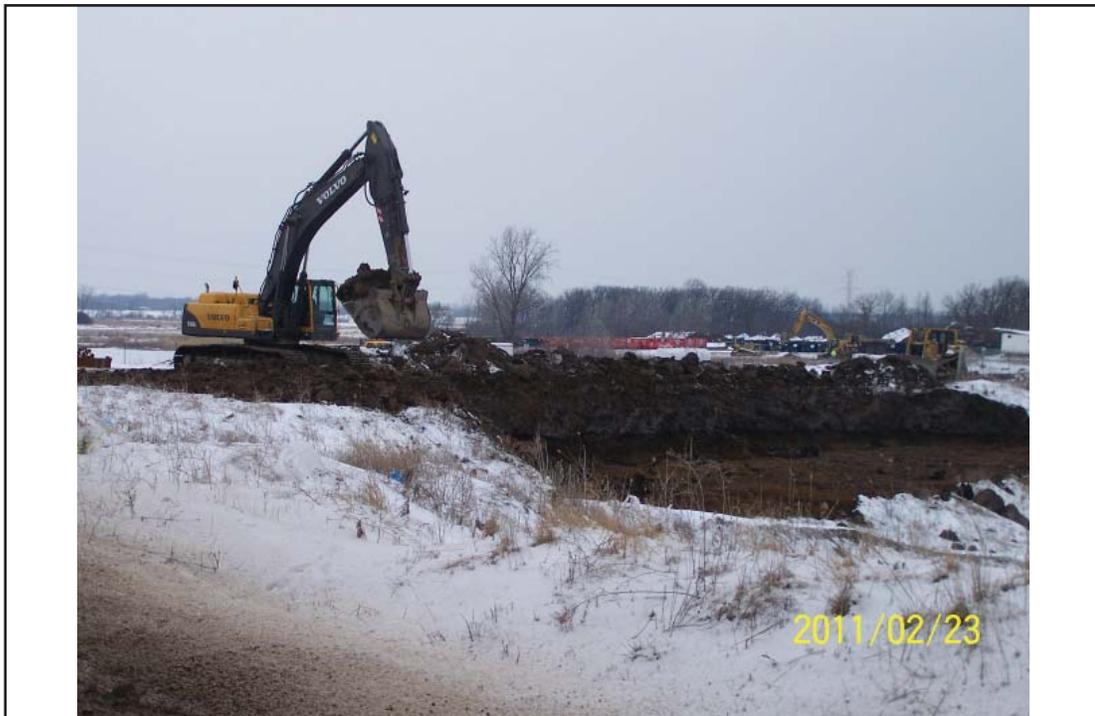
Soils being excavated for road construction

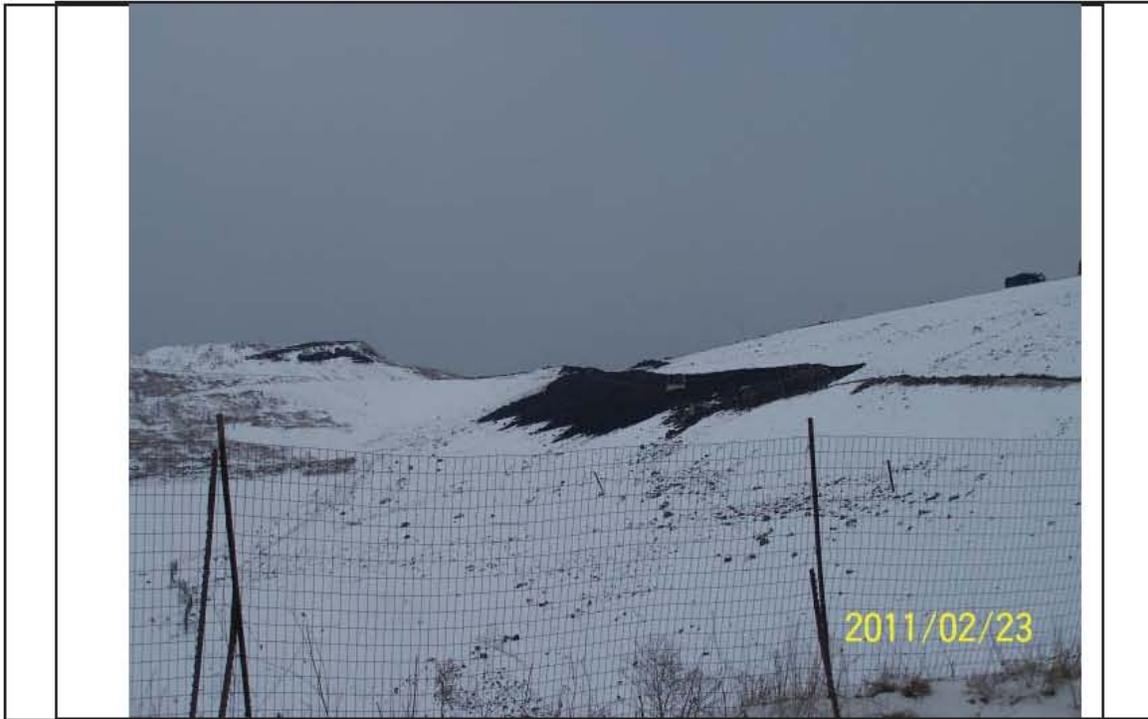
Road roughed out to top of slope

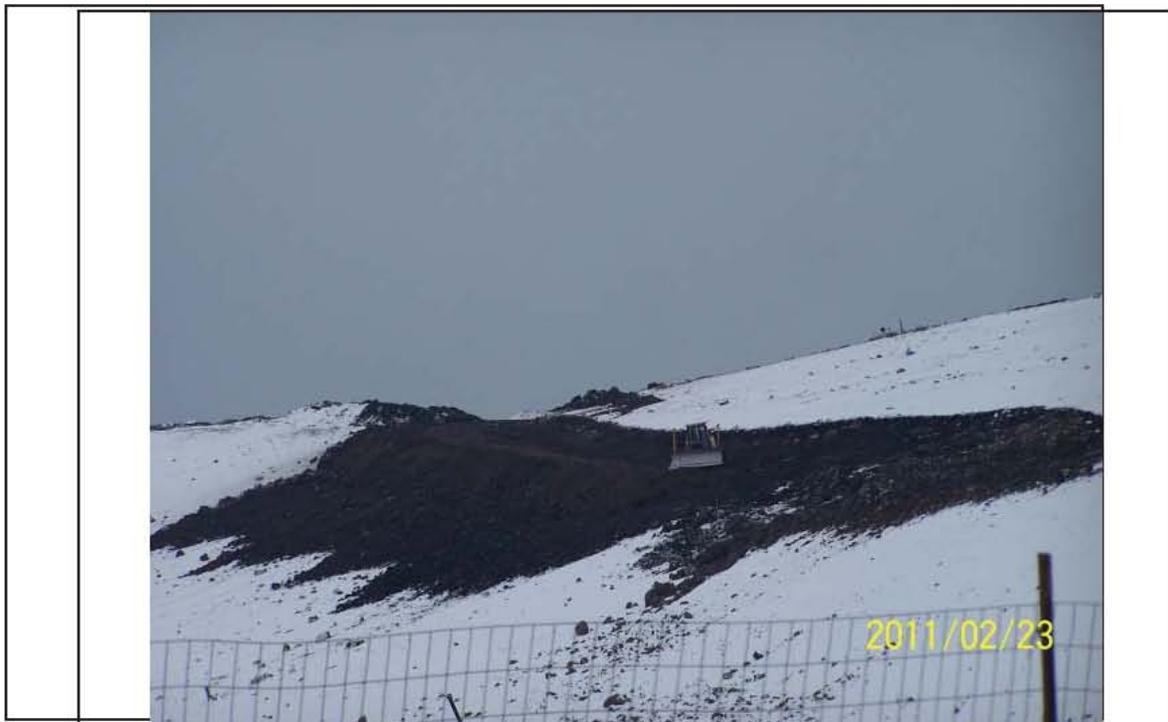
Road construction nearly completeness

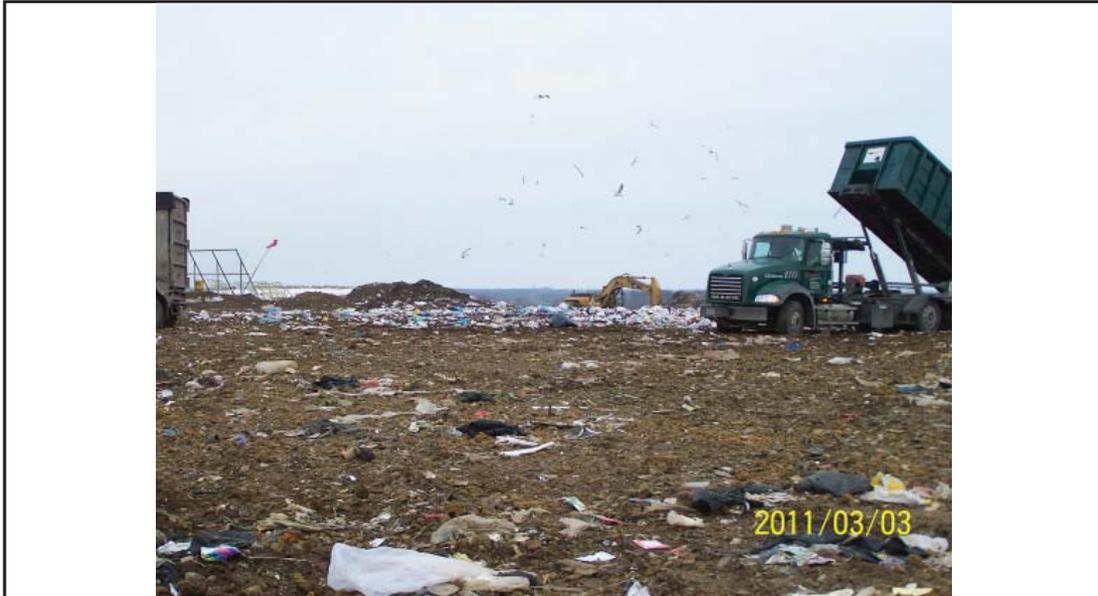
Active area after snow melt

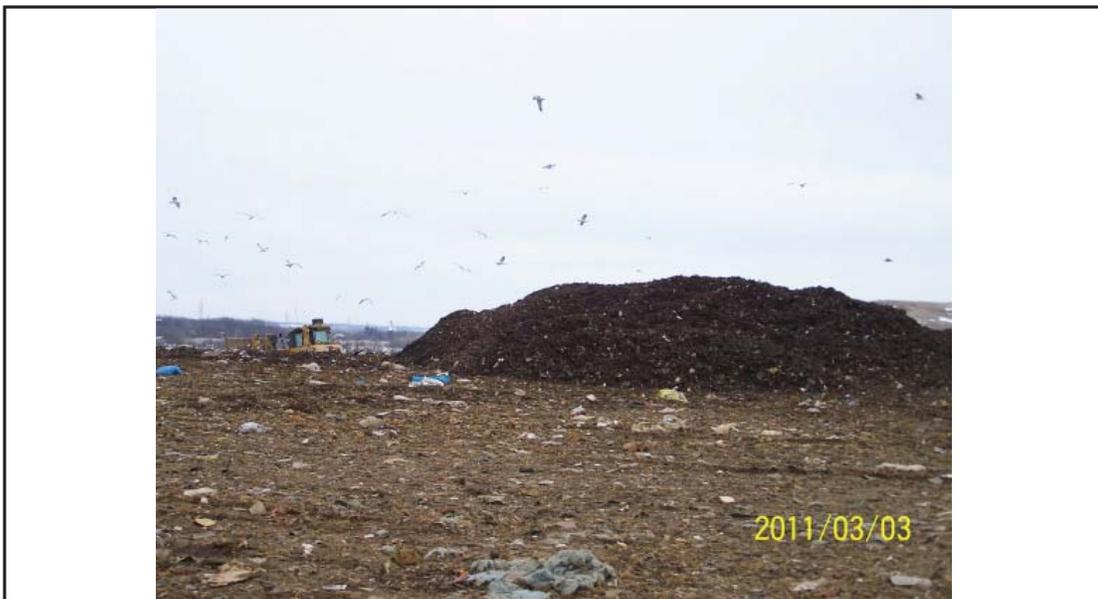
Autofluff stockpiled for daily cover
