Veolia Emerald Park Landfill
City of Muskego

2011 Veolia Emerald Park Landfill Year End Compliance Officer Report and Audit Summary

TO: Veolia Emerald Park Standing Committee
FROM: Jo-Walter Spear, Jr., P.E.
COPIES: File
DATE: 04/02/2012
PROJECT NUMBER: 1012.10030

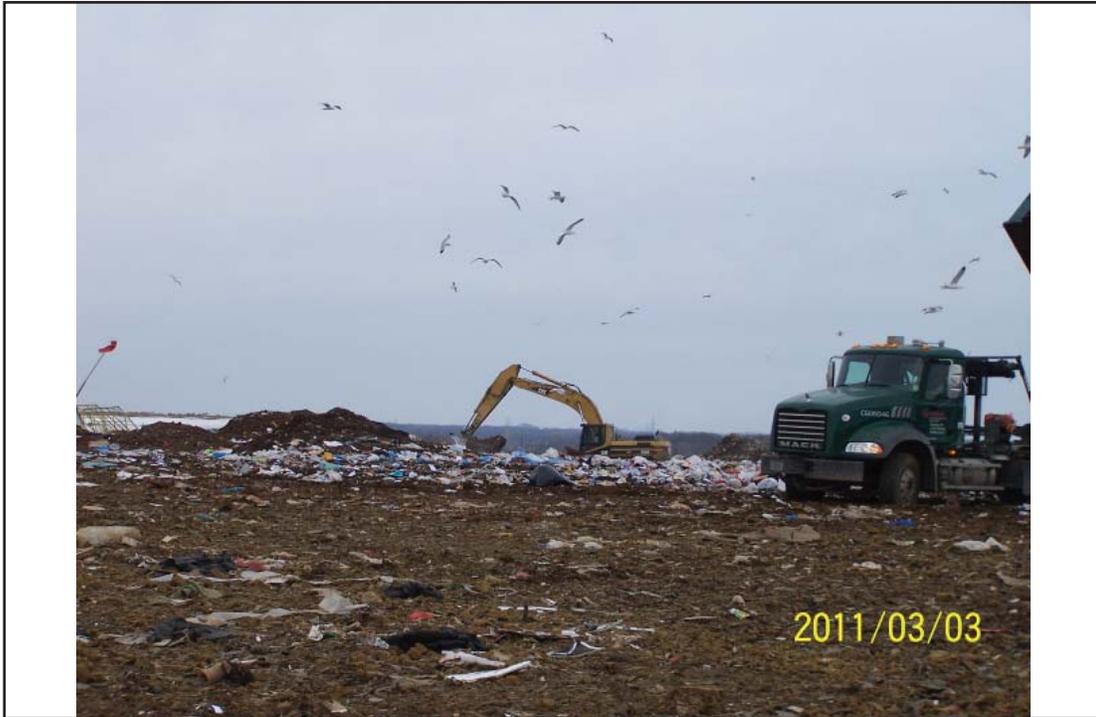
Excavator relocating C&D waste for placement of MSW

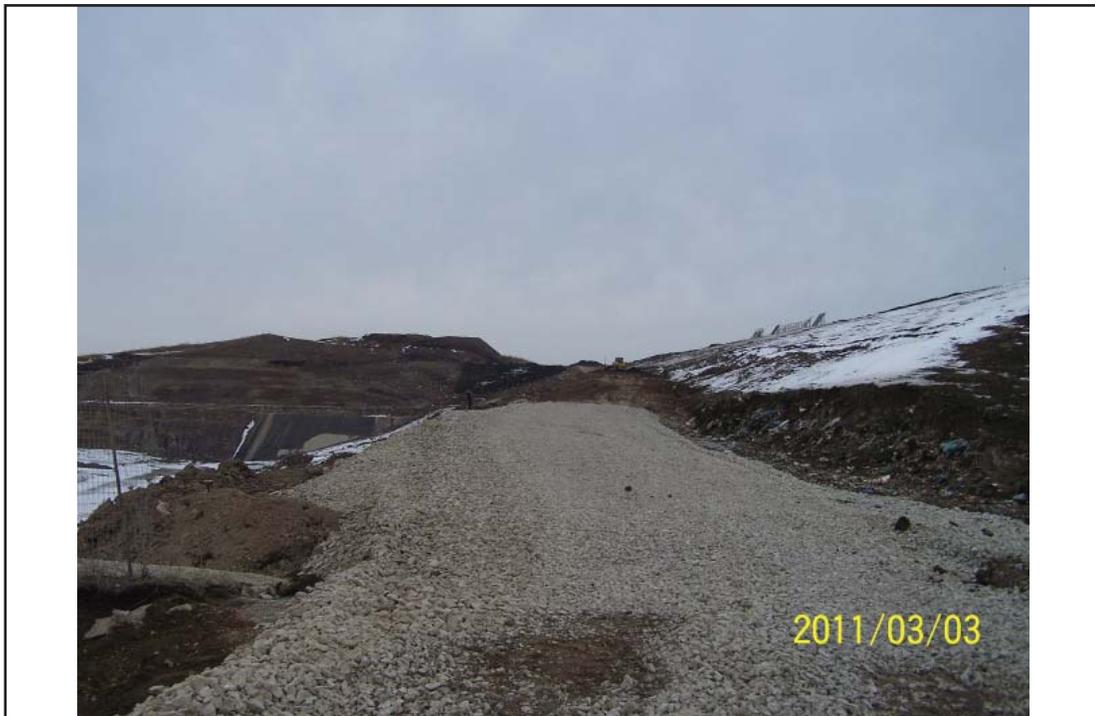
West slope road construction on going.

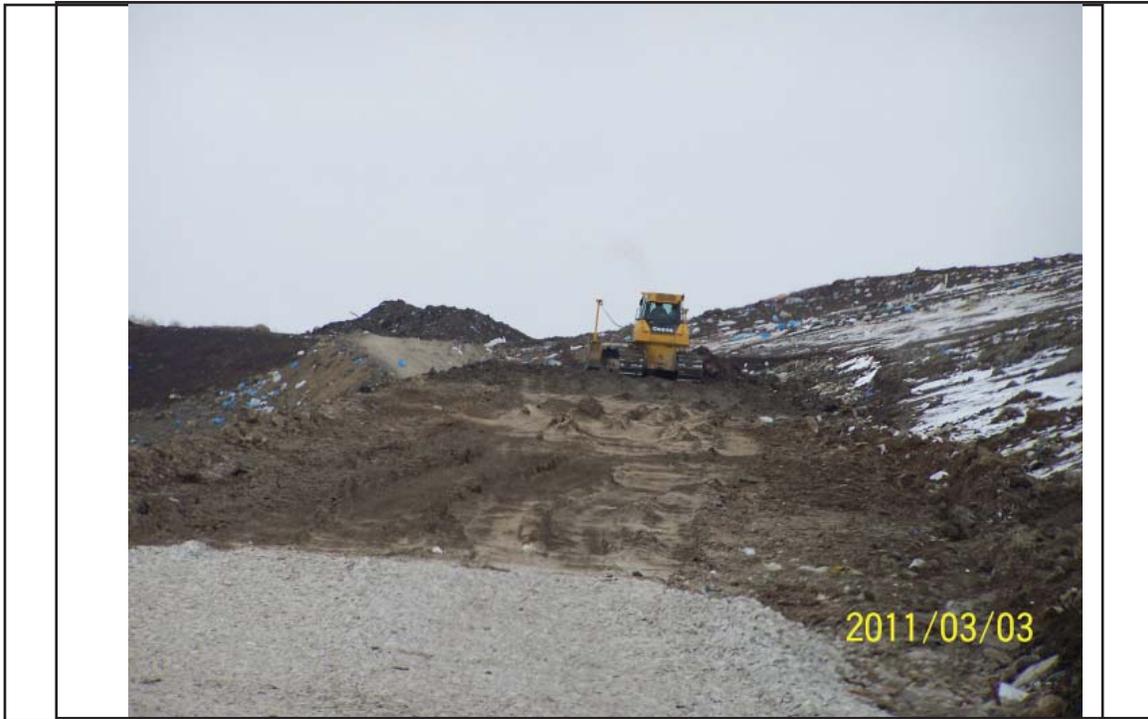
Dozer working road base

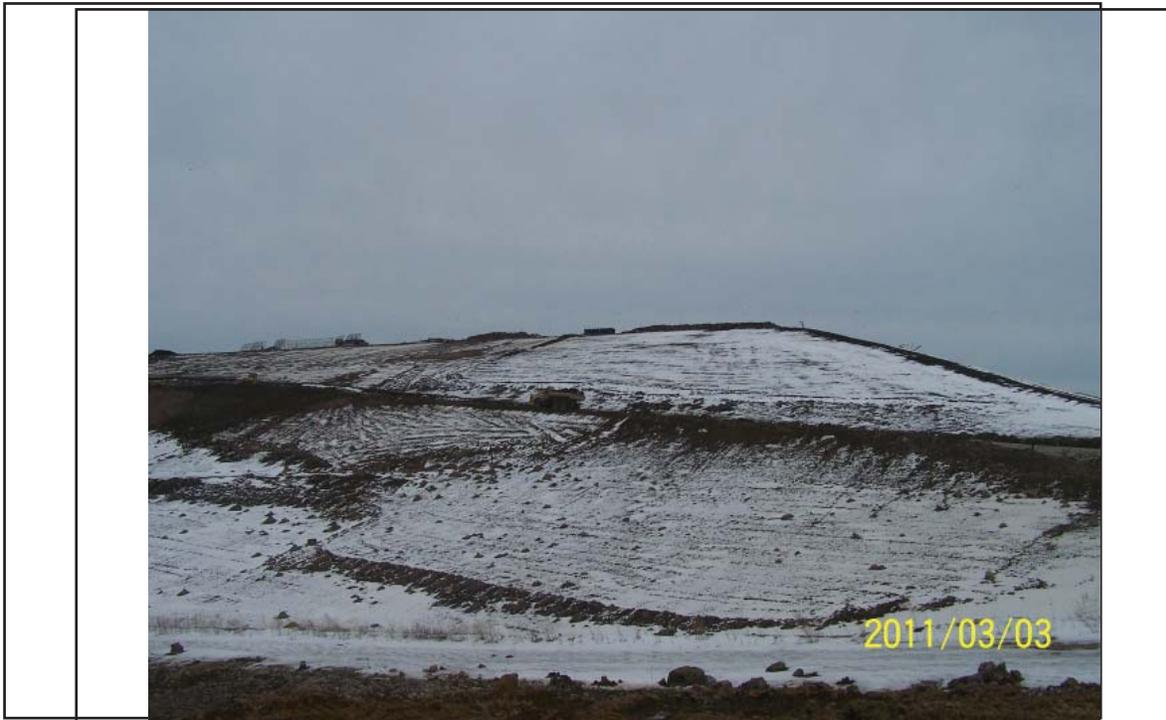
West slope of Phase 6

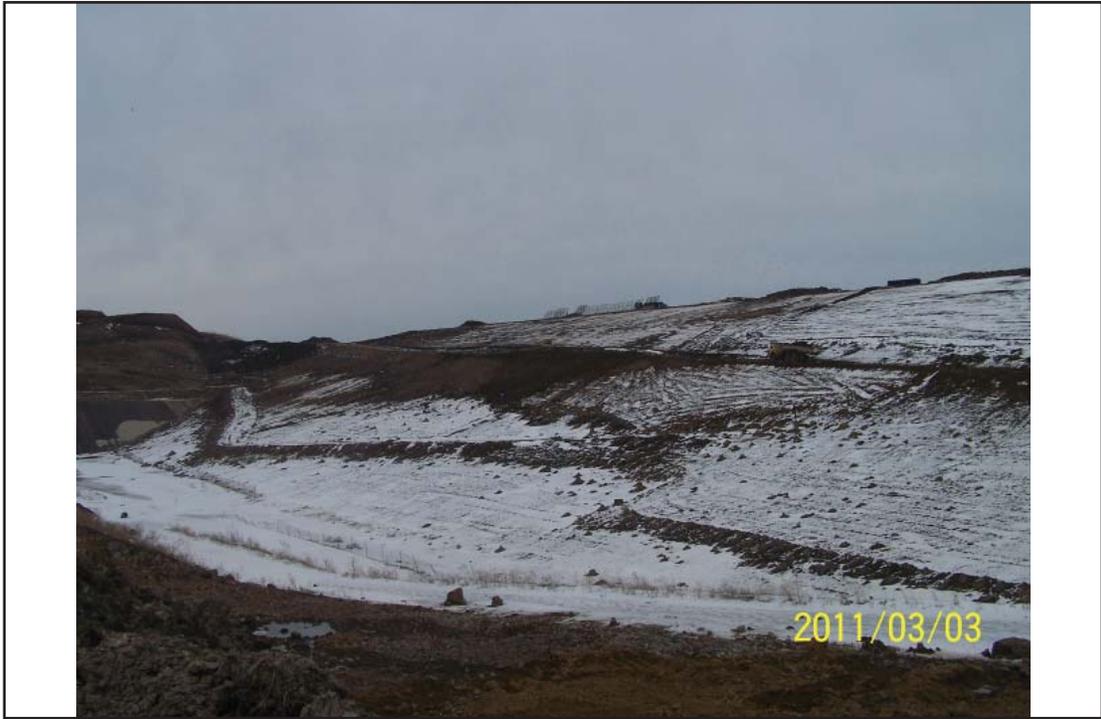
West slope of phase 6

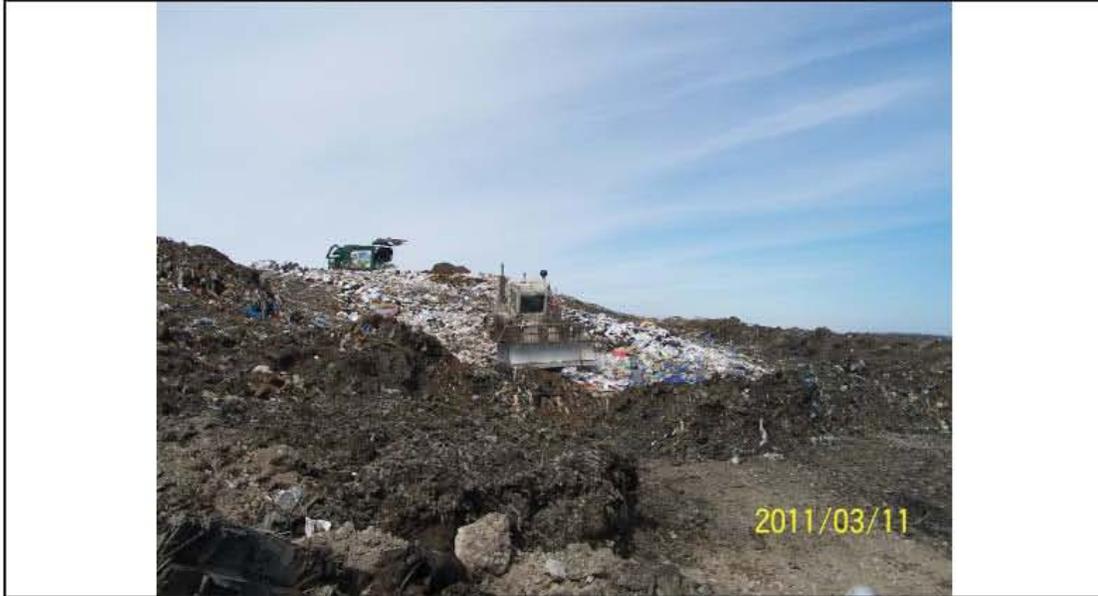
Compactor moving and compacting waste into working face from active area

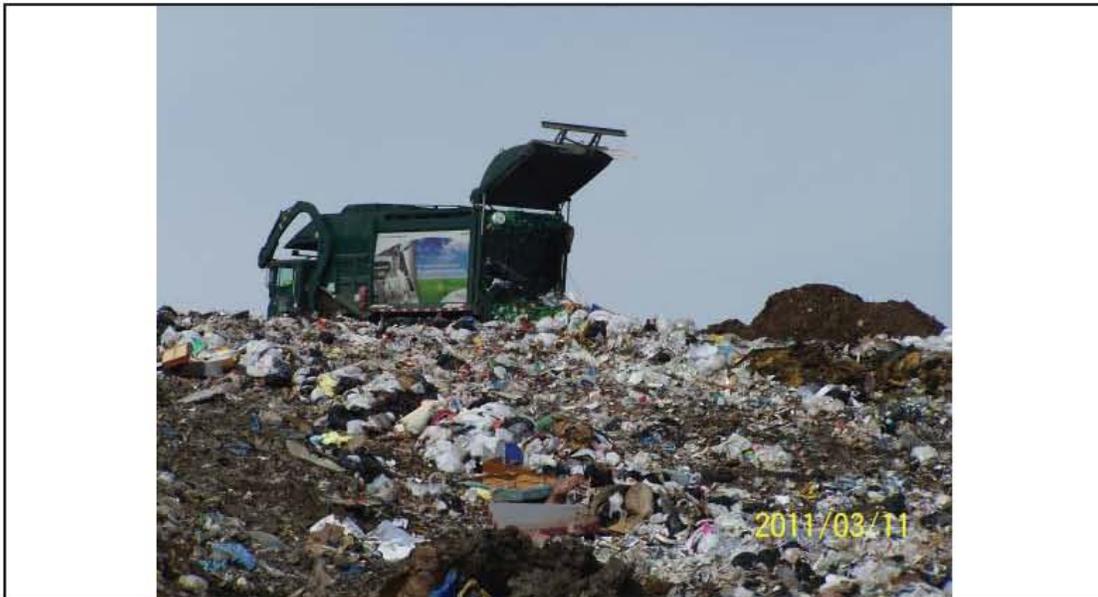
Working face

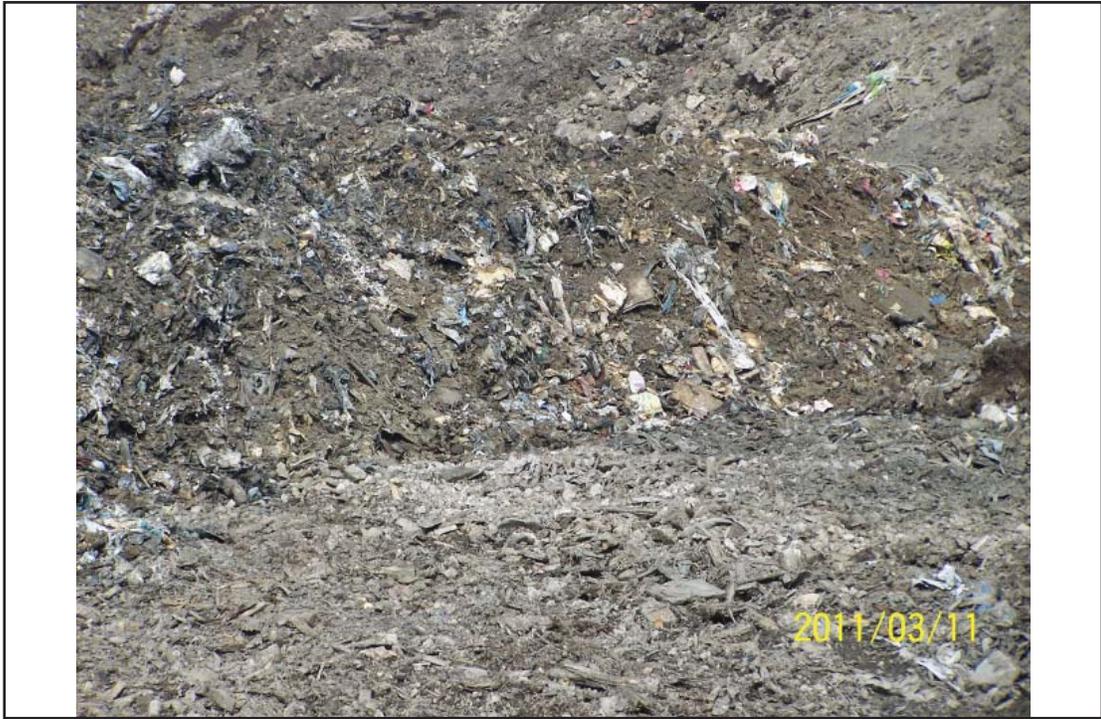
Recovered soils for daily cover

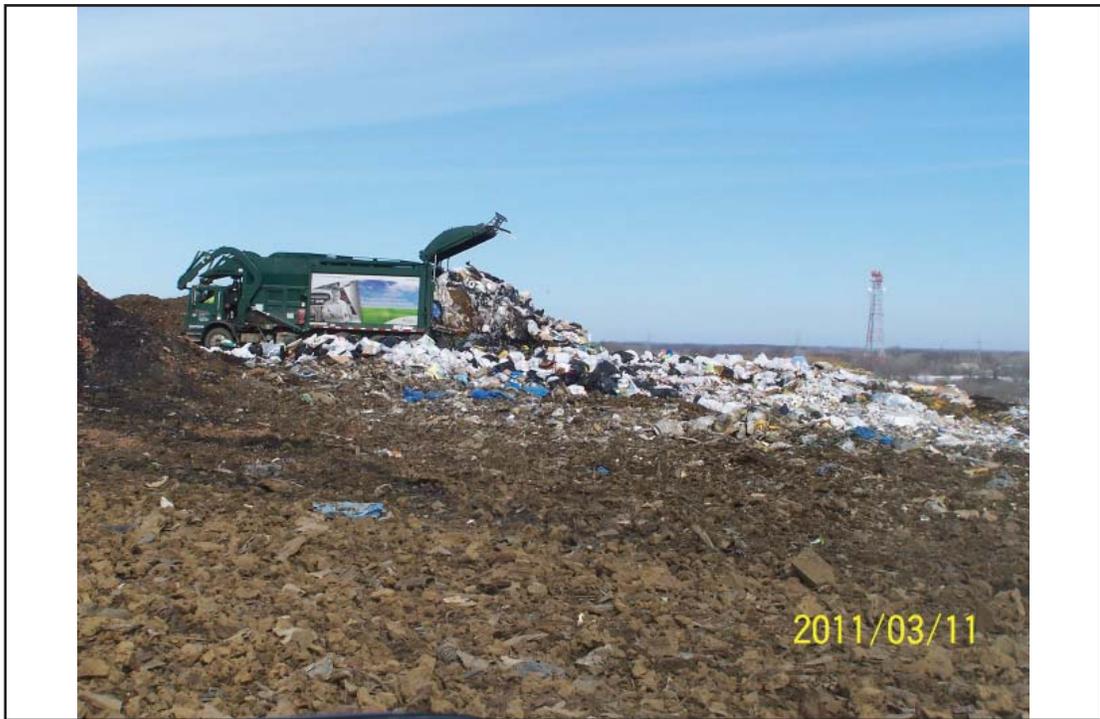
Tipping waste

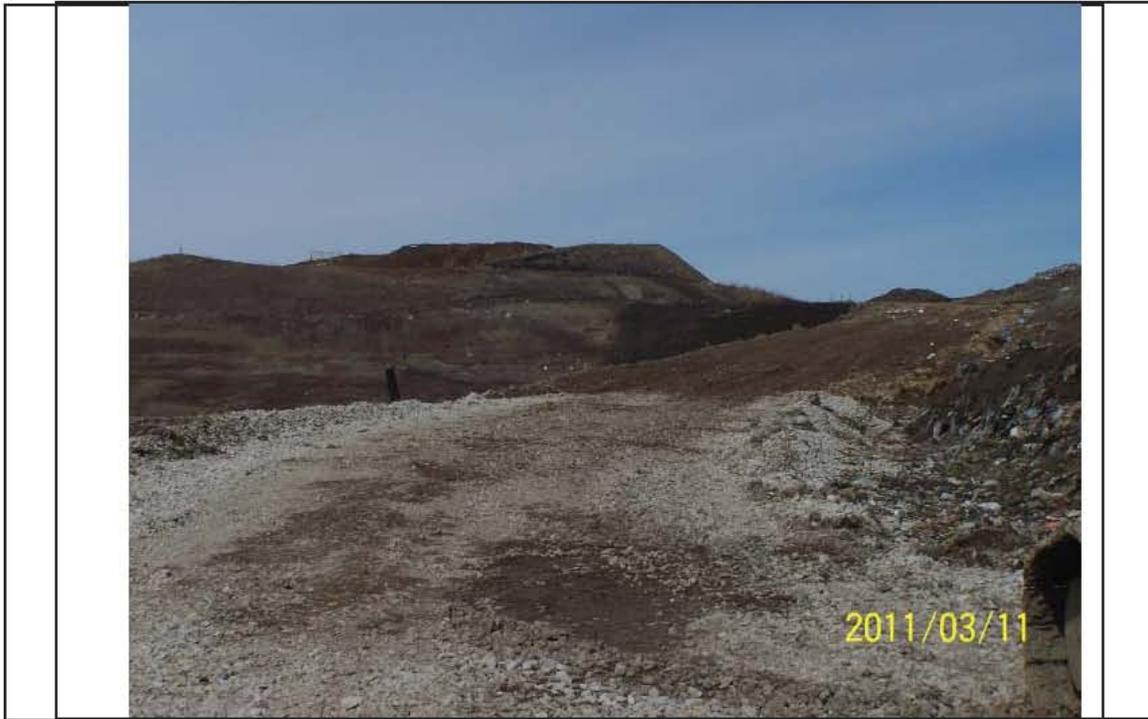
New access road still under construction

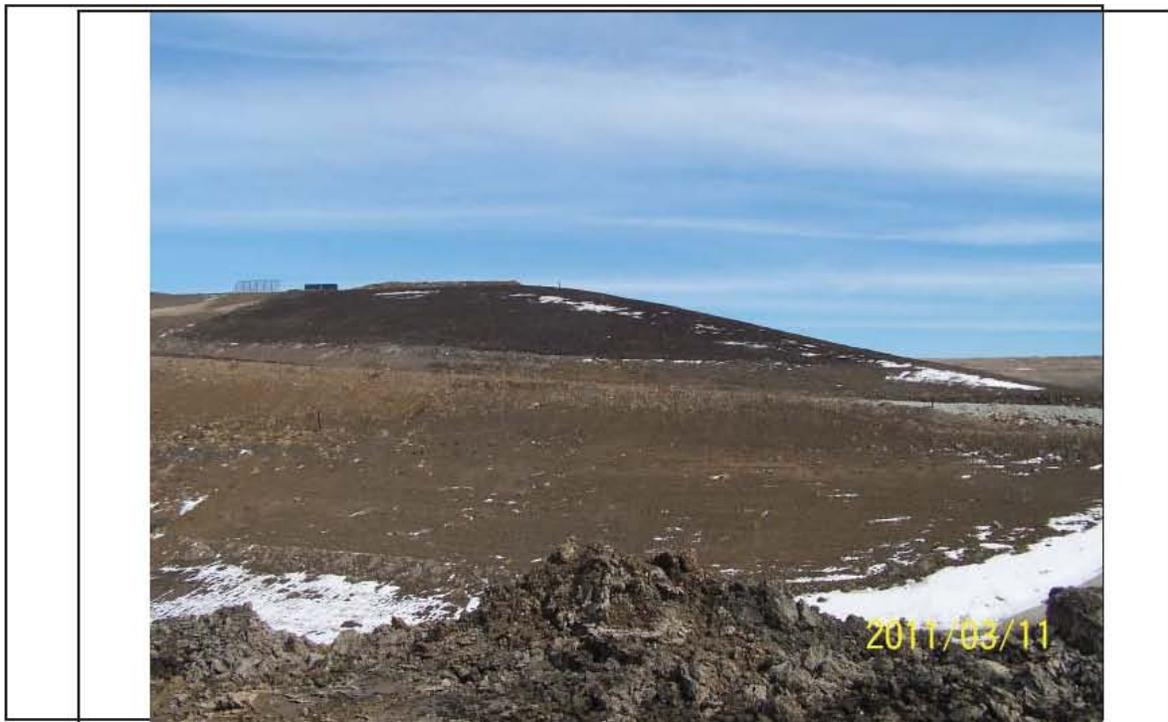
West slope of Phase 6

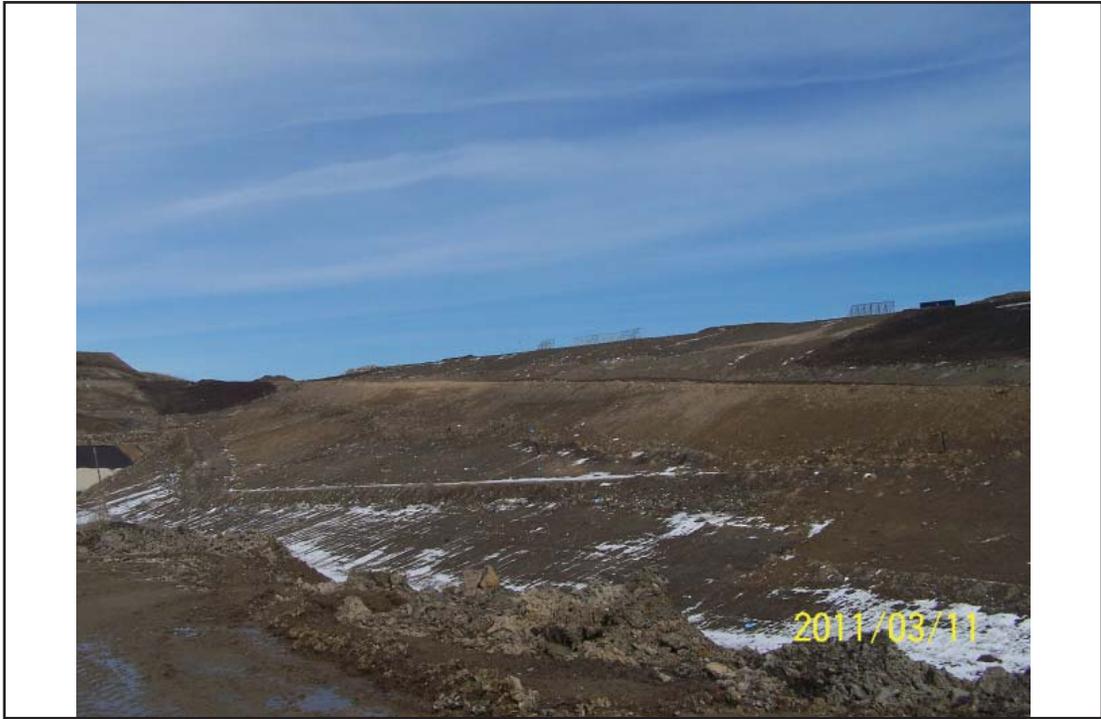
West slope of phase 6

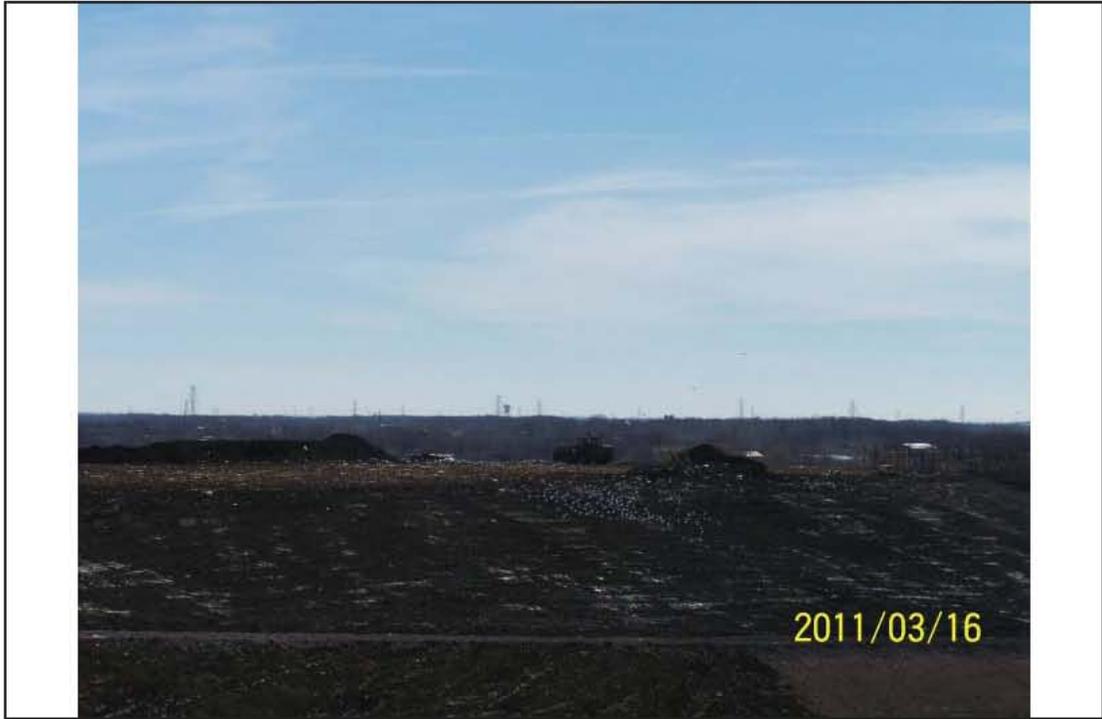
Active area

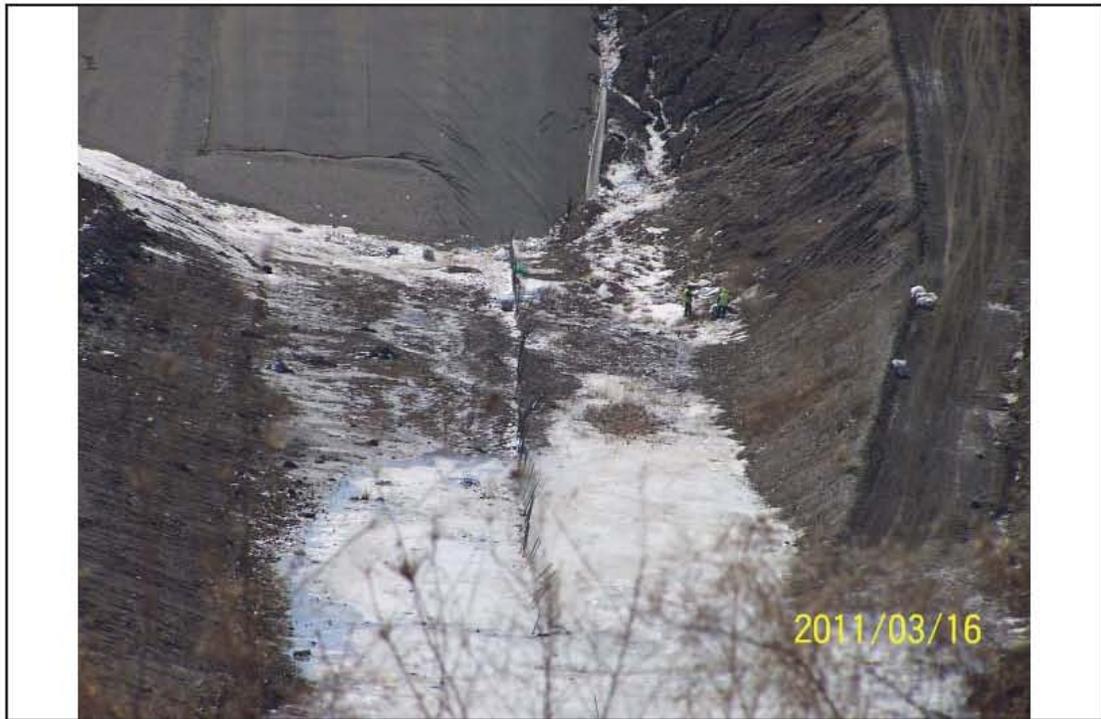
Temp Sed Basin and litter pickers.

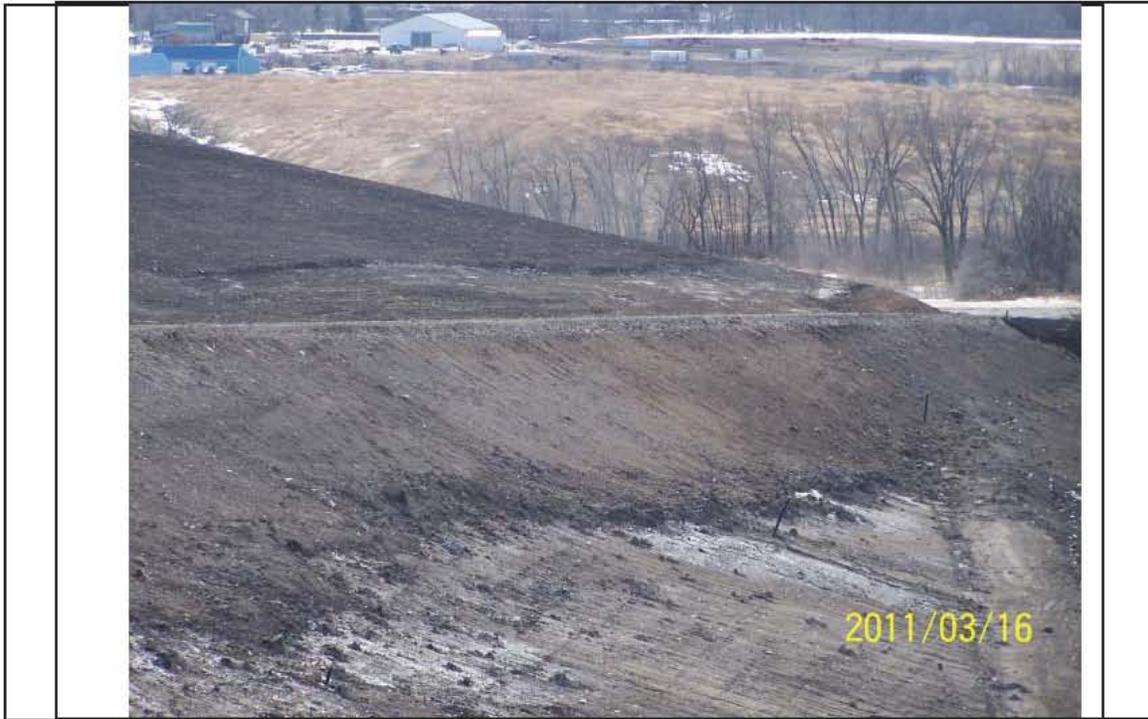
West slope of Phase 6

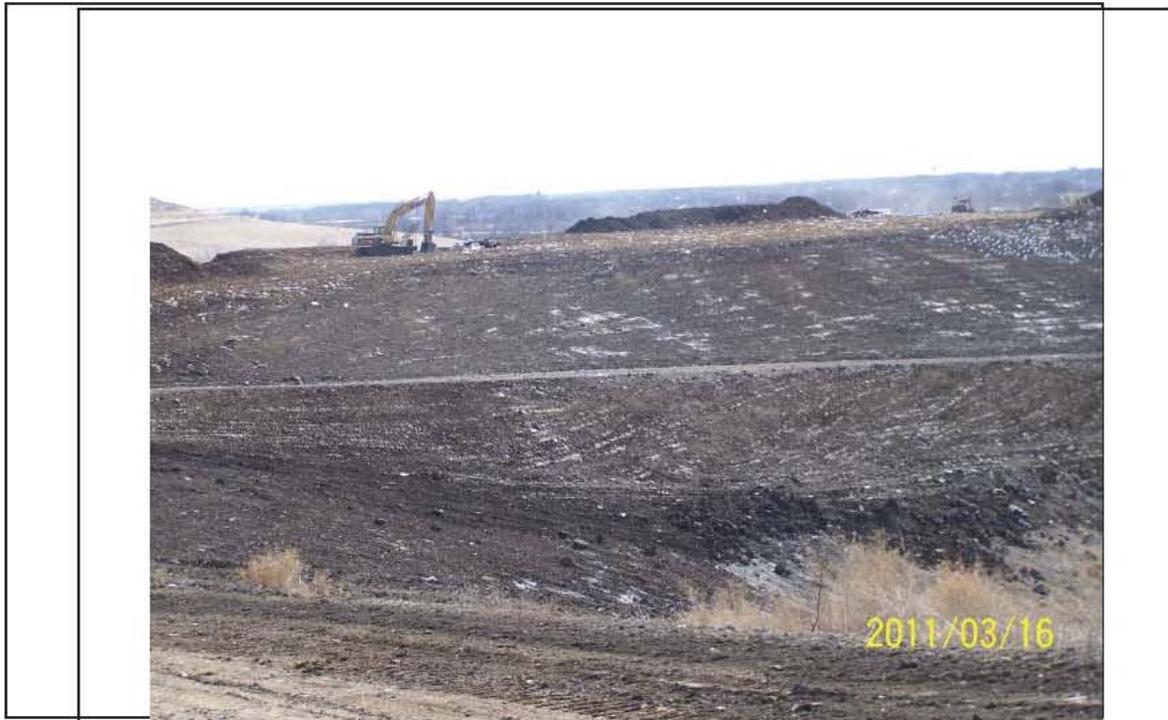
Active area and new road below

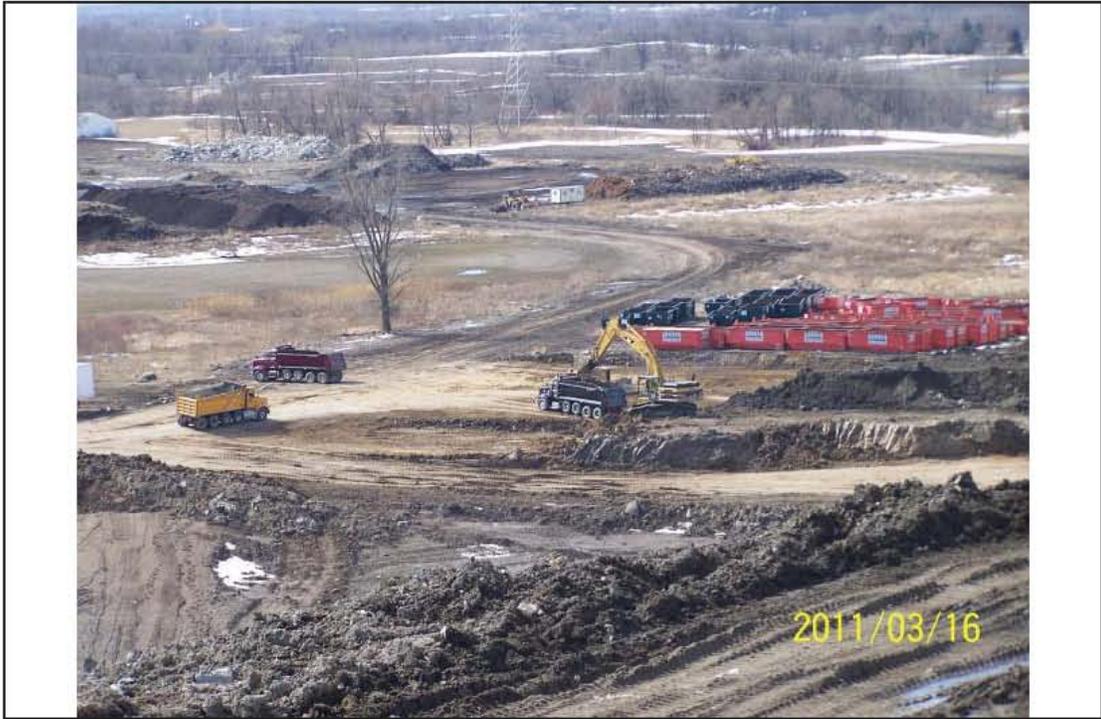
Oaks excavating and transporting stockpile

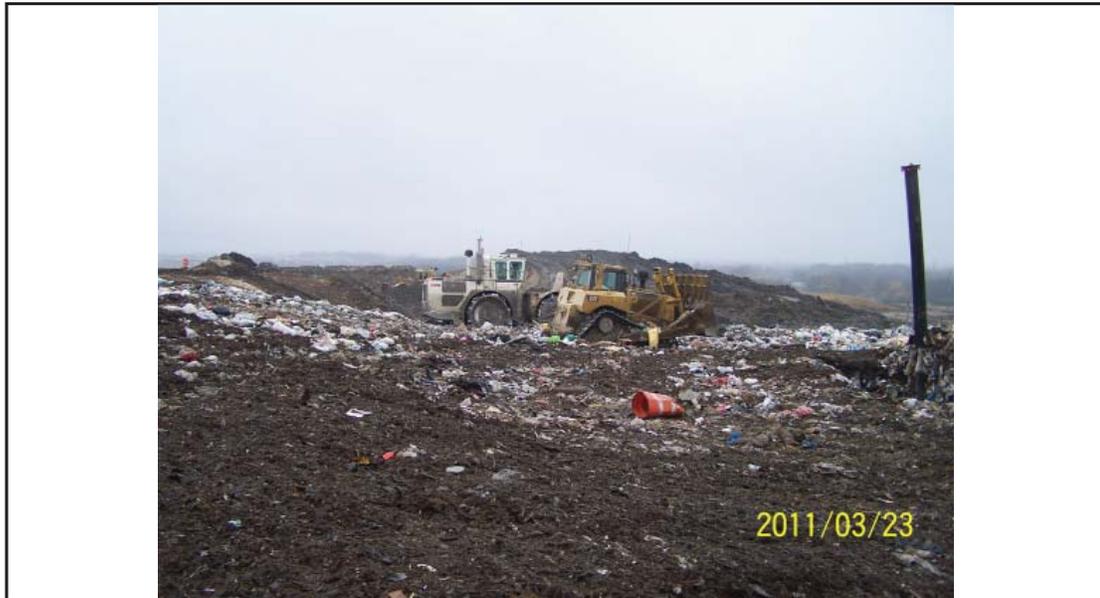
Working Face

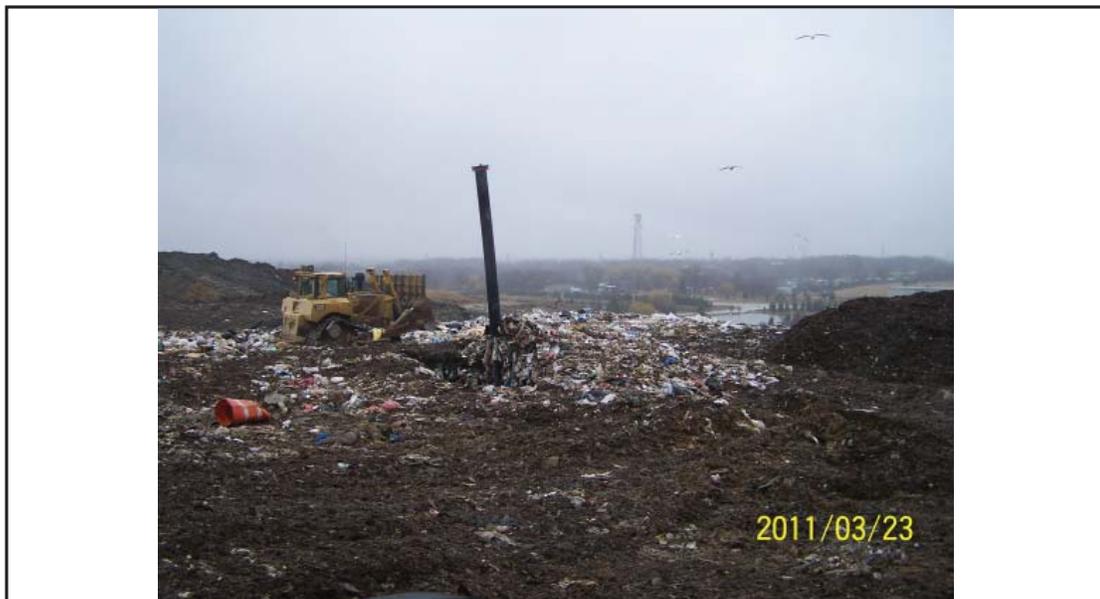
Working face viewed from Southwest, Injection Well in center of photo

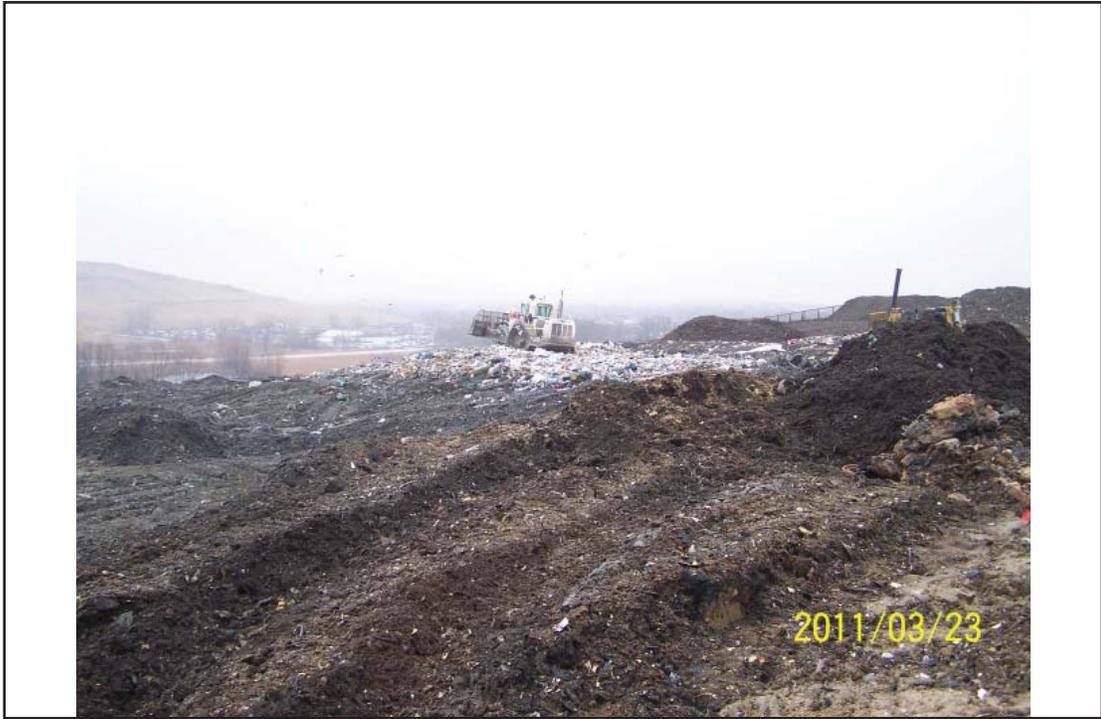
Working Face viewed from the North

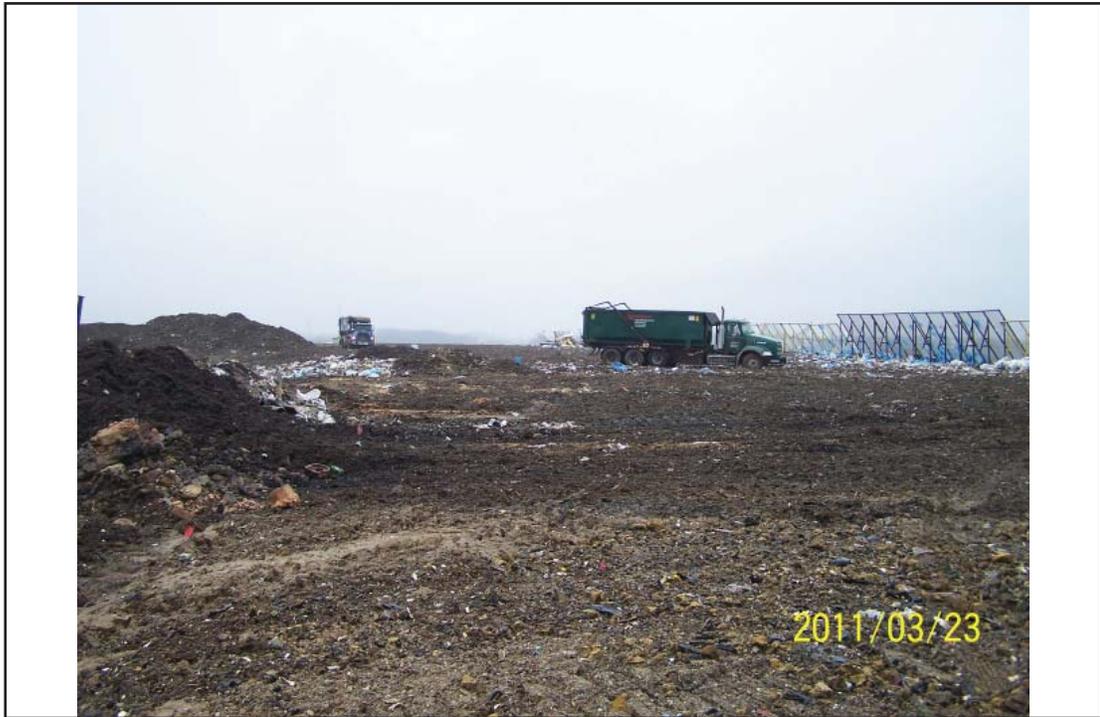
Active Area viewed from the North

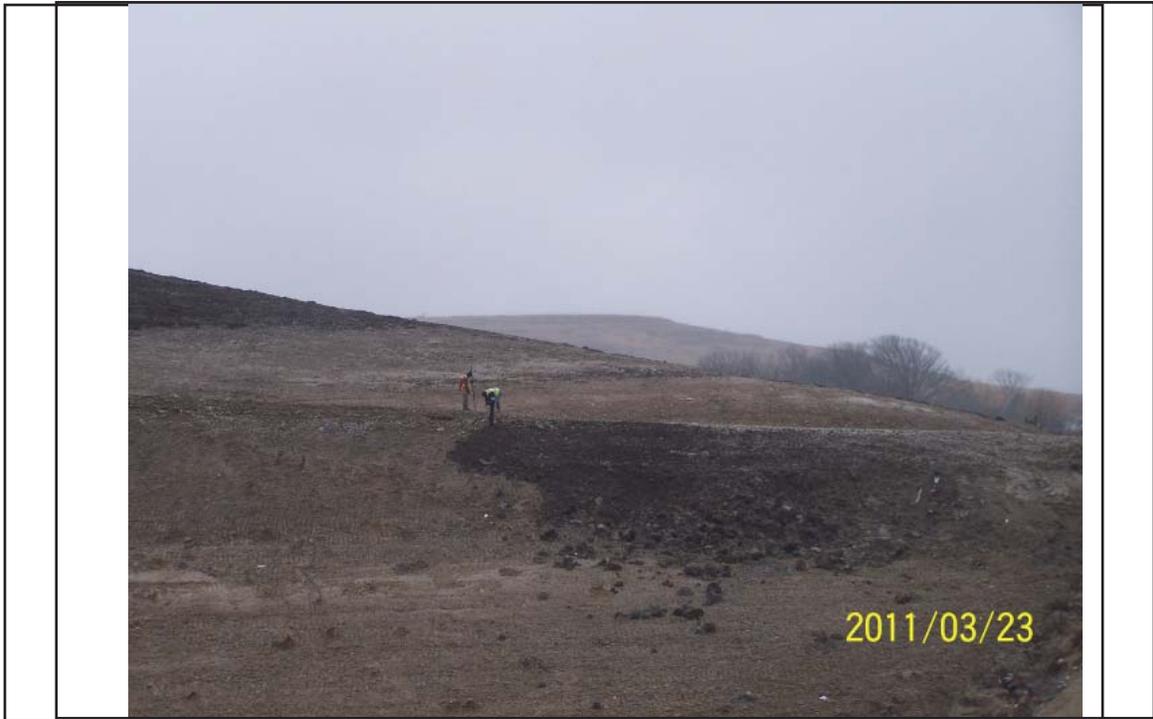
Southern end of West access road

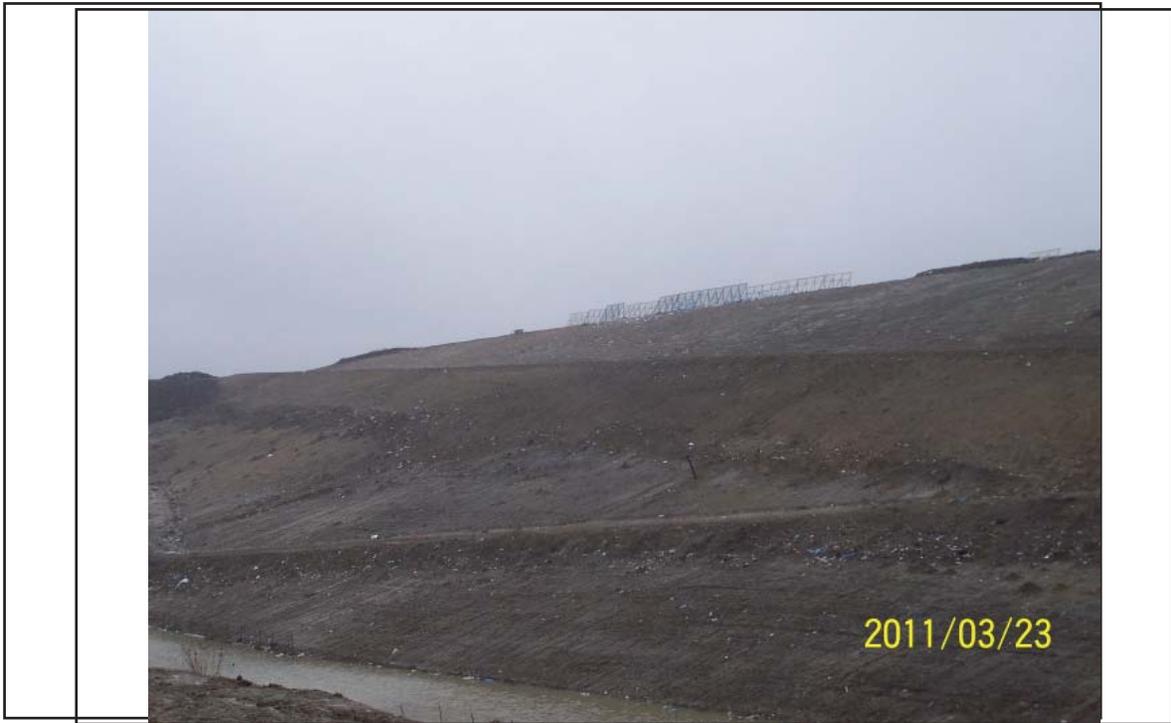
West Slope and access road

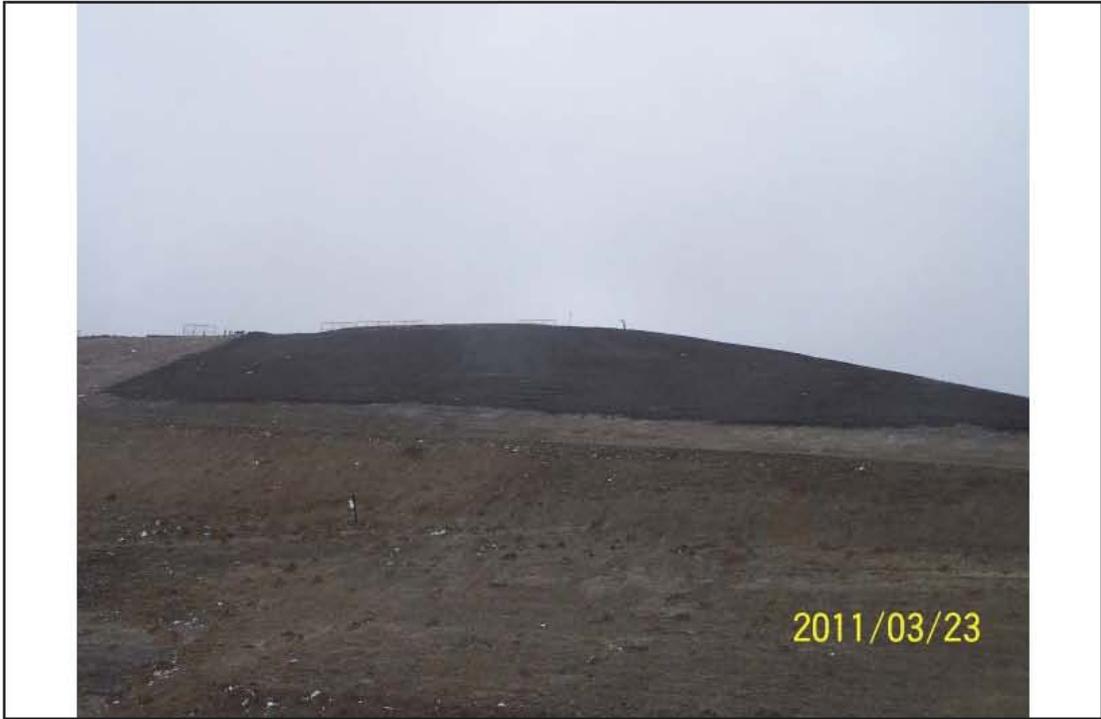
West Slope of Phase 6

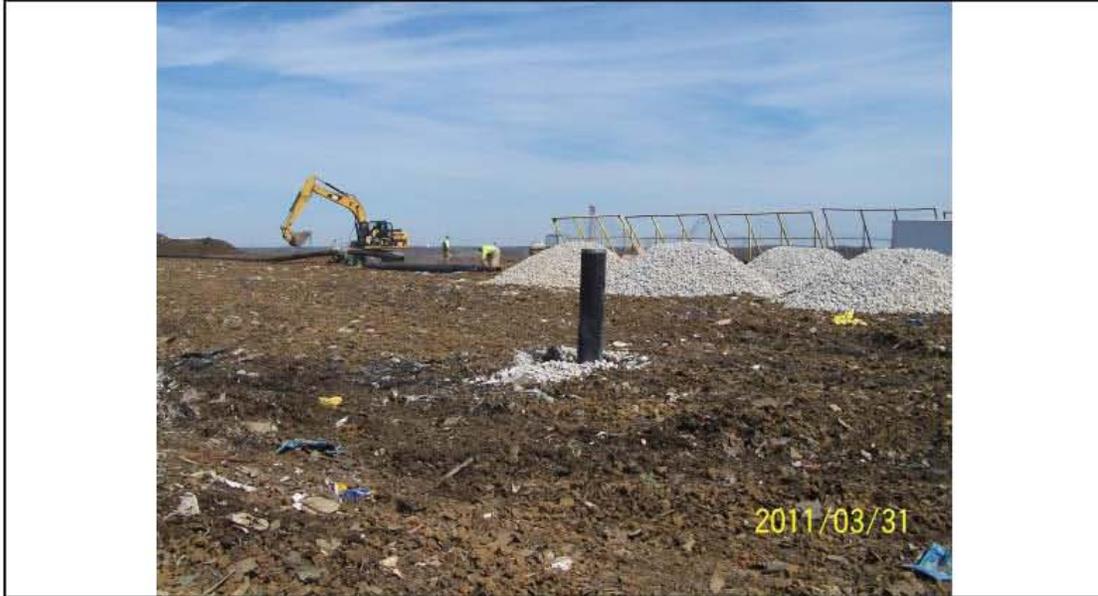
New injection well

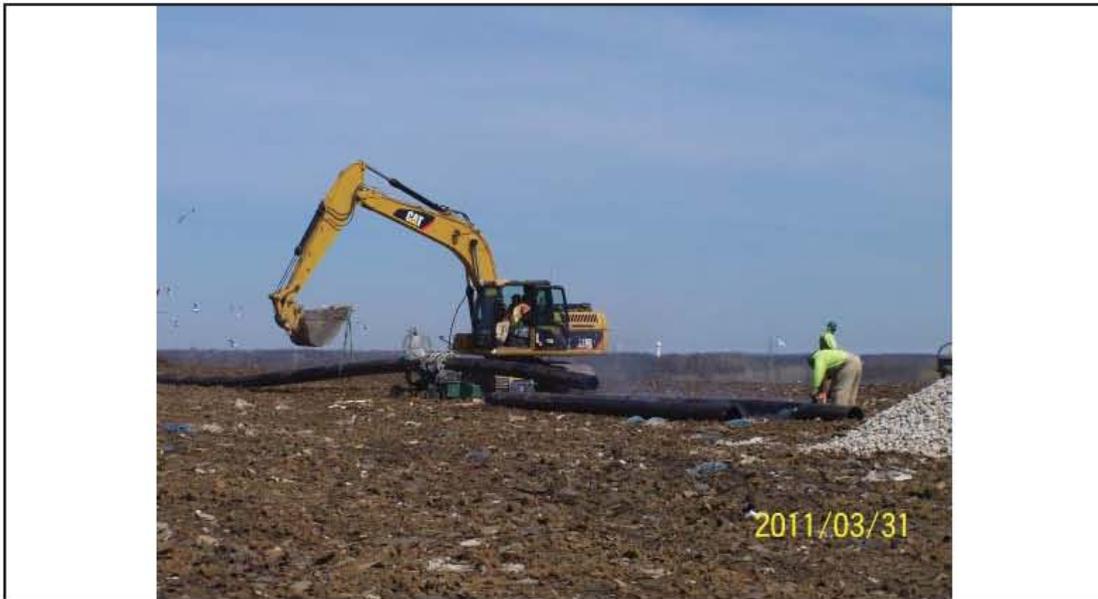
Injection well piping being welded together.

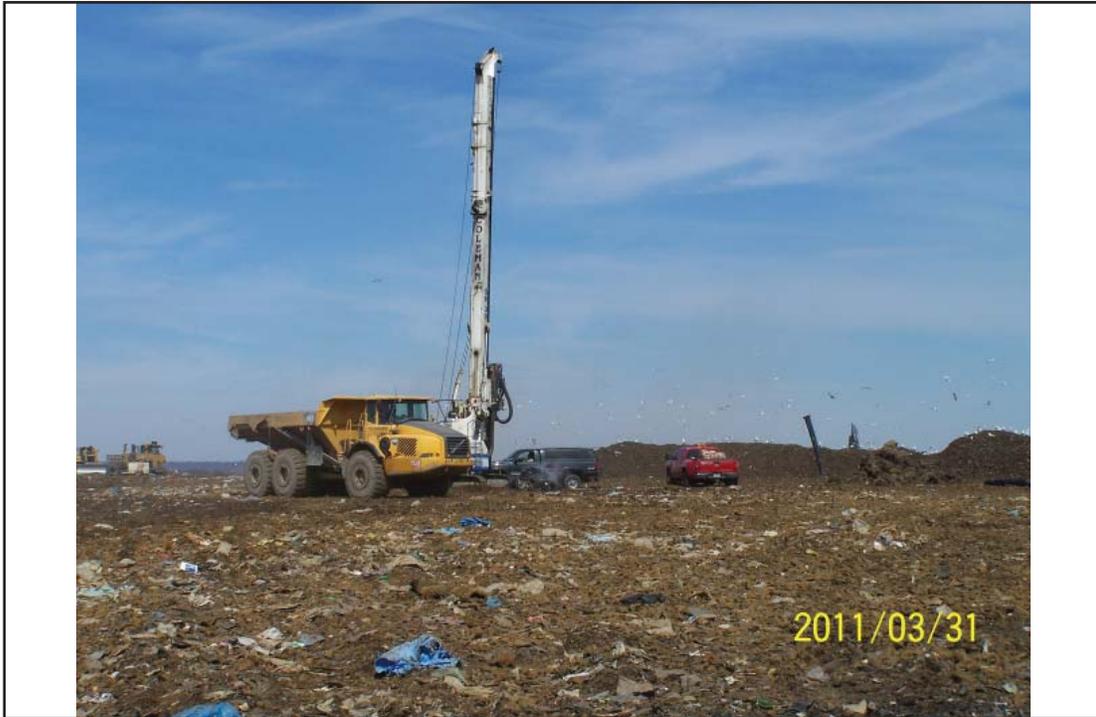
Drill rig installing injection wells

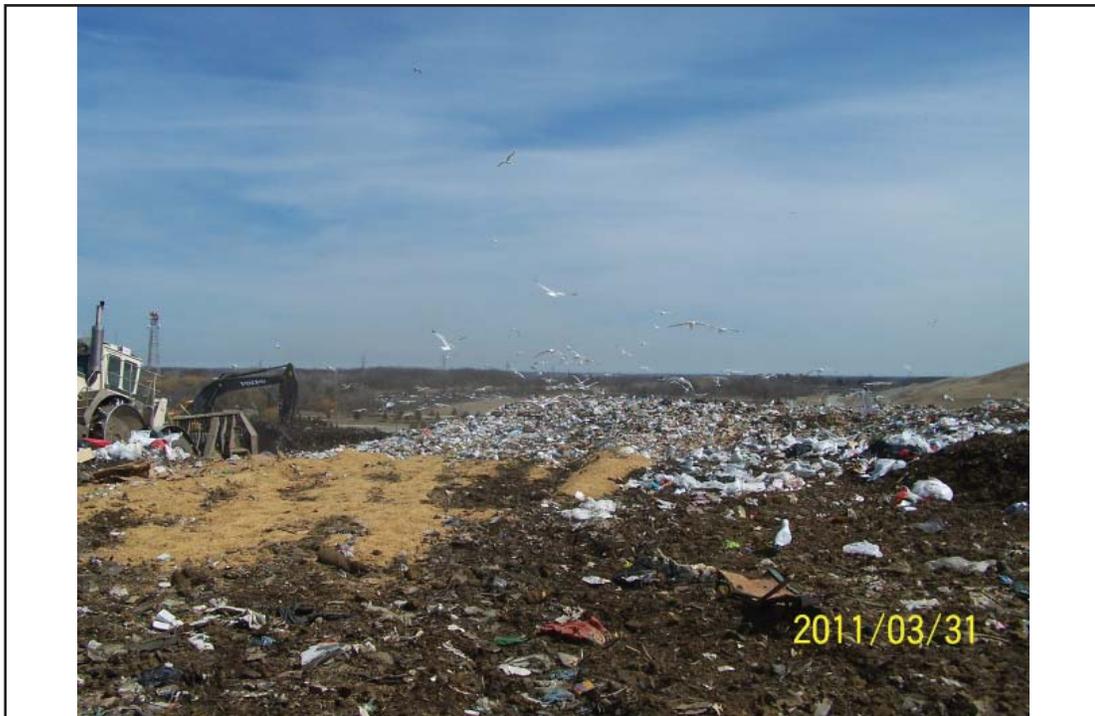
Working face

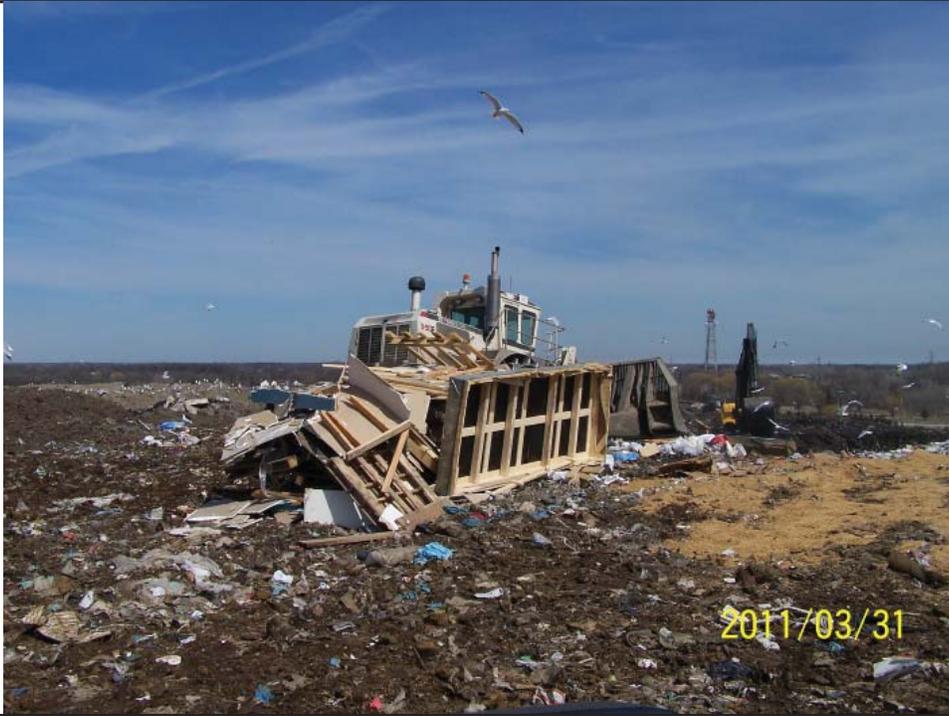
Tipping before working face

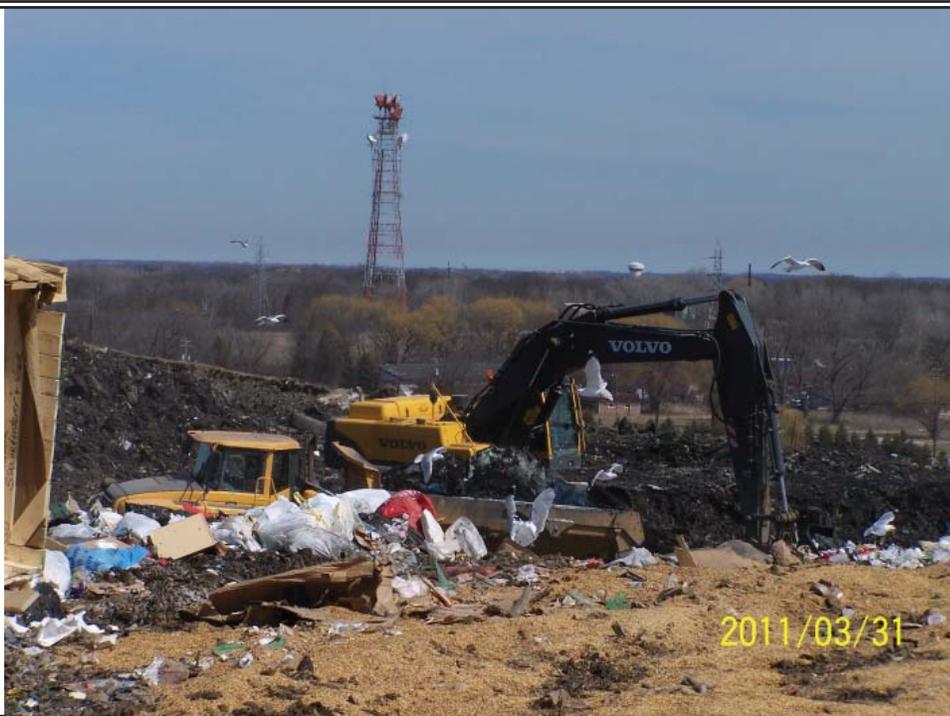
Excavator removing treated bio soils
