Veolia Emerald Park Landfill
City of Muskego

2011 Veolia Emerald Park Landfill Year End Compliance Officer Report and Audit Summary

TO: Veolia Emerald Park Standing Committee
FROM: Jo-Walter Spear, Jr., P.E.
COPIES: File
DATE: 04/02/2012
PROJECT NUMBER: 1012.10030

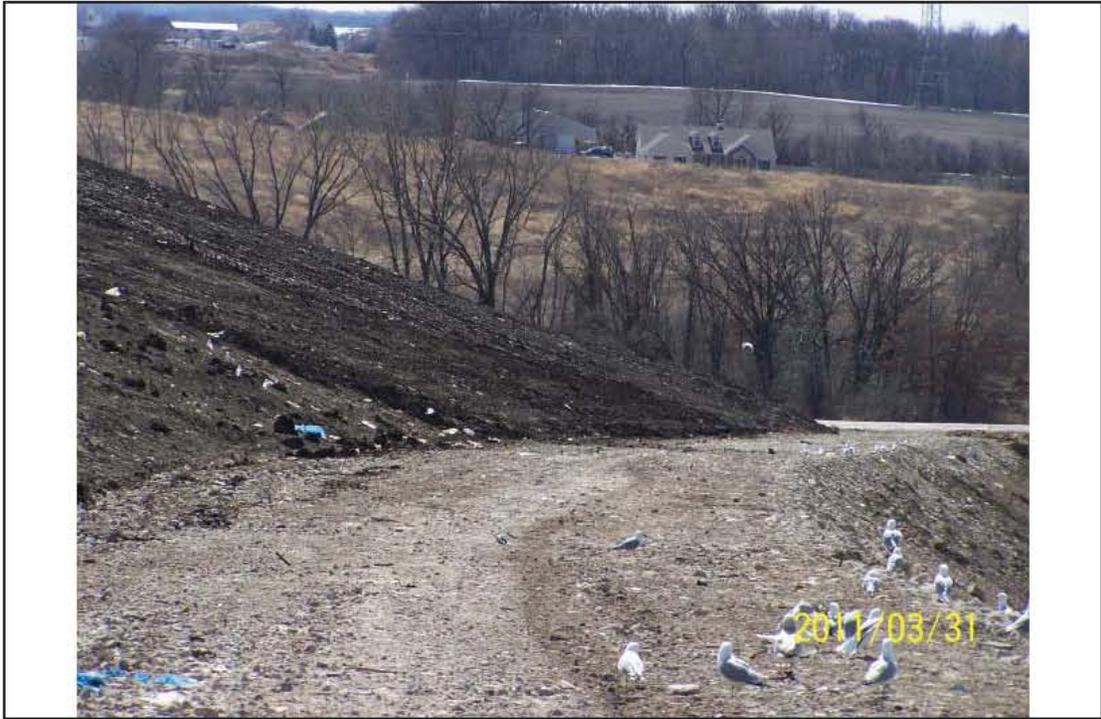
New Access road to active area, nearly complete

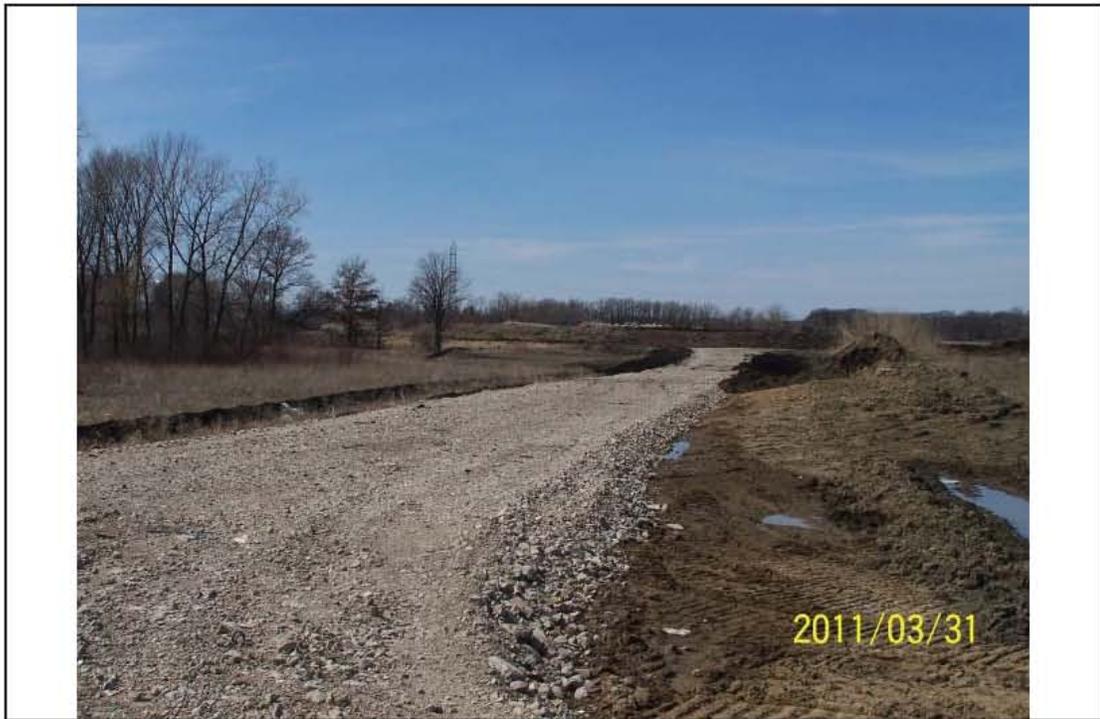
New road to compost area

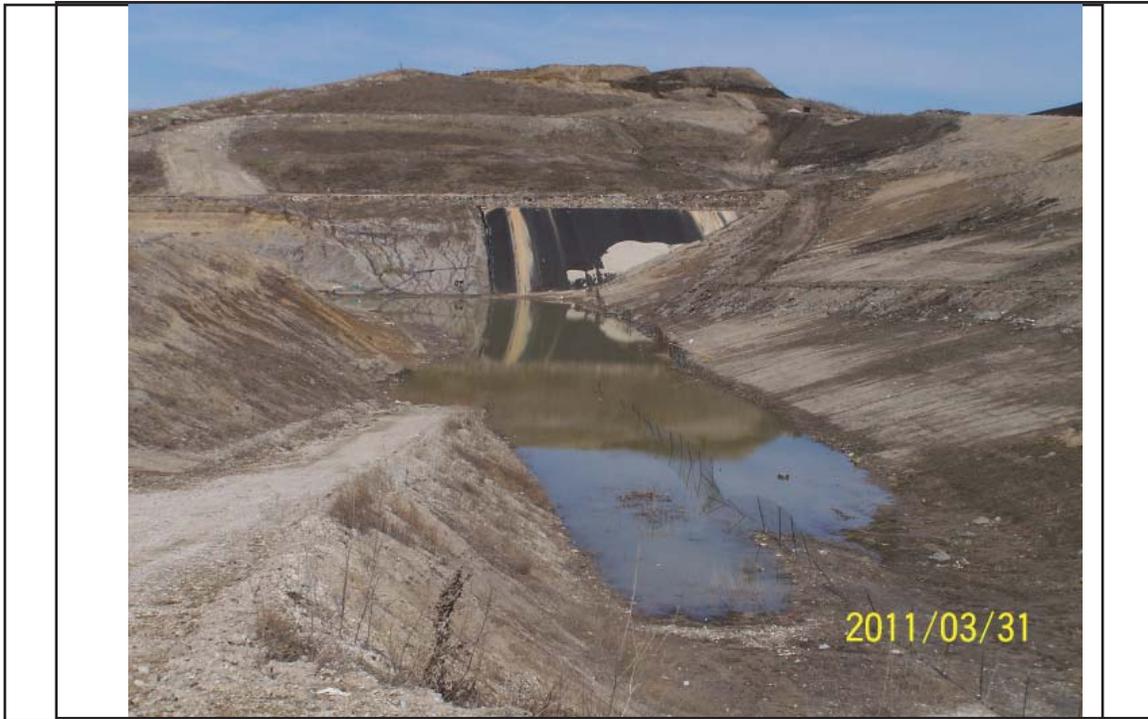
Temp Sed Basin

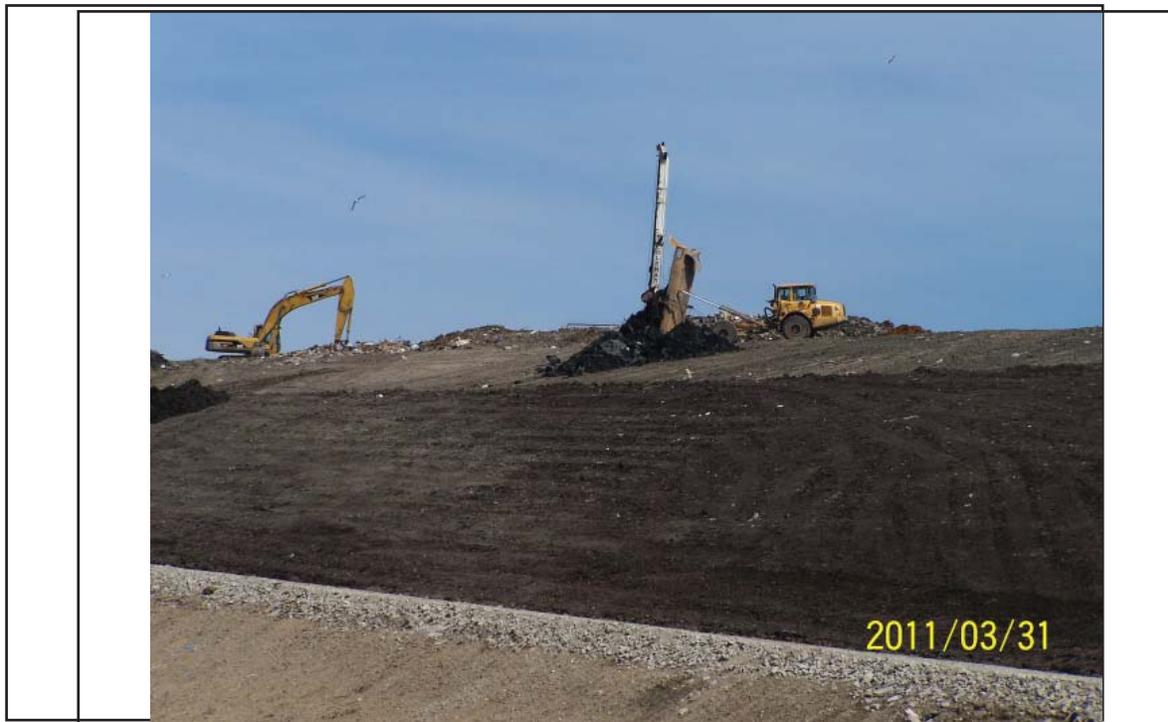
West slope and activities in Active Area

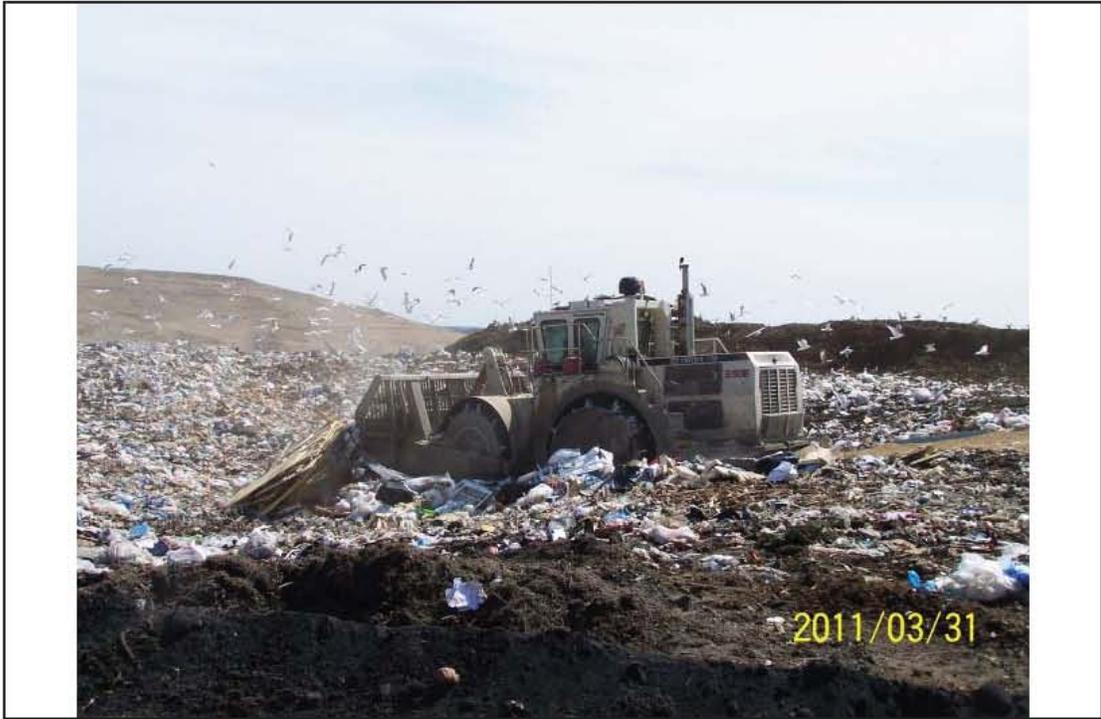
Compactor in working face

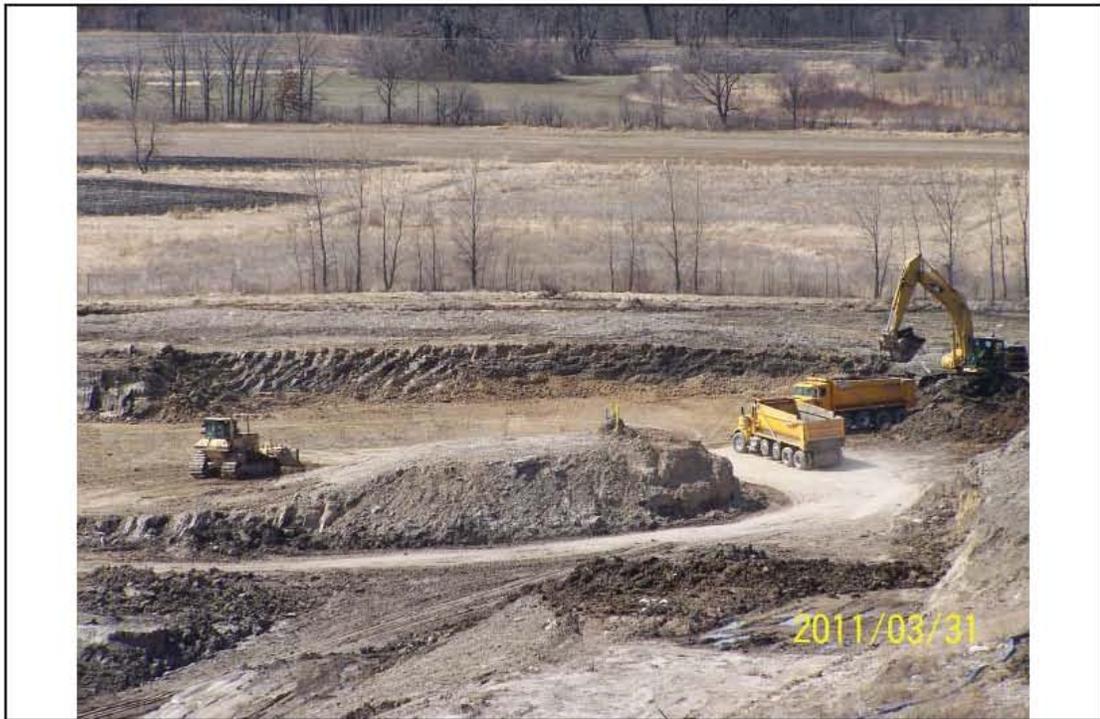
Clay stock pile being excavated and relocated to Oak's Farm

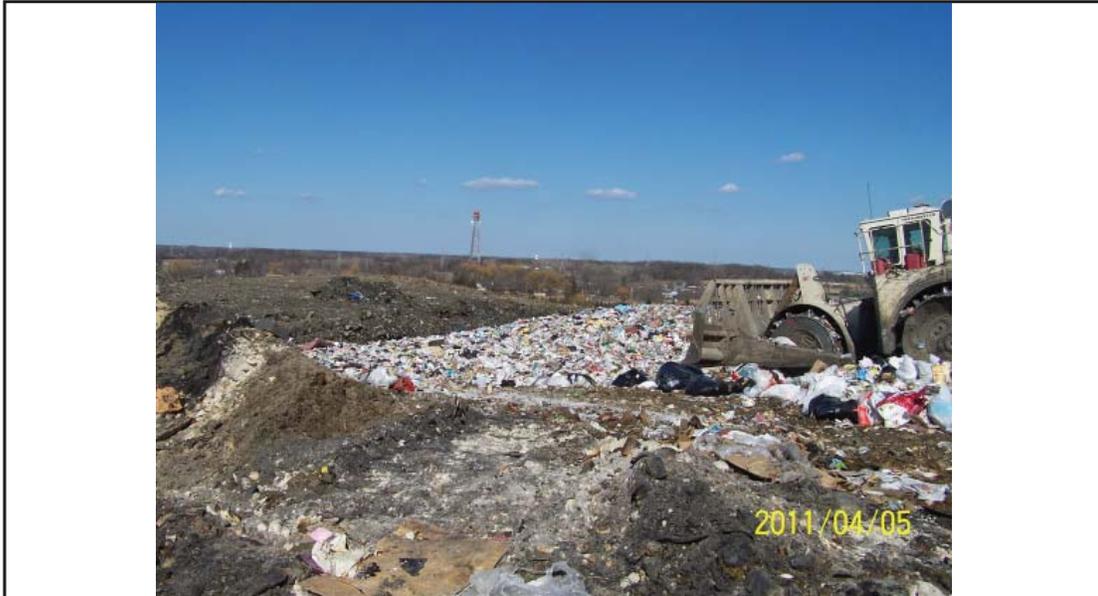
Working face

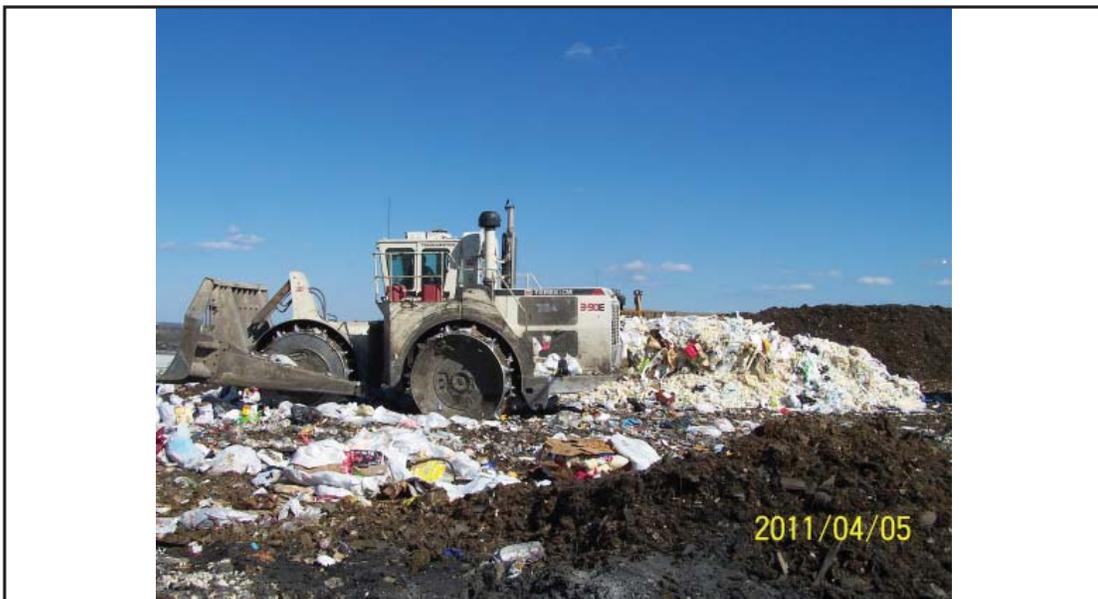
Working face

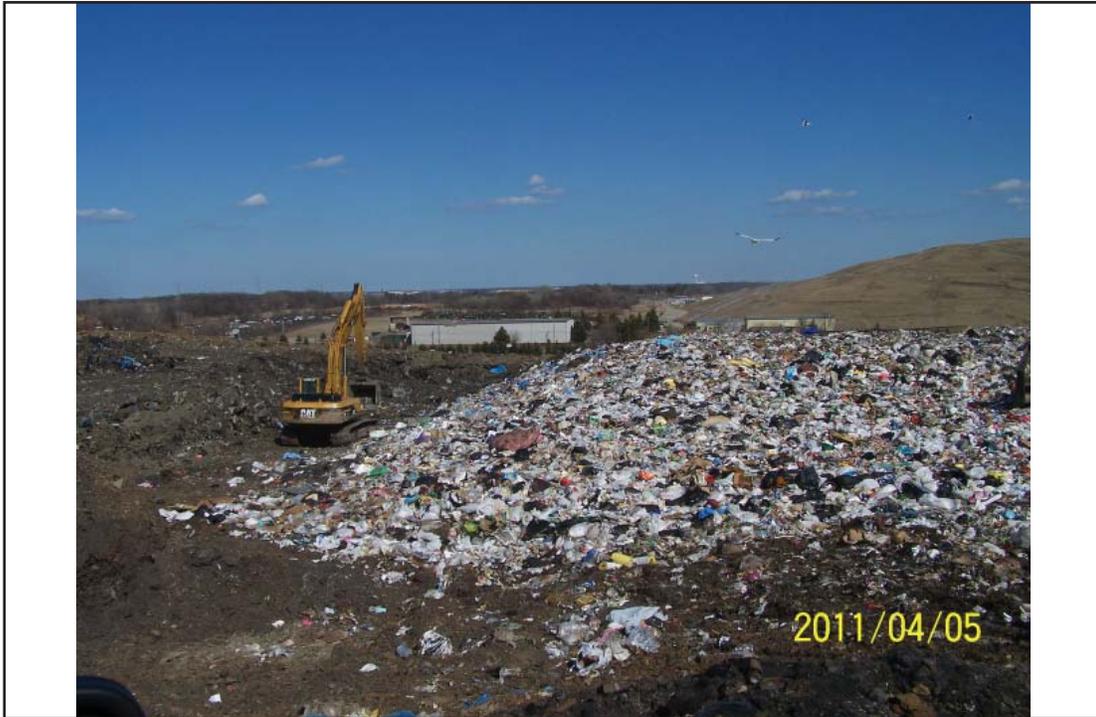
Working face, excavator moving soils

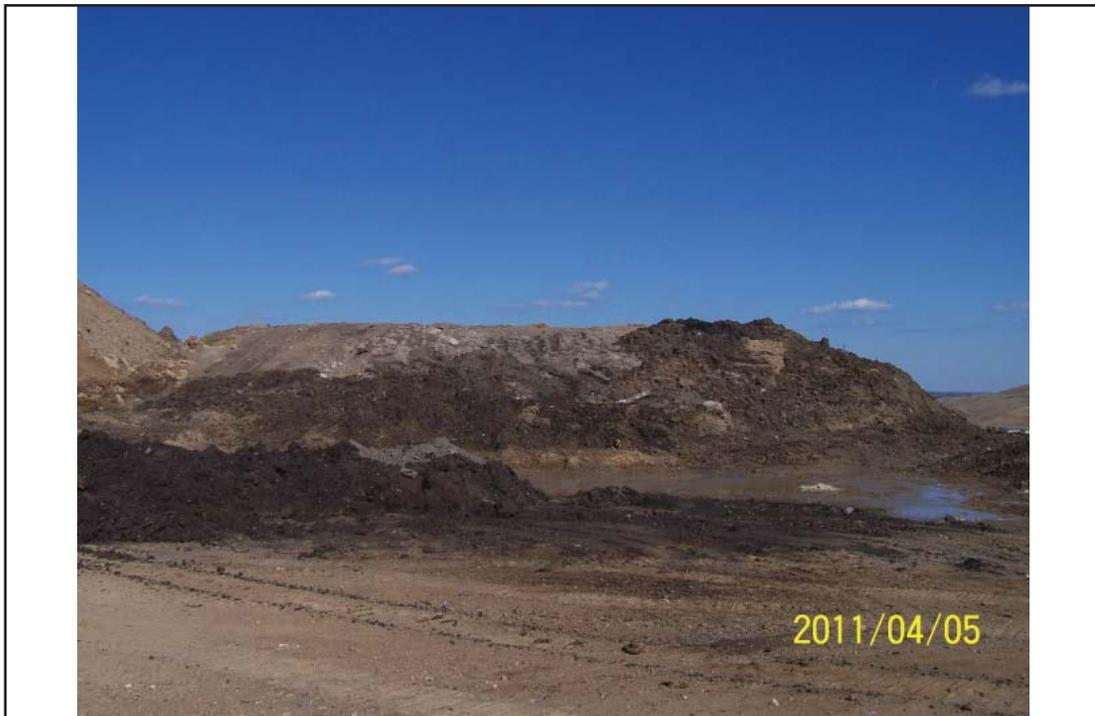
Soil tipping on Phase 3

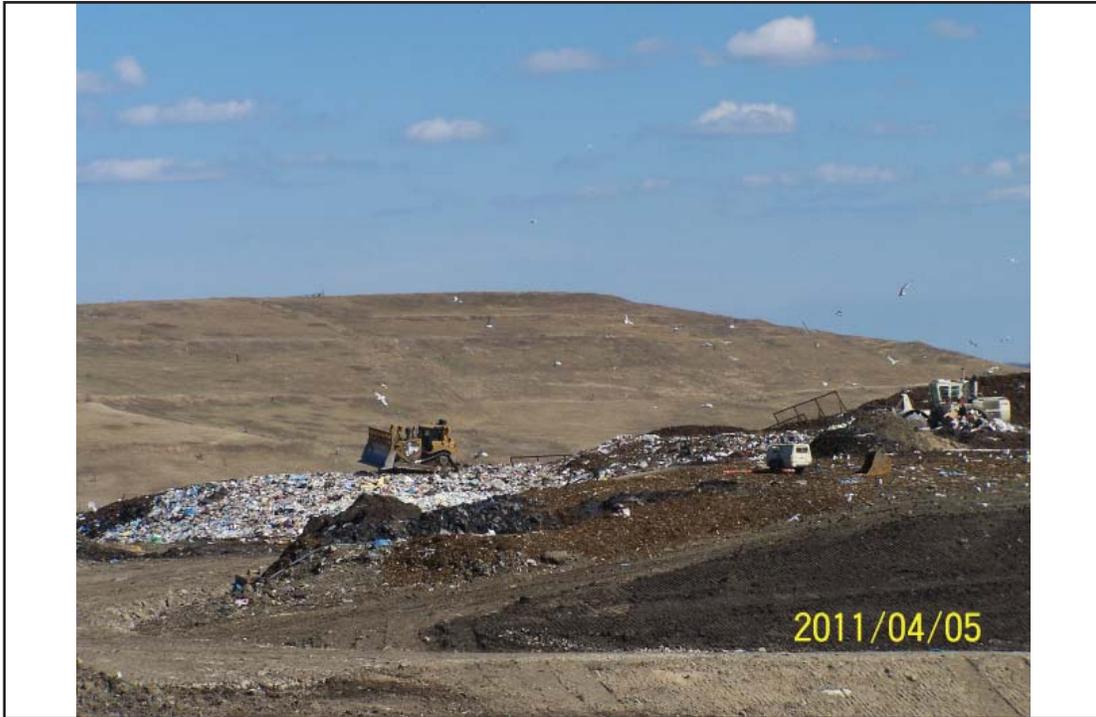
Active area

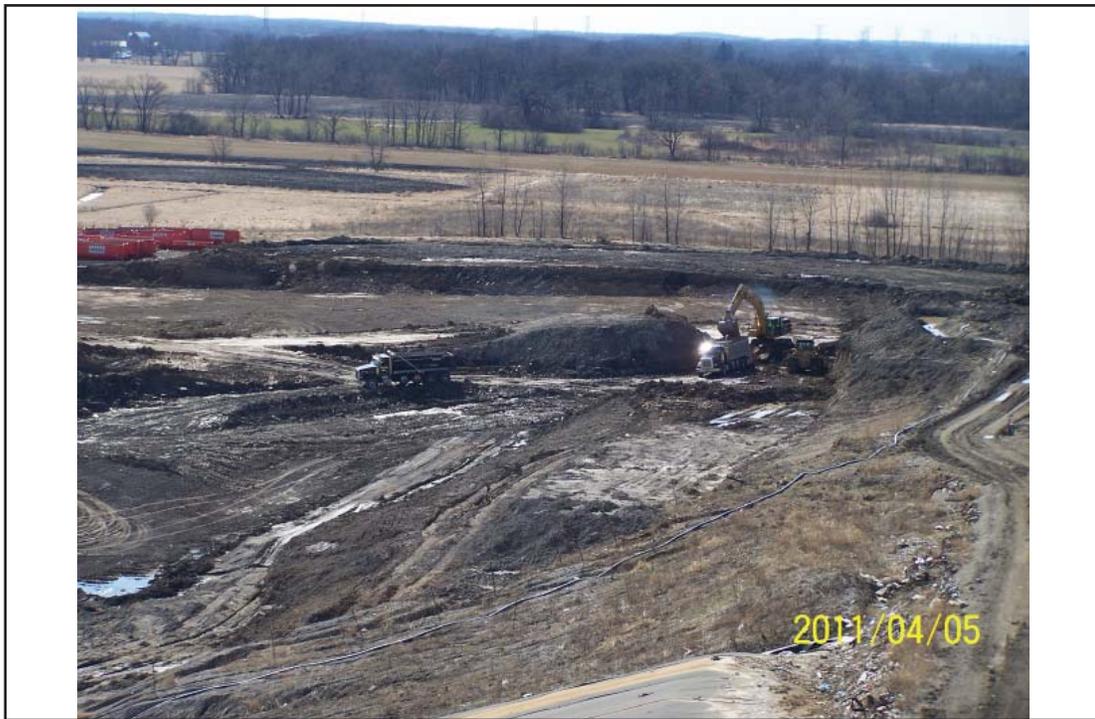
Working face

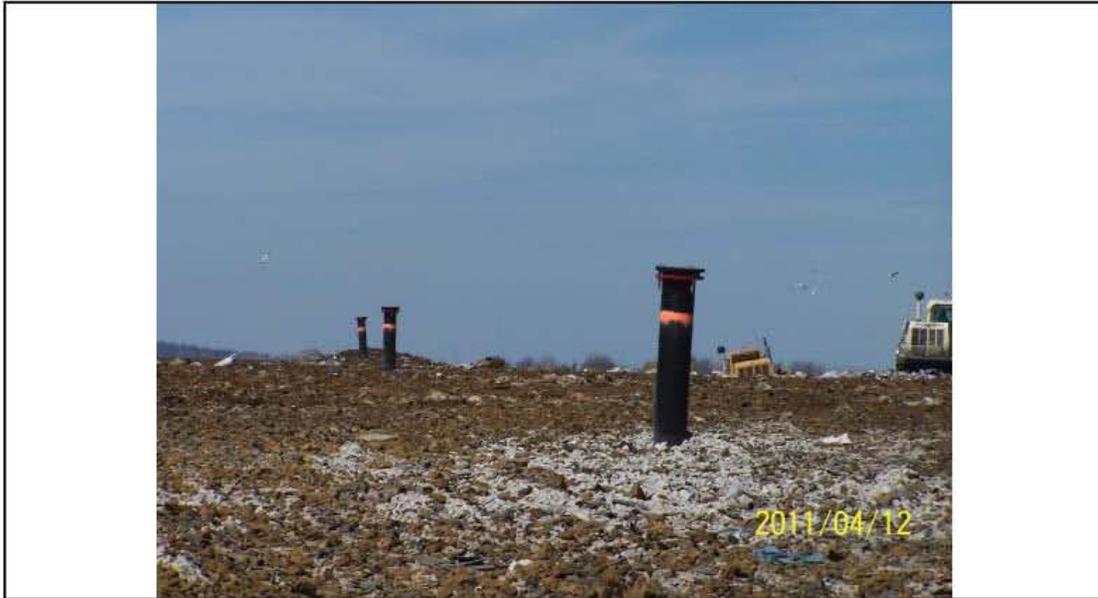
Injection wells in active area

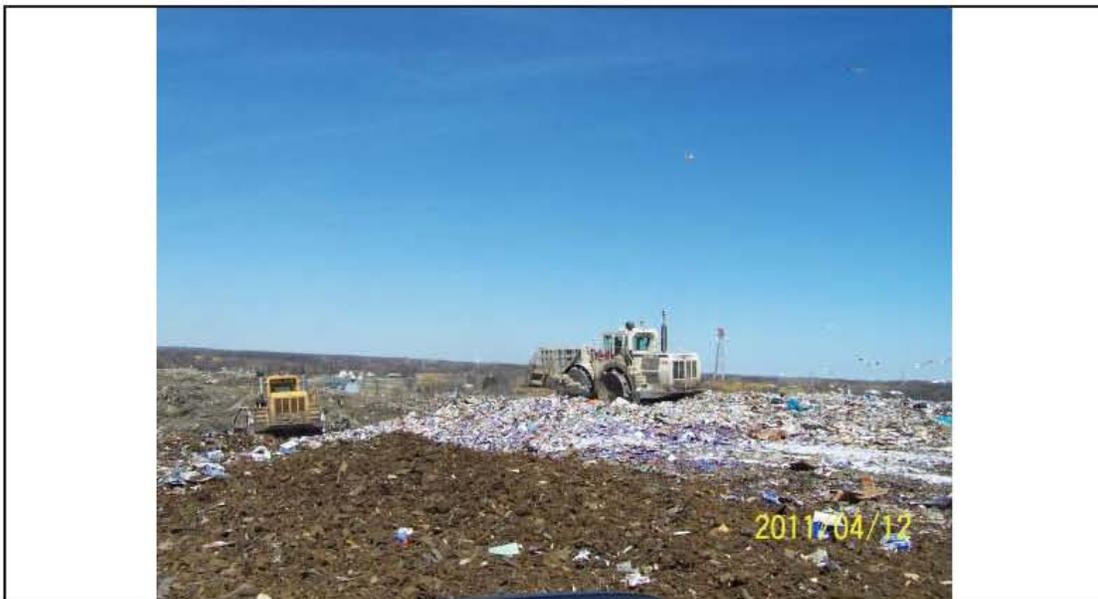
Working face

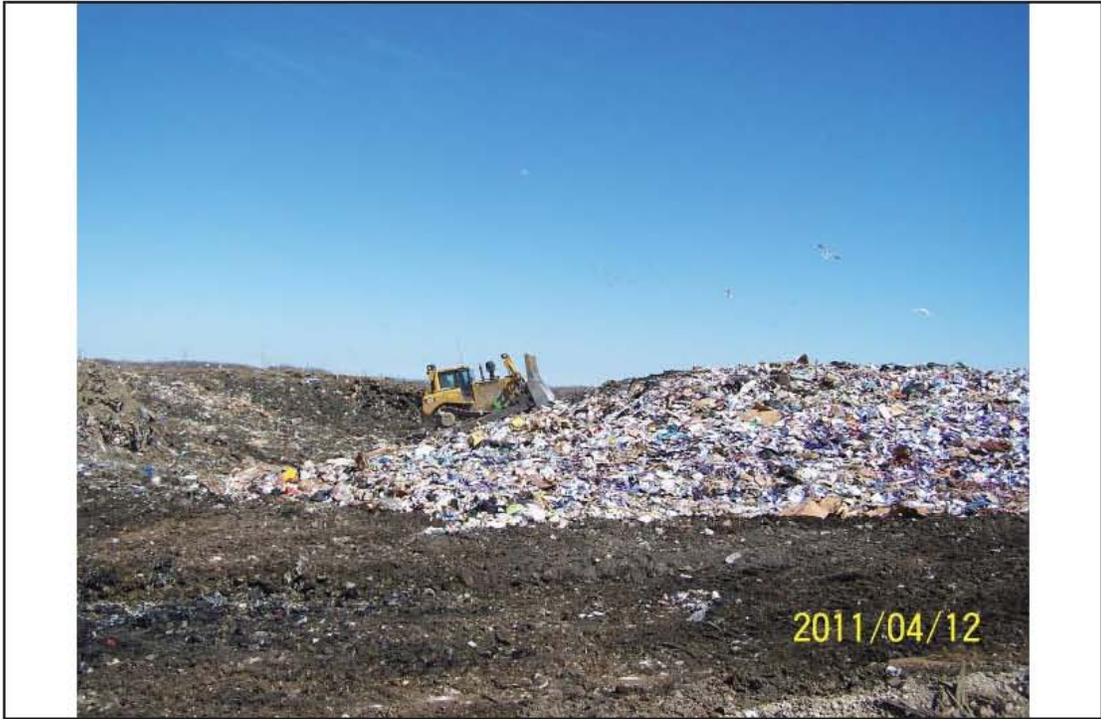
Dozer pushing waste into working face

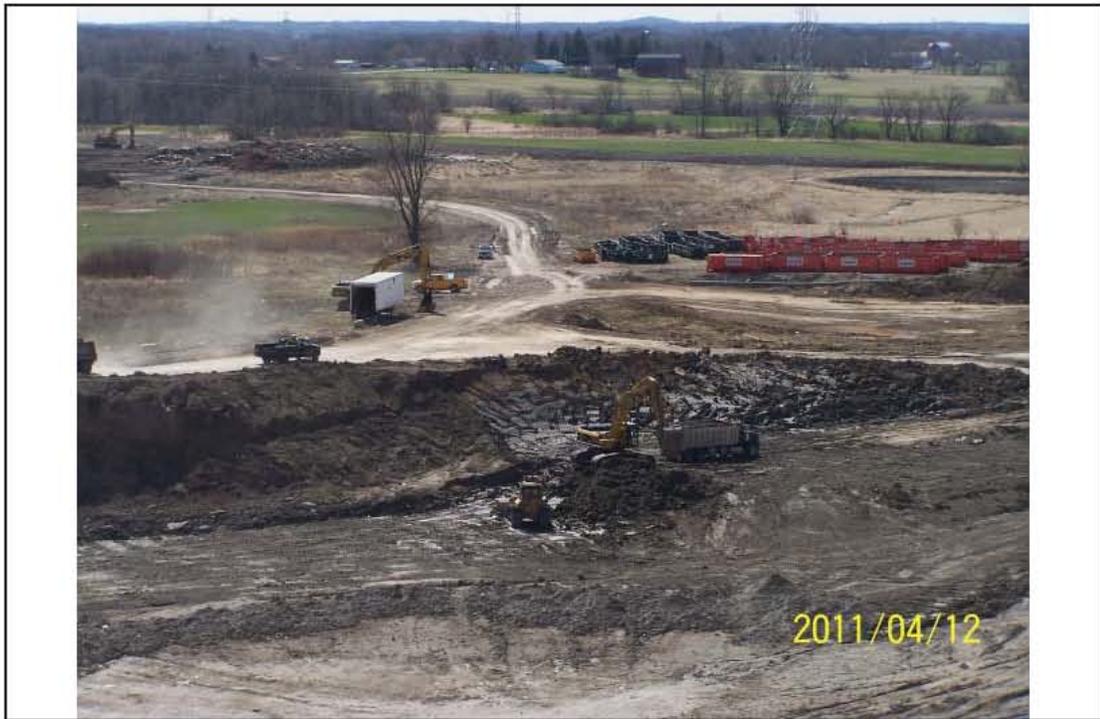
Excavation area for expansion

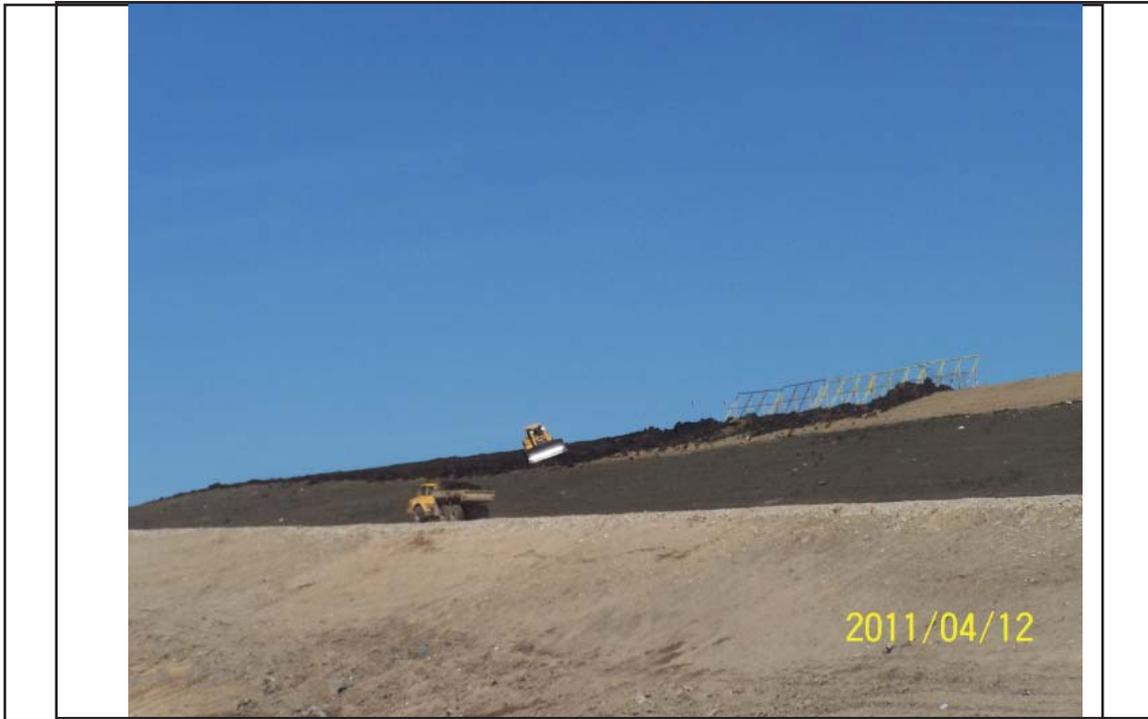
Intermediate cover being spread on West slope of Phase 6

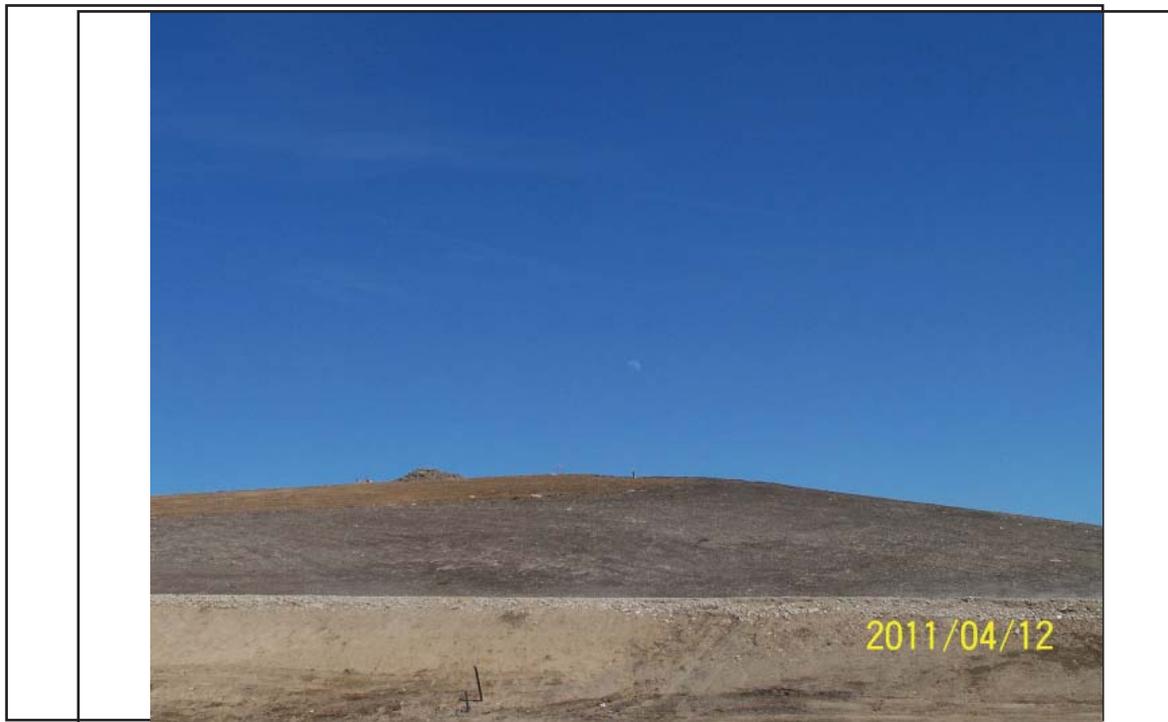
West slope of Phase 6 and new road

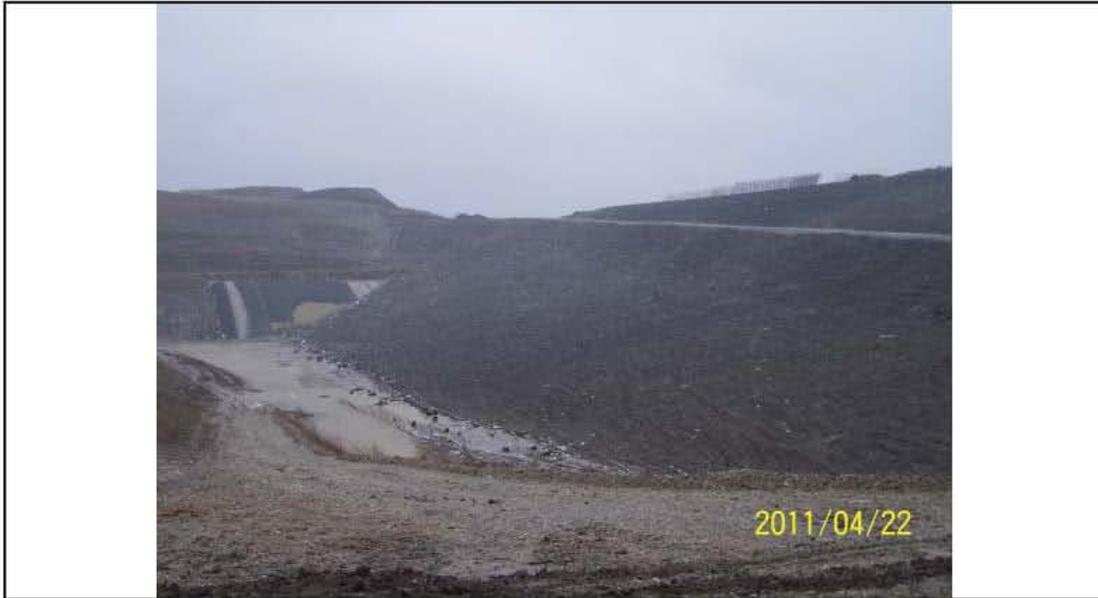
West slope and temp sed basin

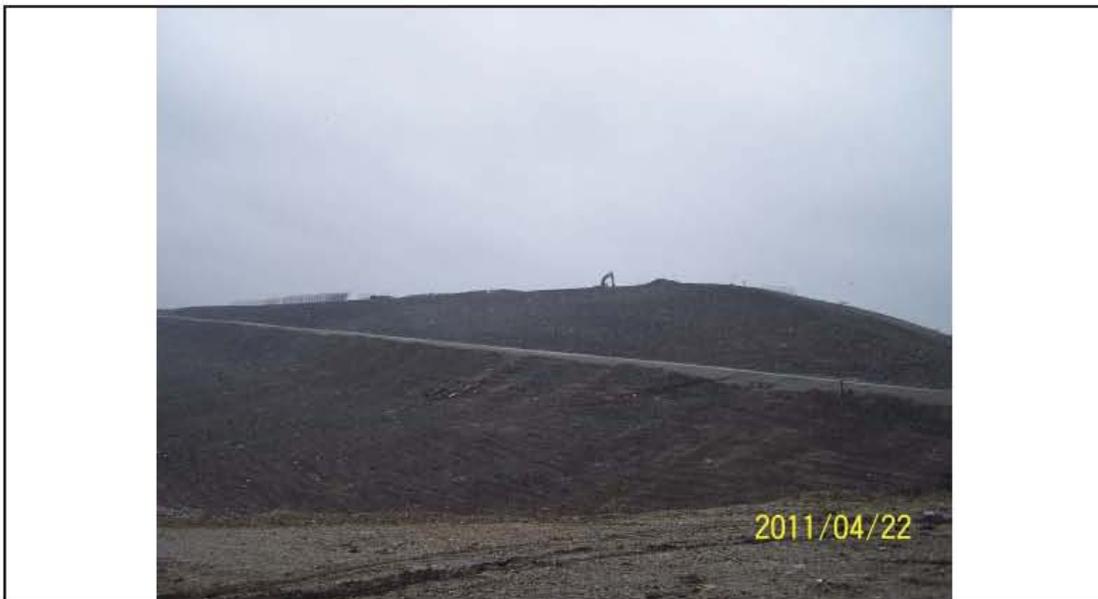
West slope with new road completed

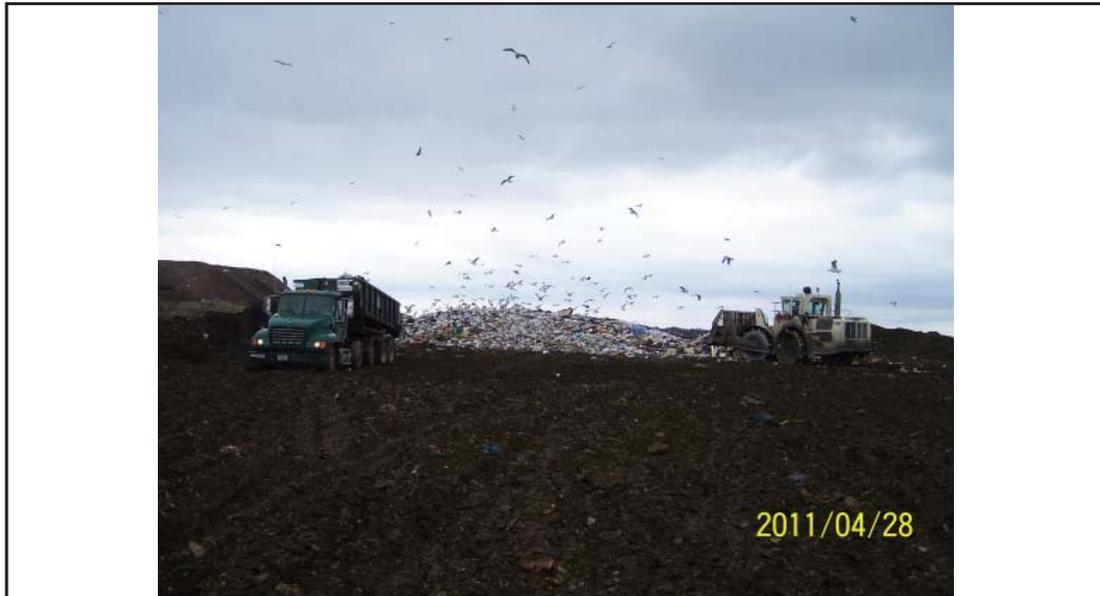
Working face, very small

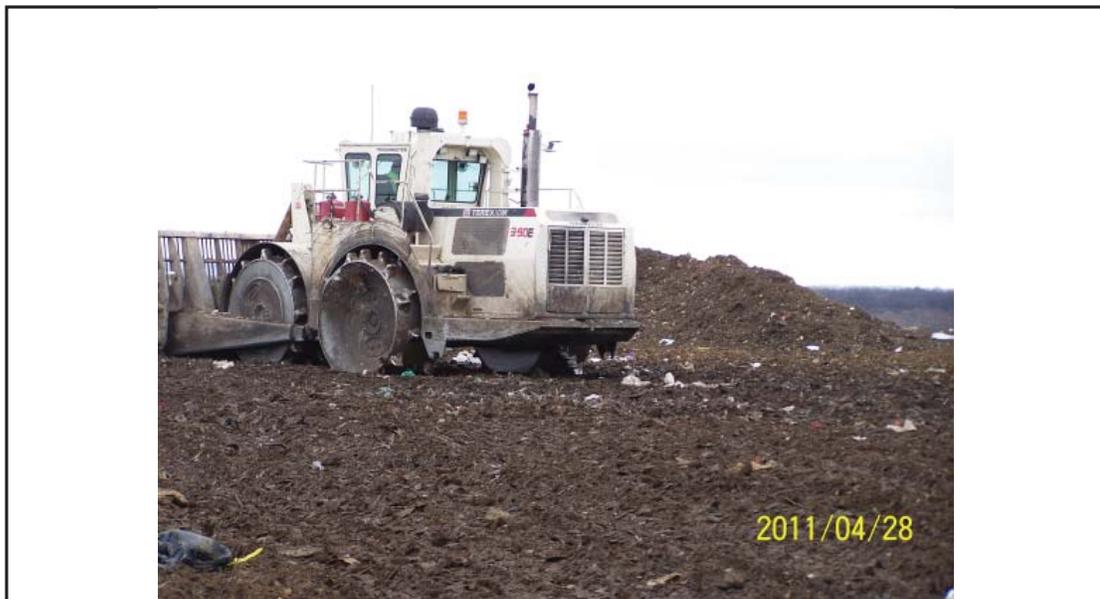
Compactor and autofluff stockpile

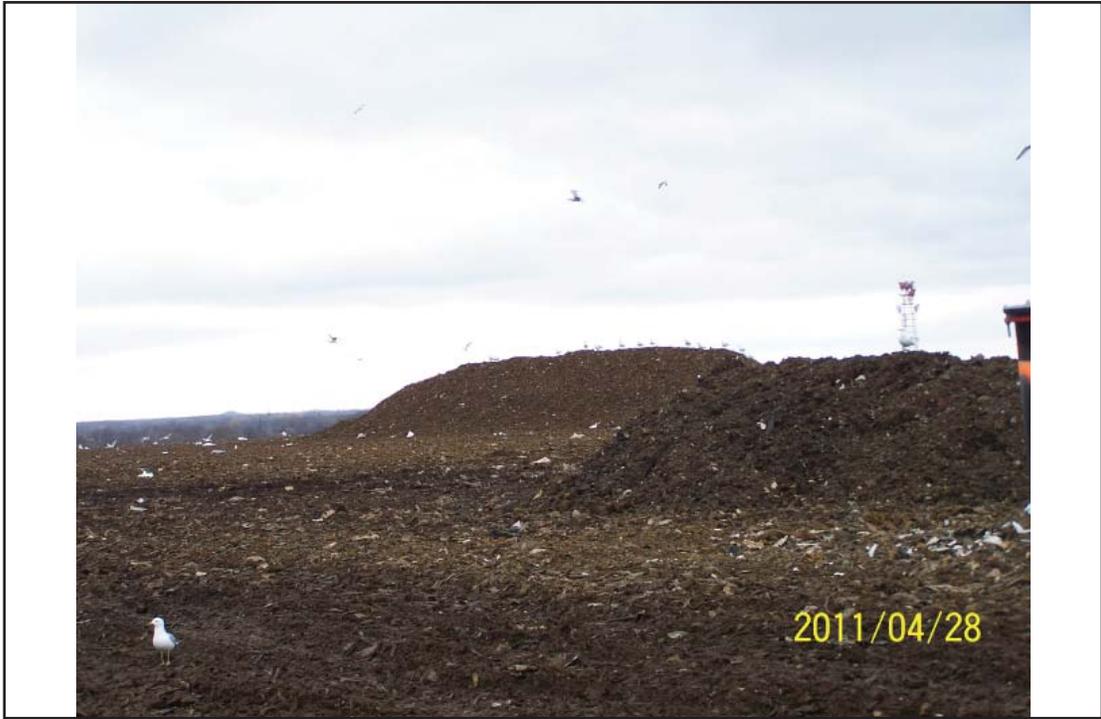
Autoluff stockpiled in abundance

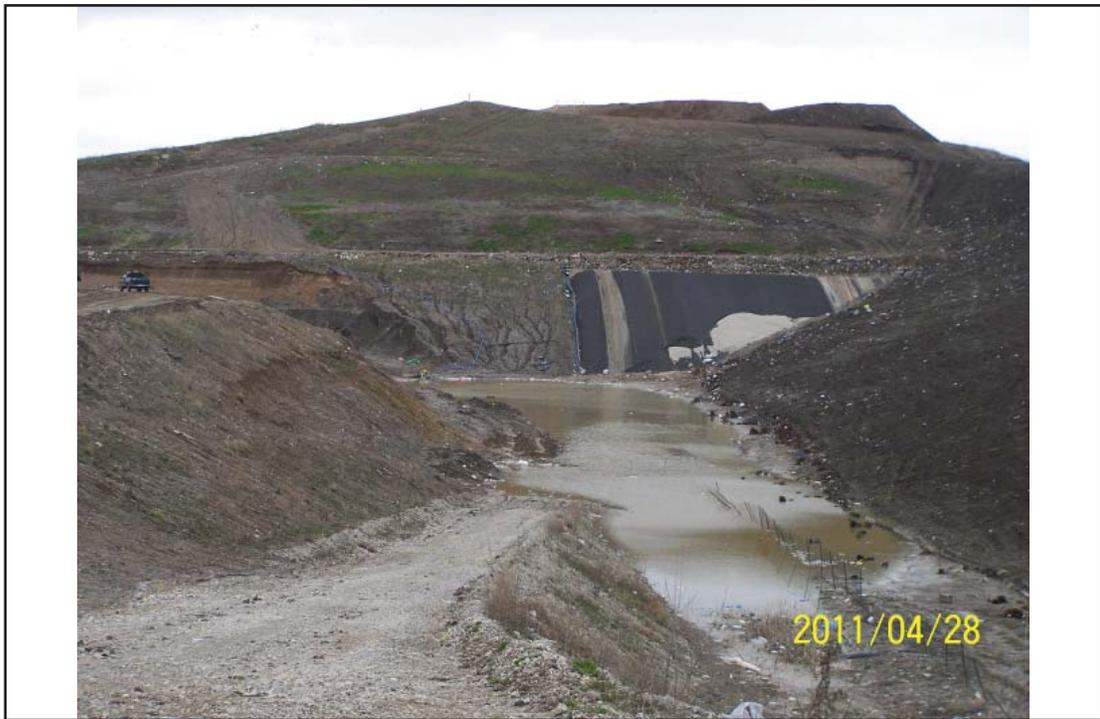
Temp Sed. Basin

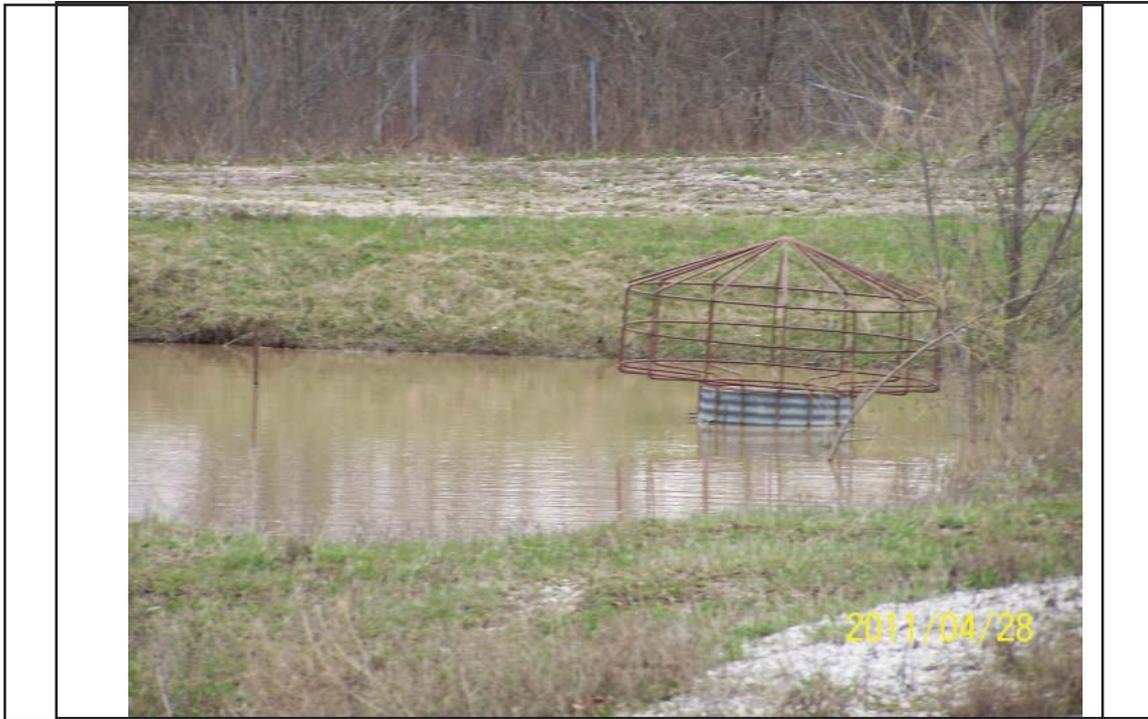
Basin's nearly full

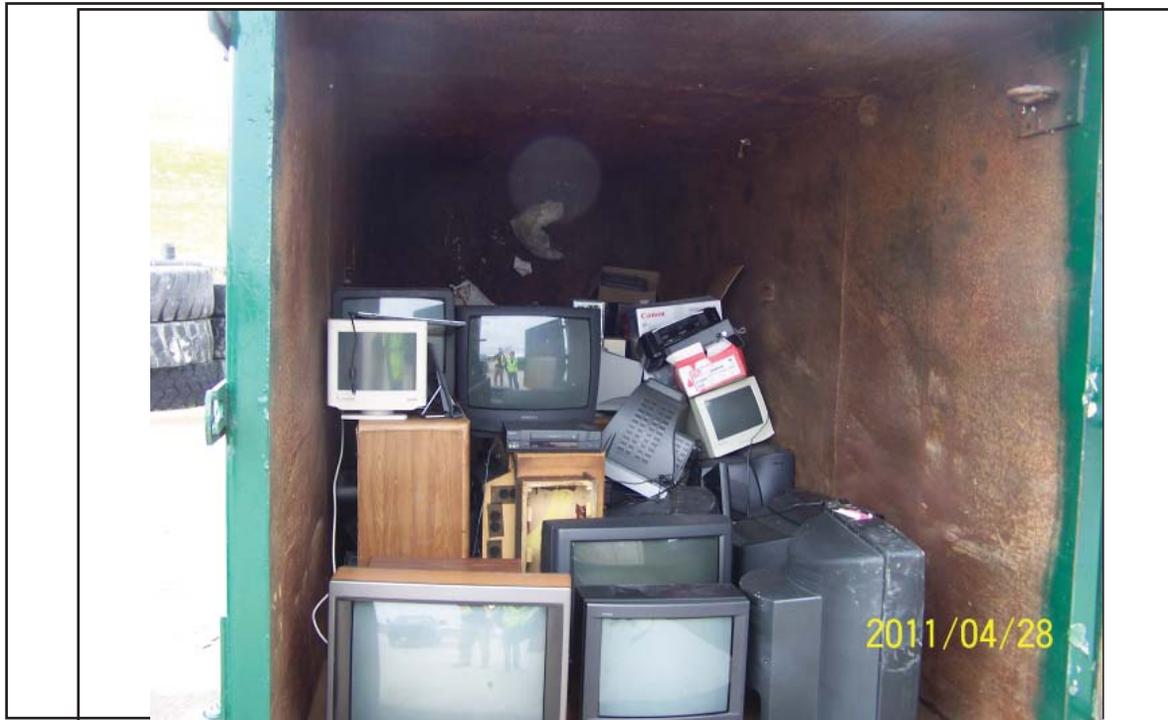
E-waste recyptical

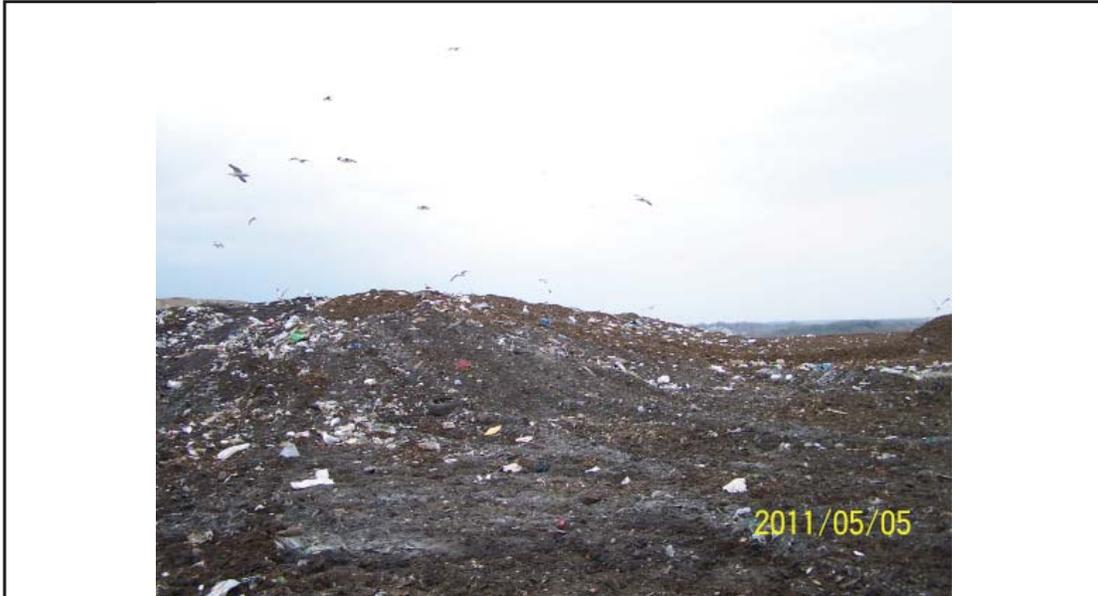
Covered working face

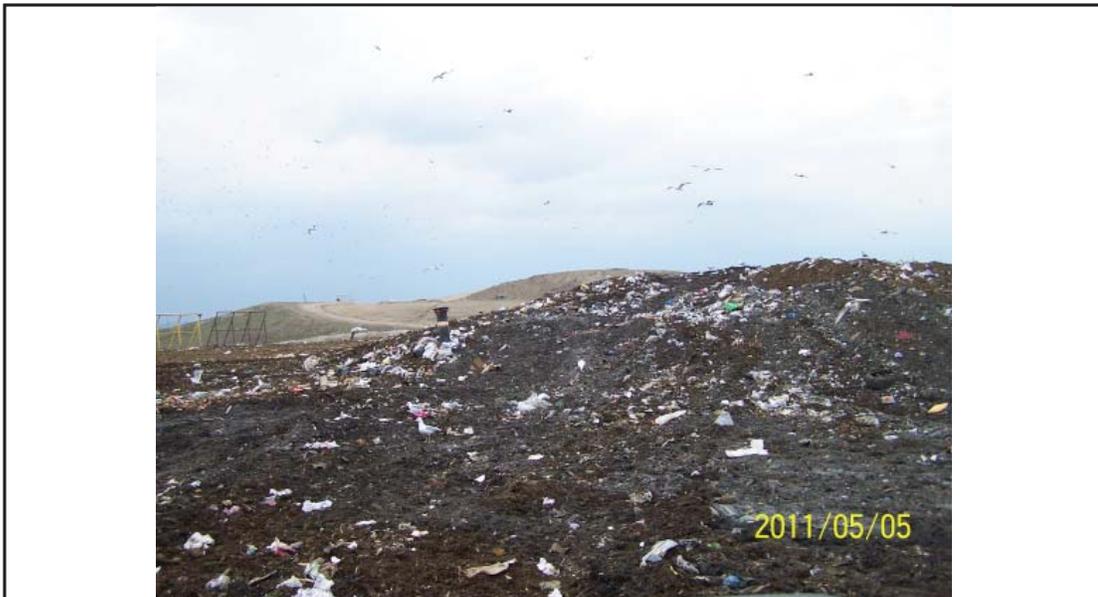
Covered working face

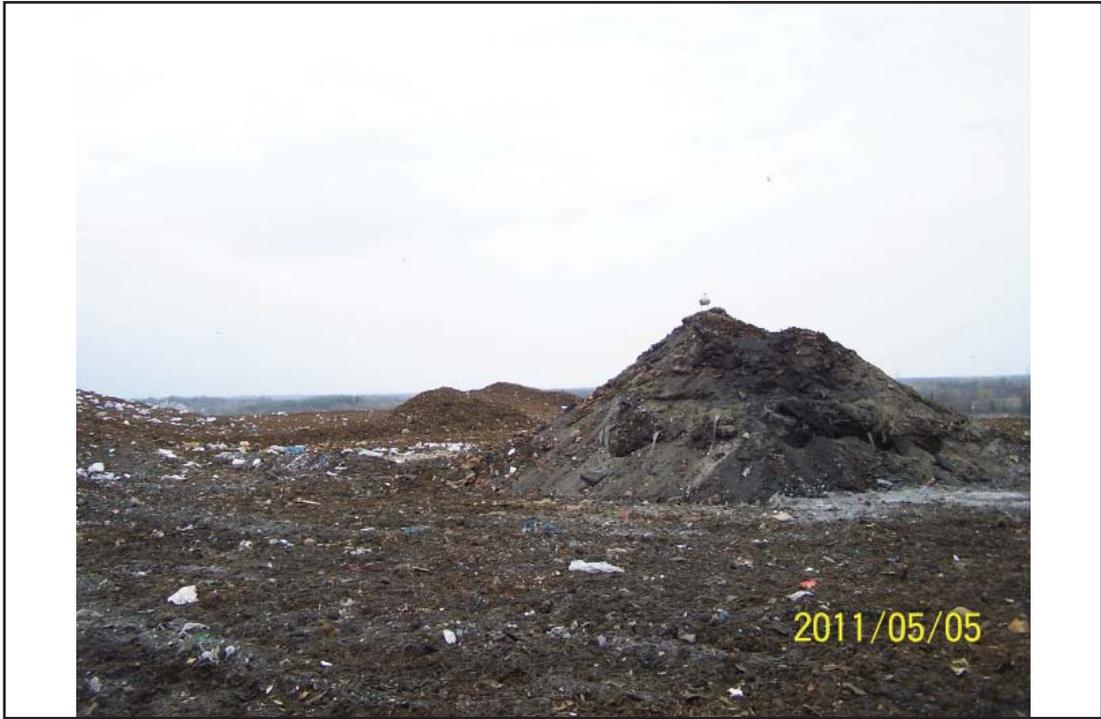
Autofluff and foundry sand stockpiles

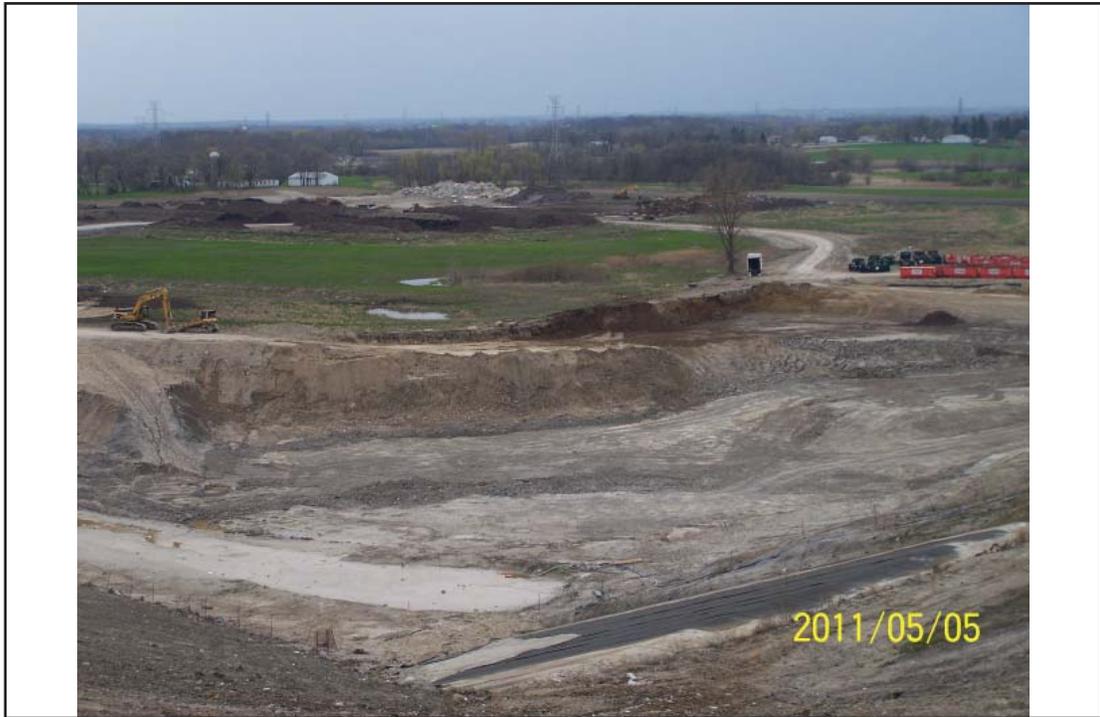
Excavation area of Phase 7
