Veolia Emerald Park Landfill
City of Muskego

2011 Veolia Emerald Park Landfill Year End Compliance Officer Report and Audit Summary

TO: Veolia Emerald Park Standing Committee
FROM: Jo-Walter Spear, Jr., P.E.
COPIES: File
DATE: 04/02/2012
PROJECT NUMBER: 1012.10030

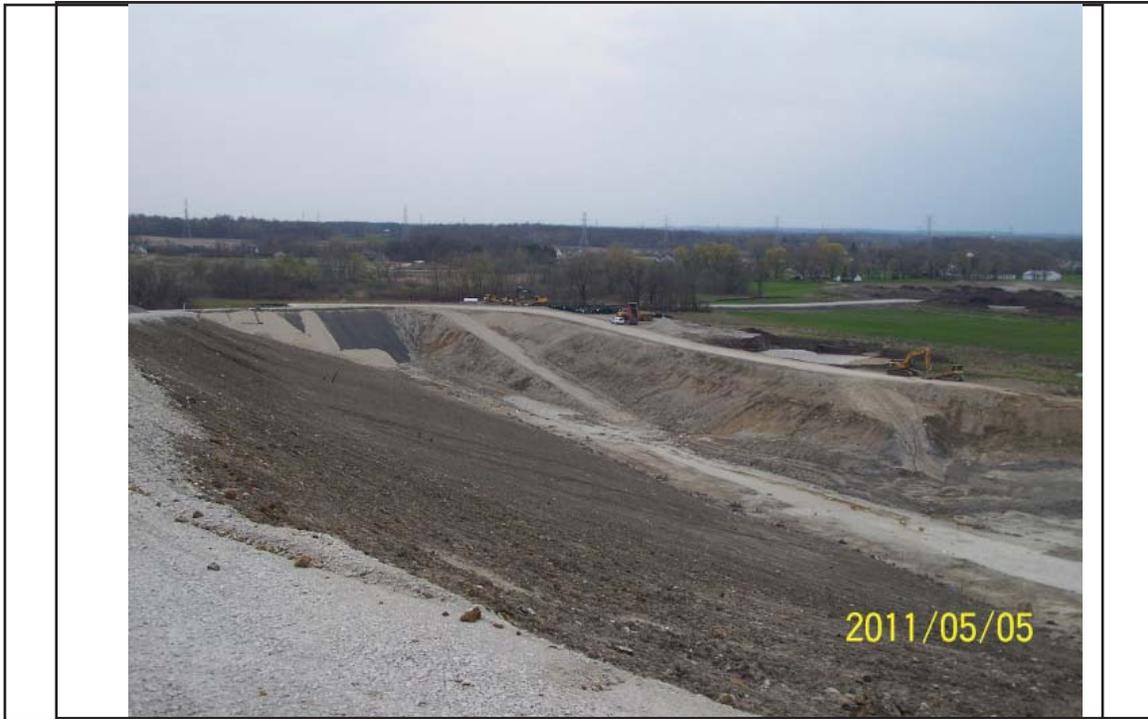
Side slopes of Phase 6, West side

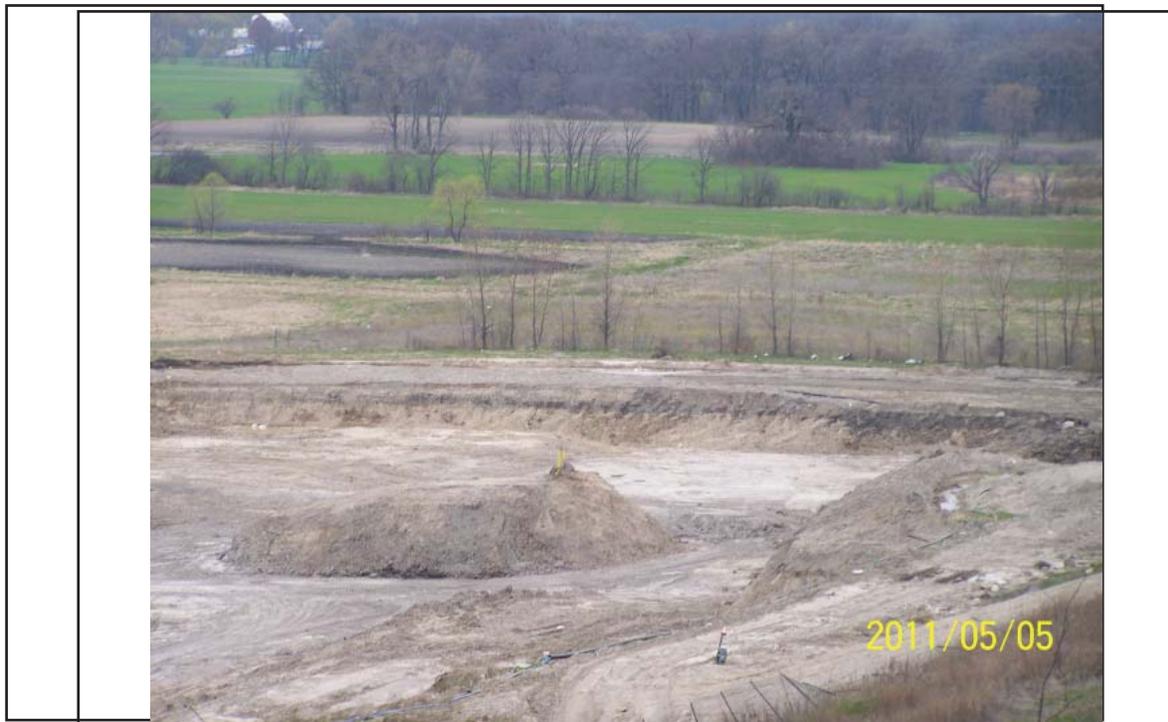
Excavation area of Phase 7

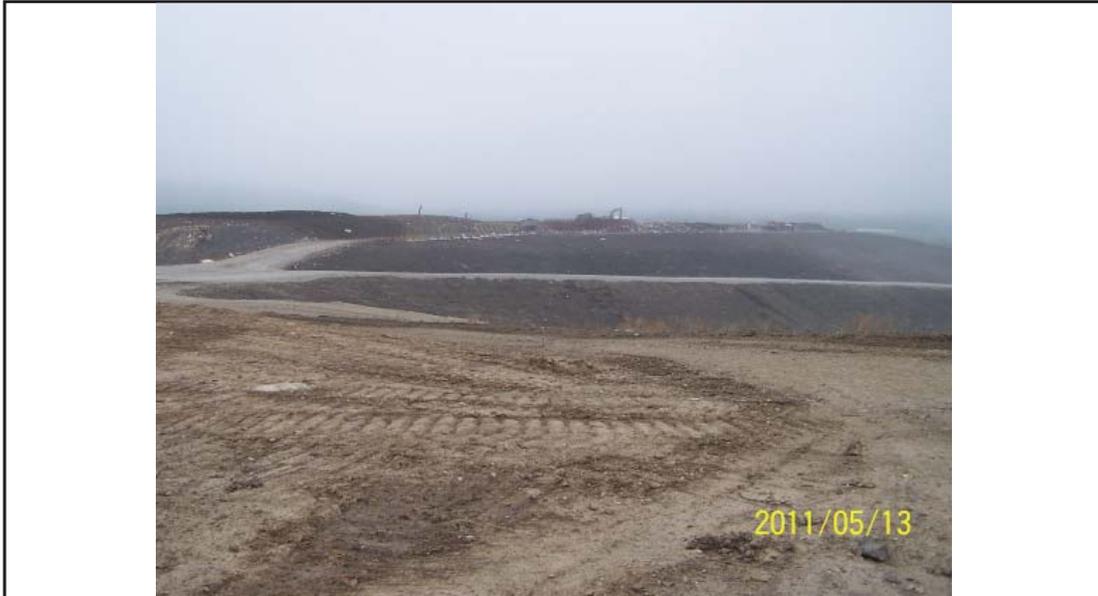
Covered working face

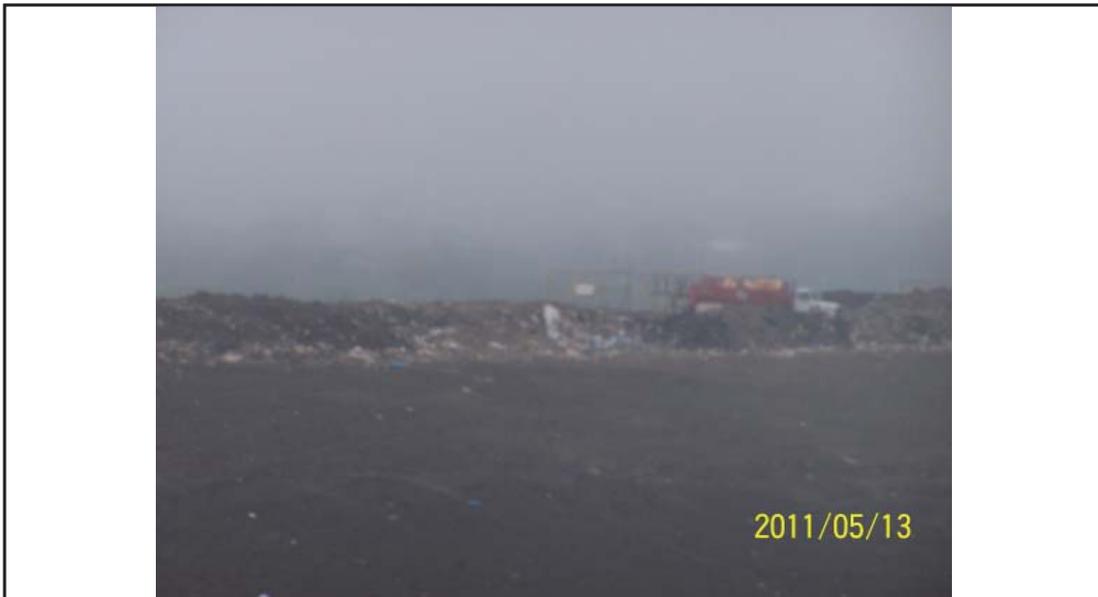
Covered working face

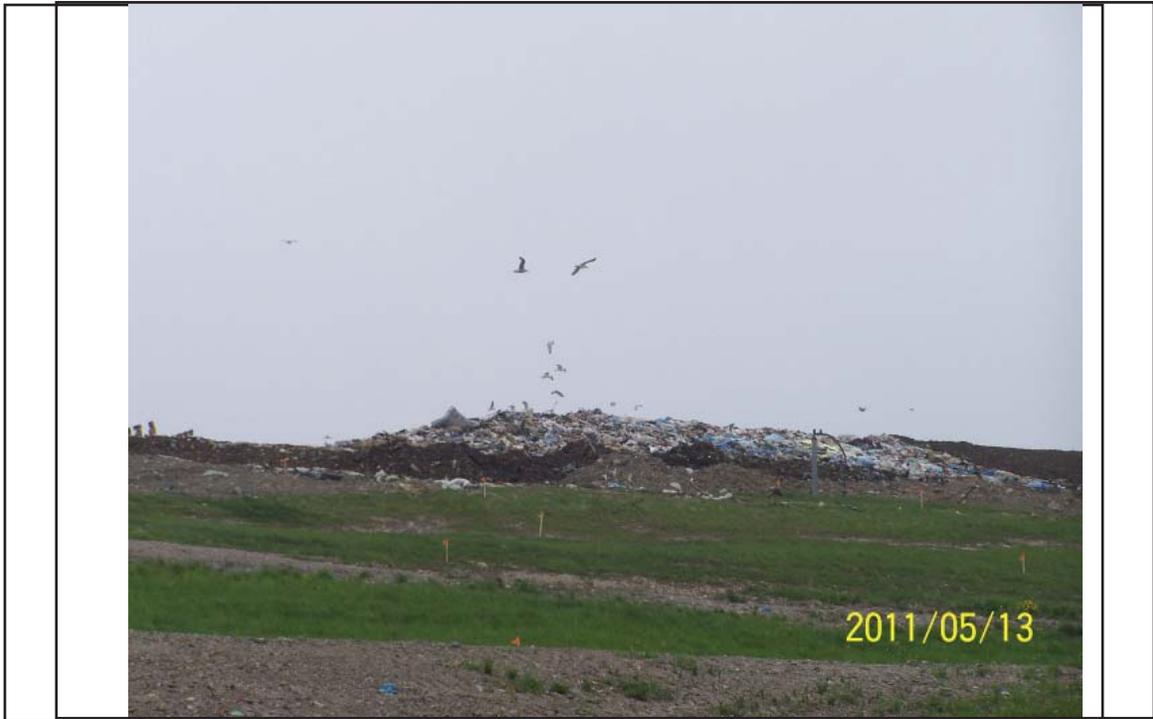
Side slopes of Phase 6, West side

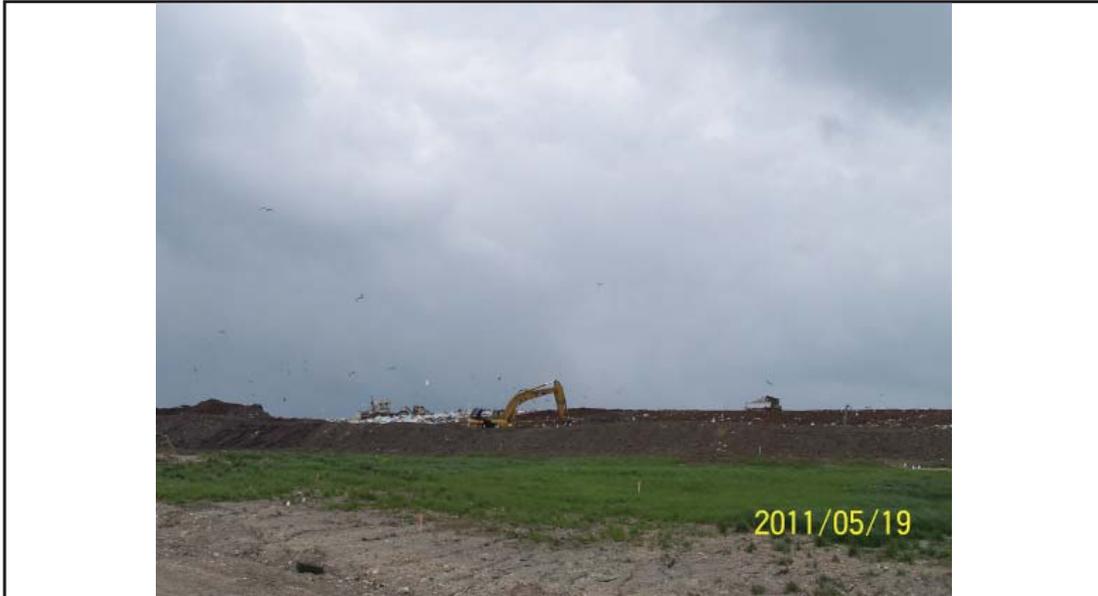
East slope of Phase 5 being prepared for receiving additional waste to bring grades to final

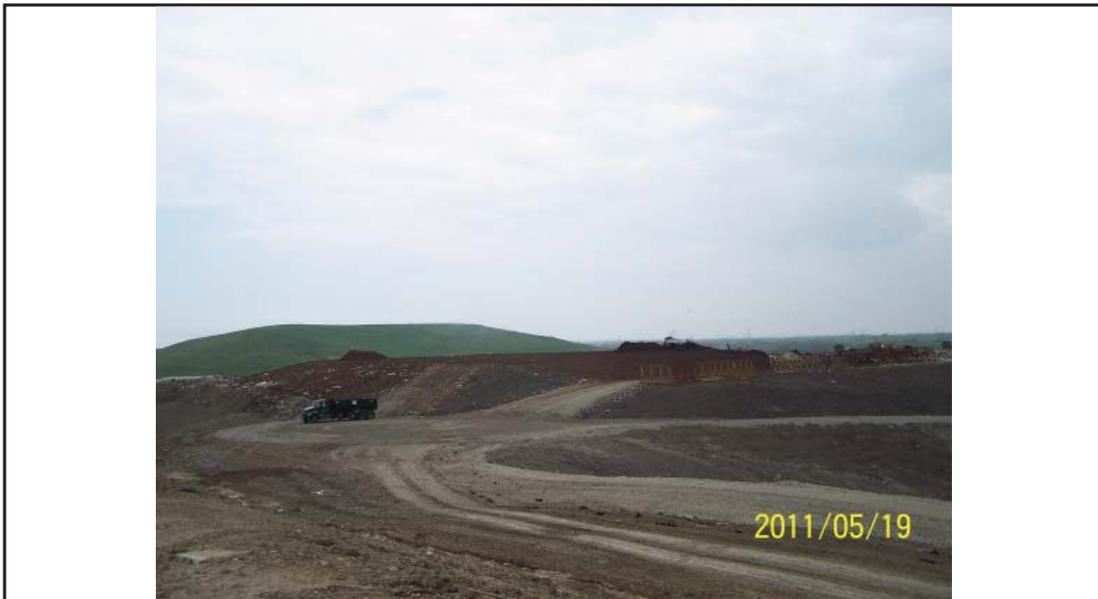
Truck turn and South end of active area

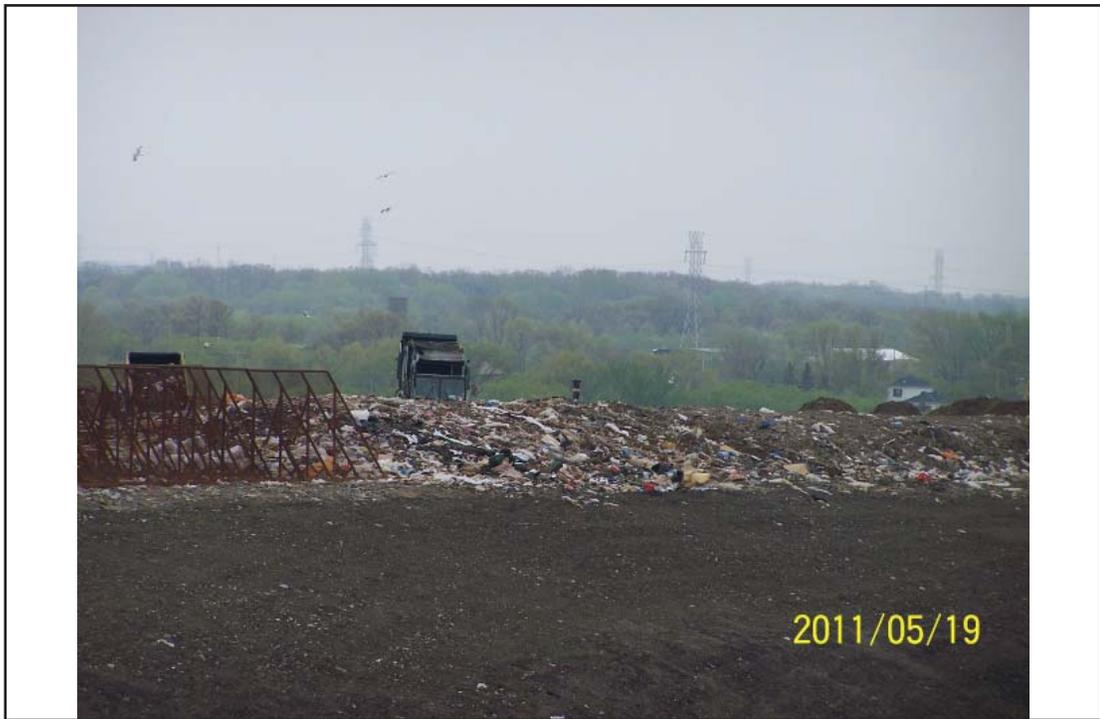
Cleanout area on West side of Active Area

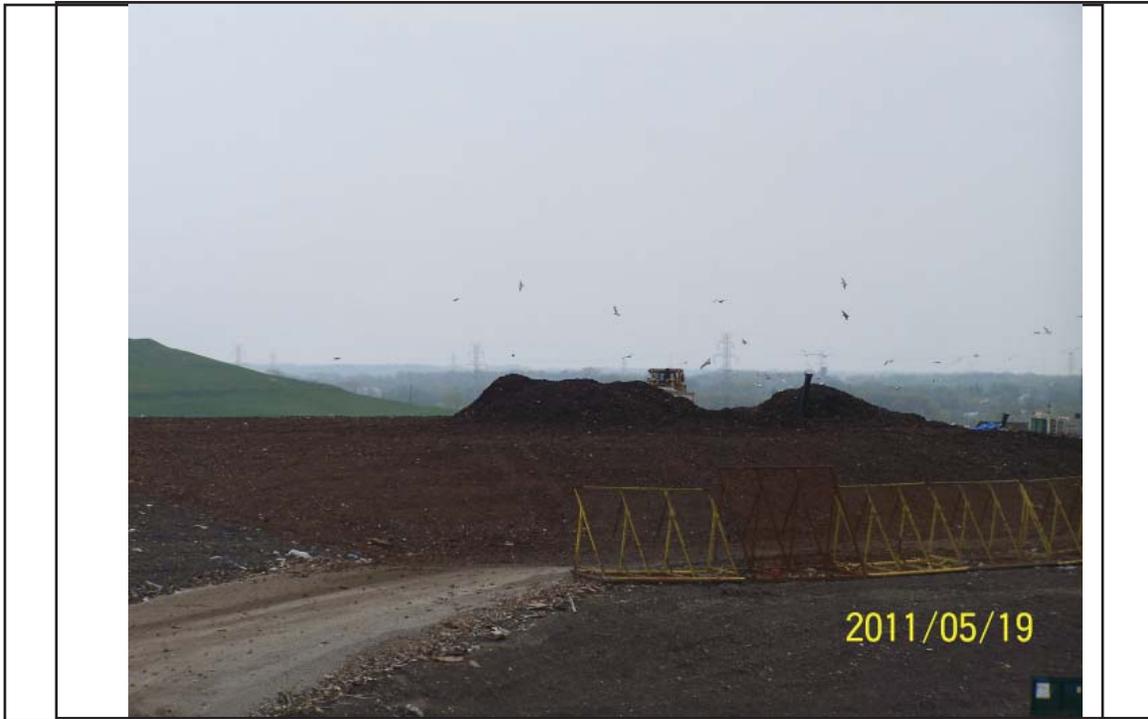
Previous working face, covered with autofluff

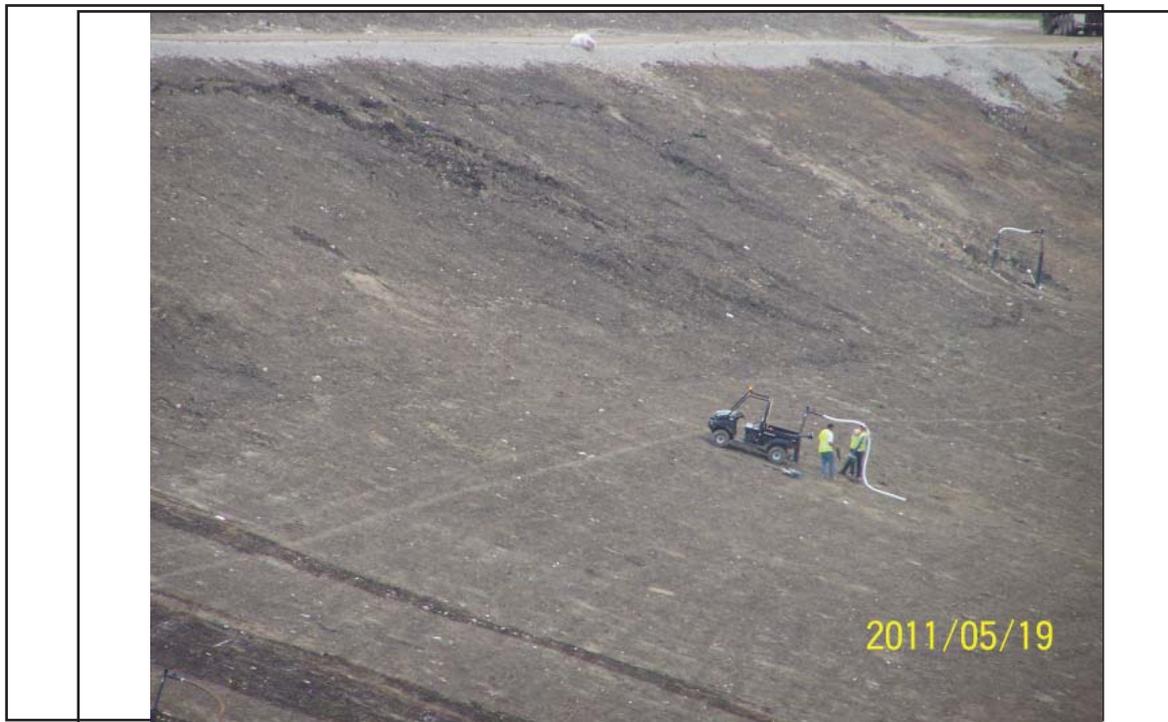
Crew connecting gas wells to the header

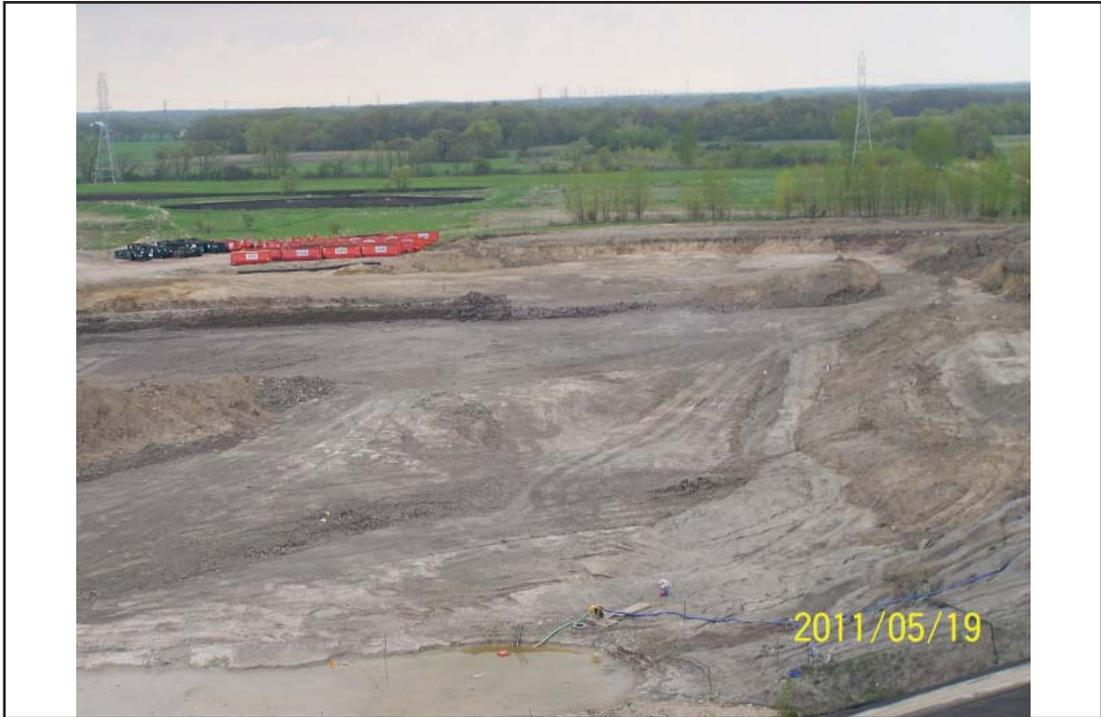
Excavation area for expansion

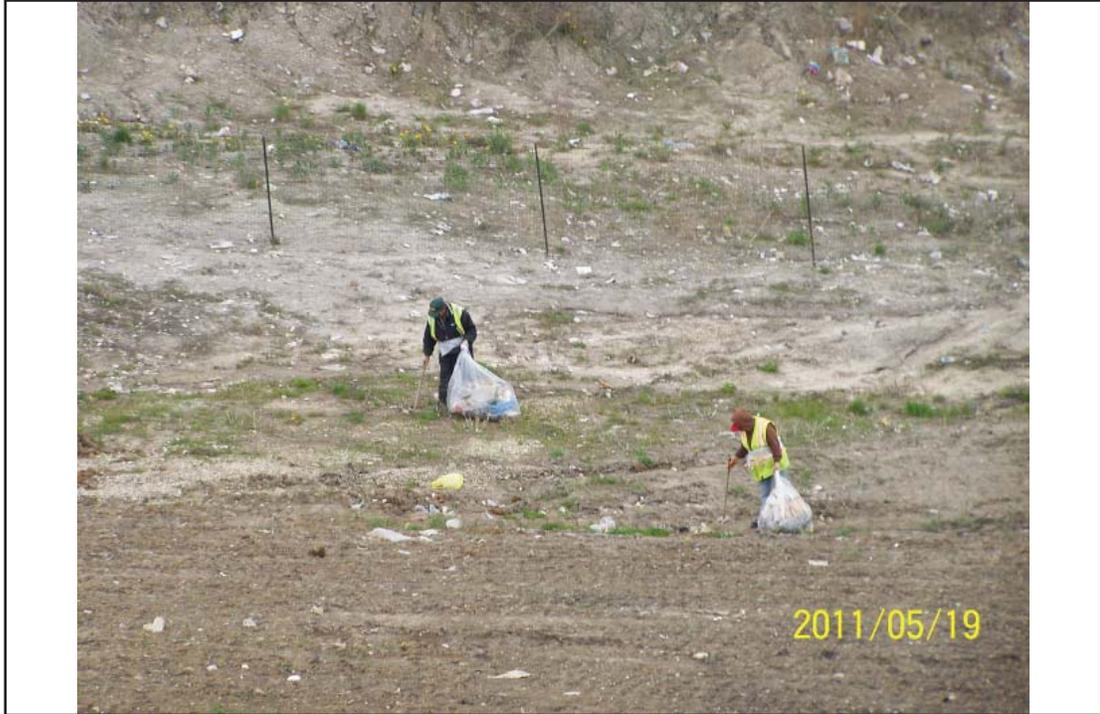
Pickers active in Phase 6W/7

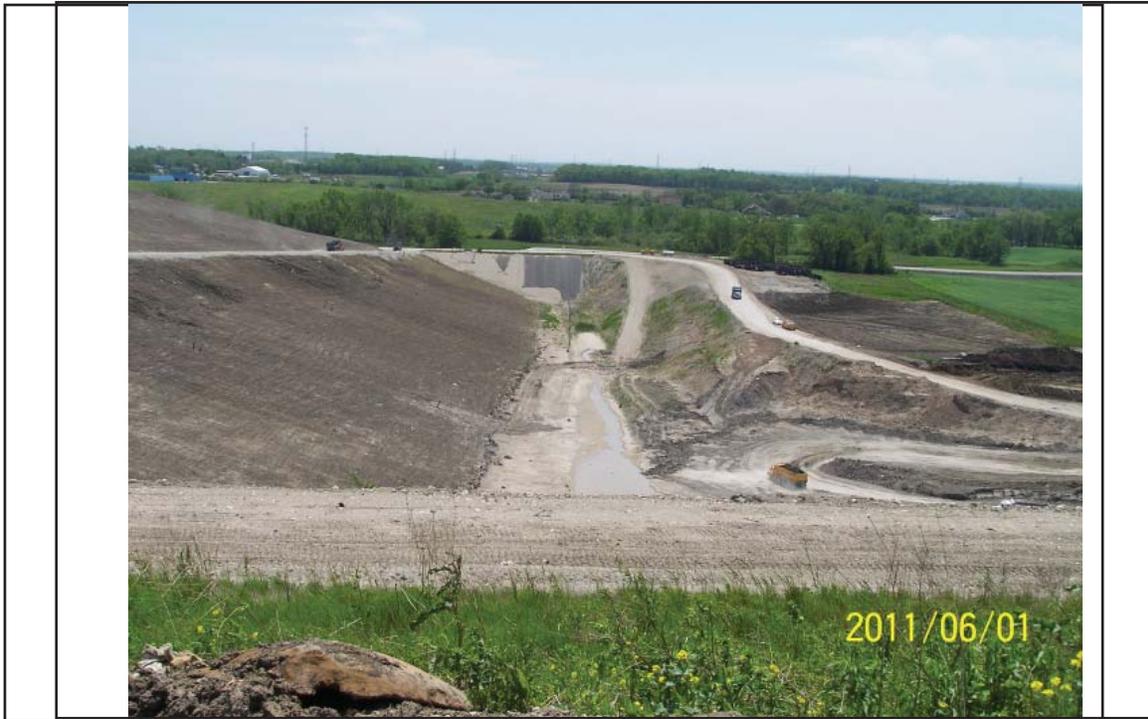
Temp Sed. Basin nearly dry

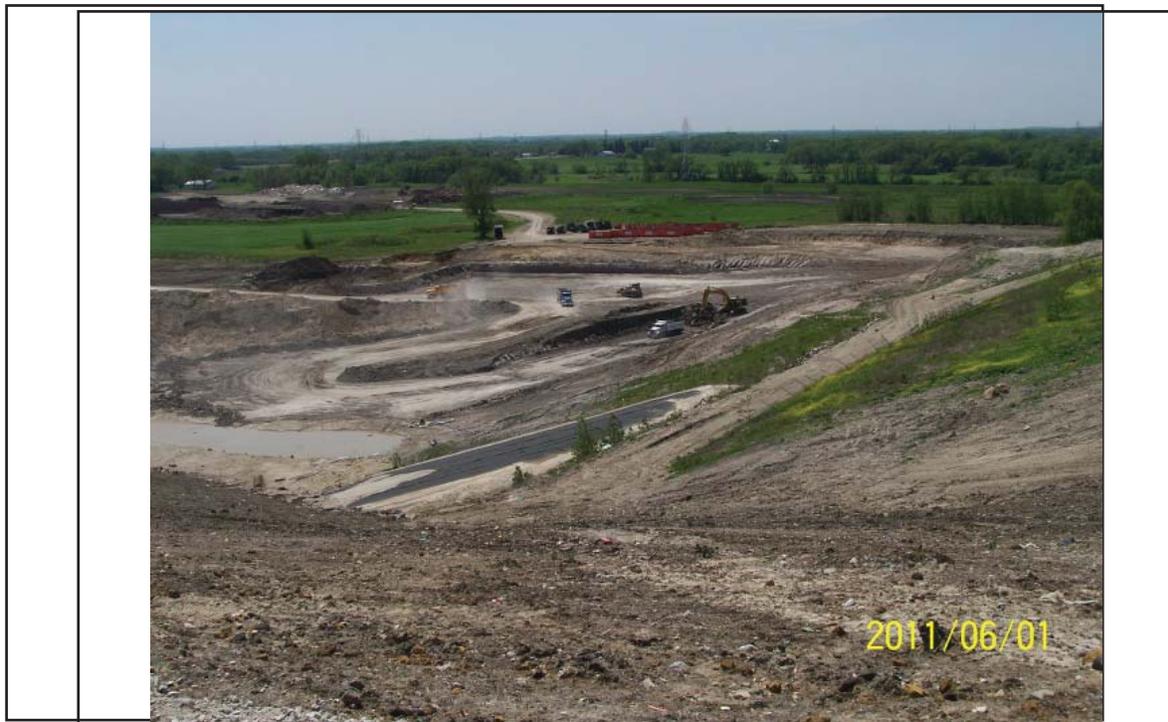
Excavation area for expansion

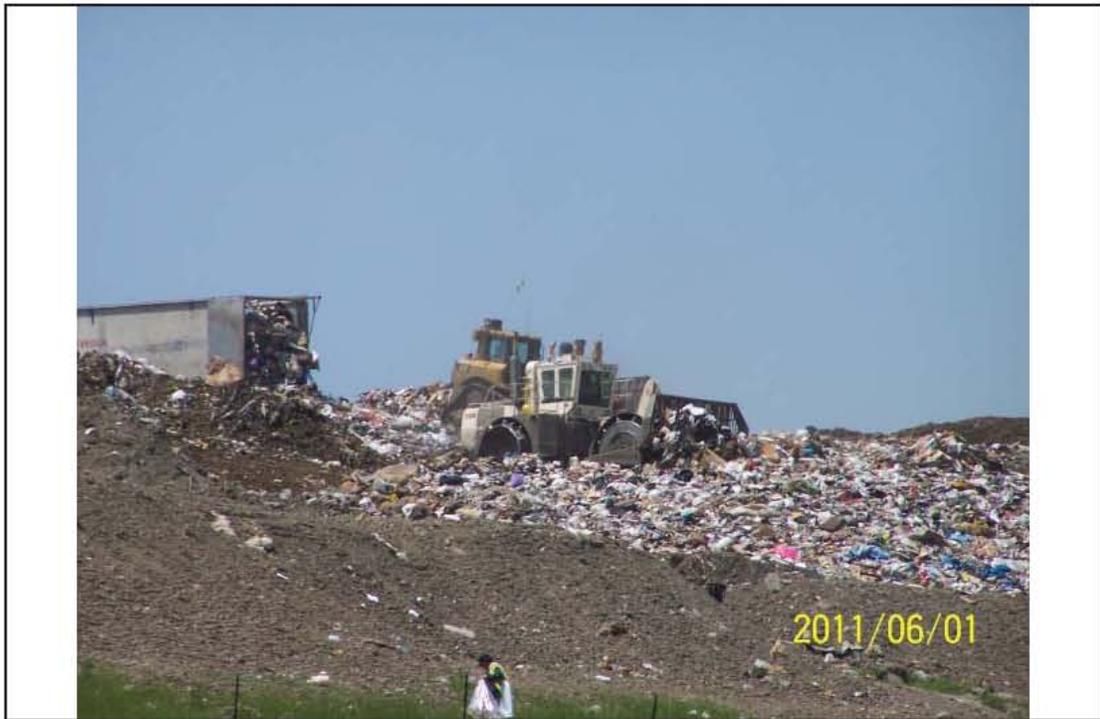
Compactor pushing waste into place and compacting placement. East slope of Phase 5

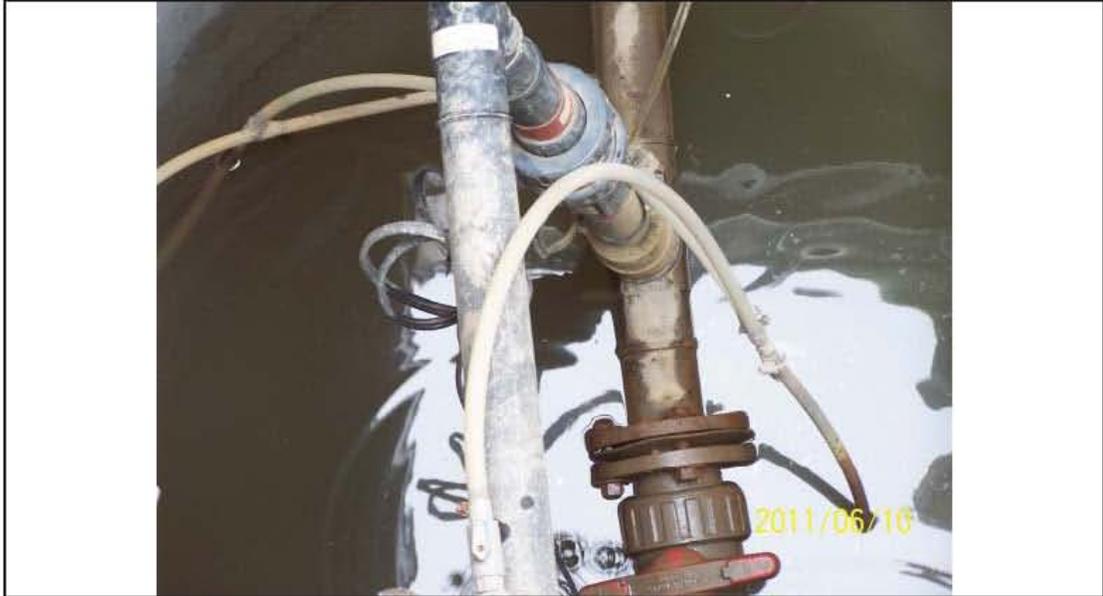
Sampling well for Leachate discharged to MMSD

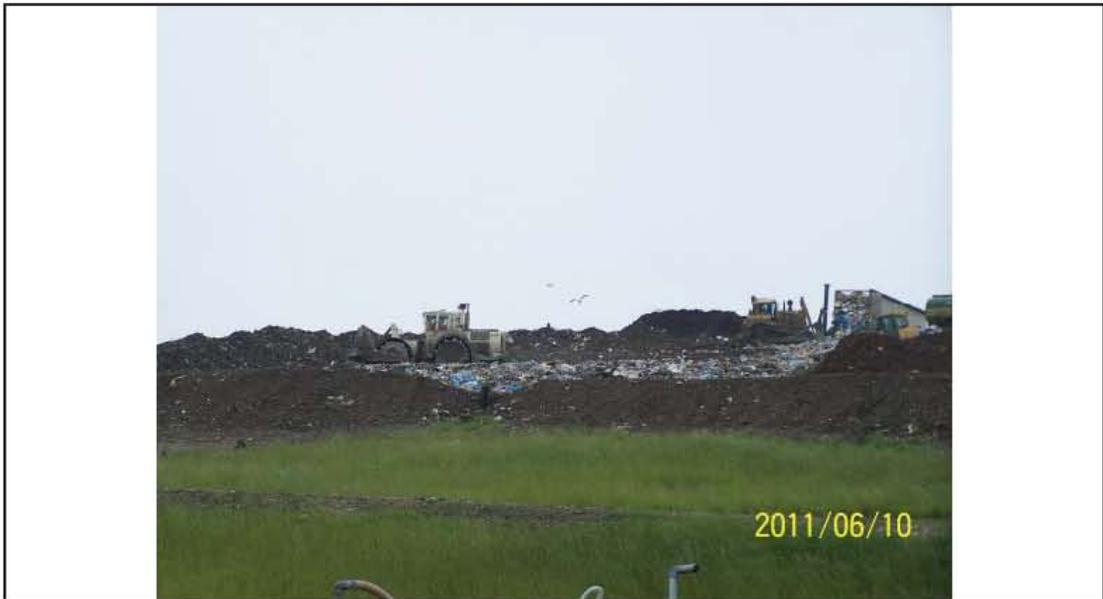
Working face on East slope of Phase 5

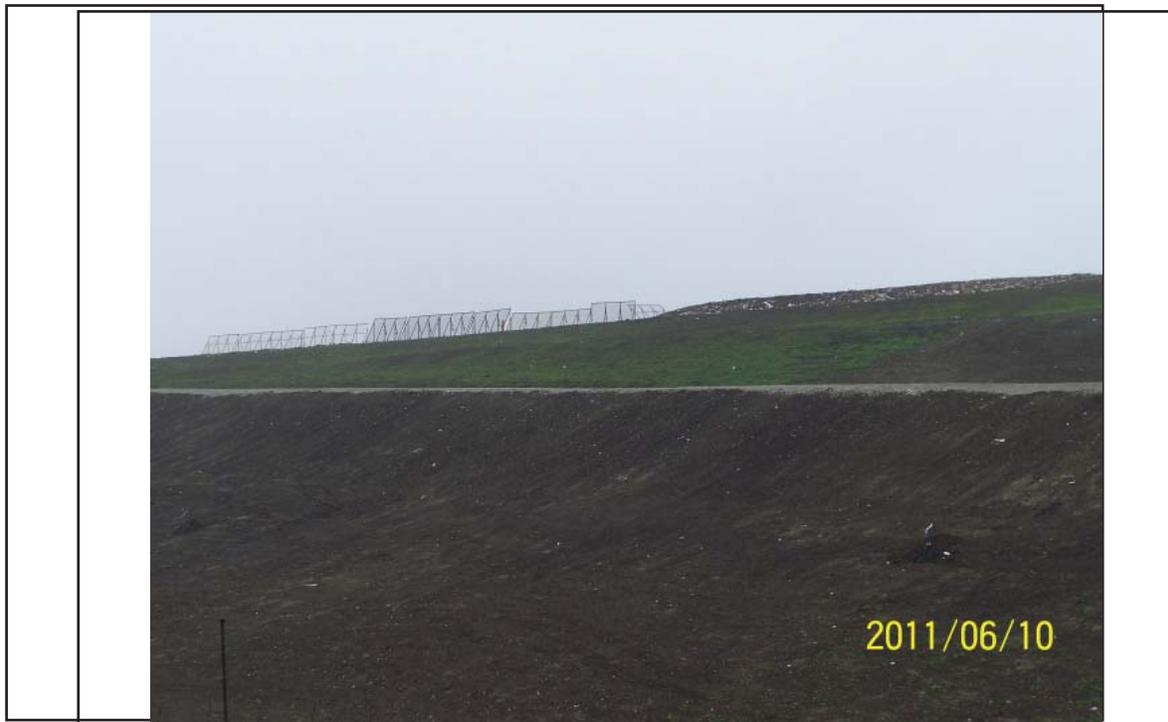
West slope Phase 6, greening nicely.

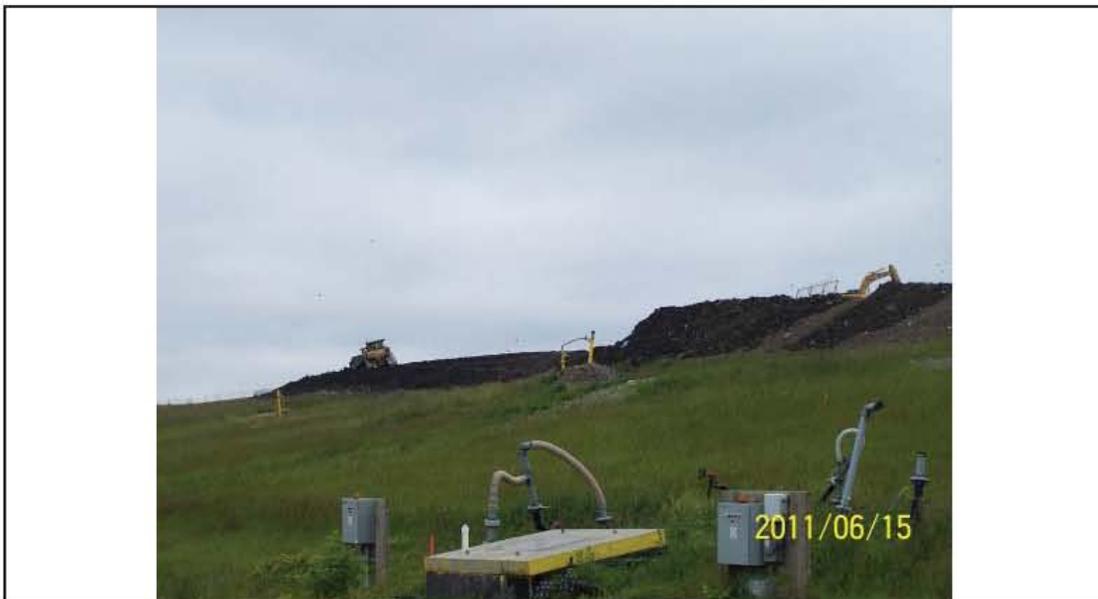
Dozer developing screening berm

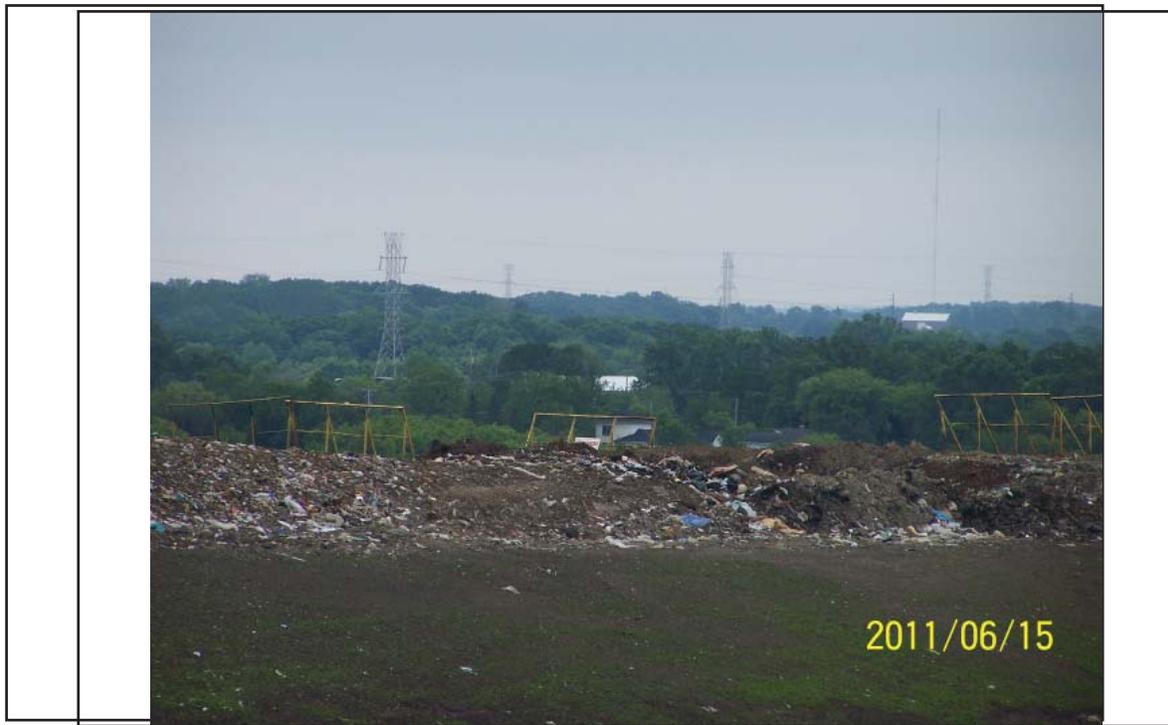
Previous cover and clean out area in Active area

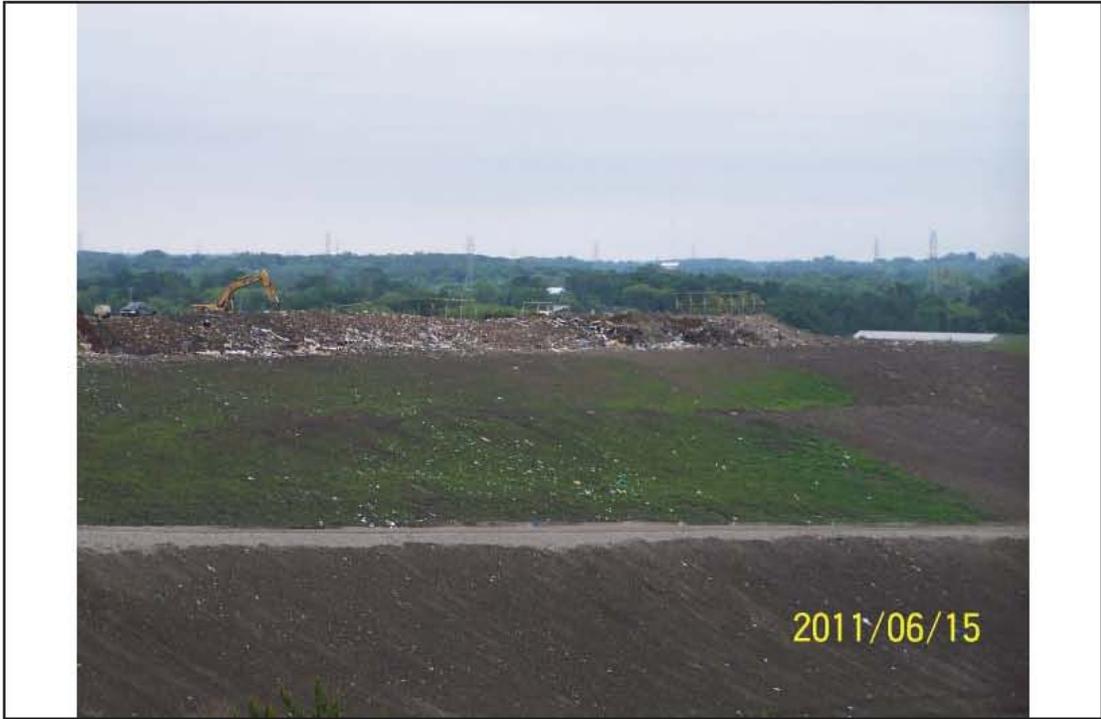
West slope of Phase 6W; tracking and litter in active area

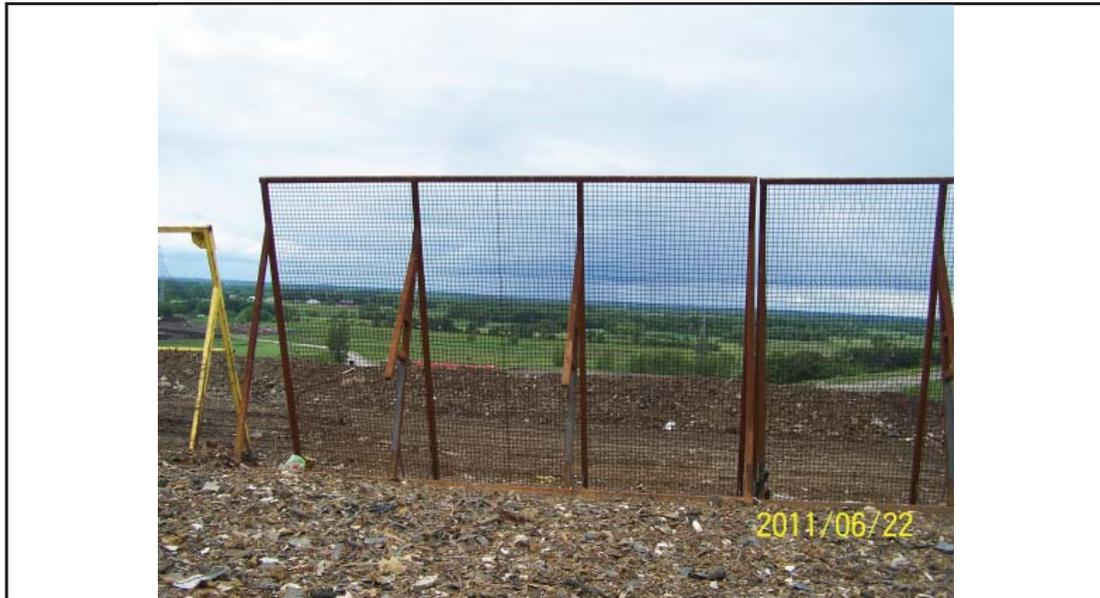
New mobile litter fence with attachments for dragging with dozer blades

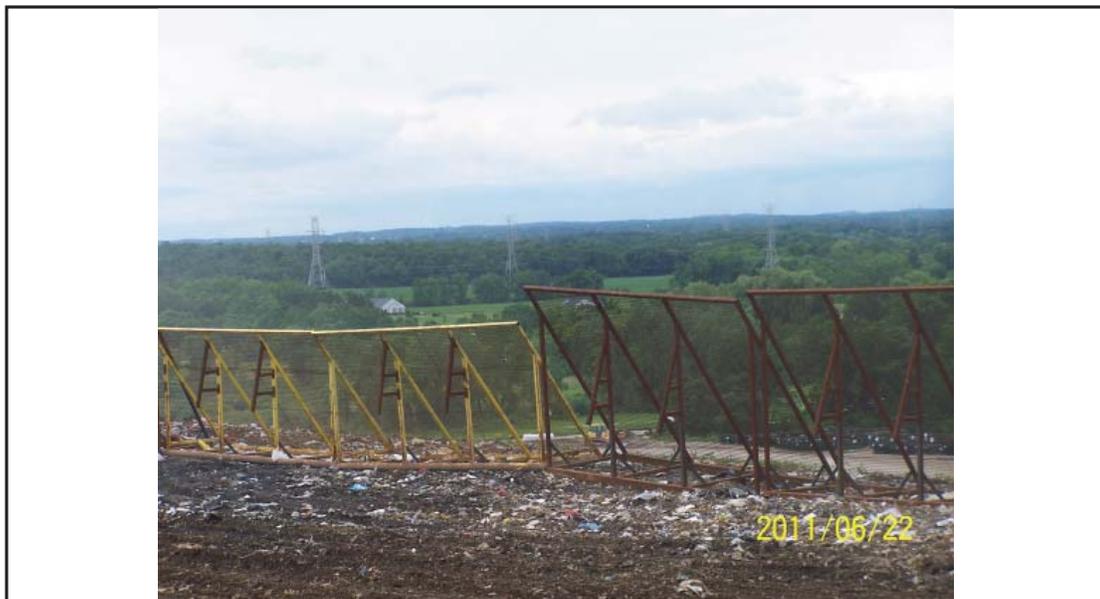
New mobile litter fences and repaired existing fences

* New litter fences & repaired fences in use.

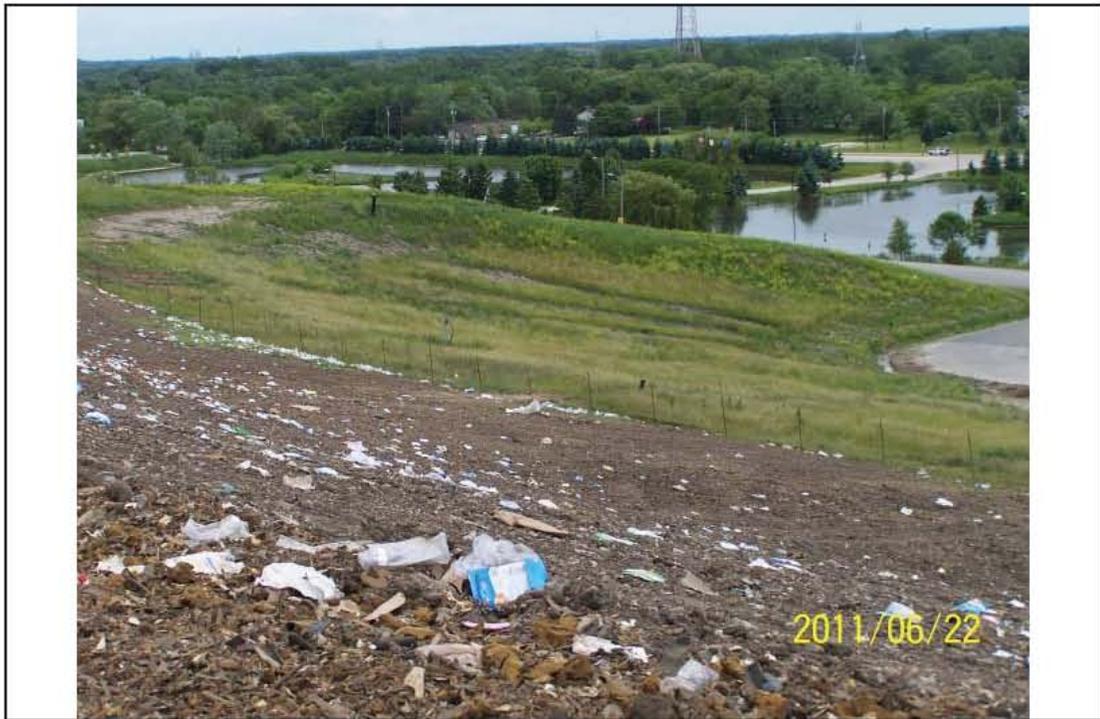
East slope of Phase 5, note new litter fence at grass edge

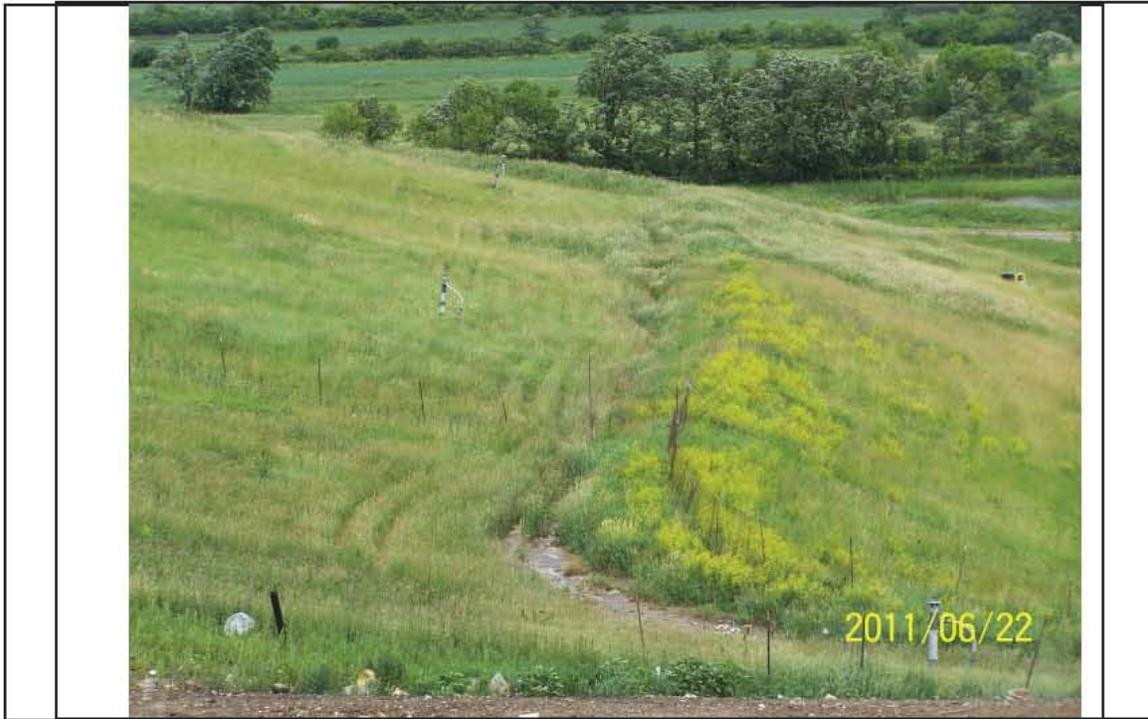
Diversion berm over closed section of Phase 3

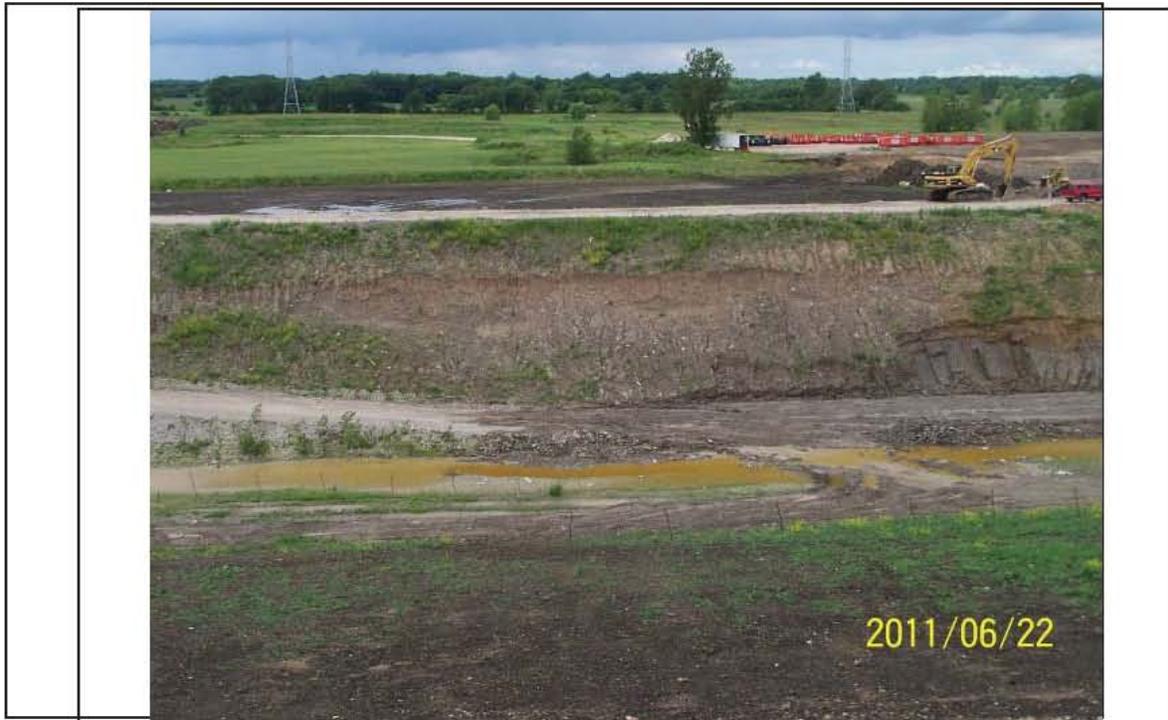
Temp Sed basin at base of Phase 6W, West slope

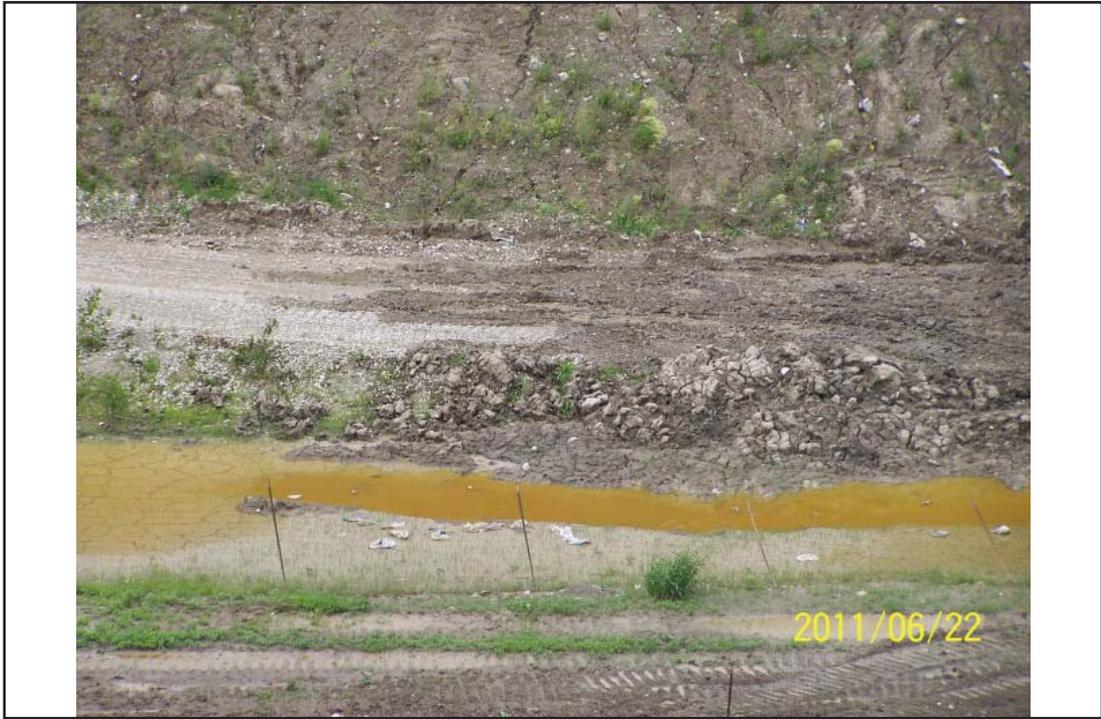
Temp Sed Basin, discoloring due to compost on slopes

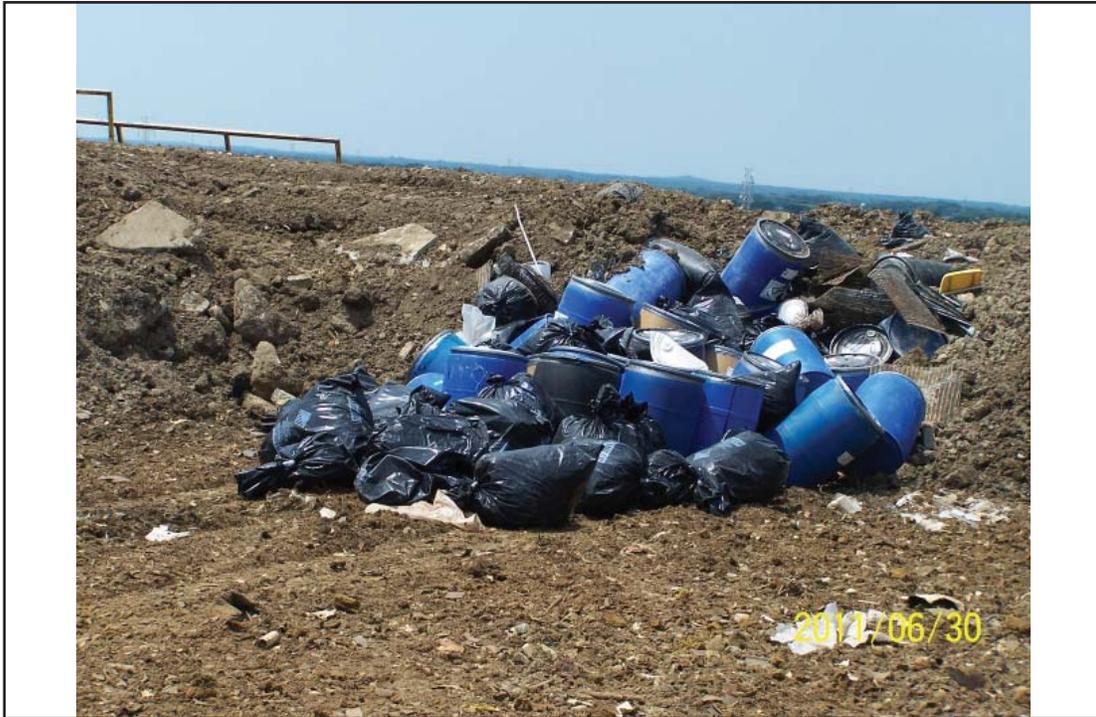
Flagging in daily cover

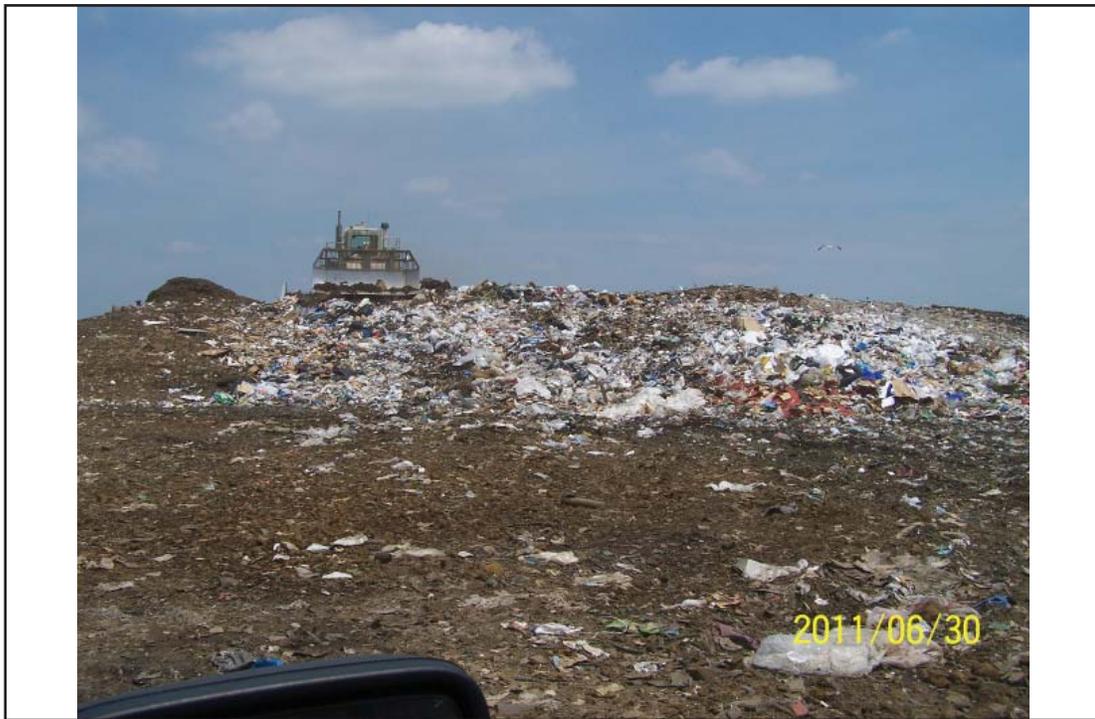
Base of working face, some flagging in previous cover
