Veolia Emerald Park Landfill
City of Muskego

2011 Veolia Emerald Park Landfill Year End Compliance Officer Report and Audit Summary

TO: Veolia Emerald Park Standing Committee
FROM: Jo-Walter Spear, Jr., P.E.
COPIES: File
DATE: 04/02/2012
PROJECT NUMBER: 1012.10030

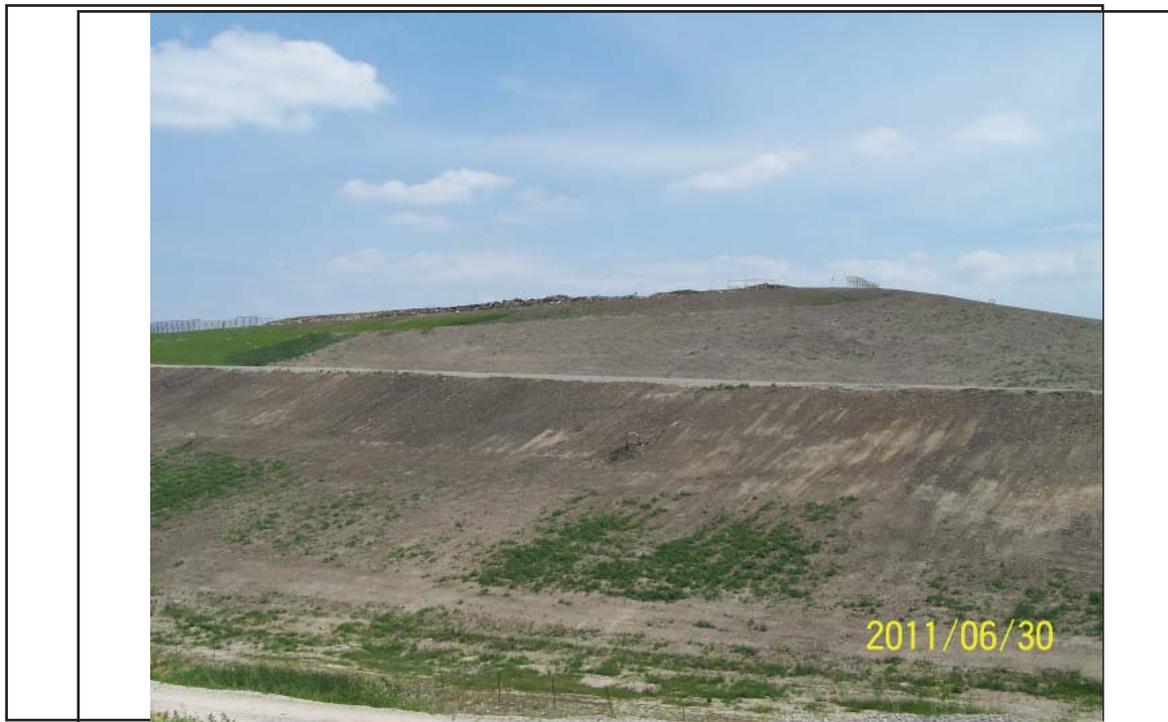
West slope of Phase 6, South of grassy areas

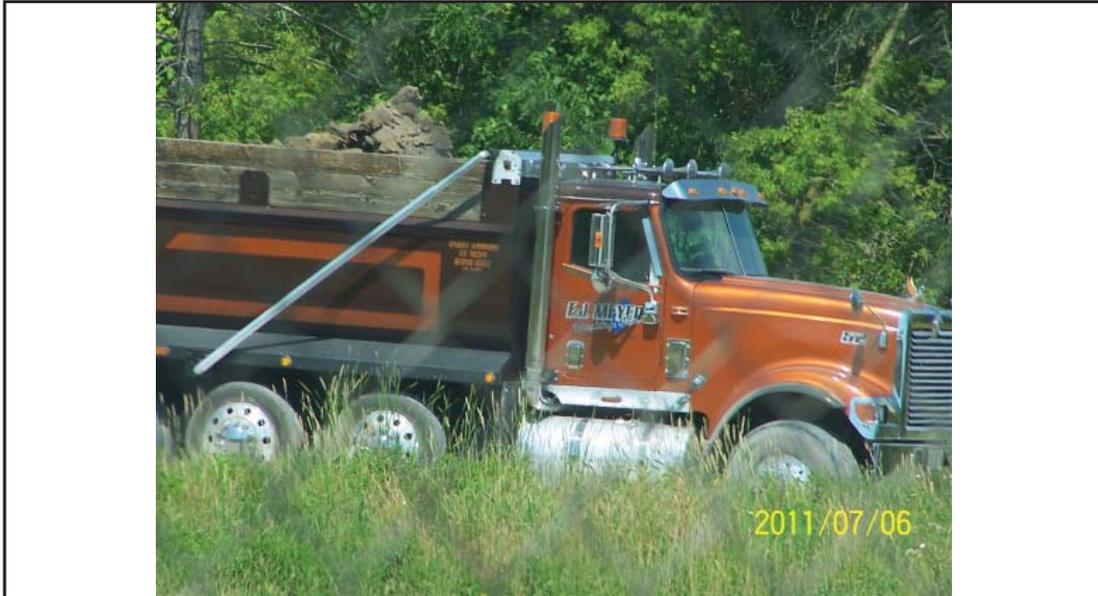
Truck with clay above running boards

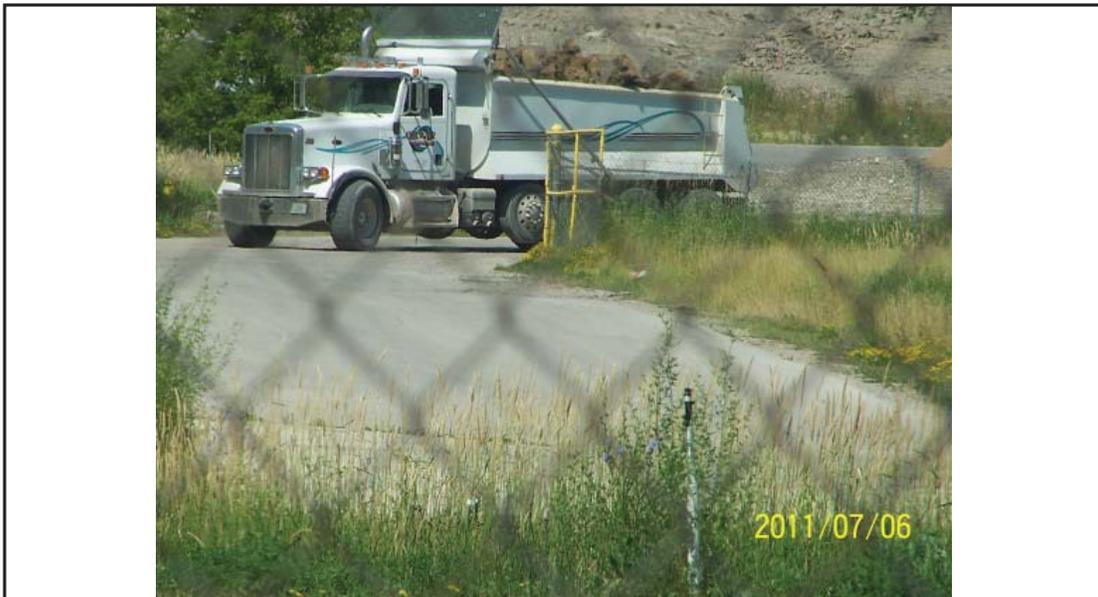
Truck with clay above running boards for entire length

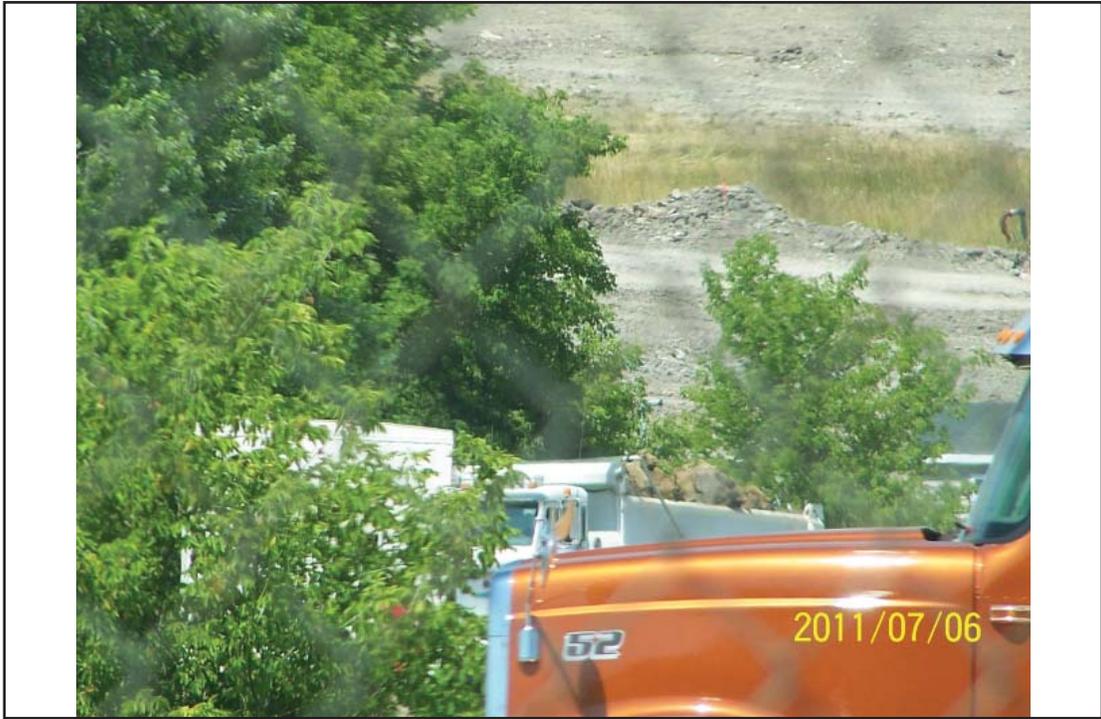
Same truck

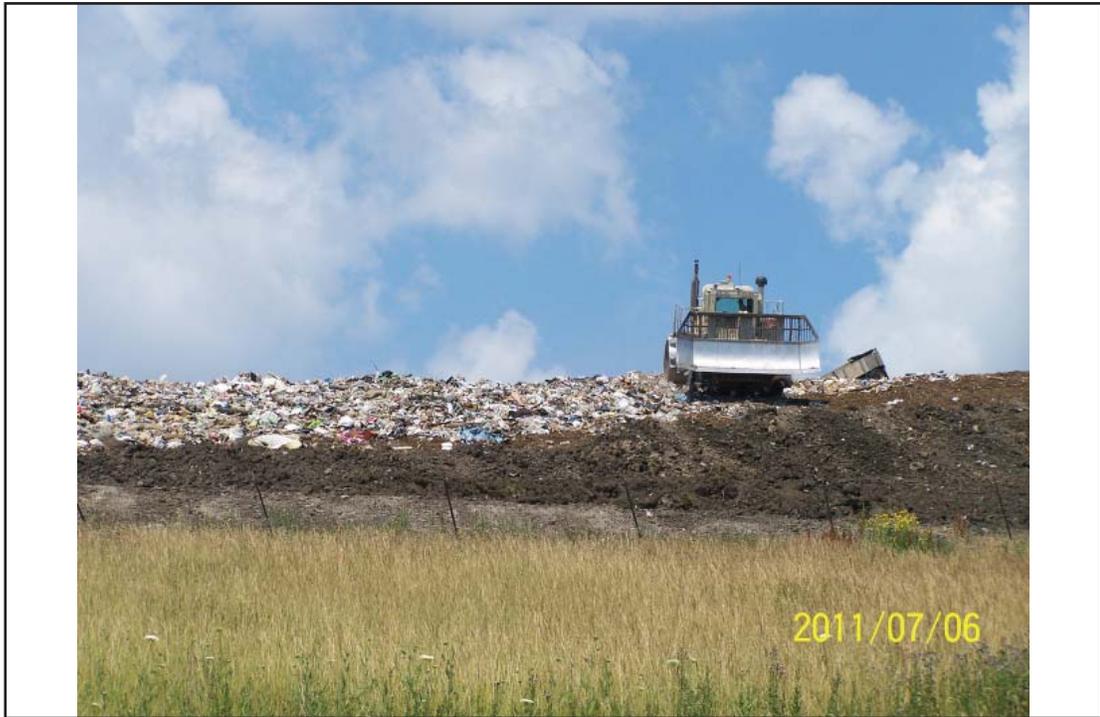
Working face viewed from East

- Working face in southeast corner of active area, exposed to highway and beyond 1000' setback
 - Cover in good condition except above access road
 - Autofluff used for daily cover

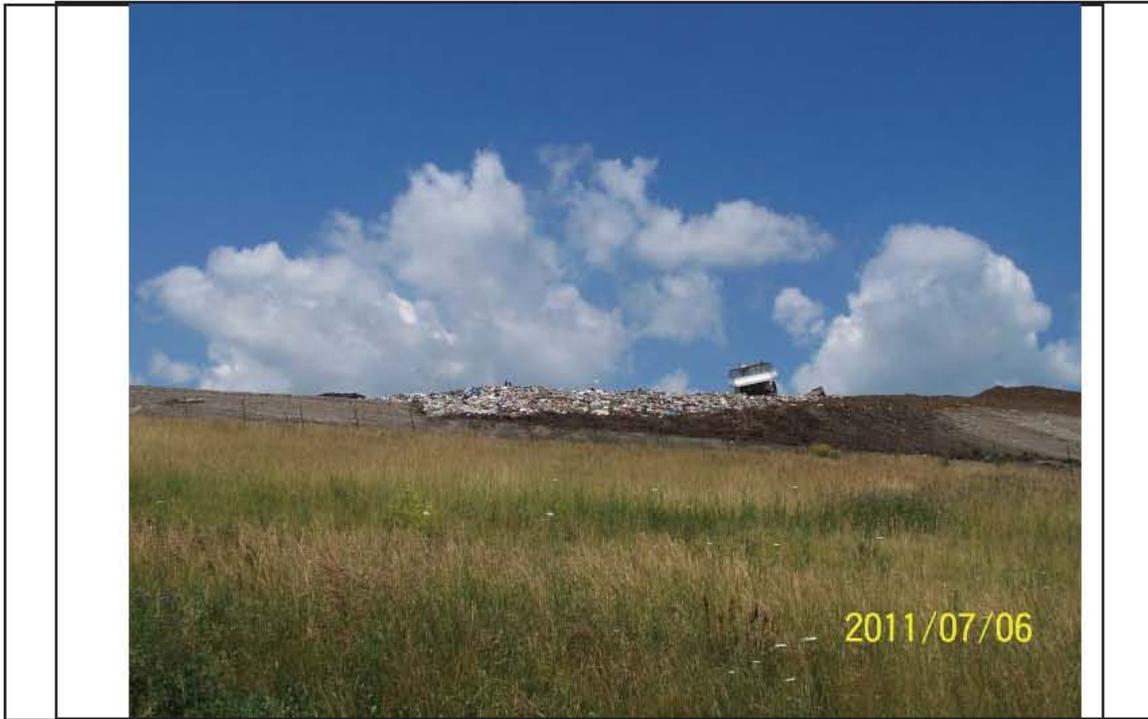
Working face viewed from the Southeast

Working face on Southeast corner
of Active Area. Exposed to highway, beyond
1000' Setback
Cover in good condition except above
access road

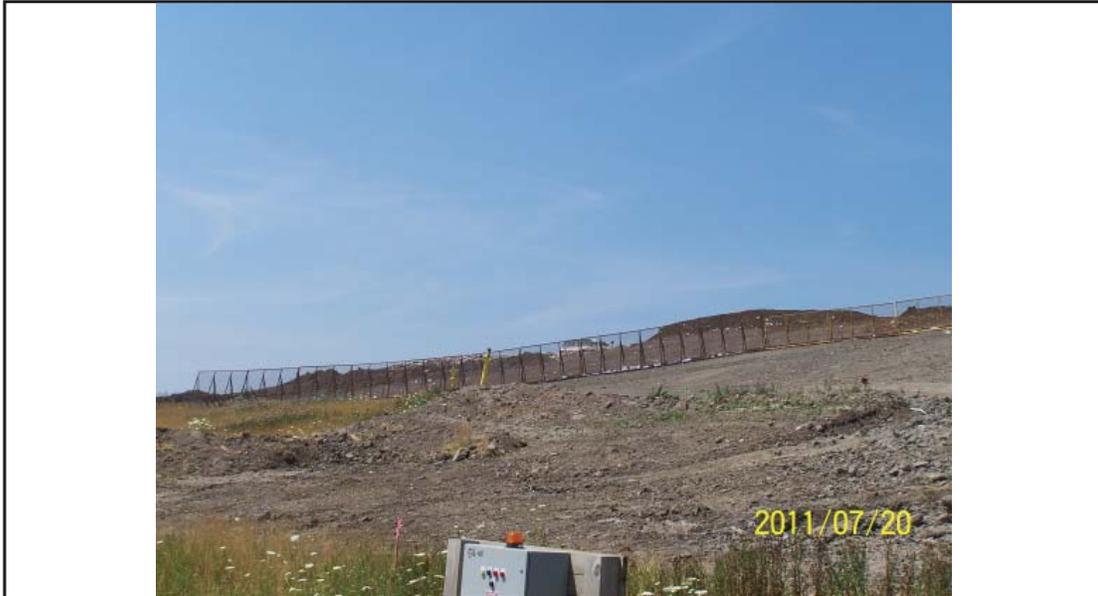
Mobil fencing wrapped about working face

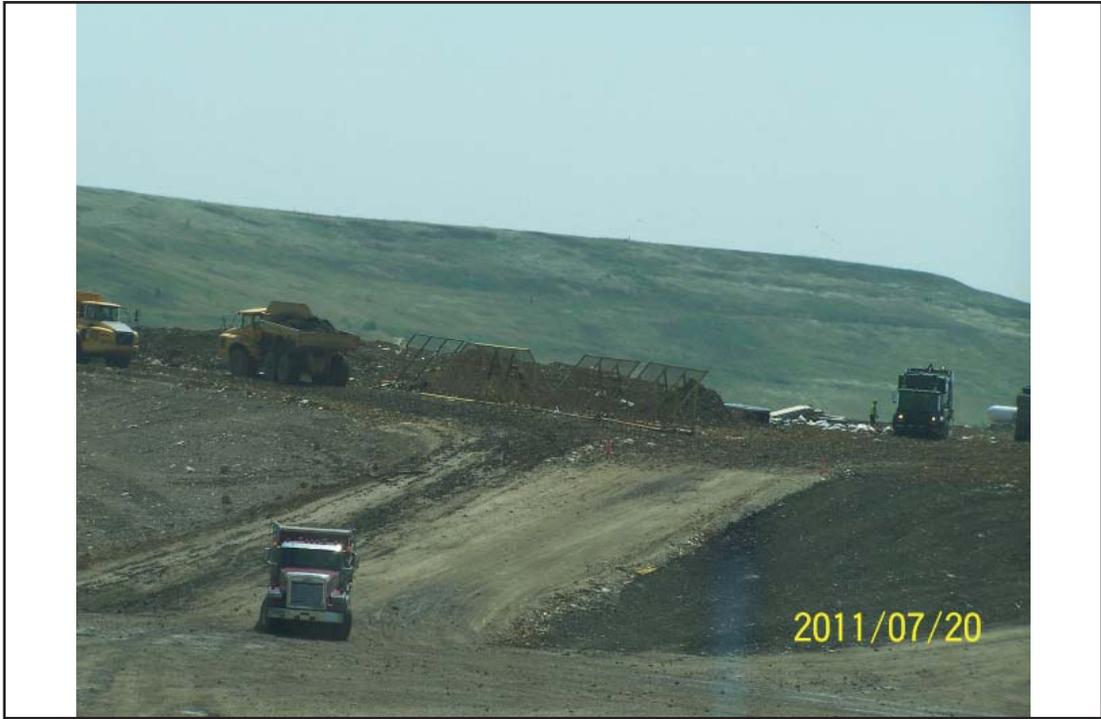
Active area access

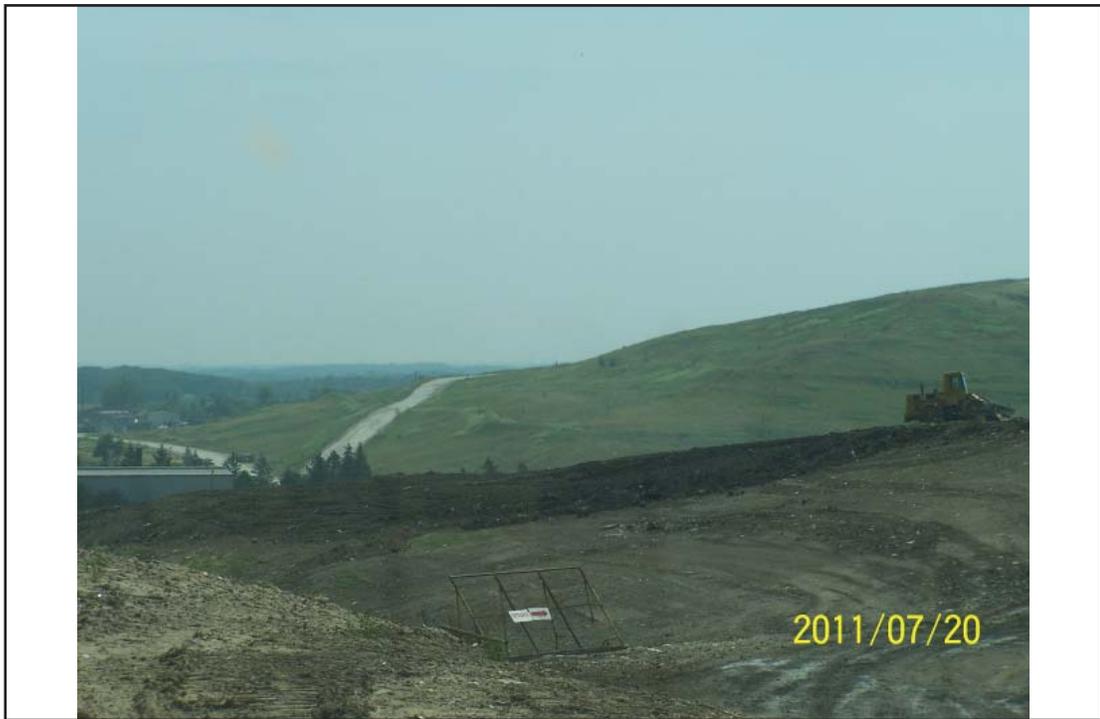
Filling on outboard slope of Phase 4 and 5

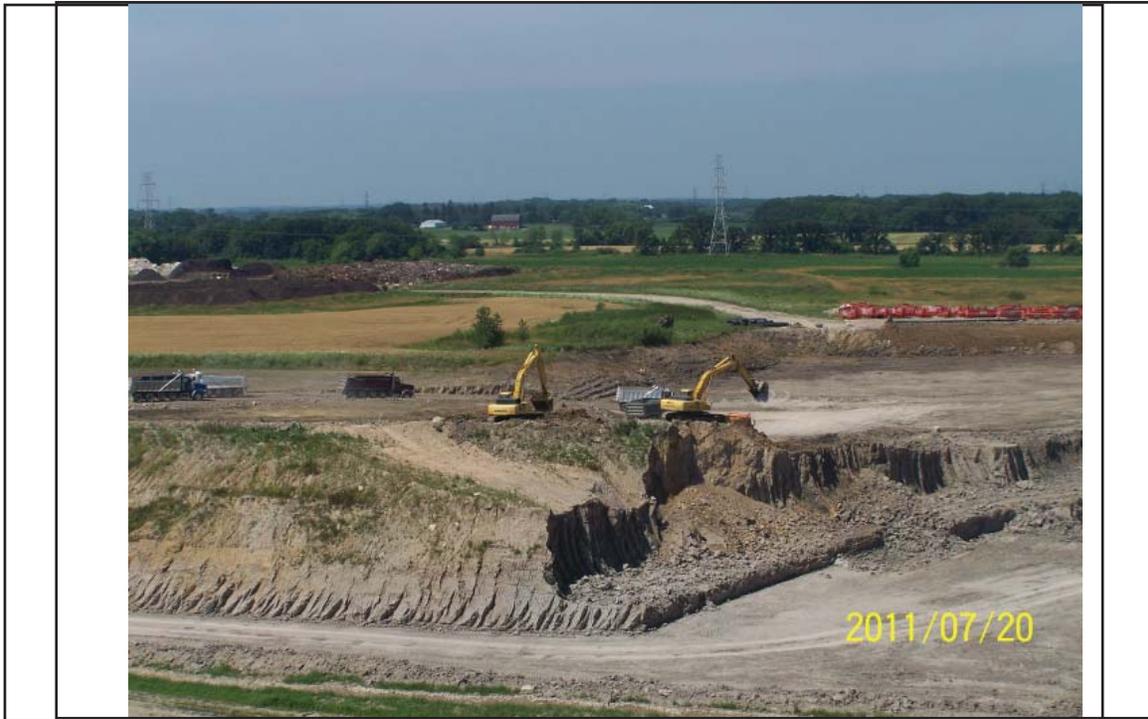
Final gross excavation of Phase 7

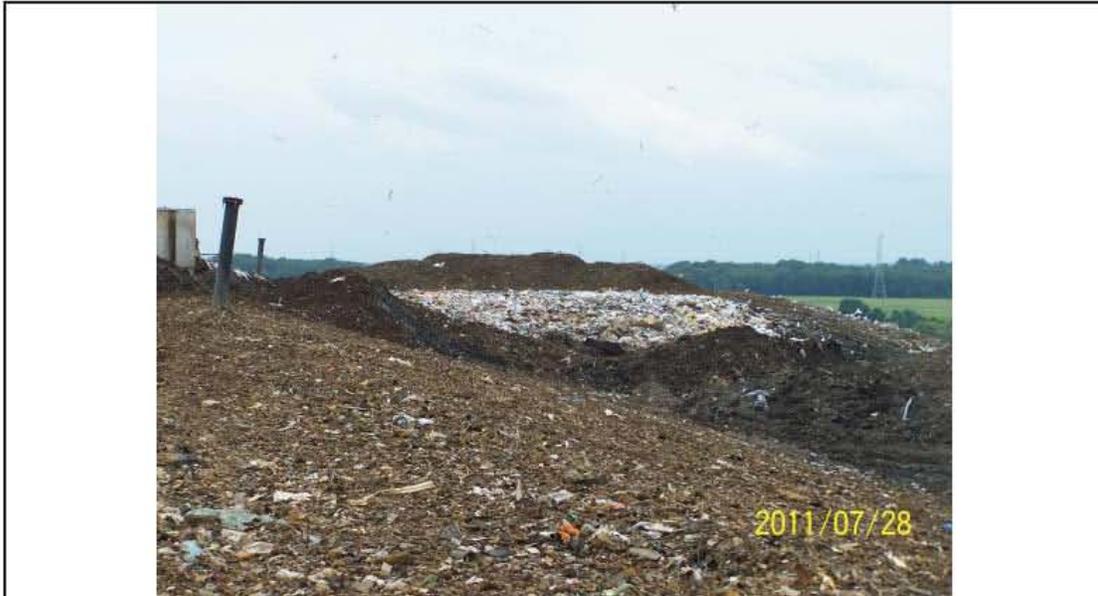
Working face on Southwest corner of Active area

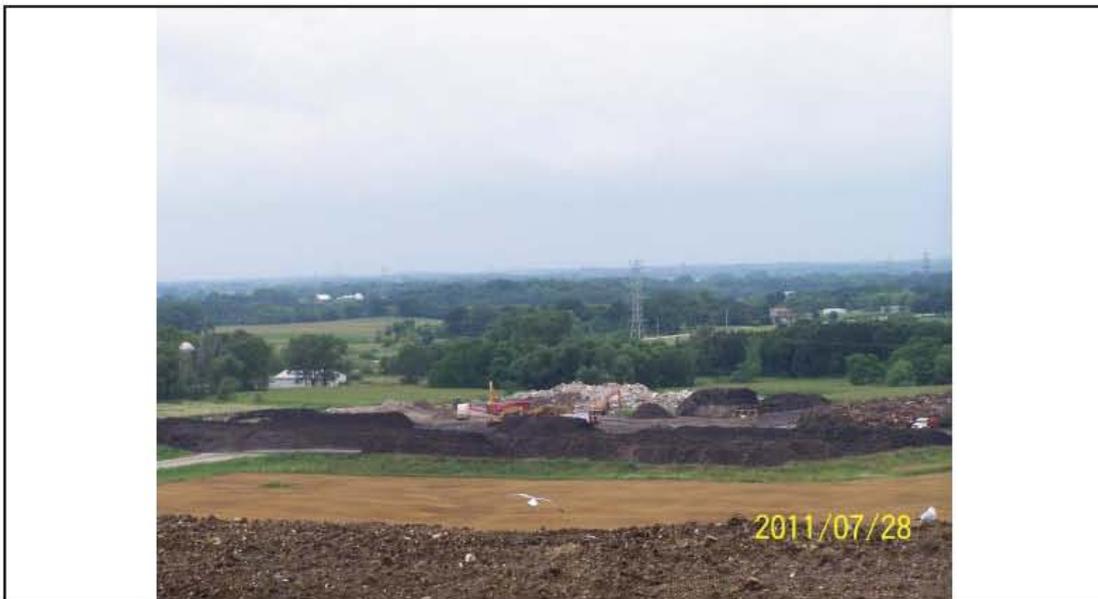
Compost Lot

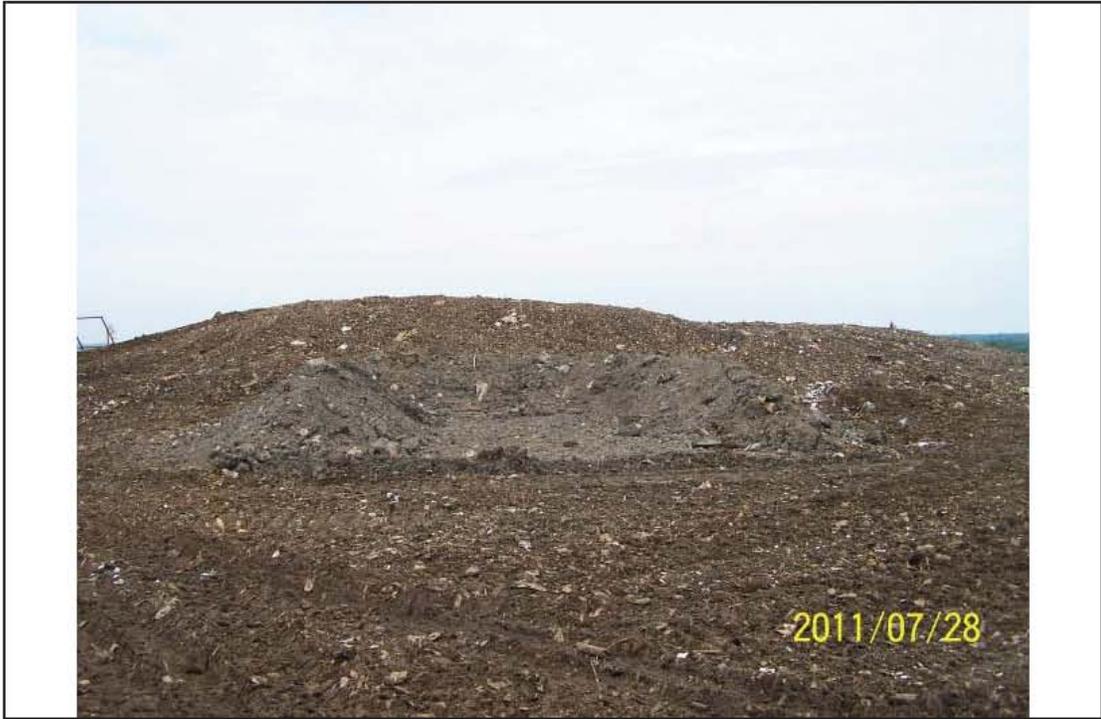
Fire pit, clay bottom with clay sides for smothering hot loads

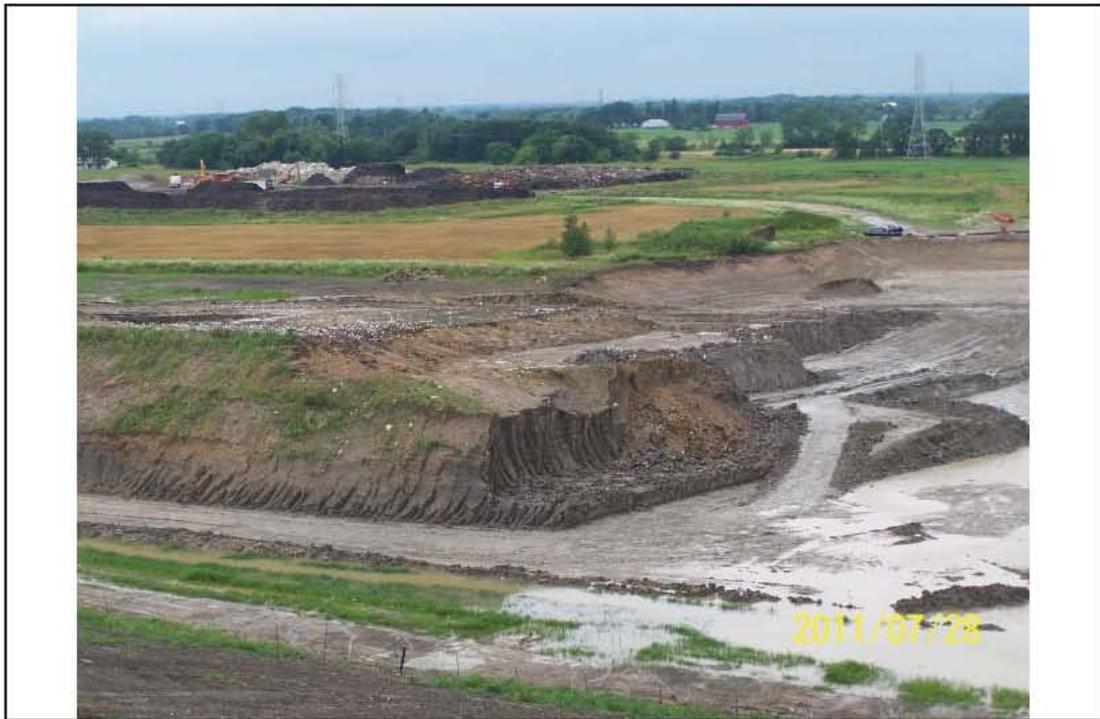
Area left to be excavated for Phase 7

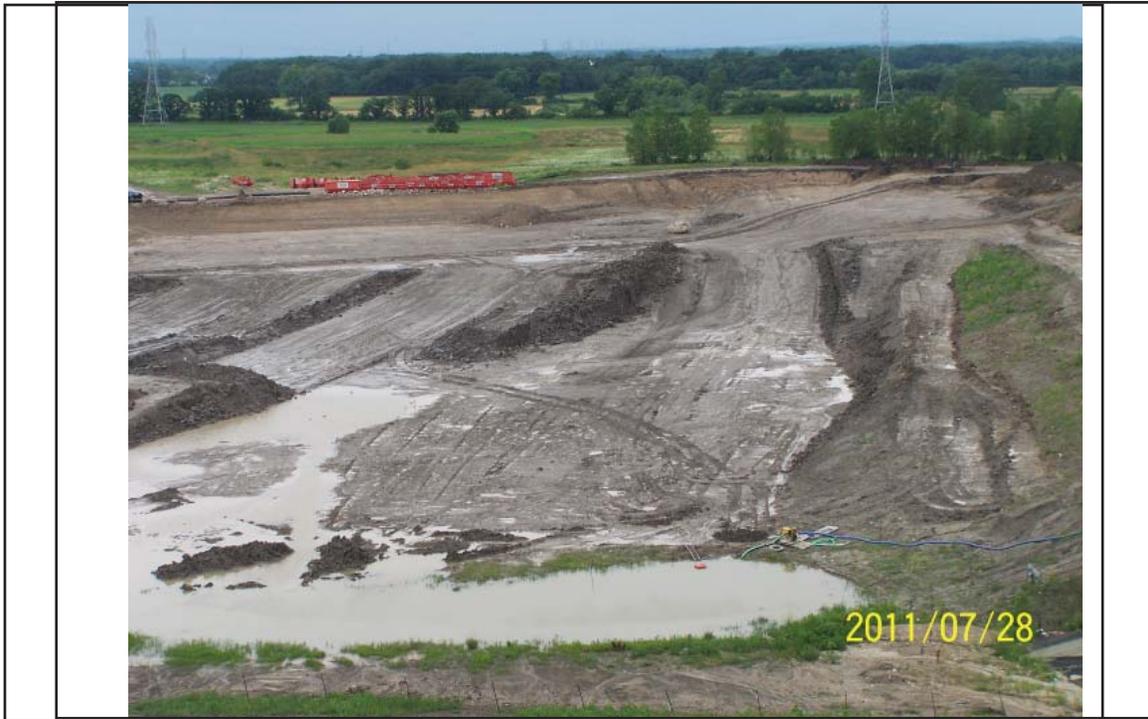
Excavation area too wet for work after storms

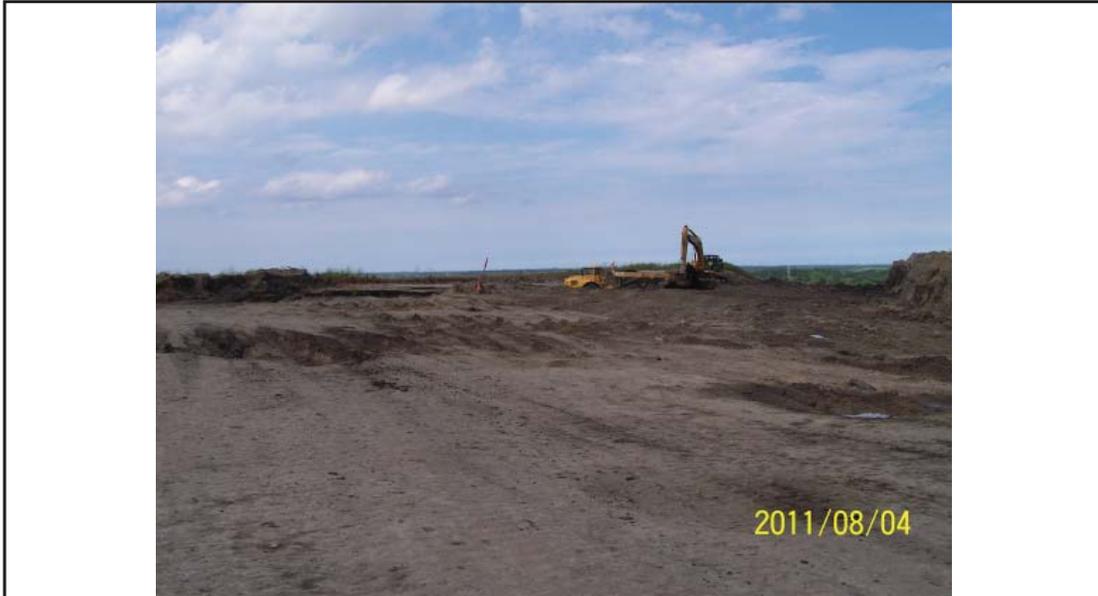
Landfill direct stockpile nearly exhausted on Phase 1 thru 3

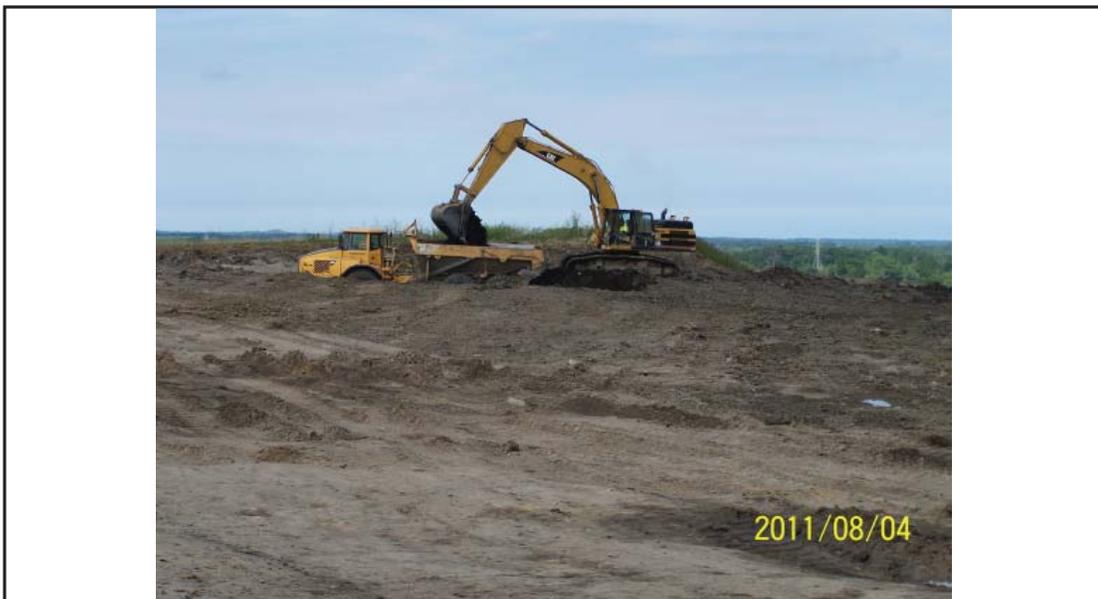
Landfill direct stock pile being excavated for use in Closure area

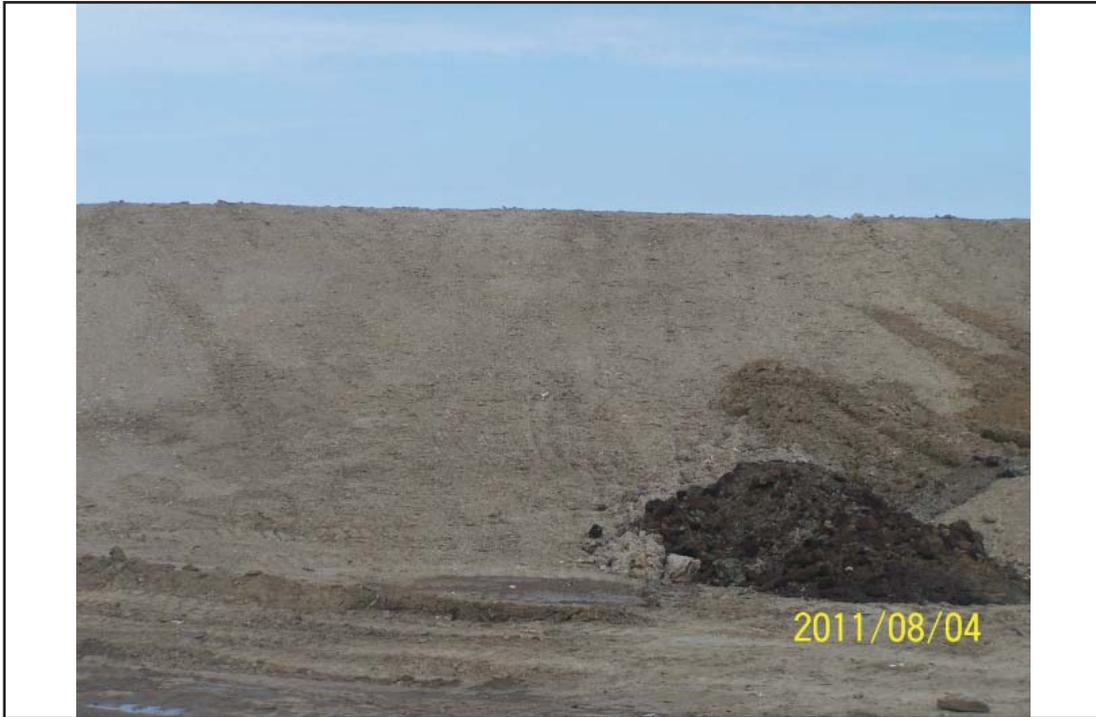
Bio-soil pile under treatment

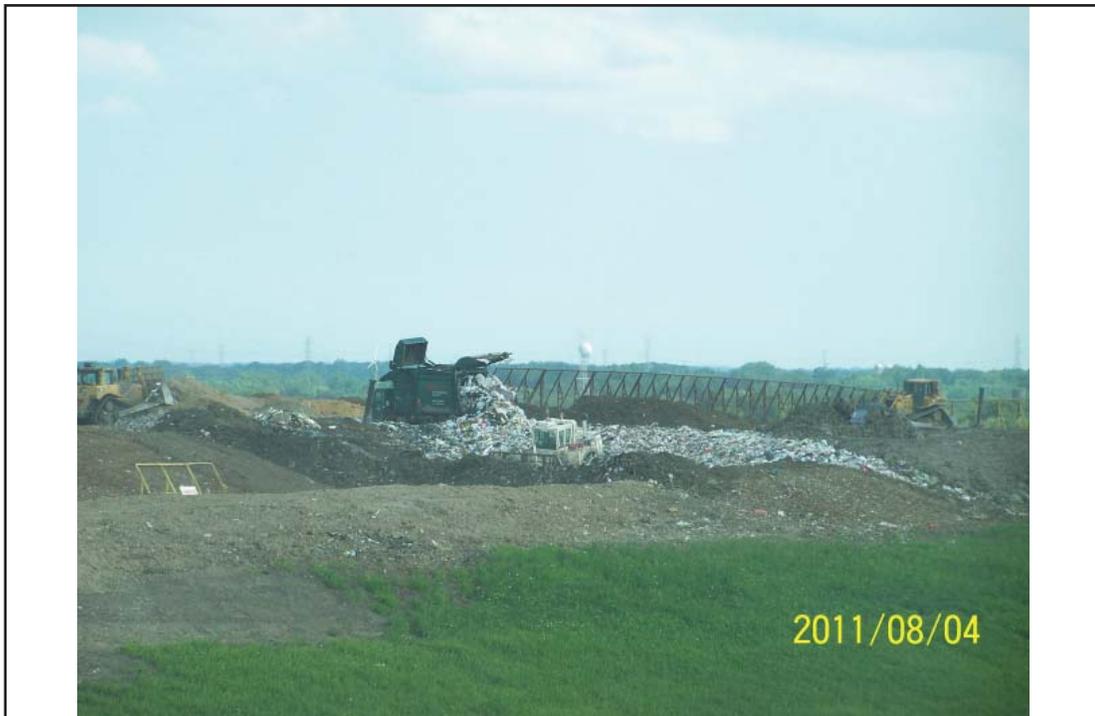
Tipping face along West top of slope, tight trench placement

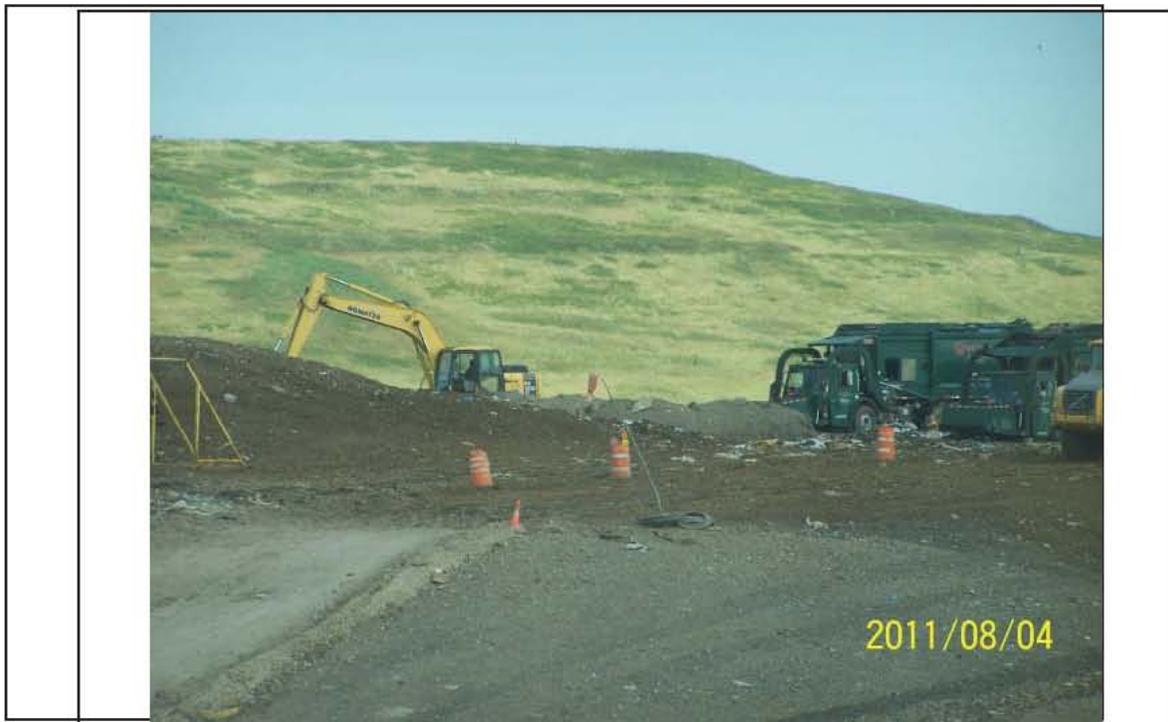
Access to working face separated by barrels for site construction traffic and site tipping traffic

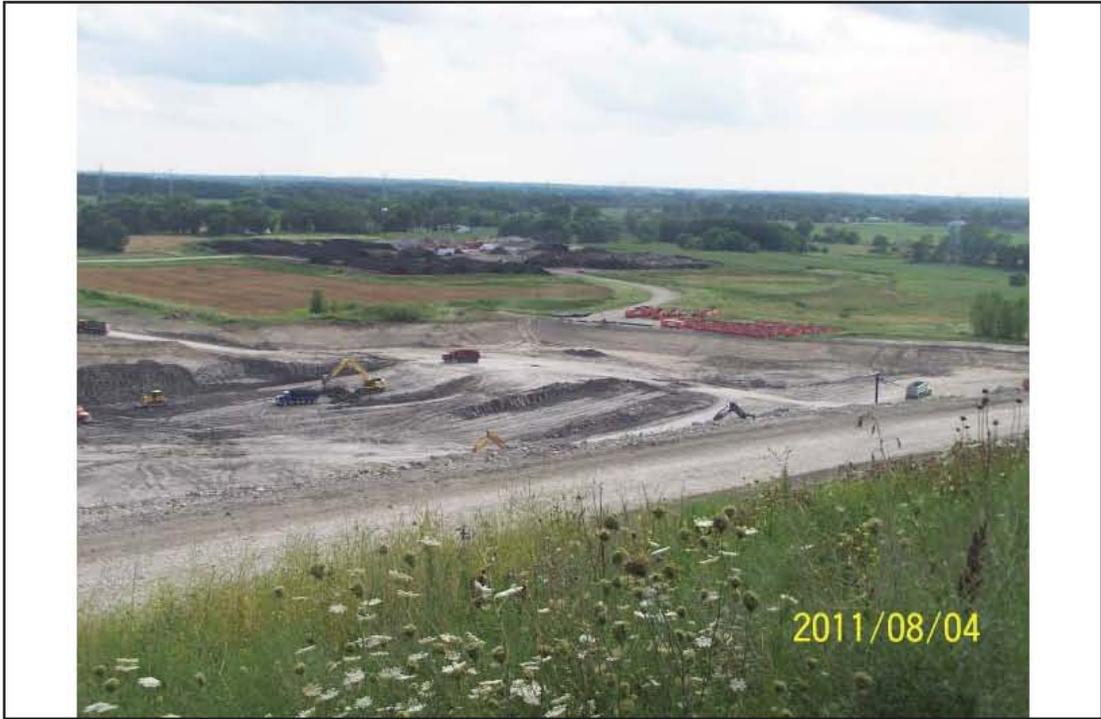
Excavation area nearing completion

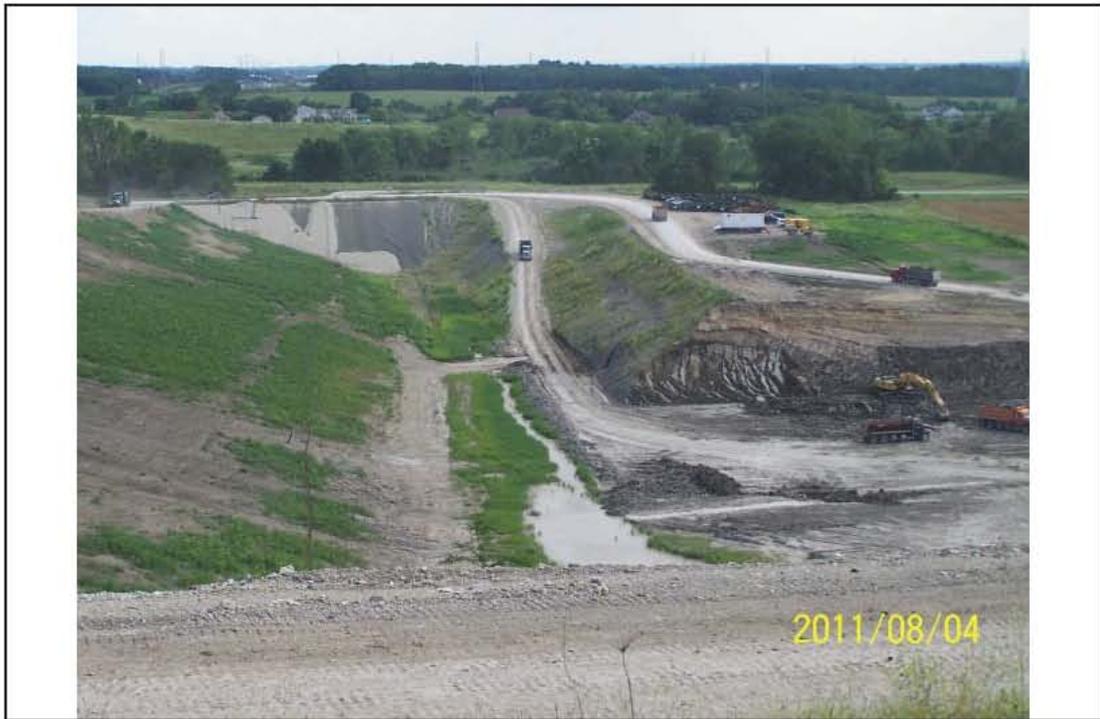
Temp Sed Basin and expansion area

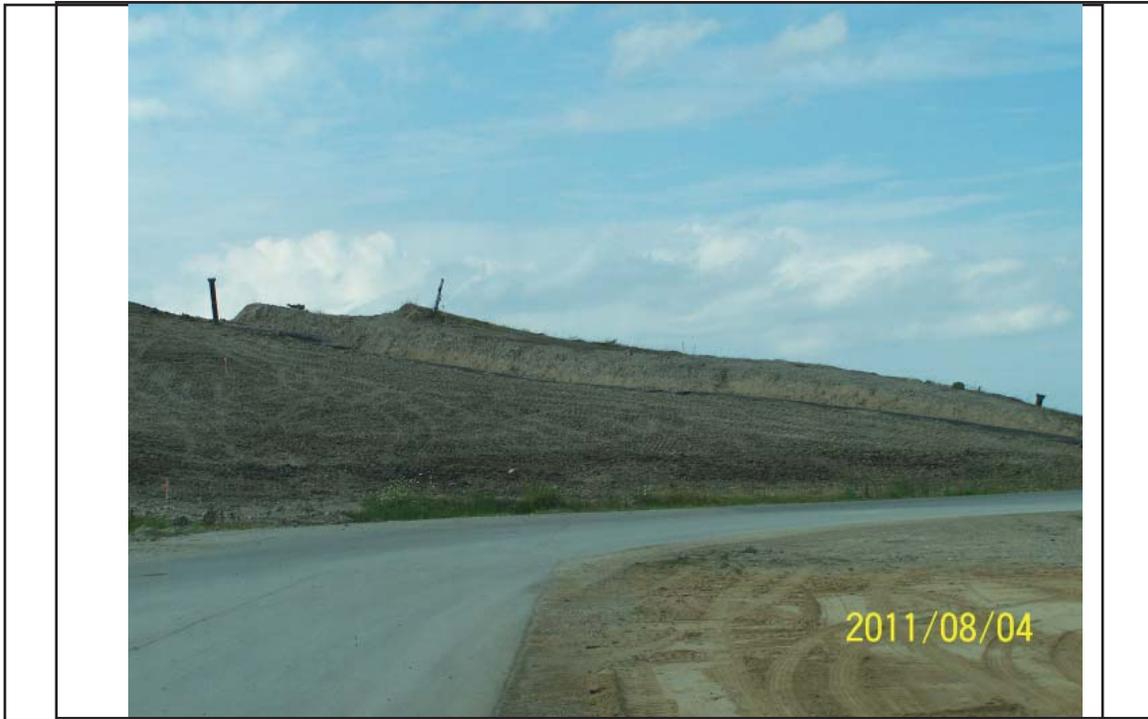
Prepared cap overlap between Phase 5 and 4

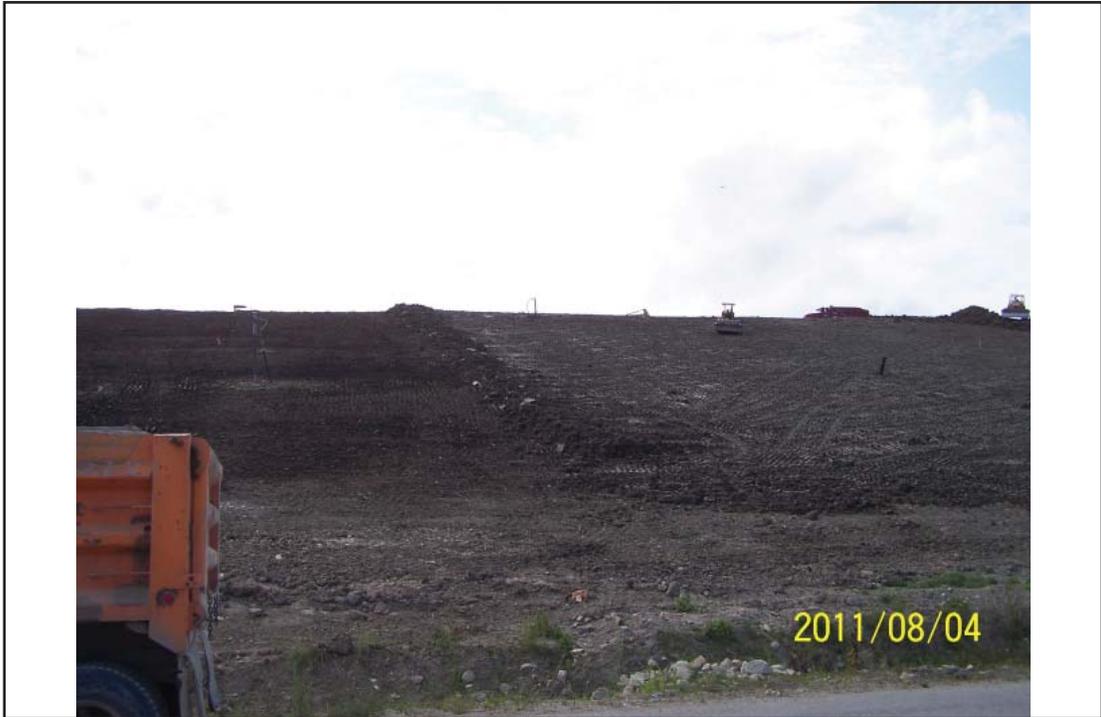
Closure area, receiving clay lifts

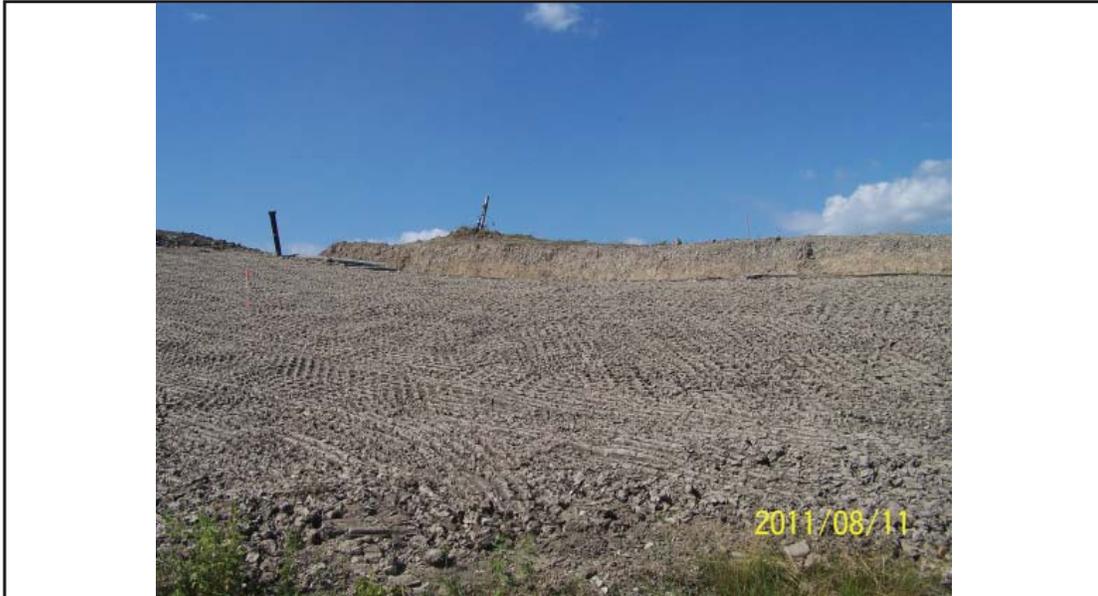
Junction between Closure Area I and Closure Area III

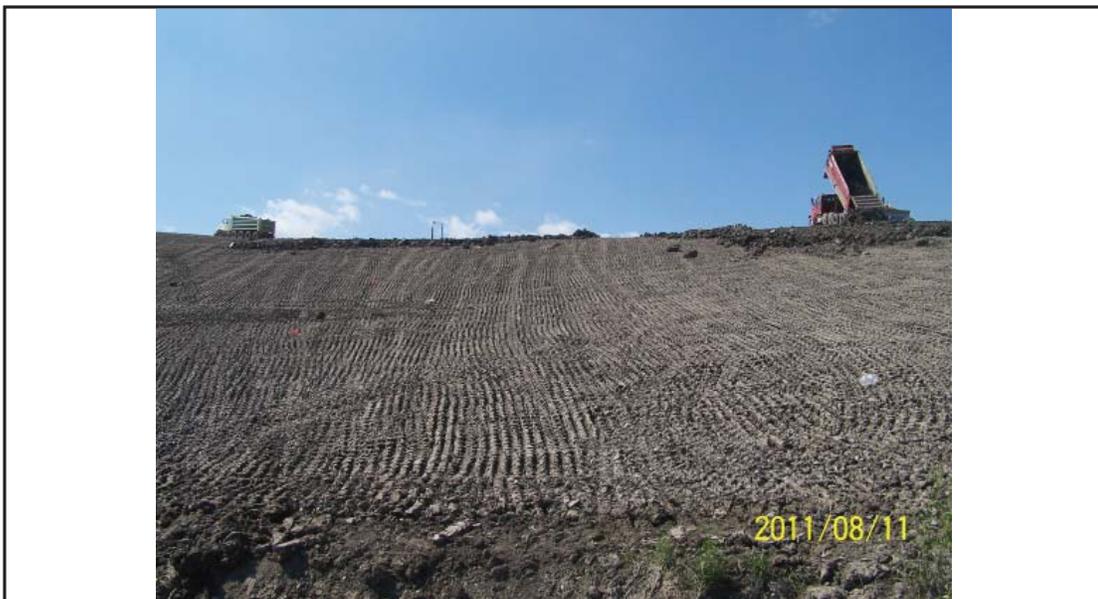
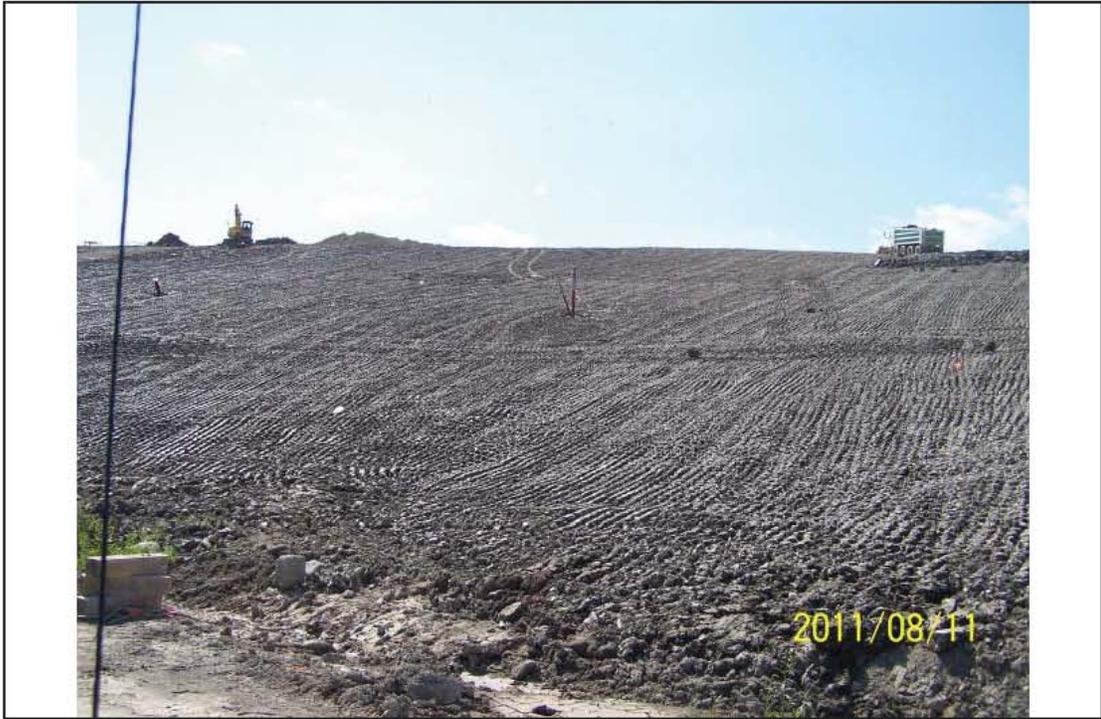
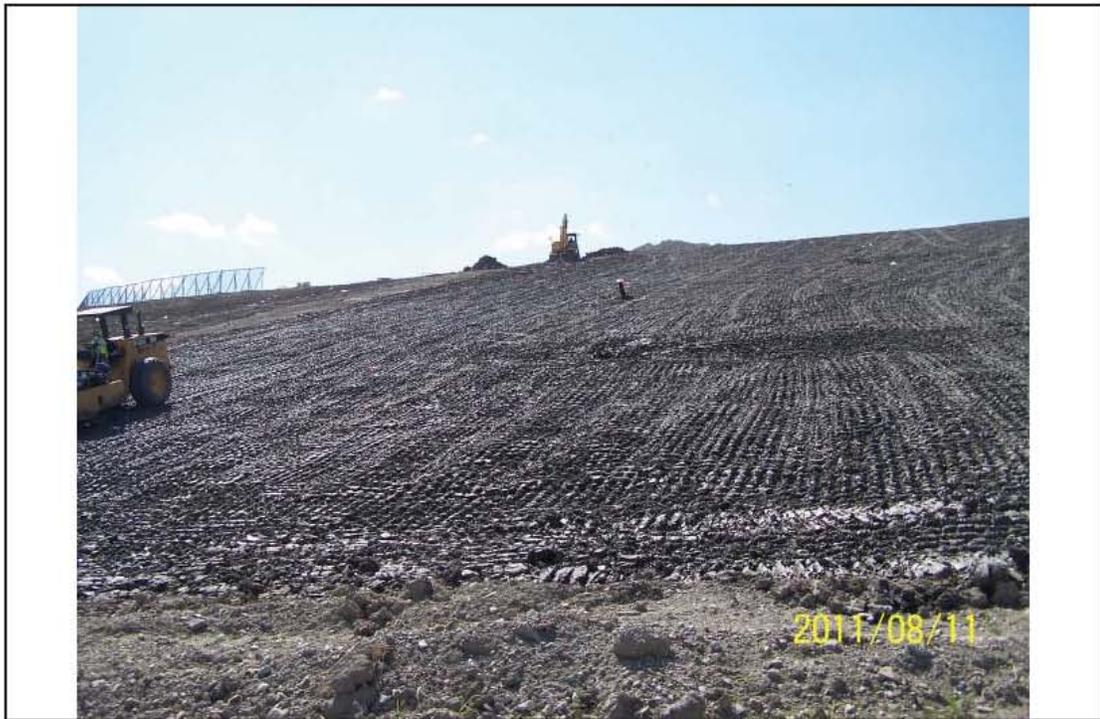
Clay placement on closure area

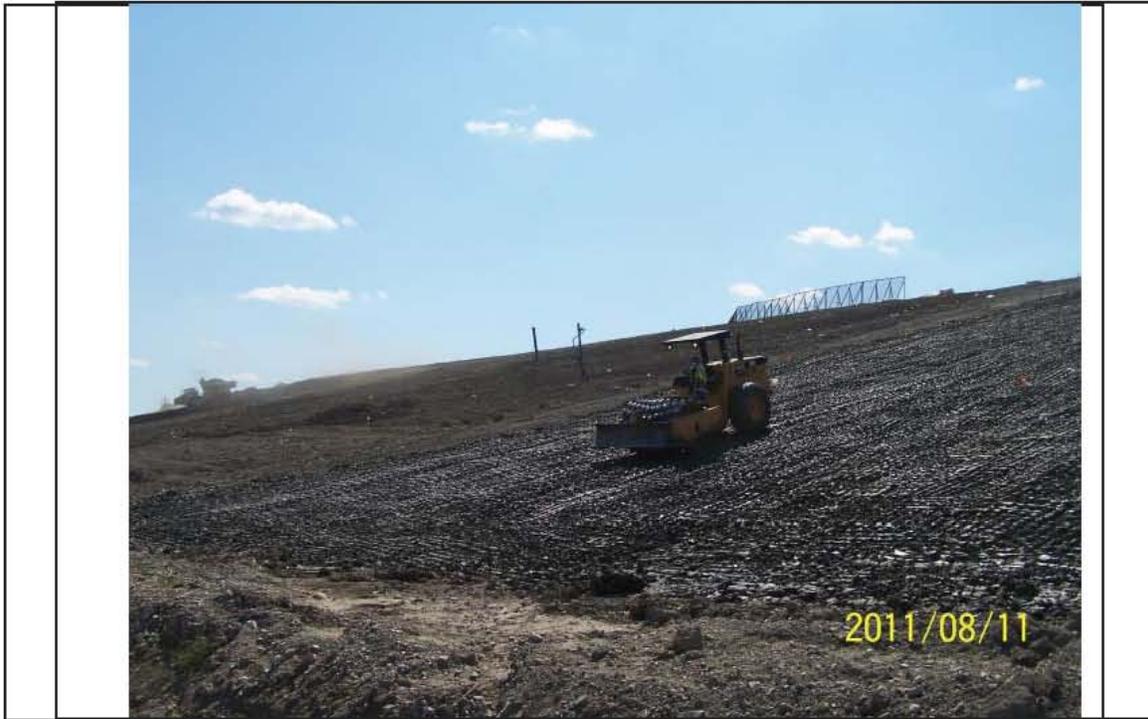
Clay compaction of Closure Area III

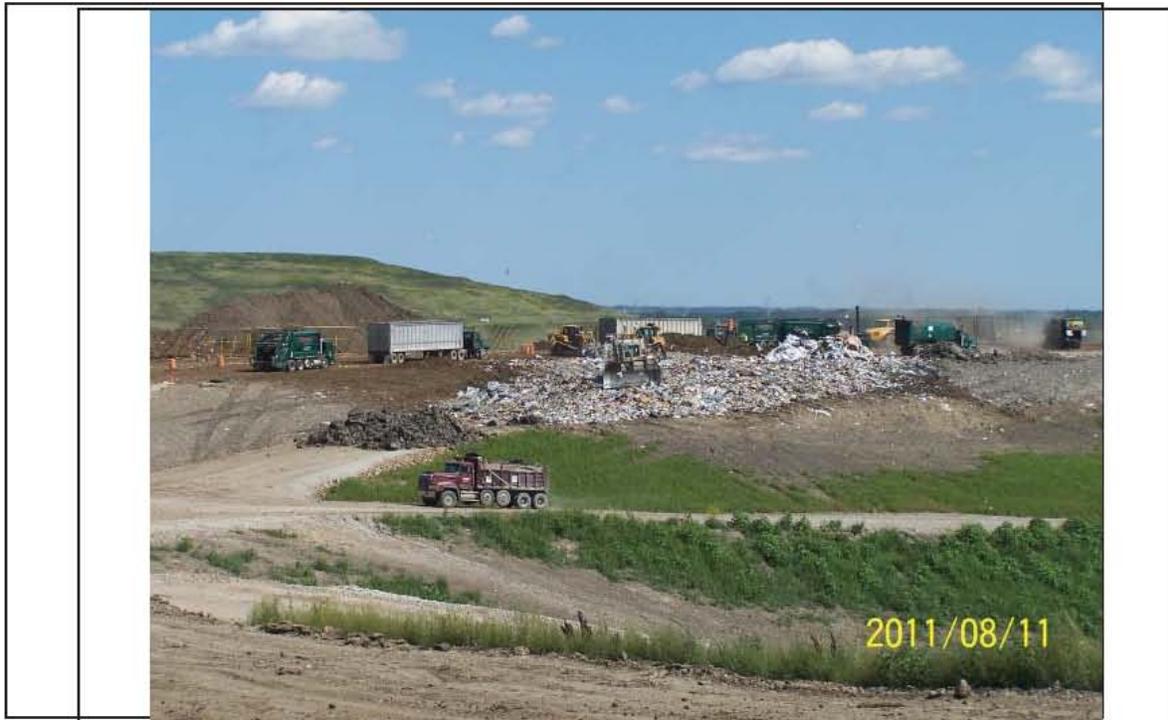
Working face in Northwest corner of active area
