Veolia Emerald Park Landfill
City of Muskego

2011 Veolia Emerald Park Landfill Year End Compliance Officer Report and Audit Summary

TO: Veolia Emerald Park Standing Committee
FROM: Jo-Walter Spear, Jr., P.E.
COPIES: File
DATE: 04/02/2012
PROJECT NUMBER: 1012.10030

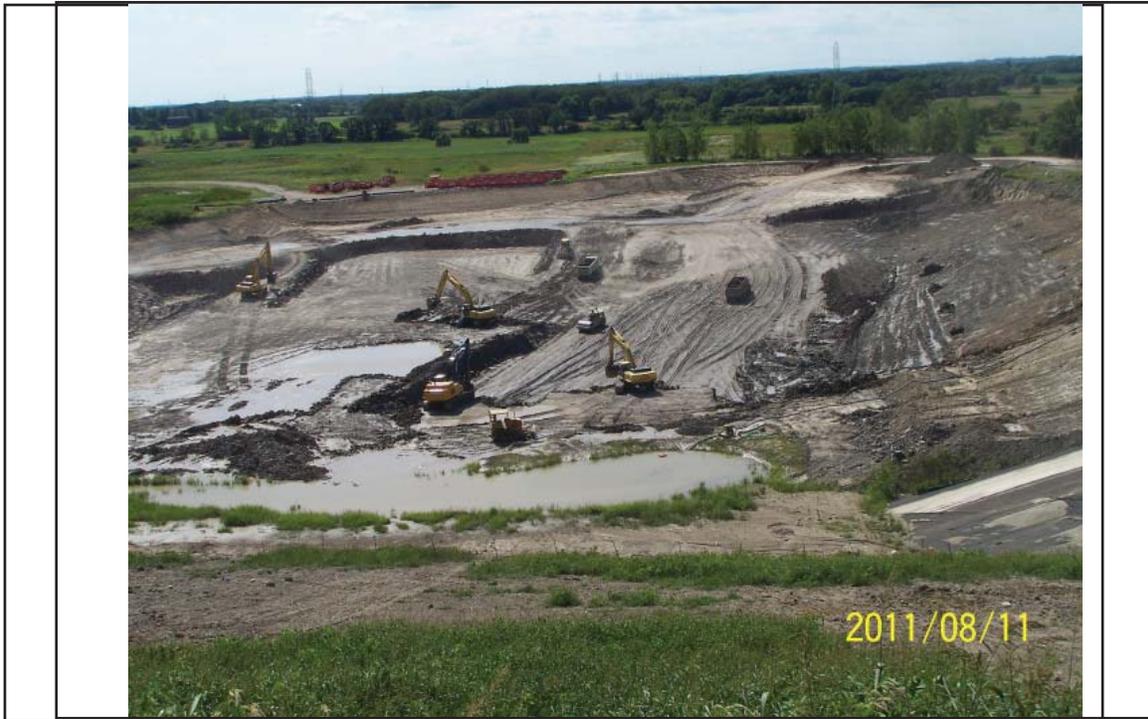
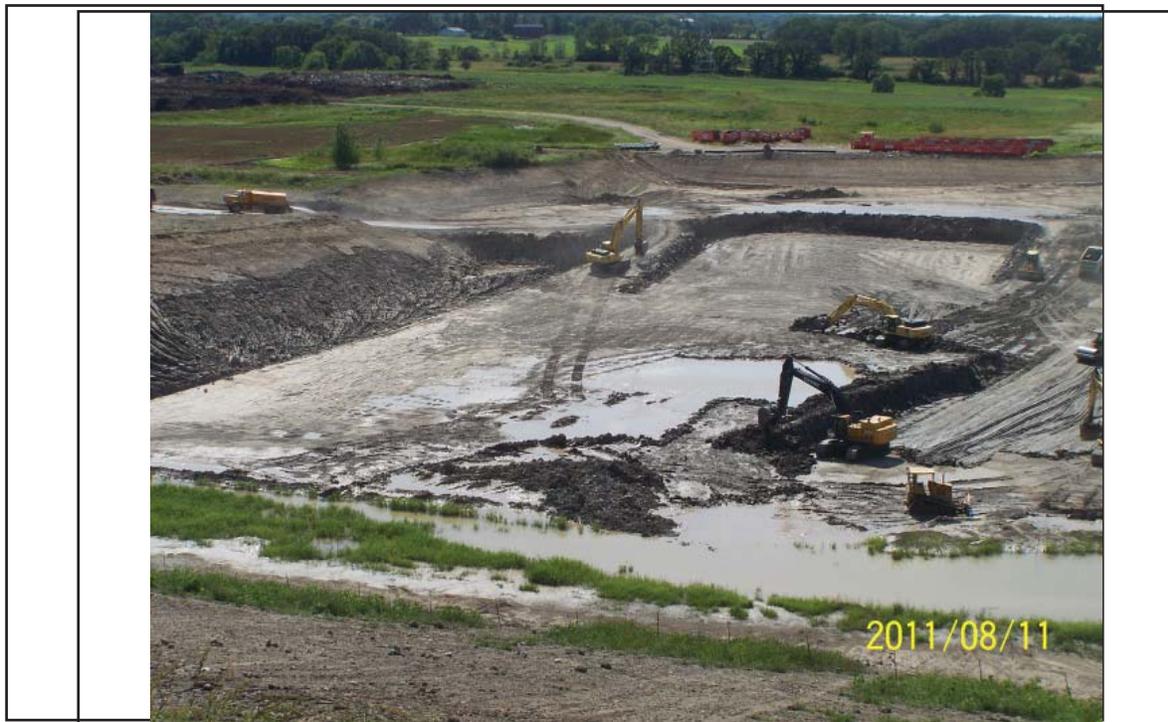
Excavation of Phase 7

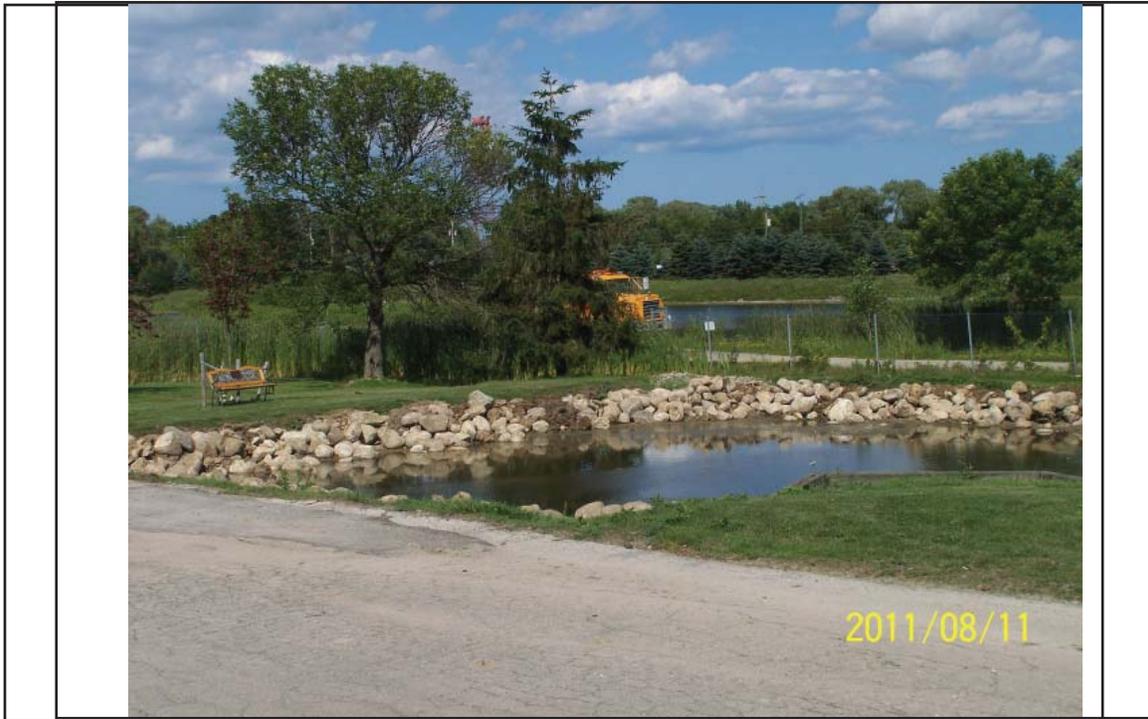
Fire pond with new border and filled

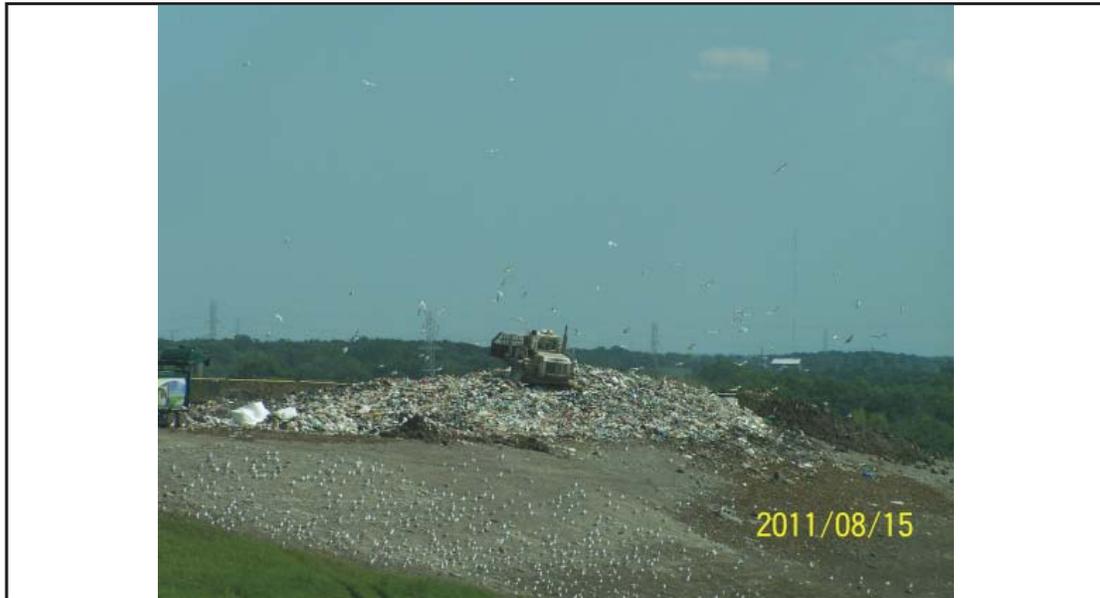
New lift in Phase 6

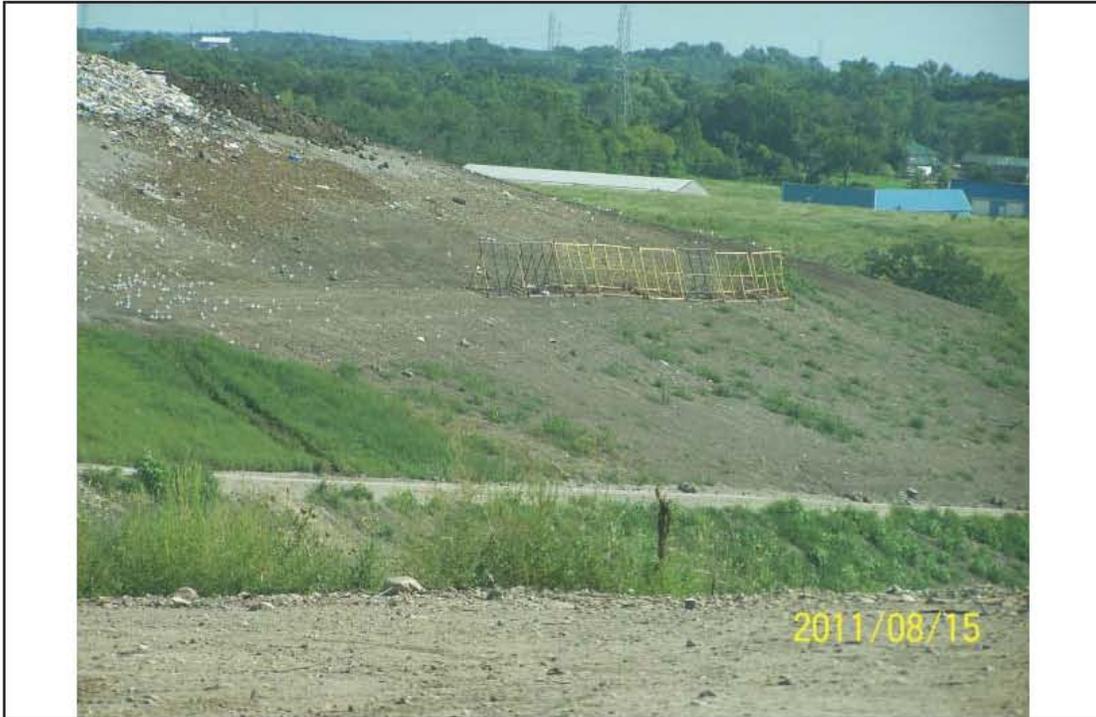
West Slope of Phase 6

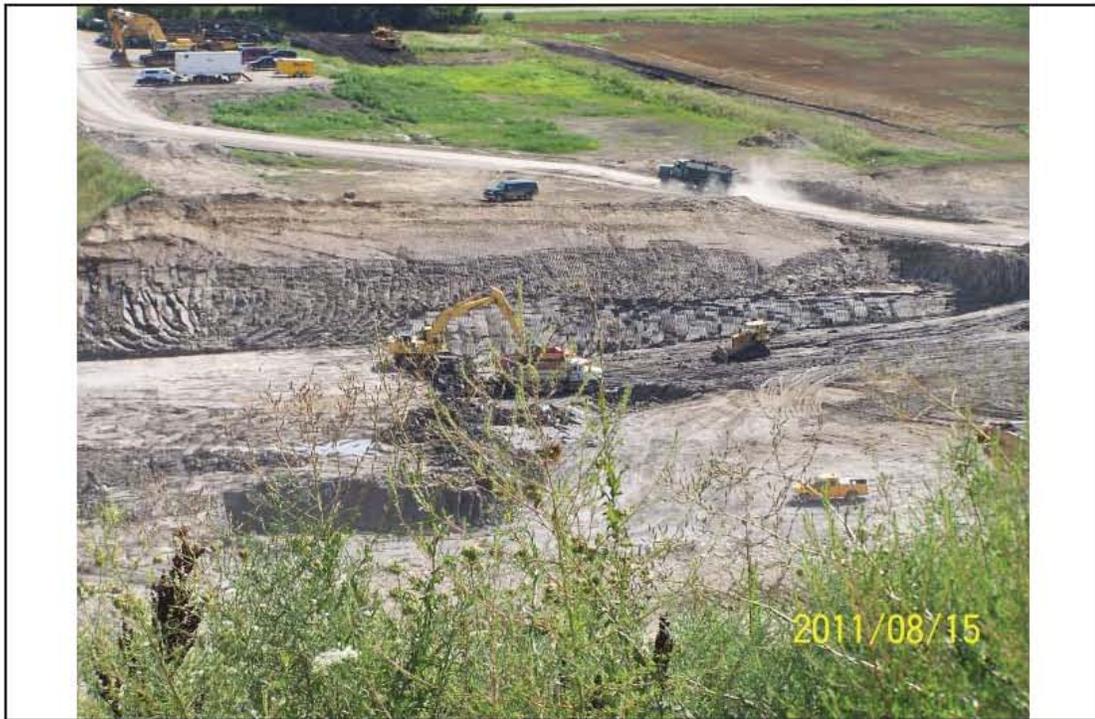
Excavation of Phase 7

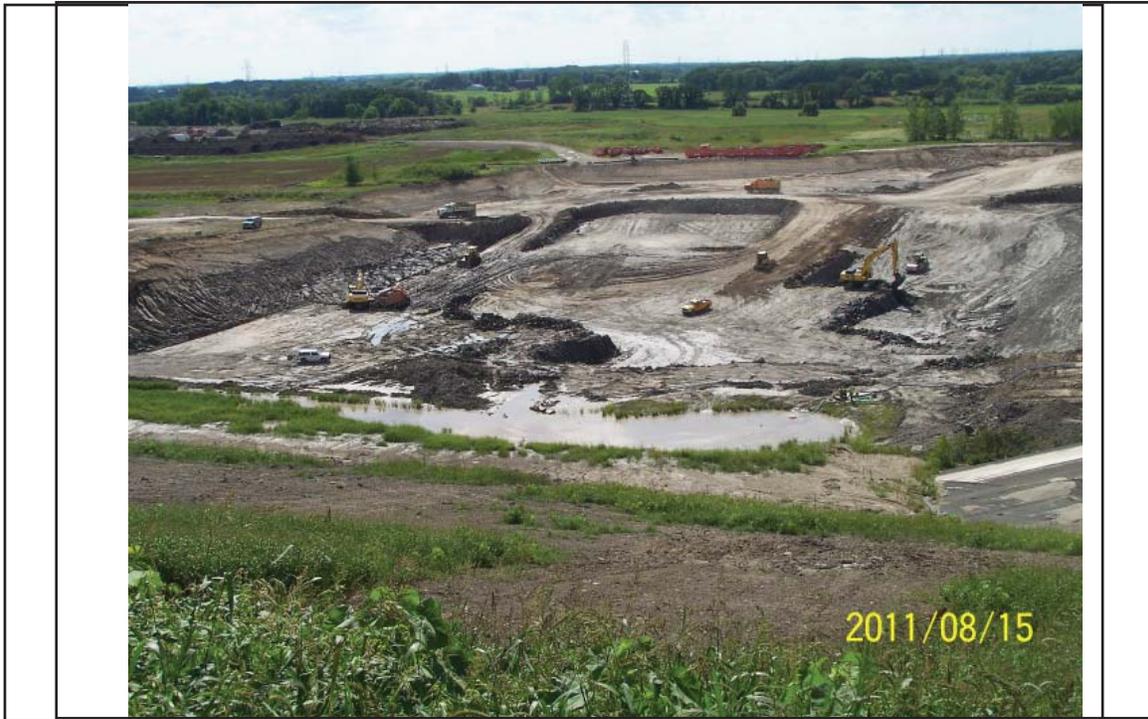
Excavation of Phase 7

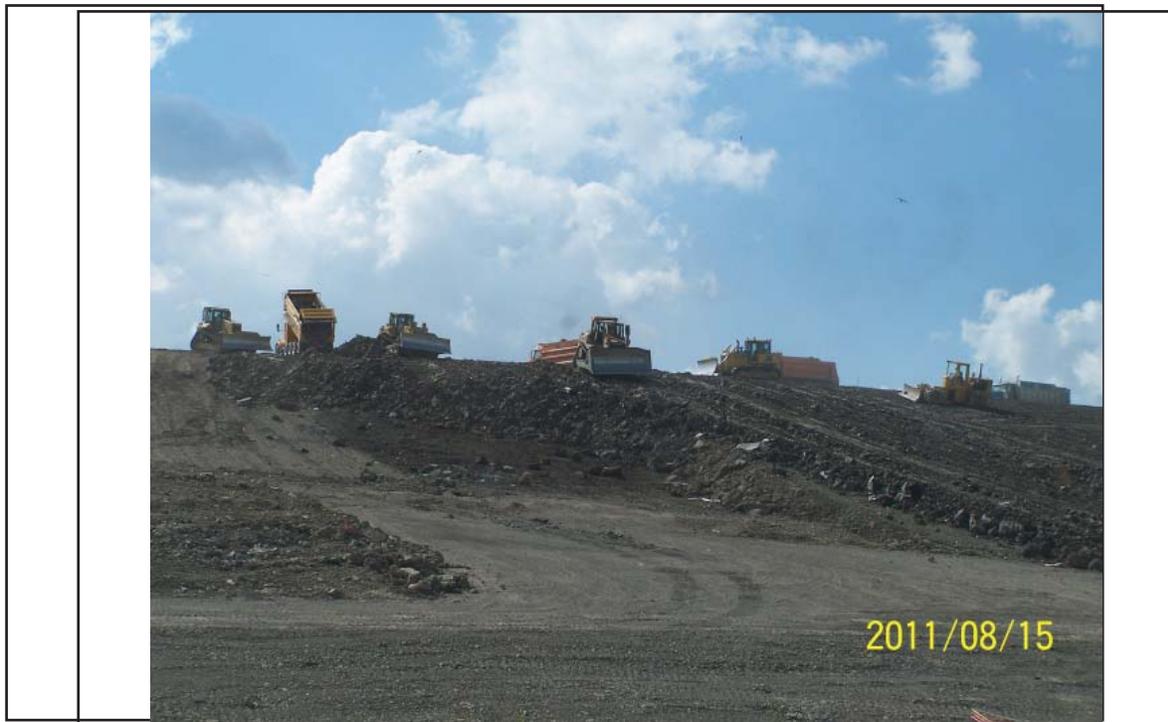
Placement of soils to bring Phase 5 East slope up to final grades for Closure Area III

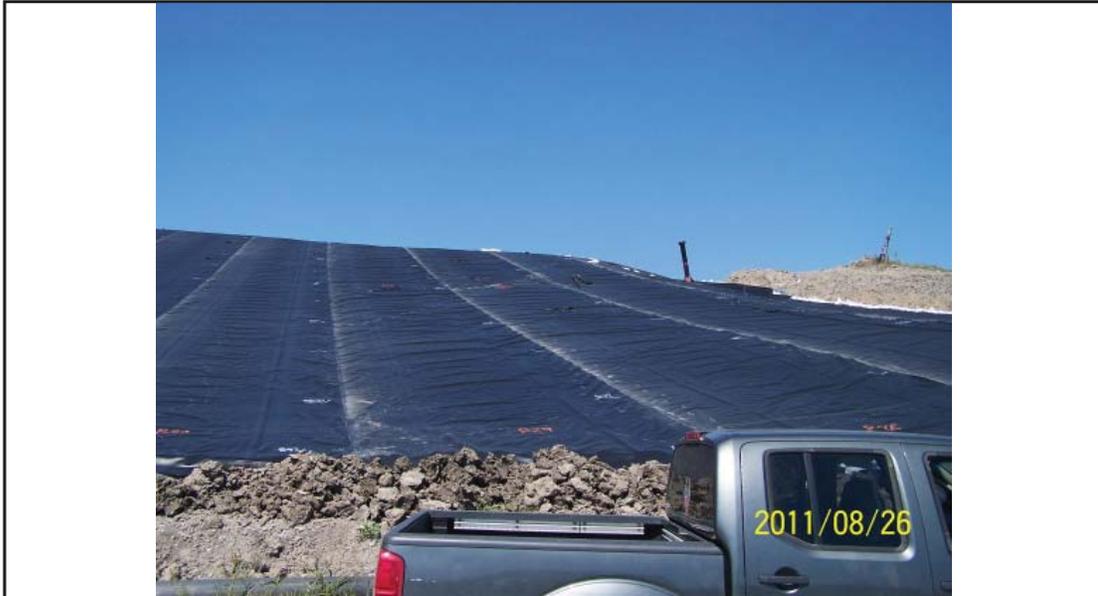
Panels of HDPE placed as part of Cap construction

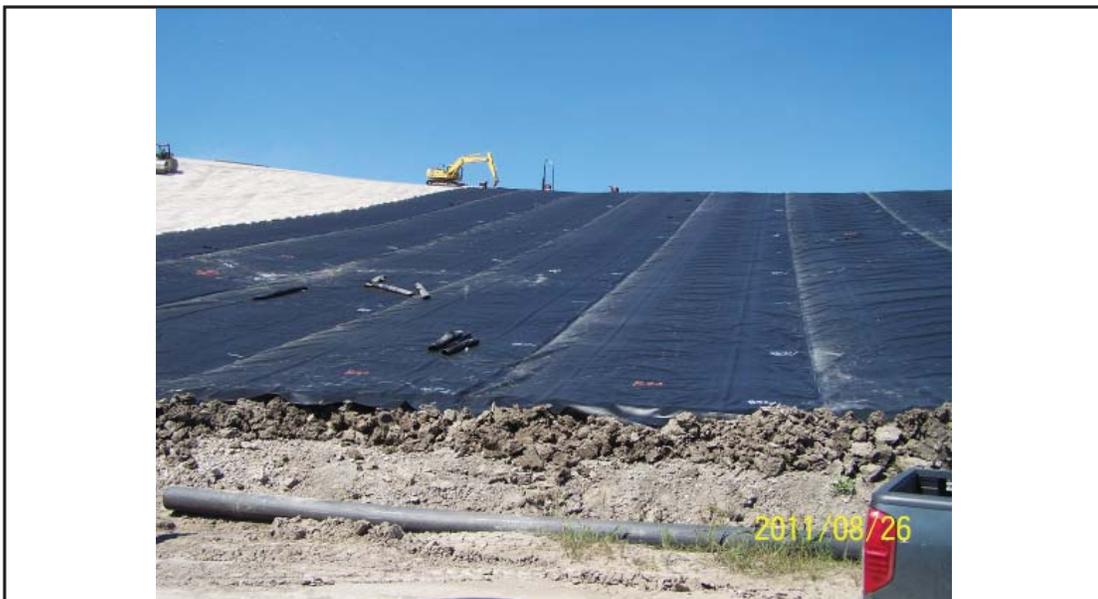
Toe of slope, anchor trench

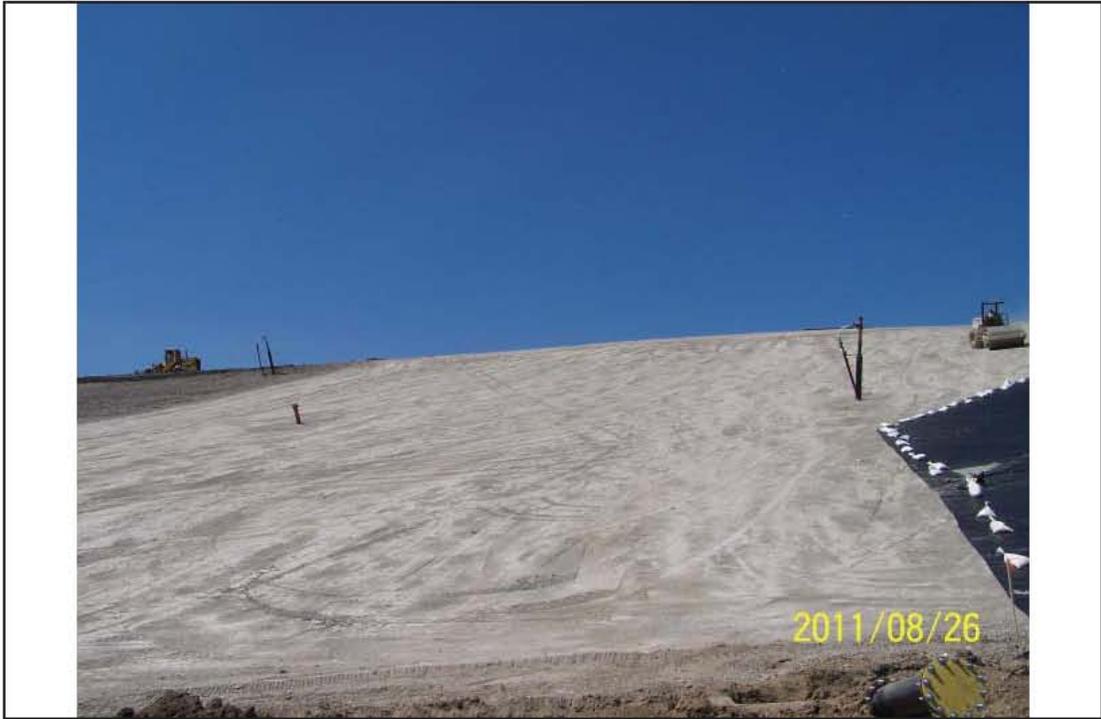
Finished clay placement awaiting HDPE Cap

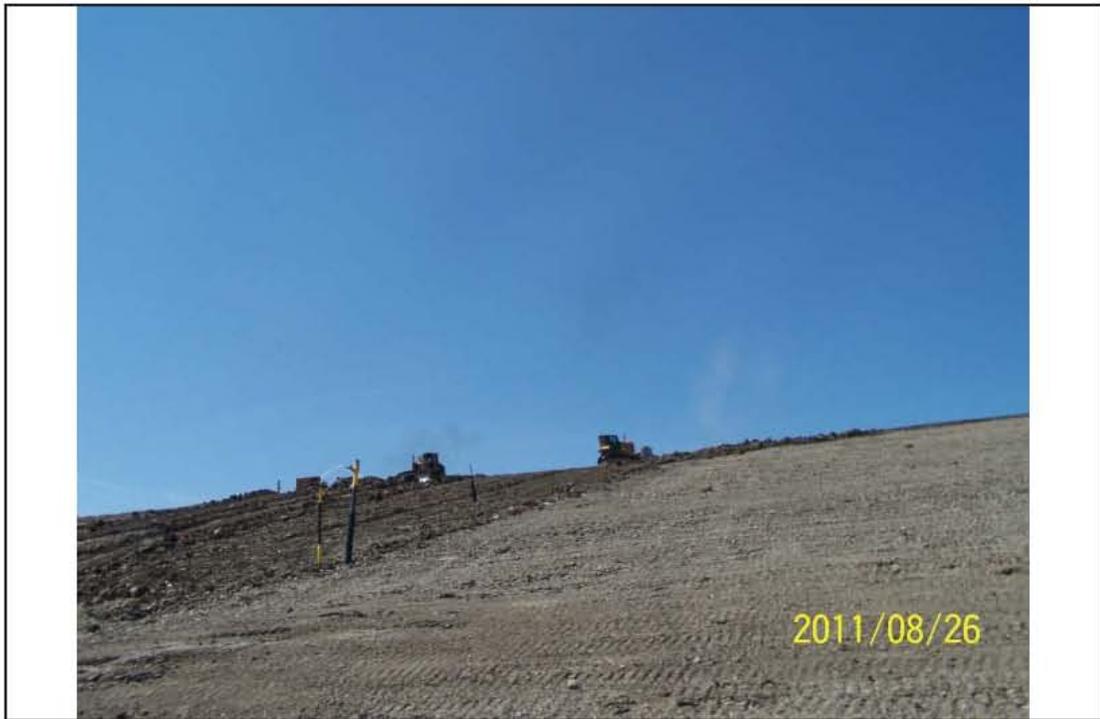
Undocumented clay cap South of HDPE cap placement

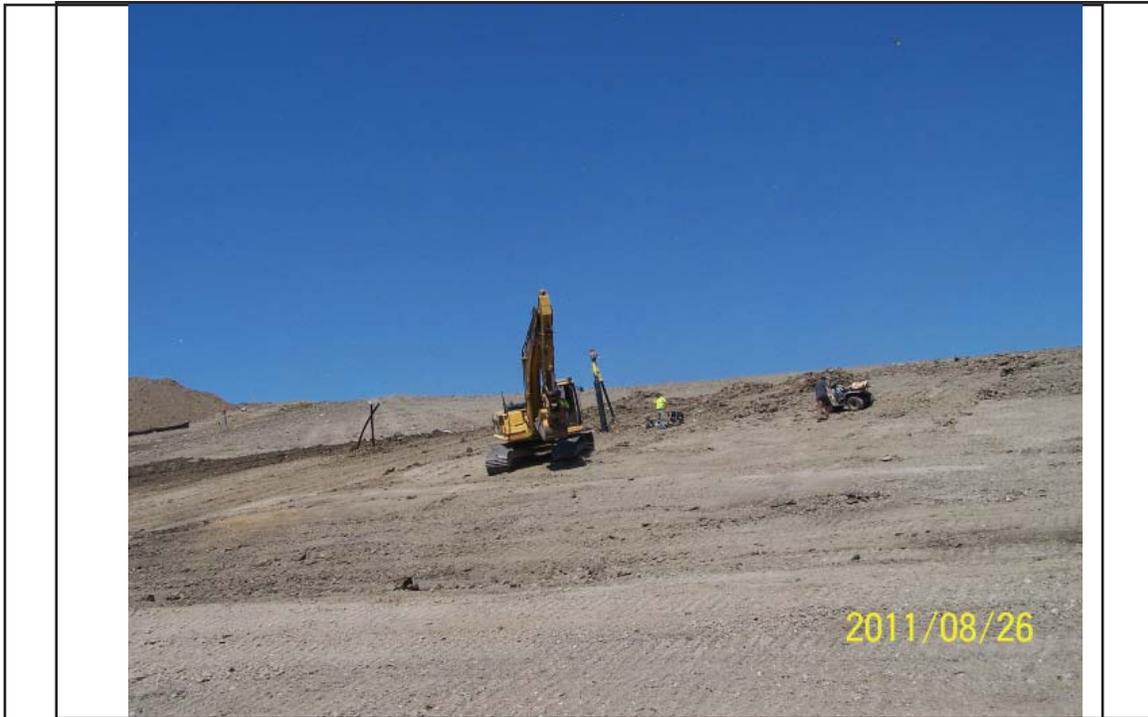
Gas well extension ongoing, along South slope of Phase 5

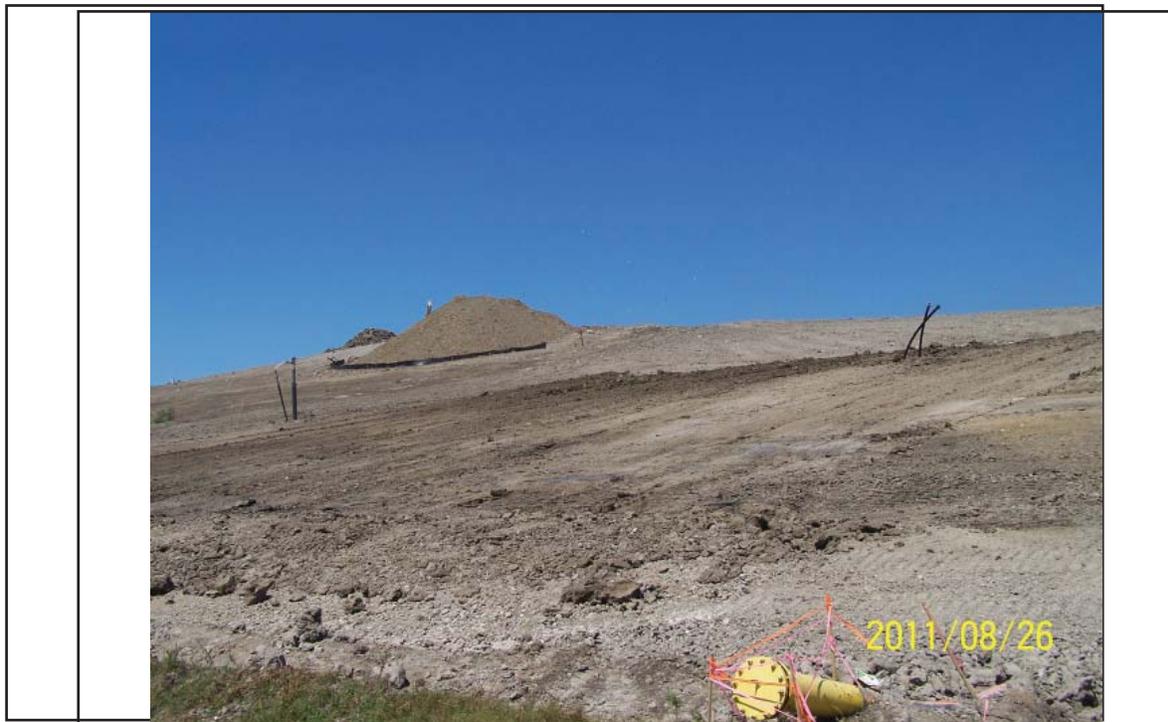
South slope of Phase 5 being restored and awaiting seeding

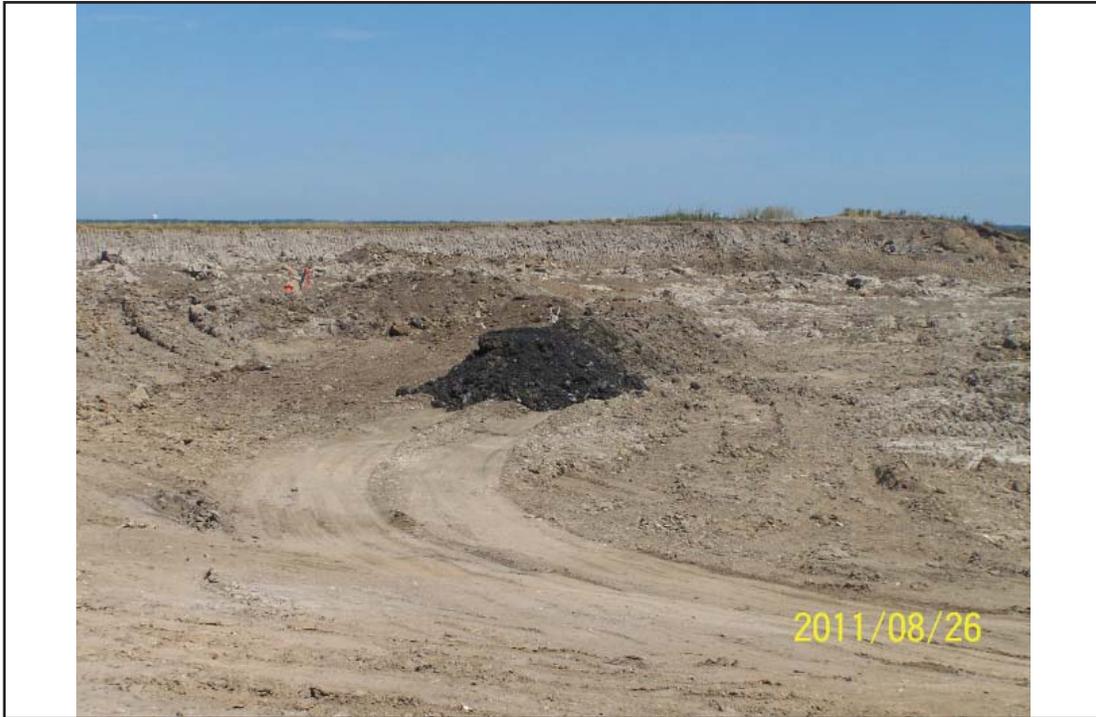
Landfill direct soils being tipped in Phase 2/3

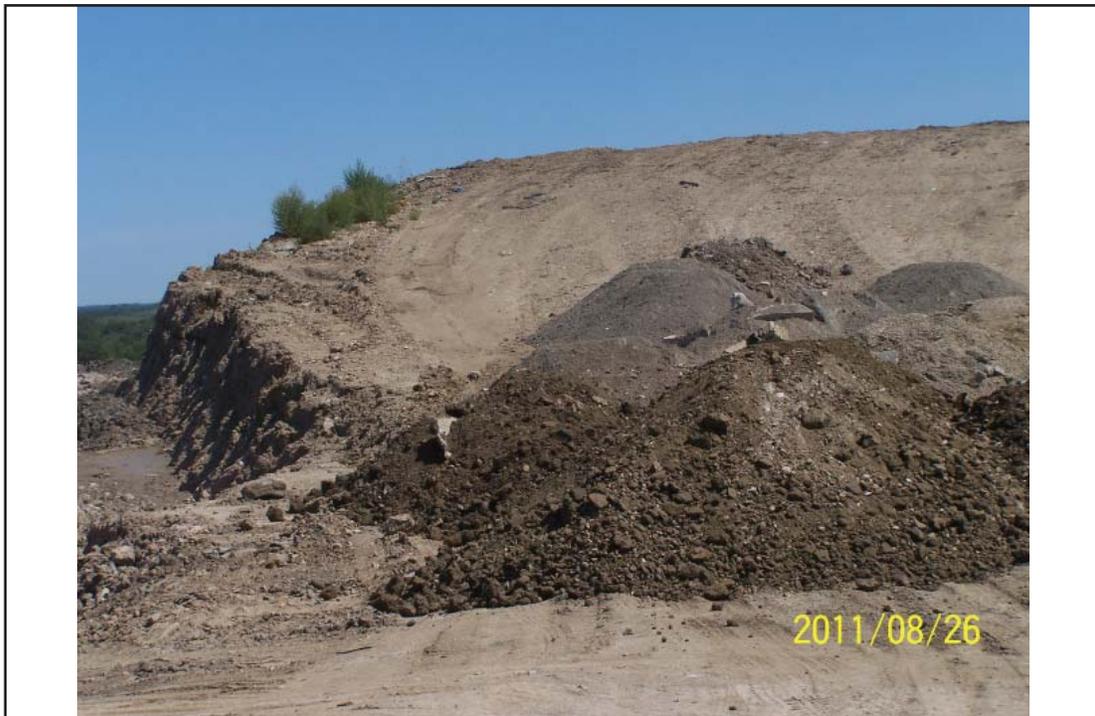
Bio soils being tipped in Phase 2/3

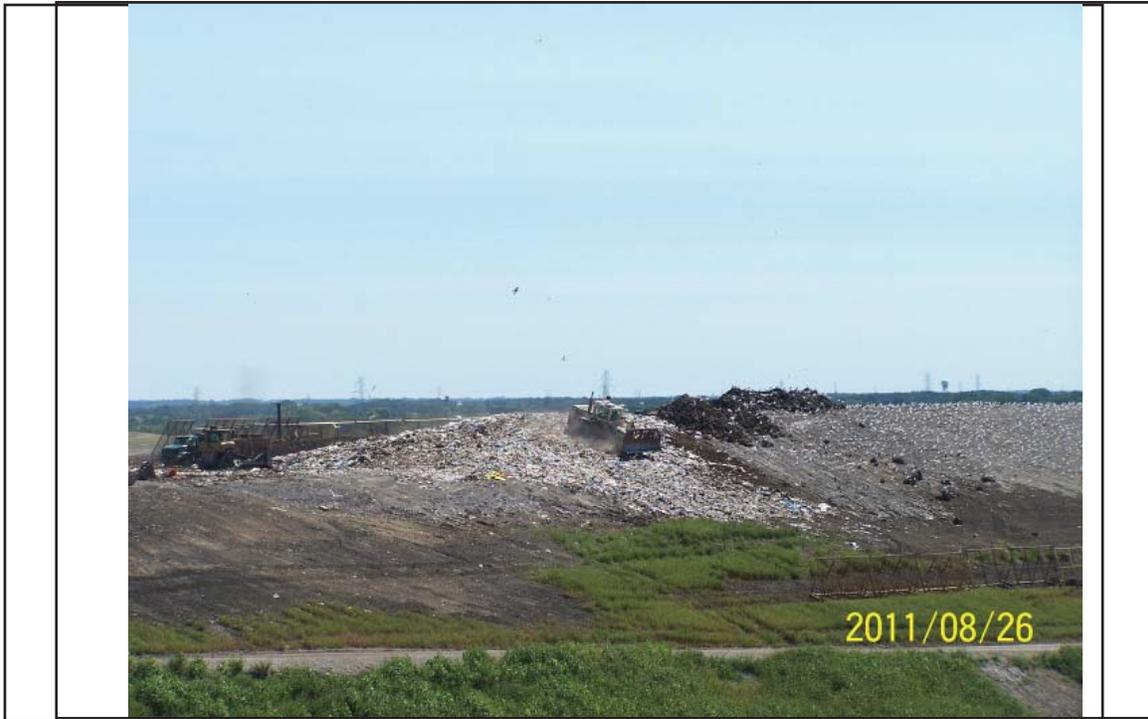
Working face on Northwest corner of Active area, Phase 6

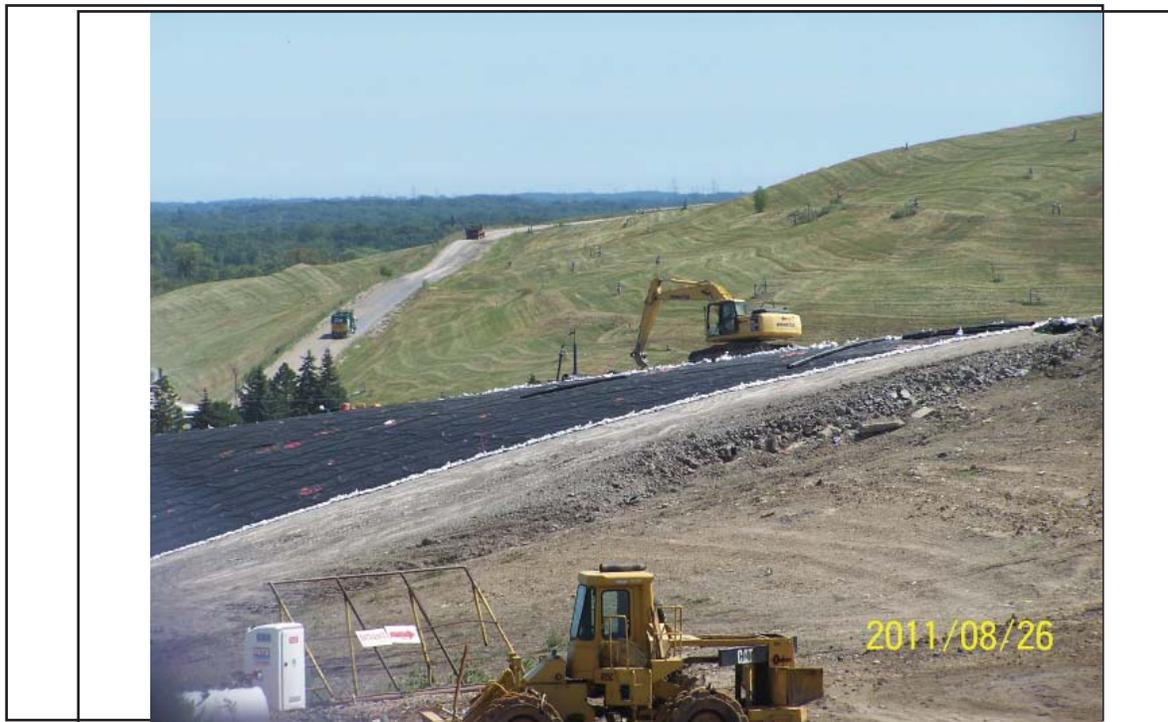
Cap placement viewed from the Northeast

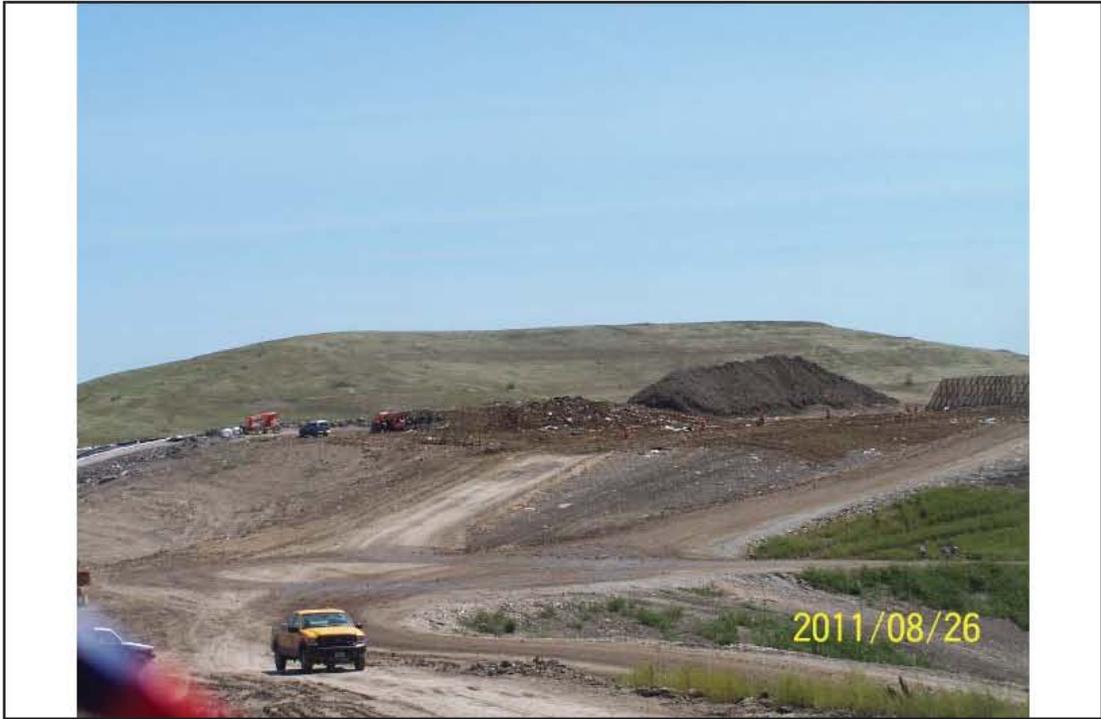
Access to active area

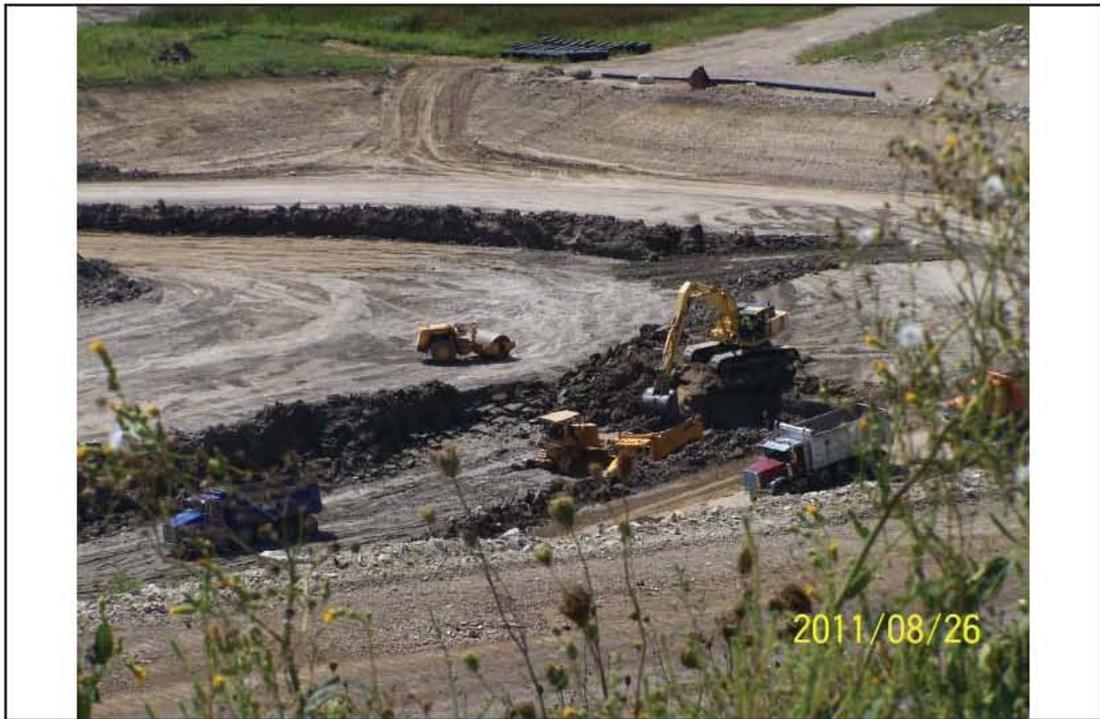
Excavation activities

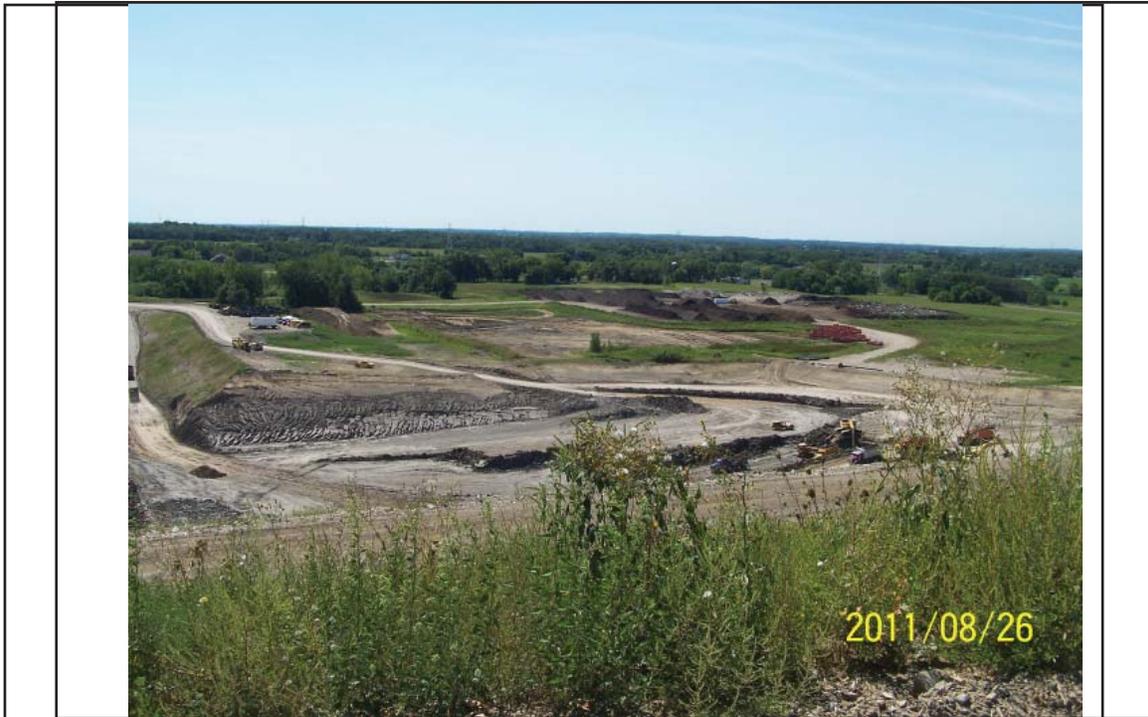
Excavation of Phase 7

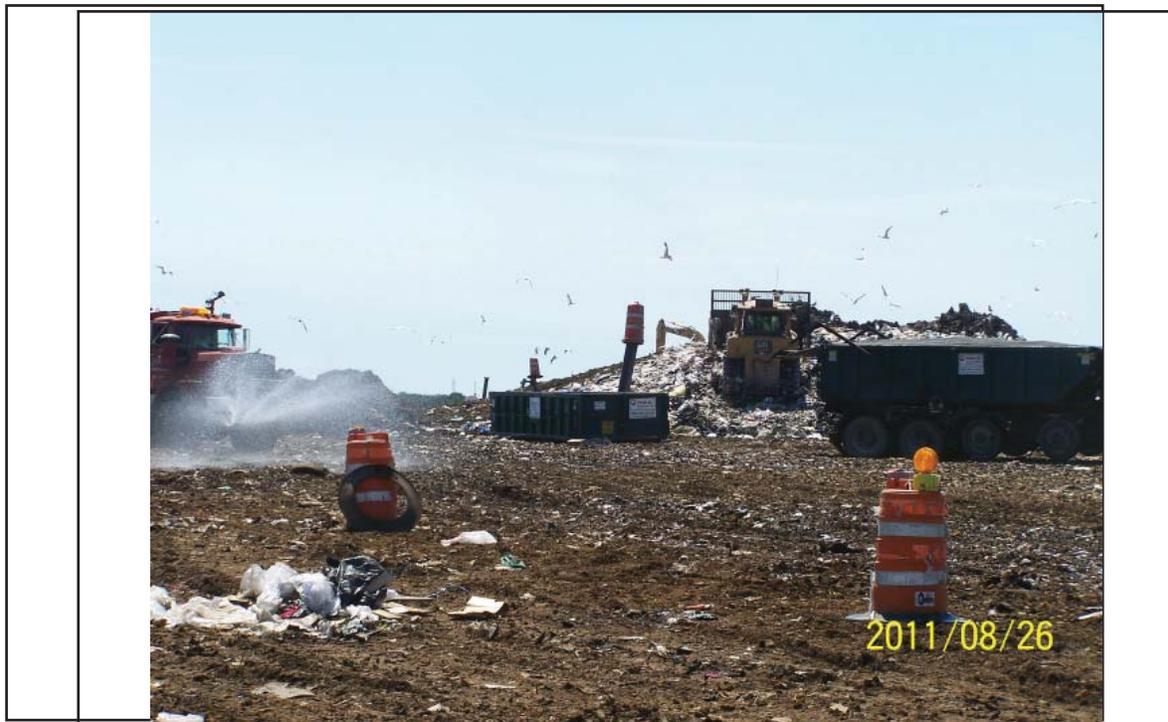
Active area with tire box, all tires tipped will go in the box rather than down slope or covered

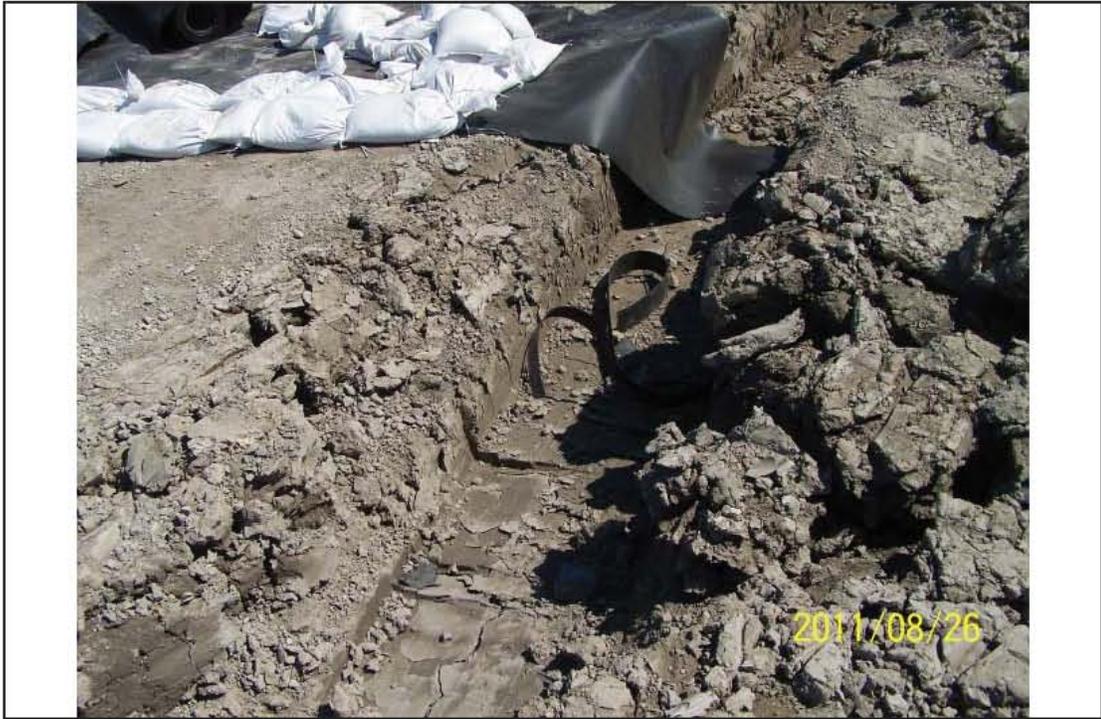
Anchor trench with cap placement

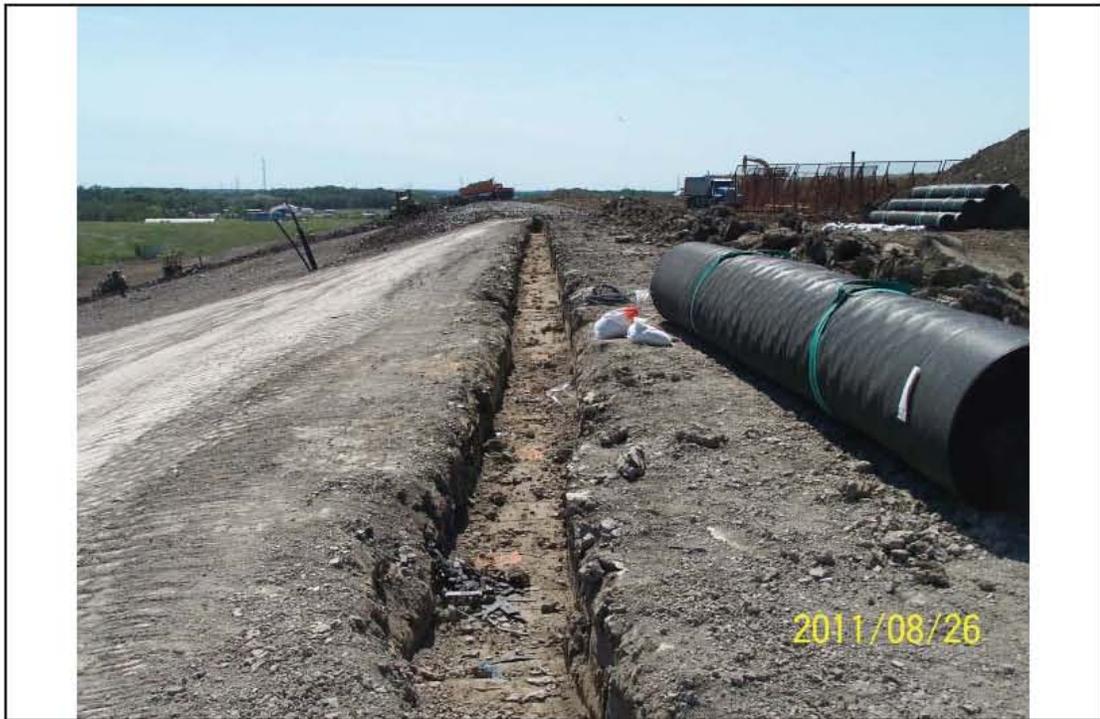
Top of slope anchor trench

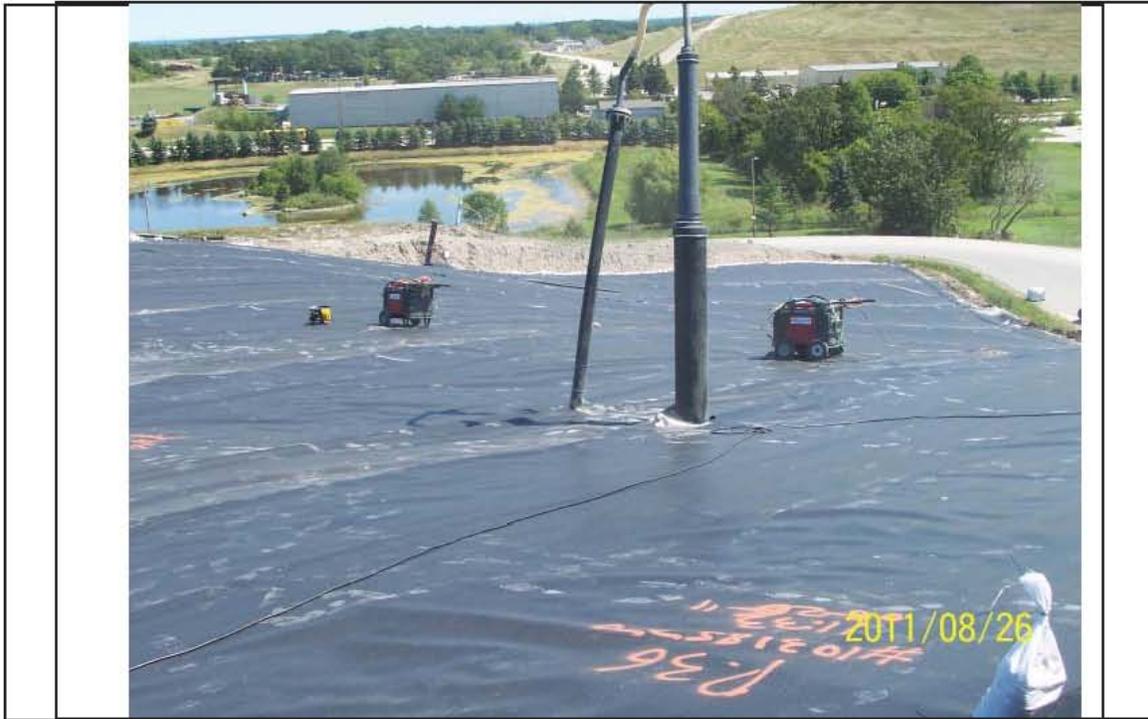
Well penetrations waiting for boots to be sealed

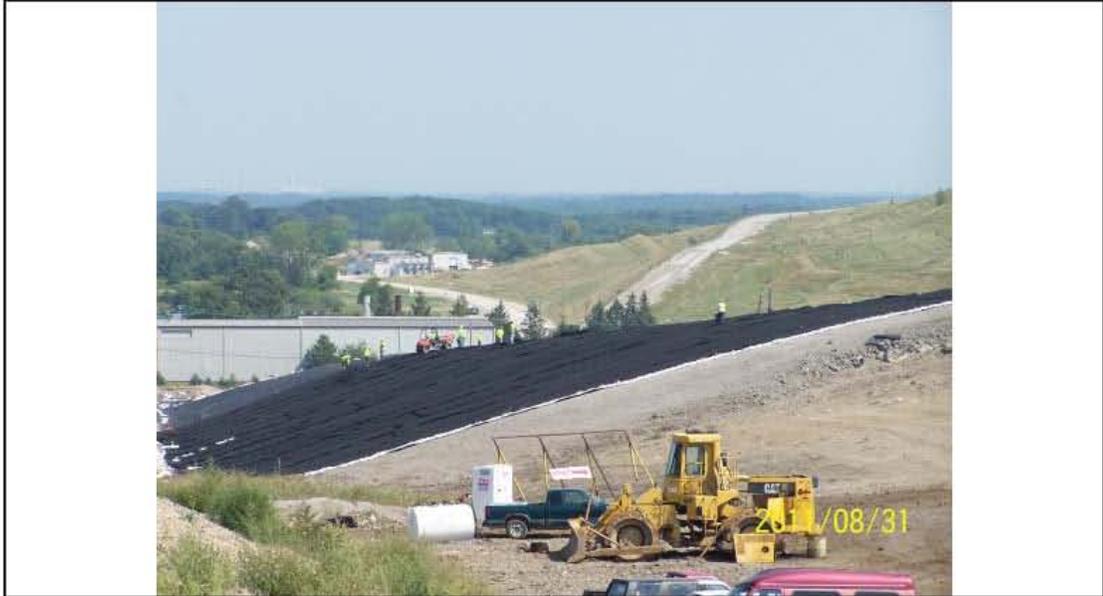
Geocomposite drainage layer placed over LLDPE cap

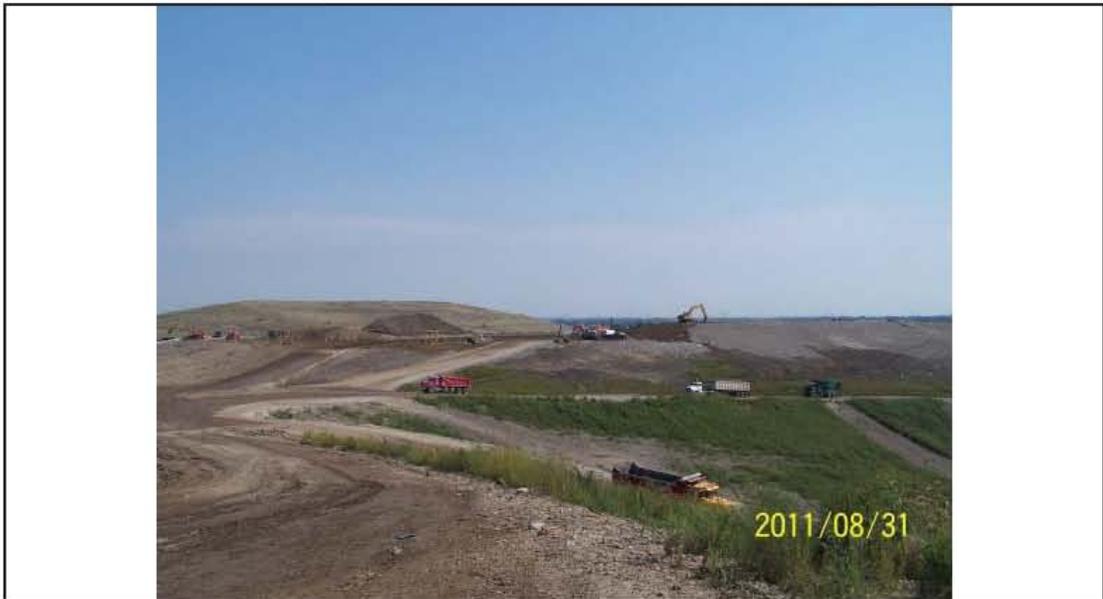
Active Area

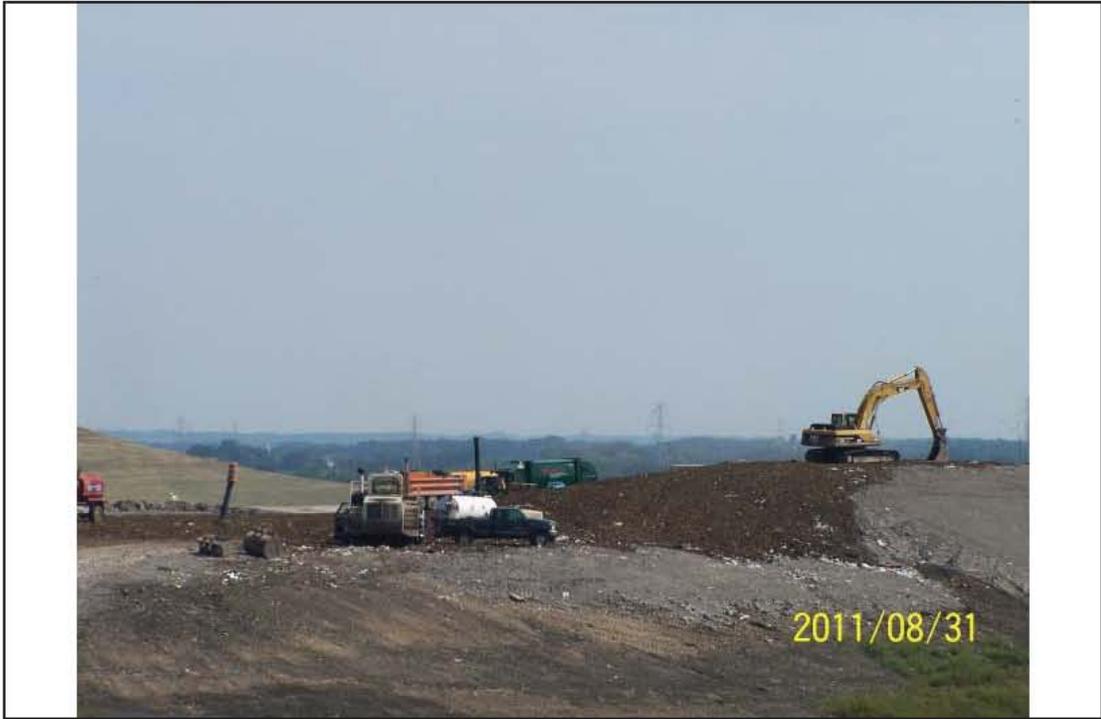
Active area, rough middle of site.

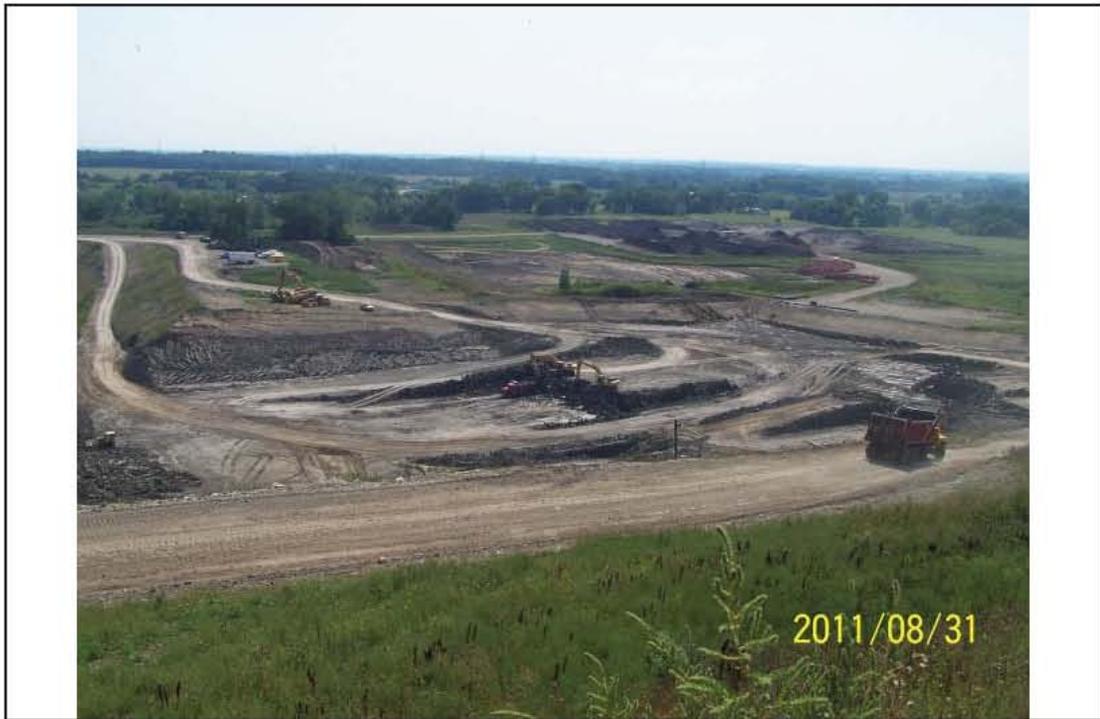
Excavation of Phase 7
